Inspection Photos

Operator: TEP ROCKY MOUNTAIN LLC #96850

Location ID: 323875

Inspection Doc: 718100115

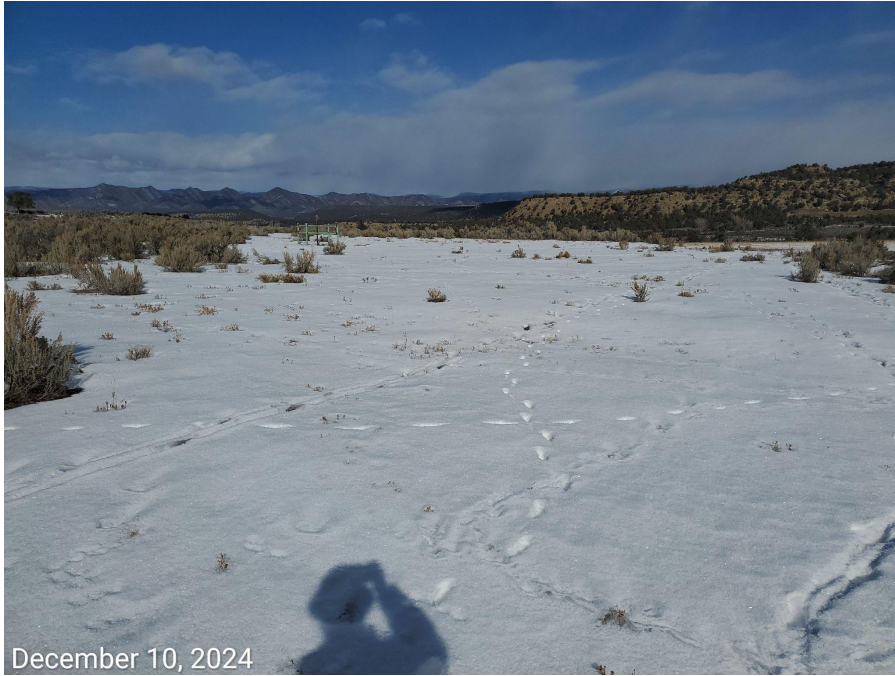
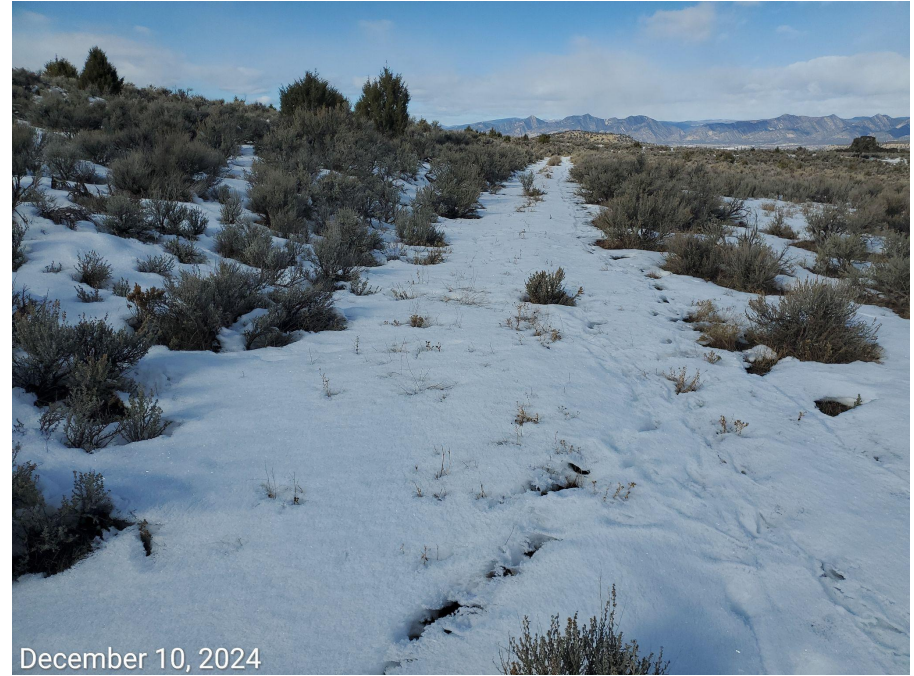
Photo 1: Limited inspection due to snow cover, however, it does not appear as though additional reclamation work has been performed, weed management efforts performed, and BMPs to stabilize the seeded soils implemented; access road has also not been recountured/regraded and reclaimed. Additionally, no Resolution stating corrective actions have been performed or completed has been submitted by the Operator pursuant to Rule 210.b
