Final Reclamation and Stormwater Inspection

Operator: FOUNDATION ENERGY MANAGEMENT LLC - 10113

Location ID: 320019

Well Name: MITCHEM #2-26X

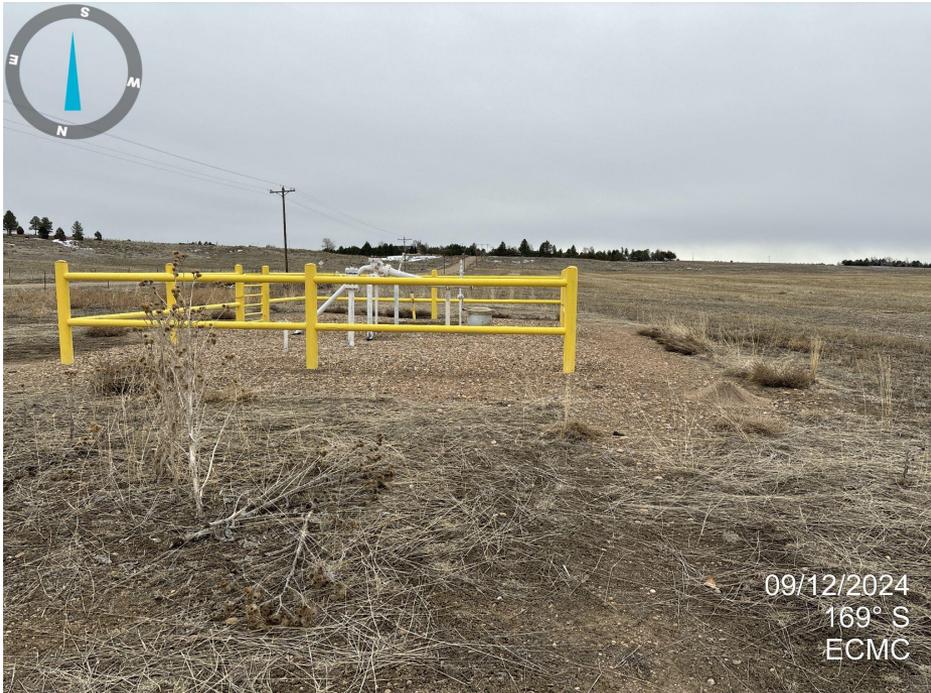
Photo 1. Looking south across former tank battery. It appears pipeline infrastructure is midstream gathering equipment.

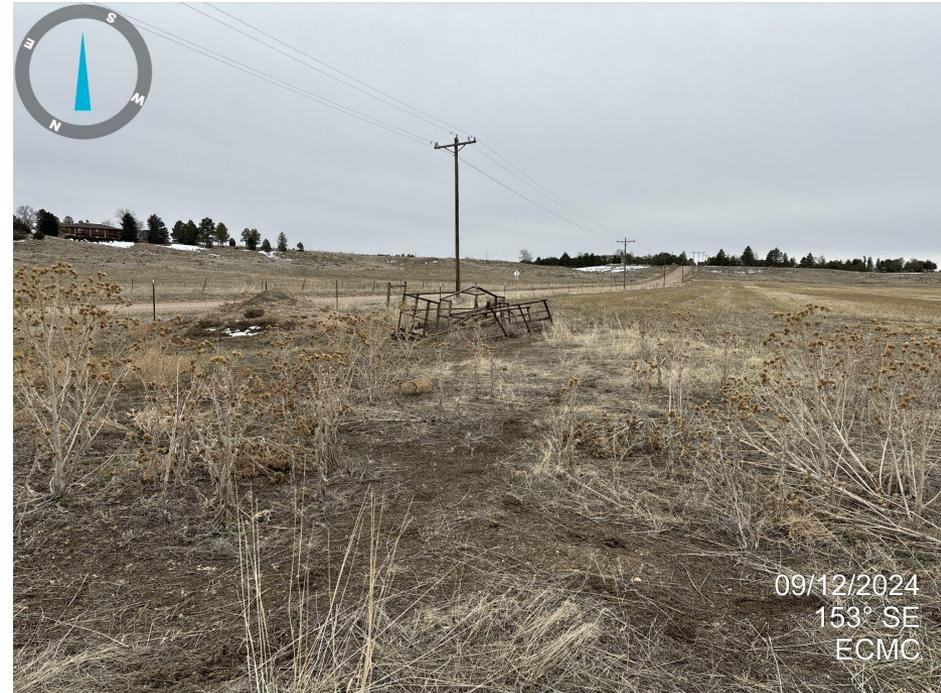
Photo 2. Photo taken looking southeast on the south side of tank battery. Metal debris, soil pile and wooden posts remain on site. Noxious weeds (Musk thistle) and undesirable vegetation (Koshia) are present throughout the site

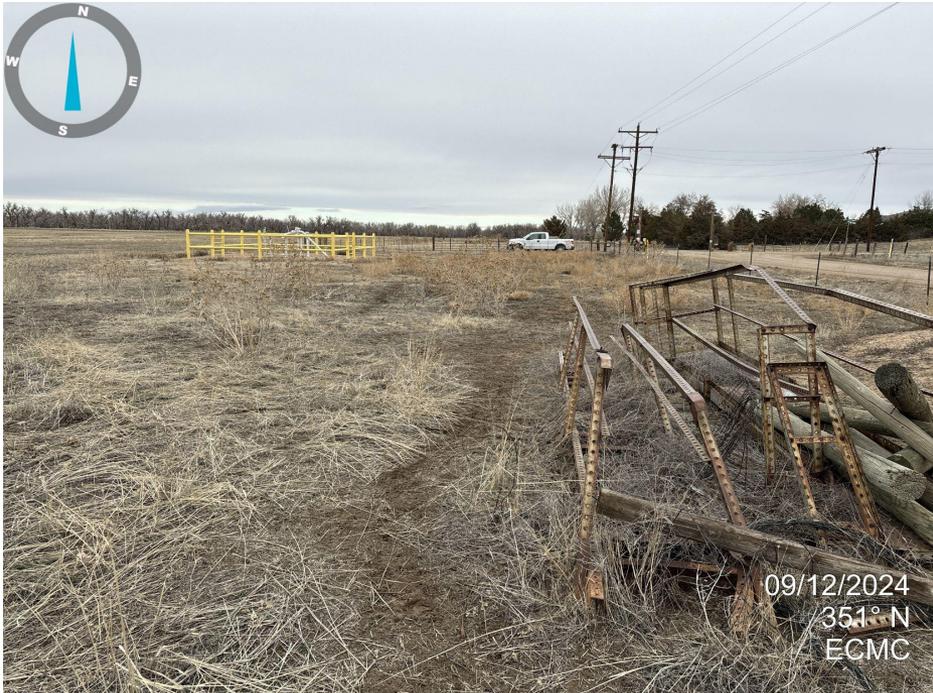
Photo 3. Looking north across tank battery. Tanks and cattle grate have been removed. Equipment and debris remain on site.

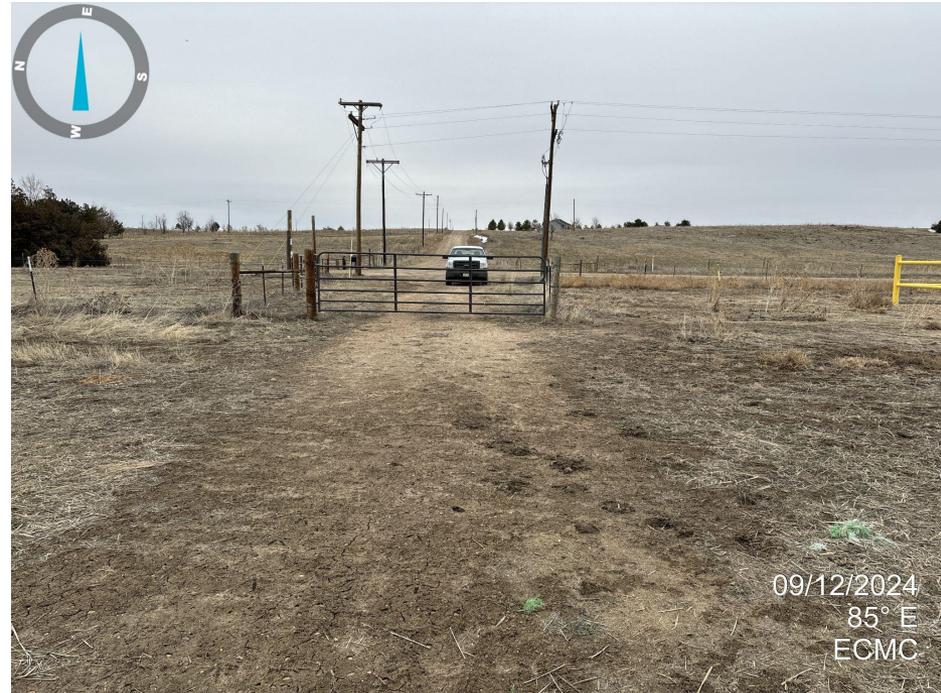
Photo 4. Photo taken looking east at access road entrance. Illustrating bare soil.

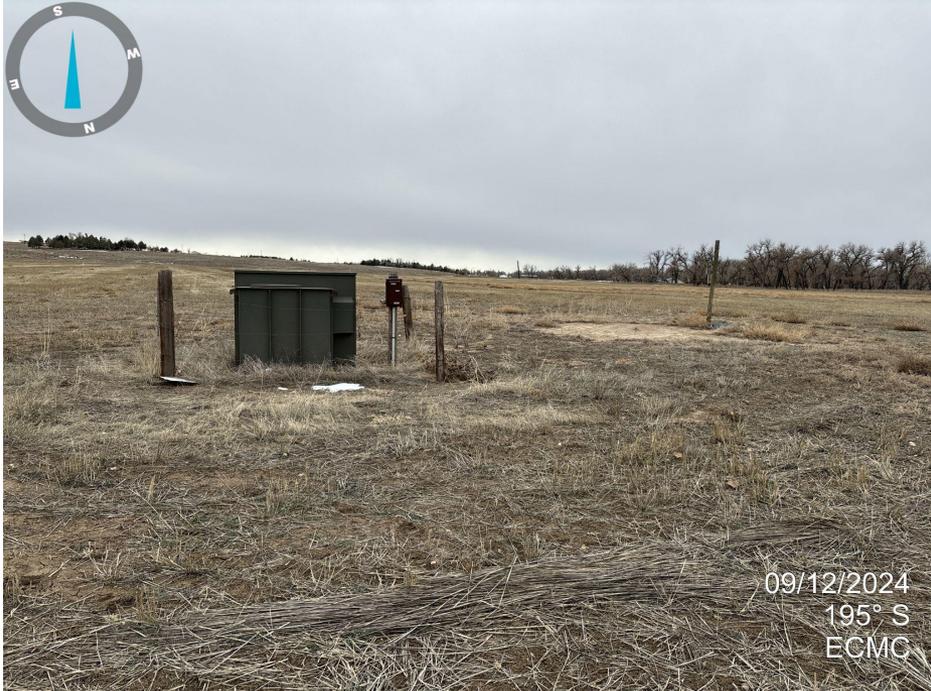
Photo 5. Looking south across well site. Electrical equipment remains on location and site has not been reclaimed.

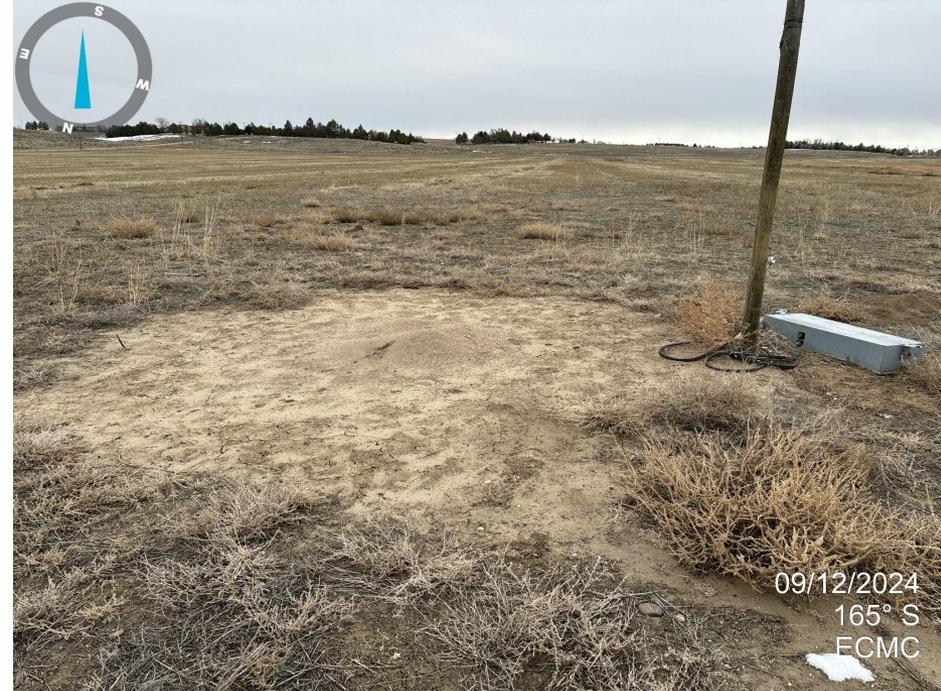
Photo 6. Photo taken looking south from wellsite. Electrical equipment and post on location, bare soil and undesirable weedy vegetation.
