Final Reclamation and Stormwater Inspection

December 18, 2024

Well Name: BBR ABBOTT FARMS #22-34

Inspection Document #: 718600107

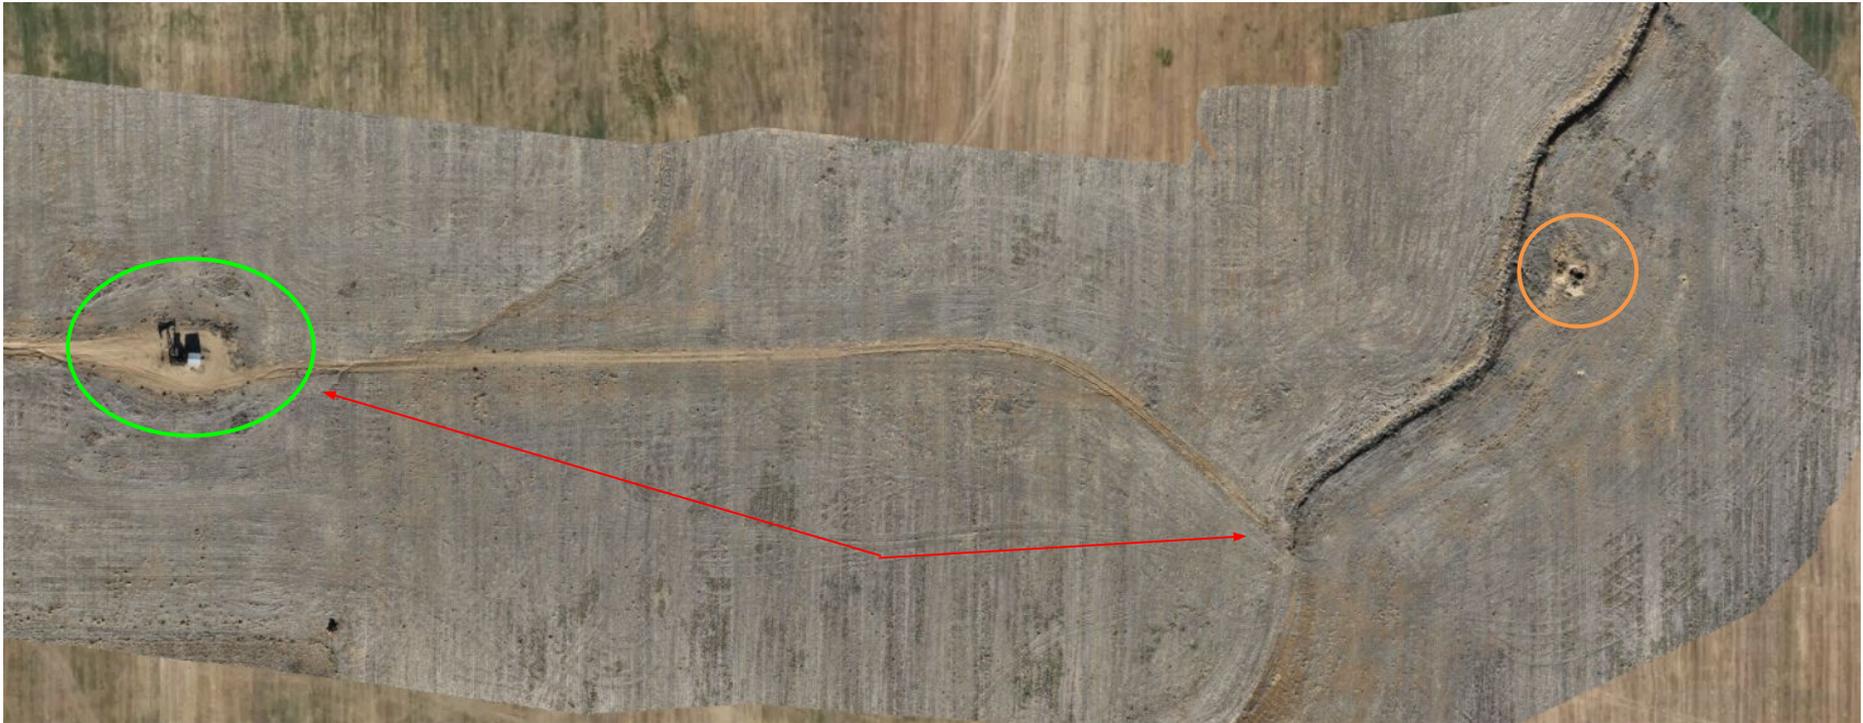
Photo 1. ECMC drone imagery taken on 12/18/2024. Overview of well location (orange) and access road (red arrows). Open excavation is present at wellsite, access road has not been reclaimed. Green circle = the active Doris #12-34 well (API # 123-10420).

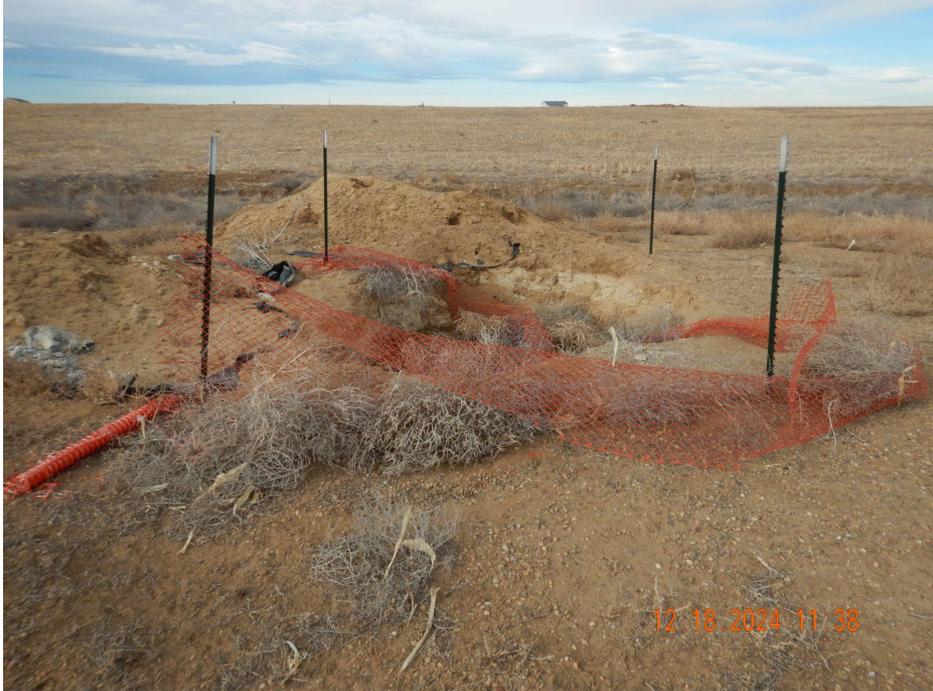
Photo 2. Looking across the wellsite. Well appears to be plugged and abandoned. Open excavation with improperly installed fences.

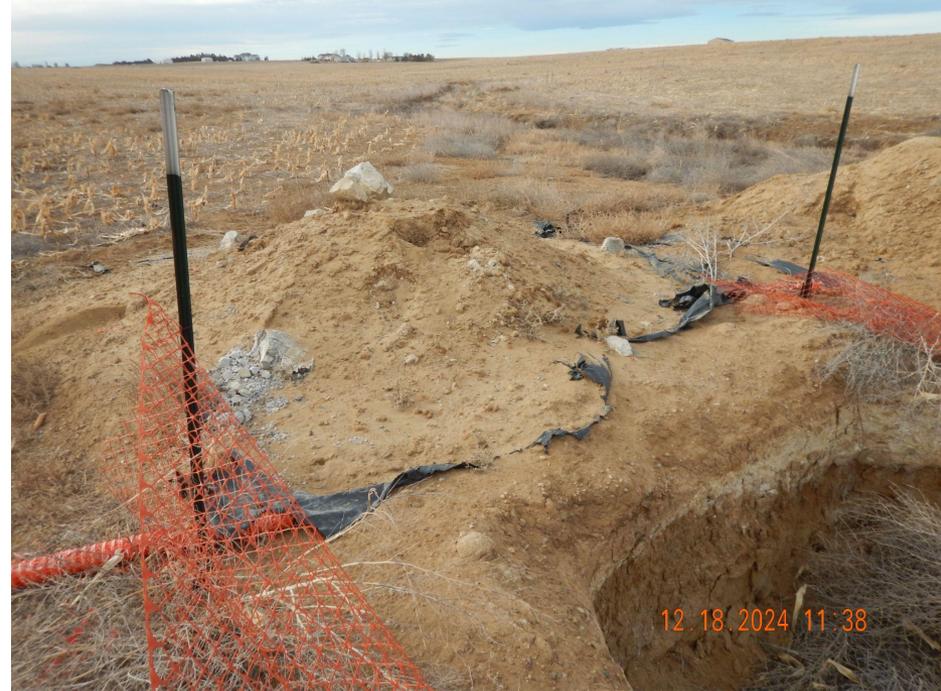
Photo 3. Soil has been placed on liners without proper stormwater BMPs. Concrete debris and trash are present.

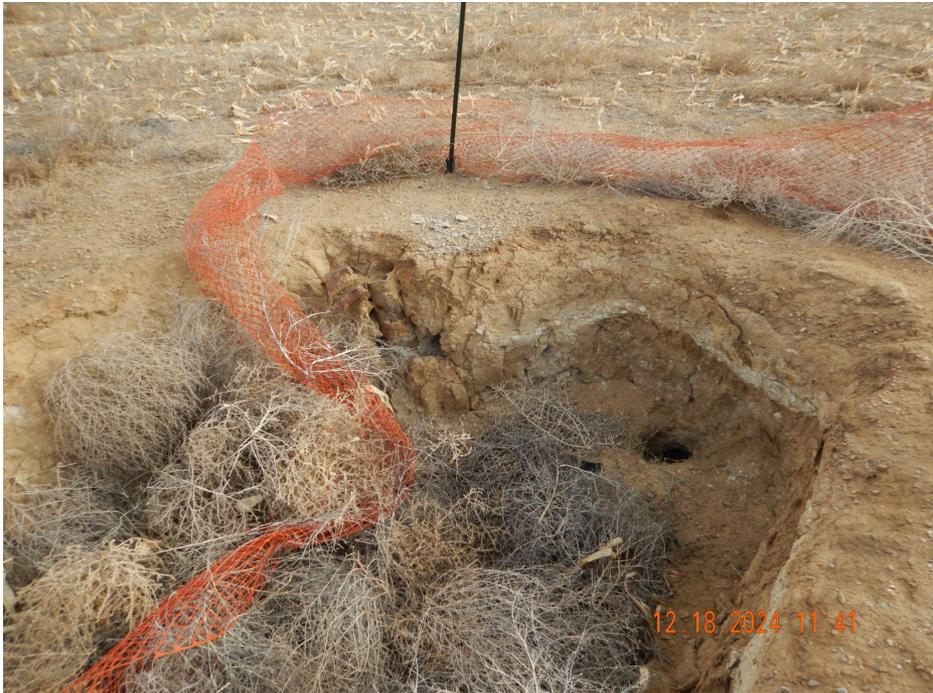
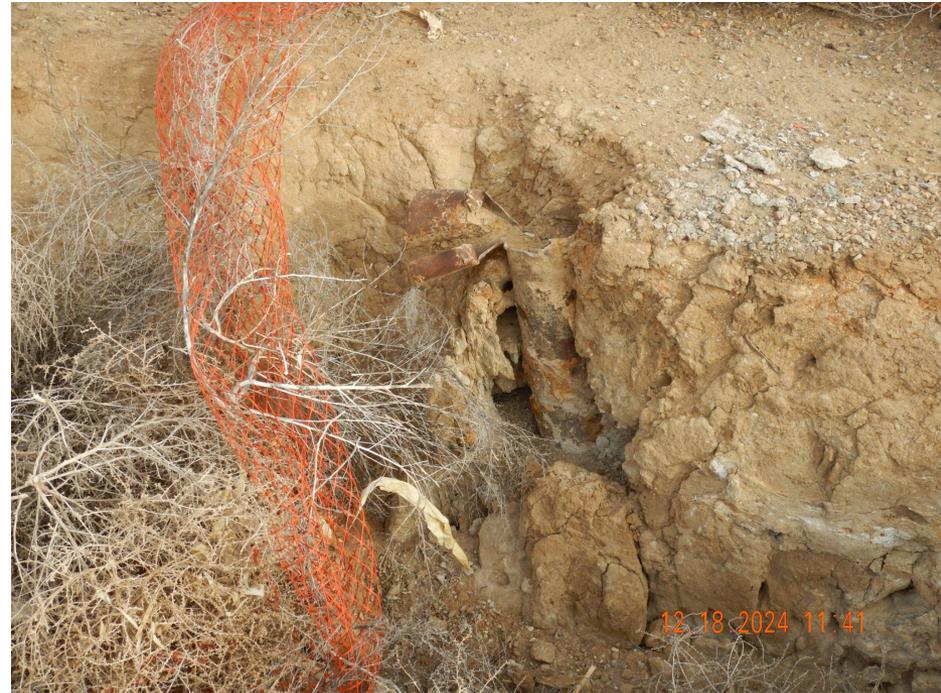
Photo 4. Debris (tumbleweed) is present within the excavation. Metal pipe, possibly the well head is visible.

Photo 5. See photo 4 comments.

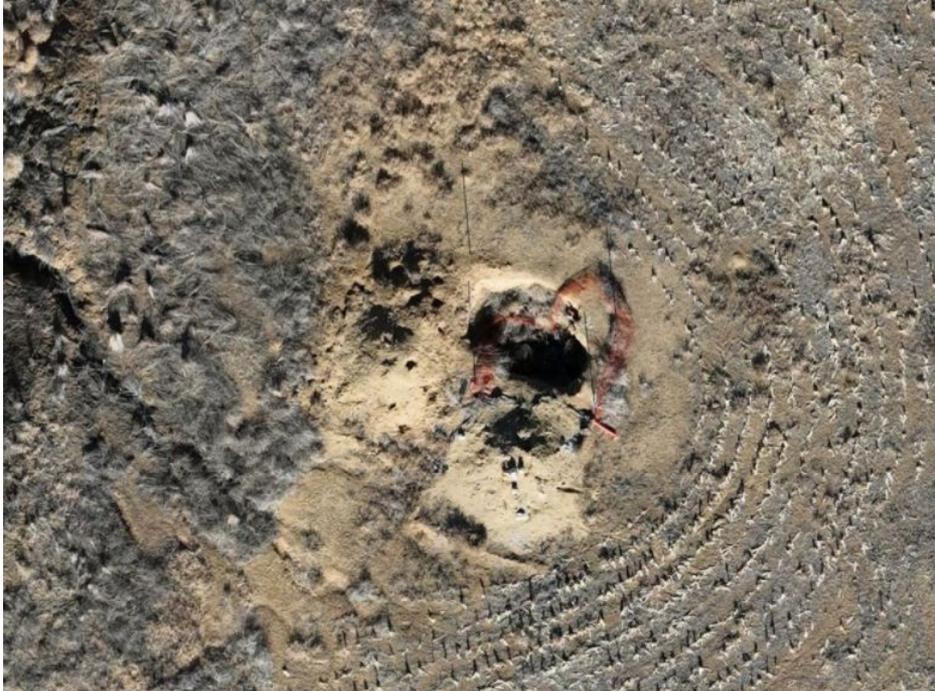
Photo 6. ECMC drone photo taken 12/18/2024 of wellsite.

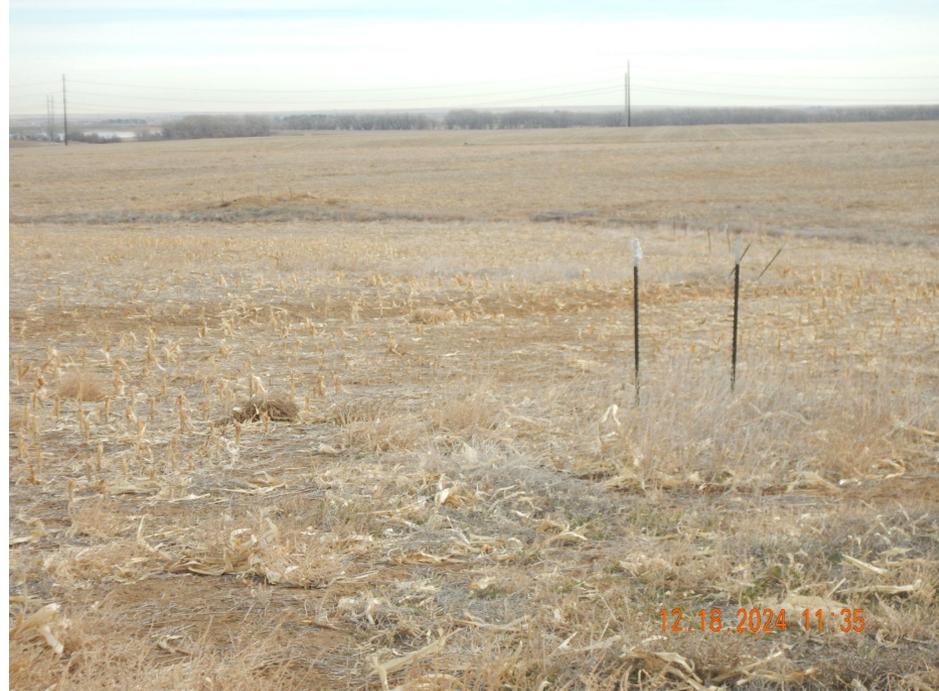
Photo 7. T-posts possibly indicating location of buried flowline. Flowline abandonment verification has not been submitted.
