REPORT OF WORK COMPLETION (ROWC)

**L3E Condensate Release
QB Energy Operating, LLC
Garfield County, Colorado
Remediation Project Number : NA**

December 26, 2024
Ensolum Project No. 09D2436025

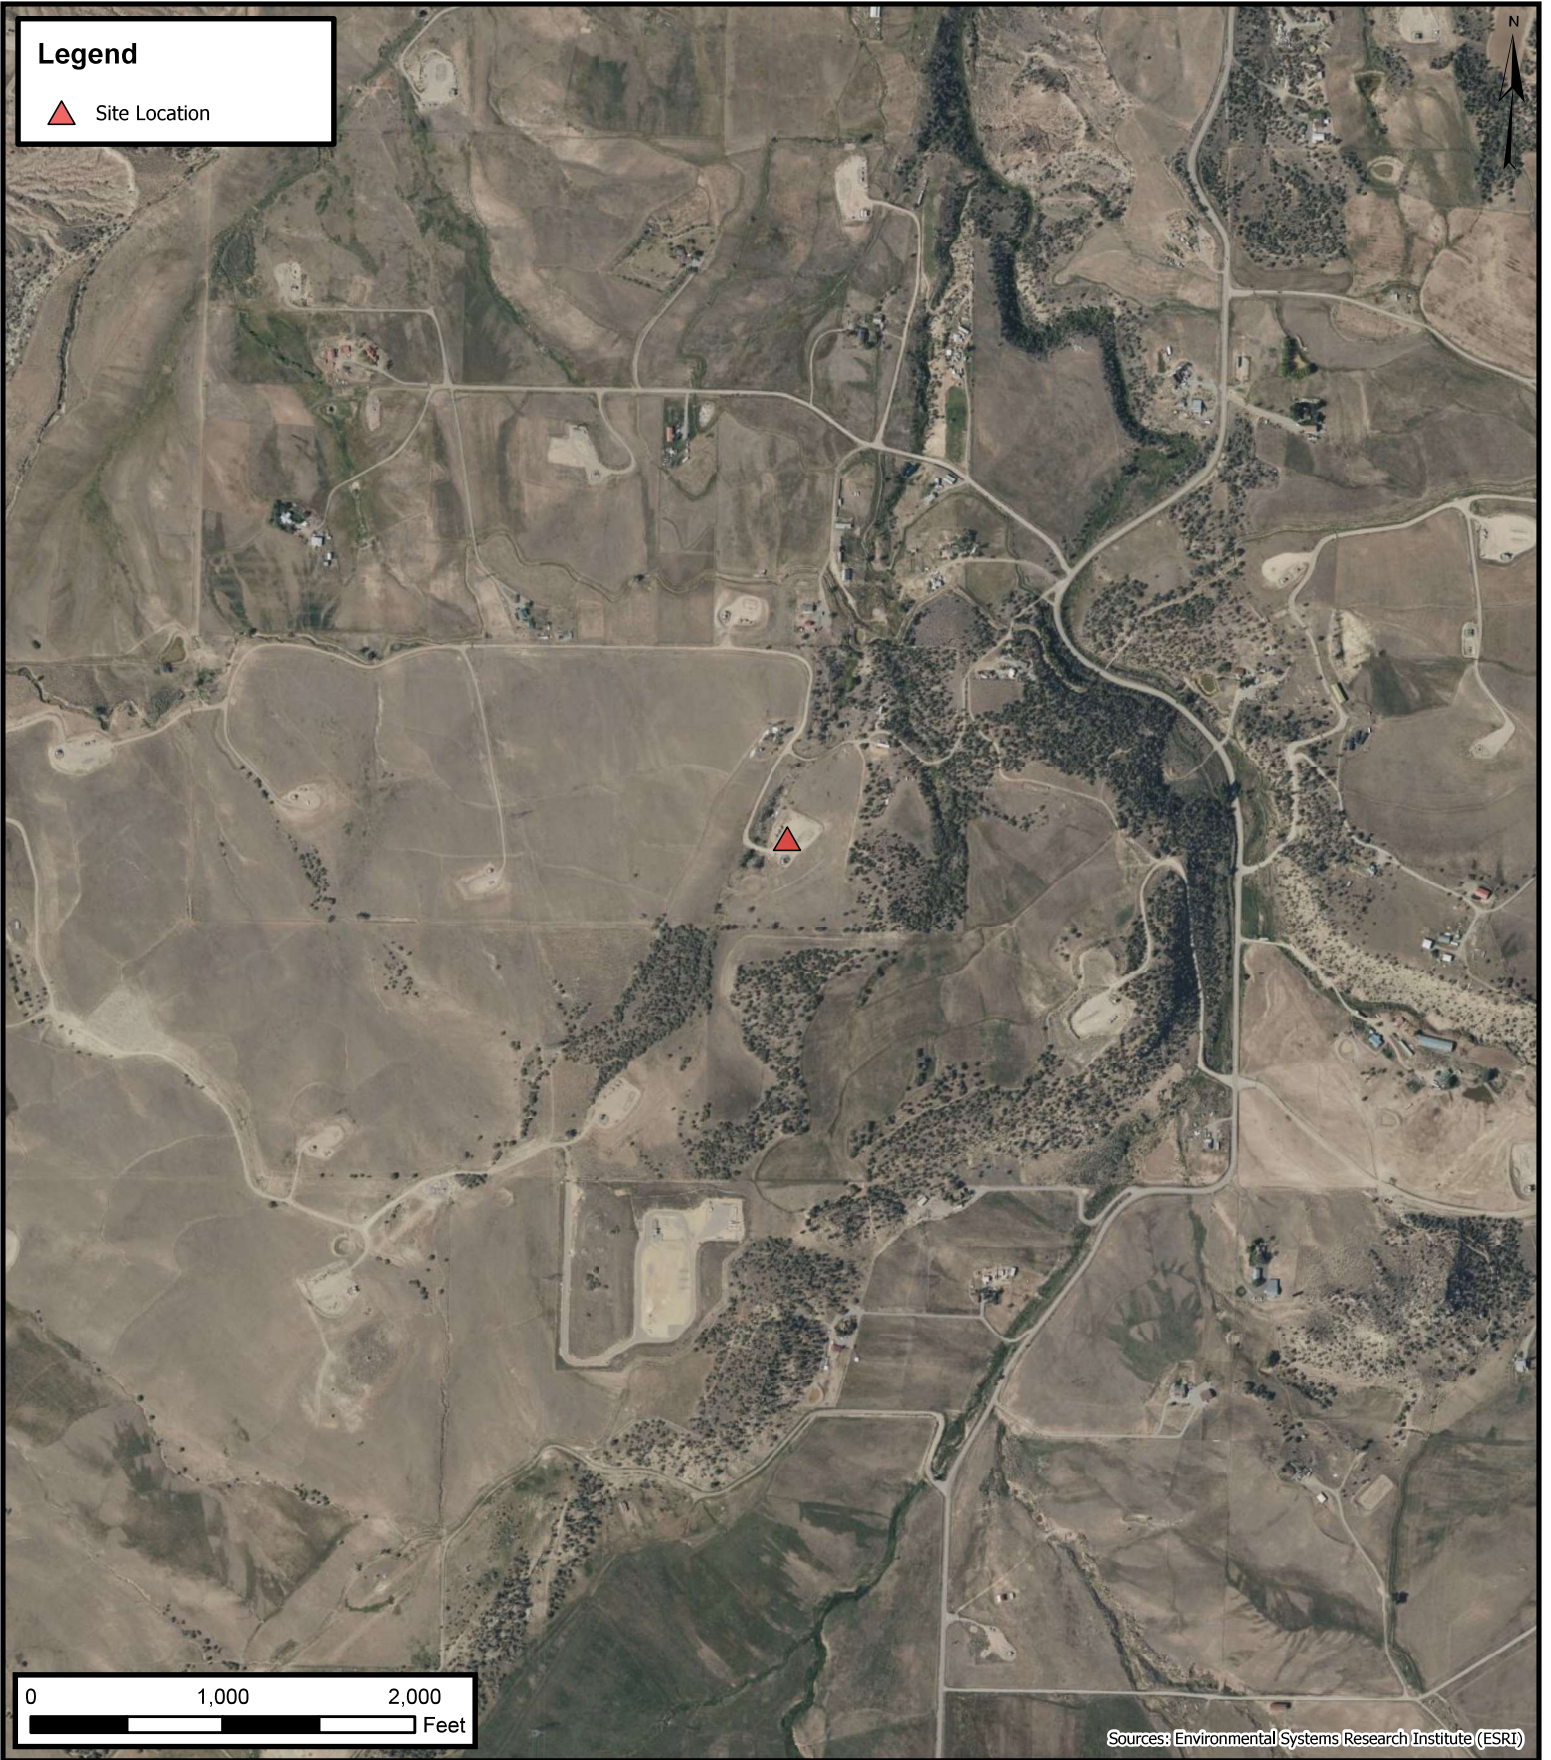
FIGURE
2

Site Vicinity Map

L3E-(POR)@0.5

MCBG-(L3E-S)

MCBG-(L3E-E)

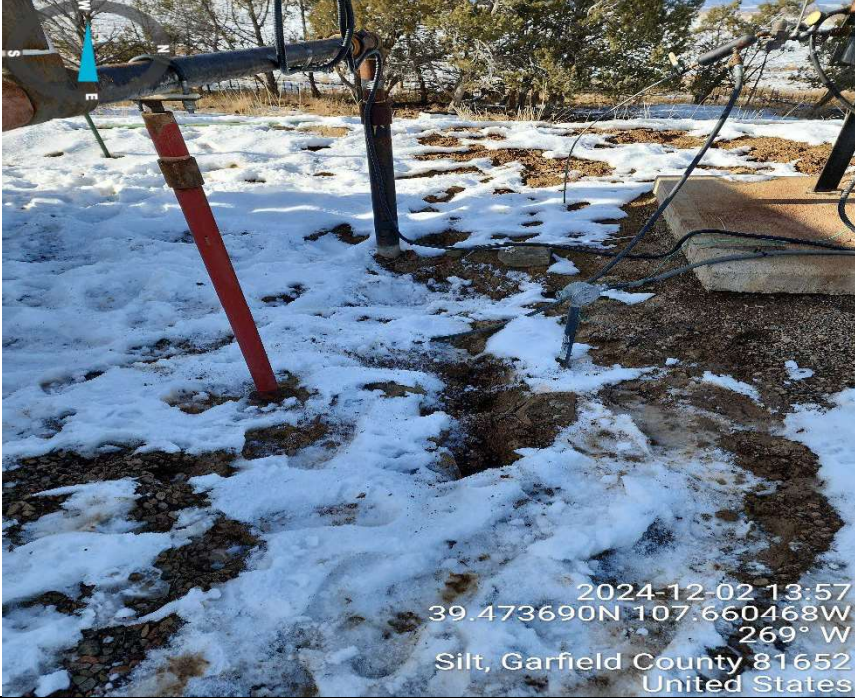
PHOTOGRAPHIC LOG		
QB Energy, LLC	L3E Garfield County, Colorado	Sample ID: L3E-(POR)@0.5
Date: 12/02/2024	Photo No. 1	Coordinates Lat/Long: 39.473698, -107.660532

<p>2024-12-02 13:57 39.473690N 107.660468W 269° W Silt, Garfield County 81652 United States</p>		
View facing west at POR.

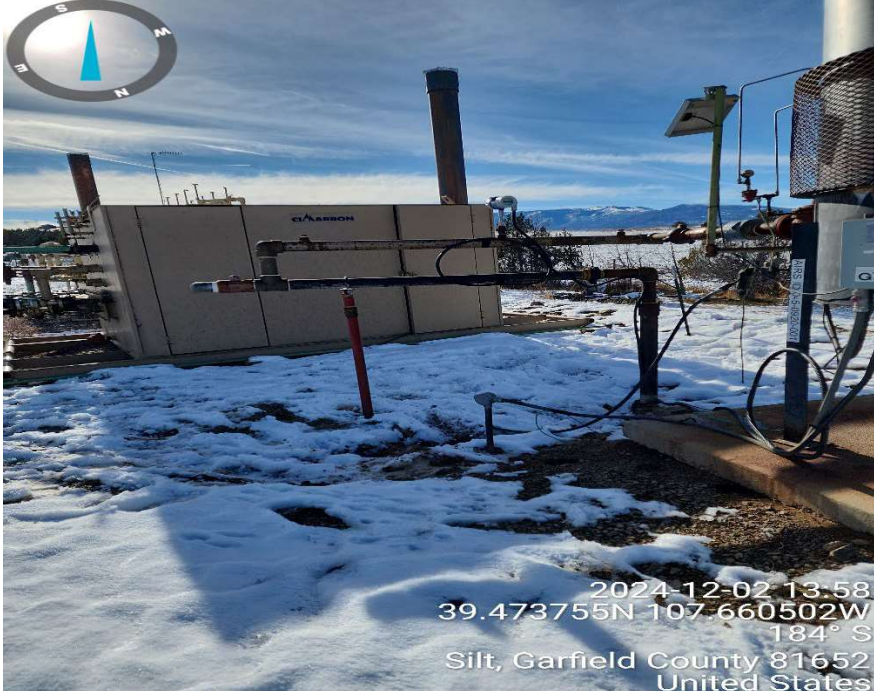
PHOTOGRAPHIC LOG		
QB Energy, LLC	L3E Garfield County, Colorado	Sample ID: L3E-(POR)@0.5
Date: 12/02/2024	Photo No. 2	Coordinates Lat/Long: 39.473698, -107.660532

<p>2024-12-02 13:58 39.473755N 107.660502W 184° S Silt, Garfield County 81652 United States</p>		
View facing south at the POR.

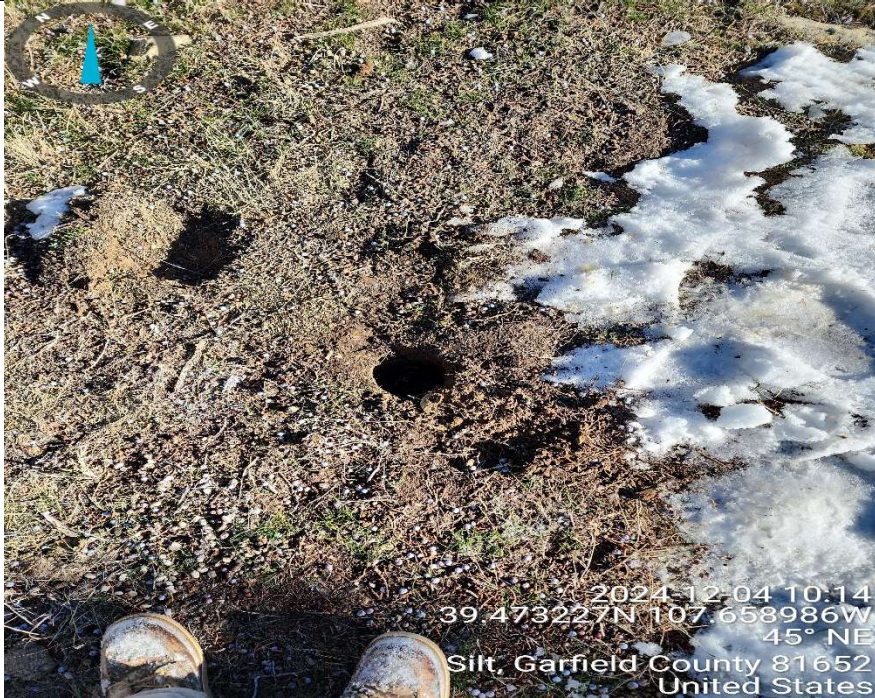
QB Energy, LLC	L3E Garfield County, Colorado	Sample ID: MCBG-(L3E-E)
Date: 12/04/2024	Photo No. 3	Coordinates Lat/Long: 39.473698, -107.660532

View facing northeast at MCBG-(L3E-E).

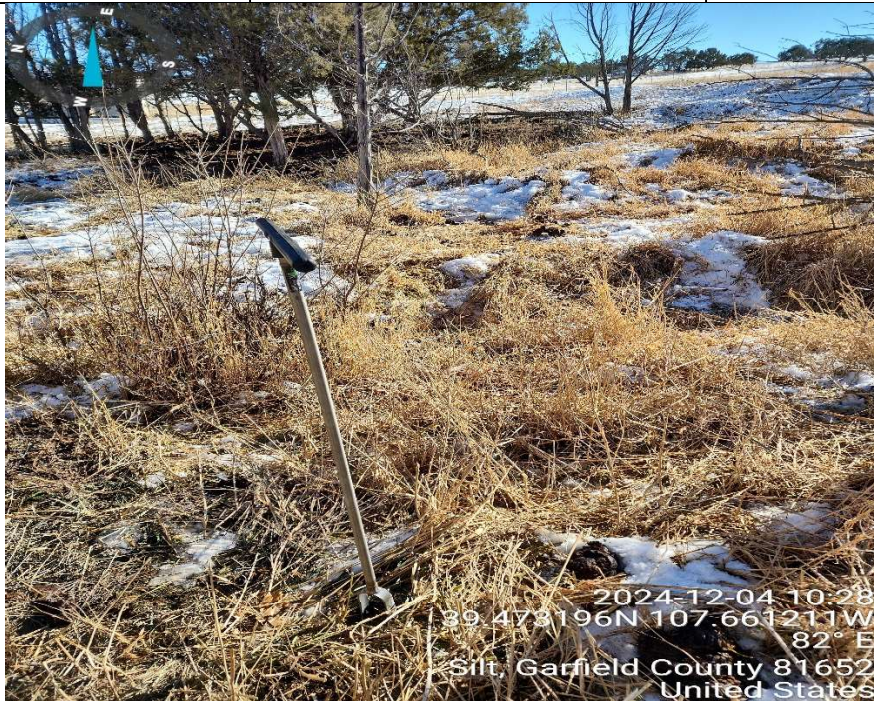
QB Energy, LLC	L3E Garfield County, Colorado	Sample ID: MCBG-(L3E-S)
Date: 12/04/2024	Photo No. 2	Coordinates Lat/Long: 39.473698, -107.660532

View facing east at the MCBG-(L3E-S).
