Final Reclamation and Stormwater Inspection

Location ID: 322212

Well Name: CANYON ENERGY STATE ALBERTA #36-34

Inspection Document #: 718600094

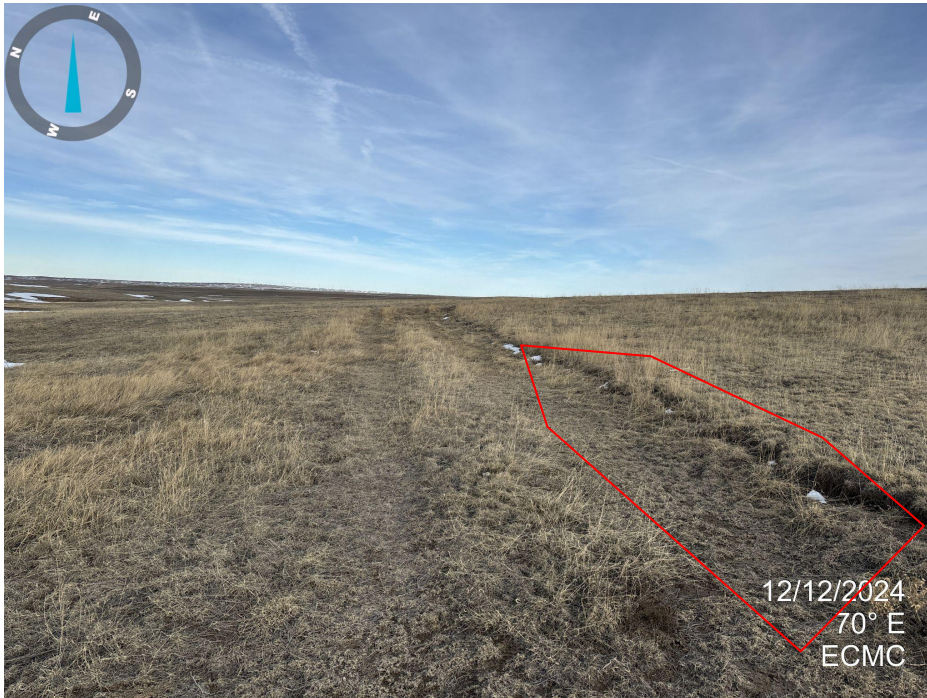
Photo 1. Photo taken Looking east along access road. Desirable vegetation coverage is progressing. Isolated areas may need recontouring or topsoil filling.

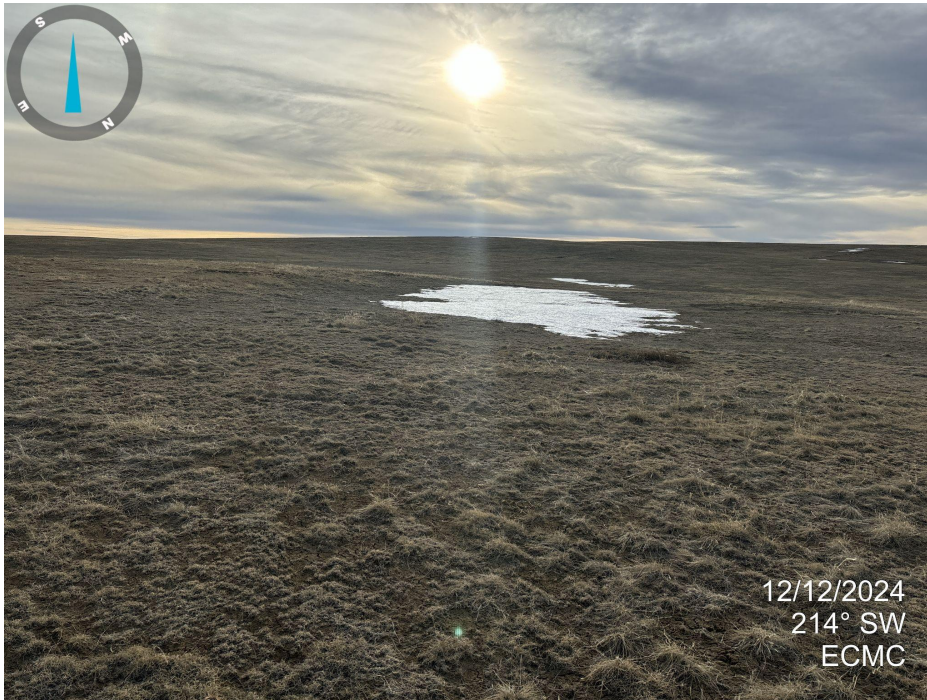
Photo 3. Picture taken from north of the site looking across to the southwest. No oil and gas equipment remains on site.

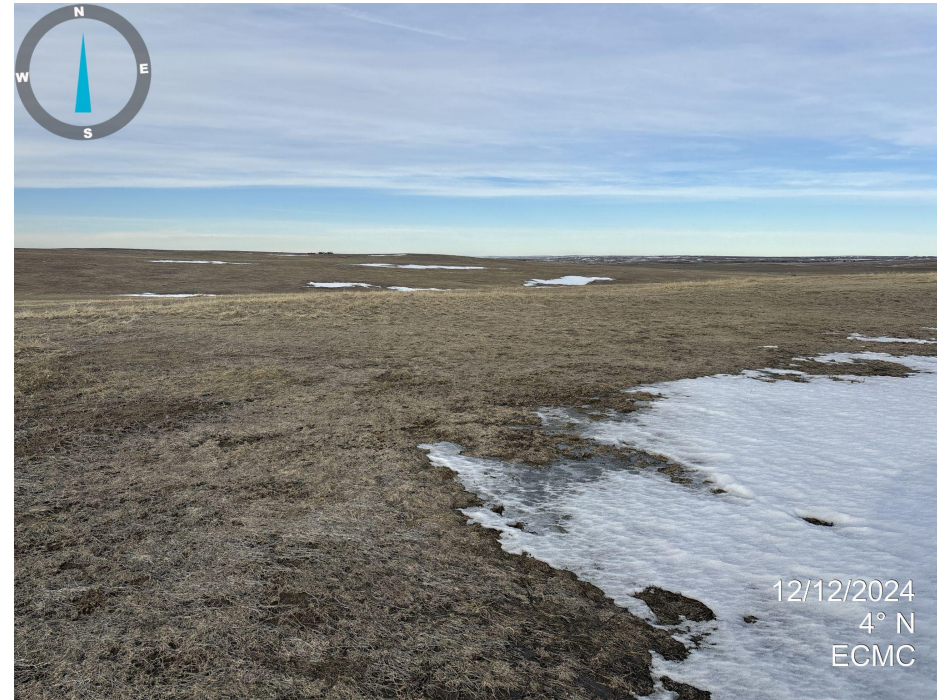
Photo 4. Photo taken from well site looking north. It appears desirable perennial plant species have begun to establish on the site.

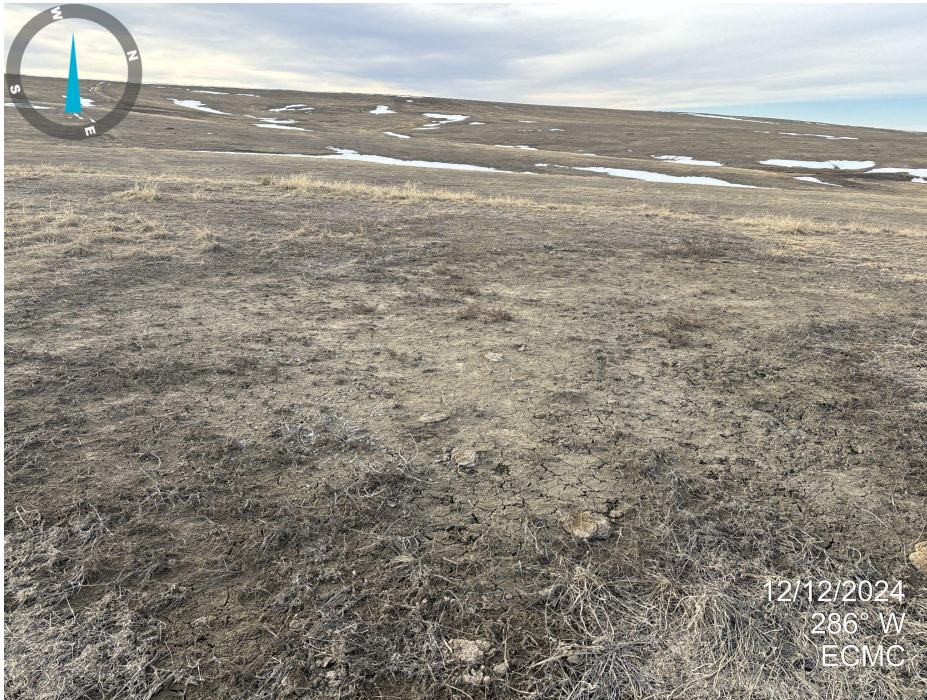
Photo 5. Picture taken from wellsite looking west over wellhead area. Illustrates an area of bare soil and weedy annual vegetation (Kochia). This area may need additional reclamation such as reseeding.

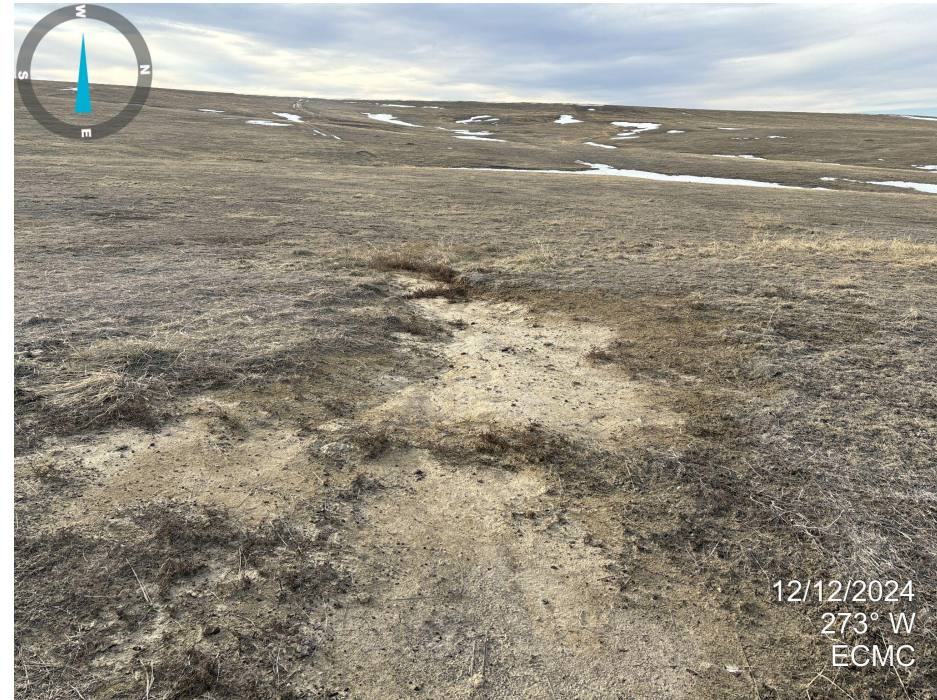
Photo 6. Photo taken on southwest side of location looking west. Area may need soil stabilization and further reclamation.
