# Inspection Photos

Operator: Simcoe LLC - 10749

Location ID: 325535

Inspection Photos  
Location Name: Couch 01-16U 1  
Location ID: 325535

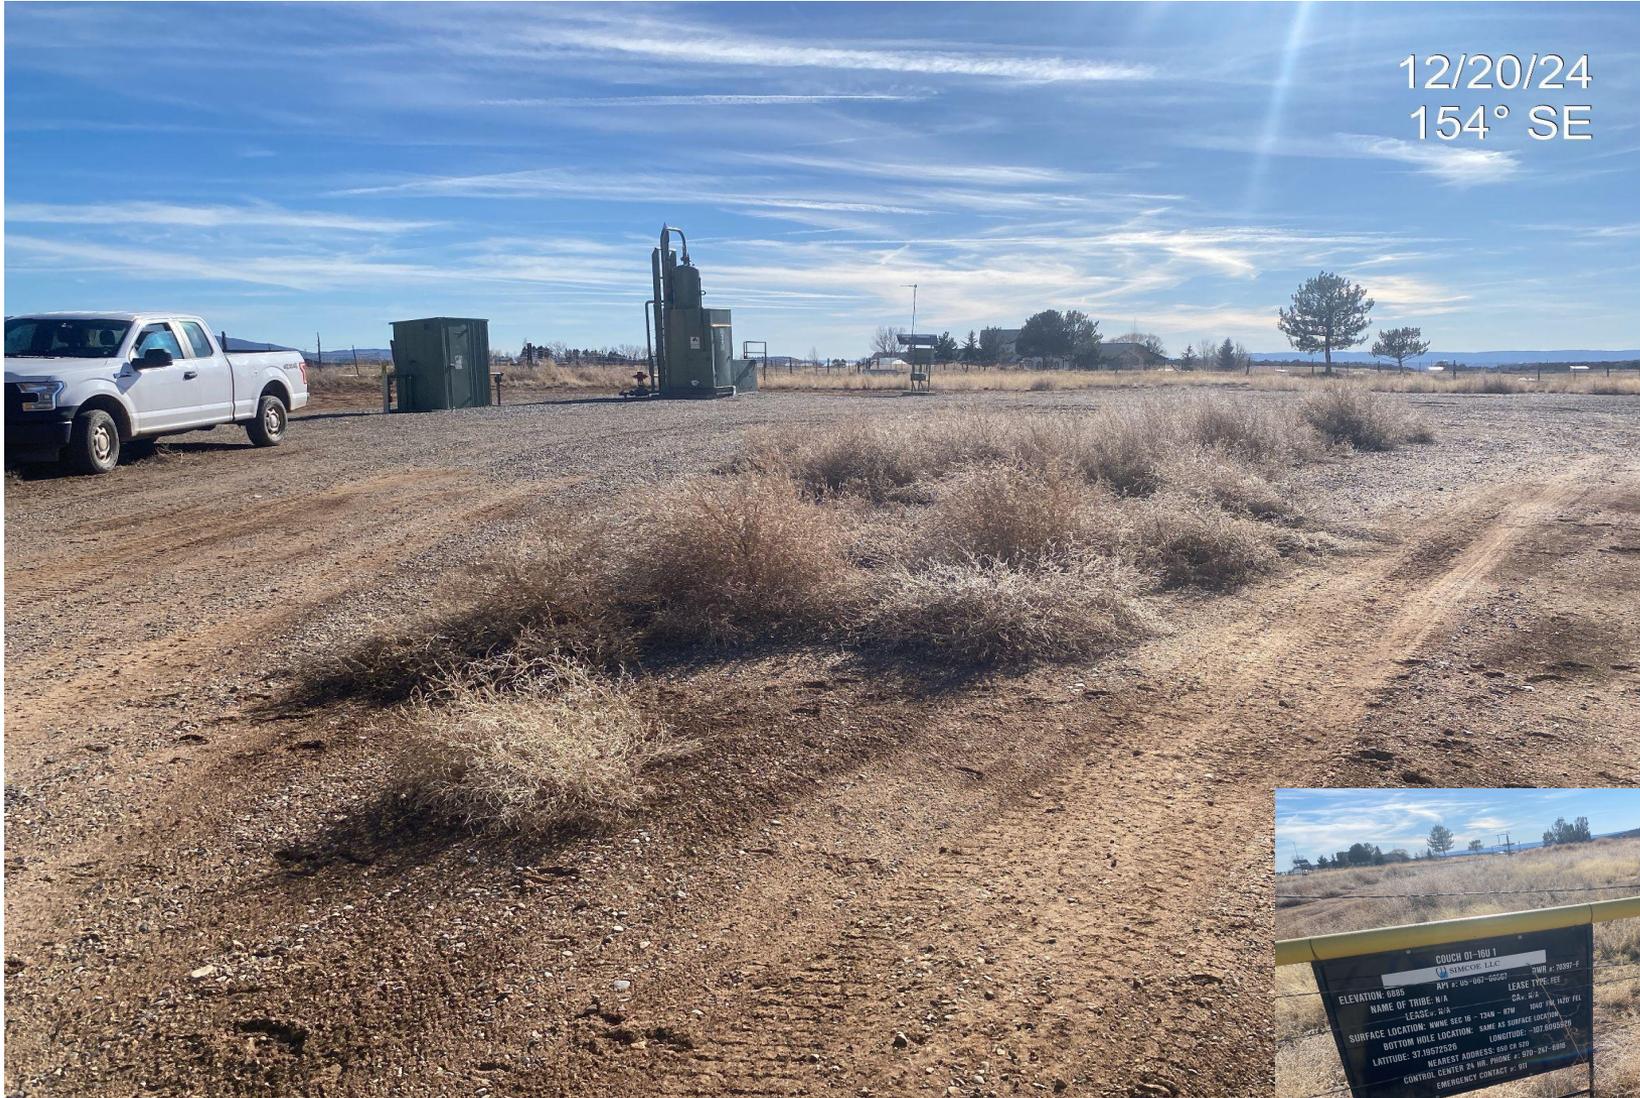
Photo 1. View of well pad taken from the access point facing center.

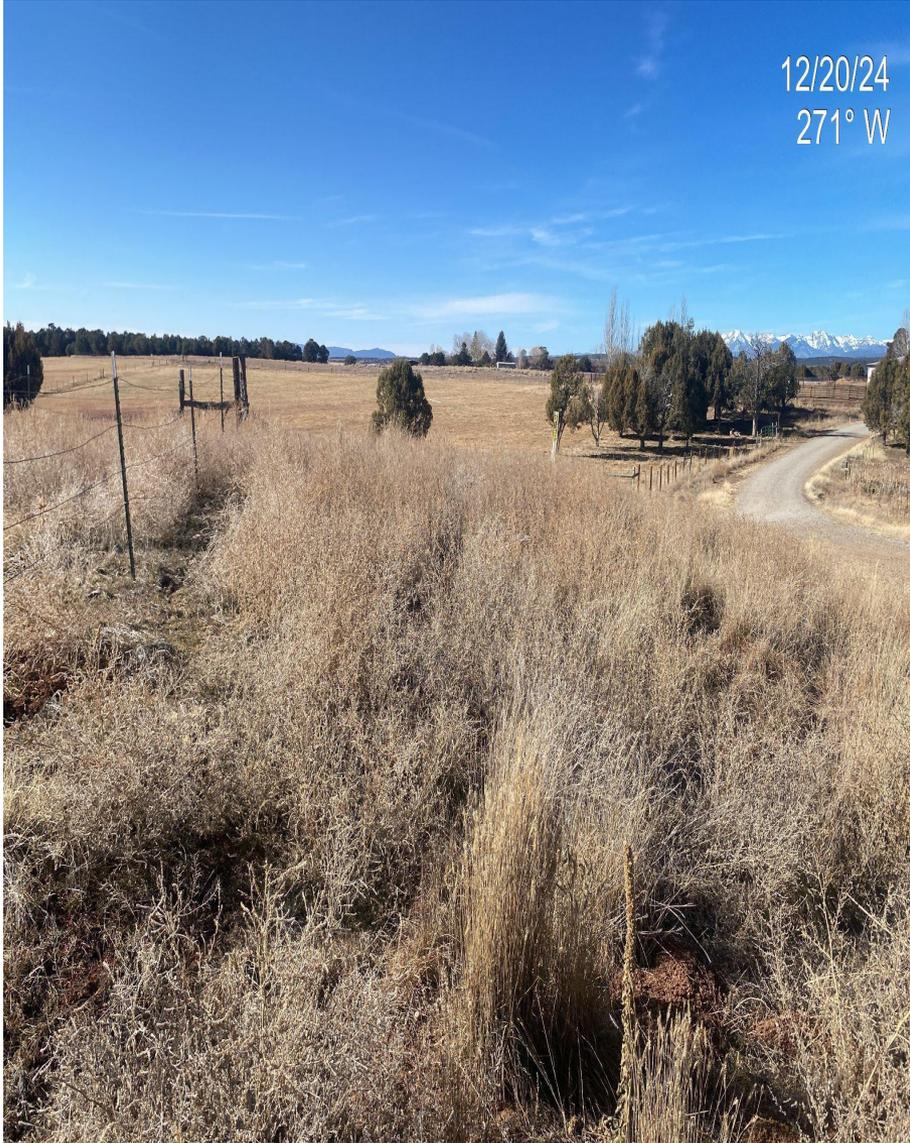
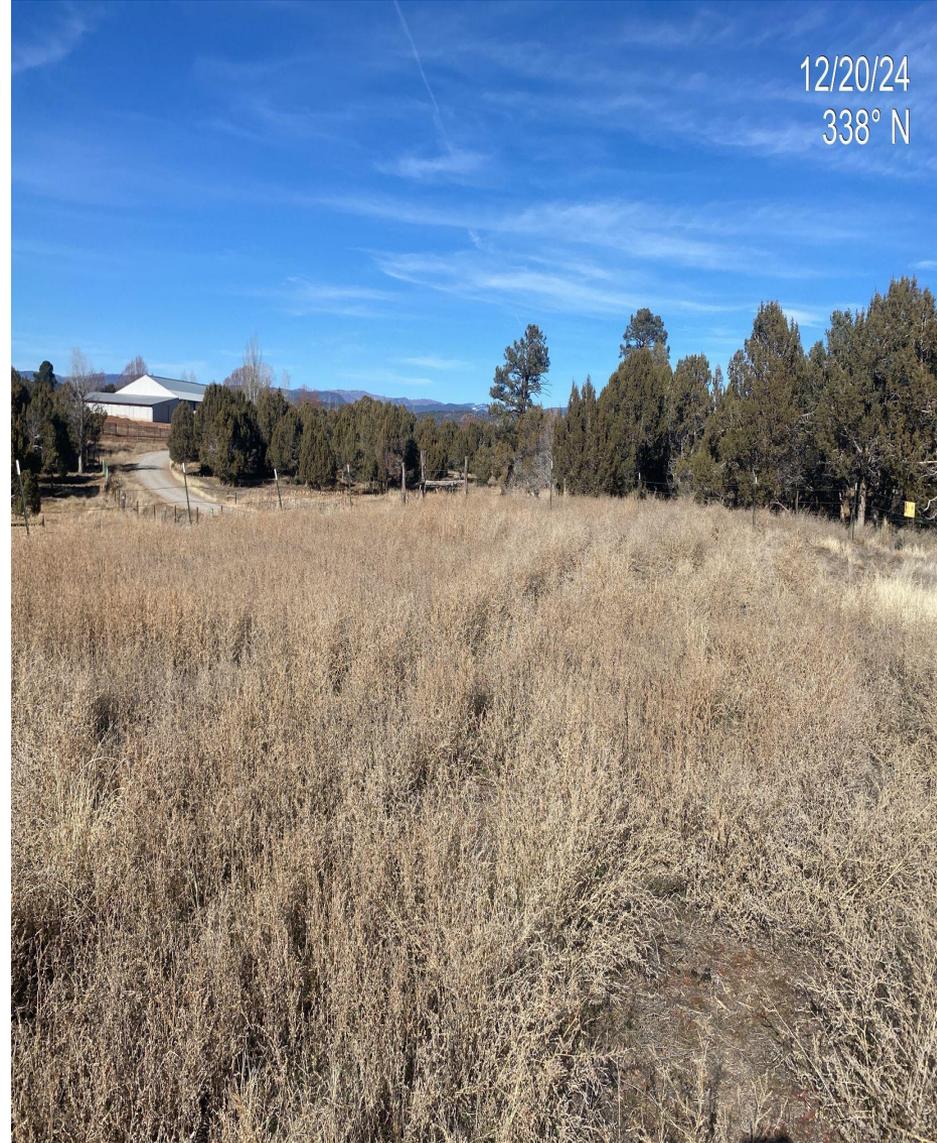
**Photo 2.** Weedy kochia debris observed dominating interim reclamation areas and interfering with establishment of desirable vegetation. Treatment efforts for jointed goatgrass that was previously observed appear successful.
