Final Reclamation and Stormwater Inspection

Operator: STELBAR OIL CORP INC - 82470

Location ID: 317155

Inspection Photos
Location Name: State B #1
Location ID: 317155

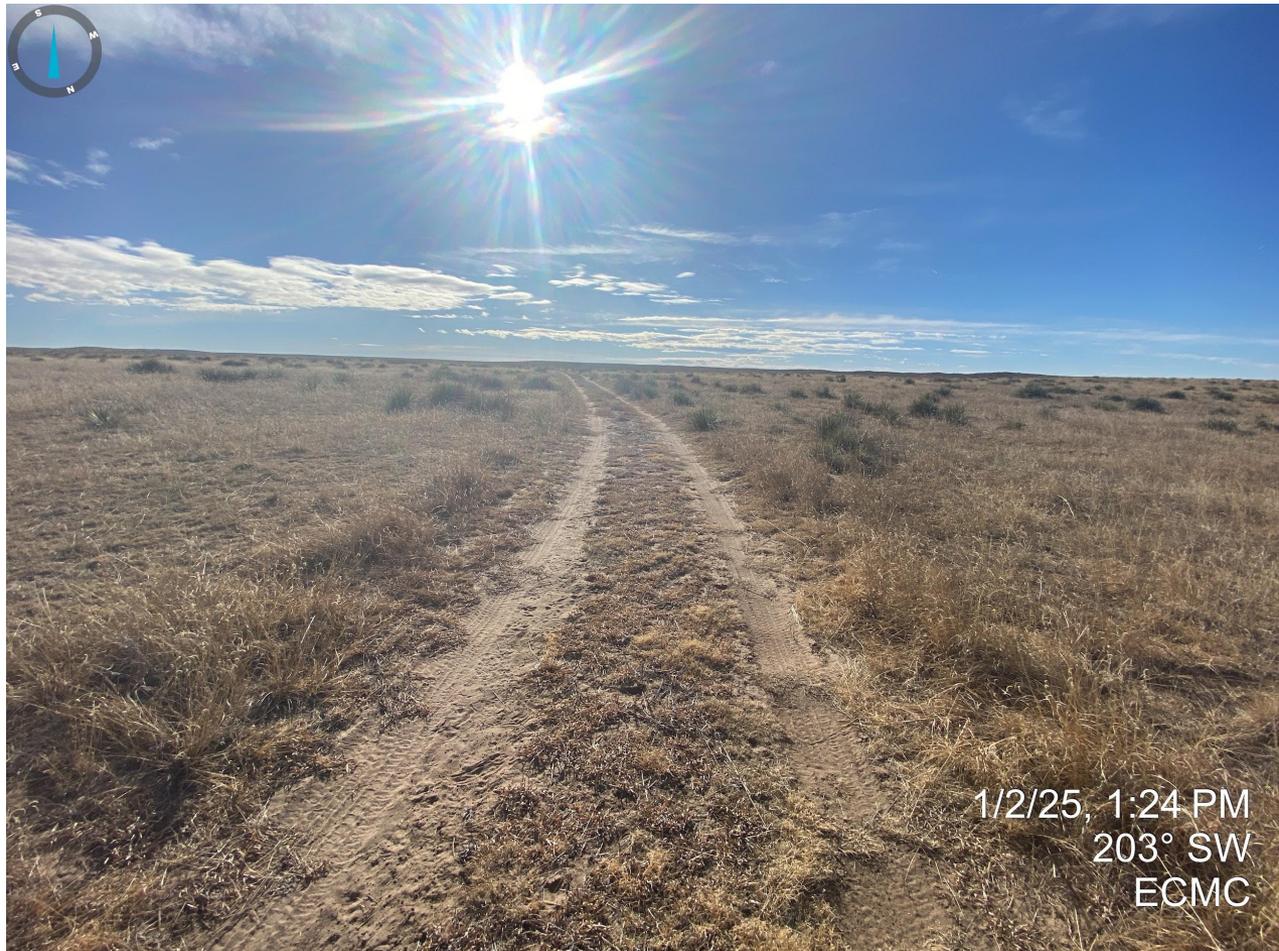
Photo 1. Taken southwest of the location, facing southwest along the access road. It does not appear that the access road has been reclaimed. See proceeding photos for additional.

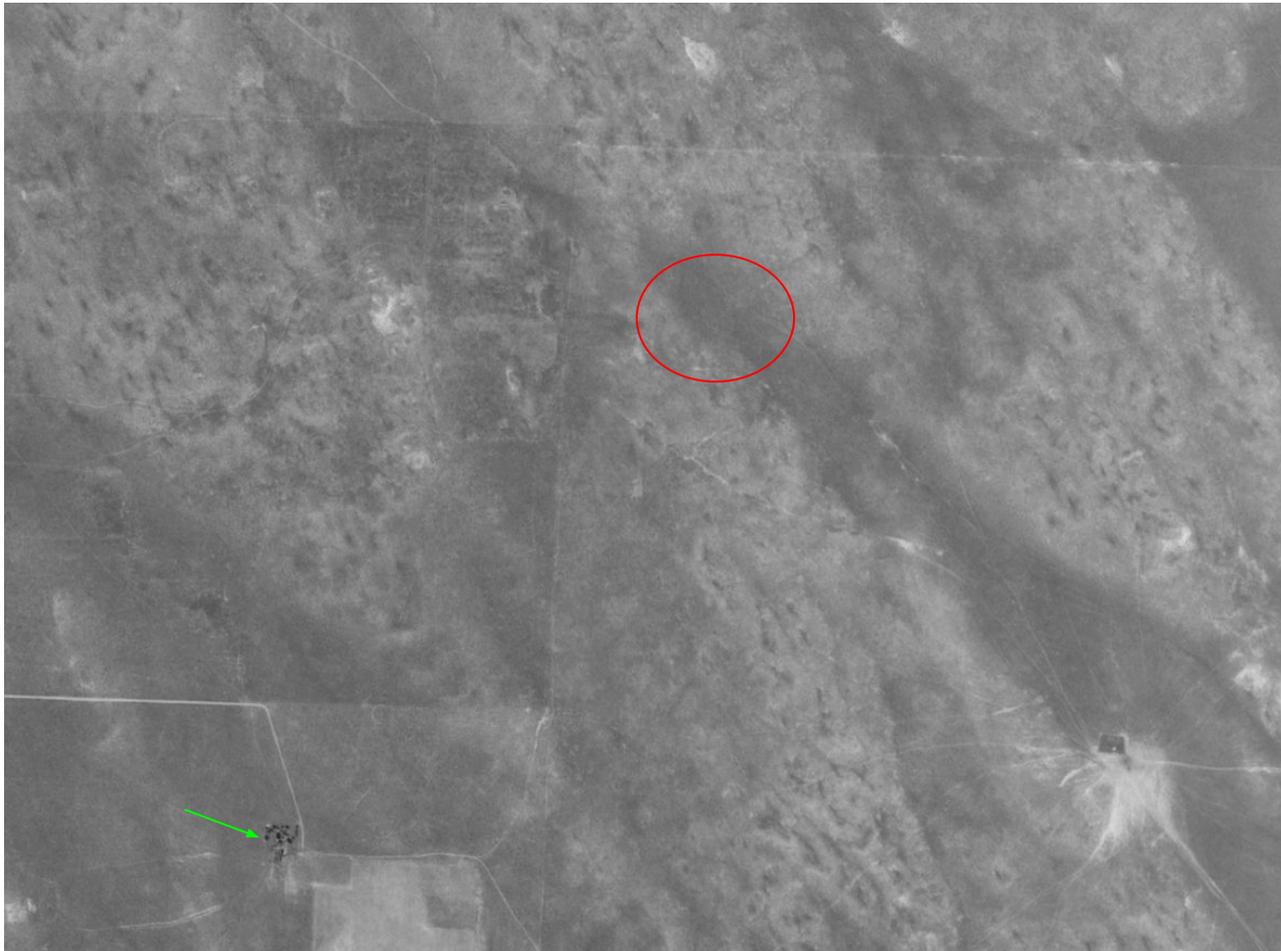
Photo 2. Aerial imagery taken 06/11/1975, approximately 3 years before Well API 121-09383 was spud (12/03/1978), illustrating that the access road does not appear to be in existence prior to oil and gas development. Red circle indicates approximate location of Well API 121-09383; green arrow represents landmark to be used as reference in proceeding photo.

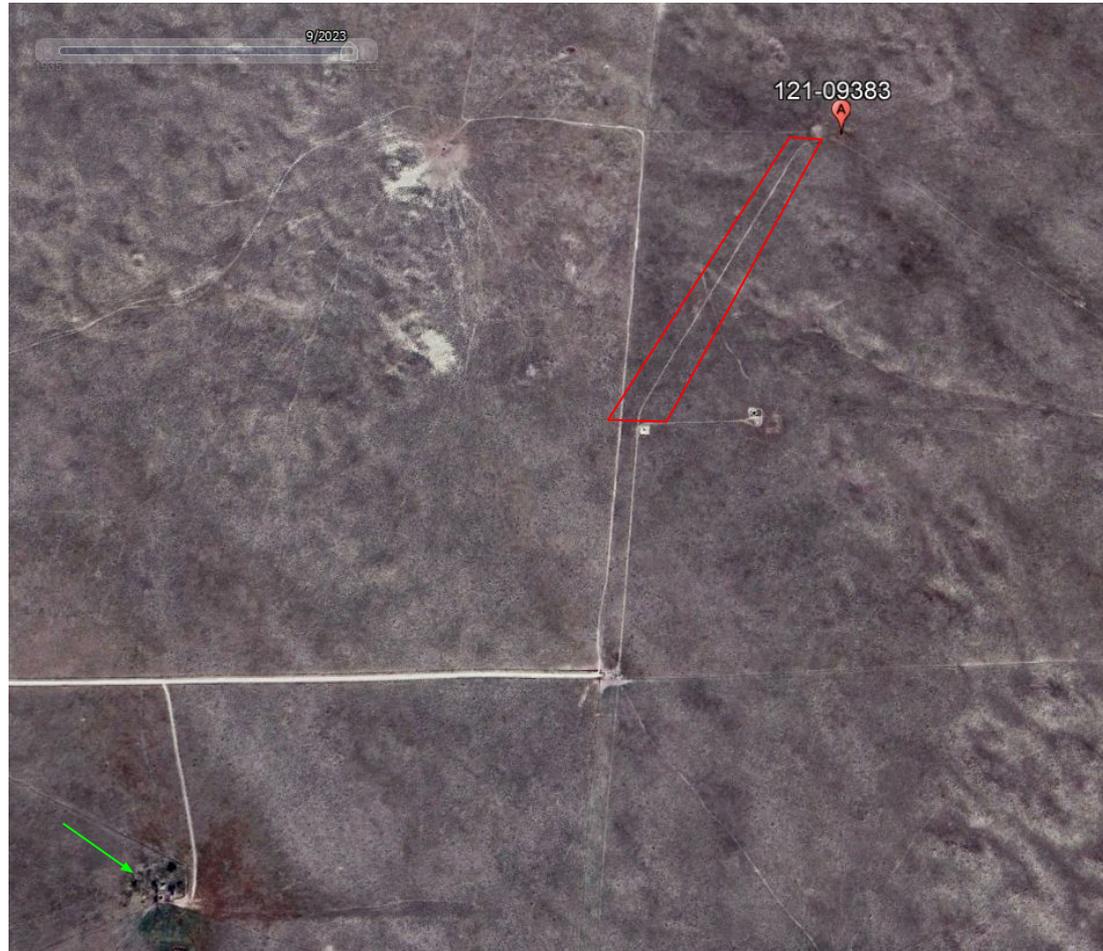
Photo 3. Google Earth aerial imagery (circa 09/2023) illustrating the access road to Well API 121-09383. Red outline illustrates access road that does not appear to have been reclaimed based on observations at the time of this inspection. Green arrow illustrates landmark used for reference with previous photo.

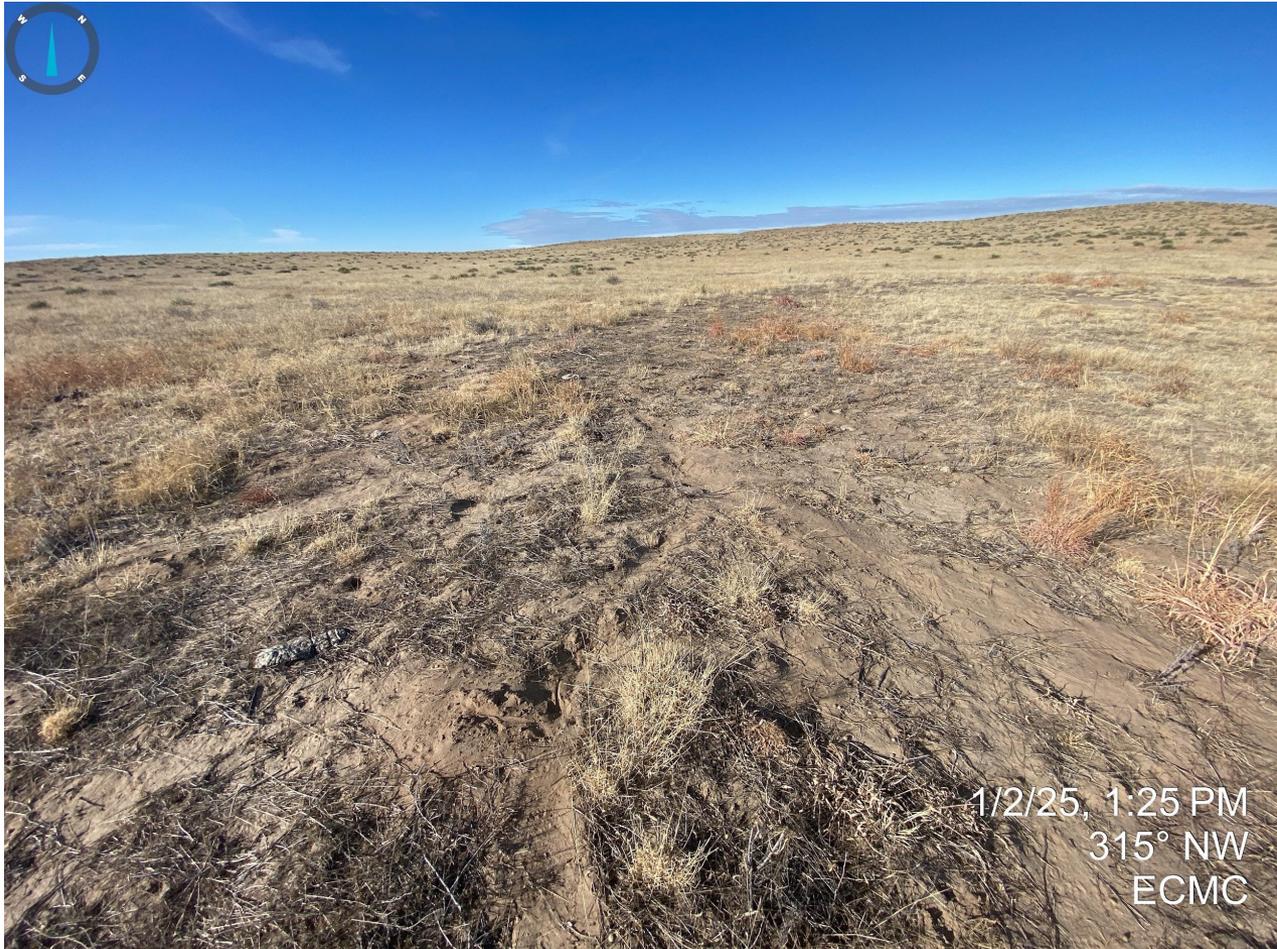
Photo 4. Taken near the southwest corner of the location. Photo illustrates evidence of bare soils within the reclaimed areas.

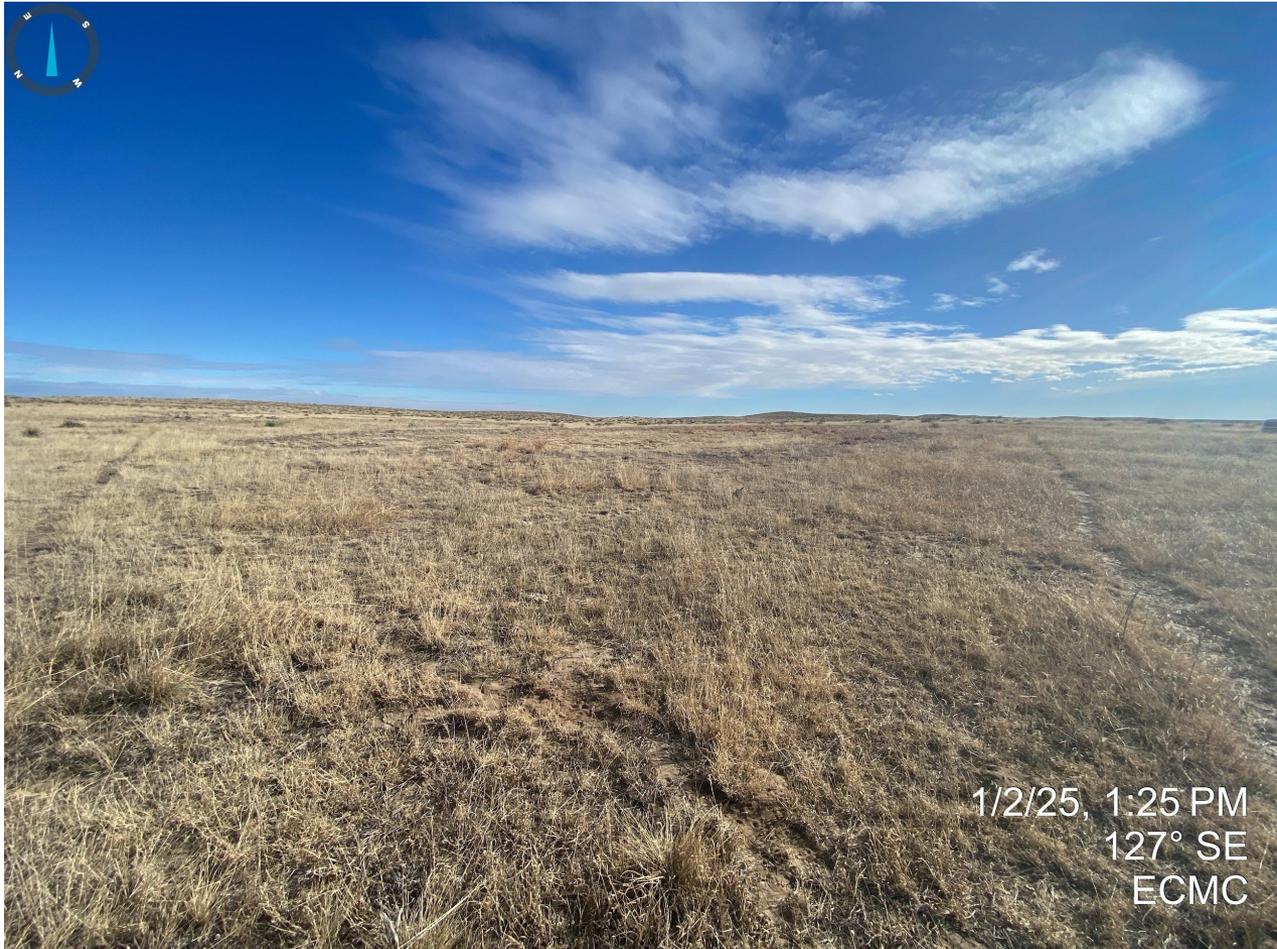
Photo 5. Taken near the northwest corner of the reclaimed location. Portions of the location appear to be progressing towards reclamation standards.

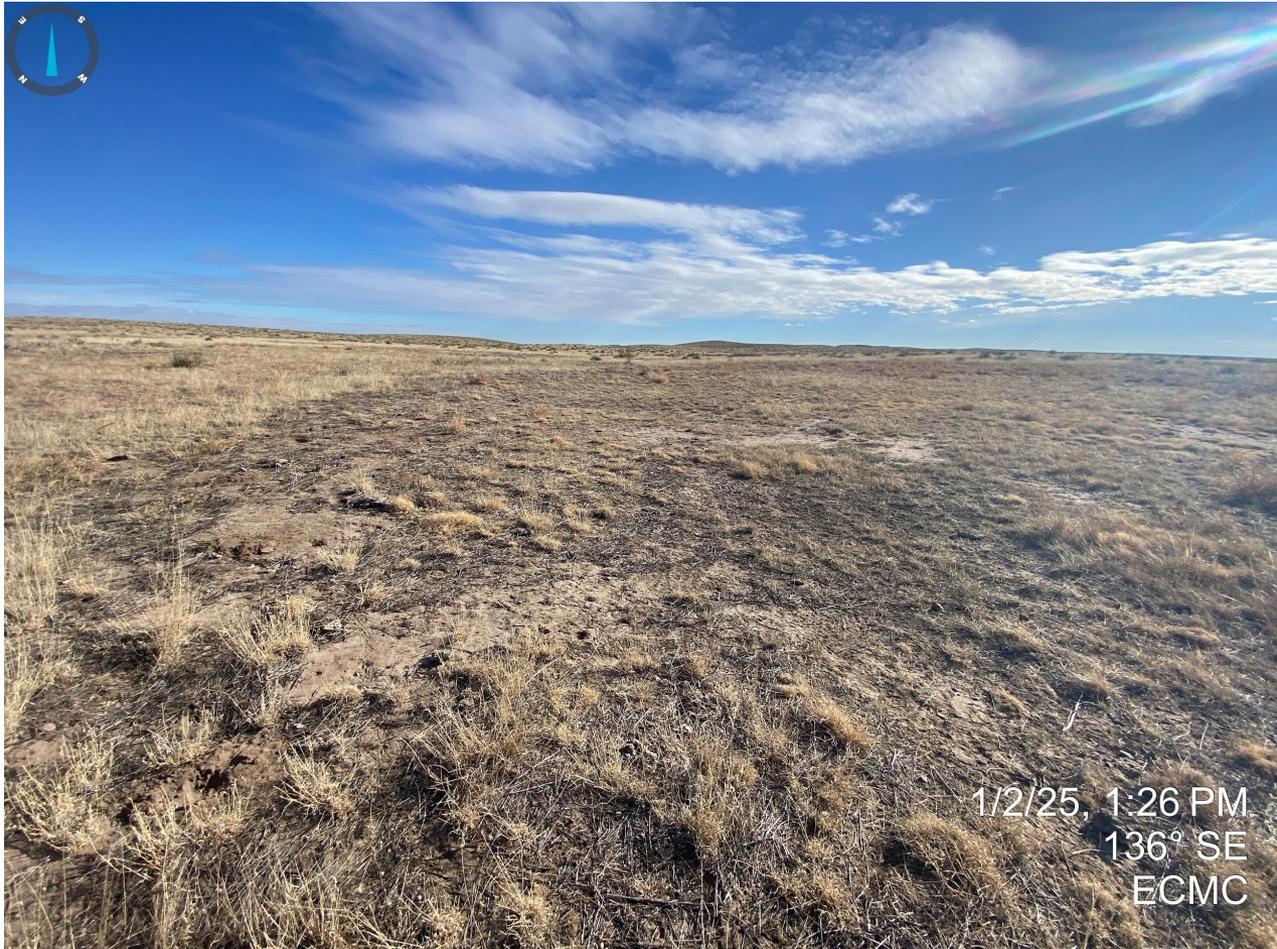
Photo 6. Taken from the northern portion of the former pit. Reclamation does not appear to be progressing with evidence of non-uniform vegetation cover resulting in bare soils.

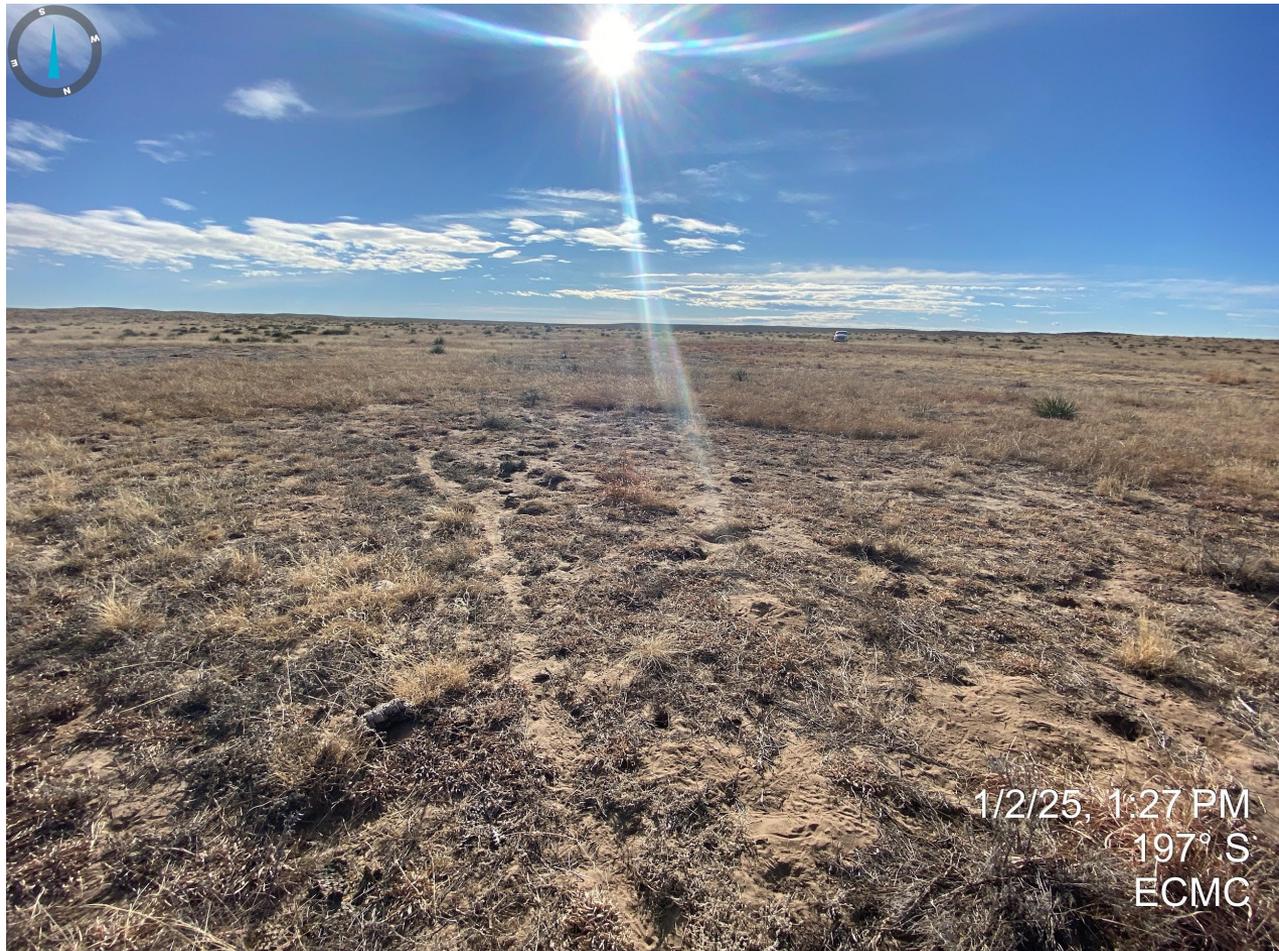
Photo 7. Taken near the northeast corner of the reclaimed location. Reclamation does not appear to be progressing with evidence of non-uniform vegetation cover resulting in bare soils.

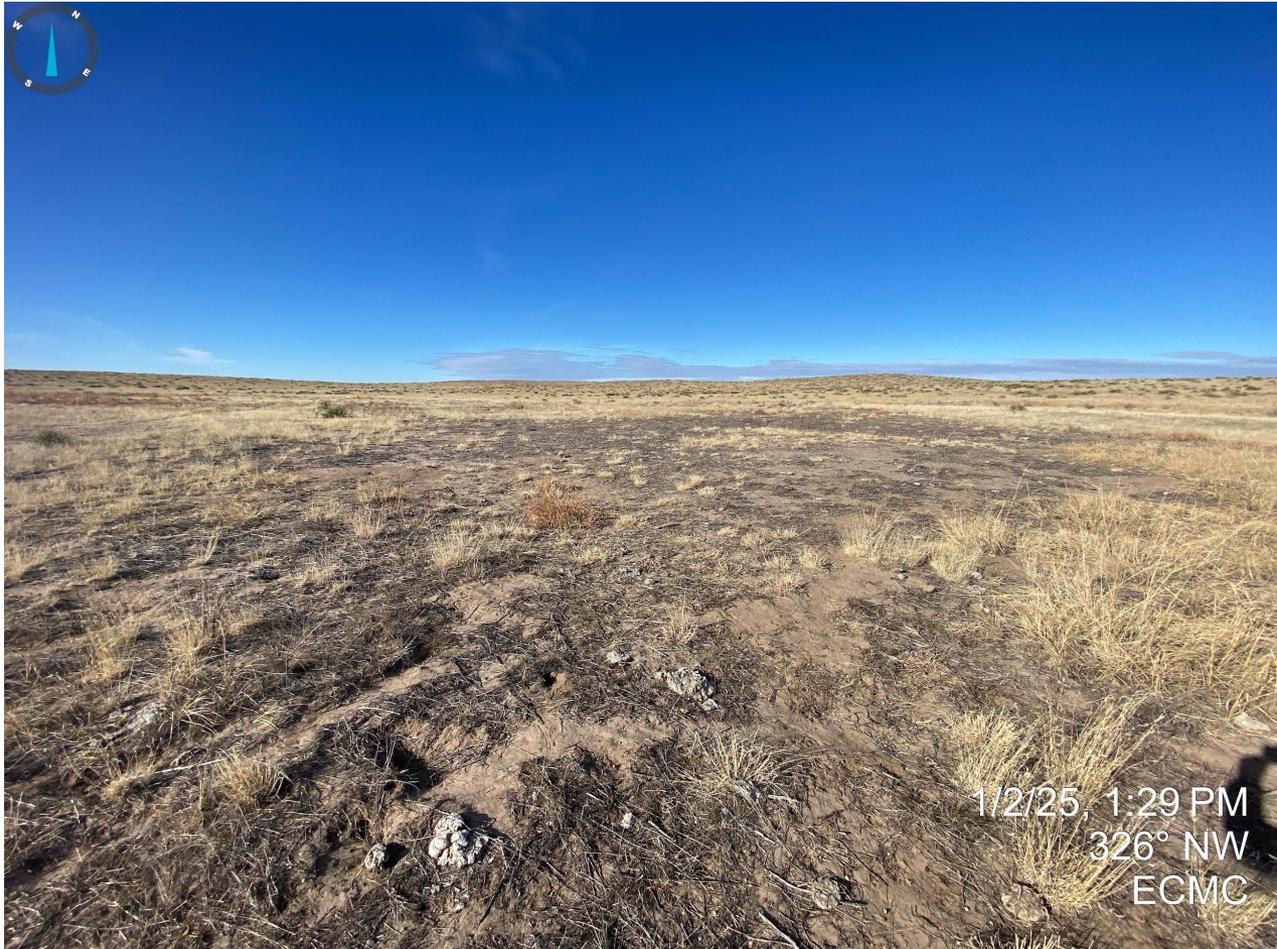
Photo 8. Taken near the southeast corner of the reclaimed location, near the former well location. Reclamation does not appear to be progressing with evidence of non-uniform vegetation cover resulting in bare soils.

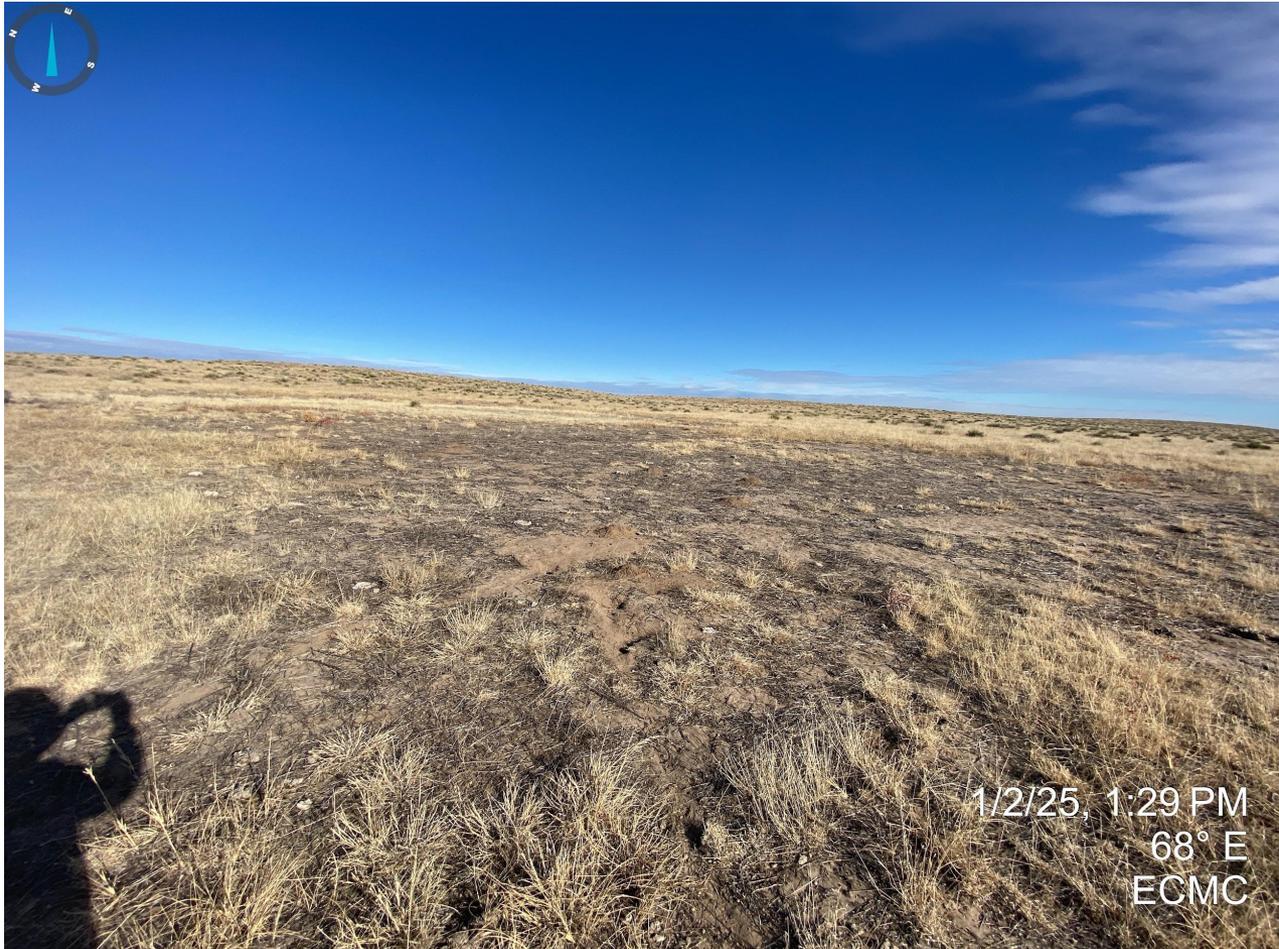
Photo 9. Continued from Photo 8, facing east.

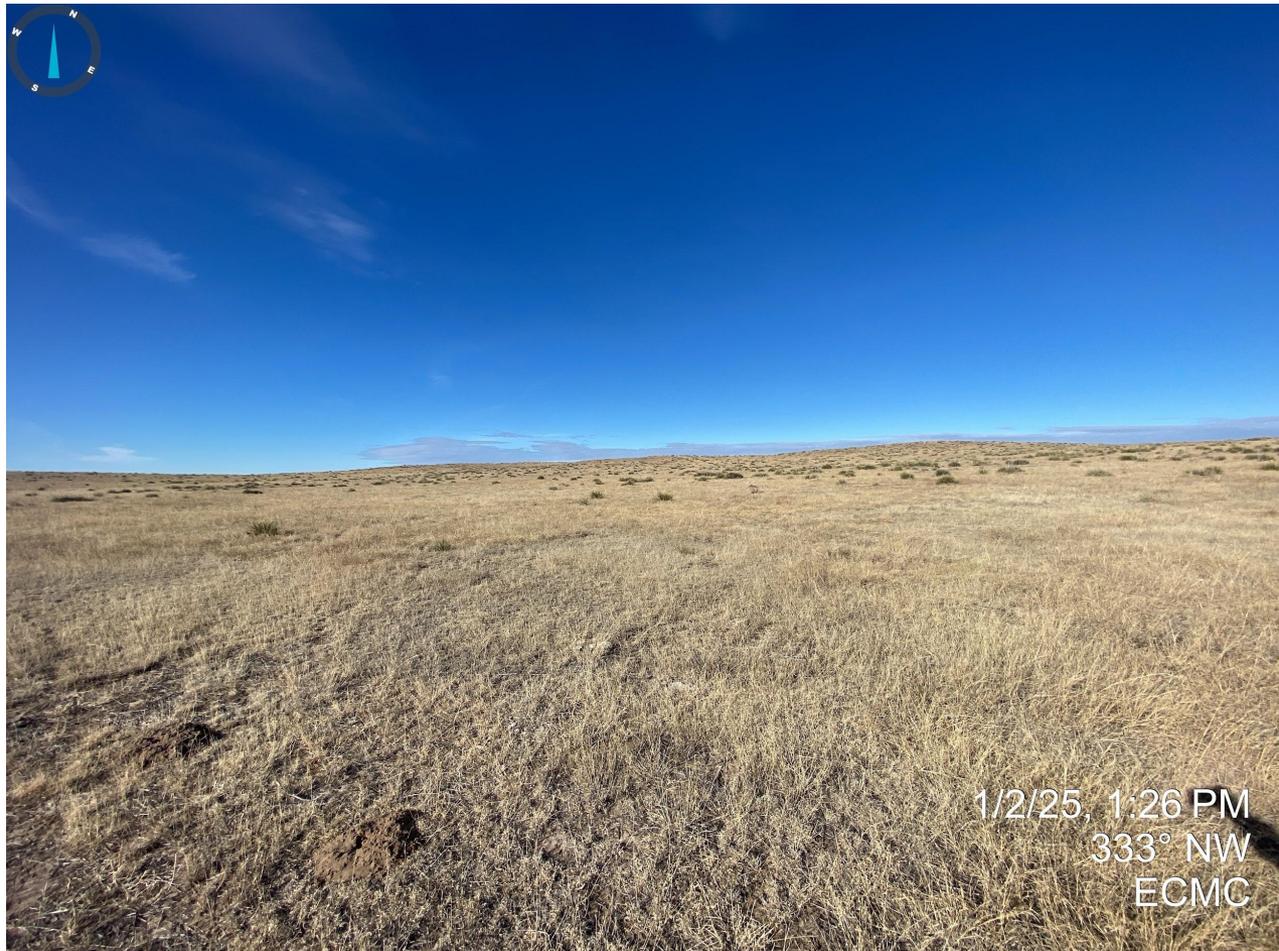
Photo 10. Adjacent reference area photo taken from the former fence line, north of the location.
