# Inspection Photos

**Operator:** WINDSOR ENERGY GROUP LLC

**Location ID:** 397591

**Inspection Doc:** 718100148

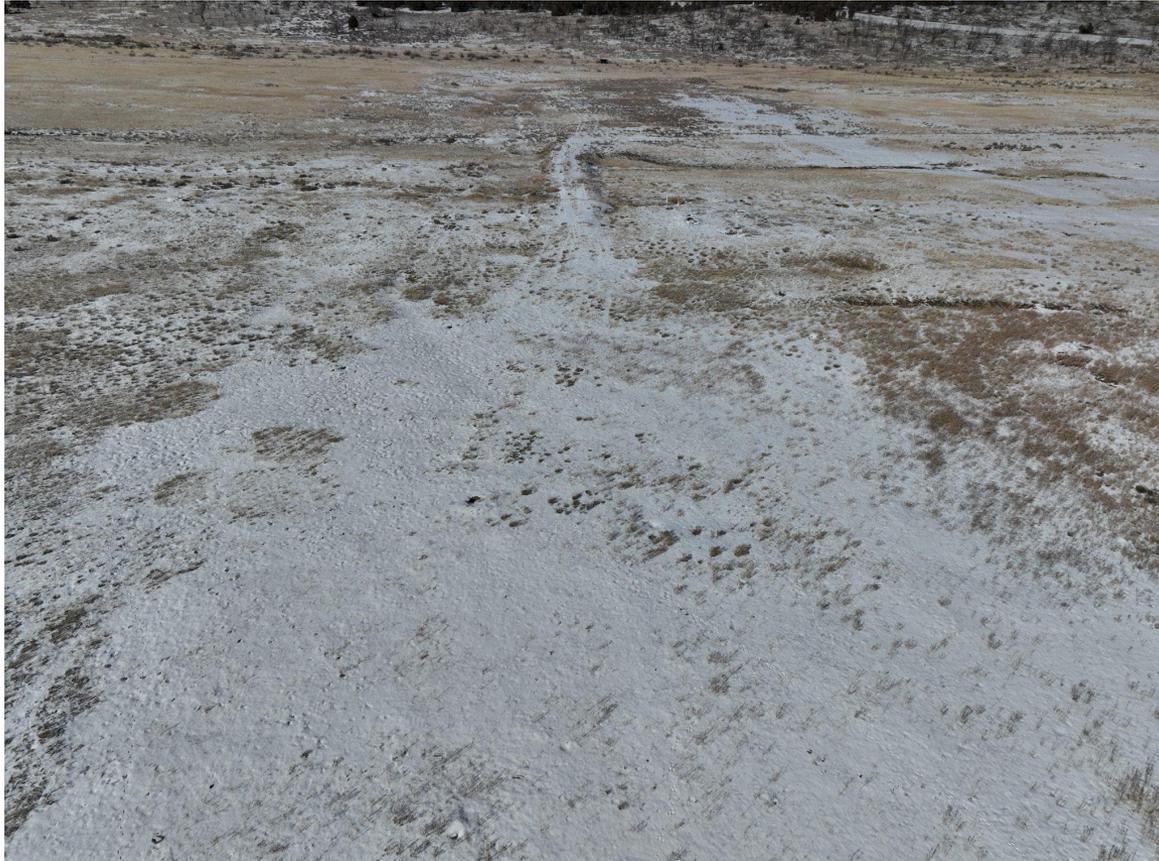
**Photo 1:** Limited inspection due to snow cover. Vegetation is not progressing towards a uniform perennial vegetative establishment. Access road has not been reclaimed (gravel/culvert remains, drainage has not been contoured/reclaimed).

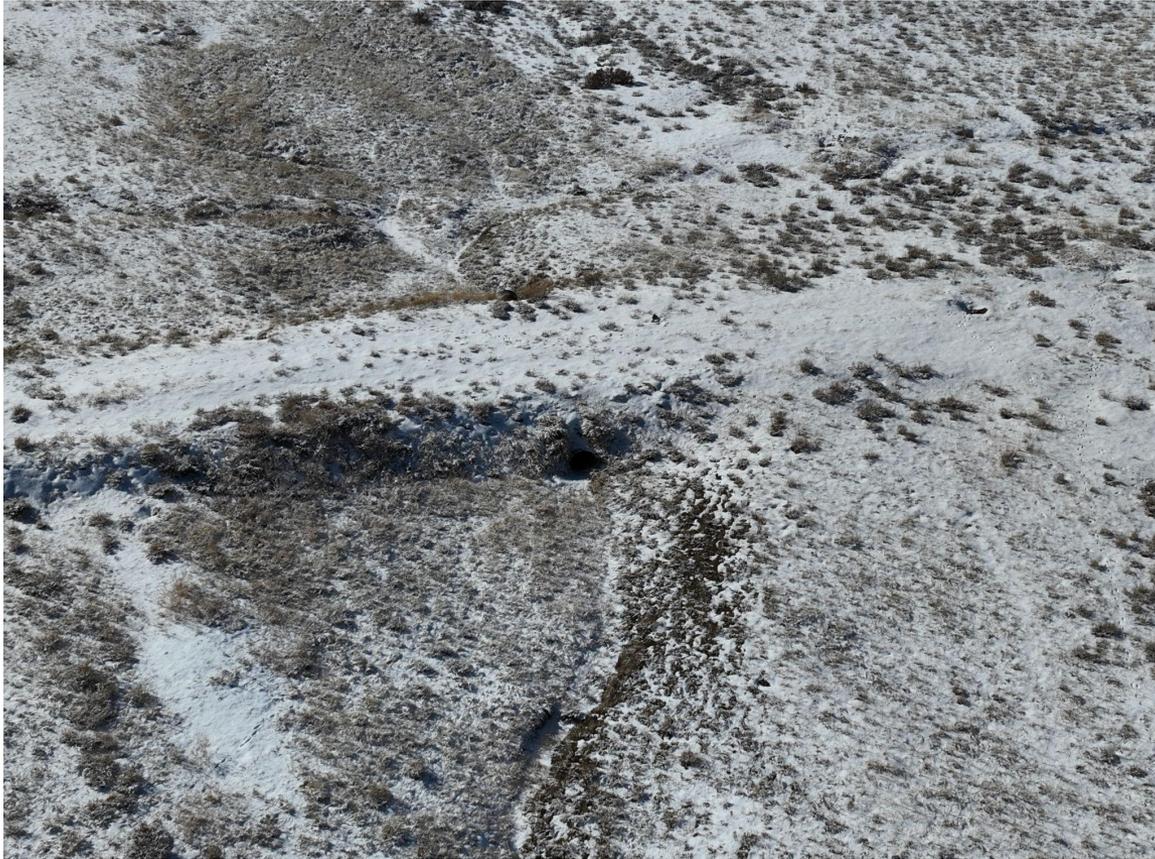
**Photo 2:** Limited inspection due to snow cover. Vegetation is not progressing towards a uniform perennial vegetative establishment. Access road has not been reclaimed (gravel/culvert remains, drainage has not been contoured/reclaimed).
