Final Reclamation and Stormwater Inspection

Operator: PDC ENERGY INC - 69175

Location ID: 464272

Inspection Photos
Location Name: Briggs TB
Location ID: 464272

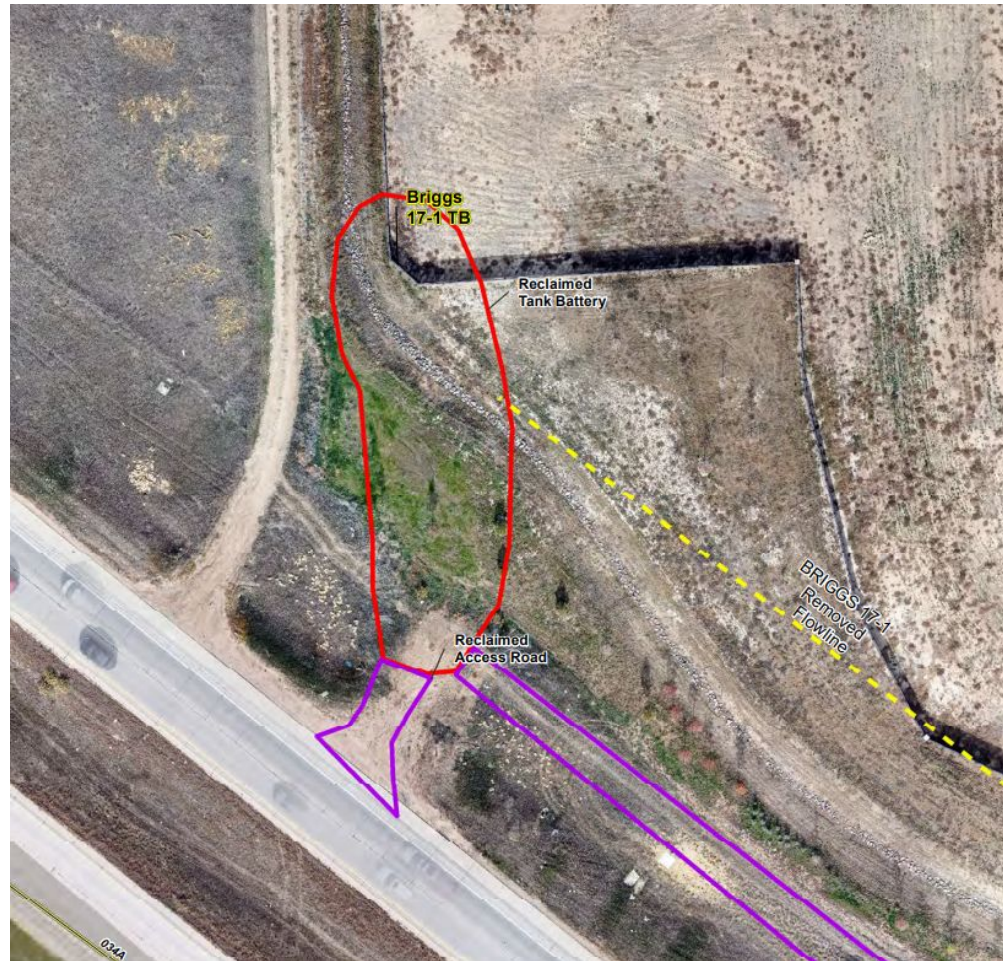
Photo 1. Screenshot from the drone closure report (doc #404013669; Page 13) indicating that the access road off of US 34 has been reclaimed. Based on review of the closure report, it does not appear that the access road has been reclaimed.

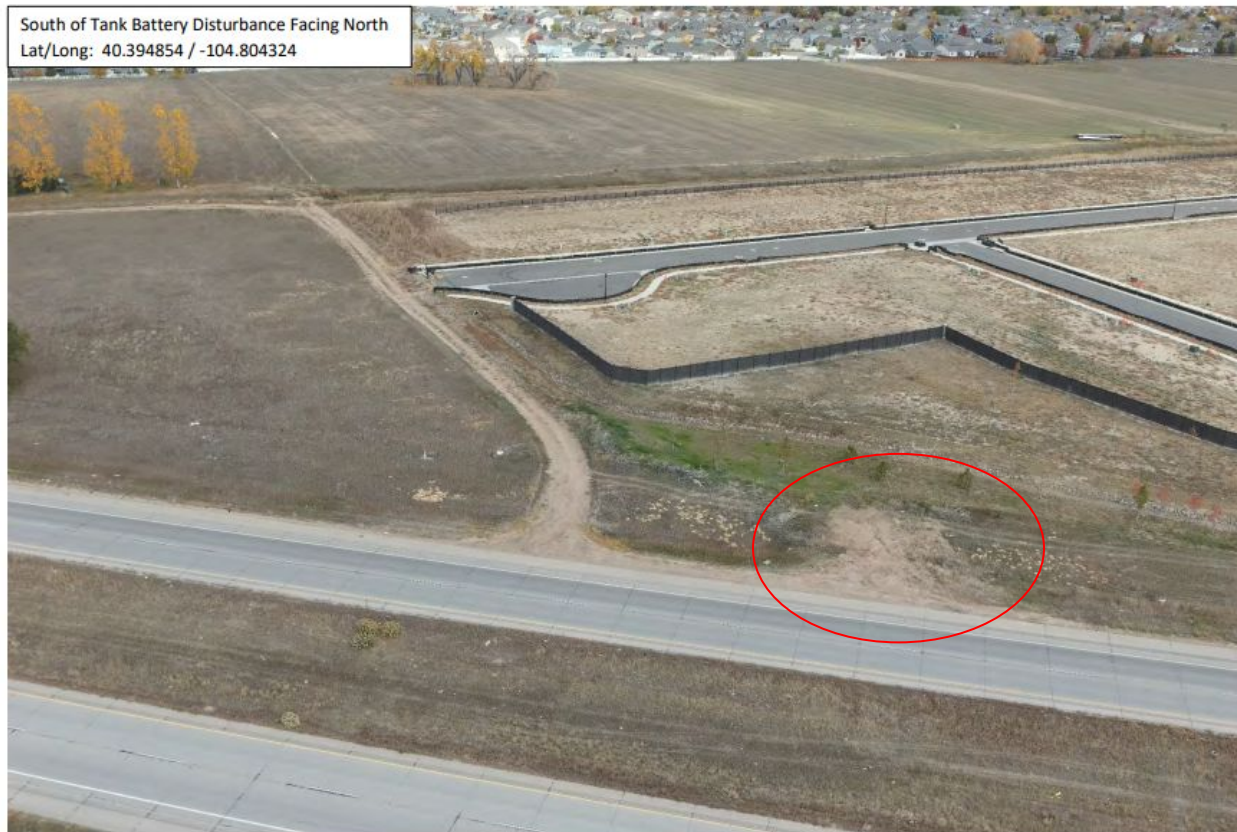
Photo 2. Screenshot from the drone closure report (doc #404013669; Page 18) illustrating that the former access road to the tank battery does not appear to have been reclaimed.

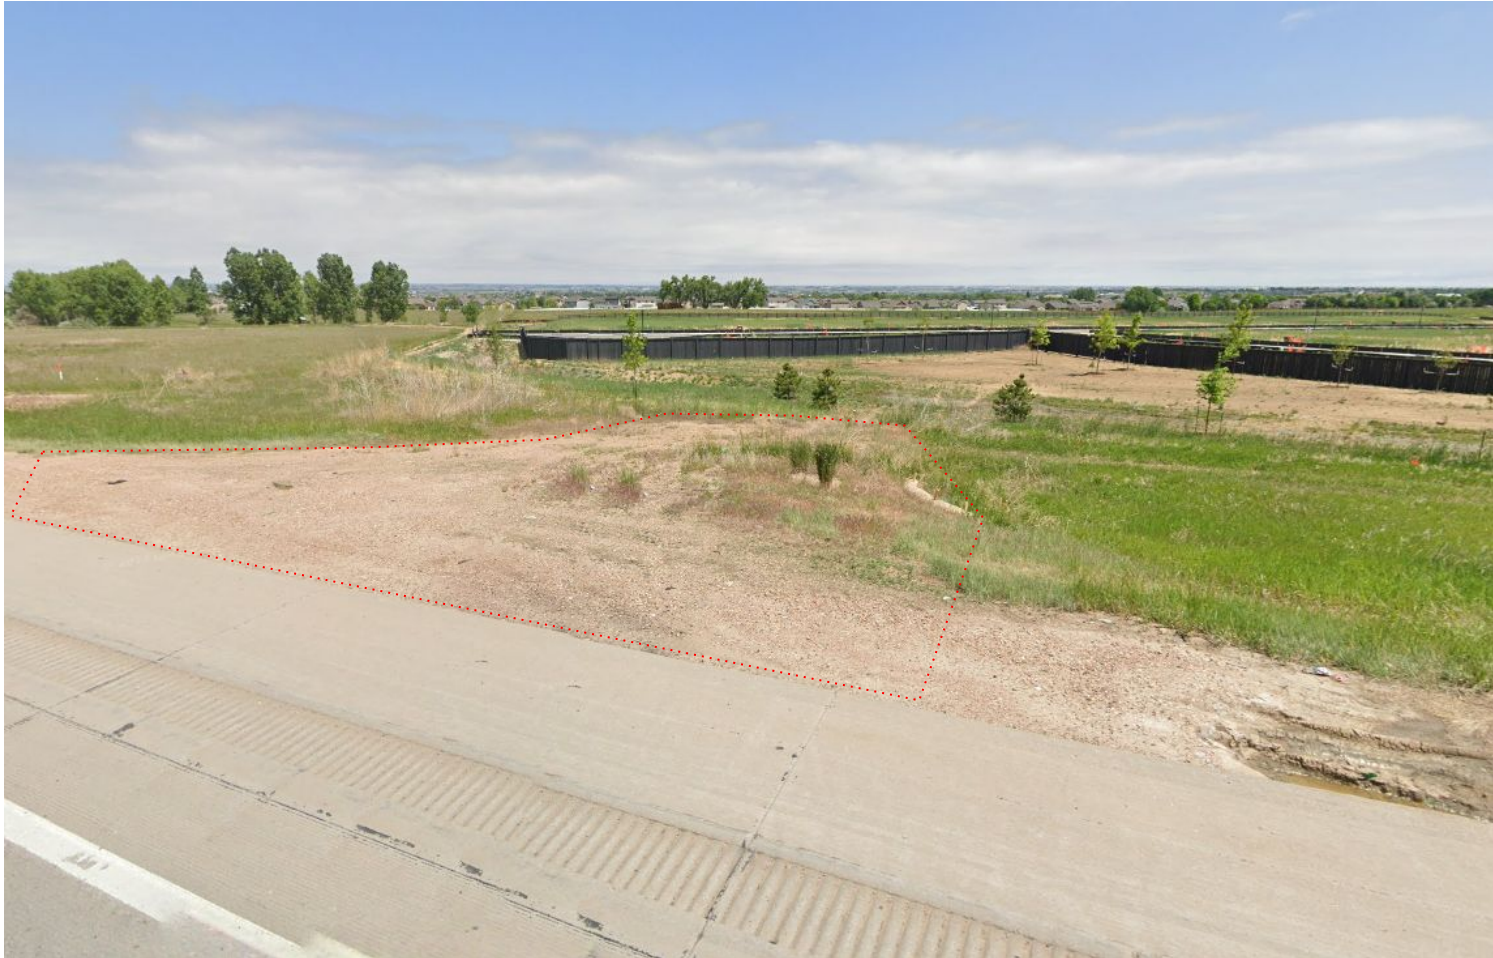
Photo 3. Google Maps imagery (reportedly from May 2024) illustrating that the former tank battery access road off of US 34 does not appear to have been reclaimed with evidence of road base material, culvert and contouring/grading that is not reflective of the adjacent areas.
