Final Reclamation and Stormwater Inspection

Operator: PDC ENERGY INC - 69175

Location ID: 460732

Well Name: SELTZER PP Facility/61S67W

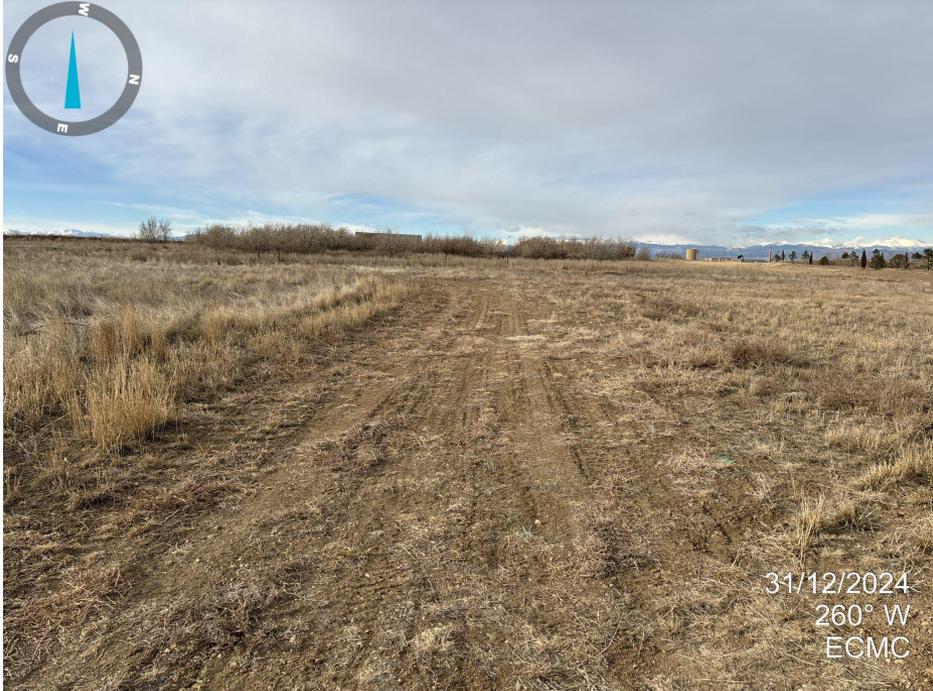
Photo 1. Photo taken from east side of site looking west. No oil and gas equipment remains on site. Appears to have been reclamation activity such as recontouring and reseeding. Desirable vegetation is progressing outside of access road. Undesirable weedy annual Kochia is present on location.

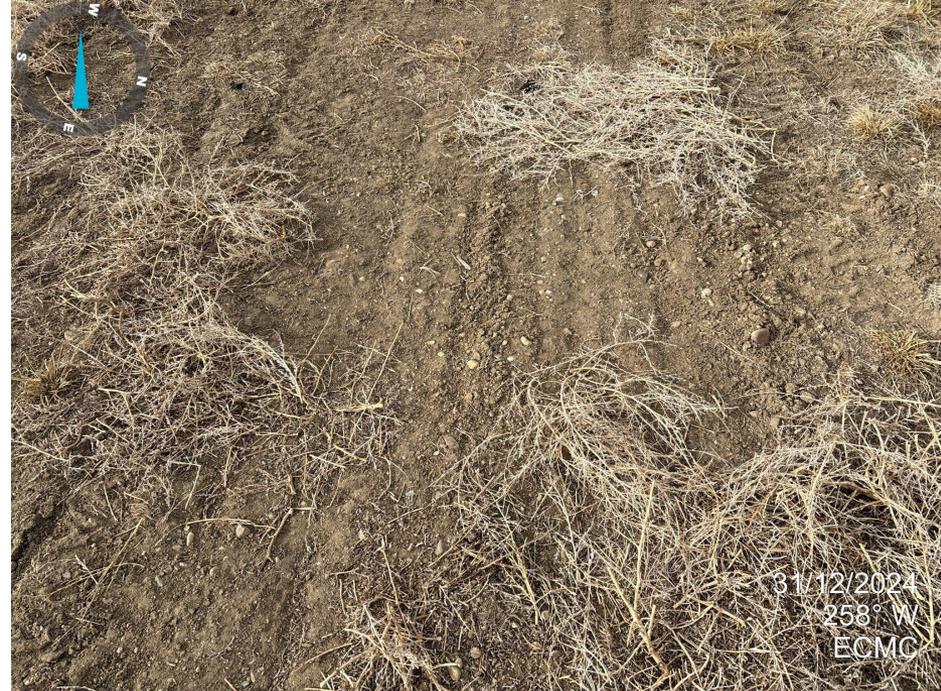
Photo 2. See Photo 1 comments. Former access road may need additional decompaction and reclamation work.

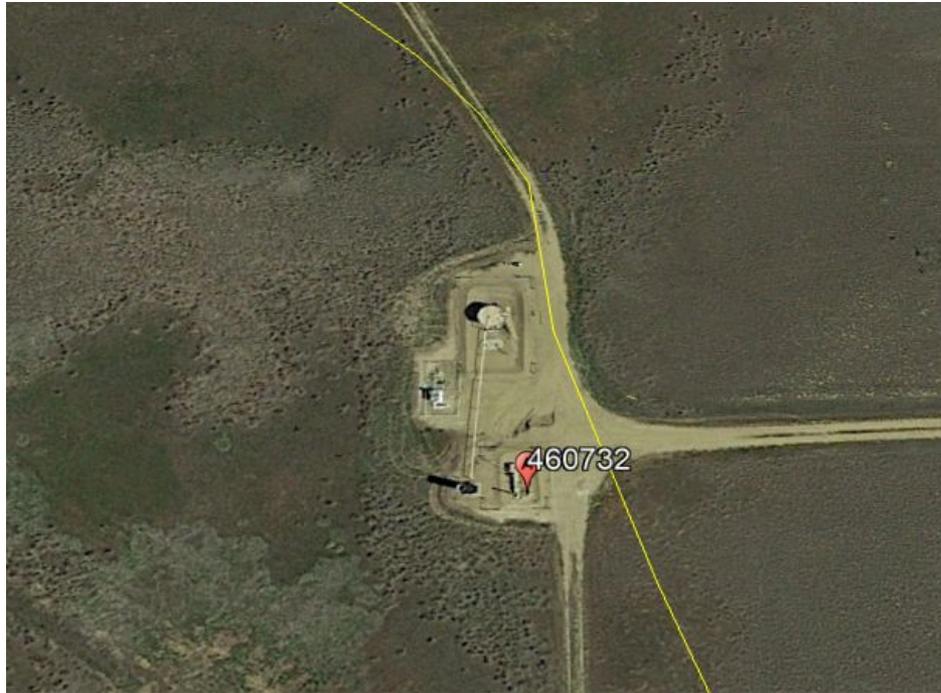
Photo 3. Google earth image taken 05/2018 of active tank battery.

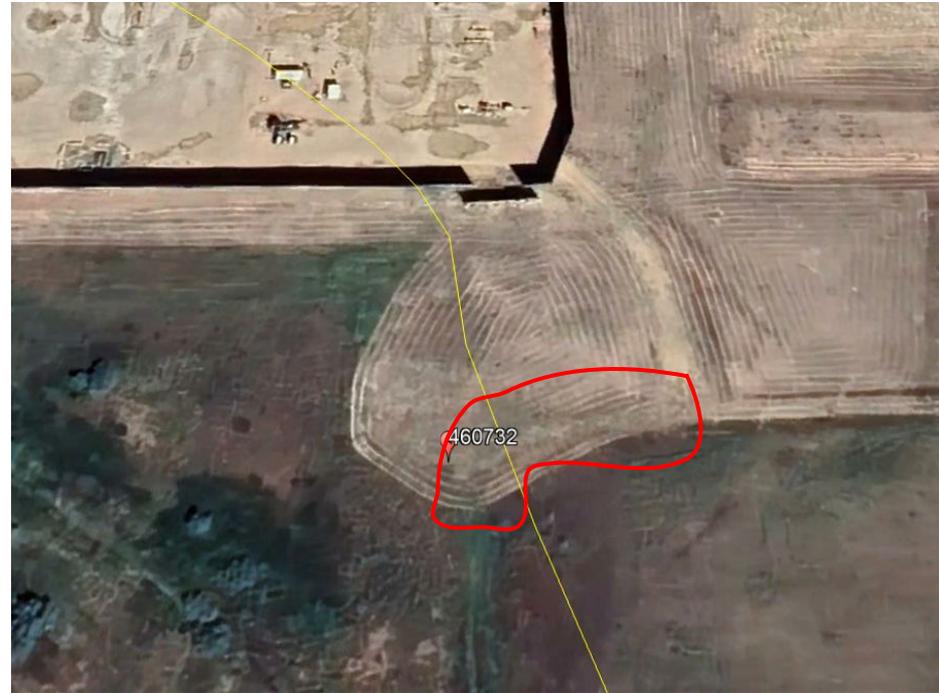
Photo 4. Google earth image taken 08/2021. Illustrating reclamation work over former tank battery location. A section of the former access road may need additional reclamation work (red circle).
