Final Reclamation and Stormwater Inspection

Operator: NOBLE ENERGY INC - 100322

Location ID: 306473

Inspection Photos
Location Name: Wells Ranch USX AA 19-23
Location ID: 306473

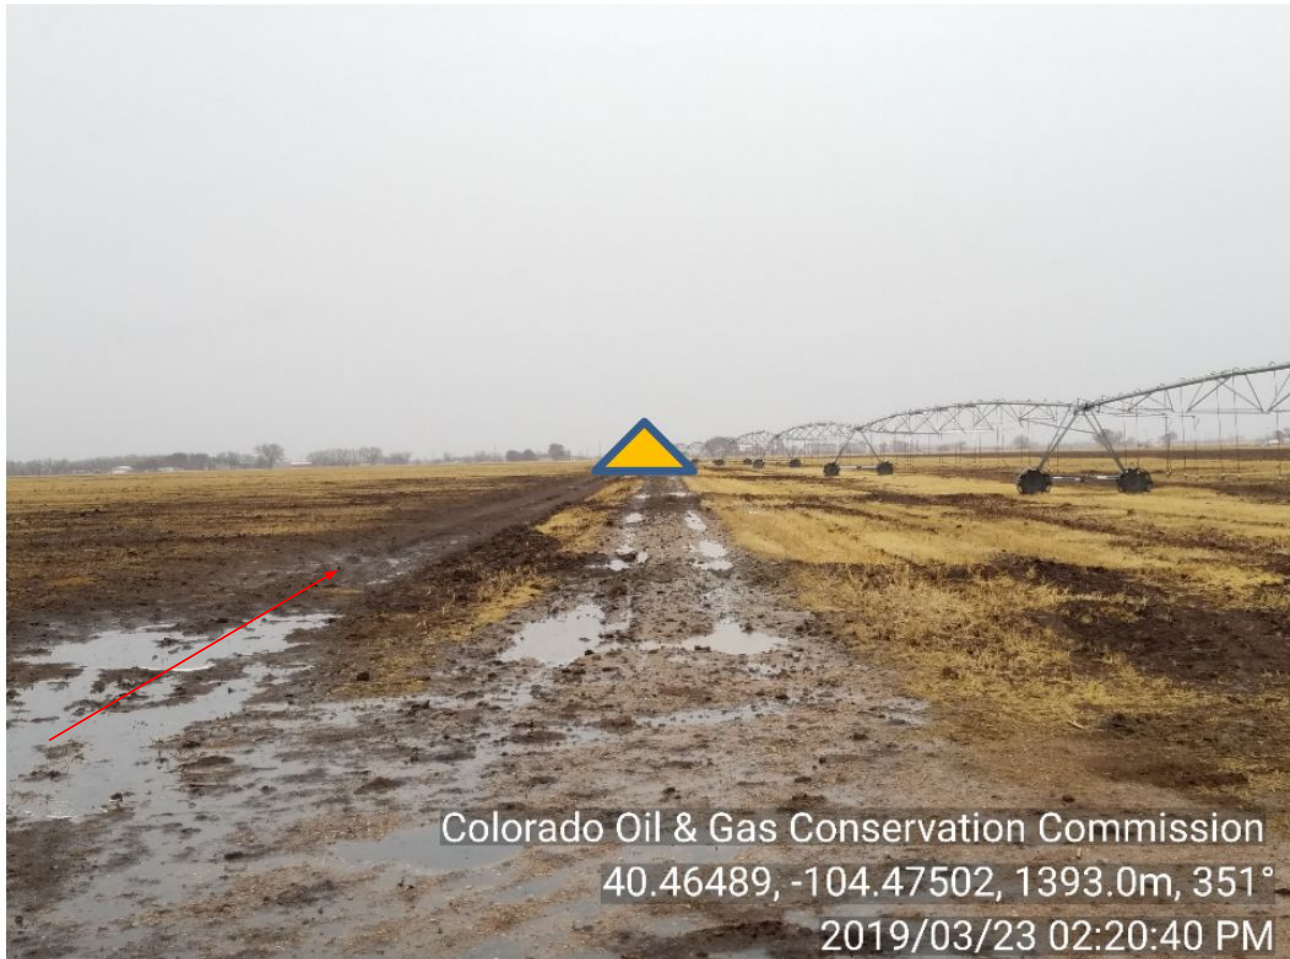
Photo 1. Photo from FIR (doc #696100614) conducted 03/23/2019, approximately 4 months after plugging and abandonment operations. Photo illustrates an access road west/left of the existing access road. It is unsure whether the access road (indicated by red arrow) is from P&A operations and/or flowline removal.

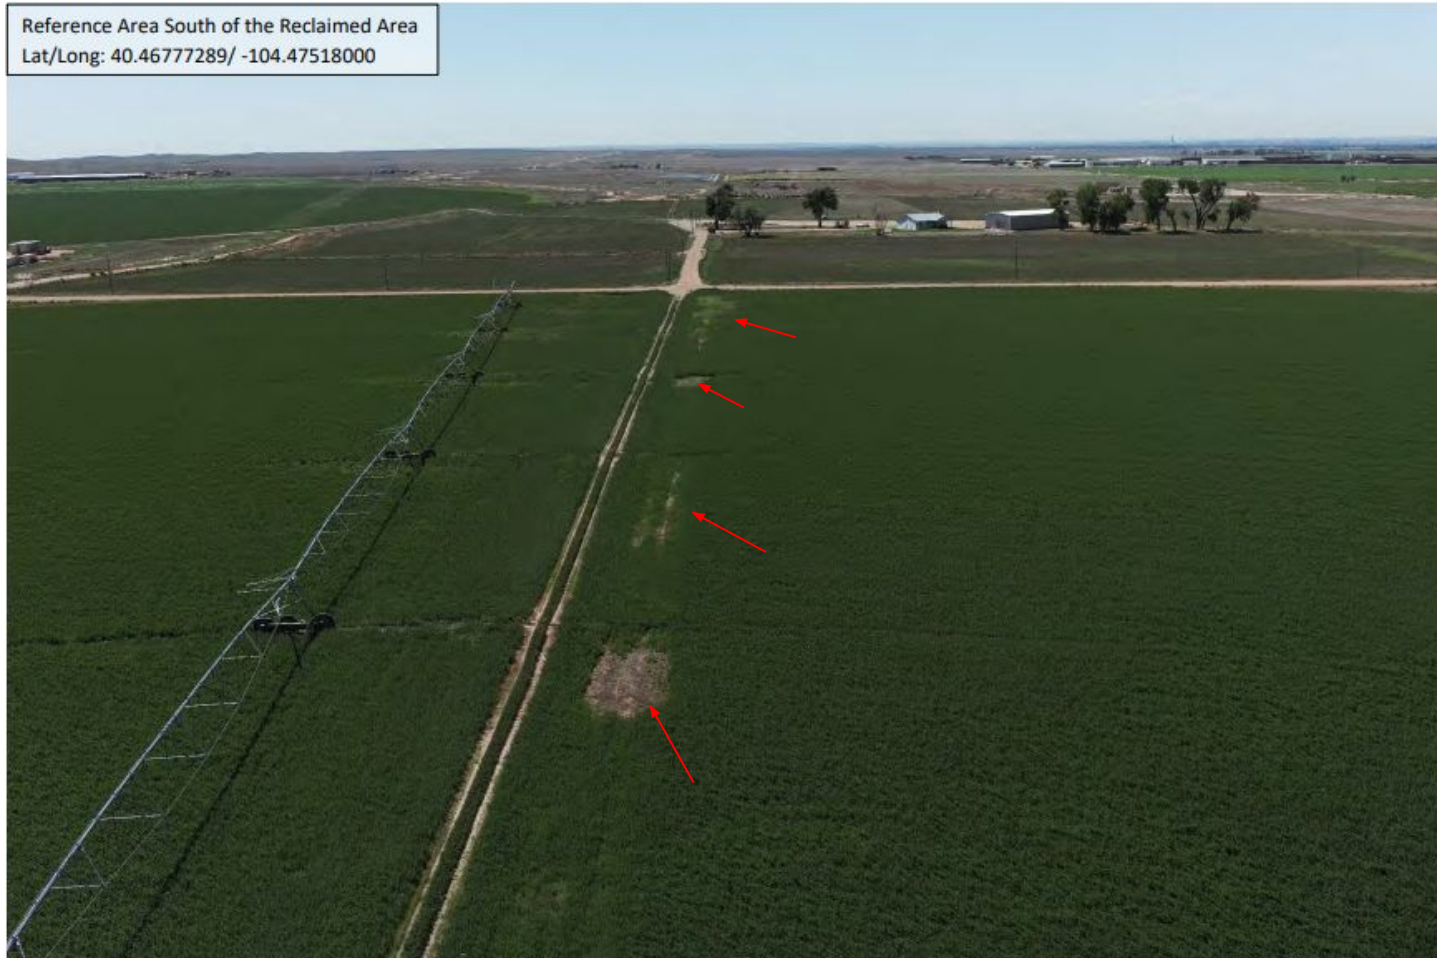
Photo 2. Drone aerial imagery taken from the drone closure report (doc #404017506; Page 19). Photo illustrates areas of non-uniform vegetation cover resulting in bare soils. A follow-up inspection will be conducted at a later date to assess the disturbance areas.
