Inspection Photos

Operator: VISION ENERGY LLC - 10770

Location ID: 312553

Inspection Doc: 718100152

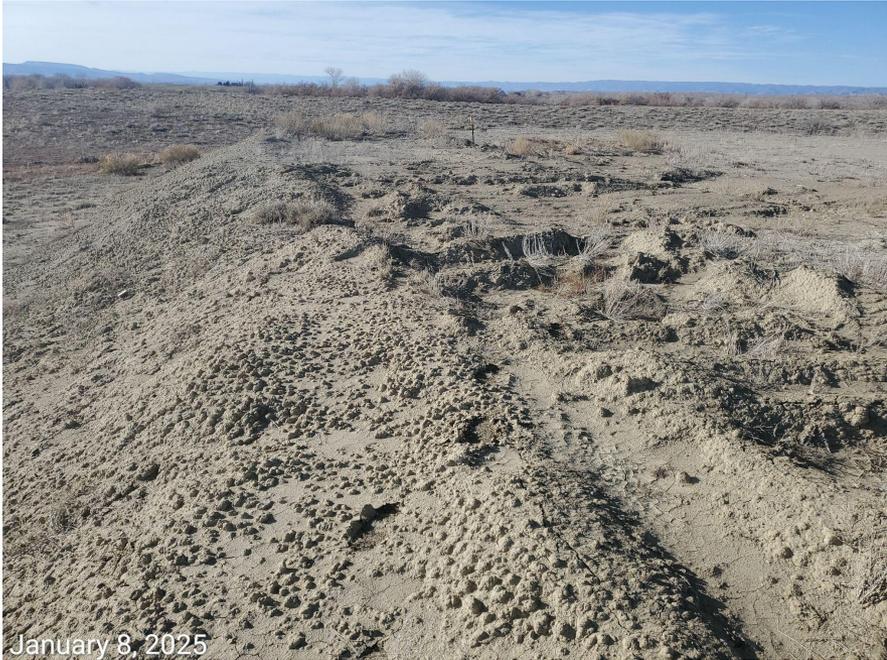
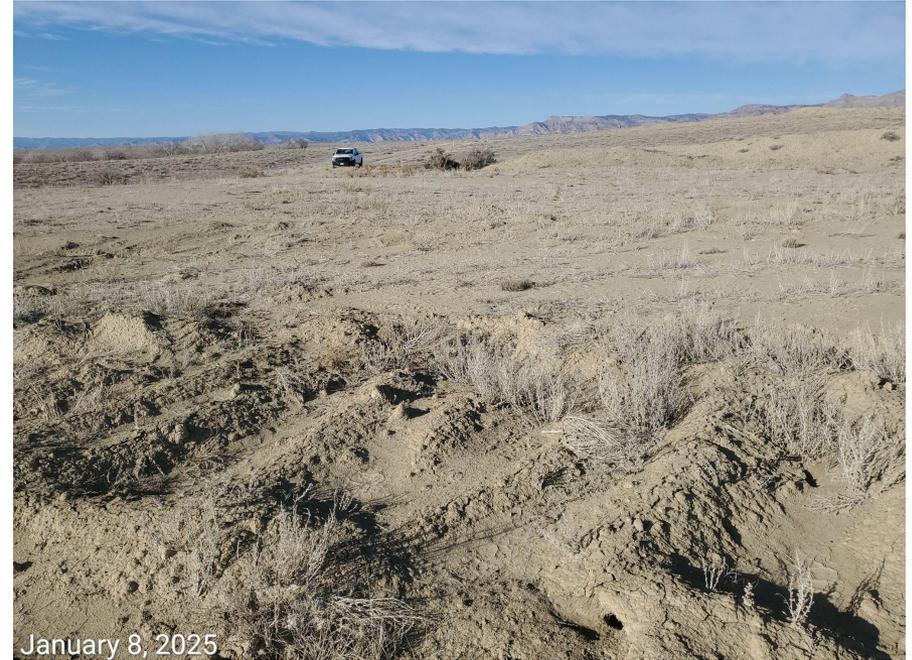
Photo 1: Photos 1-2 taken from the south end of the Location. Photos provide an overview of the Location from west, northwest, northeast to east. Photos show final reclamation has not been performed in accordance with 1004 requirements- Location/Road has not been decompacted, recontoured/regraded and reclaimed; Undesirable and Noxious Plant Species (Halogeton) observed established throughout the Location disturbance.

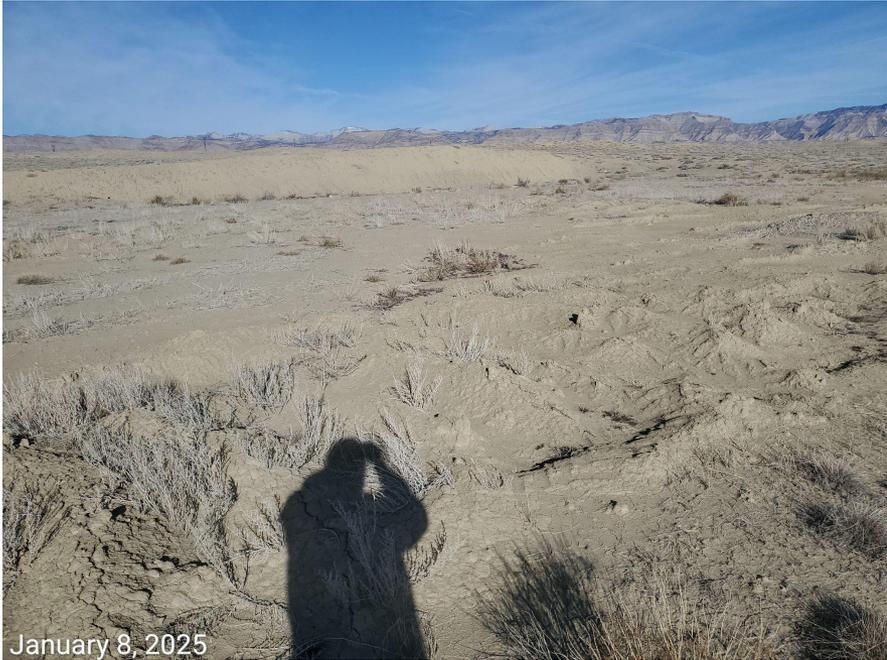
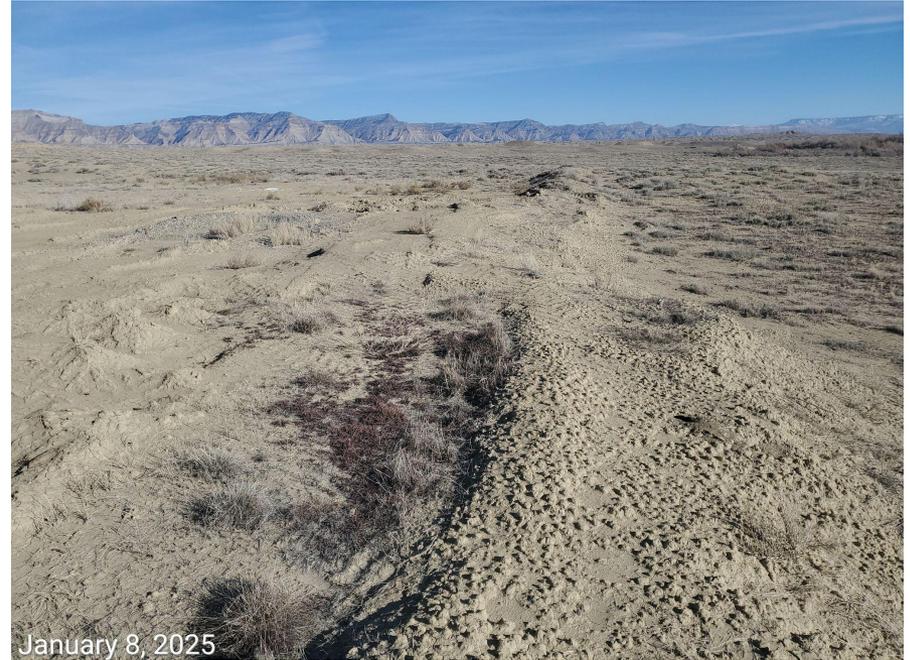
Photo 2: See comments under photo 1.

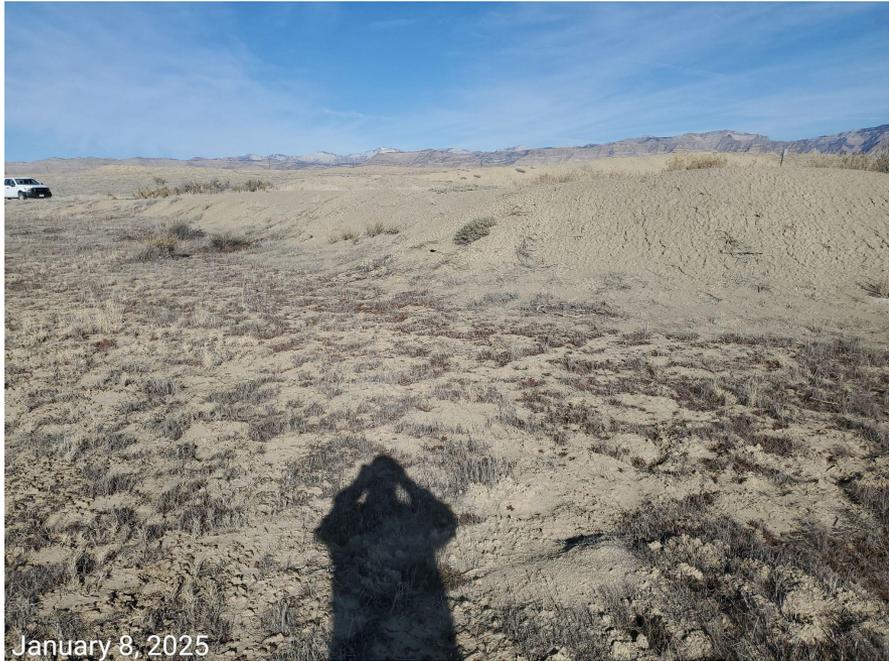
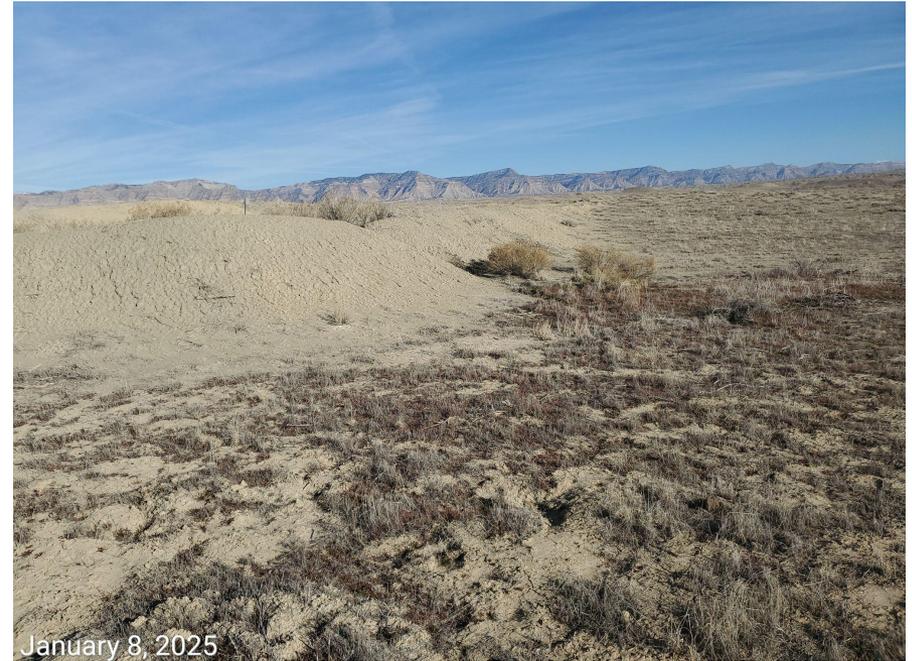
Photo 3: Photo taken from the southwest end of the Location, facing north and east. Photos show fill slopes; Location has not been decompacted, recontoured/regraded and reclaimed

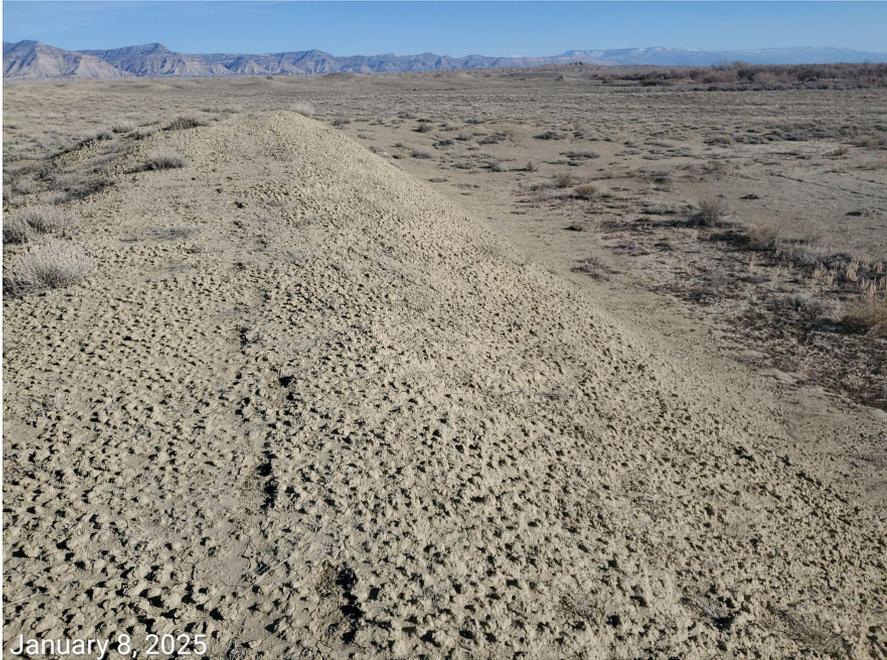
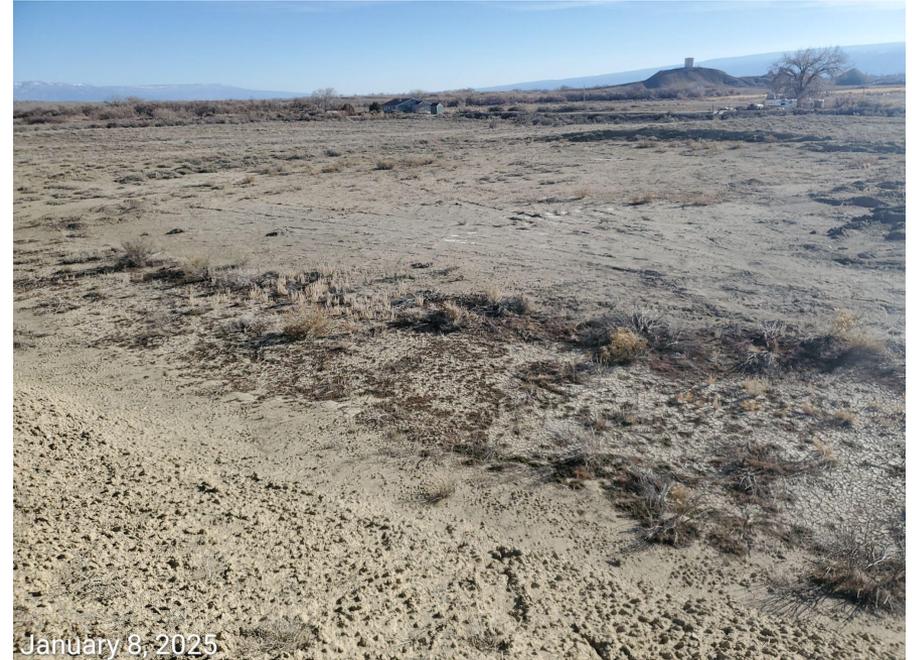
Photo 4: Photos 4-5 taken from the north end of the Location. Photos provide an overview of the Location from east. southeast, southwest to west. Photos show final reclamation has not been performed in accordance with 1004 requirements- Location/Road has not been decompacted, recontoured/regraded and reclaimed; Undesirable and Noxious Plant Species (Halogeton) observed established throughout the Location disturbance.

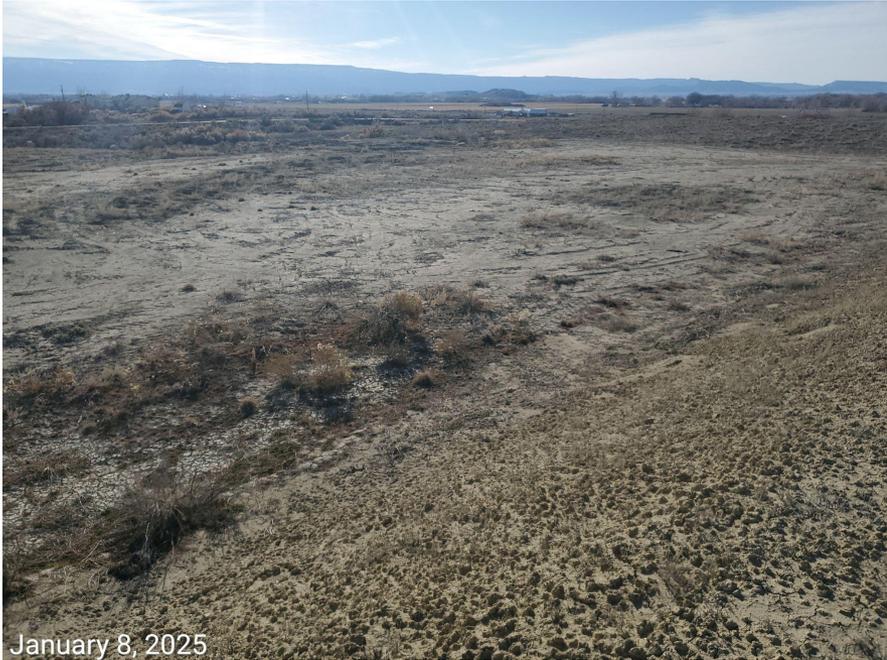
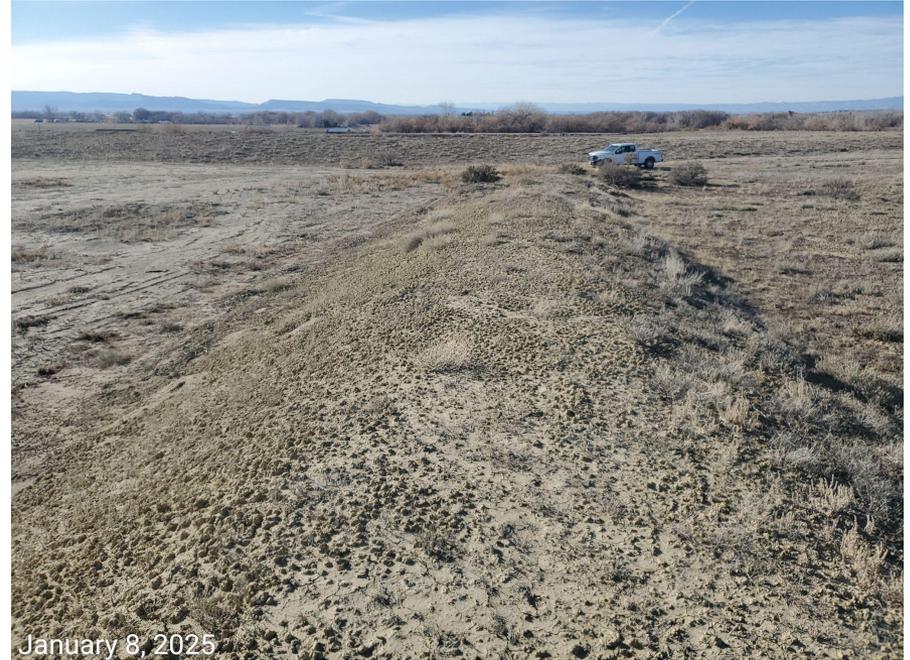
Photo 5: See comments under photo 4.

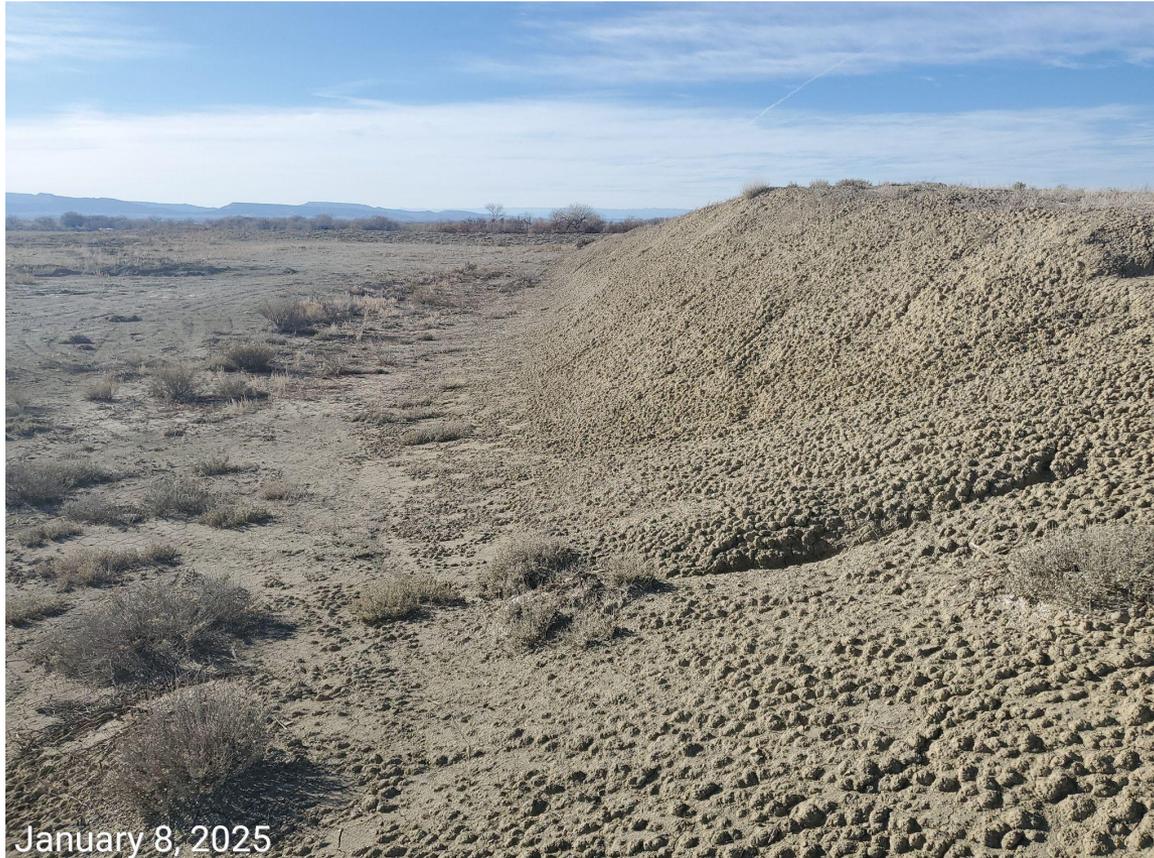
Photo 6: Photo taken from the northeast corner of the Location, facing west. Photo shows the cut slopes; Location has not been decompacted, recontoured/regraded and reclaimed

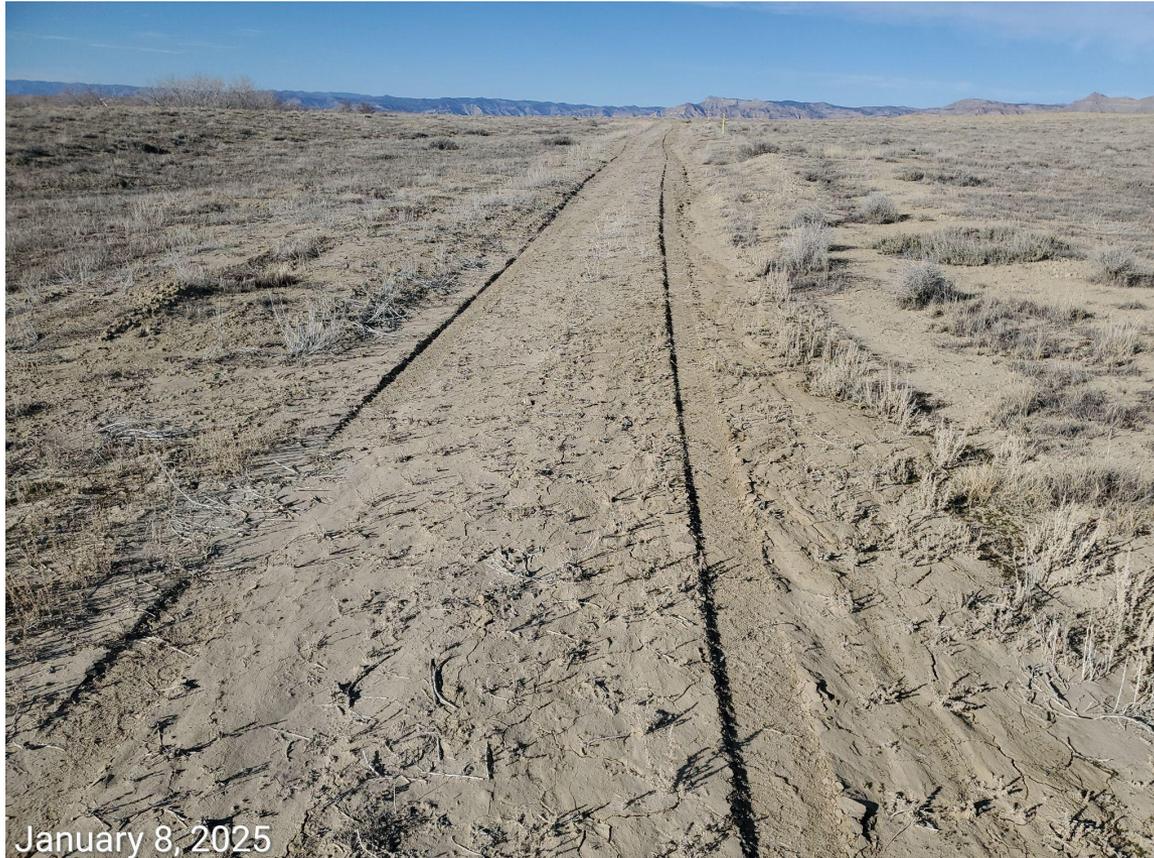
Photo 7: Photo taken from the northwest end of the Location, facing north. Photo shows access road has not been reclaimed.
