Inspection Photos

Operator: VISION ENERGY LLC - 10770

Location ID: 312383

Inspection Doc: 718100156

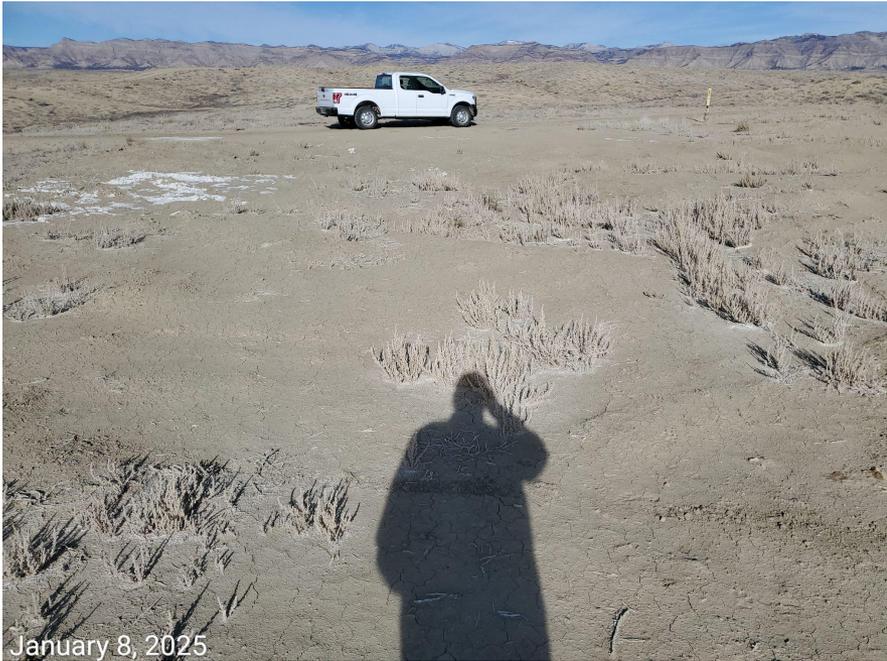
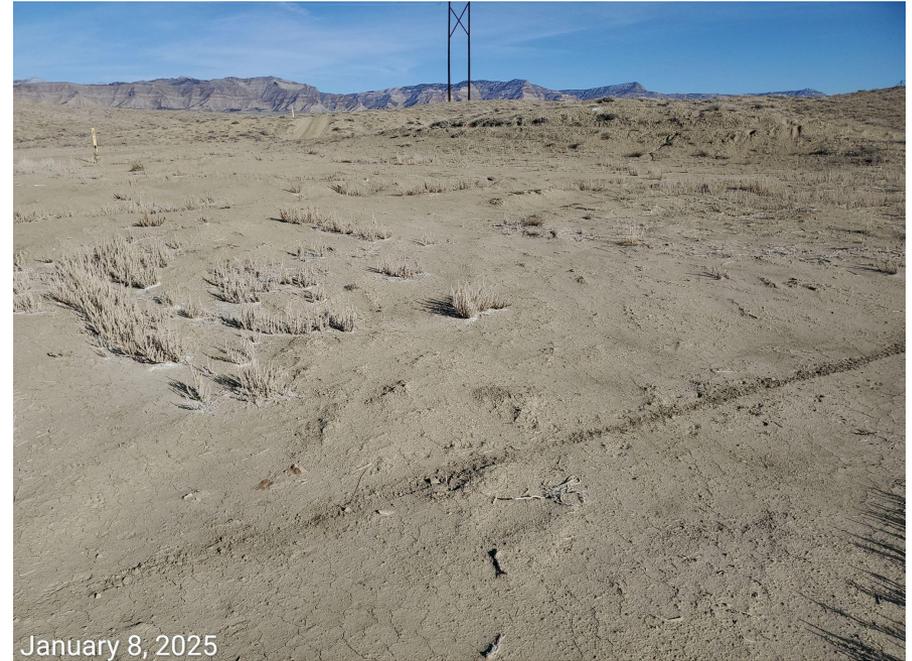
Photo 1: Photos 1-2 taken from the west end of the Location. Photos provide an overview of the Location from north, northeast, southeast to south. Photos show final reclamation has not been performed in accordance with 1004 requirements- Location has not been decompacted, recontoured/regraded and reclaimed; Undesirable and Noxious Plant Species (Halogeton) observed established throughout the Location disturbance.

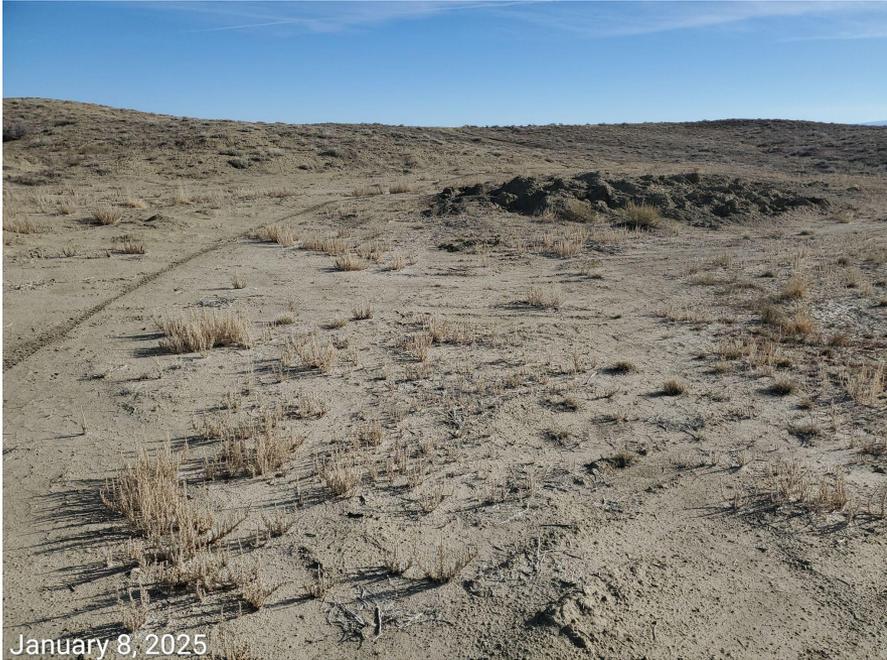
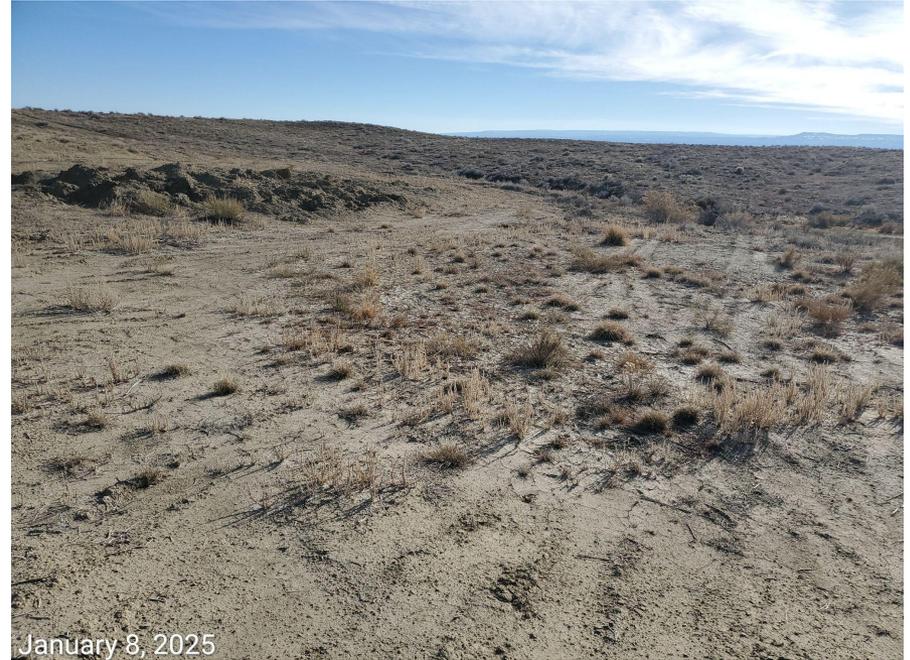
Photo 2: See comments under photo 1.

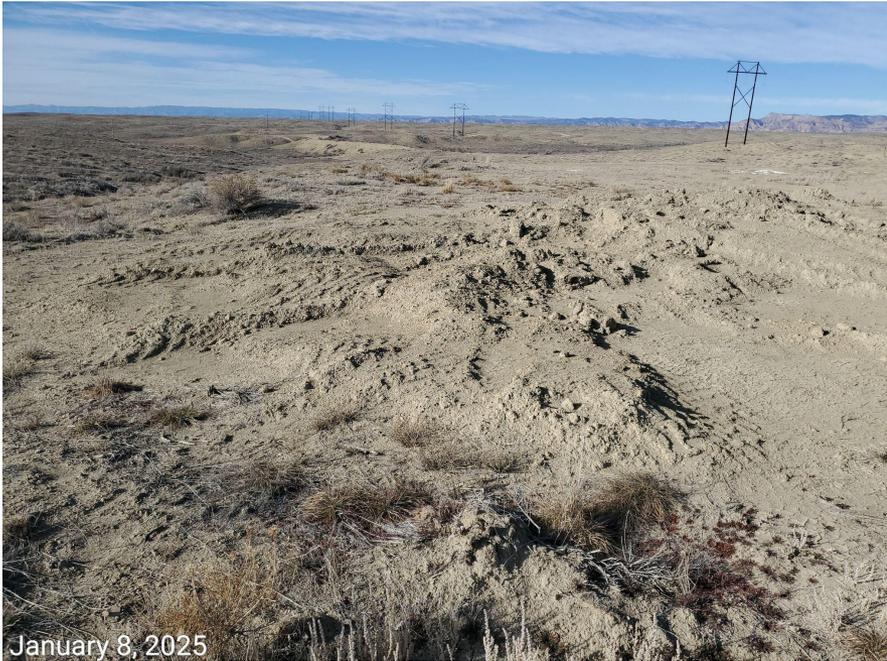
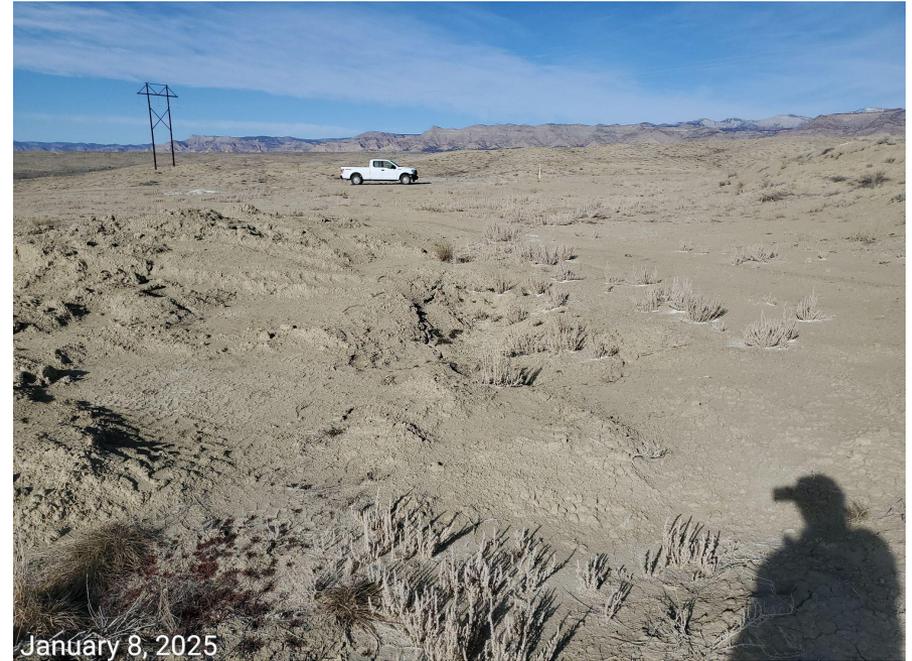
Photo 3: Photos taken from the south end of the Location. Photos provide an overview of the Location from northwest to north. Photos show final reclamation has not been performed in accordance with 1004 requirements- Location has not been decompacted, recontoured/regraded and reclaimed; Undesirable and Noxious Plant Species (Halogeton) observed established throughout the Location disturbance.

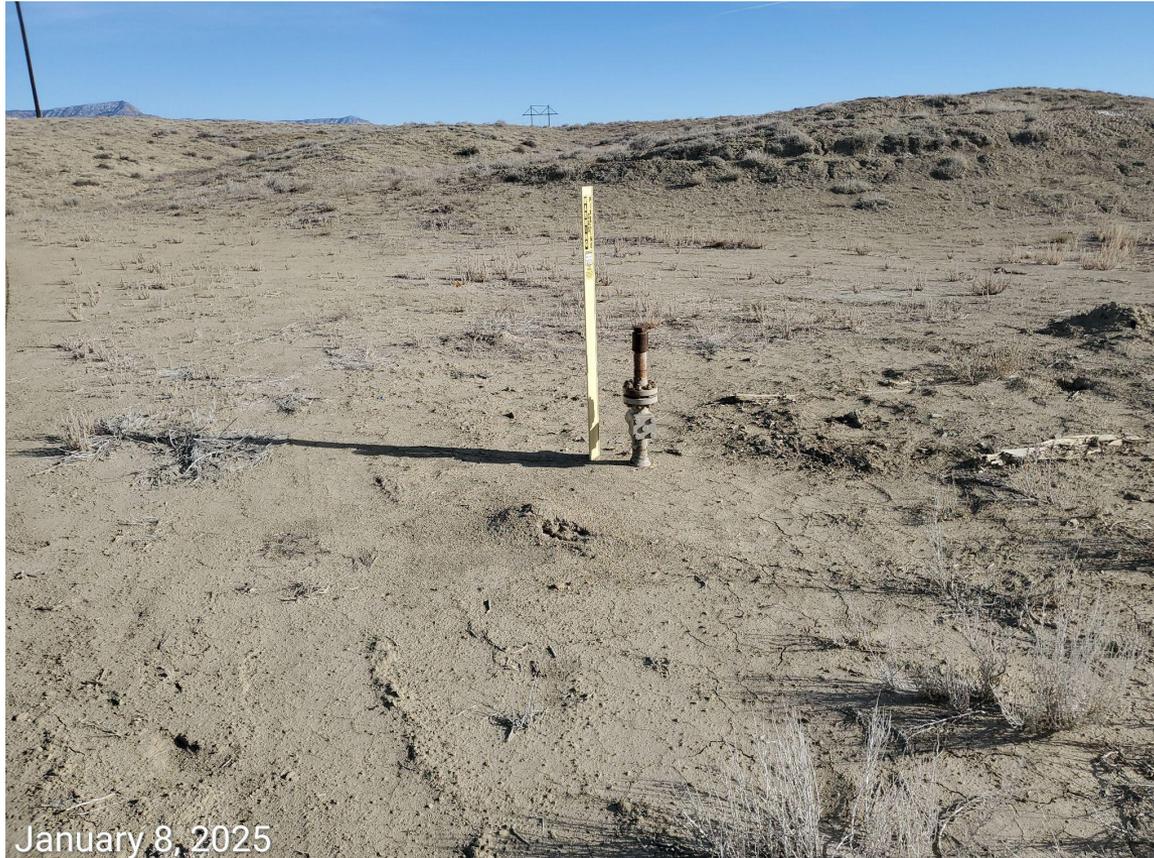
Photo 4: Photo shows surface equipment (riser) remaining on the north end of the Location.
