# Inspection Photos

**Operator:** PUBLIC SERVICE COMPANY OF  
COLORADO - 72400

**Location ID:** 312597

**Inspection Doc:** 718100168

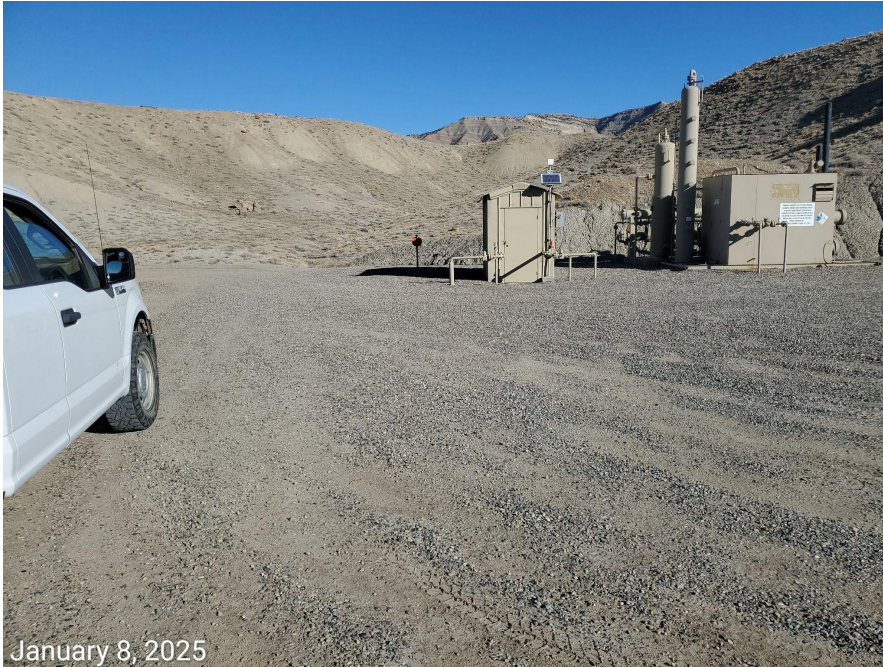
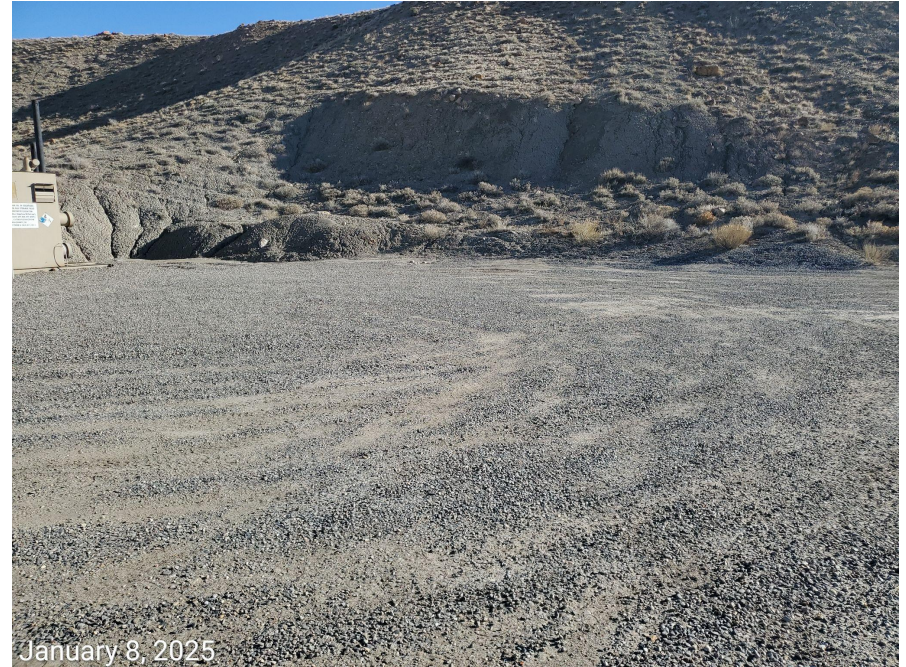
**Photo 1:** Photos 1-2 taken from the west end of the Location. Photos provide an overview of the Location north, northeast, southeast to south.

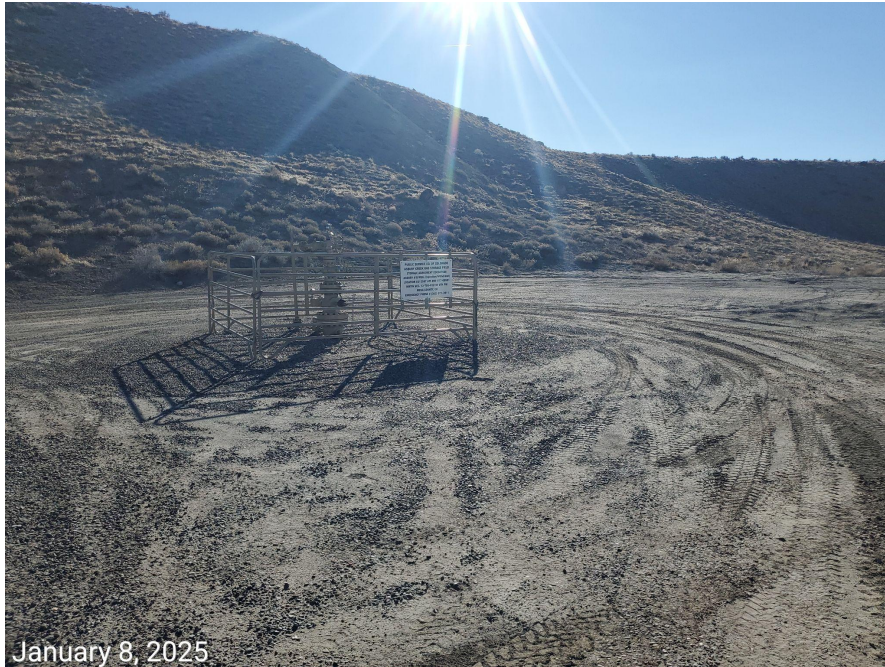
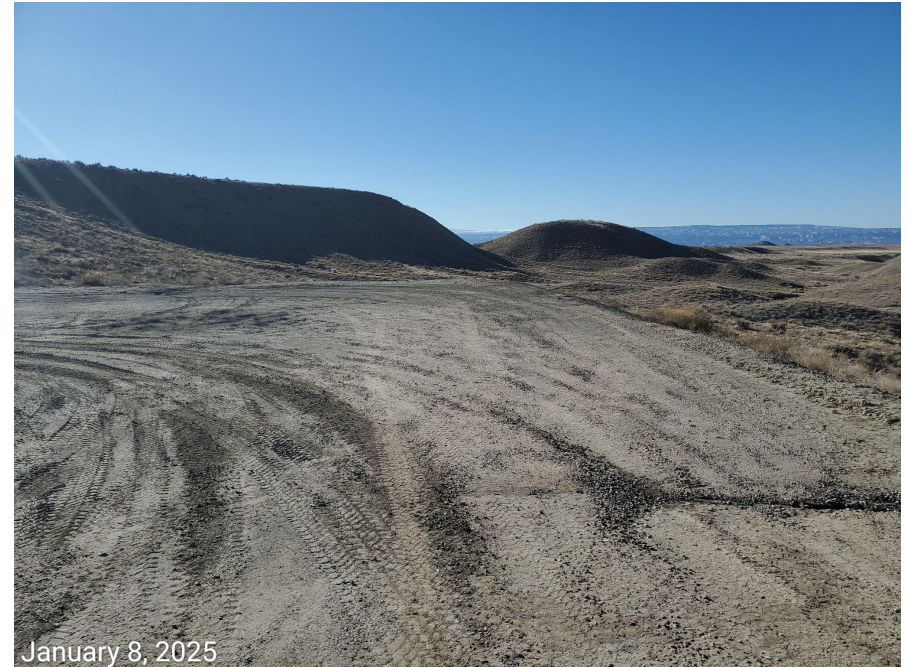
**Photo 2:** See comments under photo 1.

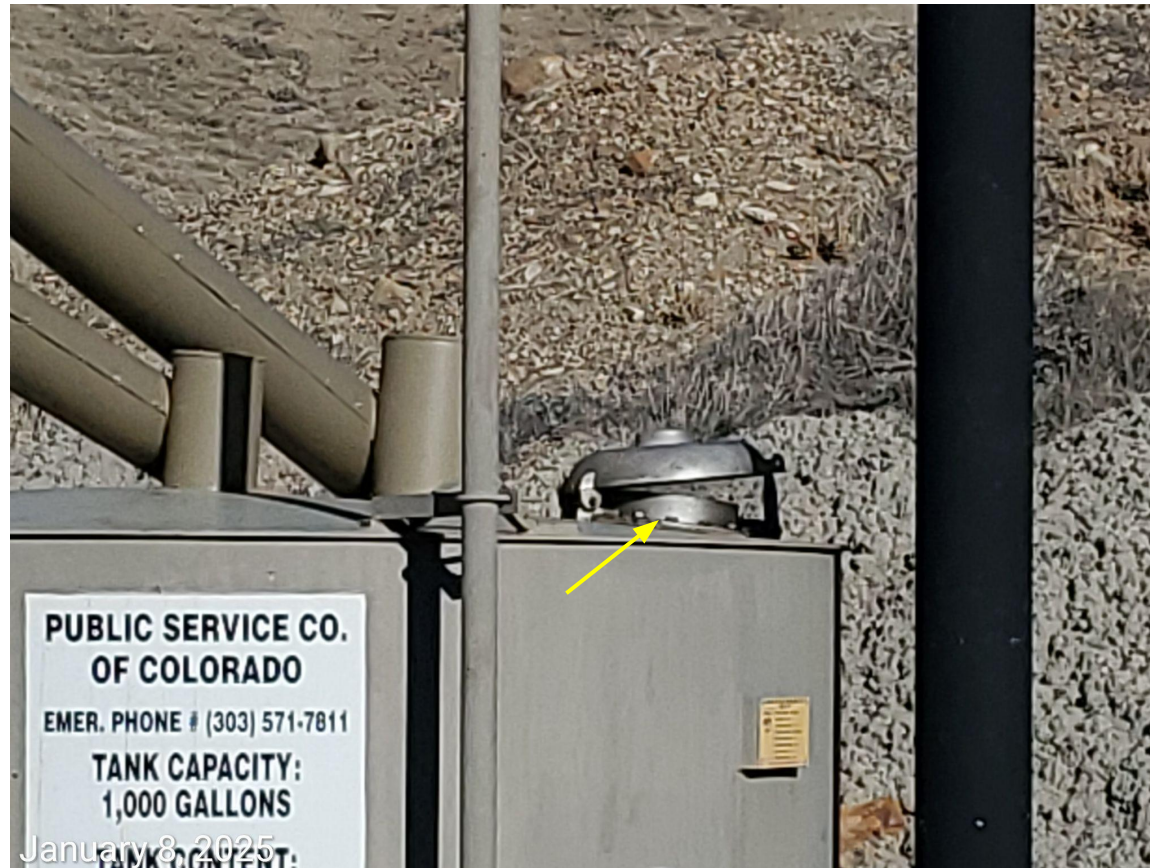
**Photo 3:** Photo shows hatch (arrow) at the produced water tank is open and currently venting to atmosphere.

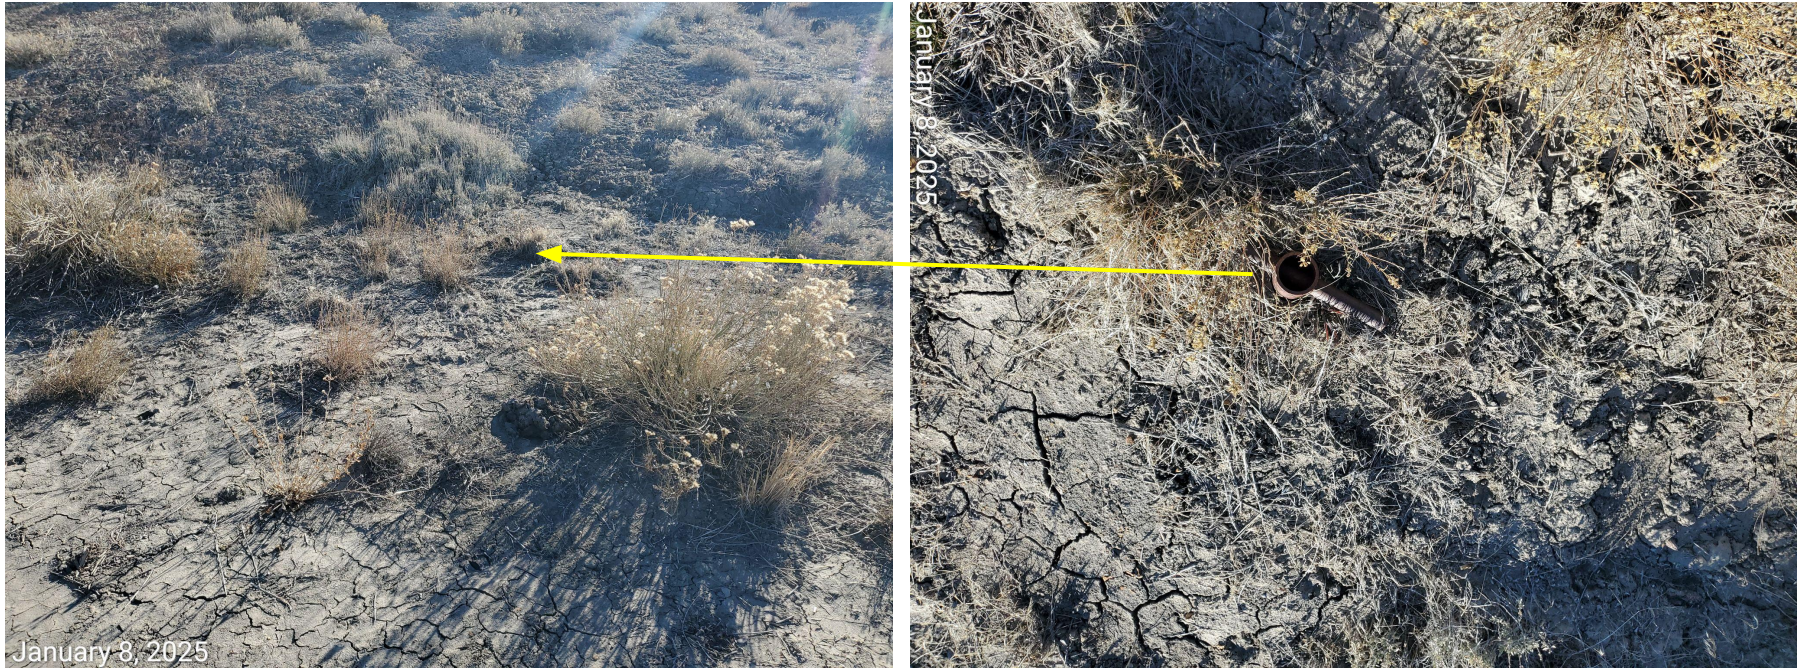
**Photo 4:** Photos 4-5 examples showing anchors on the Location have not been marked in accordance with 603.j/1003.a requirements.

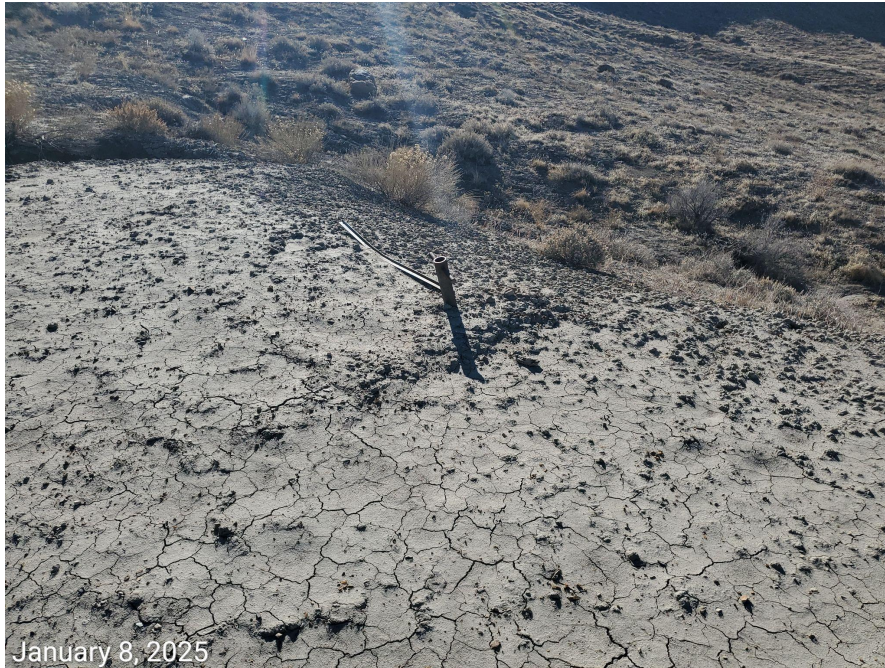
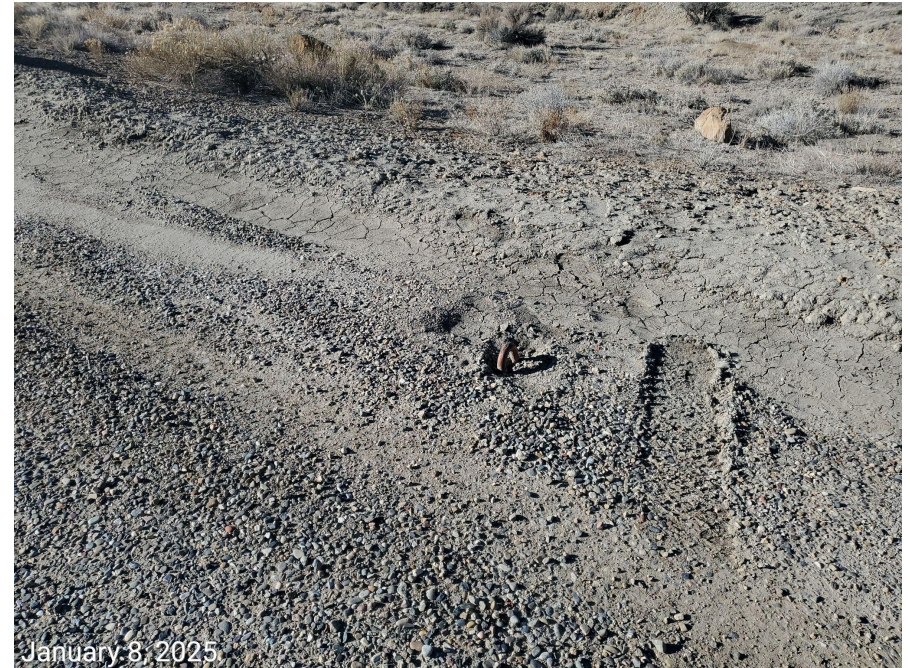
**Photo 5:** See comments under photo 4.

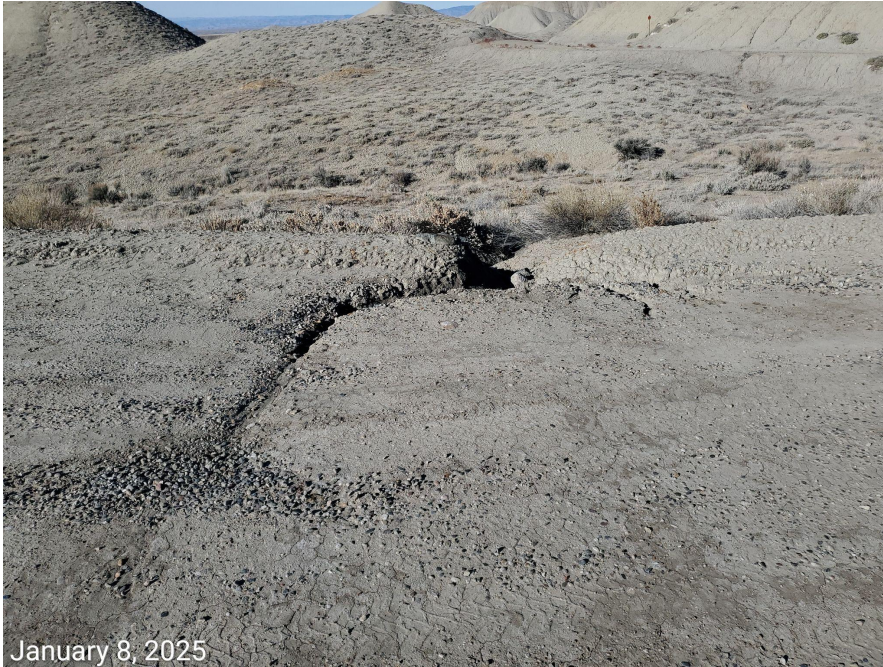
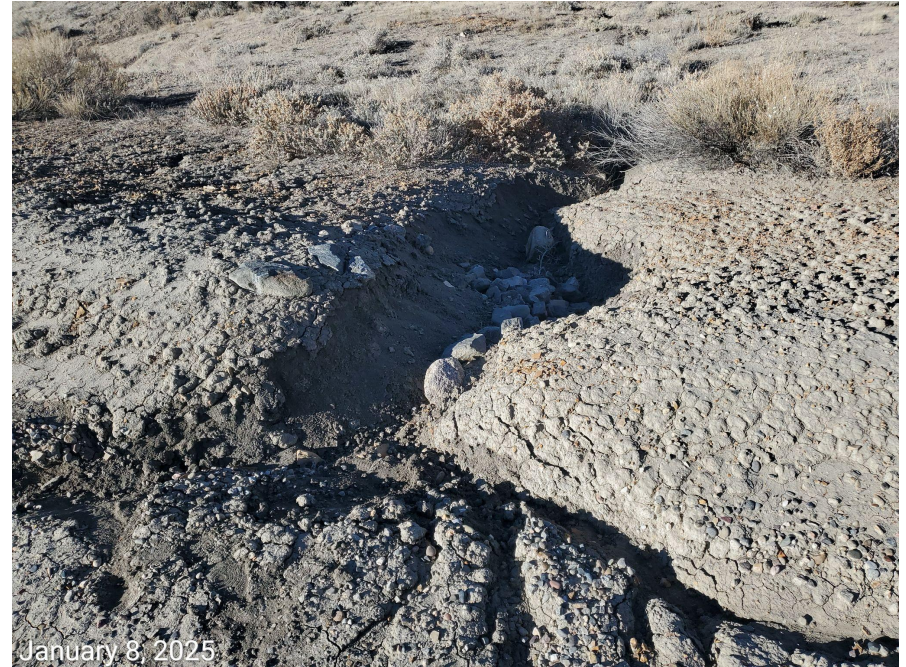
**Photo 6:** Photos examples showing erosion degradation on the west end of the Location has persisted; stormwater and erosion control measures to manage runoff in a manner that minimizes erosion, degradation and sediment transport remain missing or insufficient.

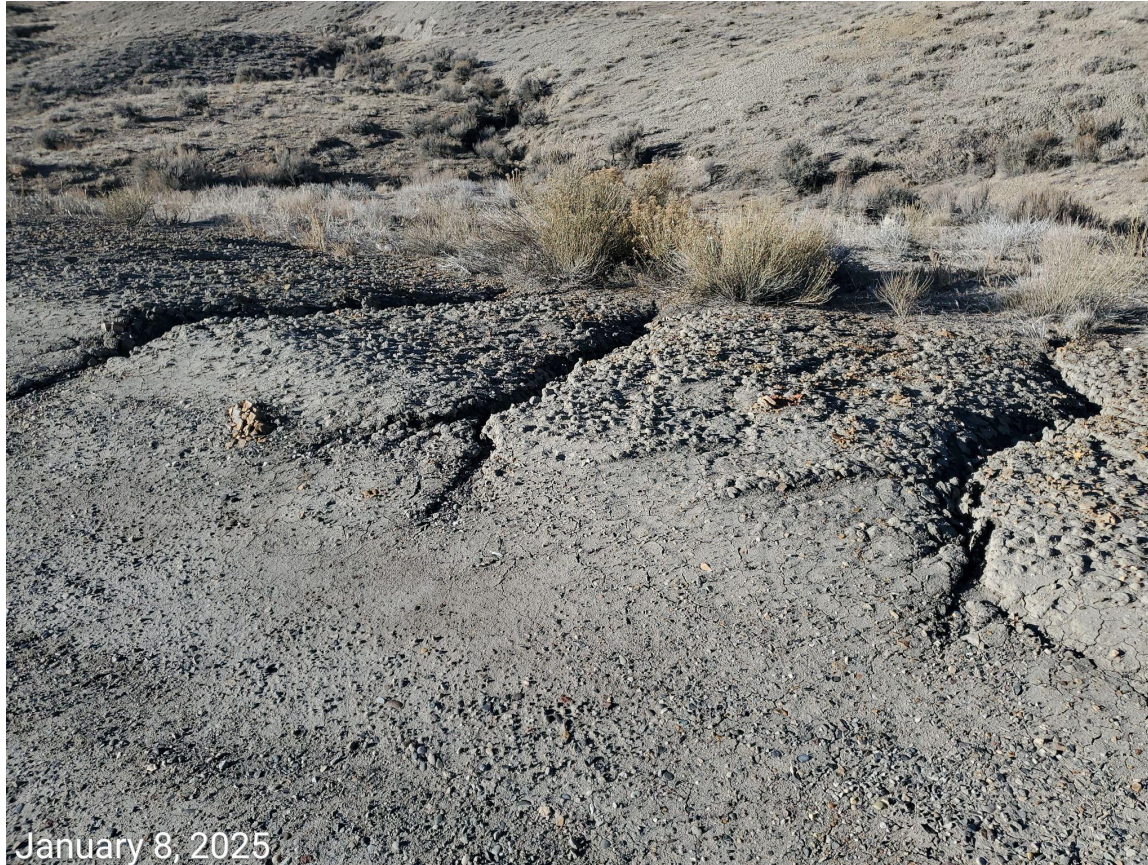
**Photo 7:** Photo examples showing erosion degradation on the west end of the Location has persisted; stormwater and erosion control measures to manage runoff in a manner that minimizes erosion, degradation and sediment transport remain missing or insufficient.

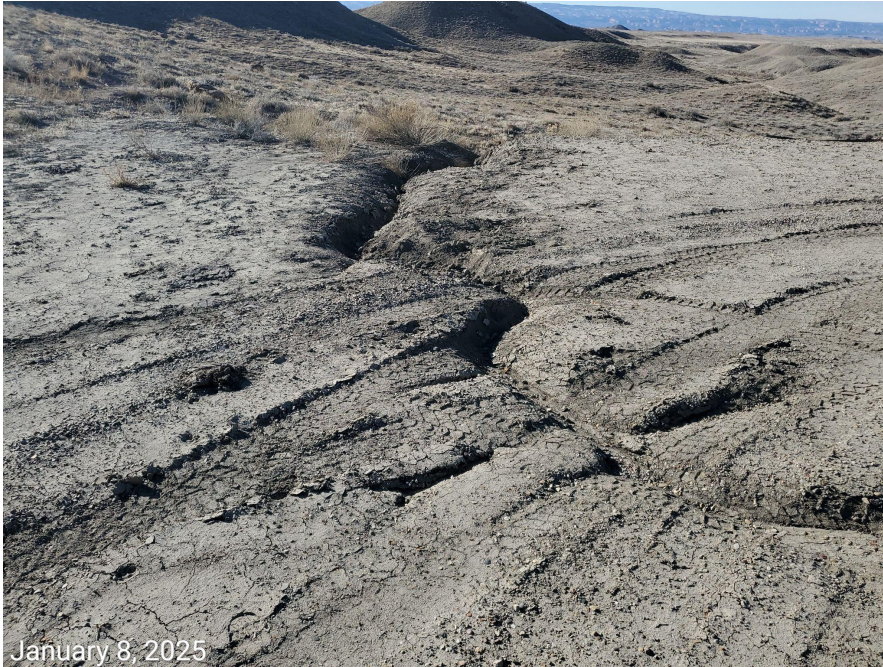
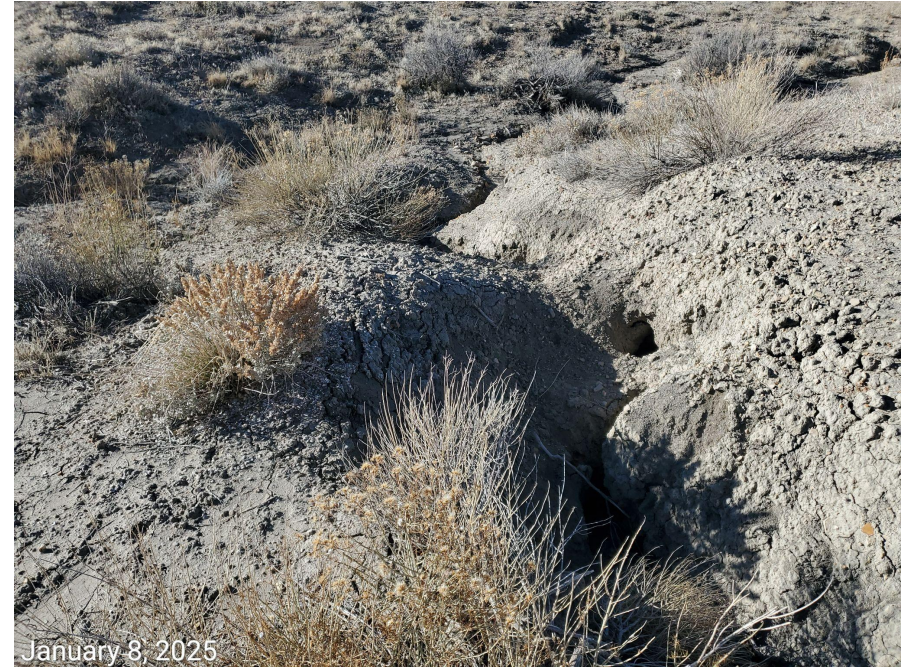
**Photo 8:** Photos examples showing erosion degradation on the south end of the Location has persisted; stormwater and erosion control measures to manage runoff in a manner that minimizes erosion, degradation and sediment transport remain missing or insufficient.

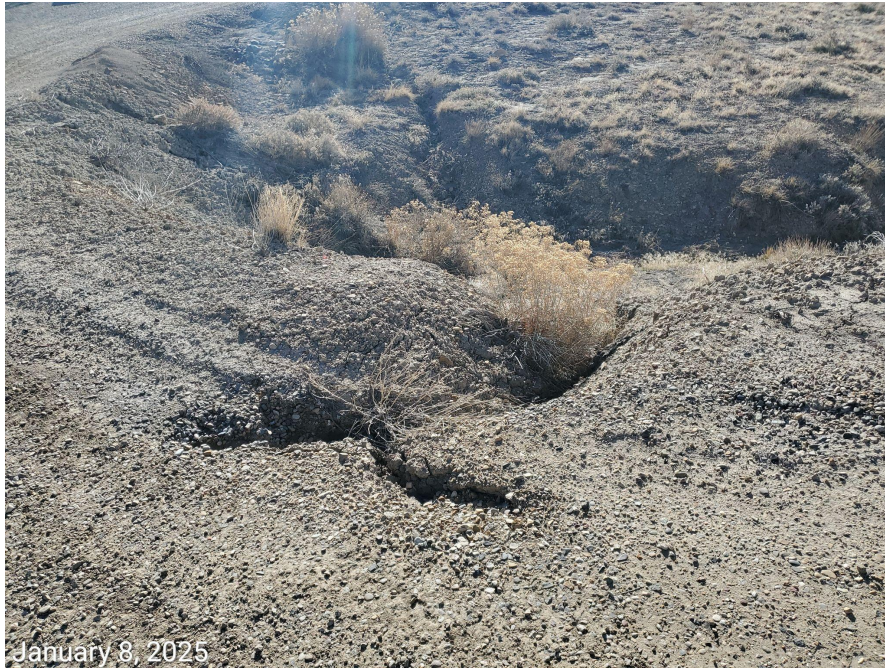
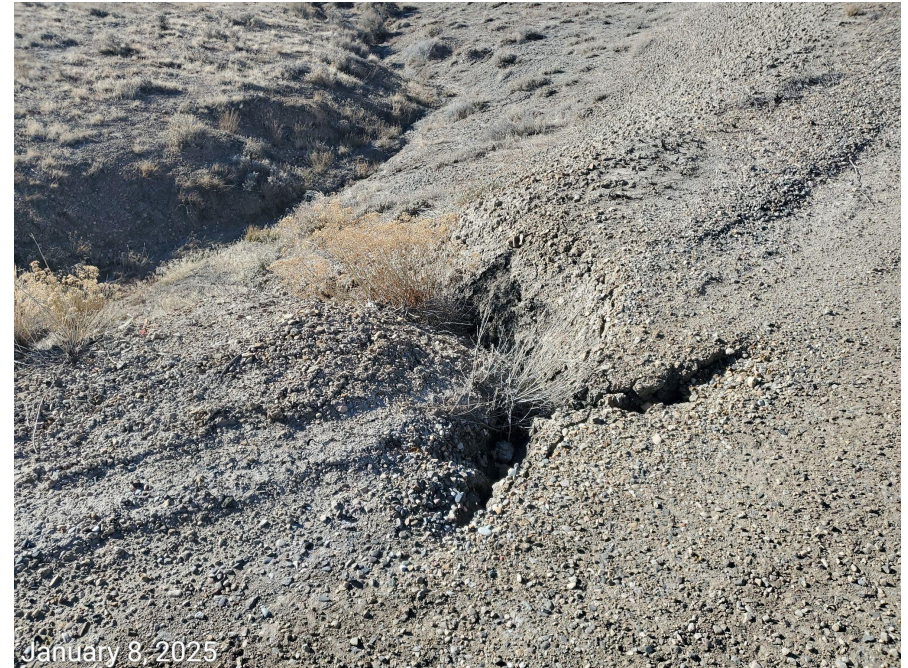
**Photo 9:** Photos examples showing erosion degradation at the access road has persisted; stormwater and erosion control measures to manage runoff in a manner that minimizes erosion, degradation and sediment transport remain missing or insufficient.

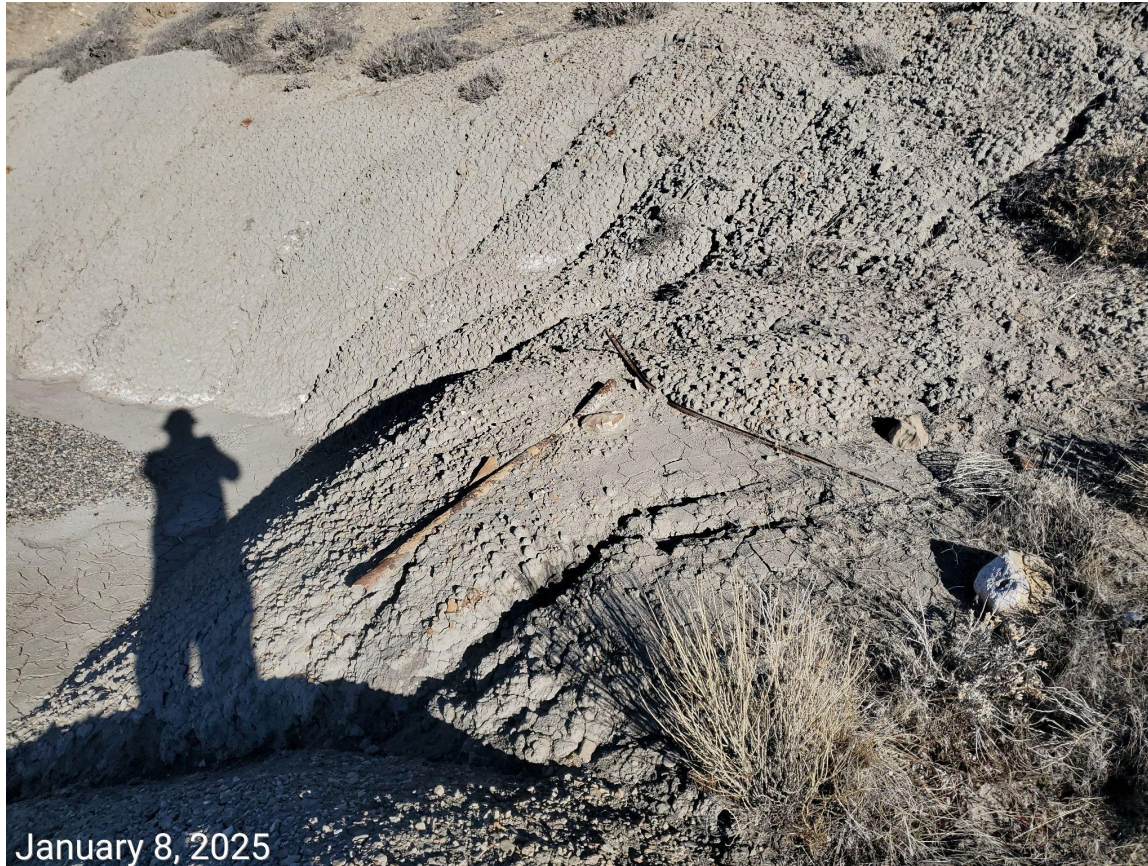
**Photo 10:** Photo shows trash/debris on the northeast end of the Location.
