Inspection Photos

Loc: 324797

Operator: WESTERN OPERATING COMPANY

Inspection Date: 1/14/2025

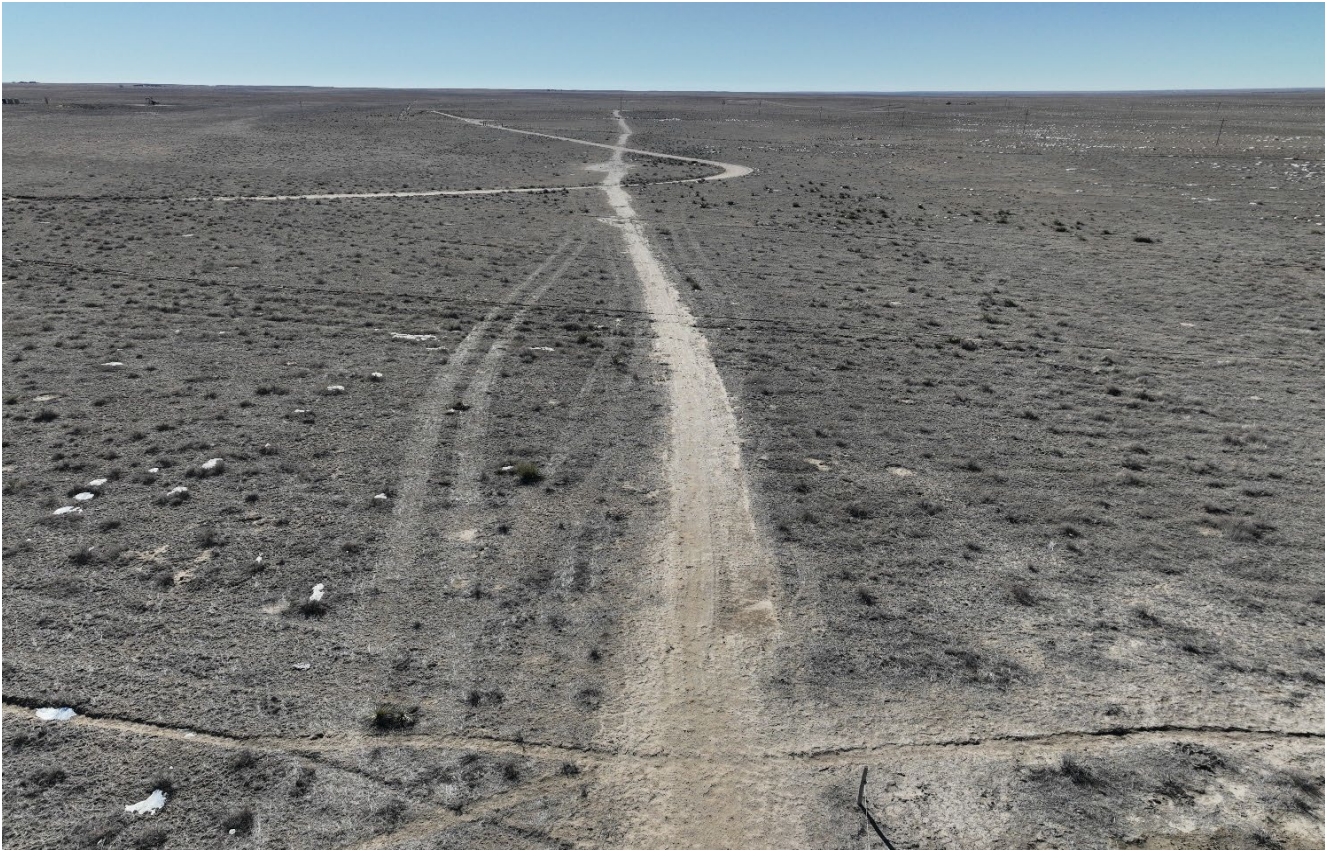
Photo 3. Facing south from the Dawson tank battery. A new flowline was installed and disturbance along the flowline must be reseeded and reclaimed before the upcoming growing season.

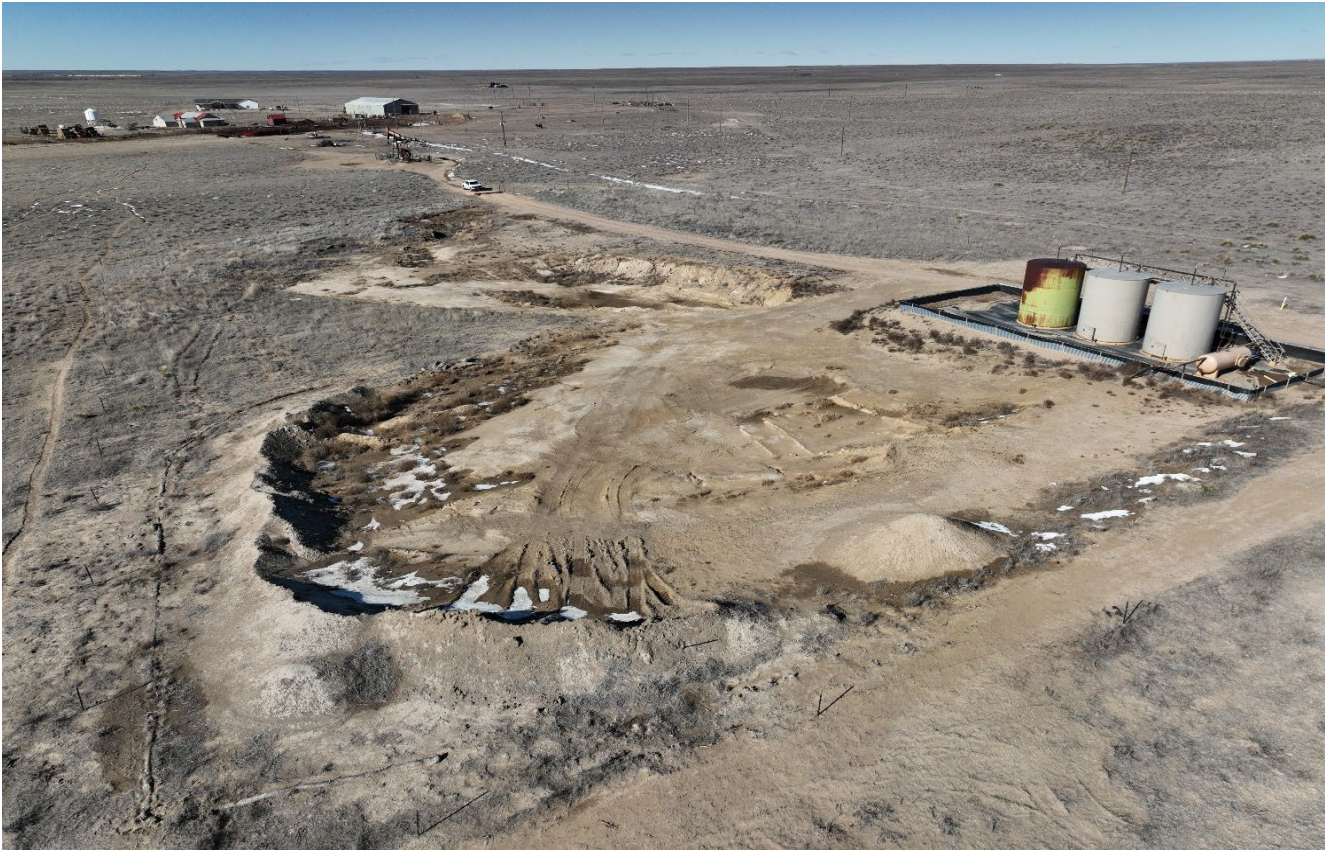
Photo 4. Facing northwest toward the tank battery and remediation area.

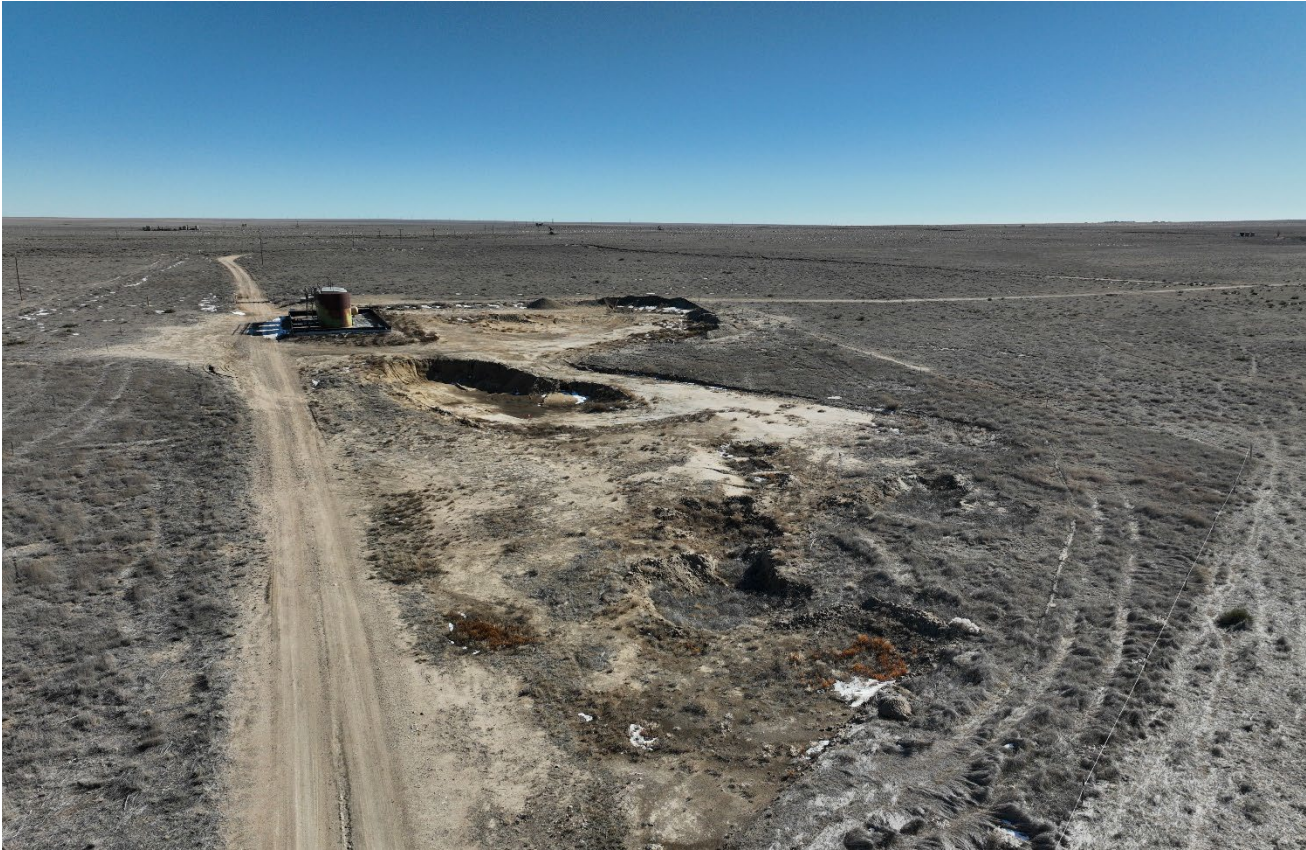
Photo 6. West side of the location facing east overlooking the remediation area.

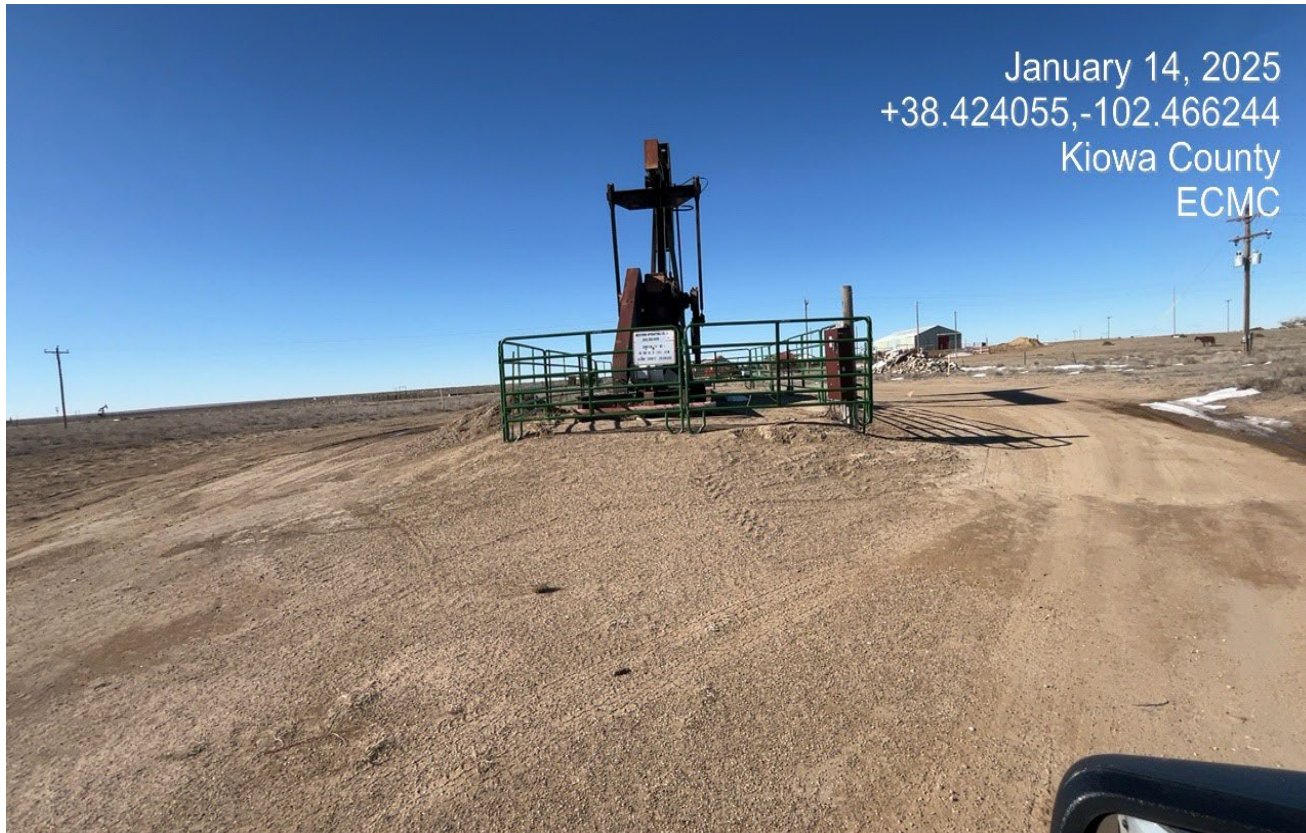
Photo 7. Facing east at the wellsite.
