Inspection Photos

Operator: TEP ROCKY MOUNTAIN LLC - 96850

Location ID: 416774

Inspection Doc: 718100195

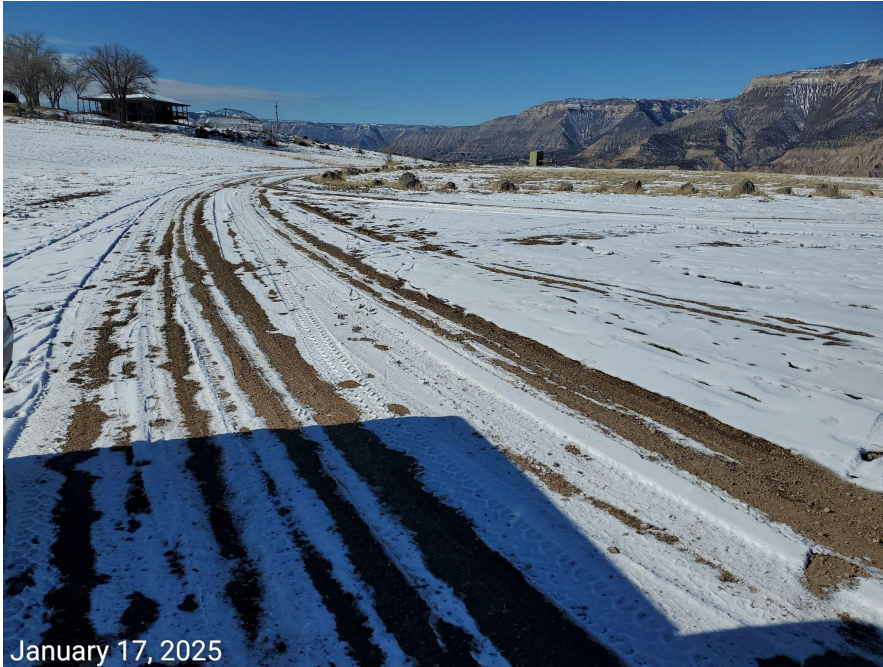
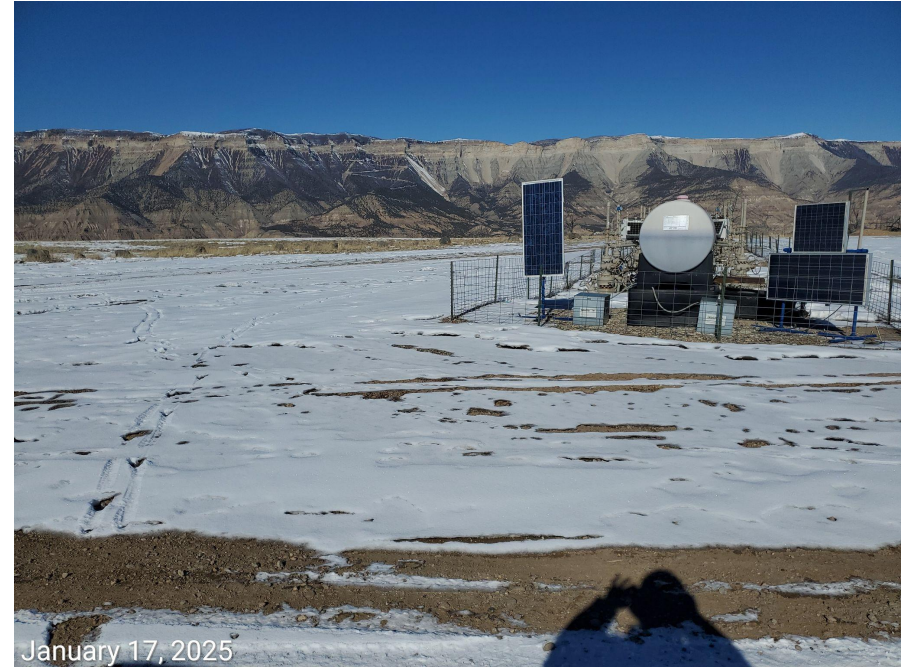
Photo 1: Photos 1-2 taken from the south end of the Location. Photos provide an overview of the Location from west, northwest, northeast to east.

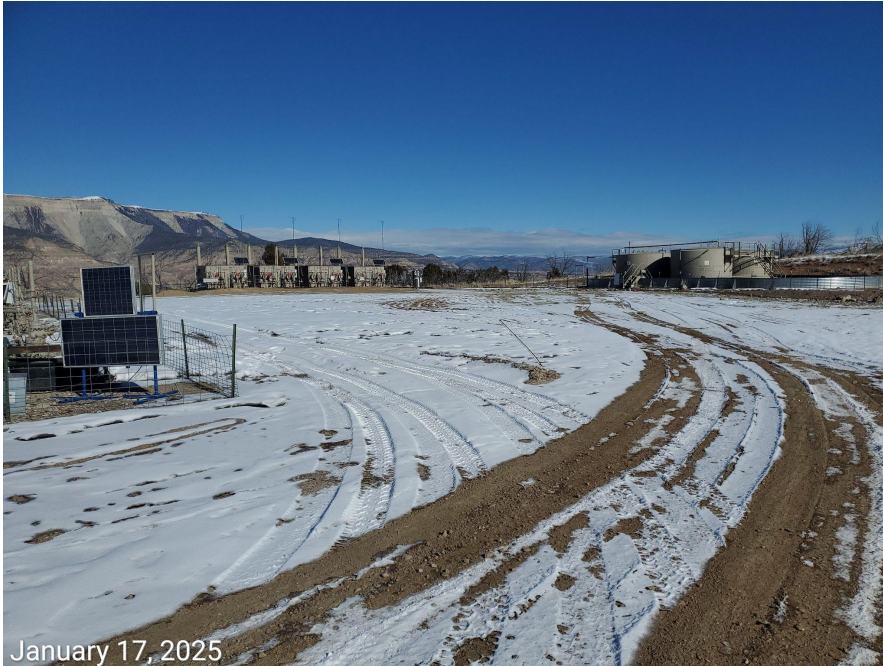
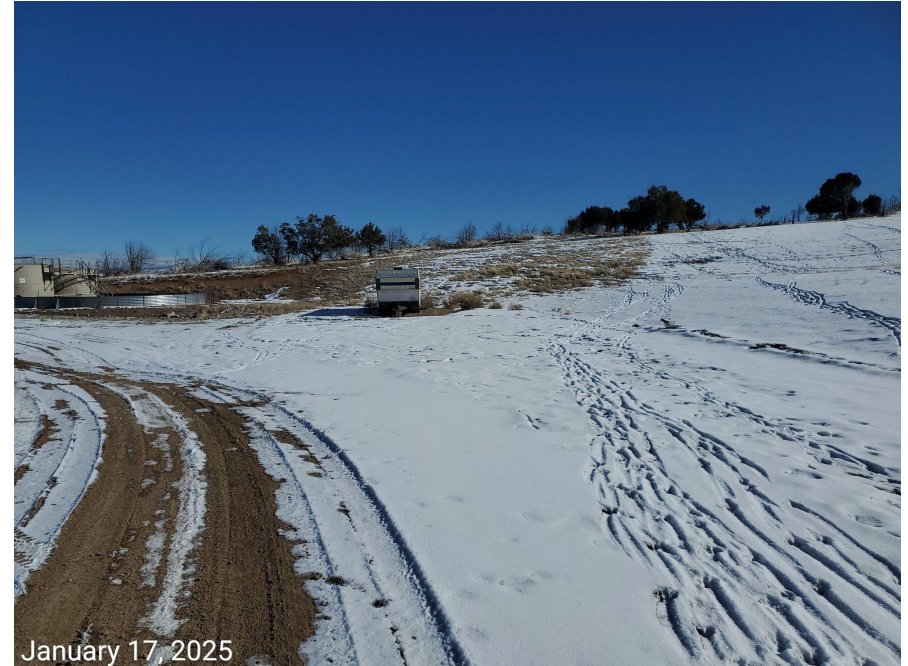
Photo 2: See comments under photo 1.

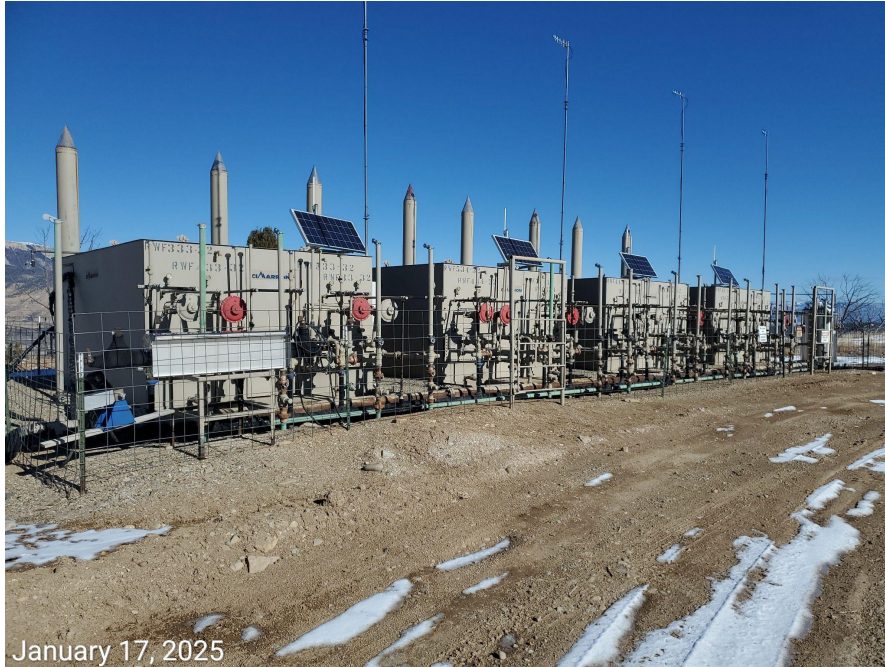
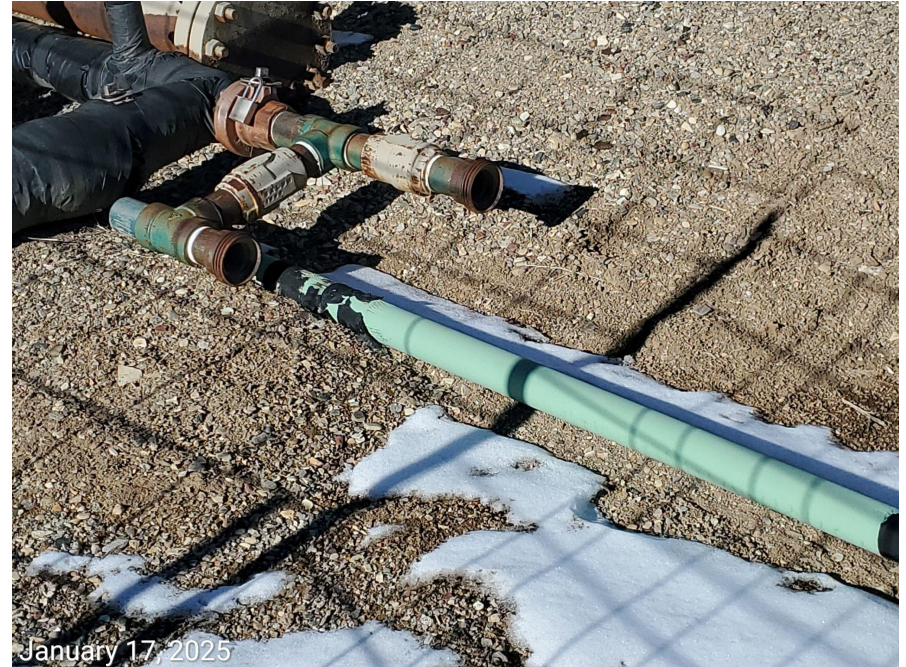
Photo 3: Pipe/Lines on the east end of the separator equipment are open/exposed.

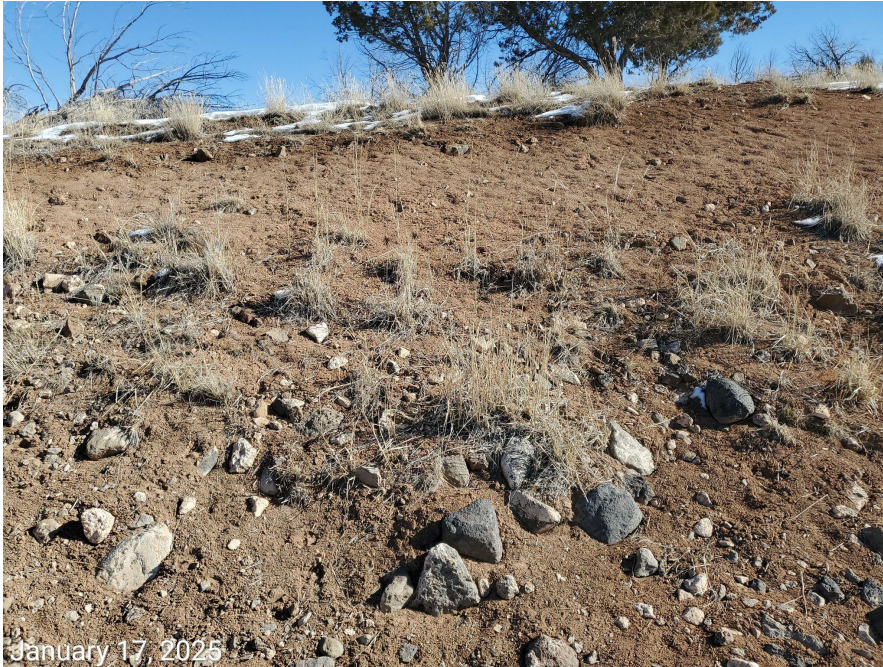
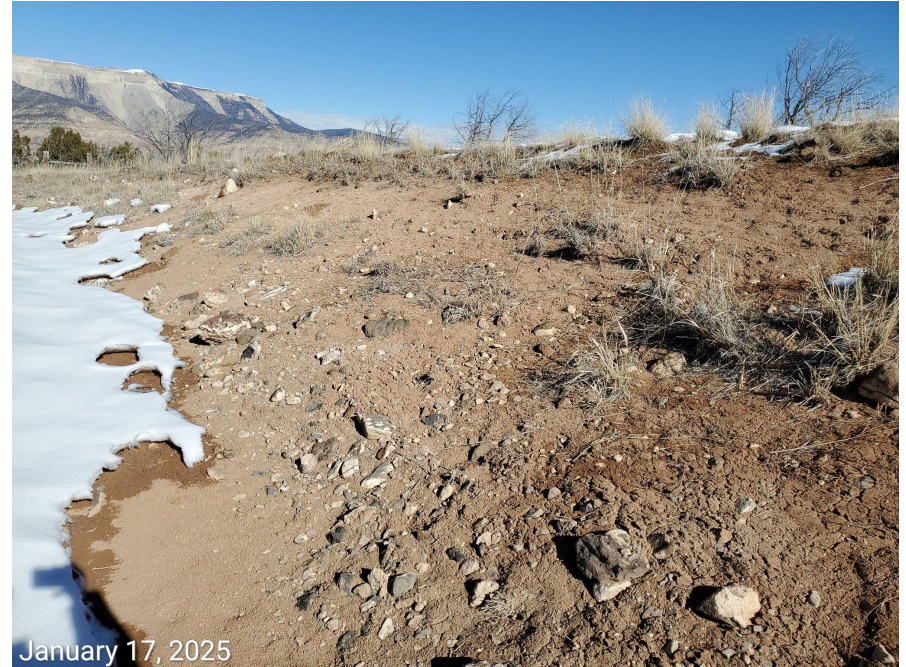
Photo 4: Photos taken from the east end of the Location. Photo shows areas of the Location where vegetation establishment is not uniform; soils are predominantly bare. Additional reclamation efforts required within these areas.

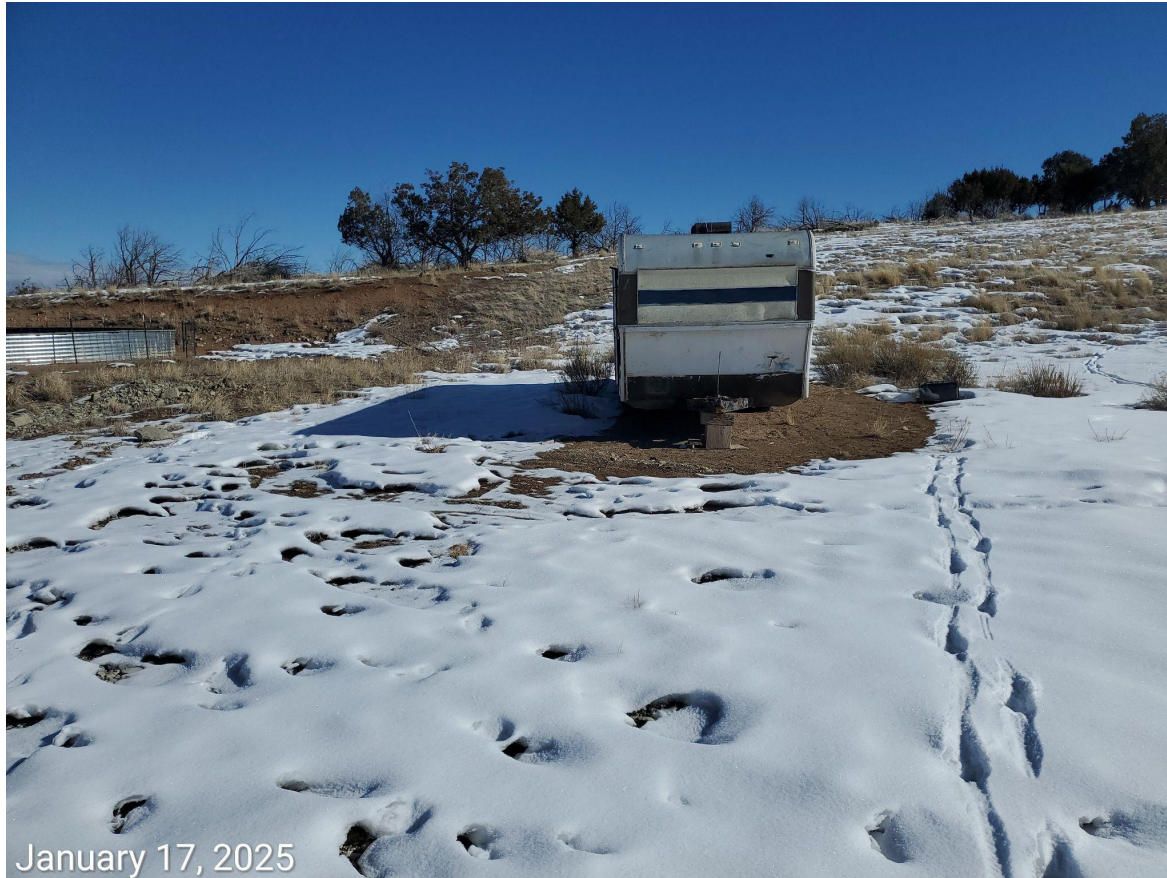
Photo 5: Photo taken from the southeast end of the Location, facing east. Photo shows trailer/trash debris remains improperly stored on the Location. This is interfering with the reclamation and Operator's ability to achieve uniform vegetative establishment.
