Operator: Crestone Peak Resources

Location Name: Left Hand 3-65 13-0

Loc ID: 455750

Inspection: 7133901101

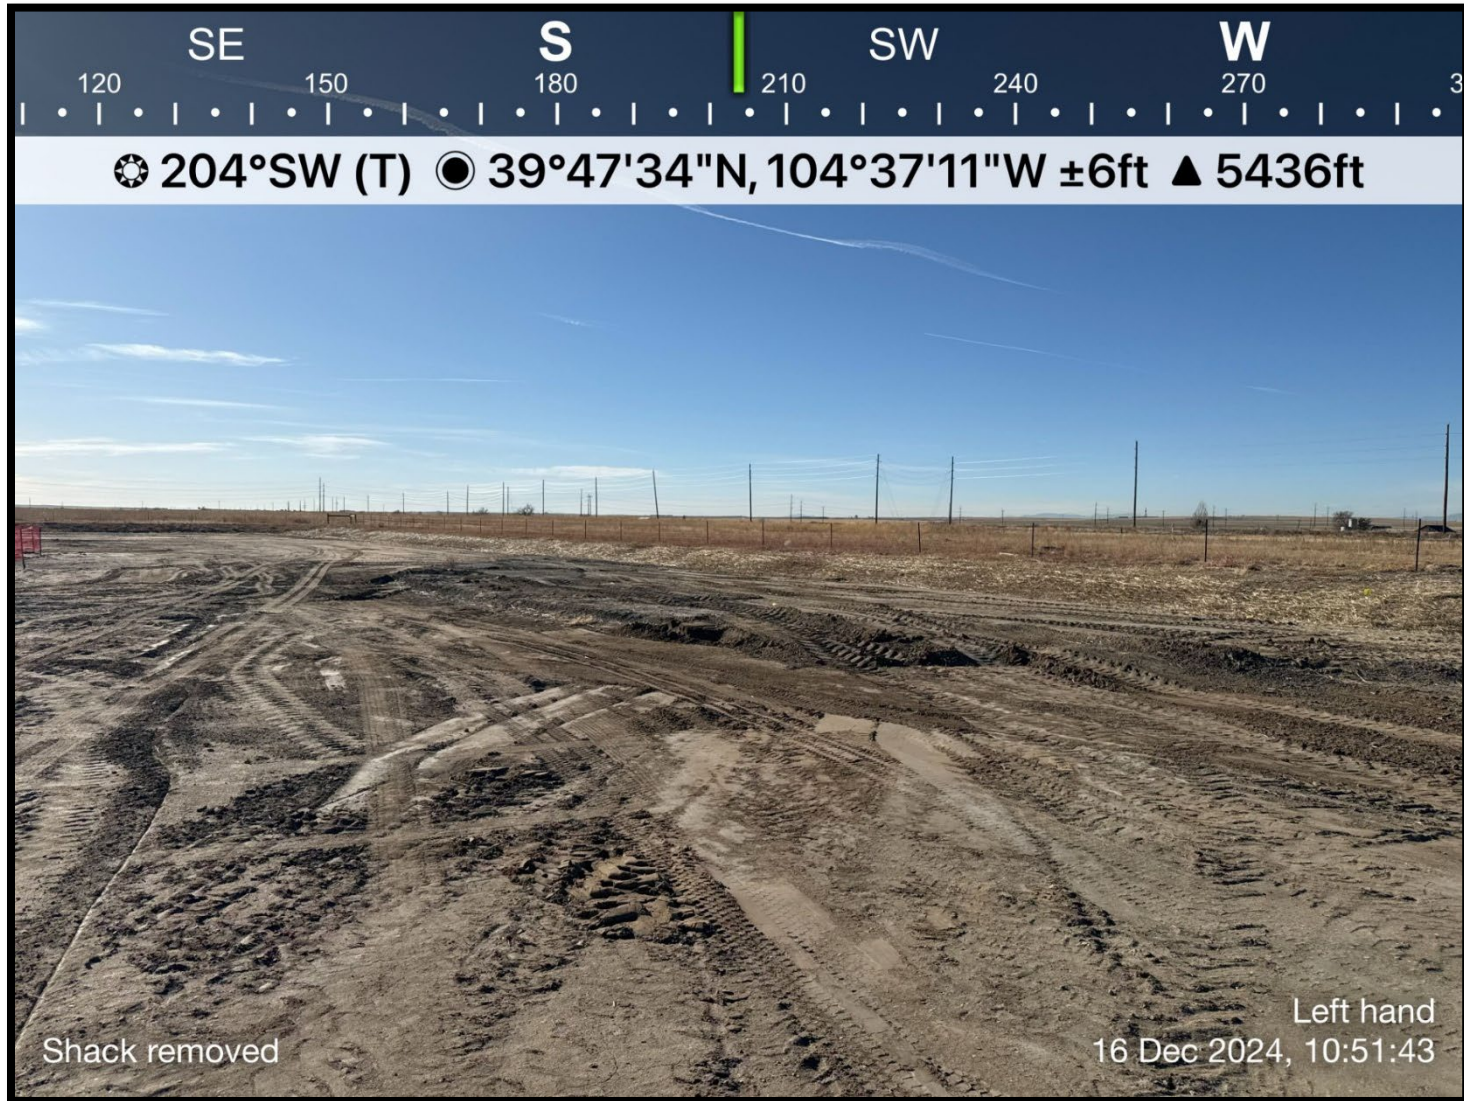
CA: One (1) meter shed remains at the location. Refer to the attached inspection photos. Comply with the reclamation rules to remove all debris, abandoned gathering line risers, flowline risers, and equipment (regardless of ownership) within three months of plugging (11/29/2023) the associated facility. All work should have been conducted by 2/29/2024.

CA Resolution: Operator has reported that midstream shack has been removed, as well as additional debris and equipment to comply with reclamation rules.
