# Final Reclamation and Stormwater Inspection

Location ID: 319795

Well Name: STATE A #3

Inspection Document #: 718600187

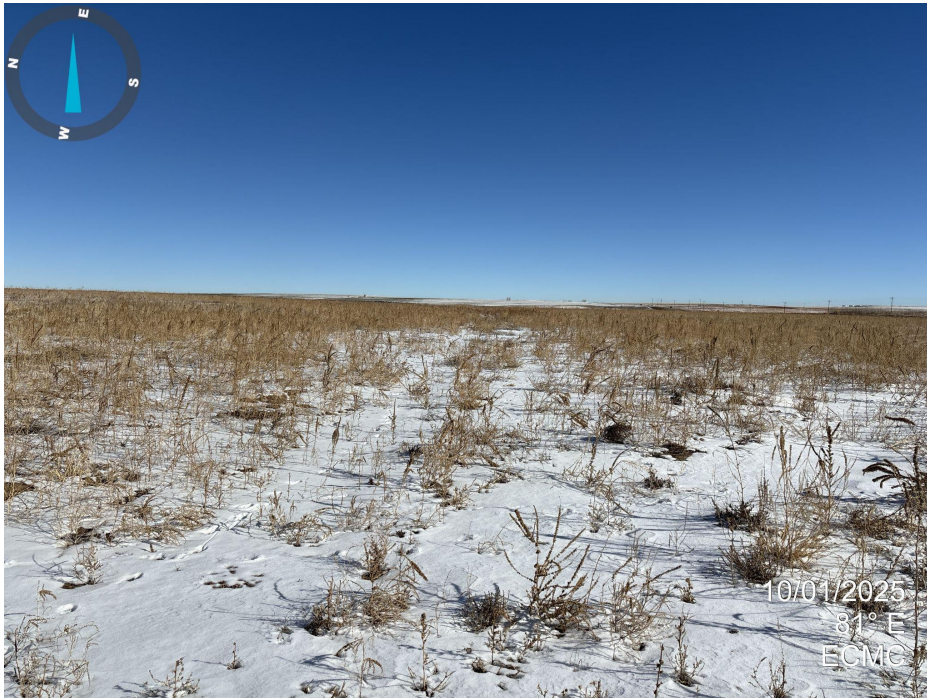
**Photo 1.** Looking east along access road from well location ID #319795 toward well site. It appears that this section of access road is progressing towards 80% of reference area vegetation.

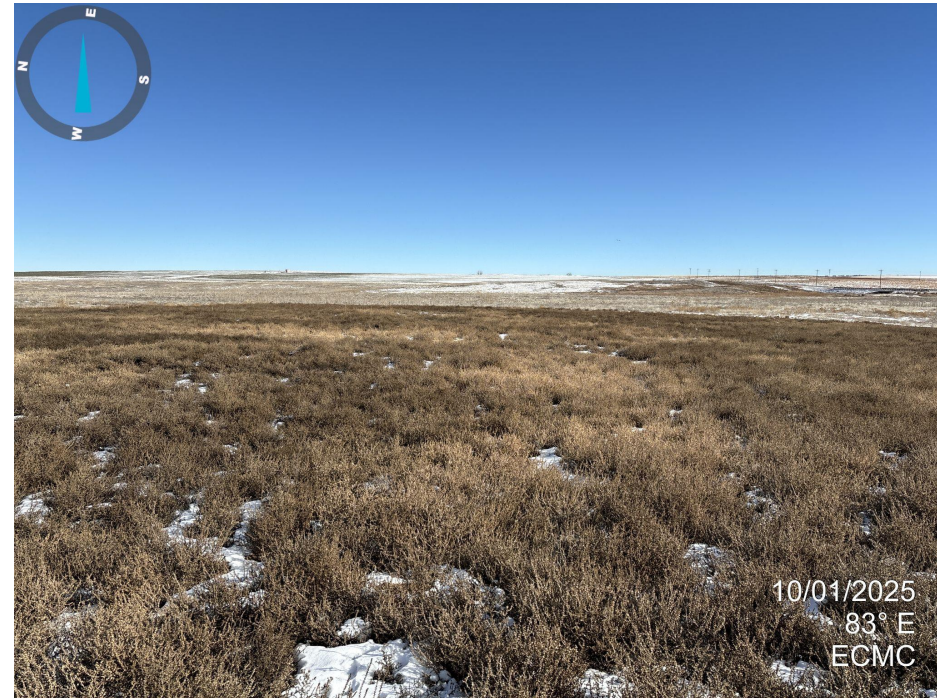
**Photo 2.** Overview of well location looking east across well site. Undesirable annual weedy species Kochia and Russian thistle dominate location.

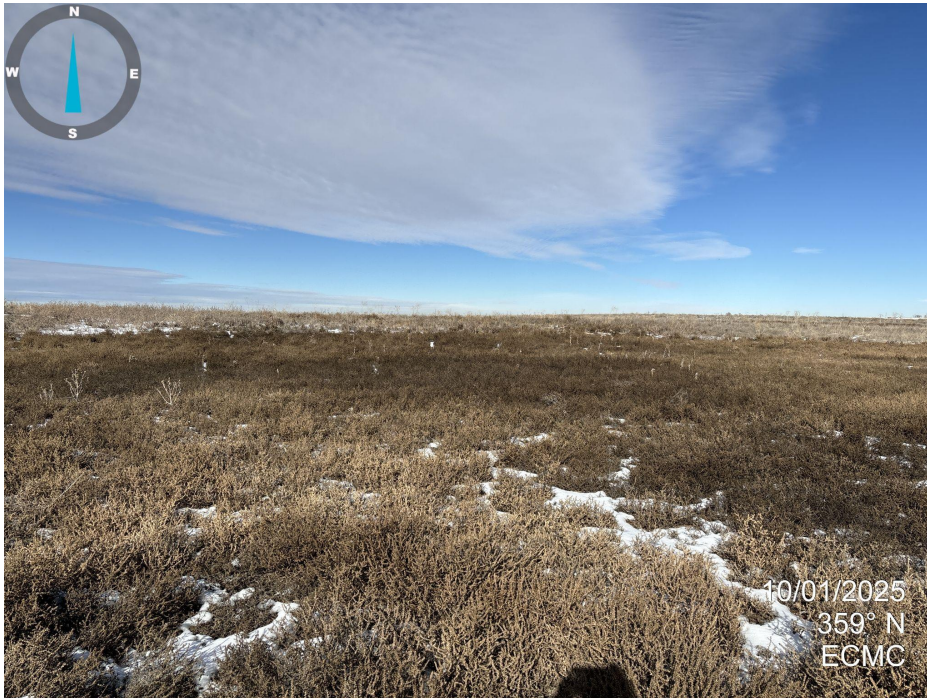
**Photo 3.** Looking north from well location. See Photo 2 comments.

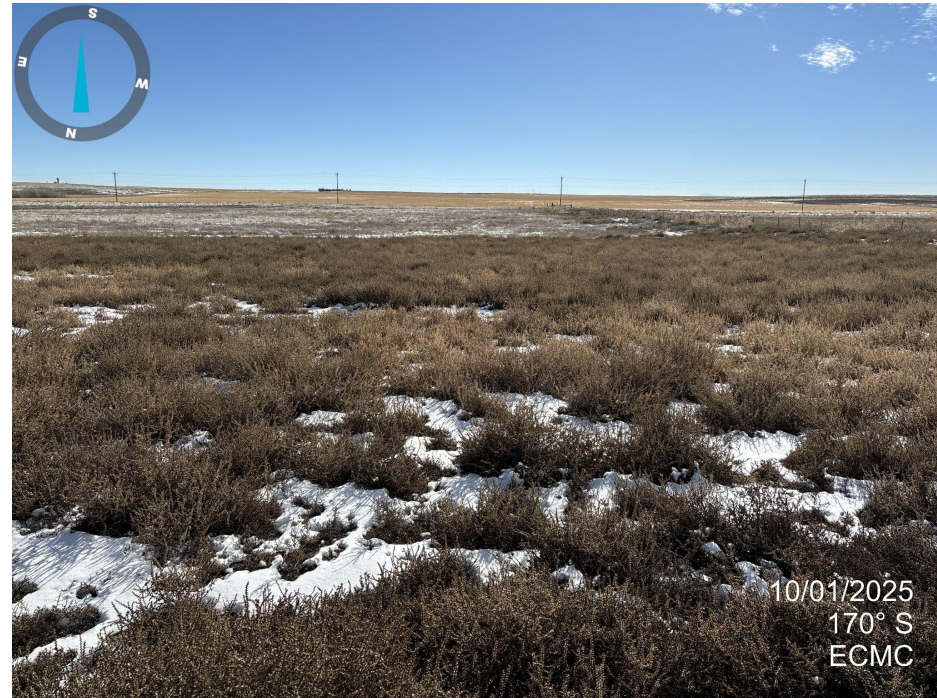
**Photo 4.** Looking south from well location. See Photo 2 comments.

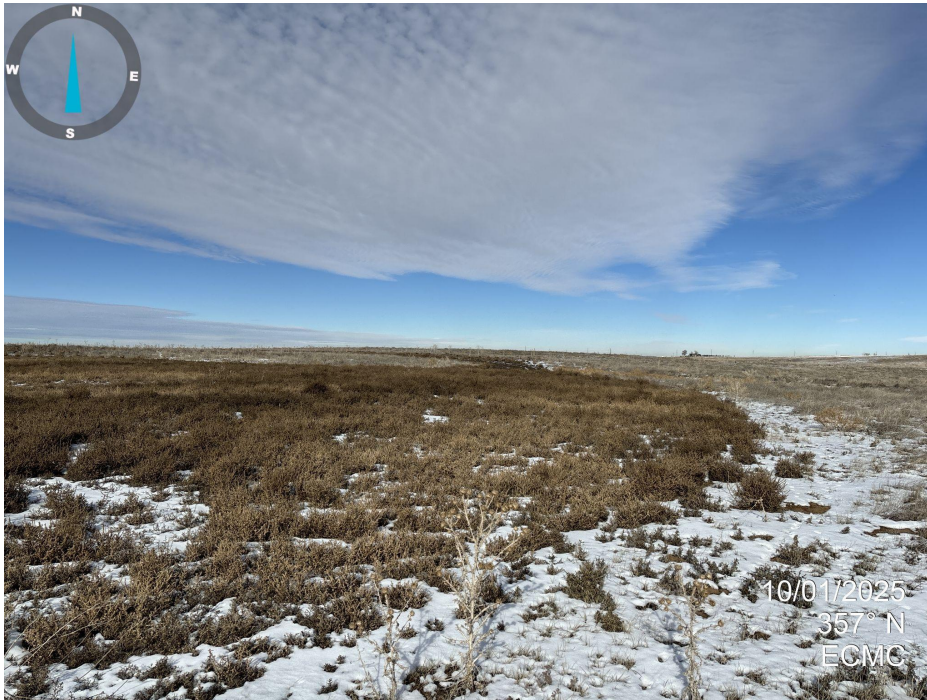
**Photo 5.** Looking north from east side of location towards northern access road. List B noxious weeds Bull thistle and Scotch thistle are present on location.

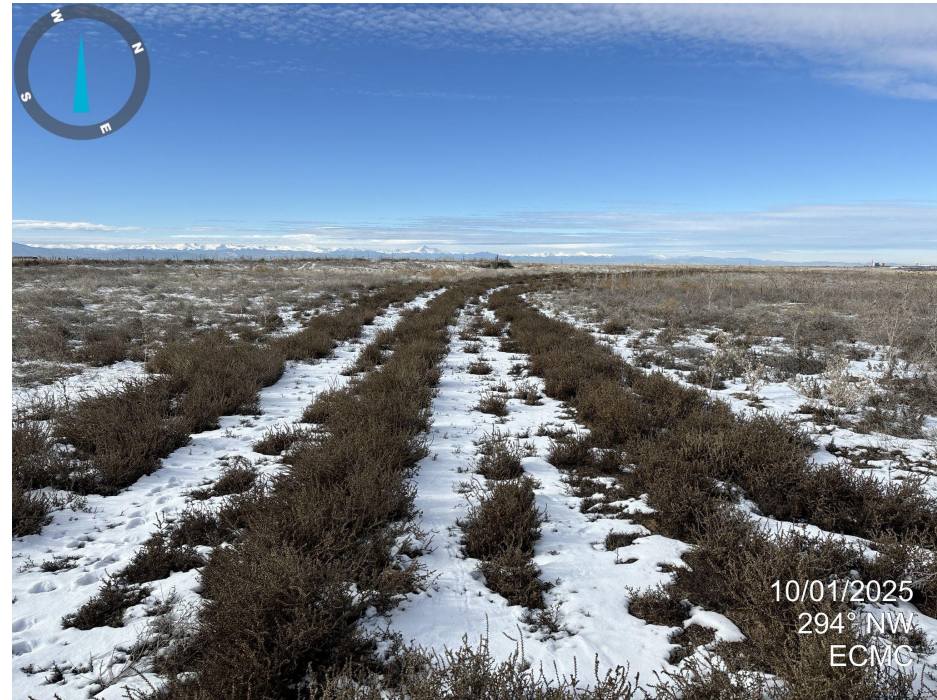
**Photo 6.** Looking west along north access road from well location. Kochia and Russian thistle are dominant along access road.

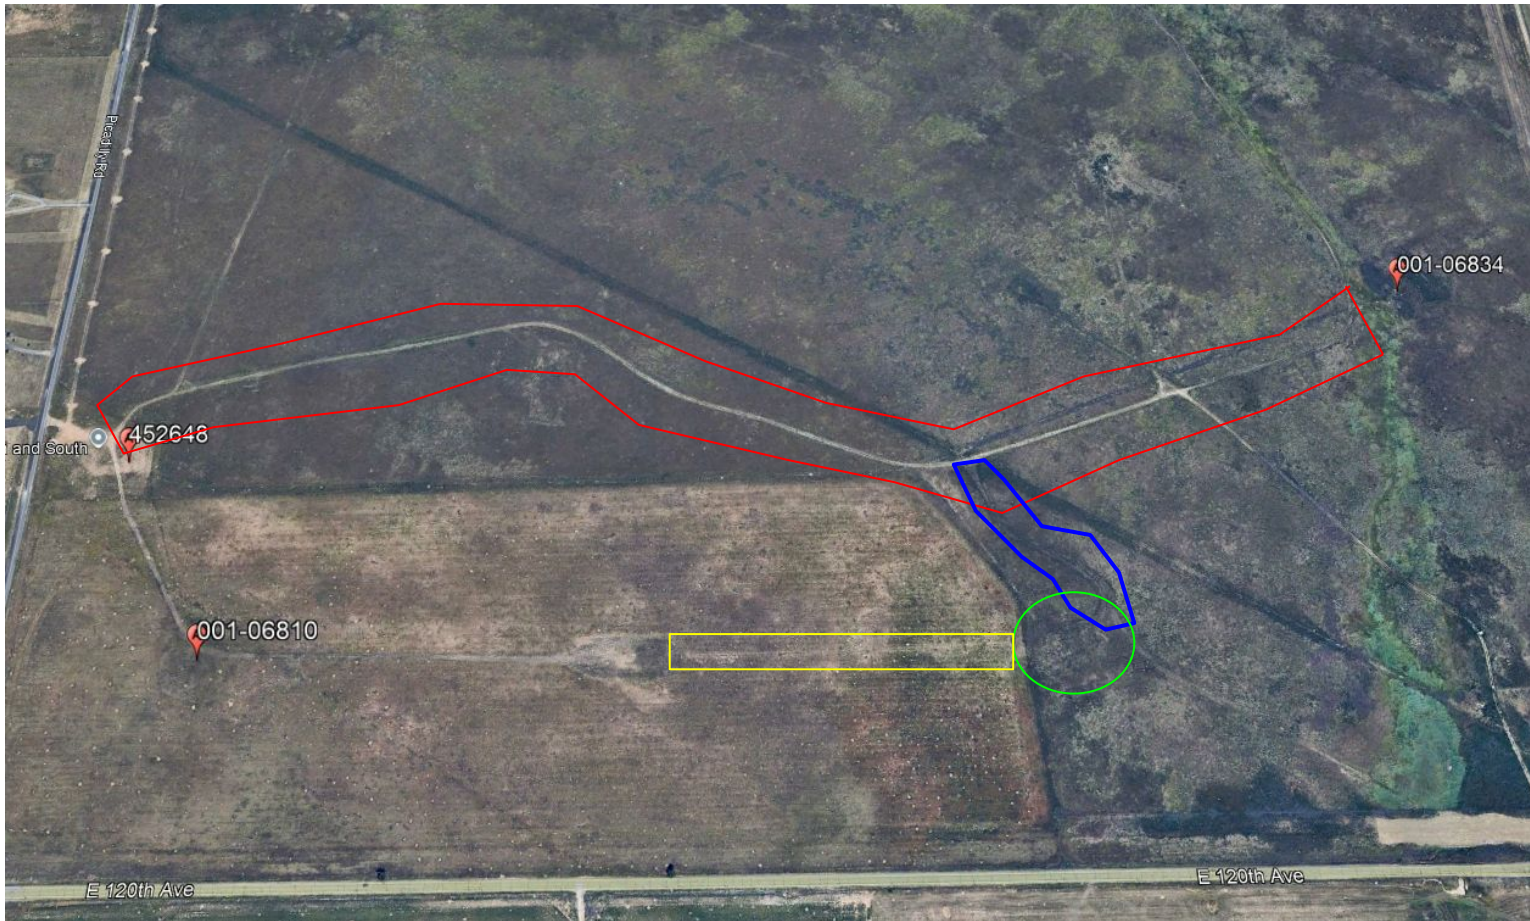
**Photo 7.** Aerial Photo from google 09/2023. All wells being serviced by main access road are plugged and abandoned. Vegetation has not established on access road. Main access road appears to require further reclamation (red circle). Also pictured, north access road (blue circle), Well location (green circle), western access road (yellow square).
