# Inspection Photos

**Operator:** CAERUS PICEANCE LLC #10456

**Location ID:** 334919

**Inspection Doc:** 718100215

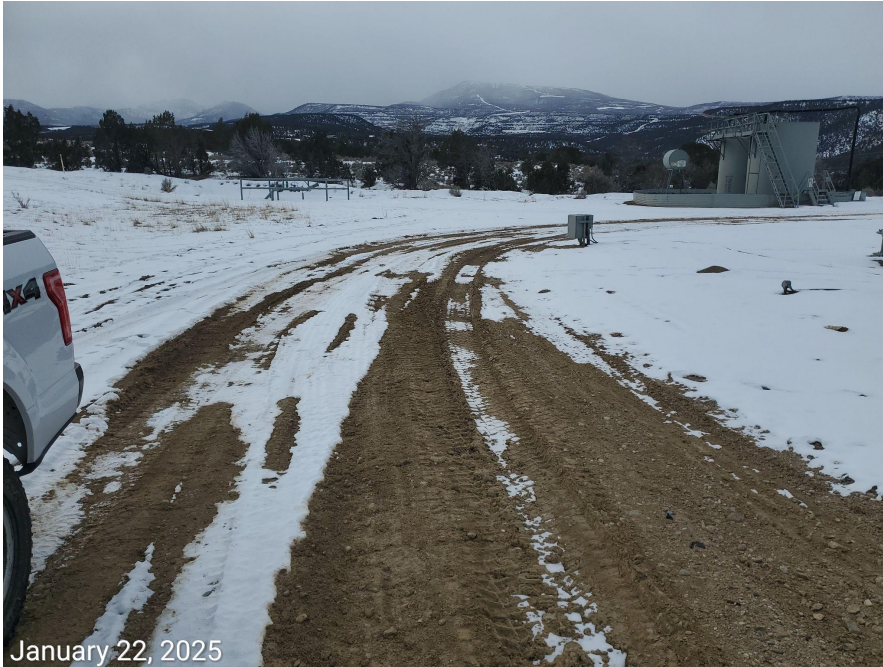
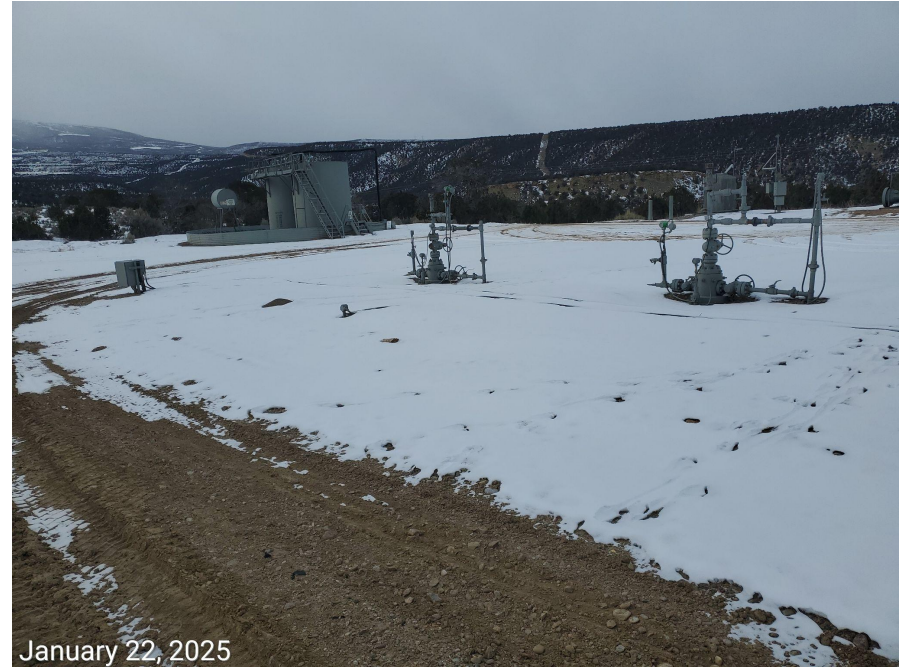
**Photo 1:** Photos 1-2 taken from the southeast end of the working pad surface. Photos provide an overview of the Location from southwest, west, northwest to northeast.

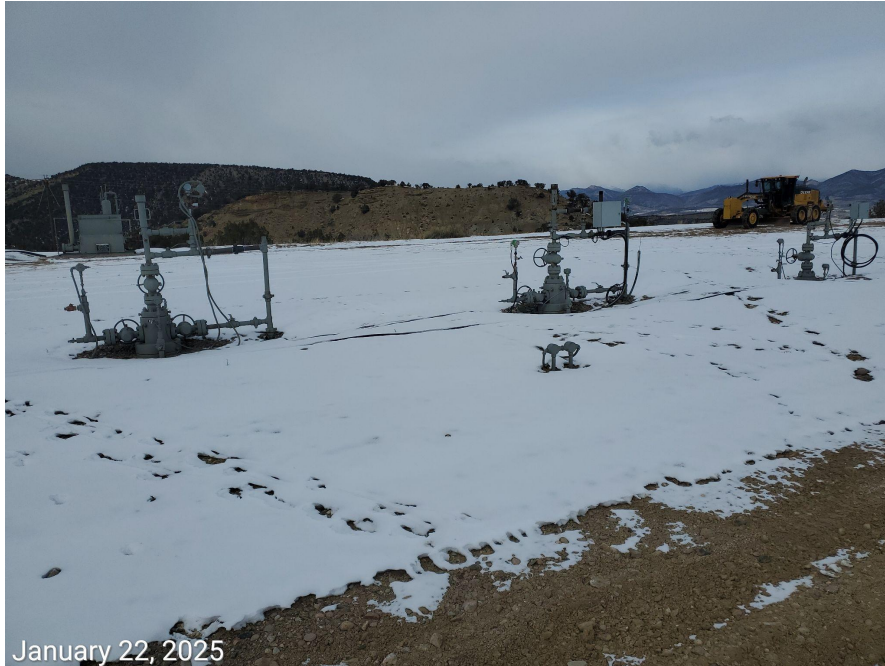
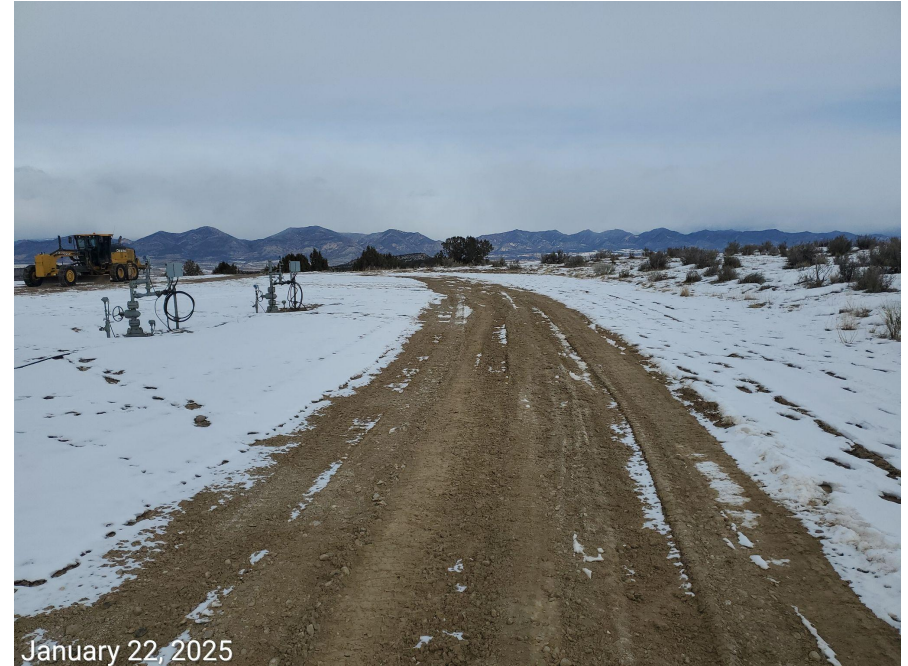
**Photo 2:** See comments under photo 1.

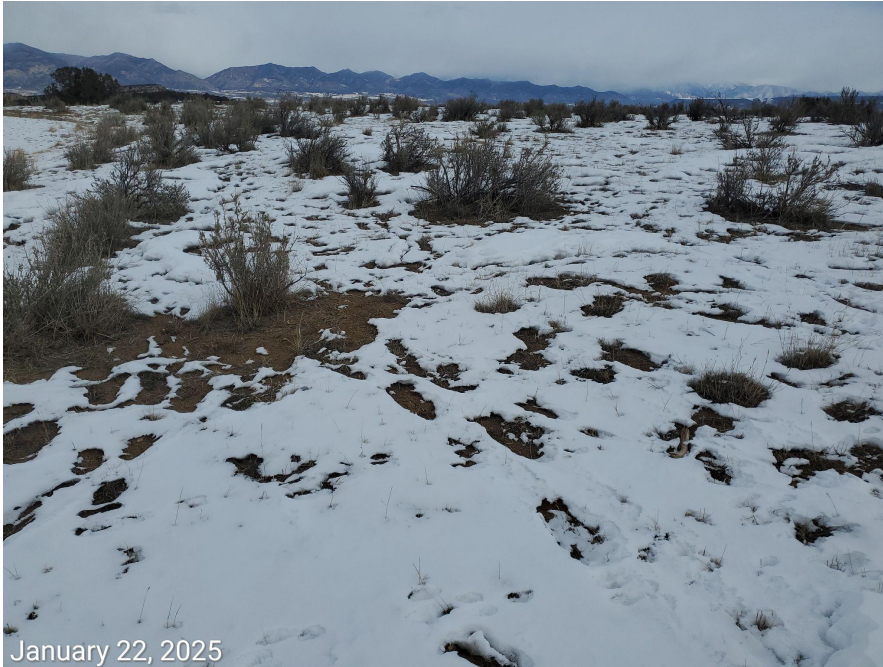
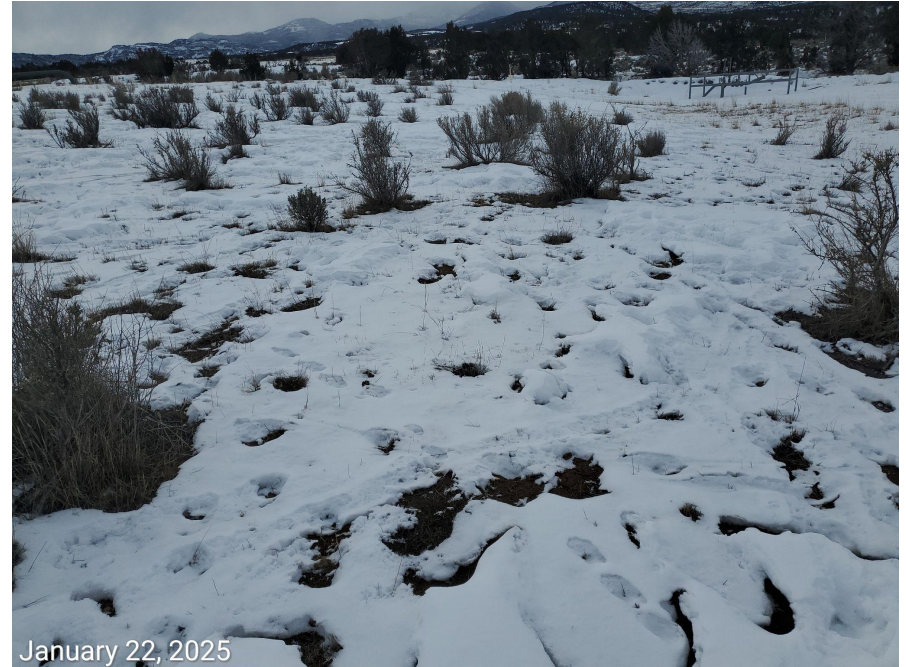
**Photo 3:** Photo example showing the interim areas of the Location. Limited inspection due to snow cover, however vegetation that was observable appears to be establishing towards 1003 standards.

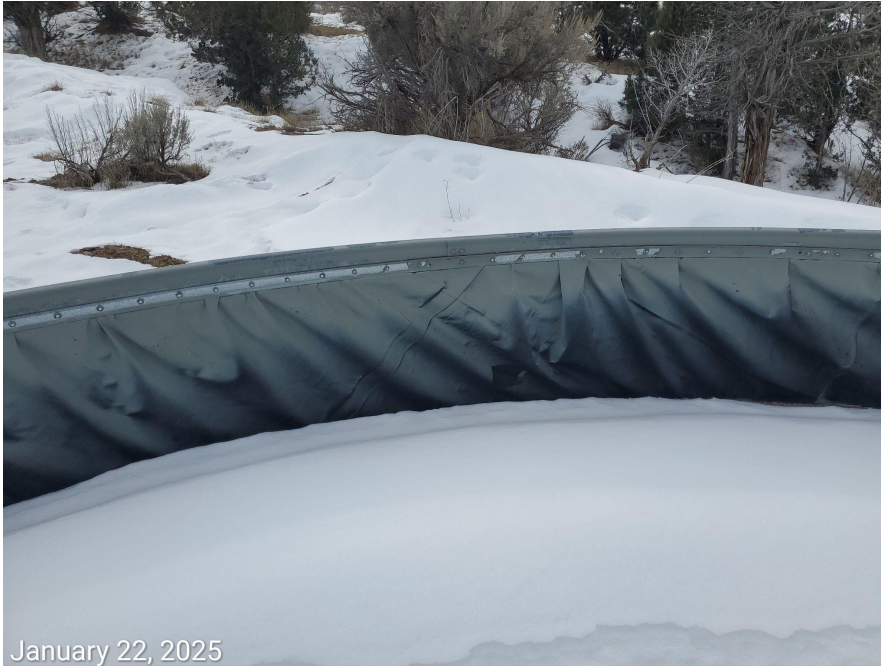
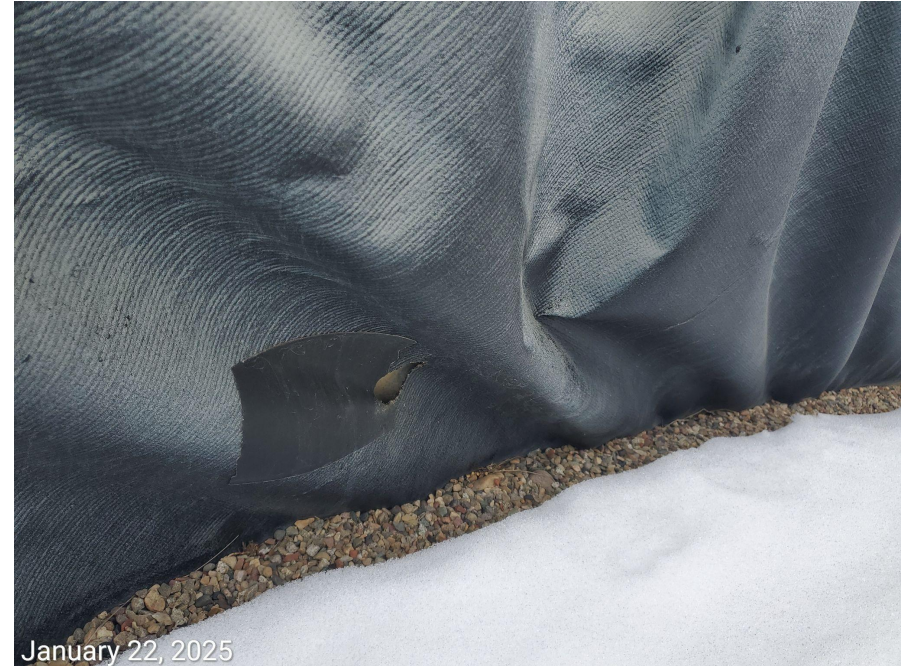
**Photo 4:** Photo shows holes/tears within the secondary containment liner

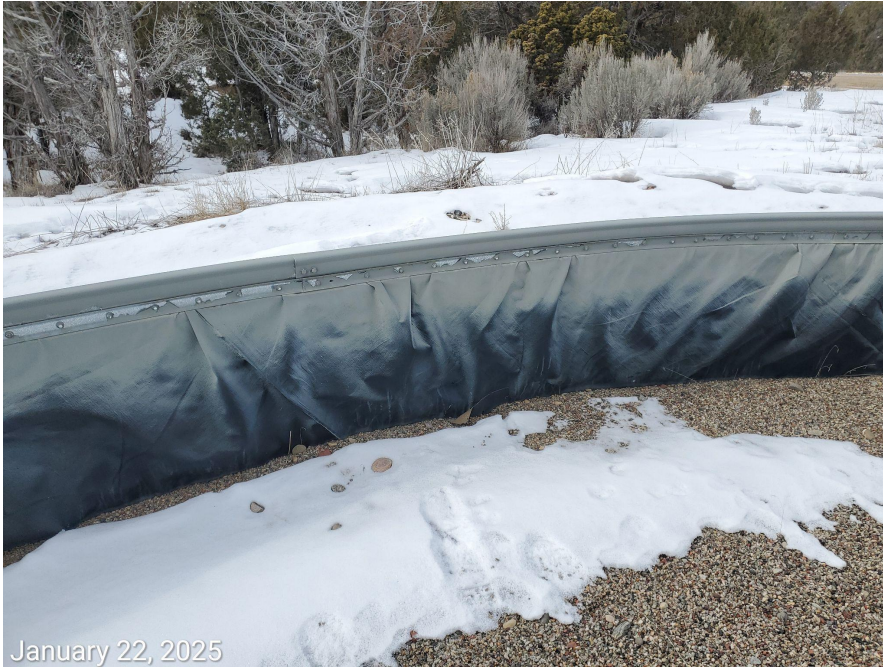
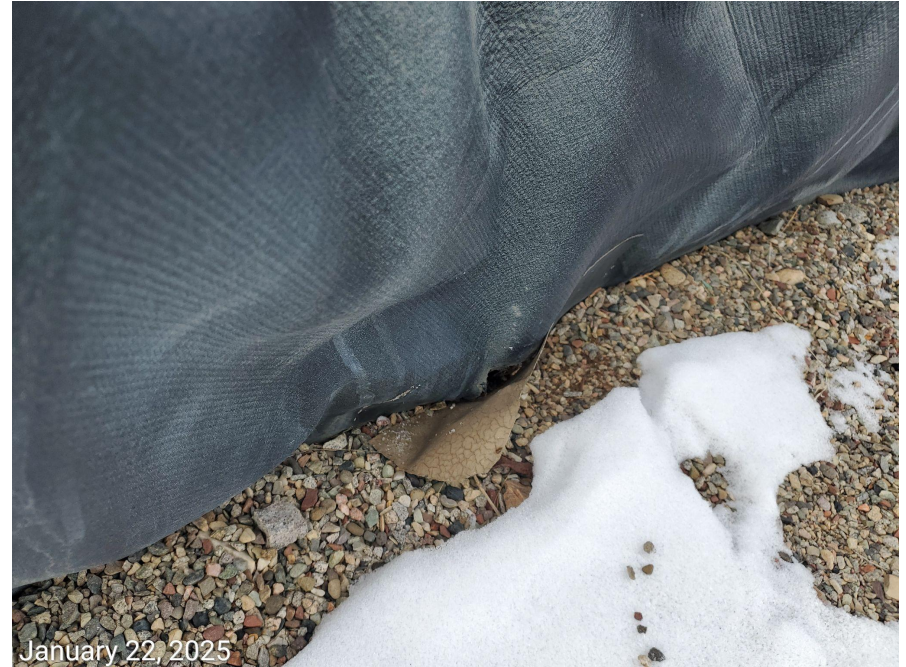
**Photo 5:** Photo shows holes/tears within the secondary containment liner; patch previously applied has separated from the liner.

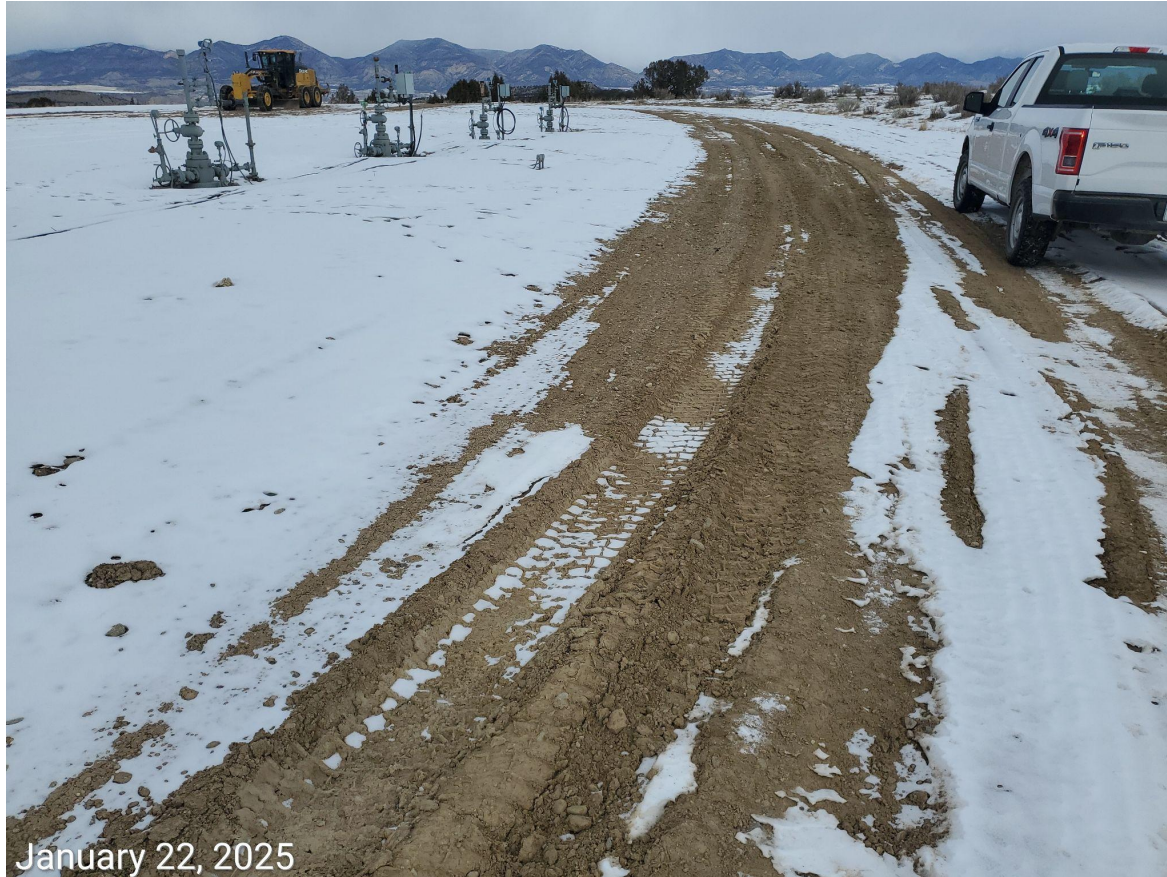
**Photo 6:** BMPs to stabilize the working pad surface, as well as to minimize vehicle tracking show signs of disrepair; tracking/ruts becoming evident. Maintenance advised.
