Inspection Photos

Loc: 321579

Operator: CITATION OIL & GAS CORP

Inspection Date: 1/28/2025

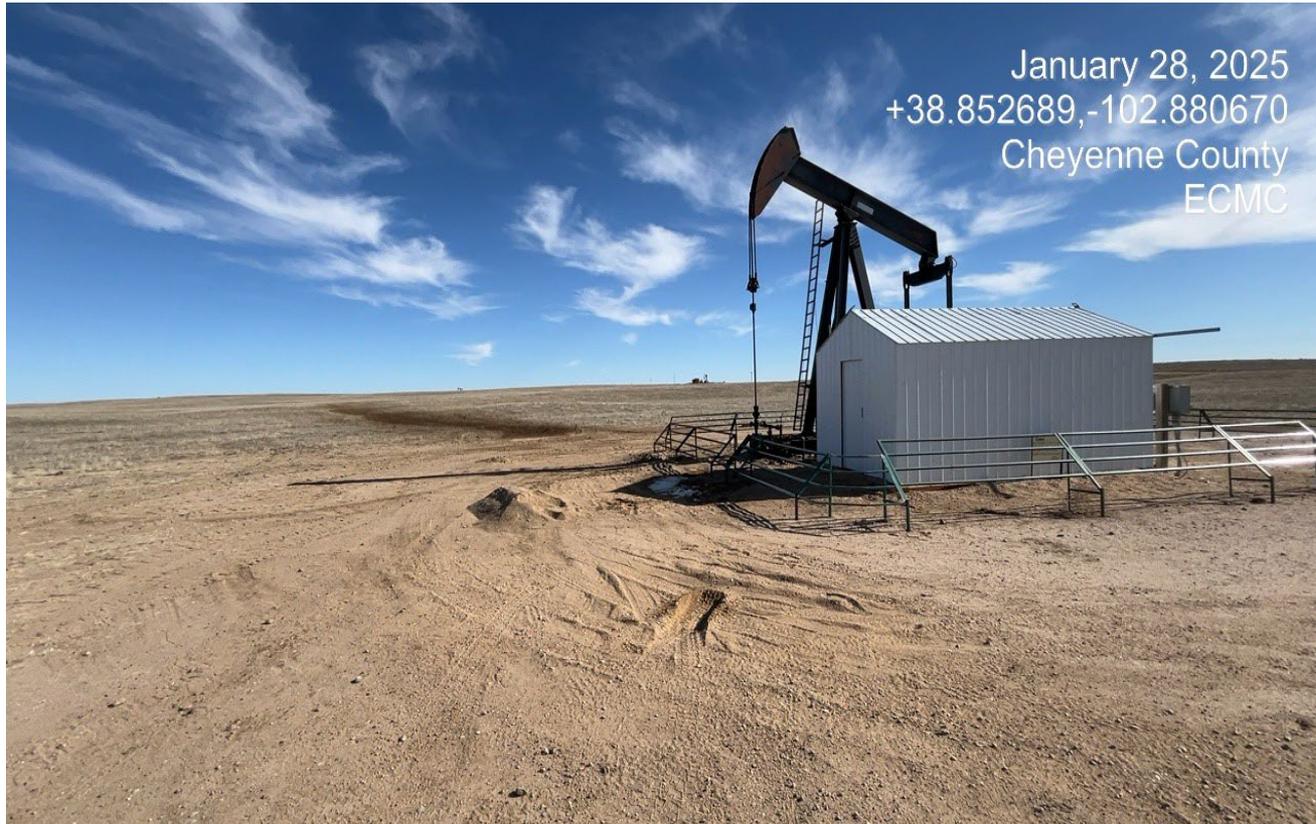
Photo 1. Facing east at the location. There was a leak at the wellhead that had just occurred. The leak misted off the location which will require the spil to be reported and properly cleaned up.

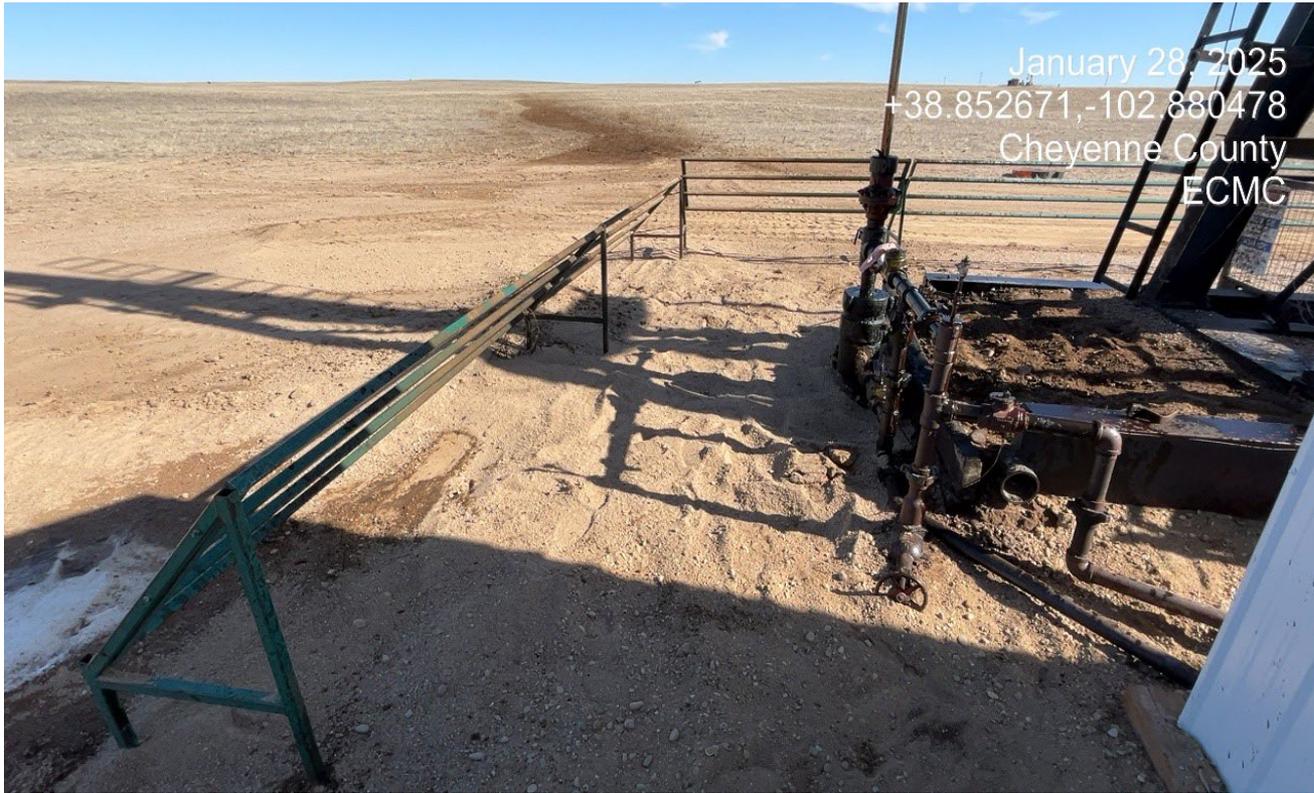
Photo 2. Facing east at the wellhead. There was a leak at the wellhead that had just occurred. Workers that were at the site have spread sand over this area and were dragging out the stained soil.

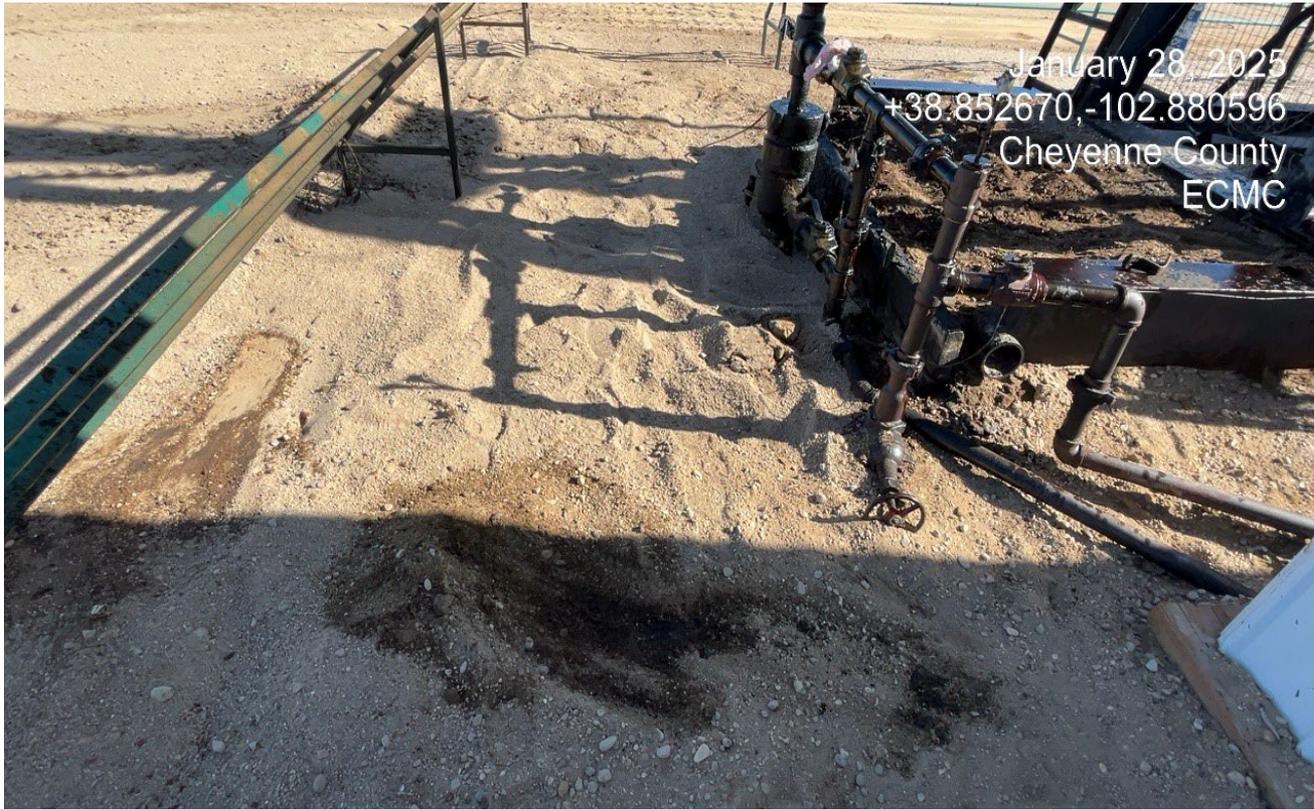
Photo 3. After pushing the sand away it was observed that there are saturated oil stained soils which must be properly cleaned up and removed.

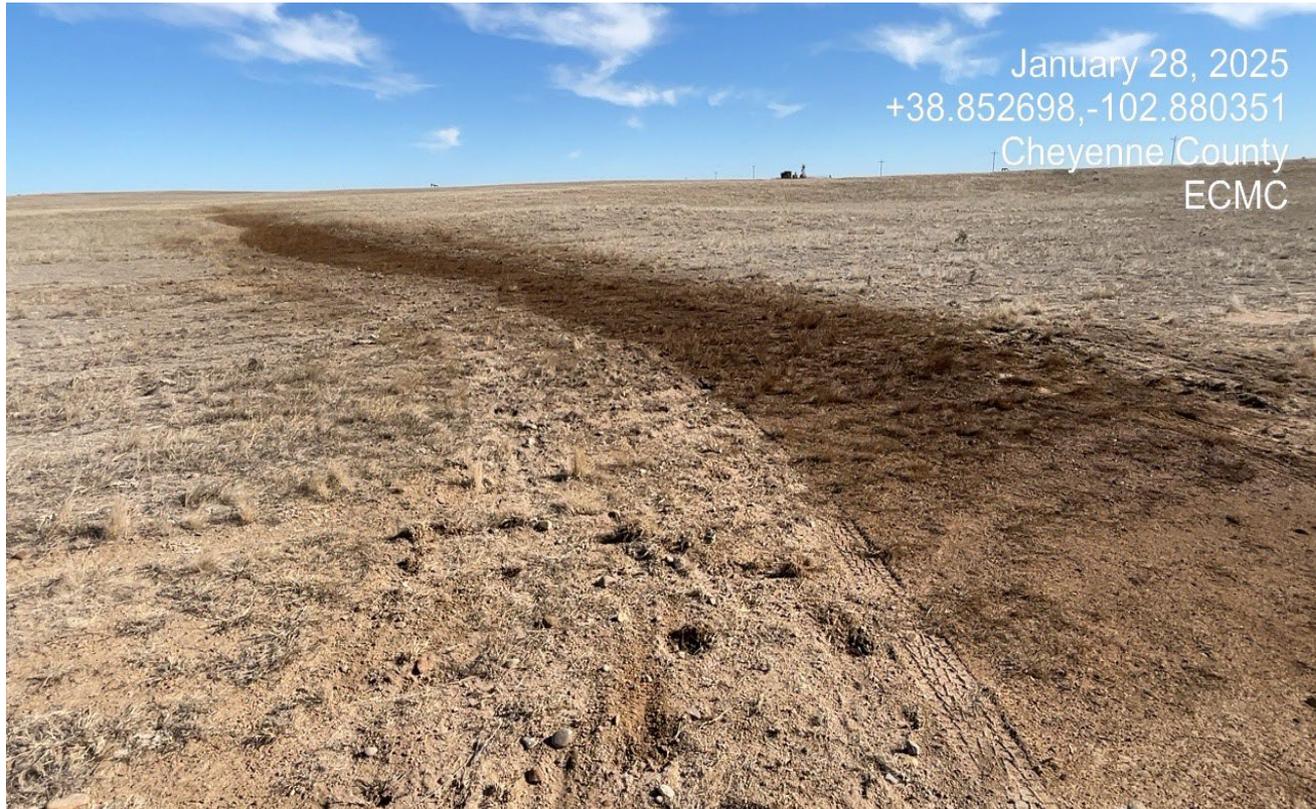
Photo 4. Facing east toward the misted spill that went off location. Part of this area was dragged which covered some of the stained soils.

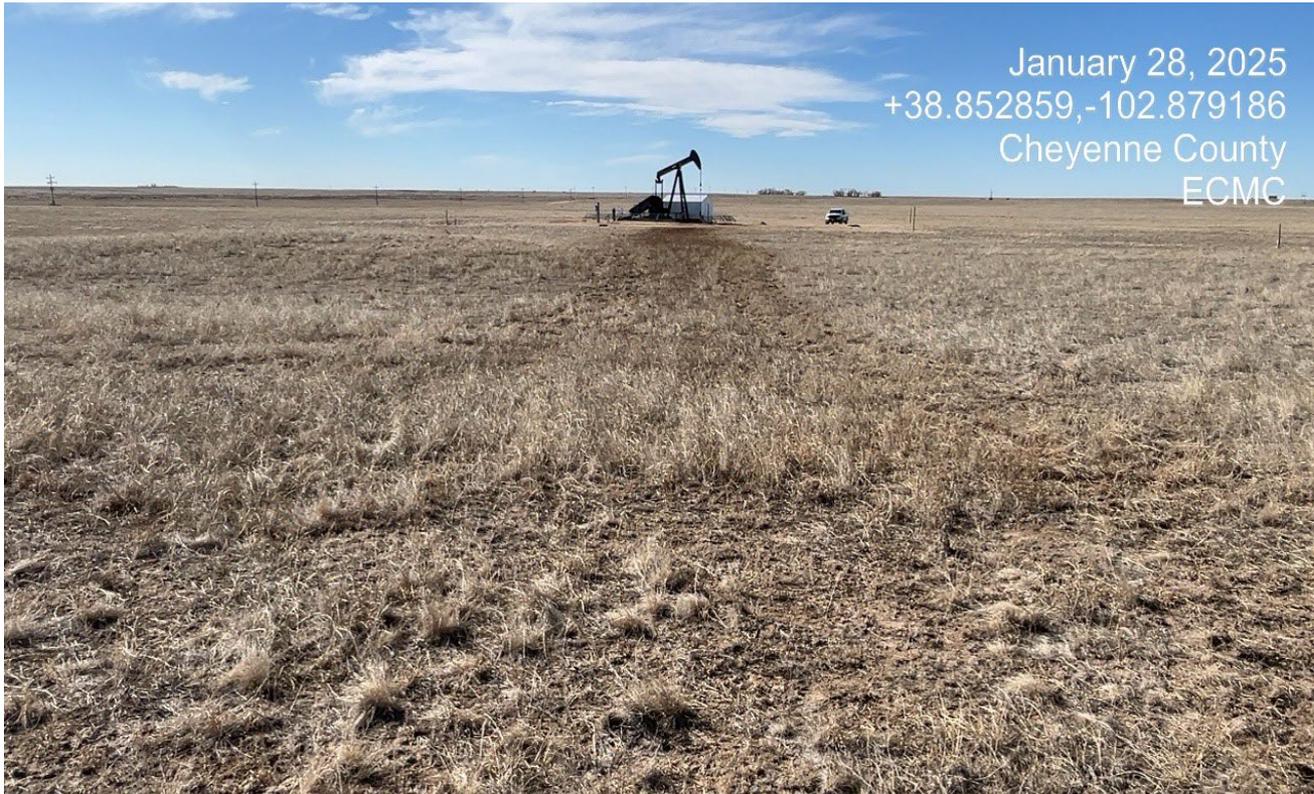
Photo 5. Standing at the approximate end of the stained grass which was 375' from the wellhead.

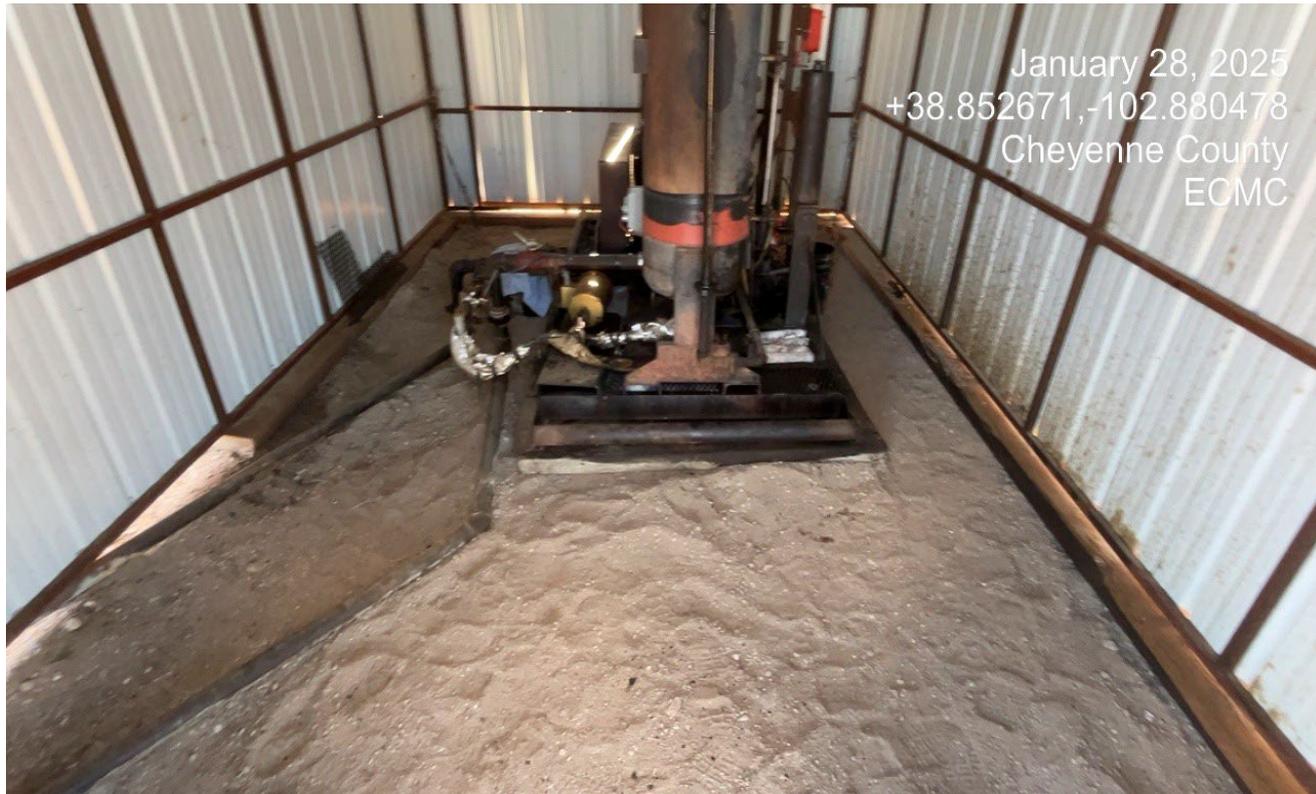
Photo 7. Inside the engine shed. It appears the leak was repaired. There is fresh sand in this area and it is presumed that oily waste was cleaned up.
