# Inspection Photos

API: 017-06678

Operator: **DECLAR OIL & GAS INC**

Inspection Date: 1/28/2025

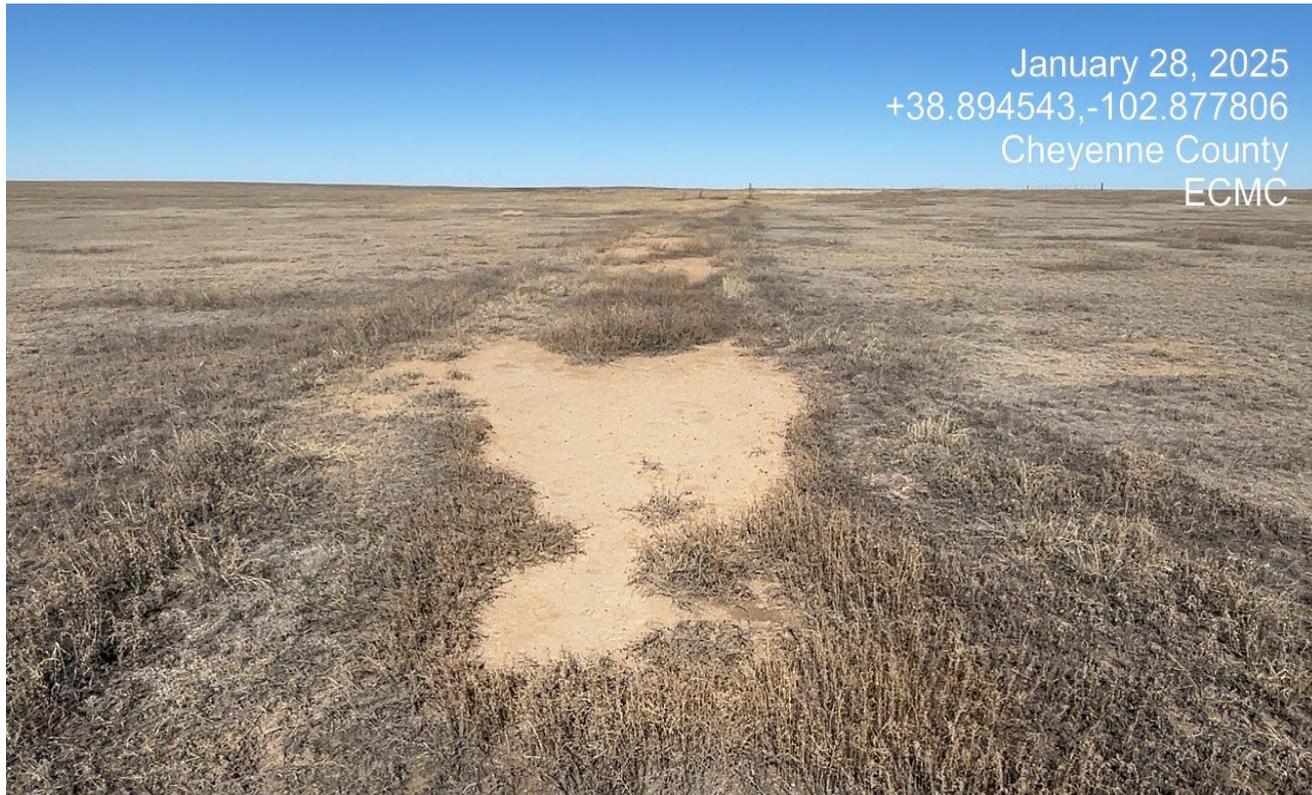
**Photo 1.** Facing north toward the access road. There are areas of the road that have not established vegetation and there are undesirable weeds.

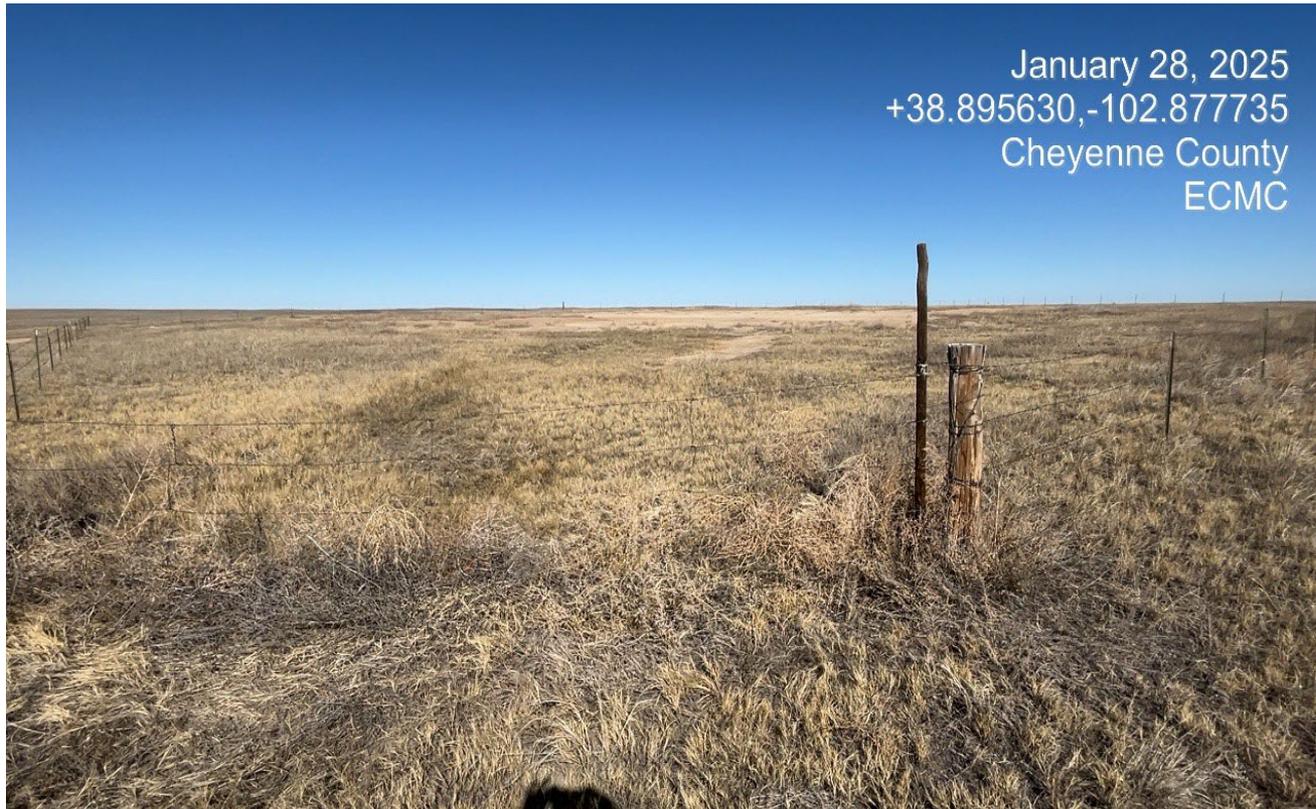
**Photo 2.** Facing north toward the location which has a fence around the perimeter.

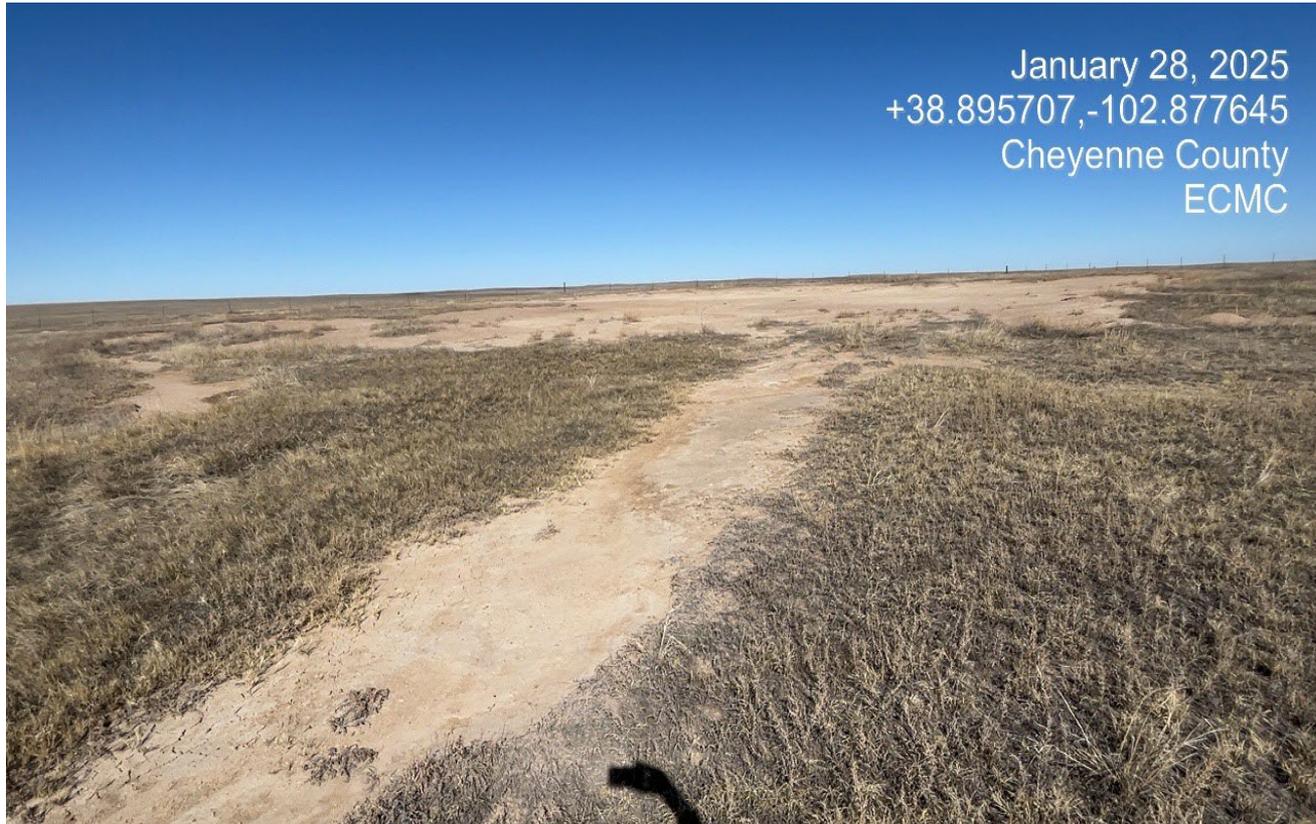
**Photo 3.** Facing north toward the location. The location is mostly bare of vegetation and appears to have impacted soils from a historic spill.

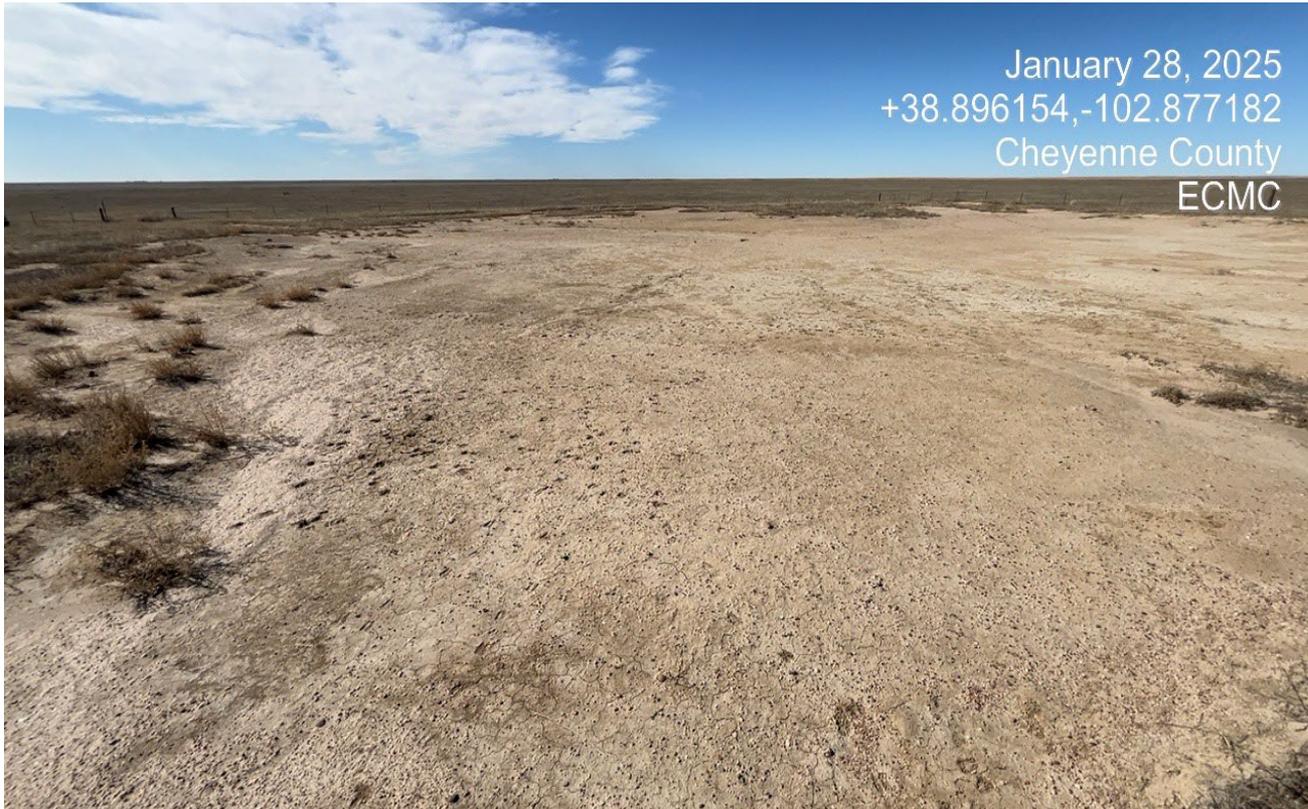
**Photo 4.** East side of the location facing west. There is no vegetation growth at the location which is approximately 250'x250'.

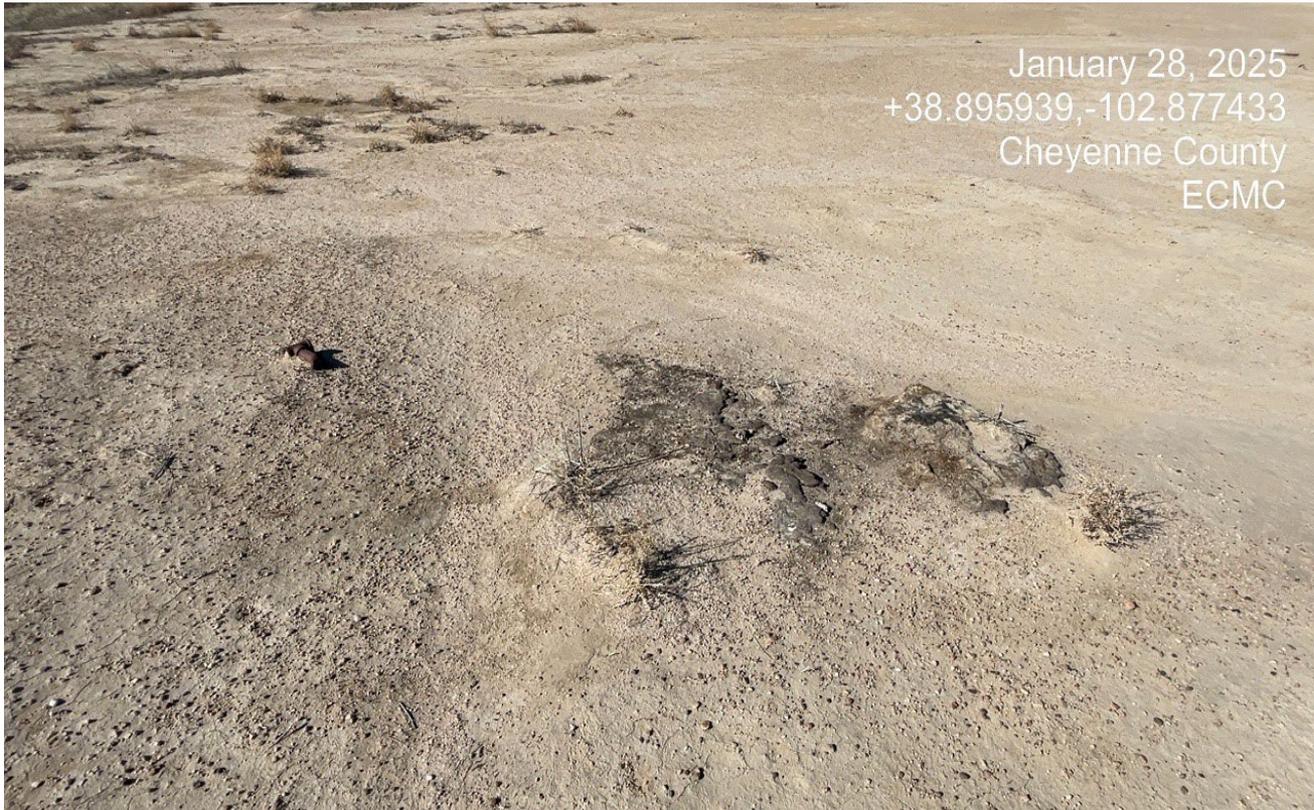
**Photo 5.** There is a black hardened hydrocarbon material at the east side of the location shown in this photo.

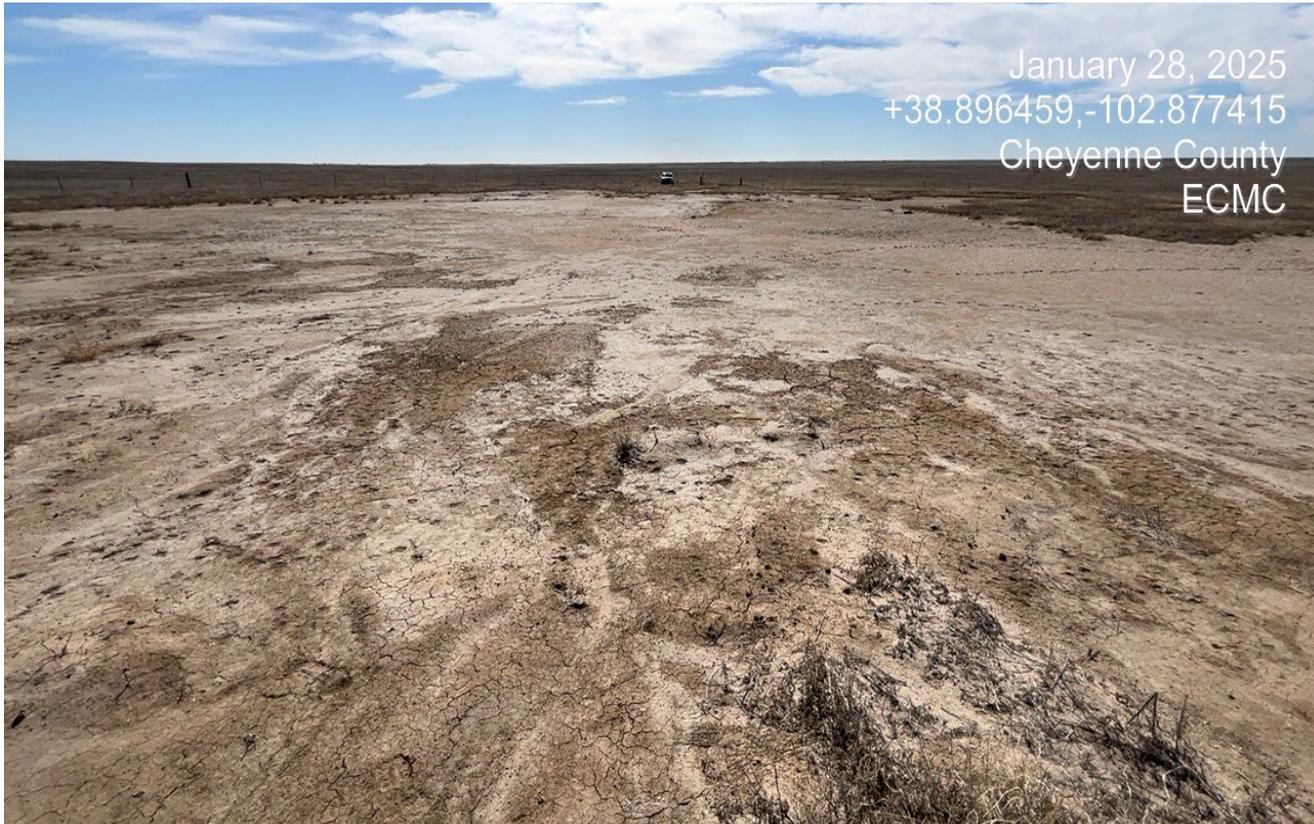
**Photo 6.** North side of the location facing south. There is no vegetation growth at the location which is approximately 250'x250'.

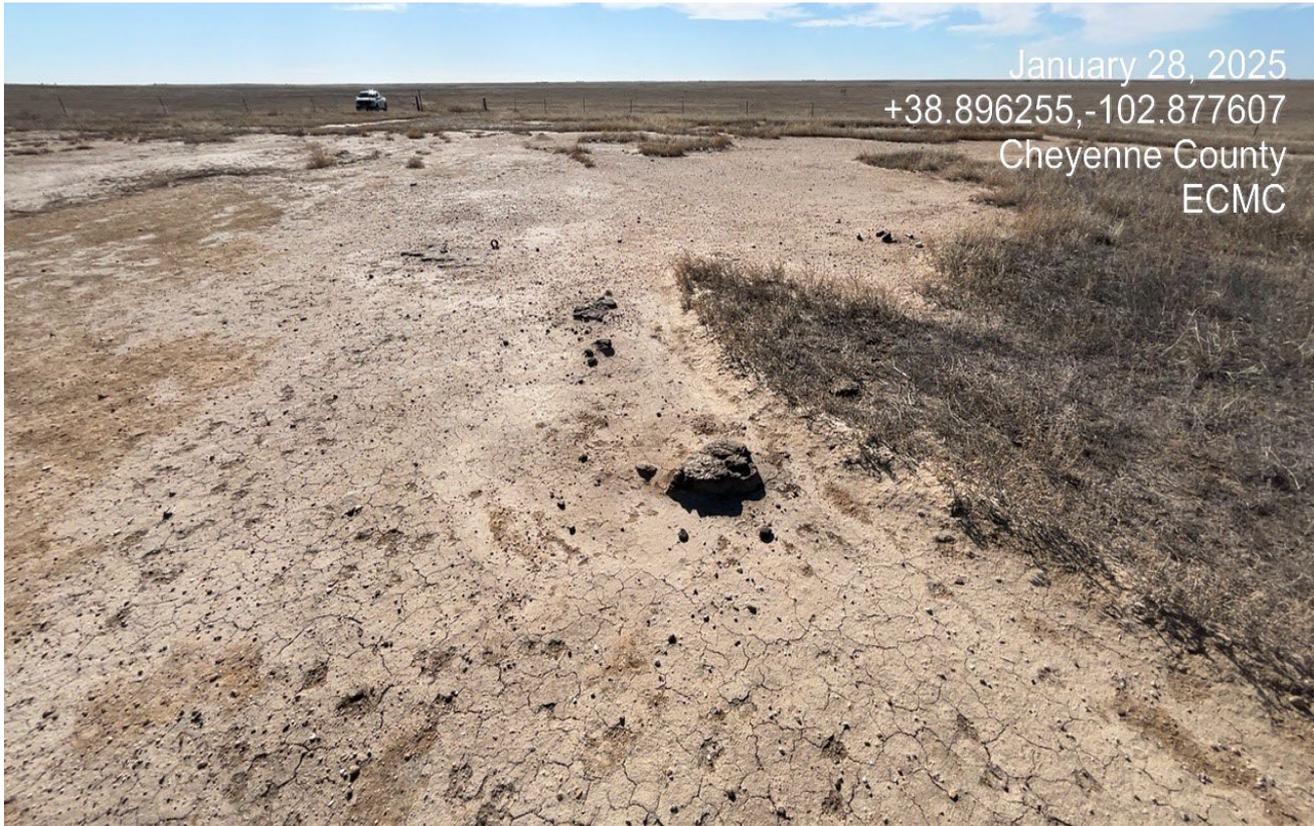
**Photo 7.** Facing south at the location. Remnants of debris remain.

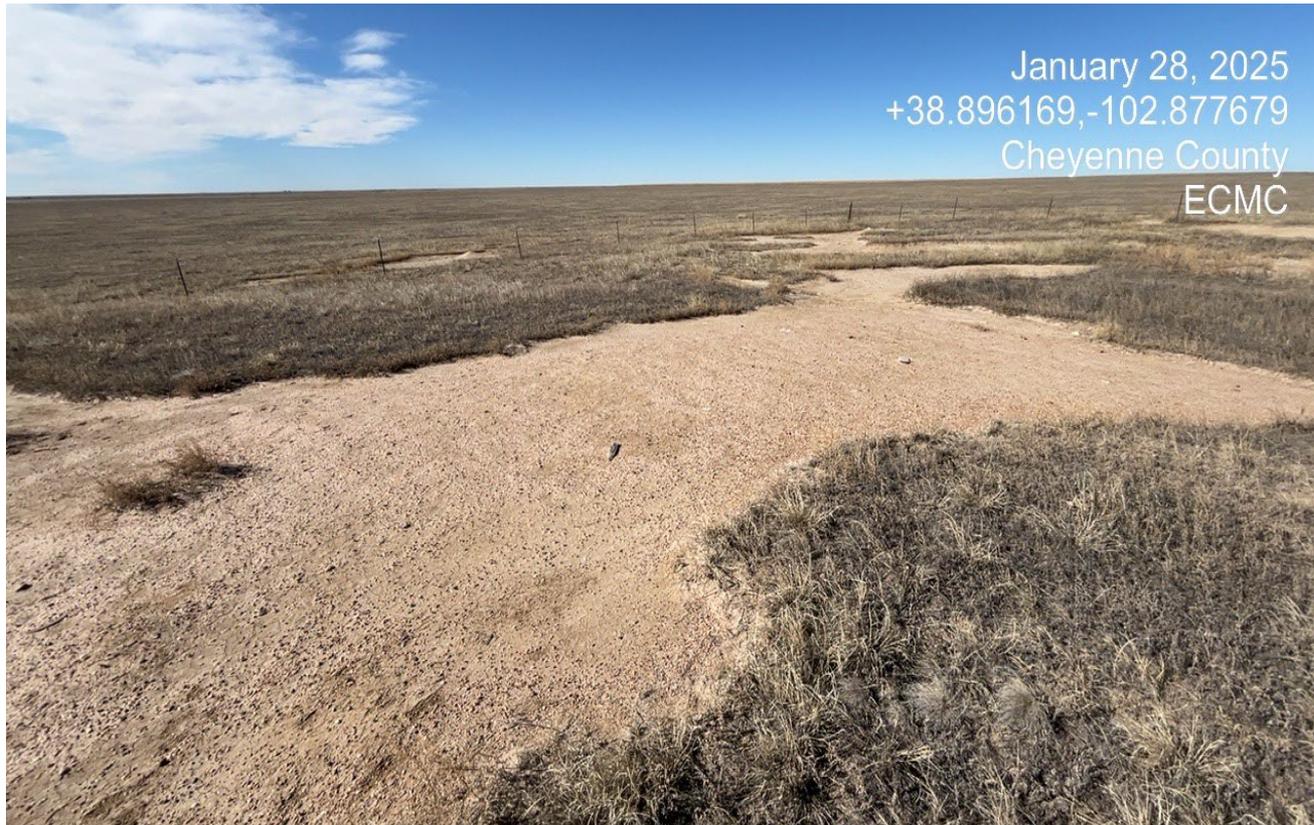
**Photo 8.** Facing west at the location. It appears there are downhill flow pattern where vegetation is not growing. This is indicative of a historic spill causing a salt kill of vegetation..

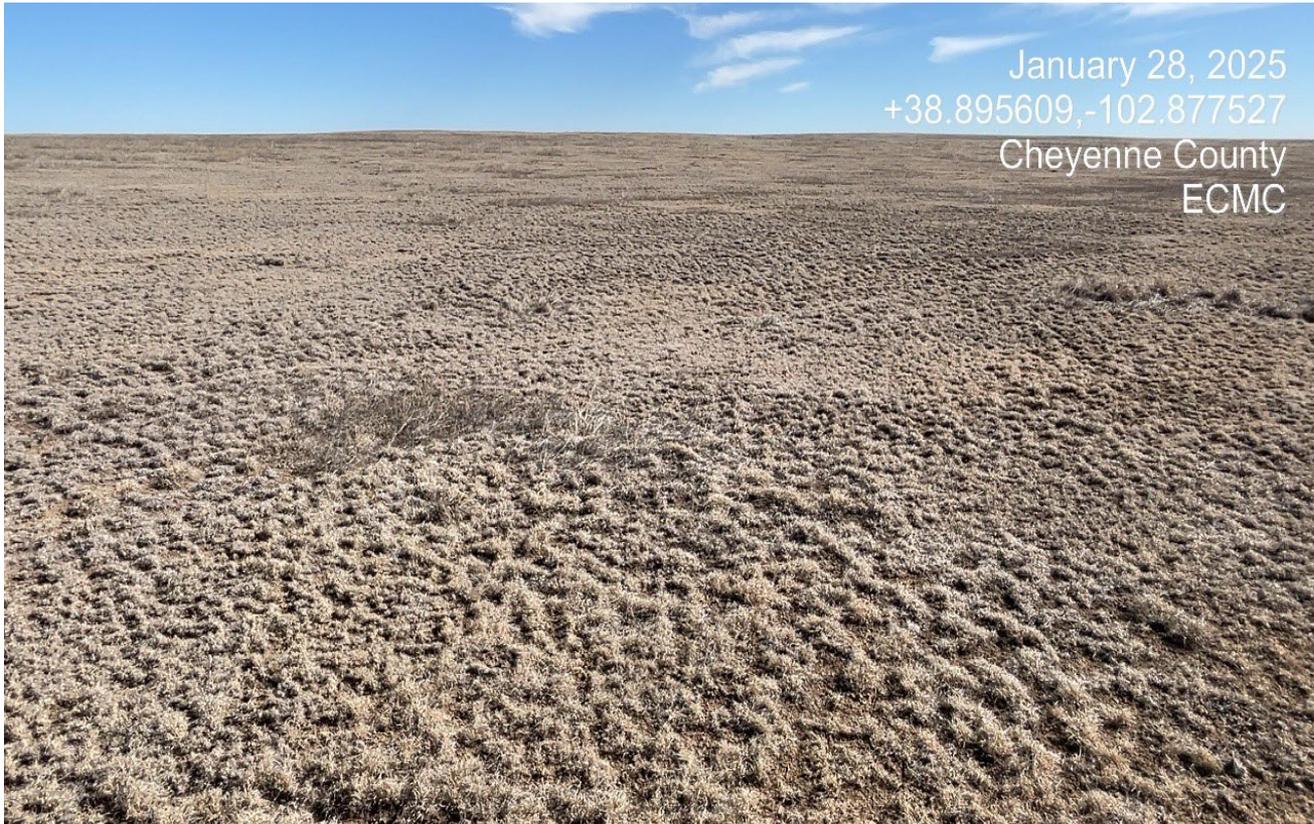
**Photo 10.** Facing east toward the surrounding undisturbed reference which consists of Blue grama, Threeawn, Sand dropseed among other native plant species.
