SITE-SPECIFIC QUALITY ASSURANCE & QUALITY CONTROL AUDIT

PERMIT CLOSURE REPORT – RANGELAND

Location ID 330368

Location Name COLORADO ENERGY FEDERAL-610N64W/14NWNW

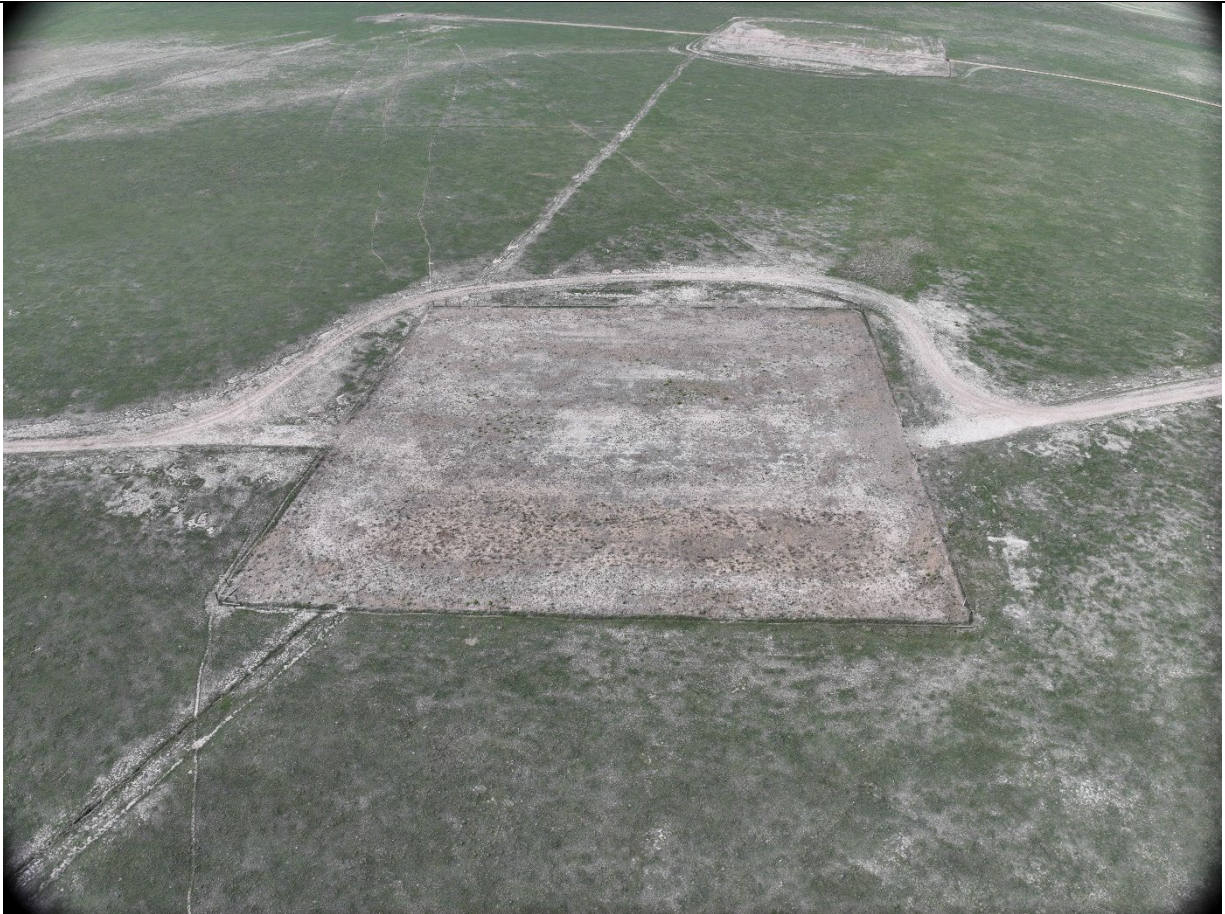
North

Cardinal directional photos of the site.

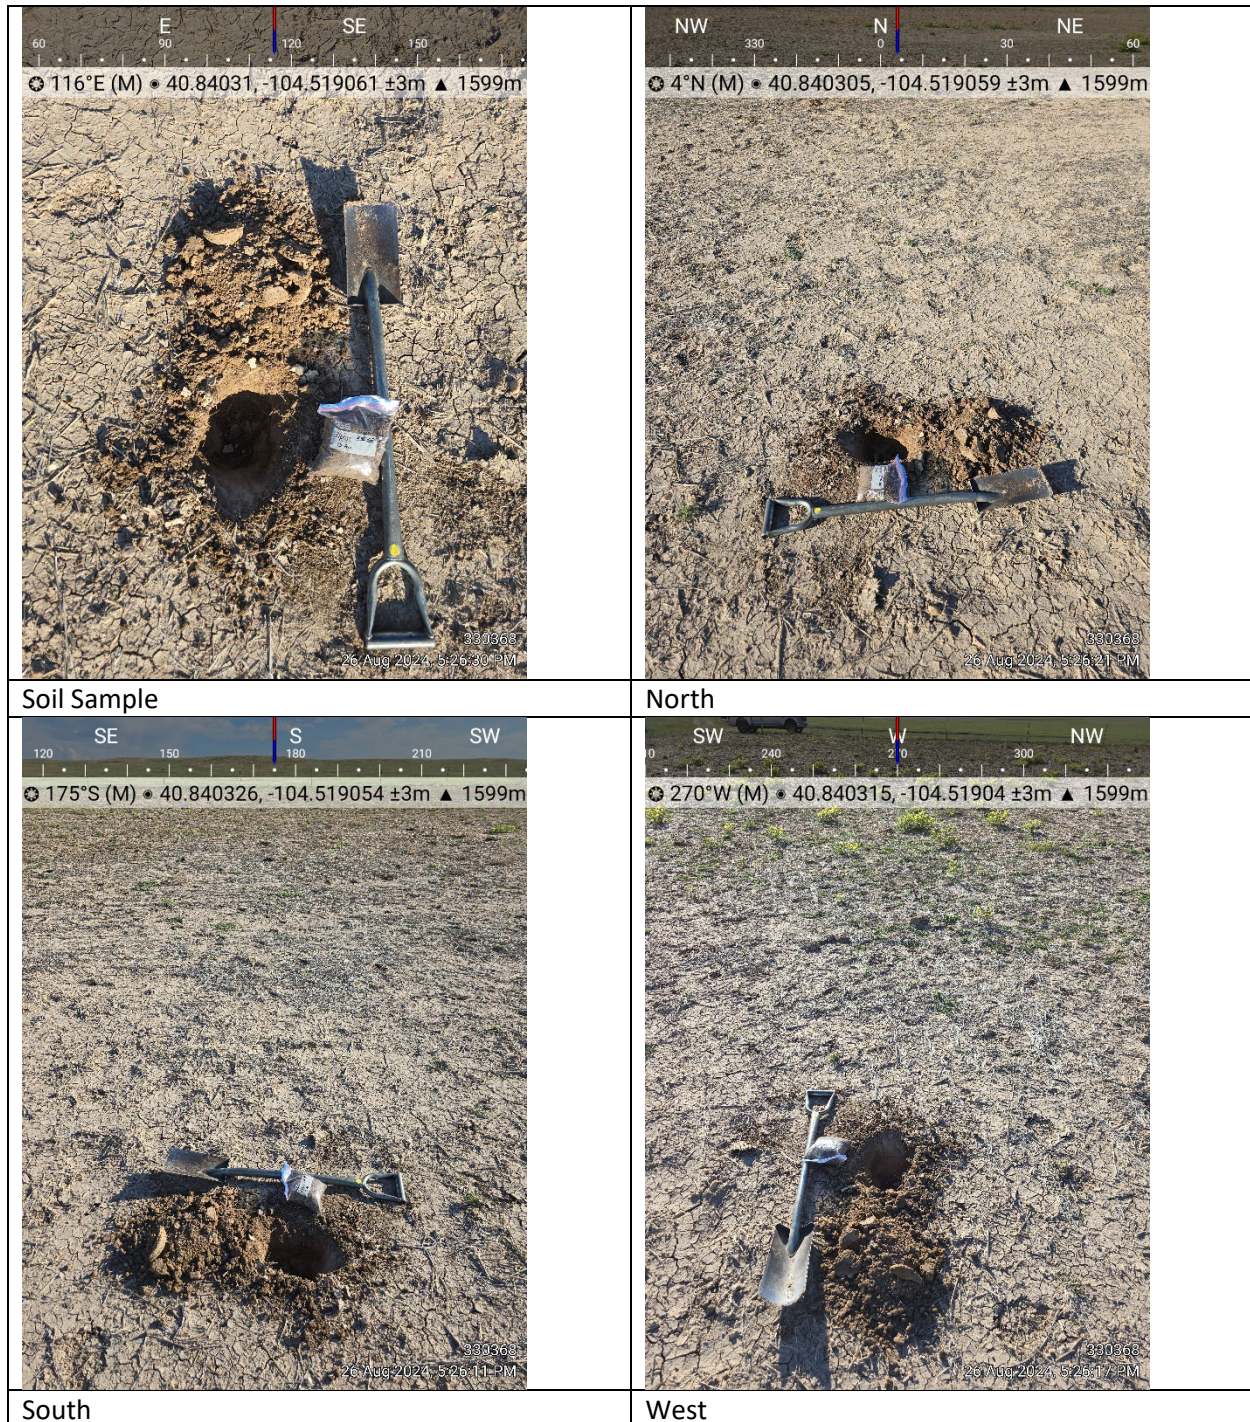
Site Photos – Soil 1 – 330368

Lat/Long: 40.84031 / -104.51901

Photo locations correspond with the overview map.

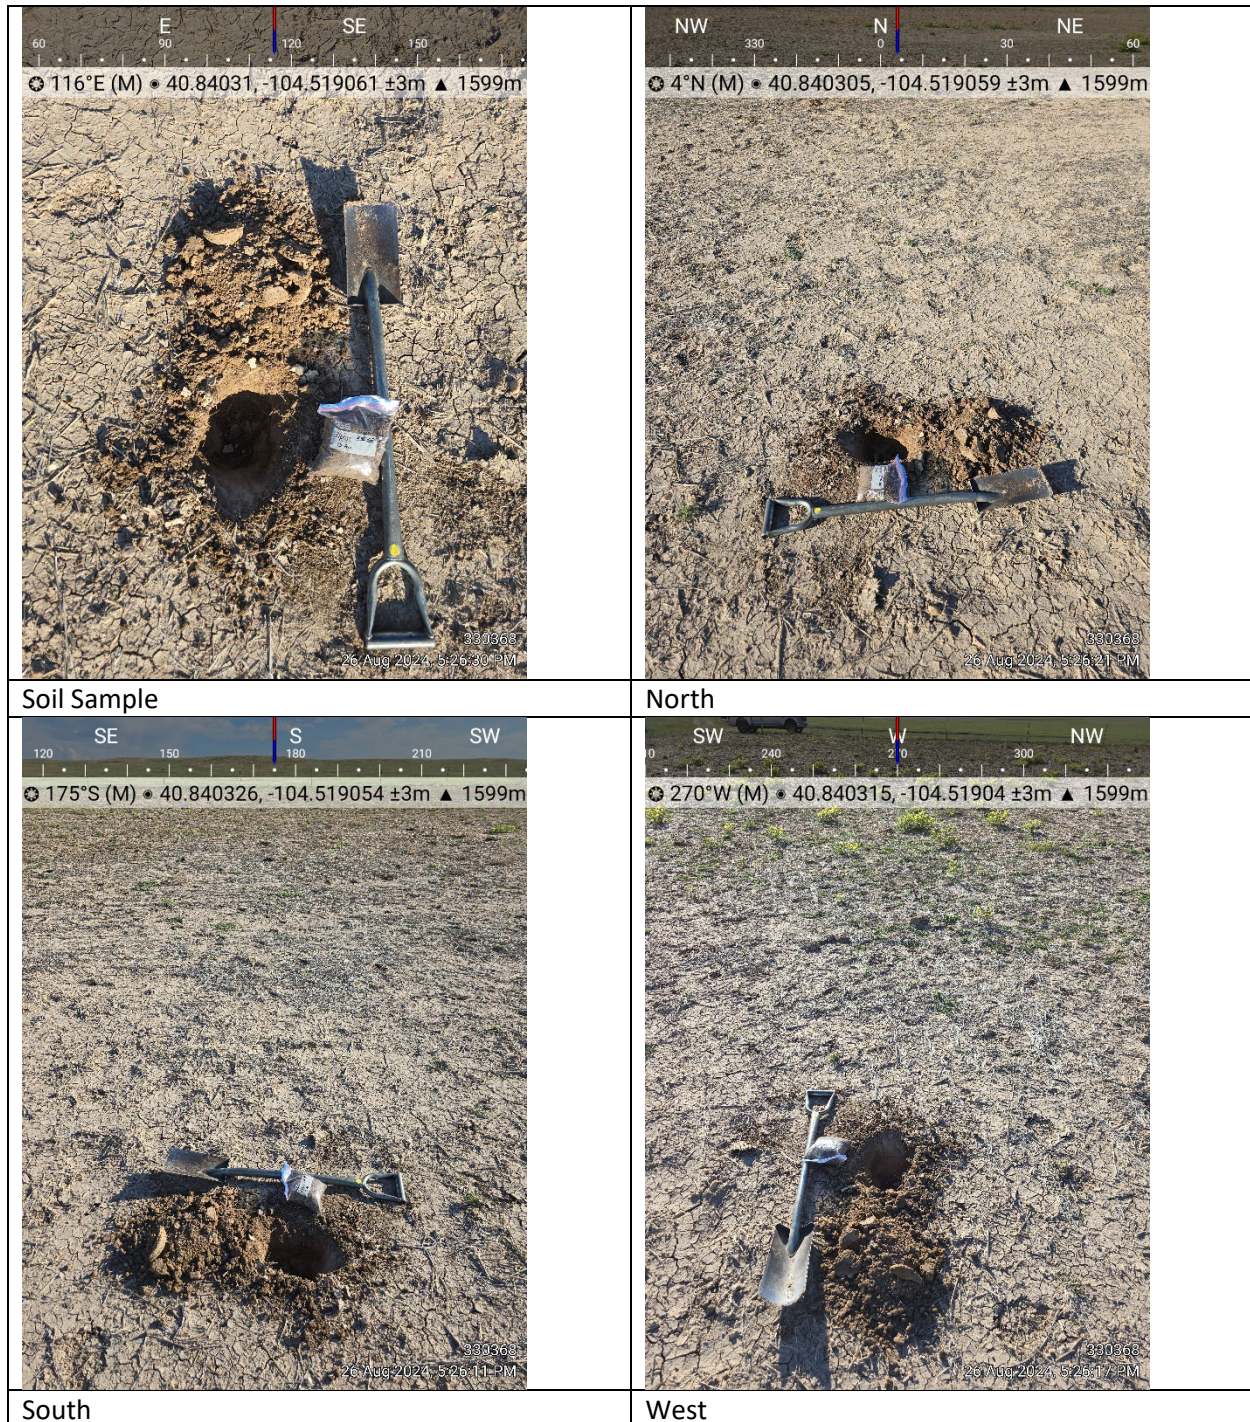
Site Photos – Soil 1 – 330368

<p>Vervain (<i>Genus Verbena</i>)</p>	<p>Buffalo-bur (<i>Solanum rostratum</i>) and Thymeleaf Sandmat (<i>Euphorbia serpillifolia</i>)</p>

<p>Field Bindweed (<i>Convolvulus arvensis</i>) List C</p>	<p>Buffalo-bur (<i>Solanum rostratum</i>)</p>

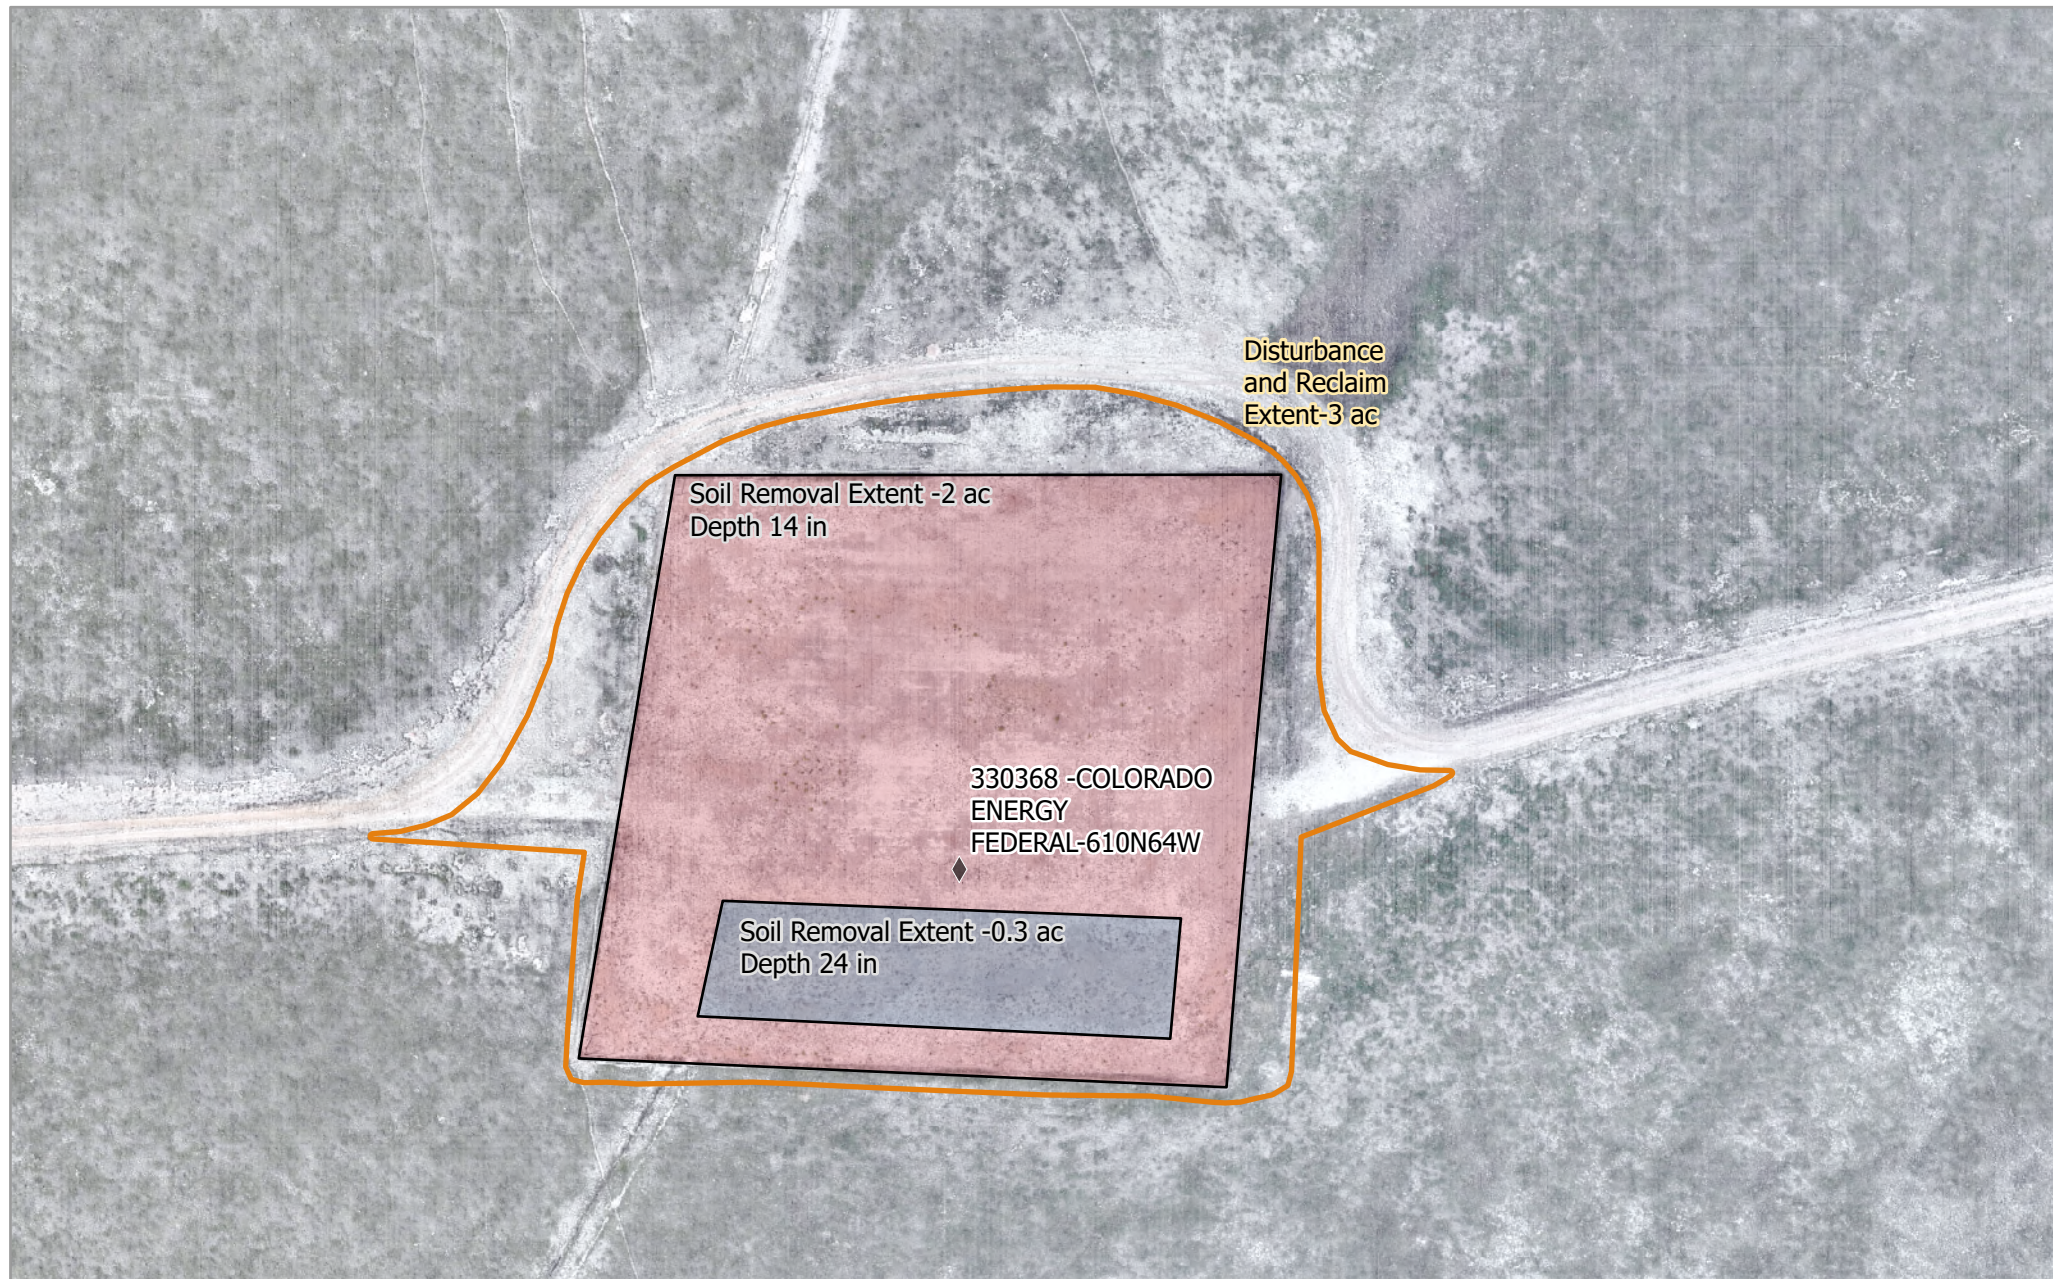
**CIV - 330368 - Colorado Energy Federal
610N64W/14NWNW**

Map Extent - Reclaim Extent

- ◆ Oil and Gas Locations
- ▭ Disturbance Boundary
- ▭ Soil Removal & Replace
- ▭ Soil Removal & Replace

- Continuous bare ground on pad
- Removal of soil up to 14 inches due to salt concentration exceed reference soils.
- Removal of soils up to 24 inches within the previous tank battery extent
- Replace soils, decompact, disc, seed, and crimp straw. Use USFS seed mix that is adjusted to work with the entire site
- Spray for pre-emergent herbicide
- Remove fence

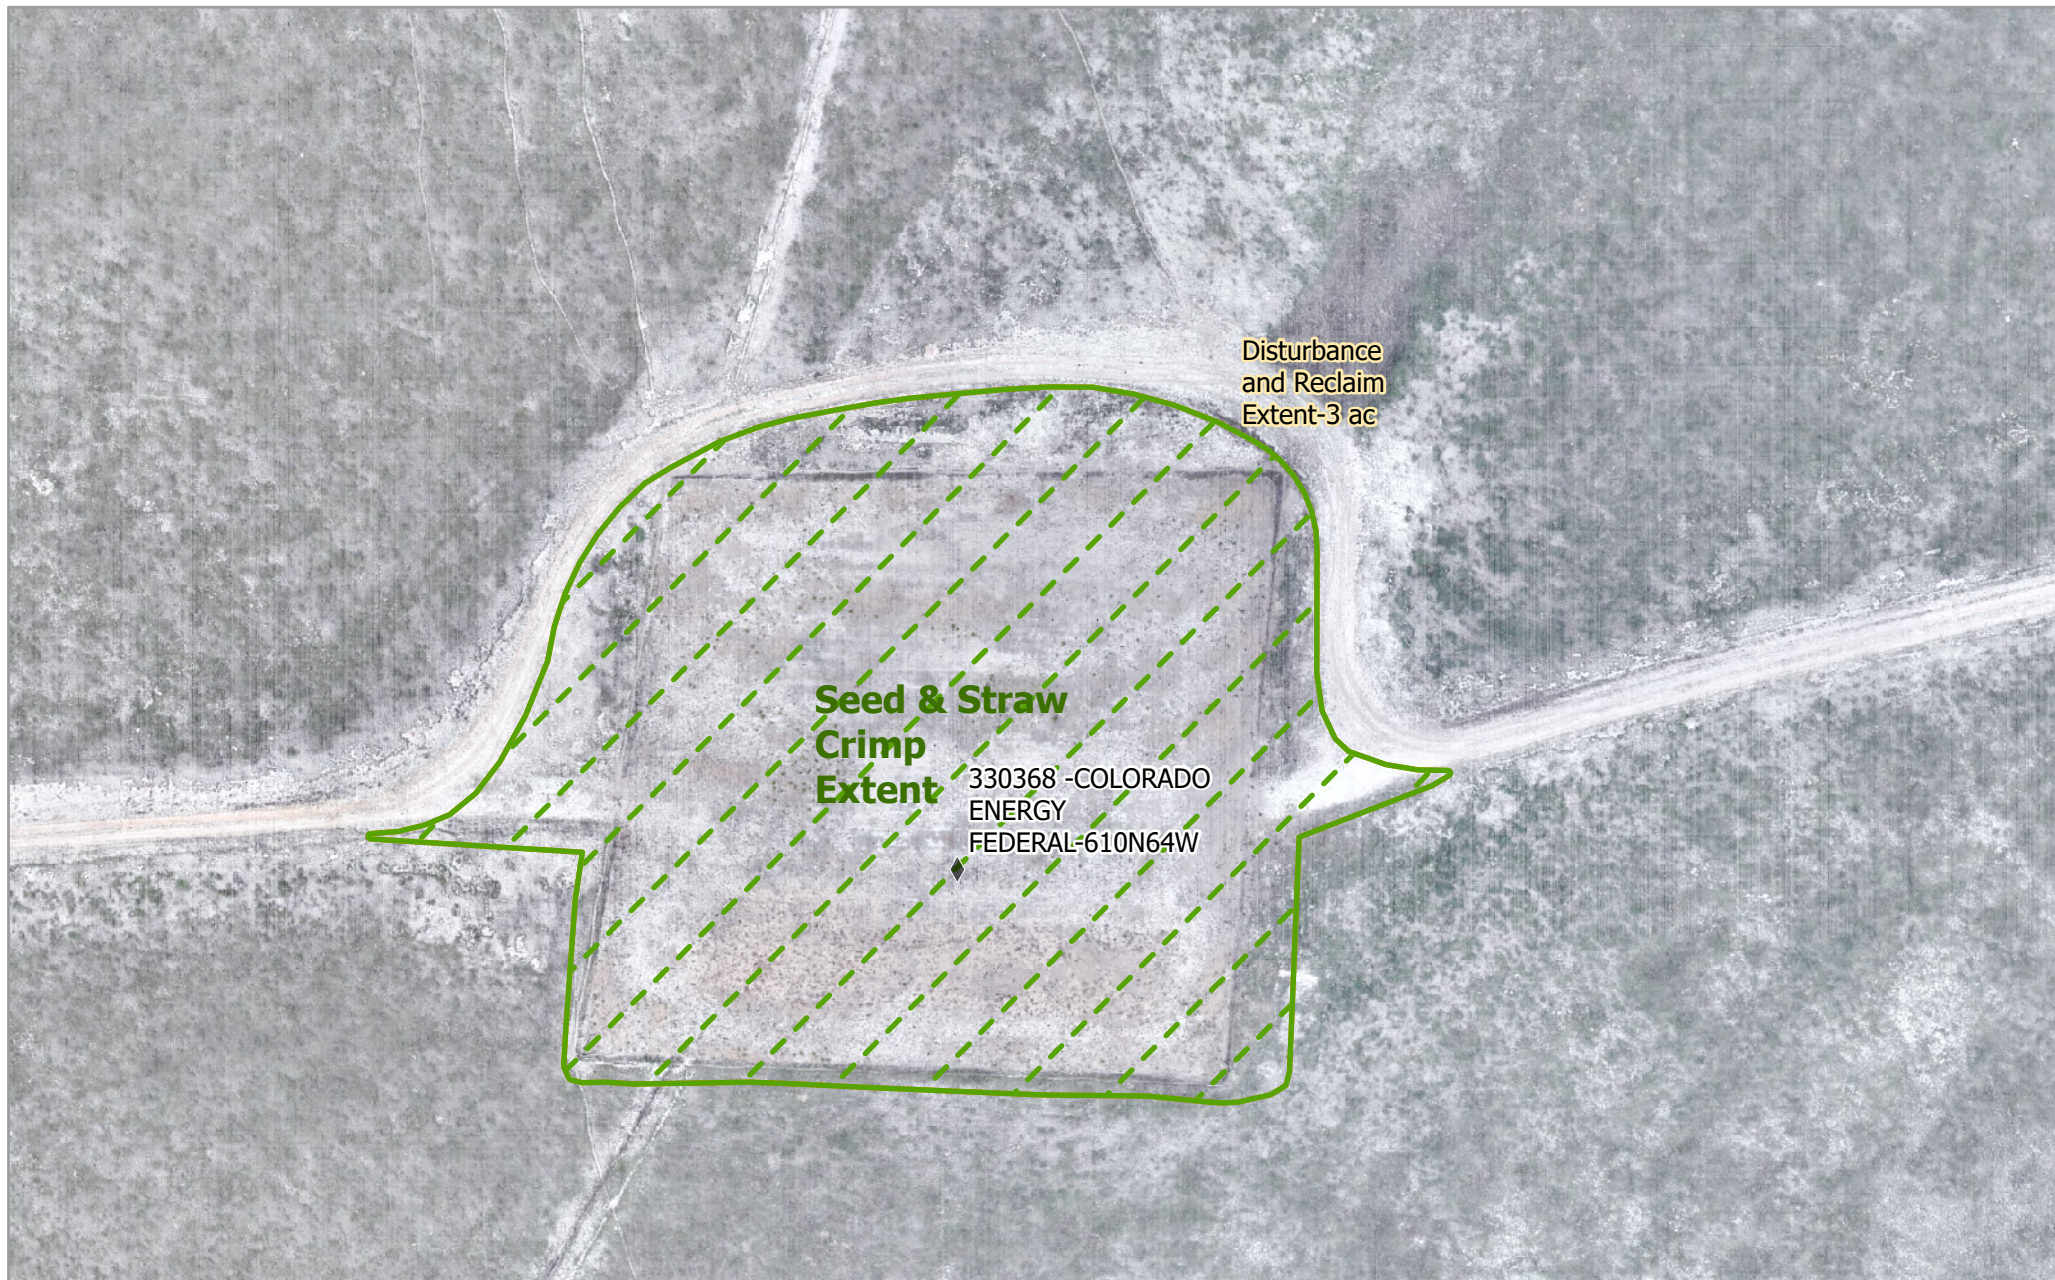
**CIV - 330368 - Colorado Energy Federal
610N64W/14NWNW
Map Extent - Reclaim Extent**

- ◆ Oil and Gas Locations
- ▭ Disturbance Boundary
- ▭ Seed Boundary

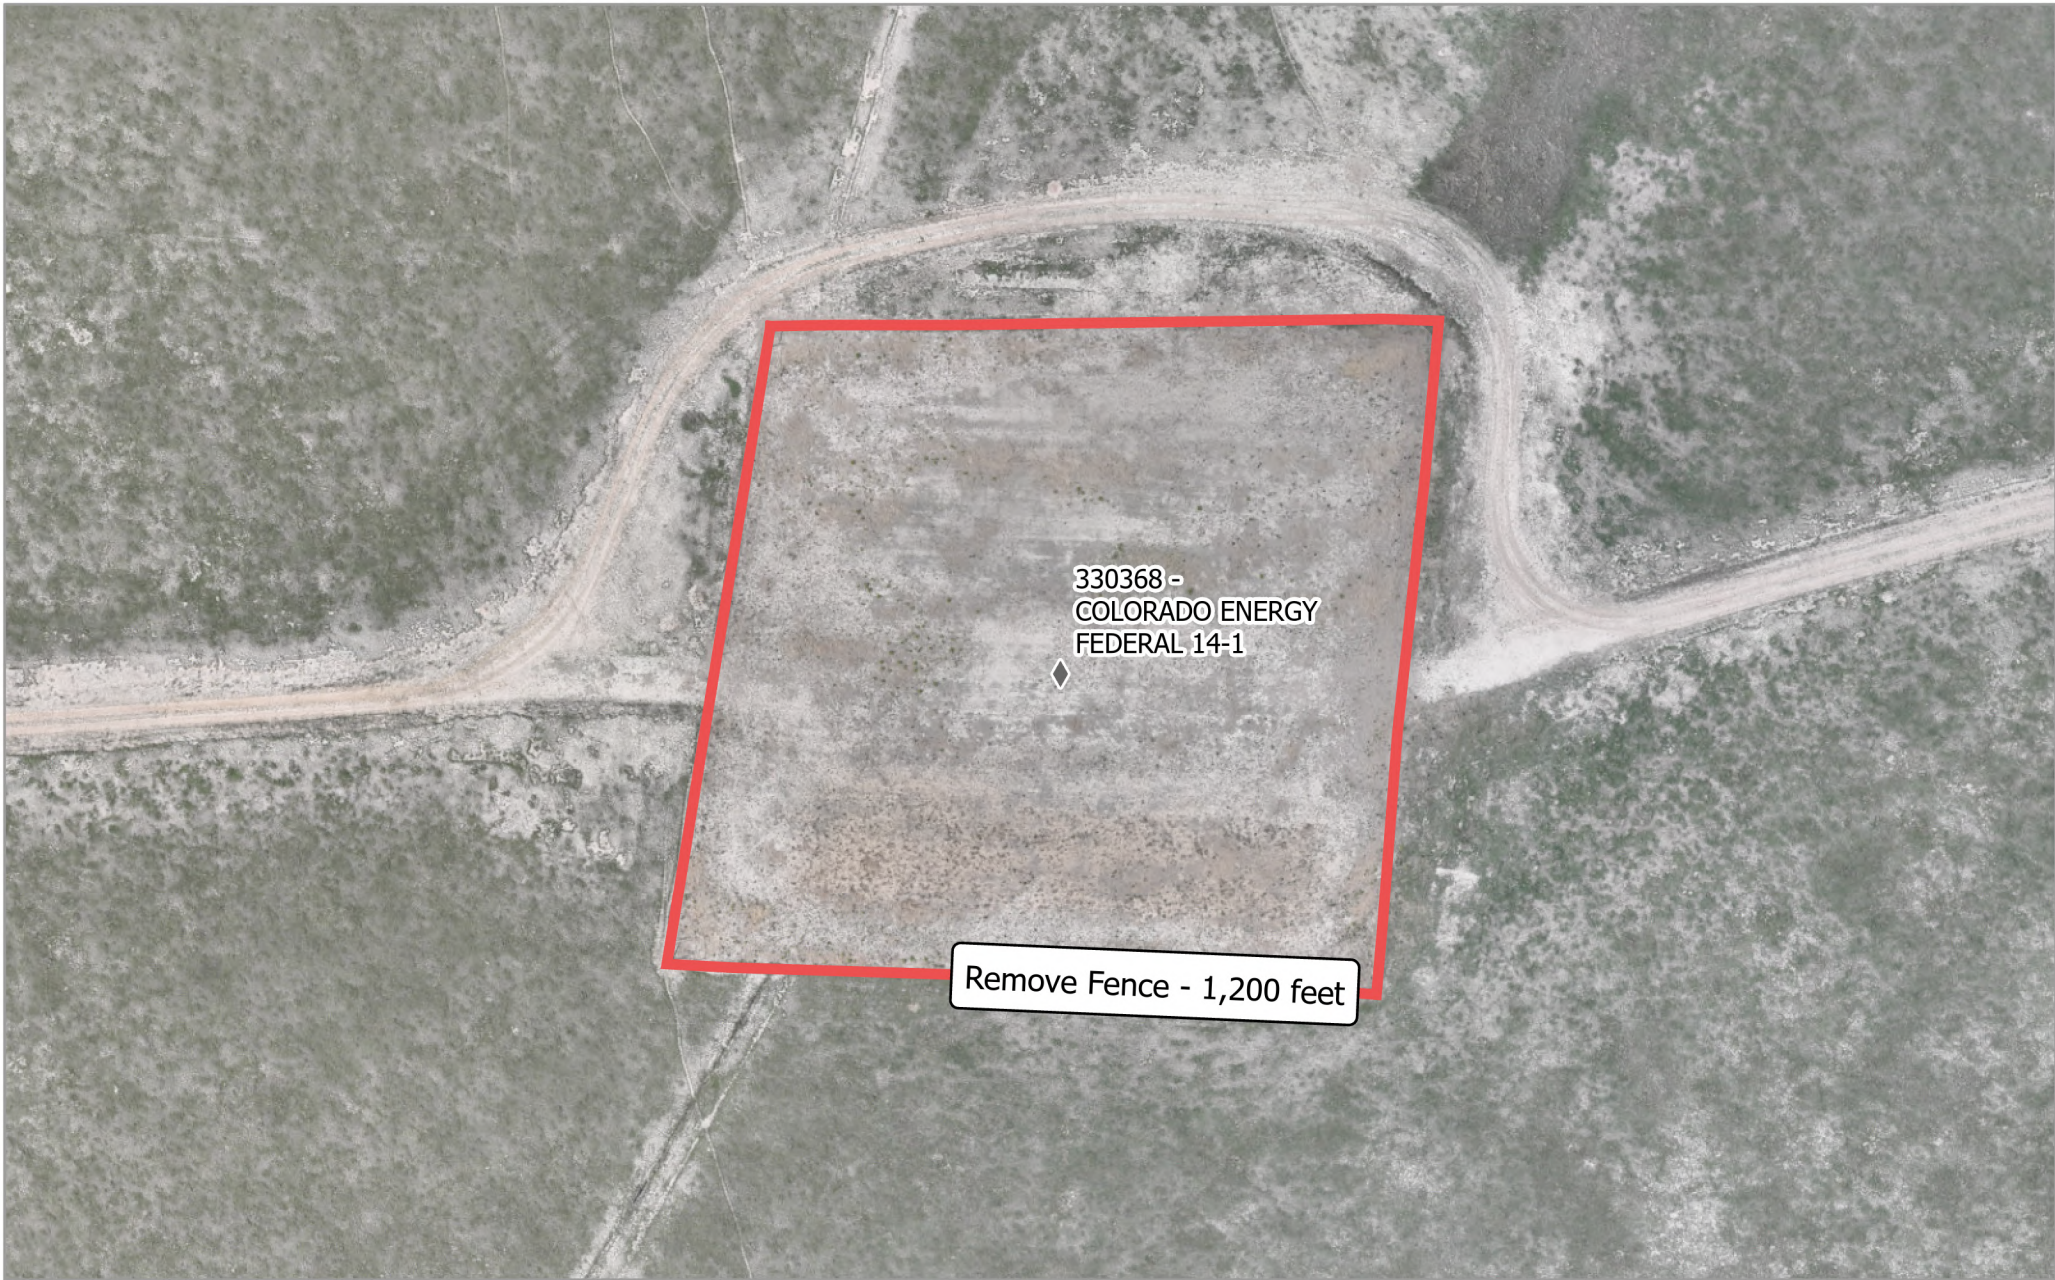
**CIV - 330368 - Colorado Energy
Federal 14-1
Map Extent - Remove Fence**

Fences remain at this location 330368.

- ◆ Wells
- Remove Fence
