SITE-SPECIFIC QUALITY ASSURANCE & QUALITY CONTROL AUDIT

PERMIT CLOSURE REPORT – RANGELAND

Location Name UPRC FEDERAL-610N64W/23SWNW

SITE-SPECIFIC RECLAMATION PLAN

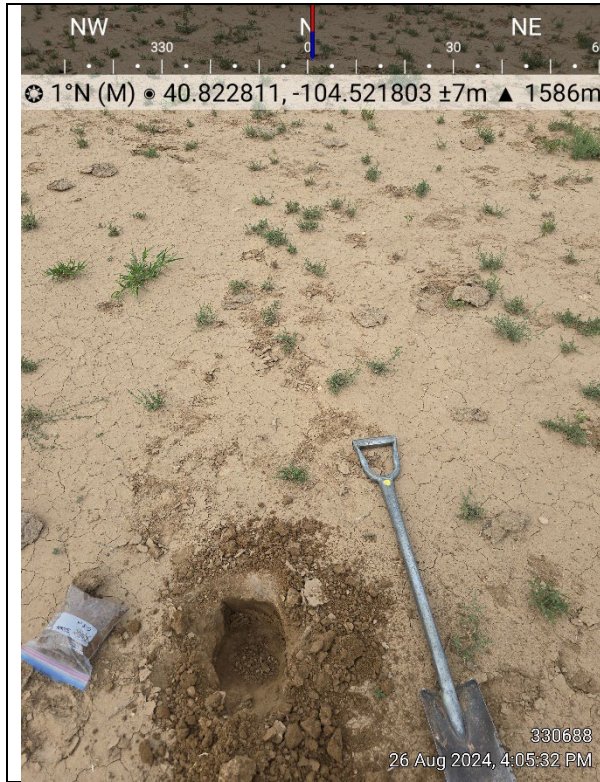
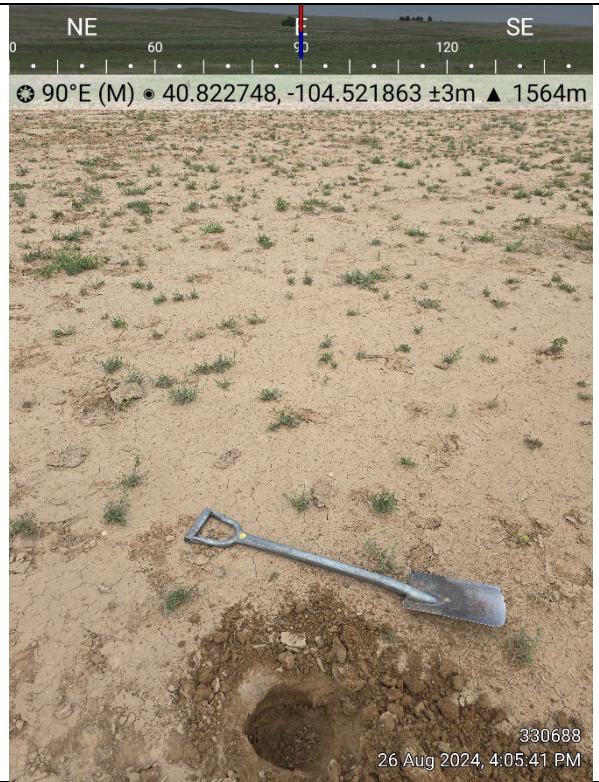
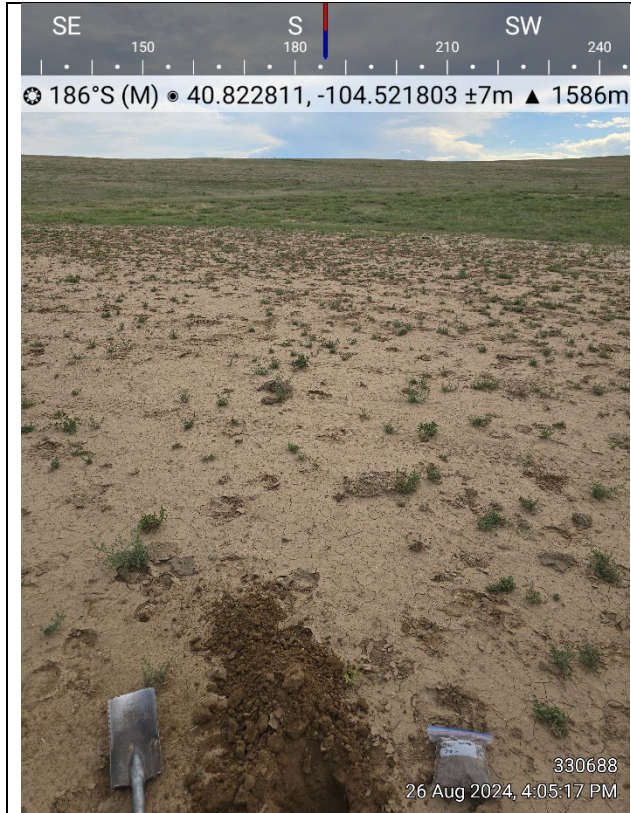
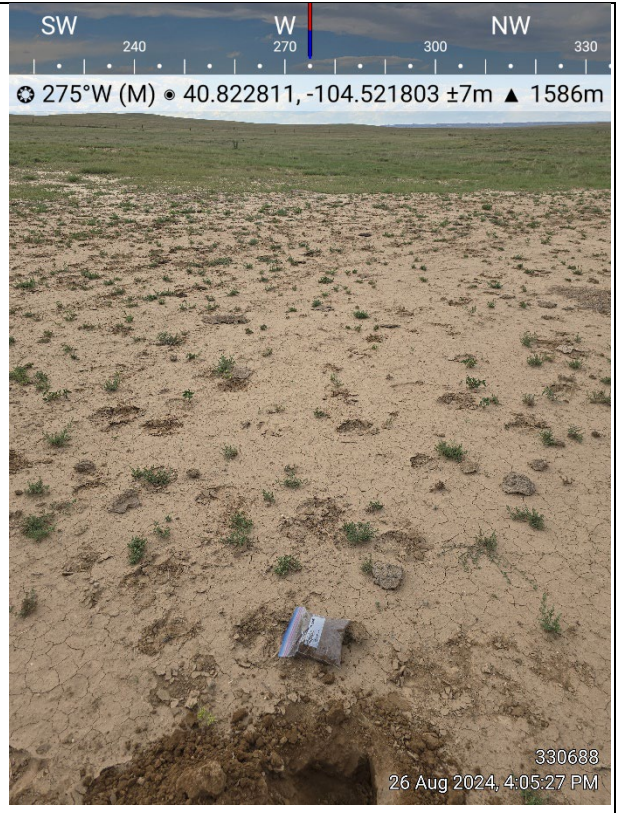
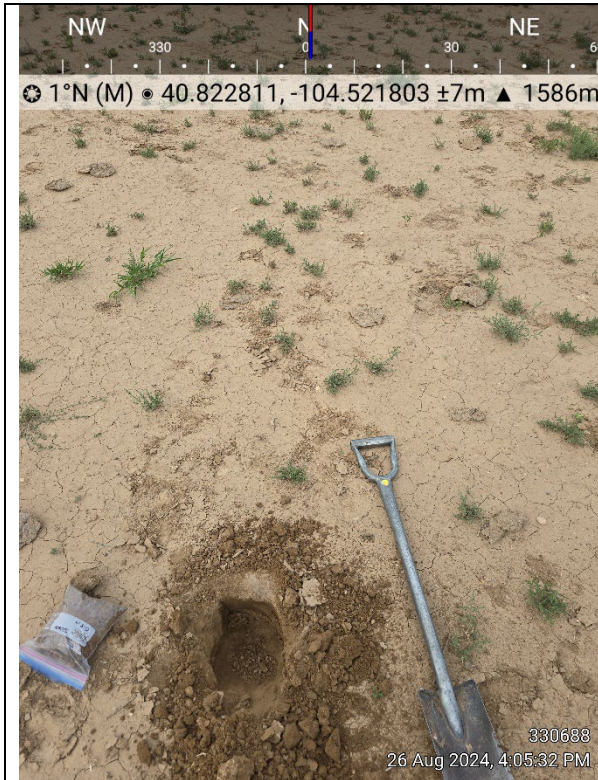
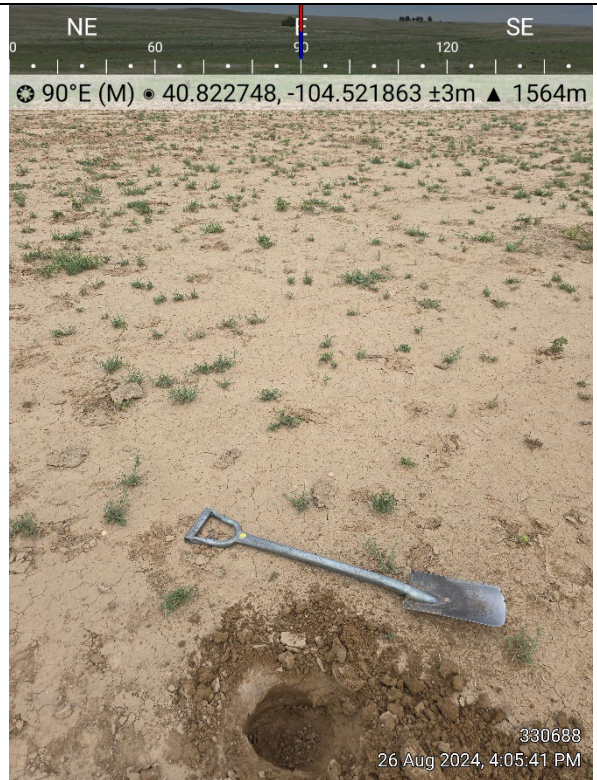
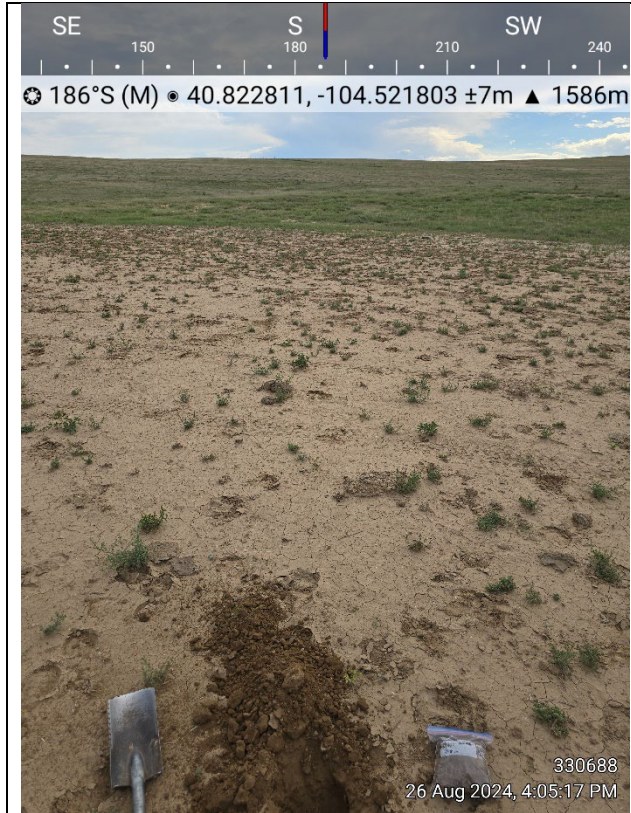
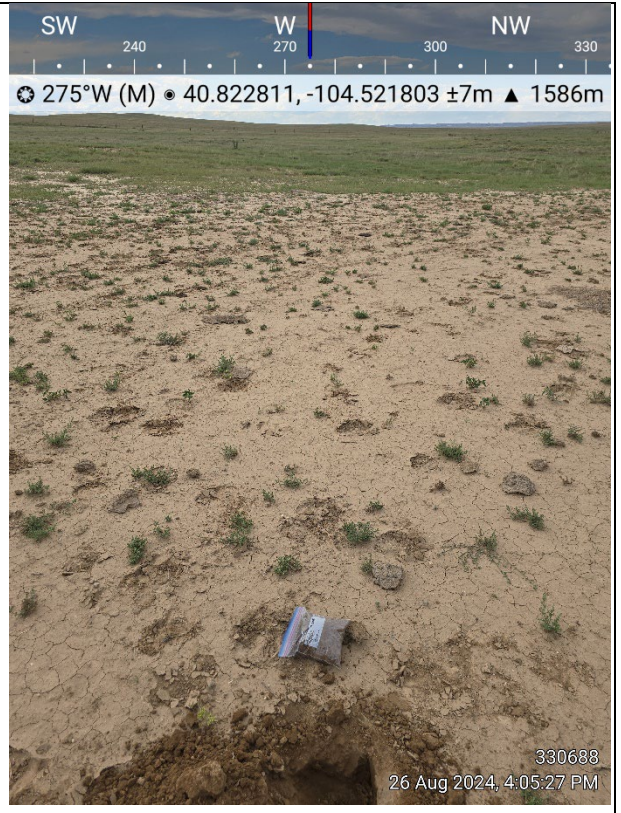
Site Photos – Soil 3 - 330688

This site has elevated values for Electric Conductivity (EC) and Sodium Absorption Ratio (SAR*), which is indicated by the elevated concentration of Sodium. SAR values that approach and exceed 1, indicate the presence of naturally occurring salts or the accumulation of salts based on other factors.

In addition, the analysis performed at the laboratory identified the presence of two additional salts – Chloride and Sulfate. These salts at elevated concentrations, typically above 100 ppm, can impede plant growth depending on environmental conditions, previous land use activities and other soil properties.

- Continuous bare ground on road and pad
- Weed impact kochia, lamb quarter, Buffalo-Bur and thistle.
- Weed impact along the fence line near entrance gate – kochia, dandelions, puncture vine, and cheatgrass
- Recommendations
 - Removal of soil to 12 inches due to salt concentration exceed reference soils
 - Replace, decompact, disc, seed, and straw crimp. Use USFS seed mix that is adjusted to work with the entire site
 - Remove culvert

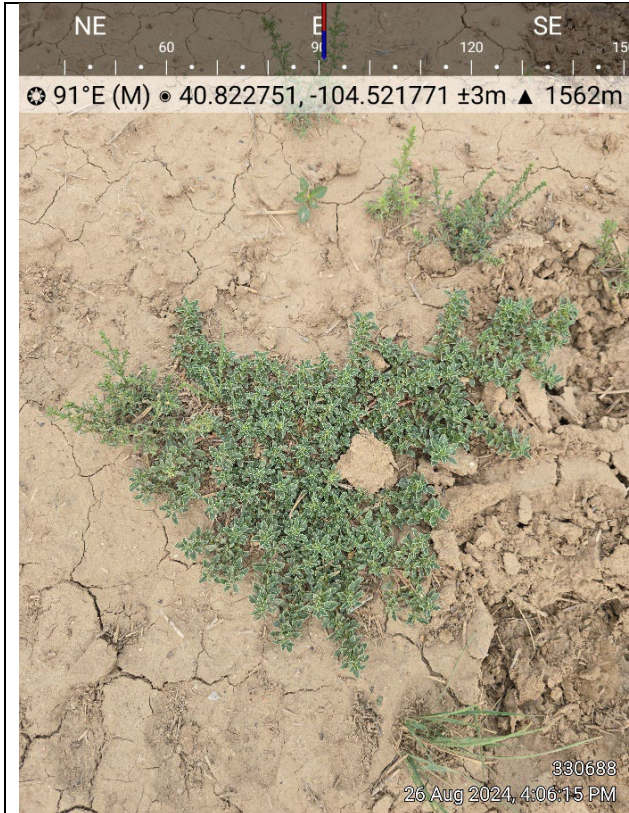
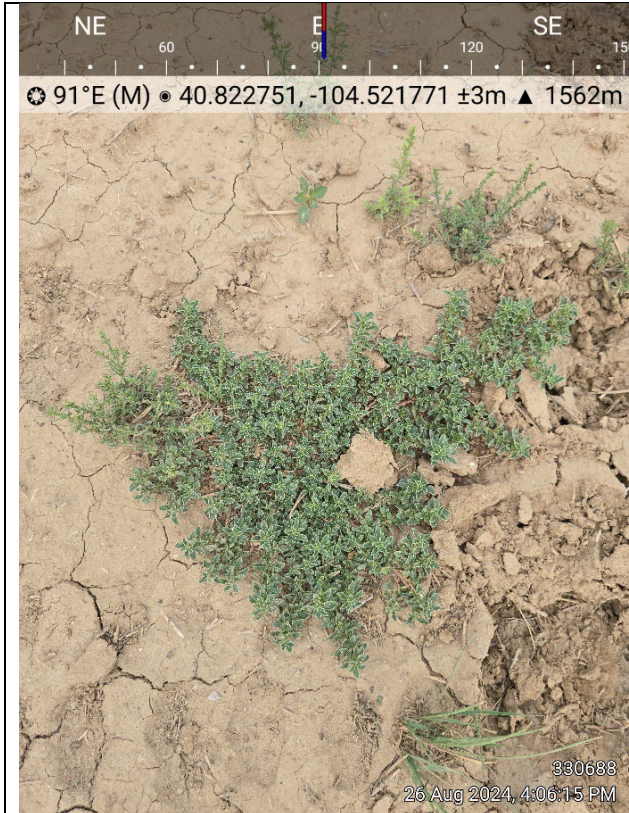
Amaranthus (*Genus Amaranthus*)

Amaranth (Genus *Amaranthus*)

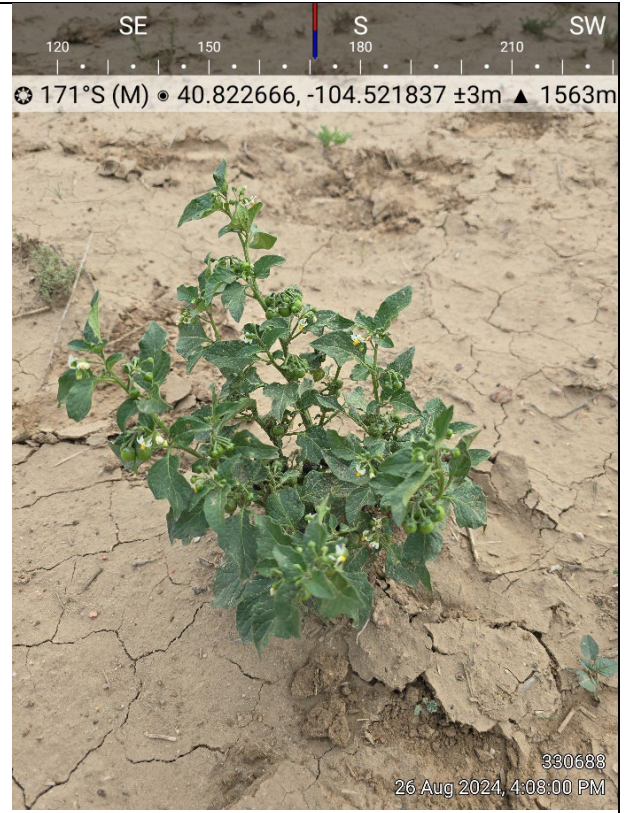
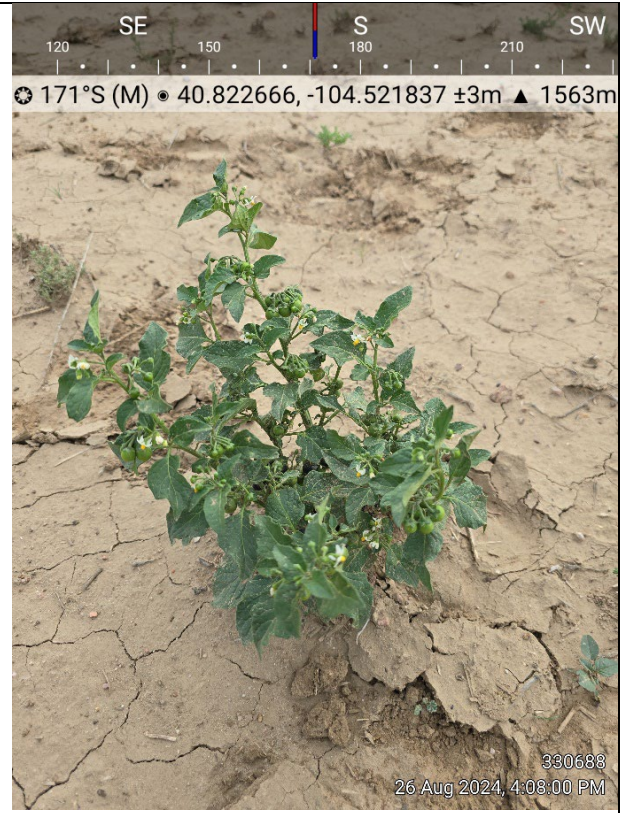
Black Nightshade (*Solanum nigrum*)

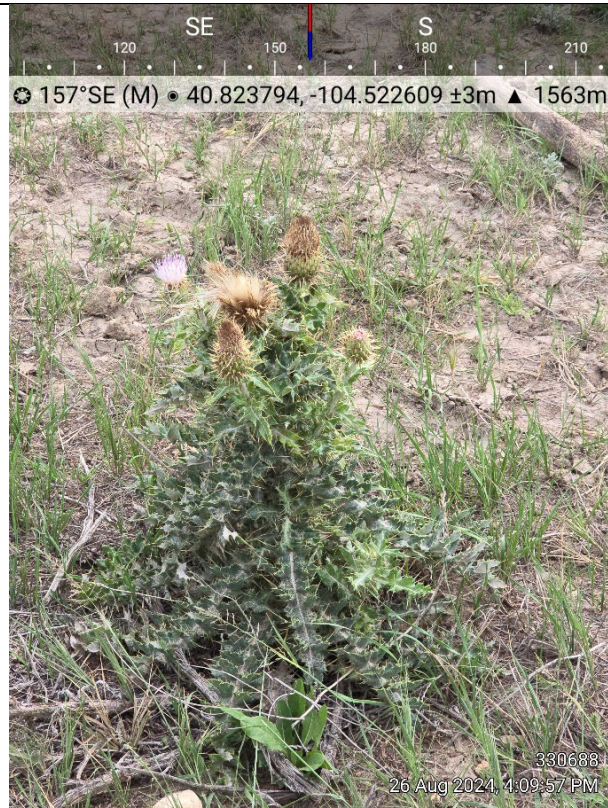
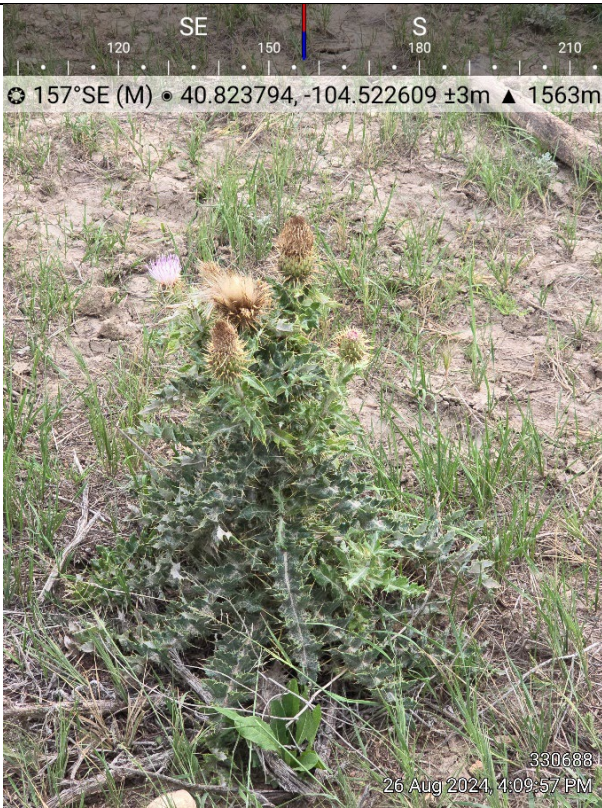
Plume Thistle (*Genus Cirsium*)

Plume Thistle (Genus *Cirsium*)

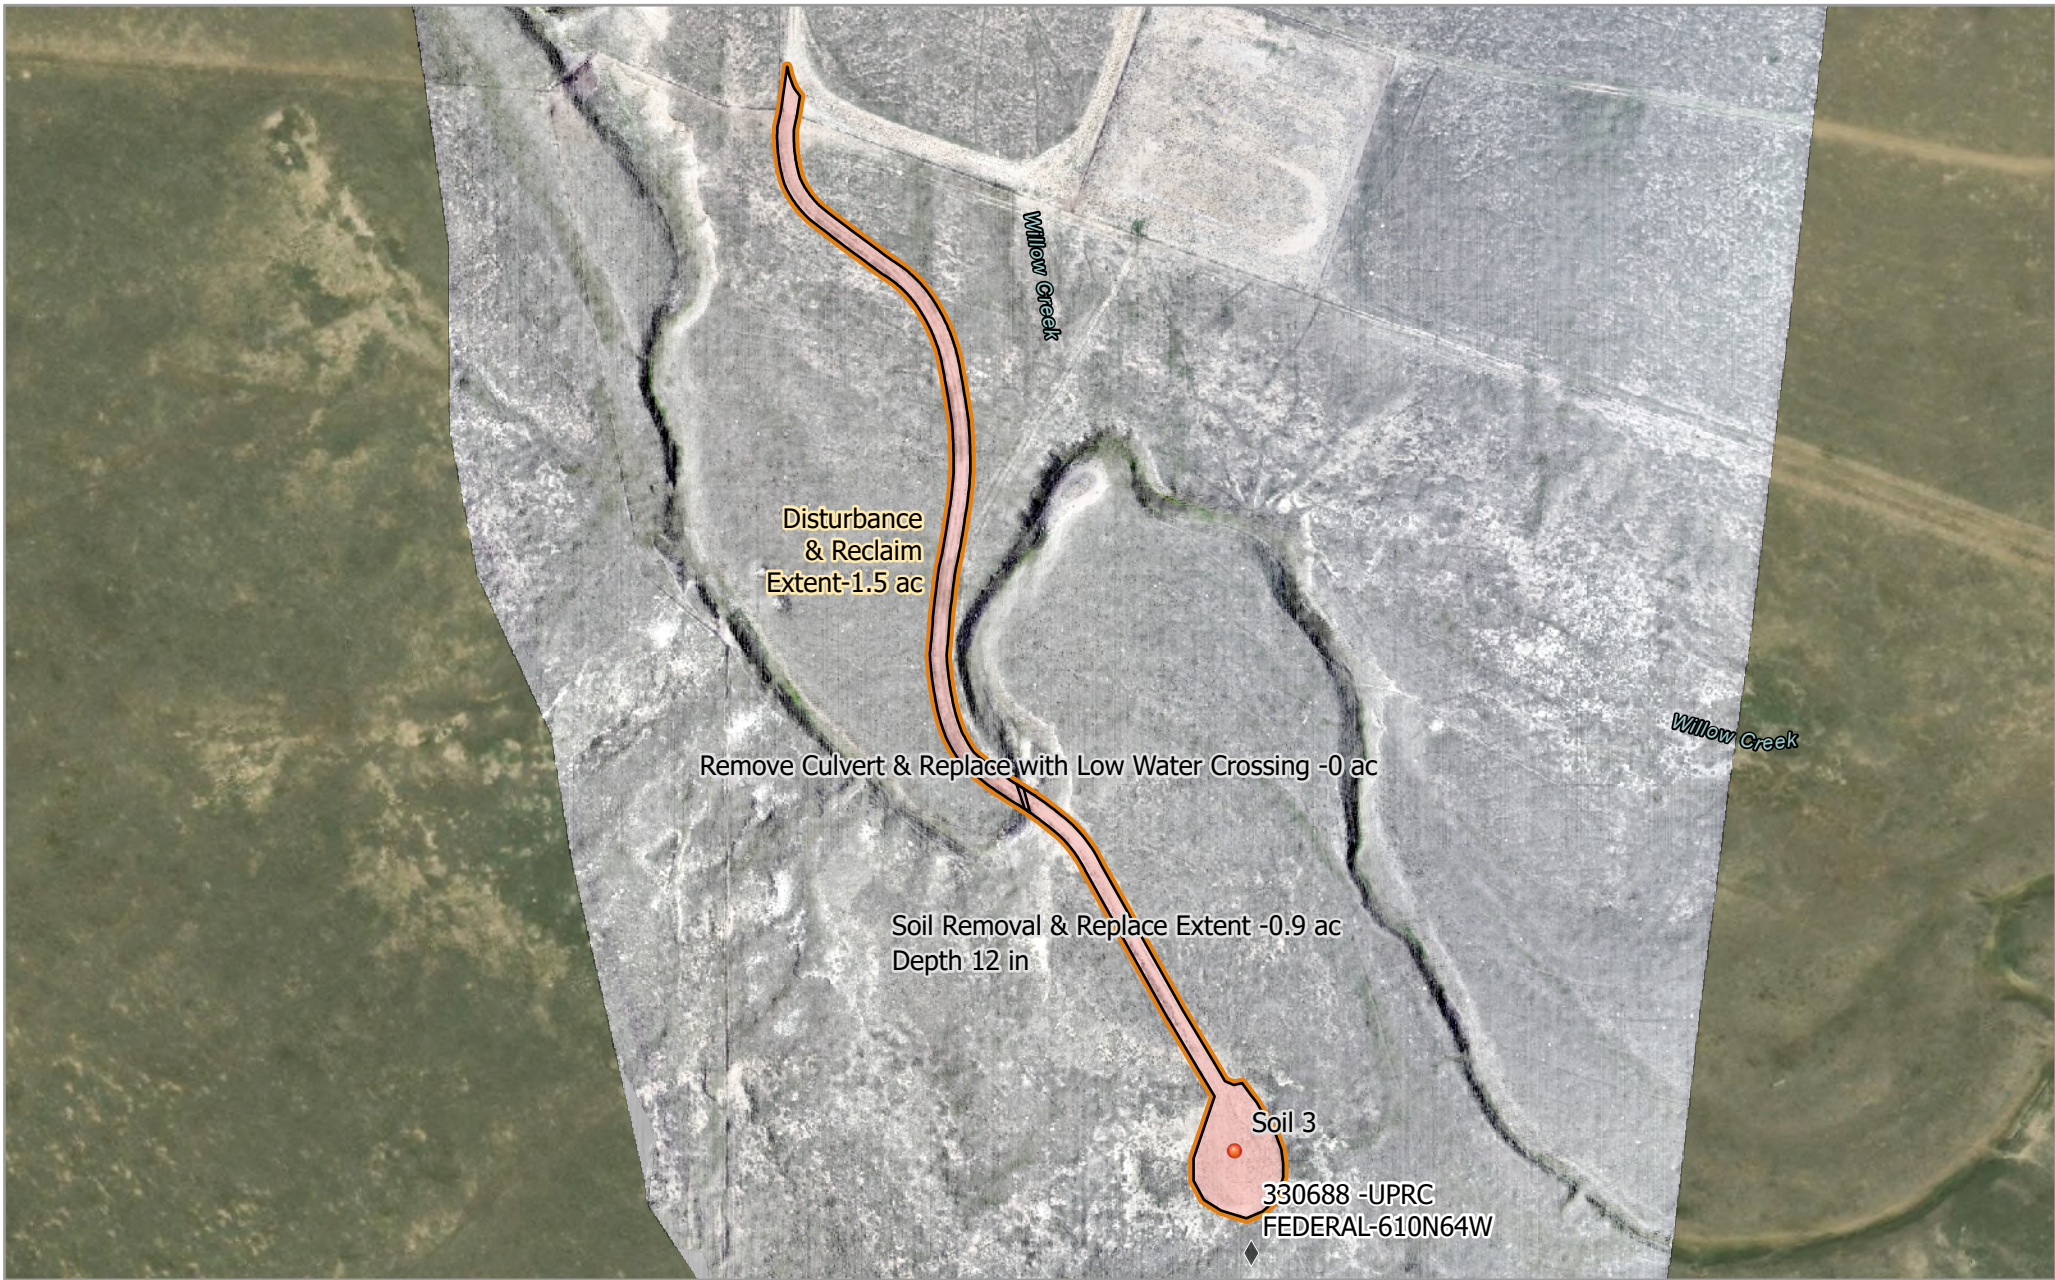
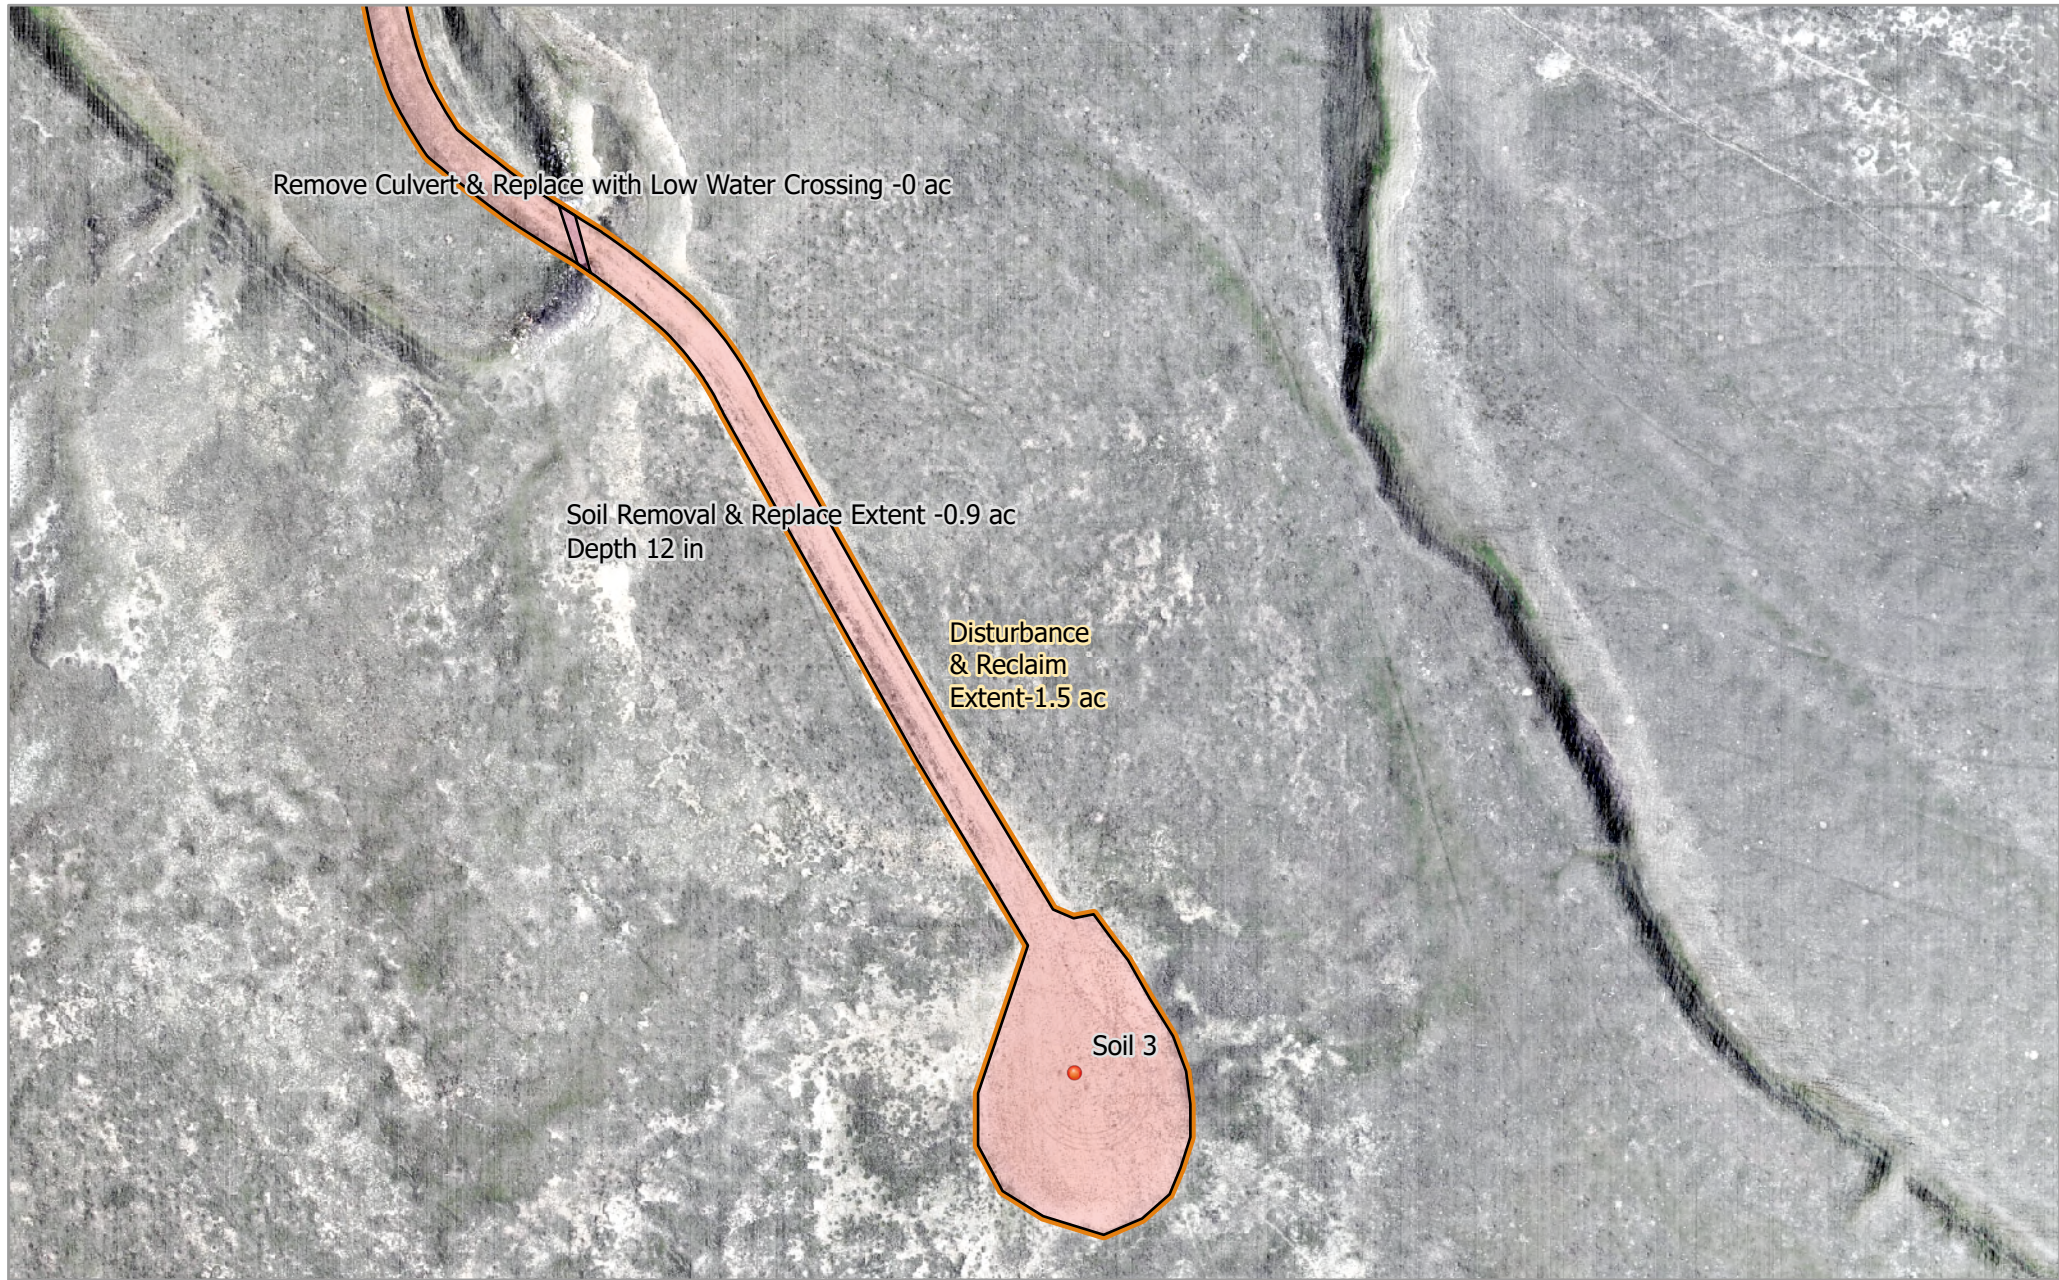
CIV - 330688 - UPRC Federal 610N64W / 23SWNW

Map Extent - Reclaim Extent

- ◆ Oil and Gas Locations
- Soil Sample Point
- ▭ Disturbance Boundary
- ▭ Soil Removal & Replace
- ▭ Remove Culvert

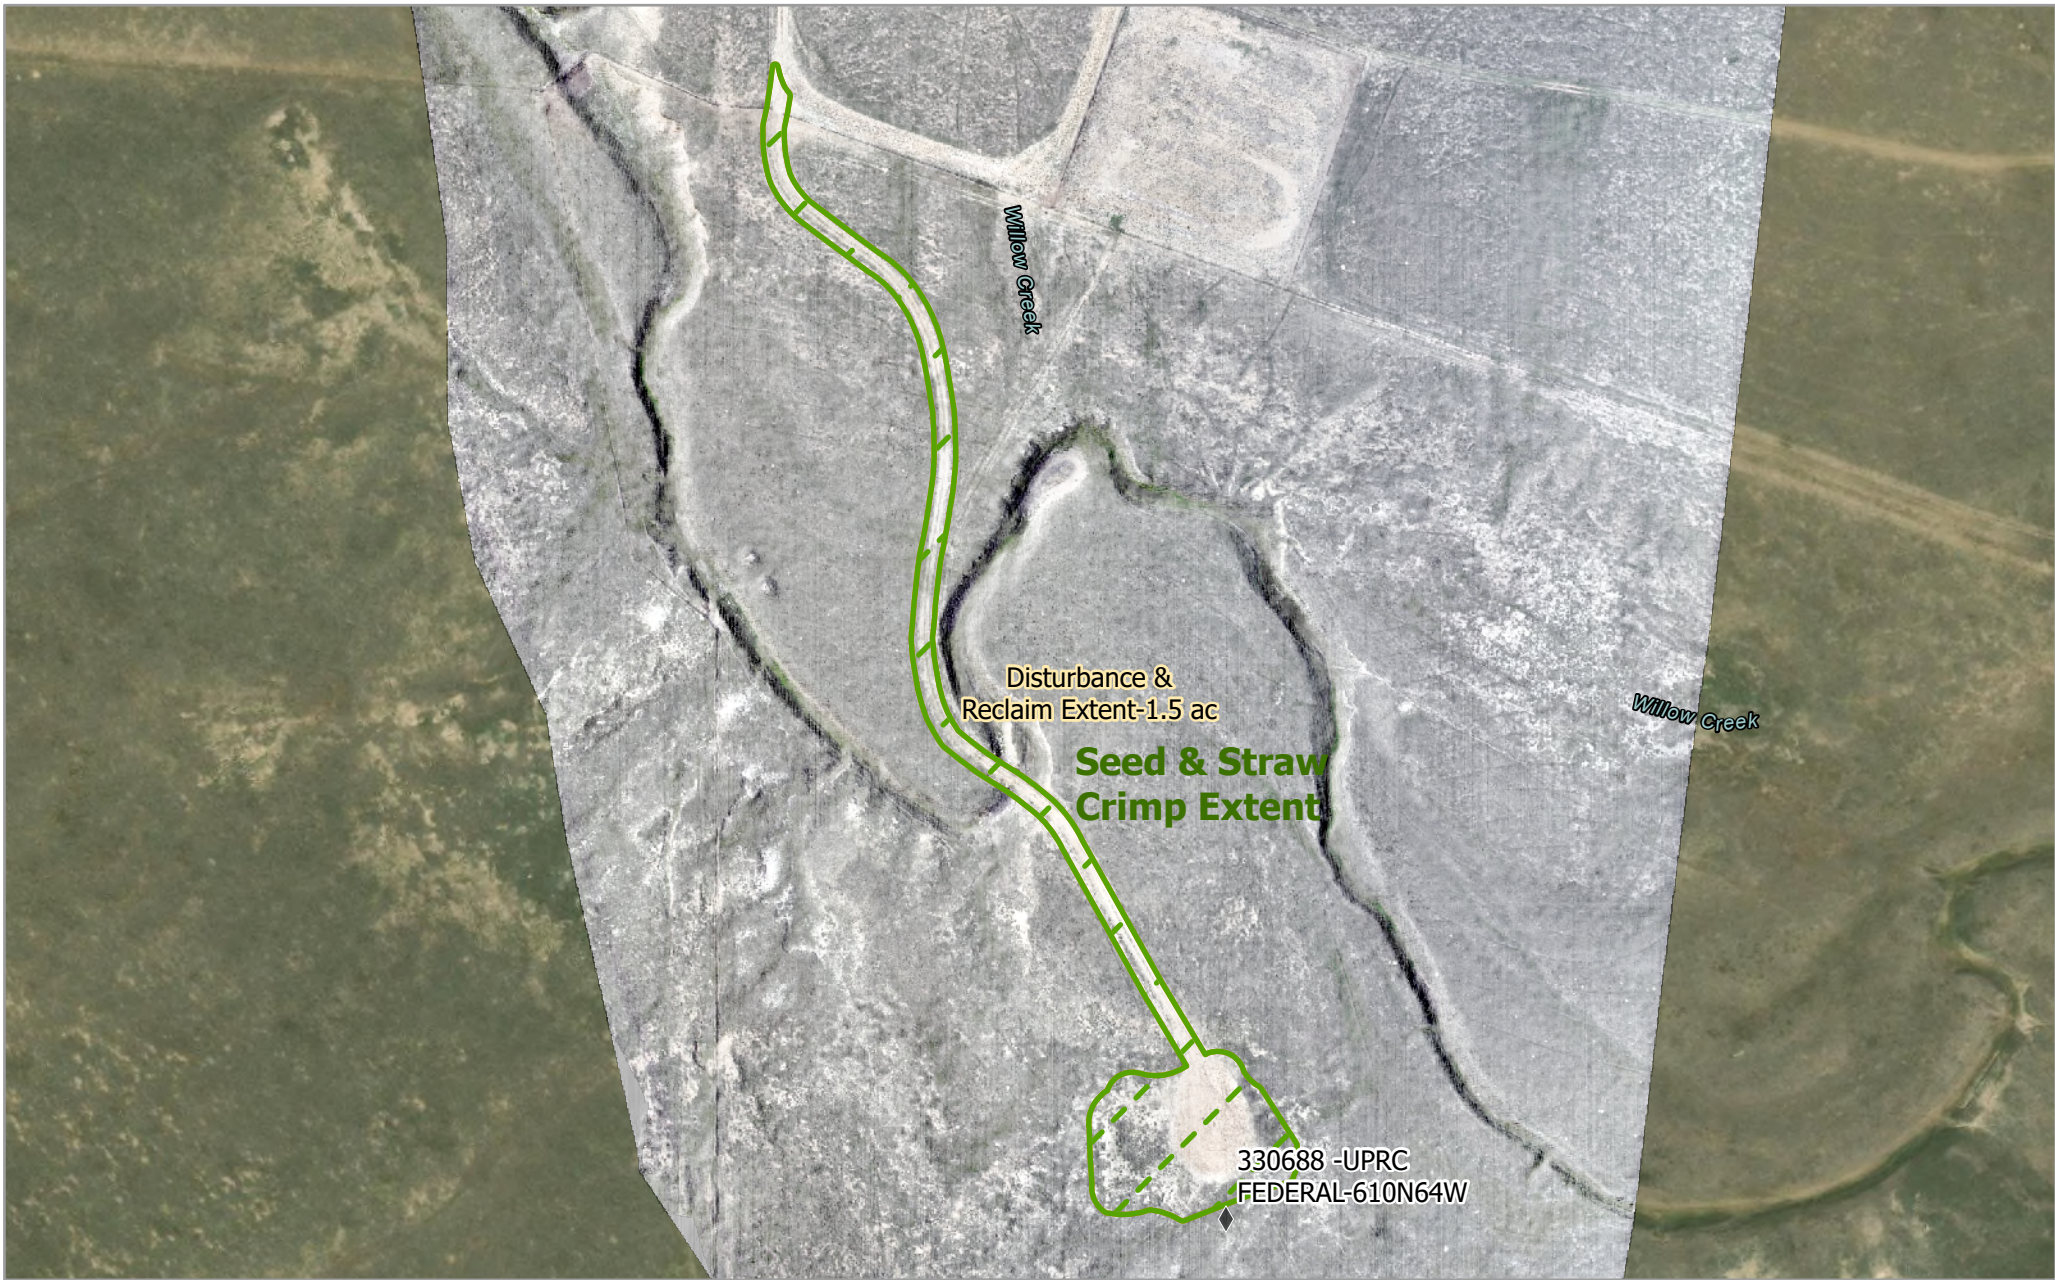
**CIV - 330688 - UPRC Federal
610N64W/23SWNW
Map Extent - Reclaim Extent**

- ◆ Oil and Gas Locations
- ▭ Disturbance Boundary
- ▭ Seed Boundary
