PERMIT CLOSURE REPORT – RANGELAND

Location Name COLORADO ENERGY FEDERAL-610N64W/14SWSW

SITE-SPECIFIC RECLAMATION PLAN

Failed Reclamation Inspection

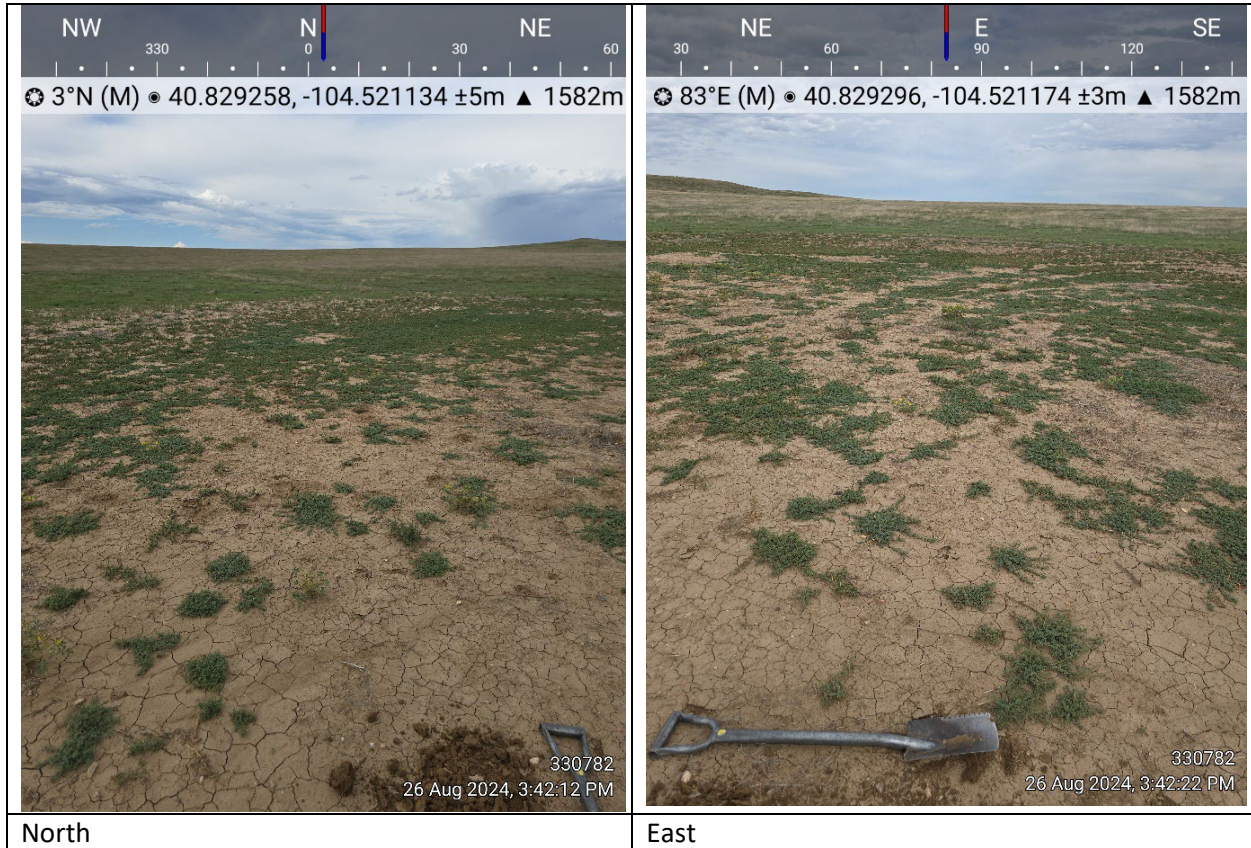
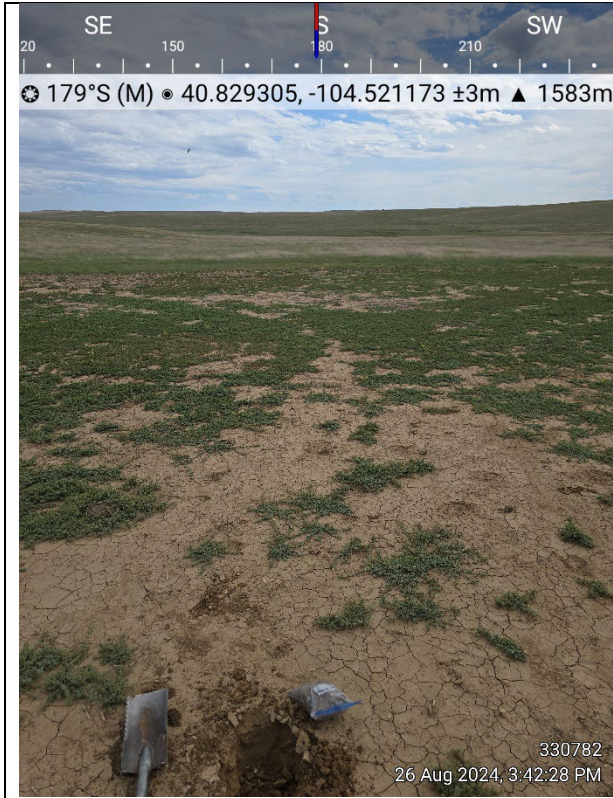
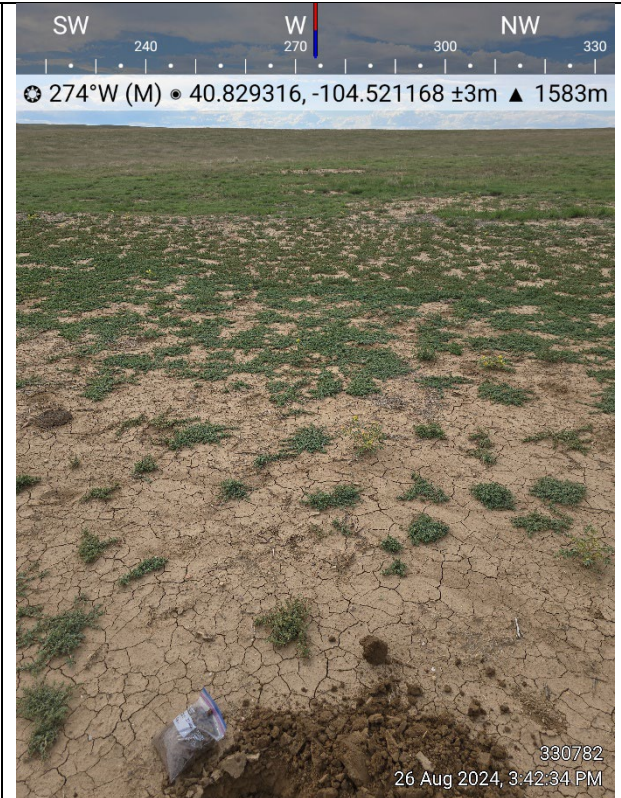
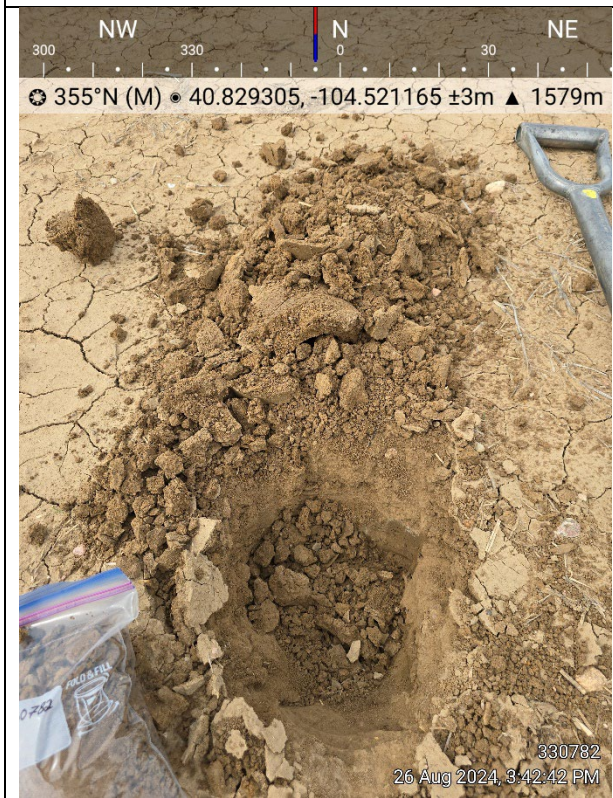
Site Photos – Soil 4 – 330782

Exposed soils have moderate susceptibility to water erosion and are in the high susceptible group for wind erosion due to ecosystem dynamics and vegetative cover.

South

West

North and Ground

- Continuous bare ground on road and pad
- Weed impact primarily broadleaf weeds
- Recommendations
 - Remove, replace, decompact, disc, seed, and crimp straw. Use USFS seed mix that is adjusted to work with the entire site

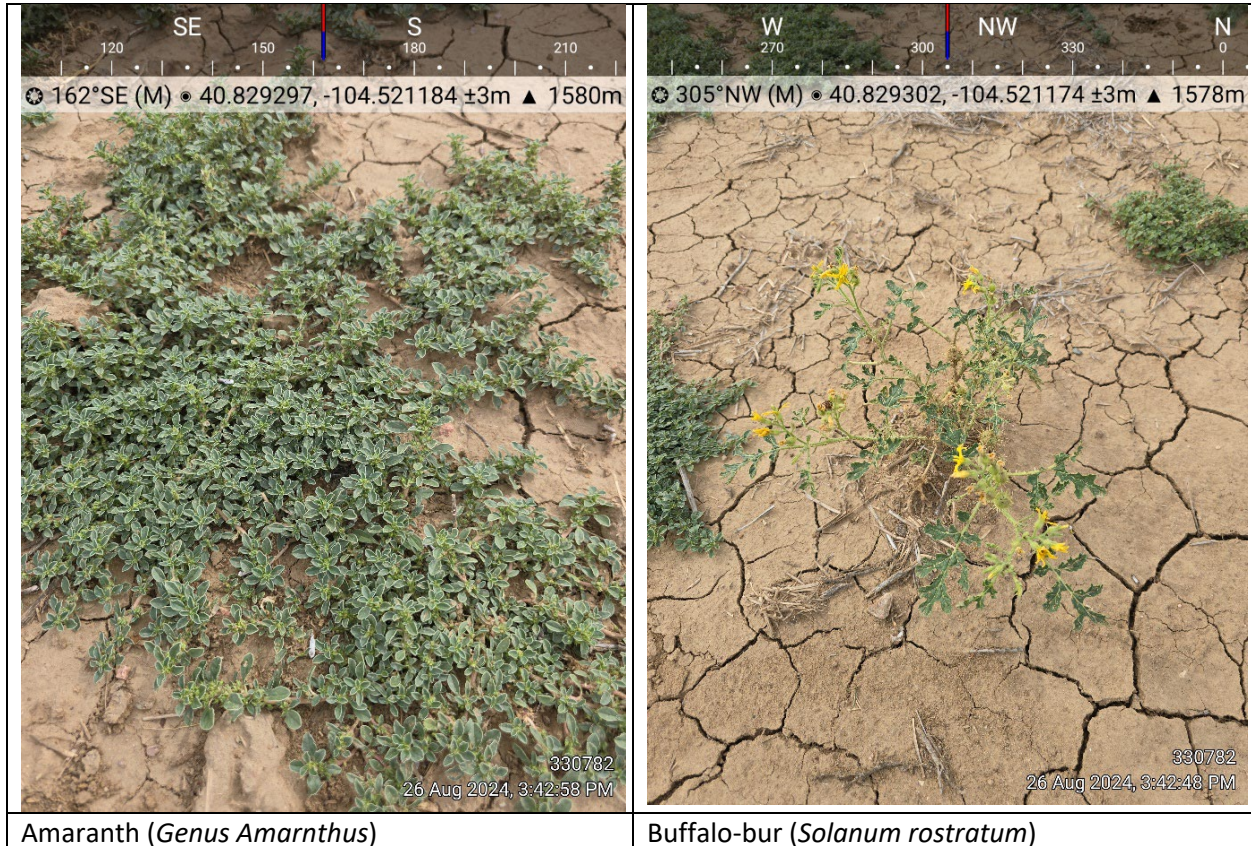
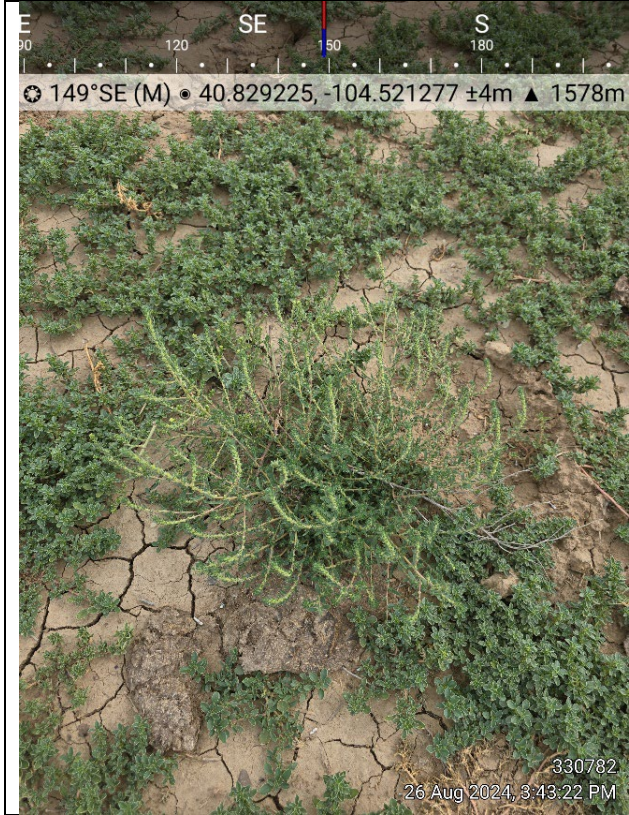
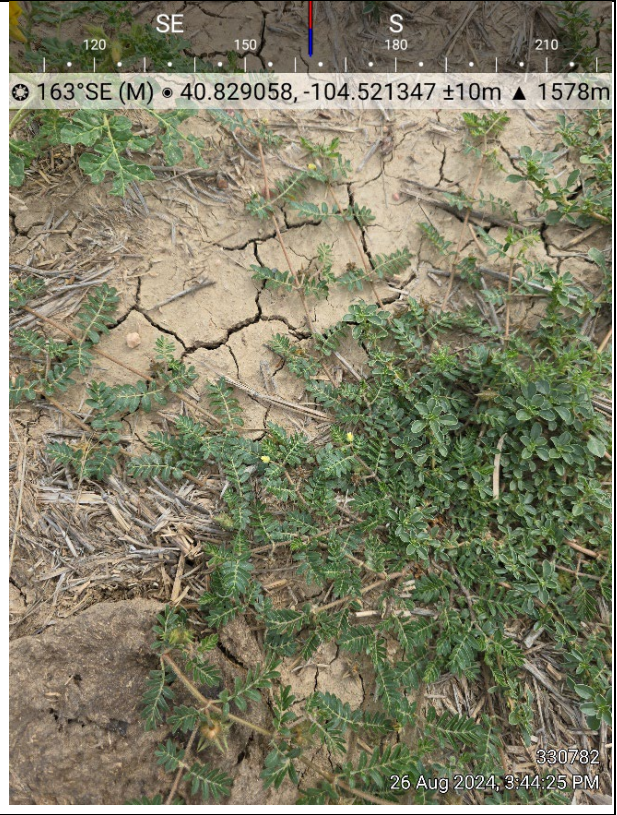
Site Photos – Vegetation 330782

Site vegetation observations took place in Aug within the reclamation extent. Weeds are the primary vegetation during the site visit.

Amaranth (*Genus Amaranthus*)

Buffalo-bur (*Solanum rostratum*)

Kochia (*Bassia scoparia*)

Puncturevine (*Tribulus terrestris*) List C

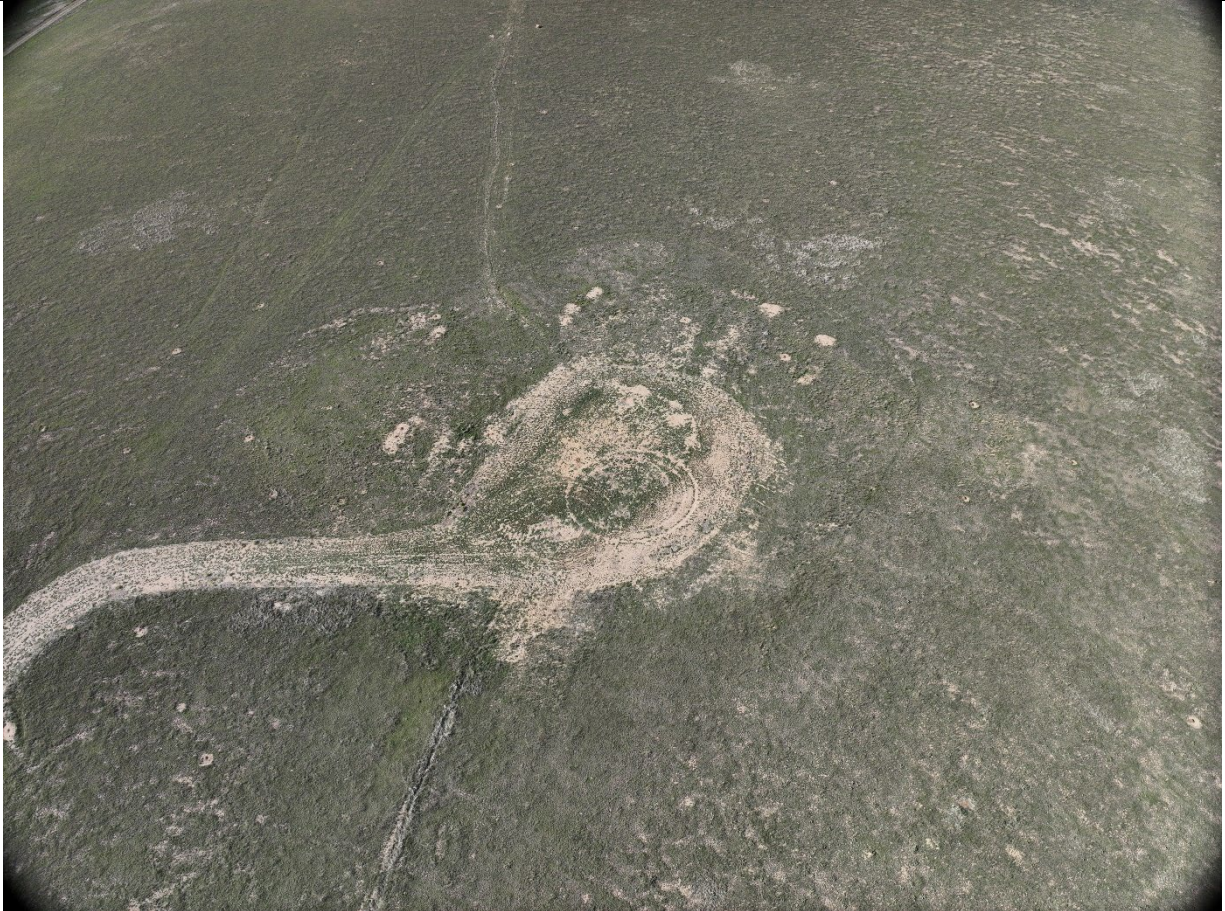
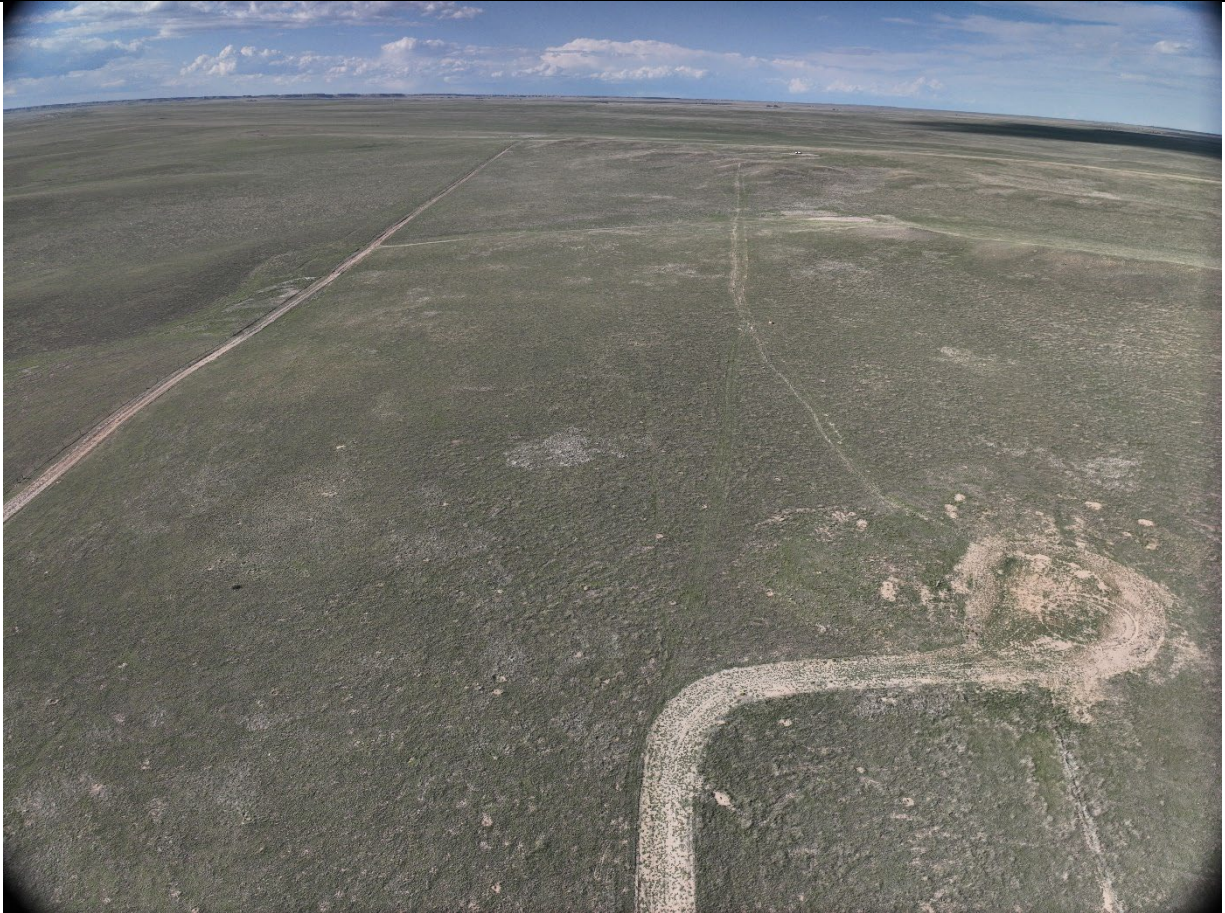
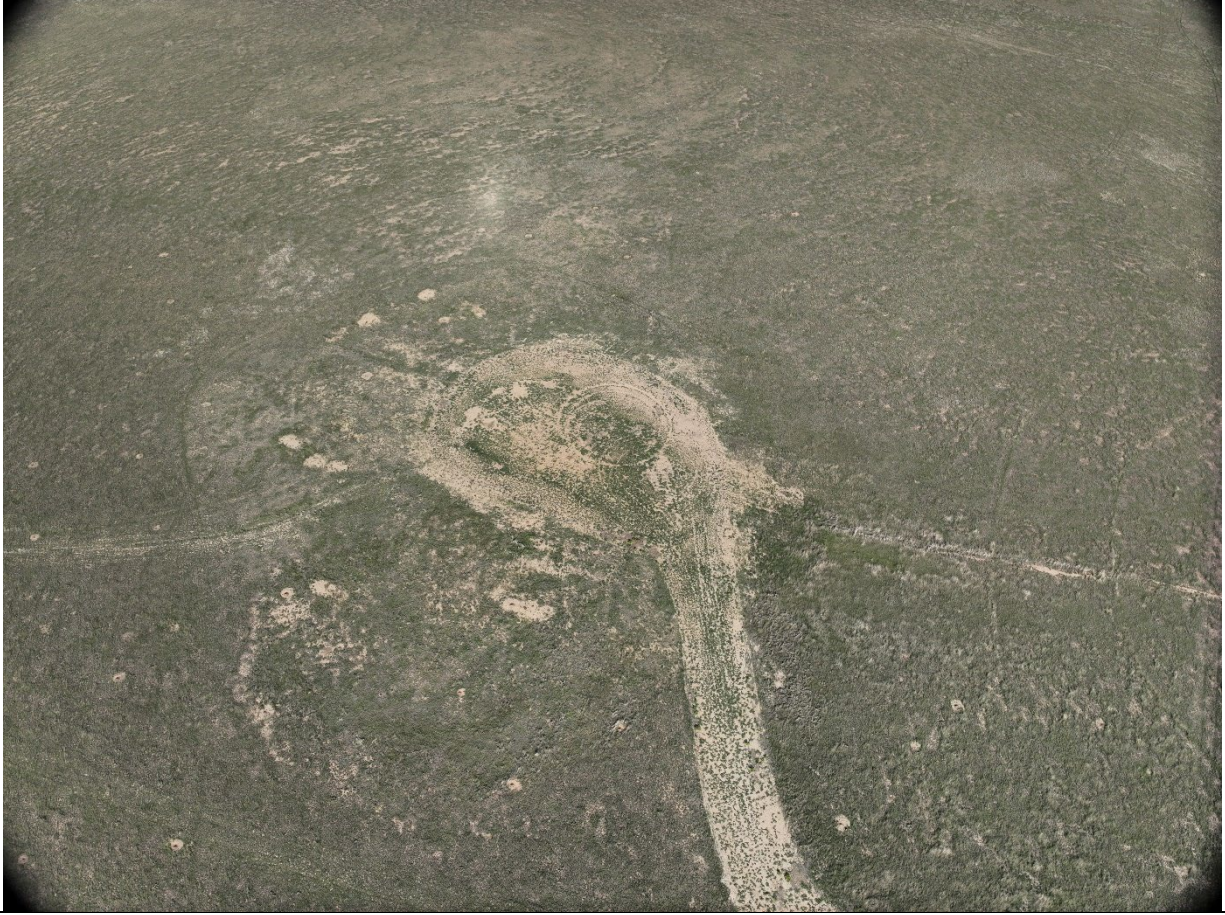
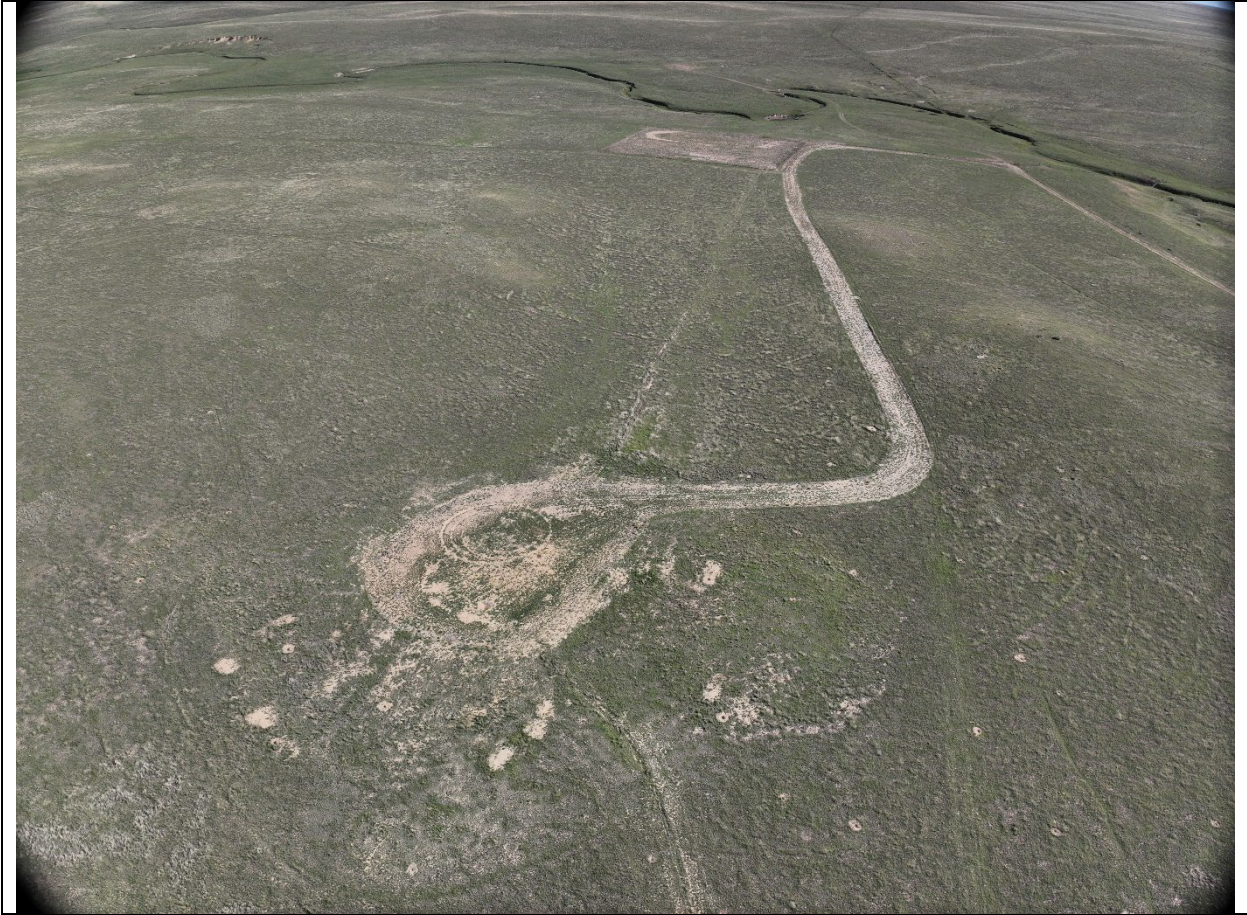
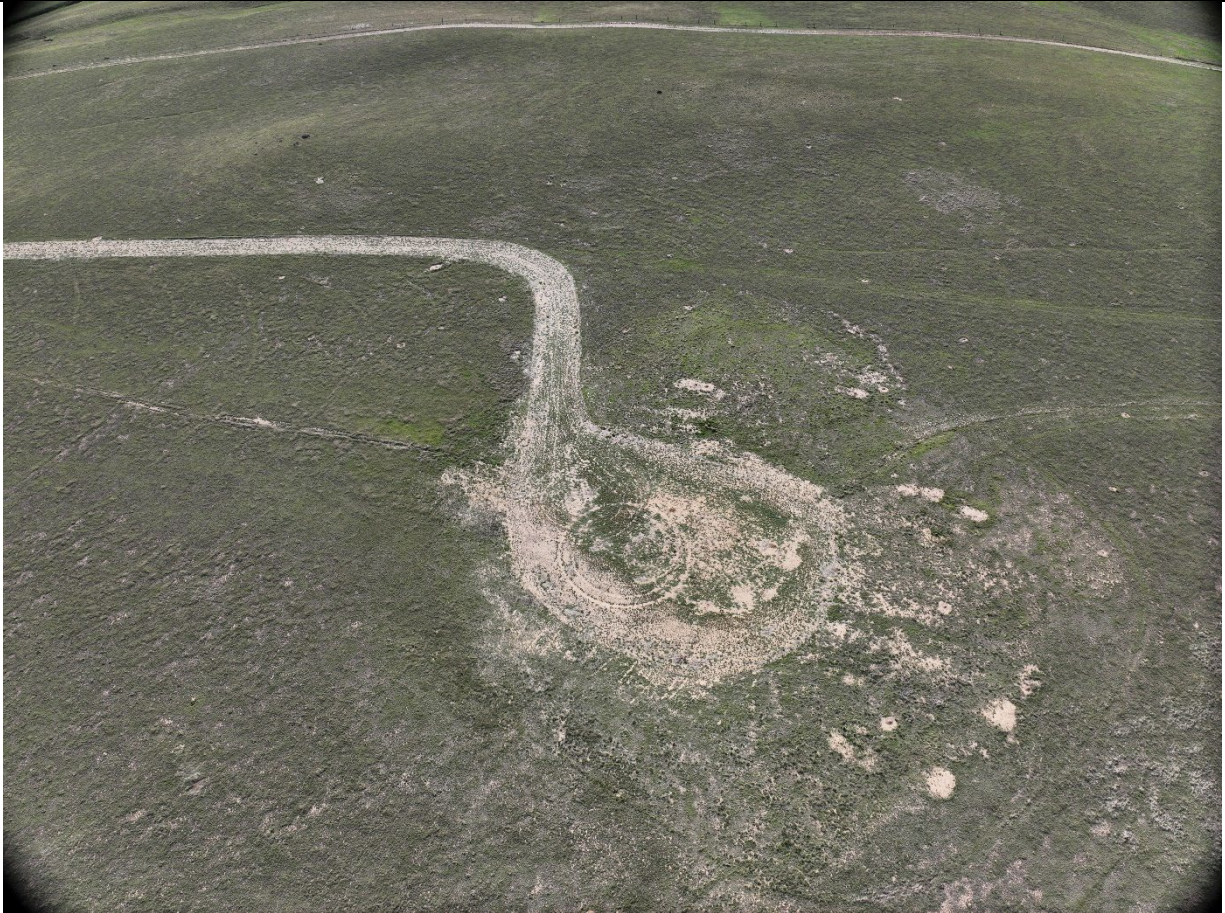
Site Photo

North

East

South

West

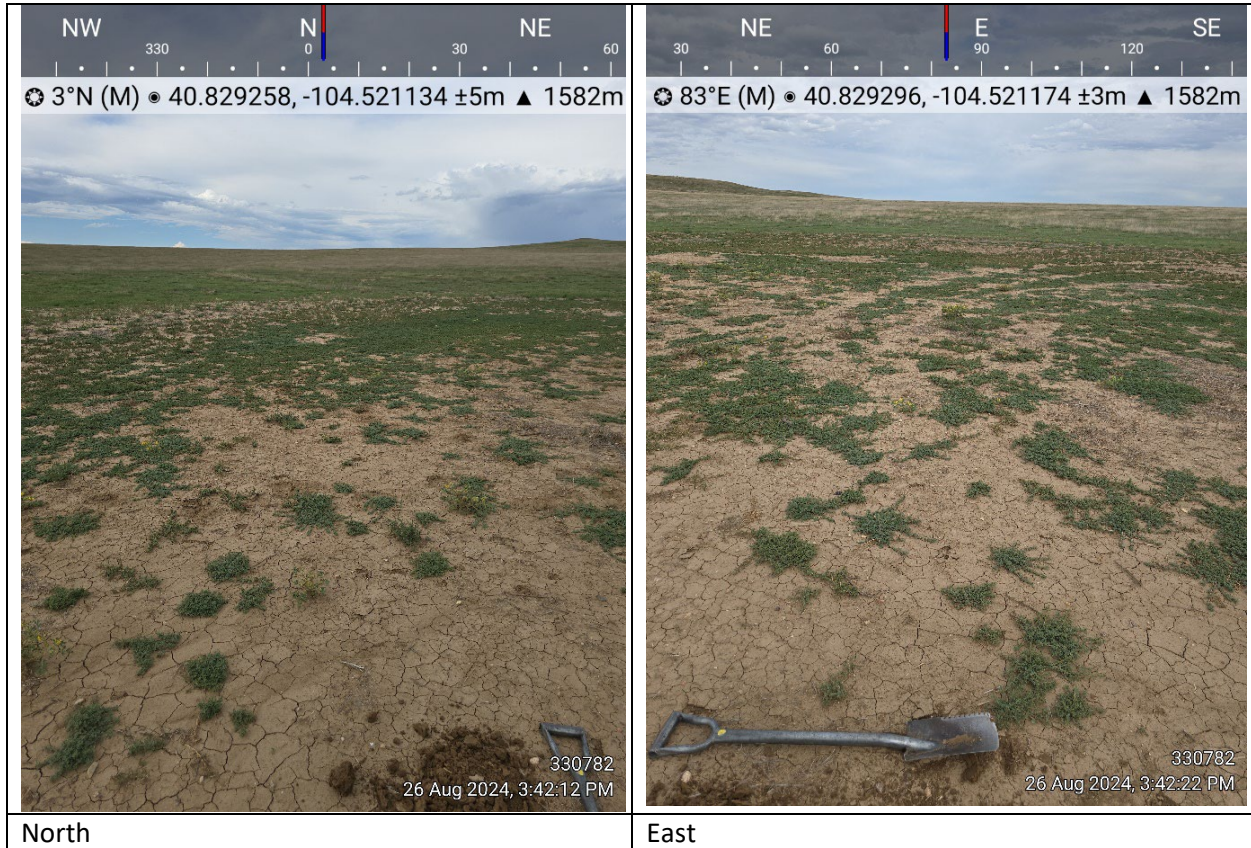
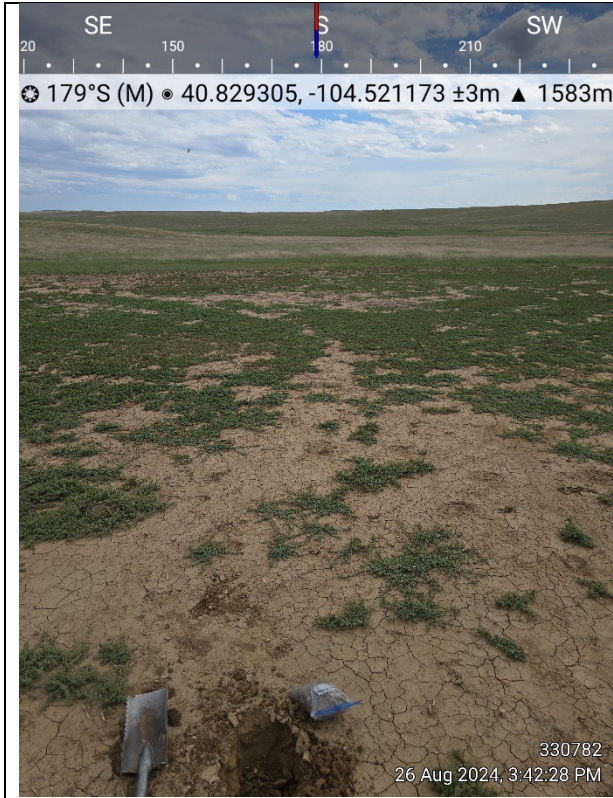
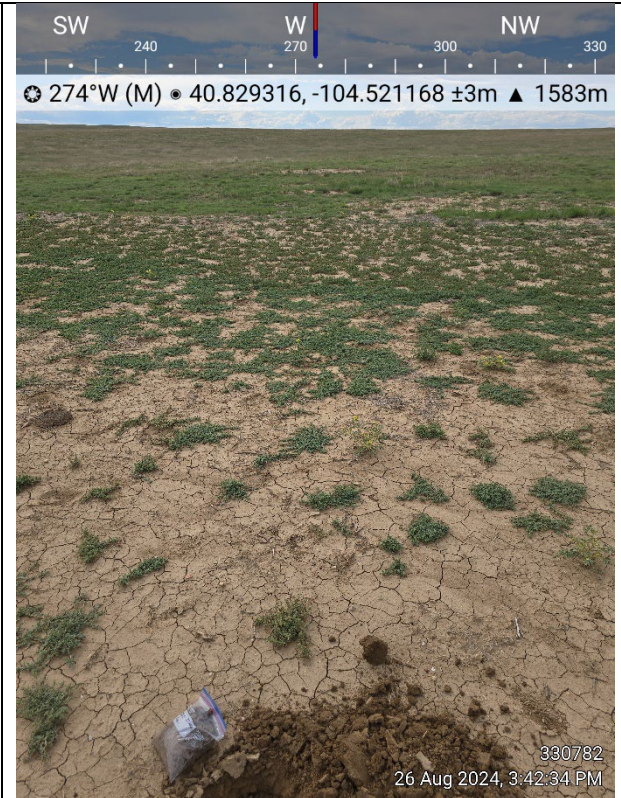
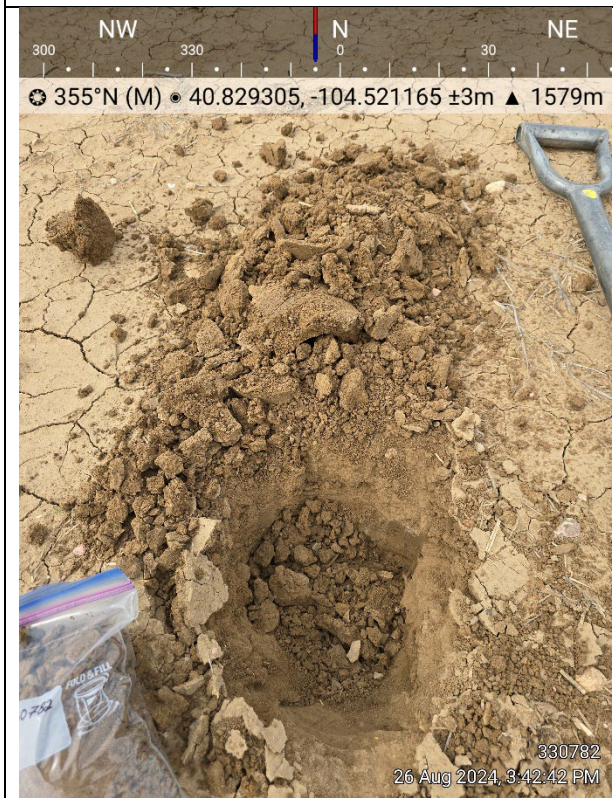
Site Photos – Soil 4 – 330782

South

West

North and Ground

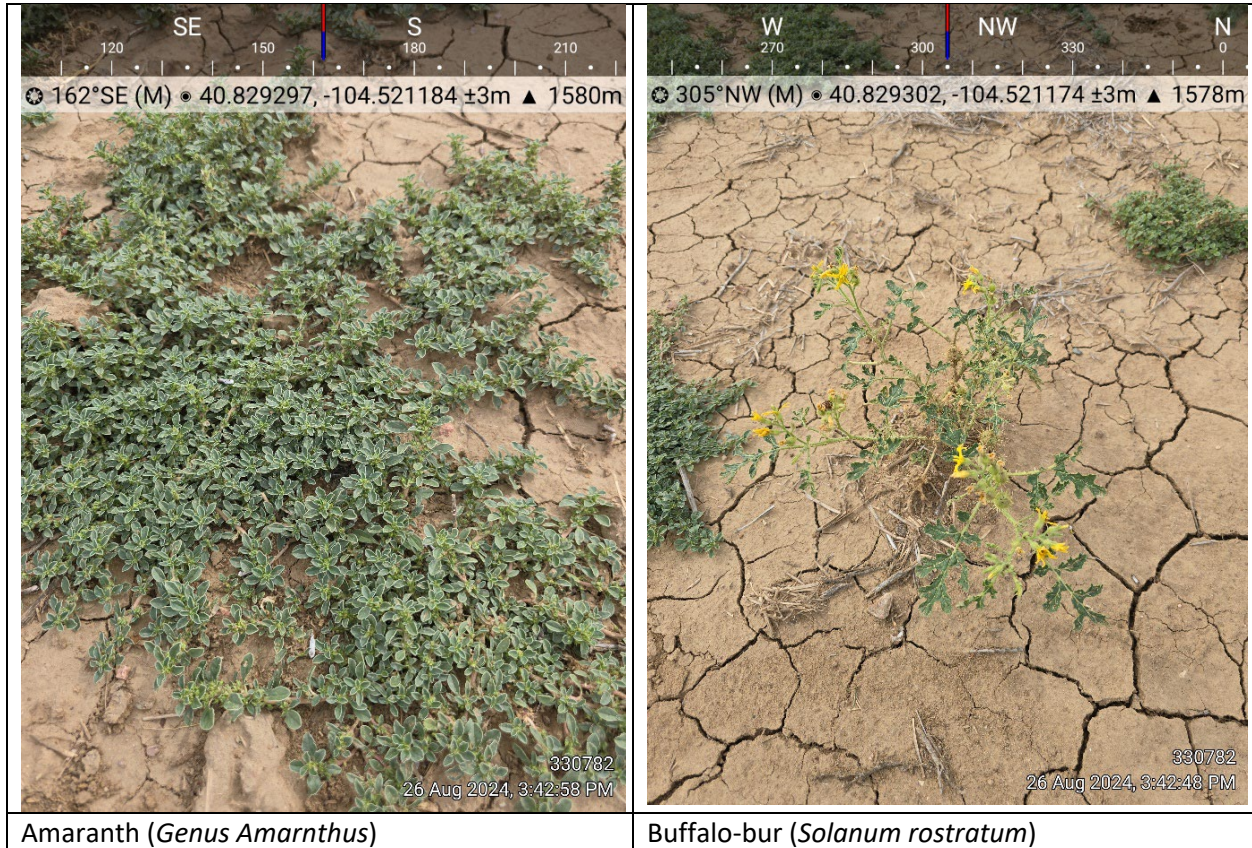
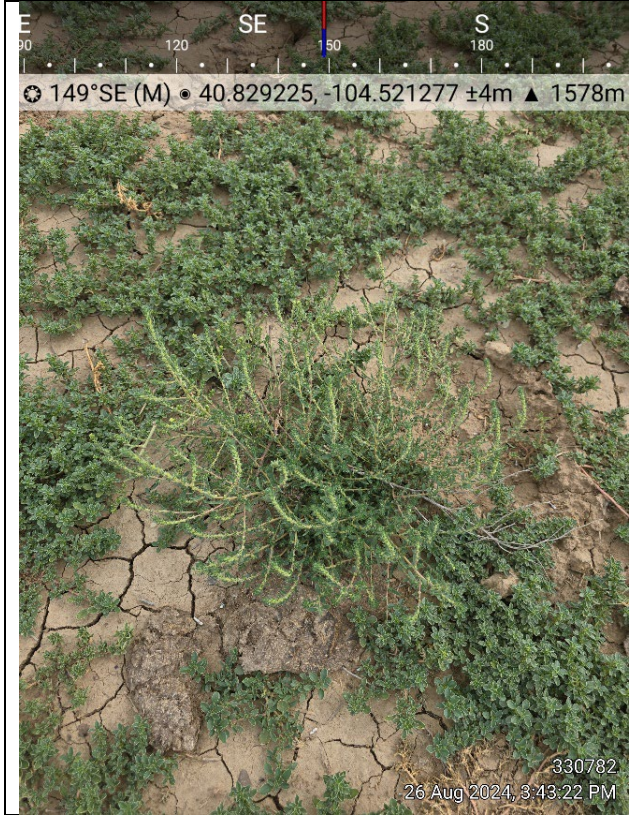
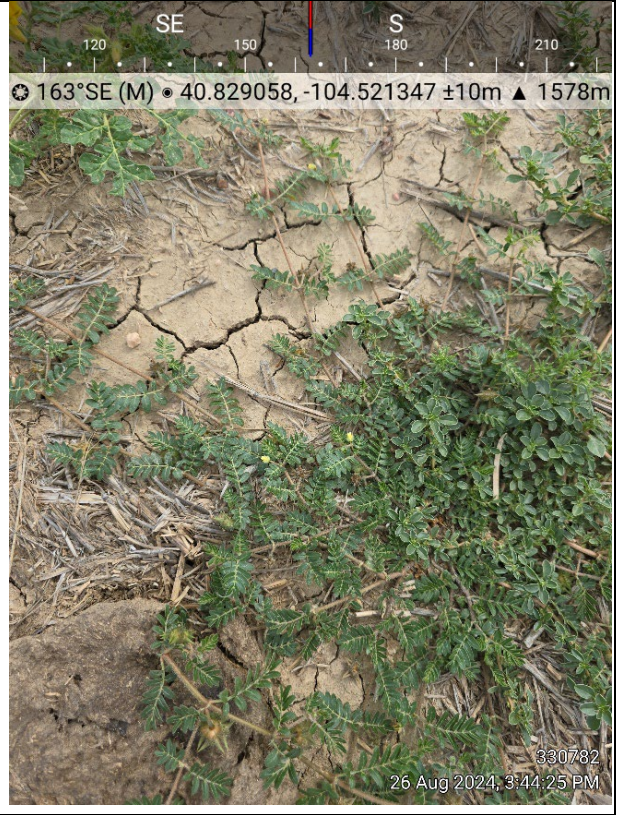
Site Photos – Vegetation 330782

Amaranth (*Genus Amaranthus*)

Buffalo-bur (*Solanum rostratum*)

Kochia (*Bassia scoparia*)

Puncturevine (*Tribulus terrestris*) List C

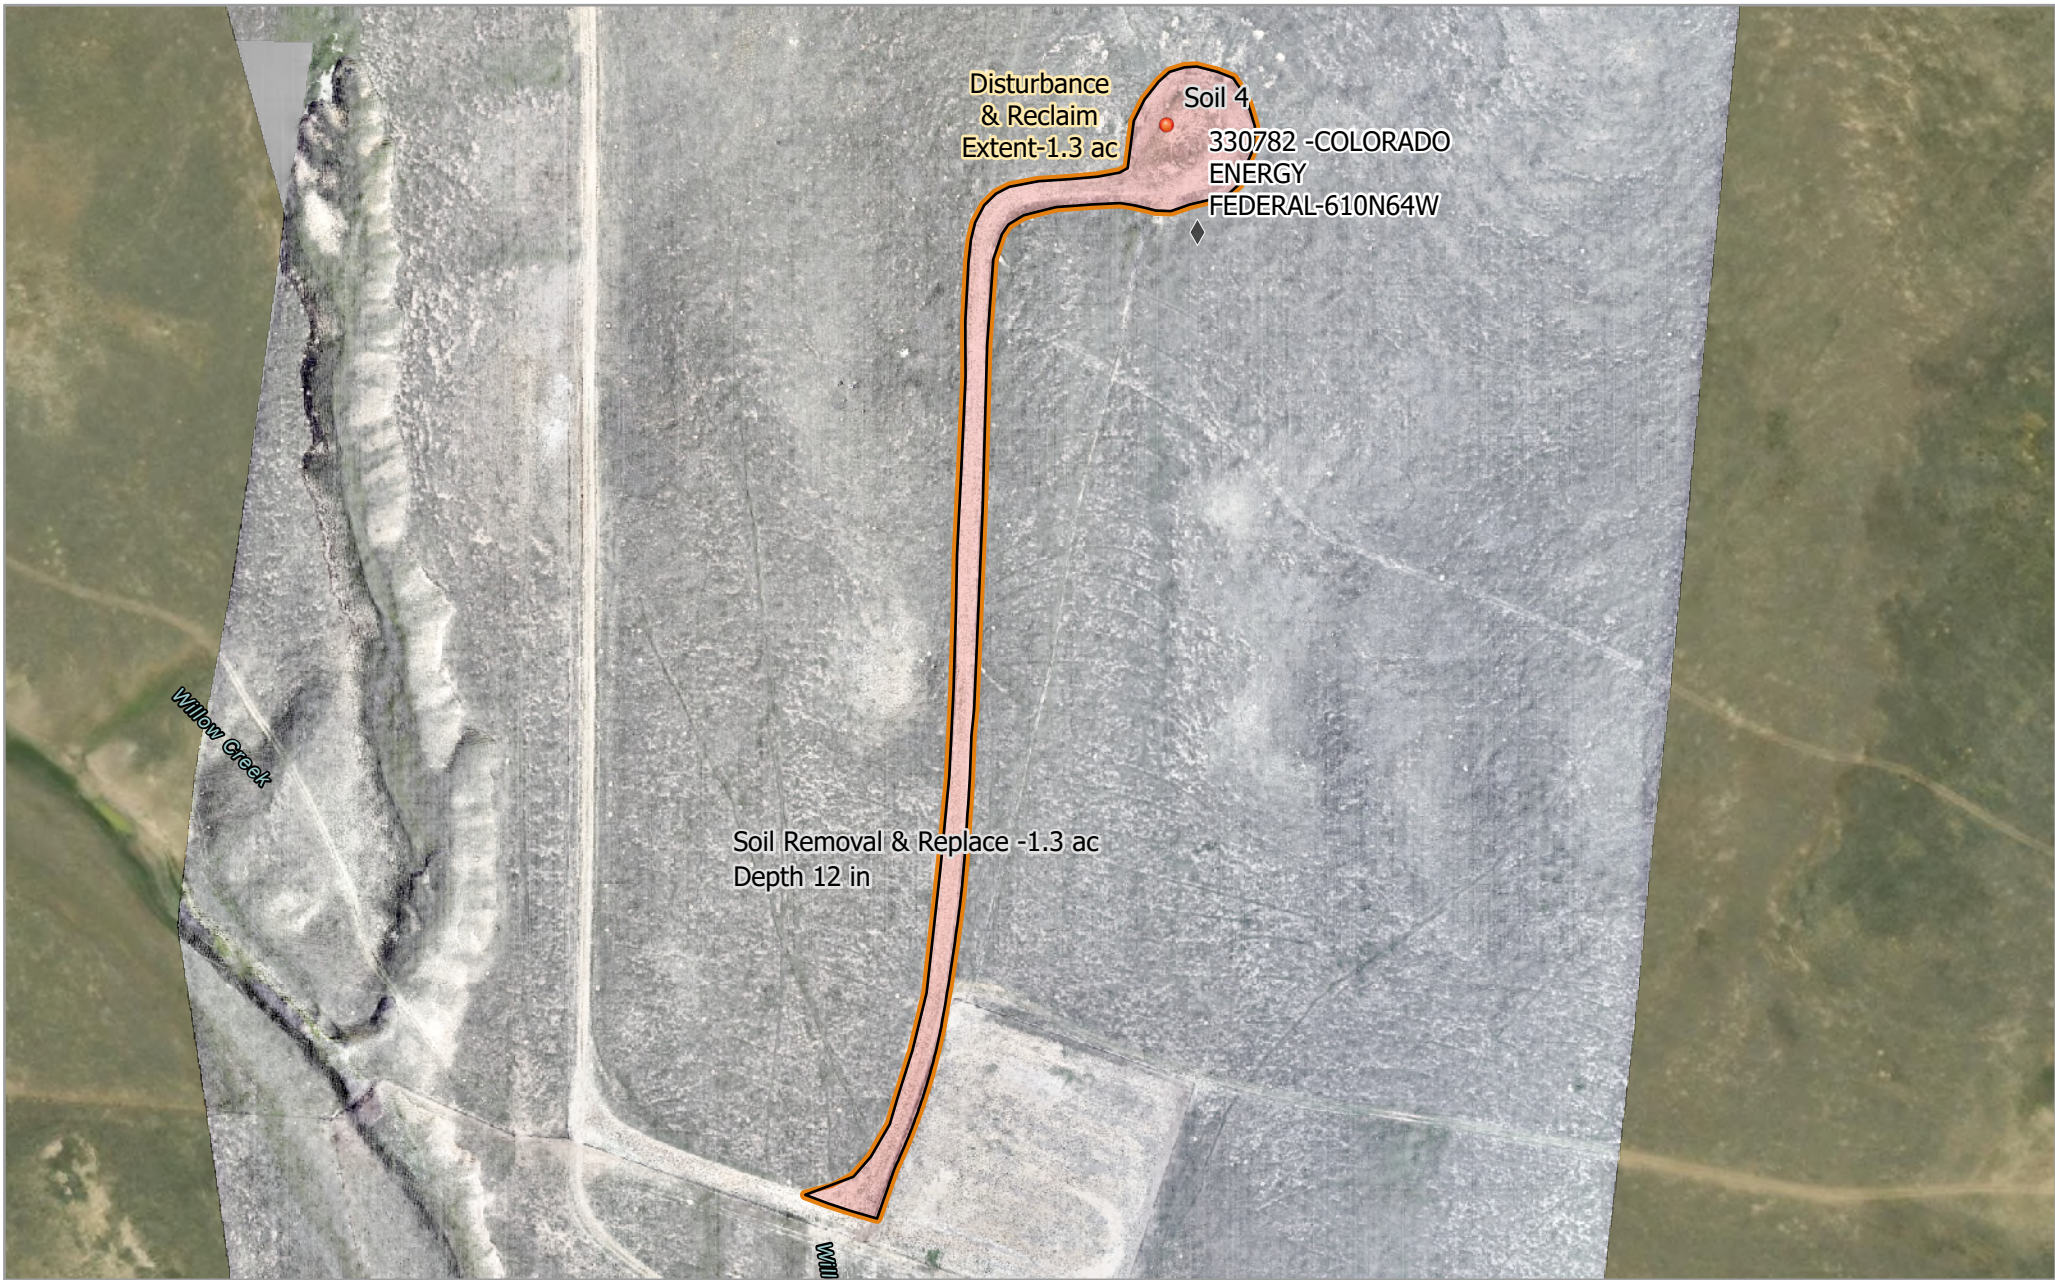
**CIV - 330782 - Colorado Energy Federal
610N64W/14SW**

Map Extent - Reclaim Extent

- ◆ Oil and Gas Locations
- Soil Sample Point
- ▭ Disturbance Boundary
- ▭ Soil Removal & Replace

Step	Description	Complete Date
1 – Soil Samples	Collection of soil samples from the site	26 Aug 2024
2 – Remove Exclusion Fence	Removal of fences as per reclamation plan	Week of April 1, 2025
3 – Soil Removal to Mapped Extent – 1.32 acres	Removal of non-compliant soil to 12 inches within the reclaim extent.	Week of April 1, 2025
4 – Soil Removal Inspection	In-person inspection and confirmation with soil sampling	Week of April 1, 2025
5 – Imported Soil Sample Test Results Review*	Verification of imported soil with current lab test results	Week of April 7, 2025
6 – Soil Import	Import soil as specified in the plan	Week of April 14, 2025
7 – Seeding	Planting appropriate seed mix for reclamation 20 PLS/sq ft	Week of April 28, 2025
8 – Straw Spread and Crimp	Spreading and crimping straw to stabilize soil apply 2 tons/acre	Week of May 5, 2025
9 – Monitor	Continuous monitoring post reclamation	2025 - 2027

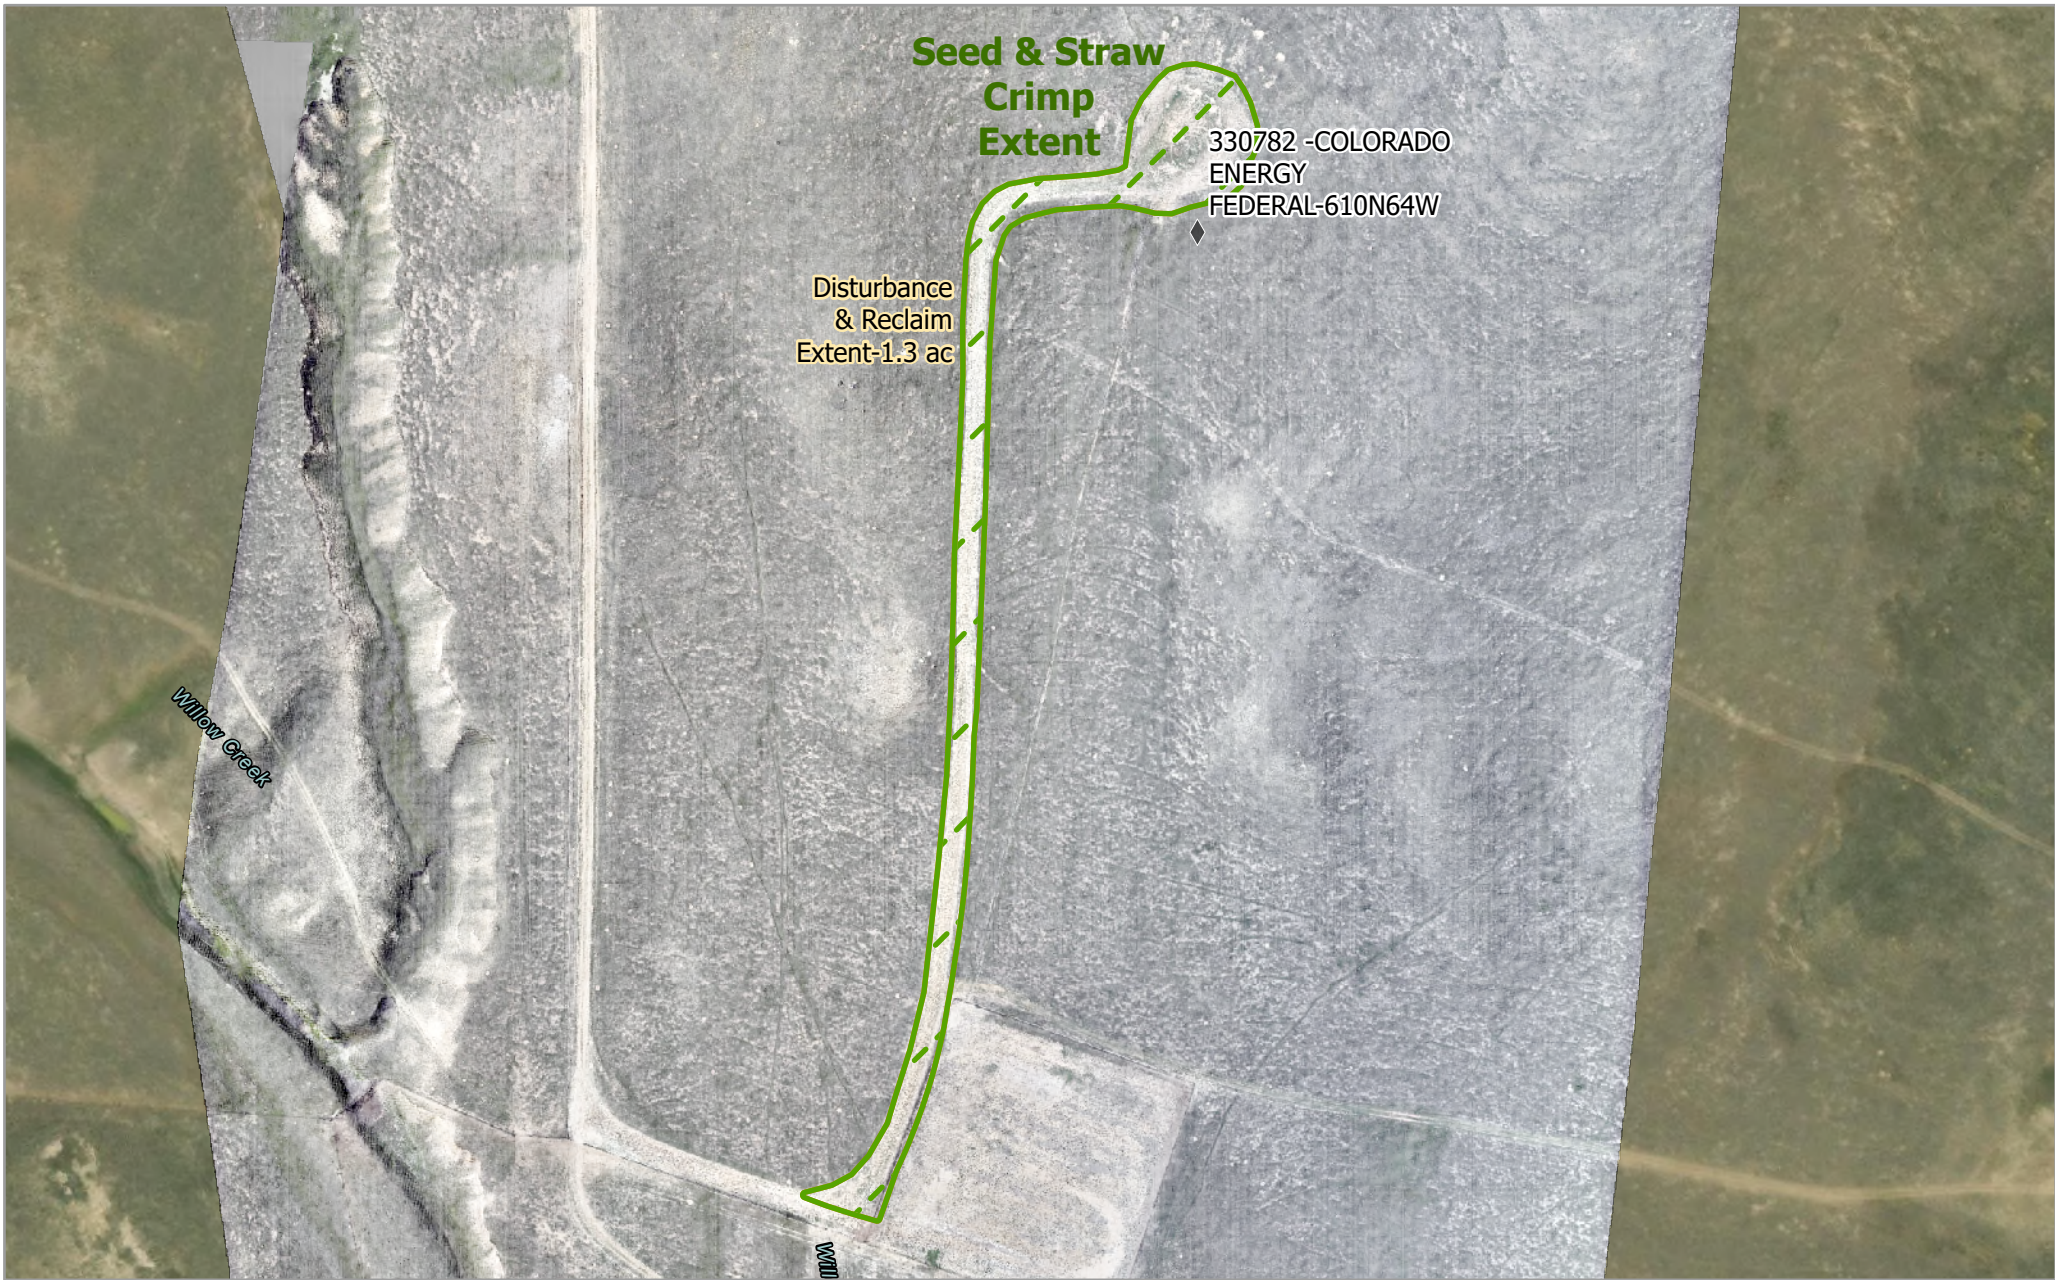
**CIV - 330782 - Colorado Energy Federal
610N64W/14SW**
Map Extent - Reclaim Extent

- ◆ Oil and Gas Locations
- ▭ Disturbance Boundary
- ▭ Seed Boundary
