Inspection Photos

Operator: LONE MOUNTAIN PRODUCTION
COMPANY - 51090

Location ID: 312348

Inspection Doc: 718100233

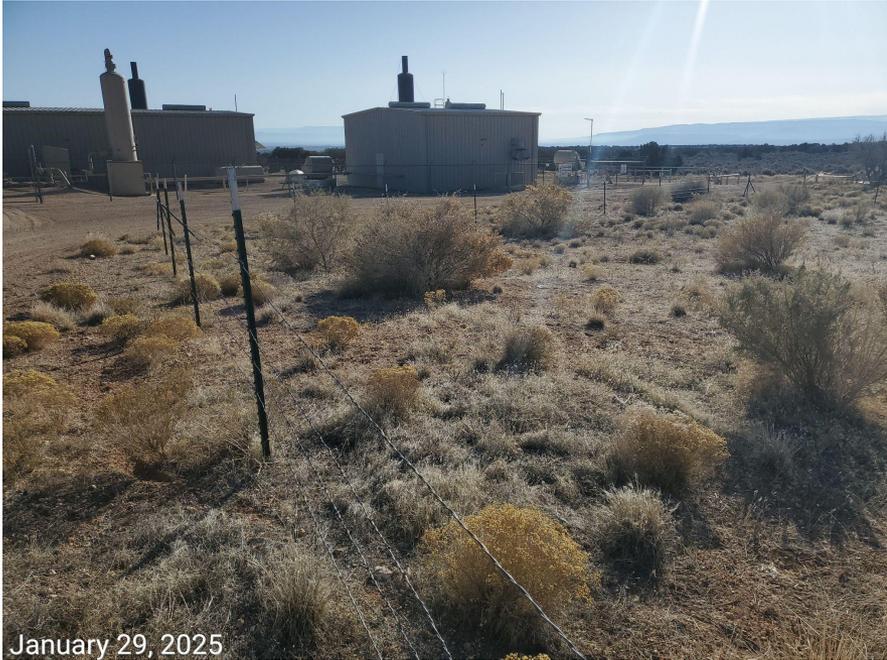
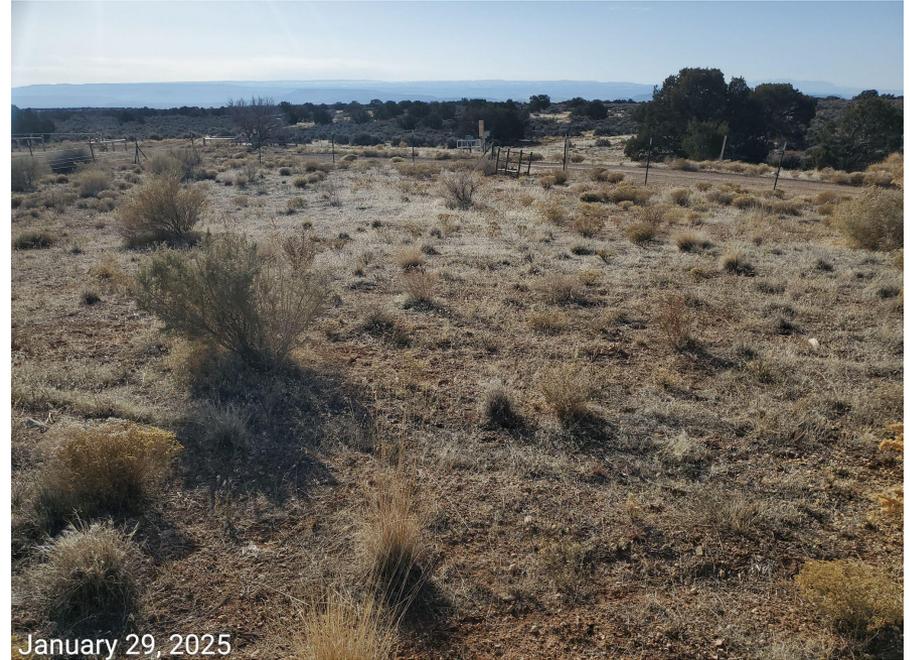
Photo 1: Photos taken from the north end of the Location; based on historic aerial imagery, the well was located within areas of the current compressor station; the remaining production facilities were located within the areas of these photos. Photos provide an overview of the Location from east, southeast, southwest to west.

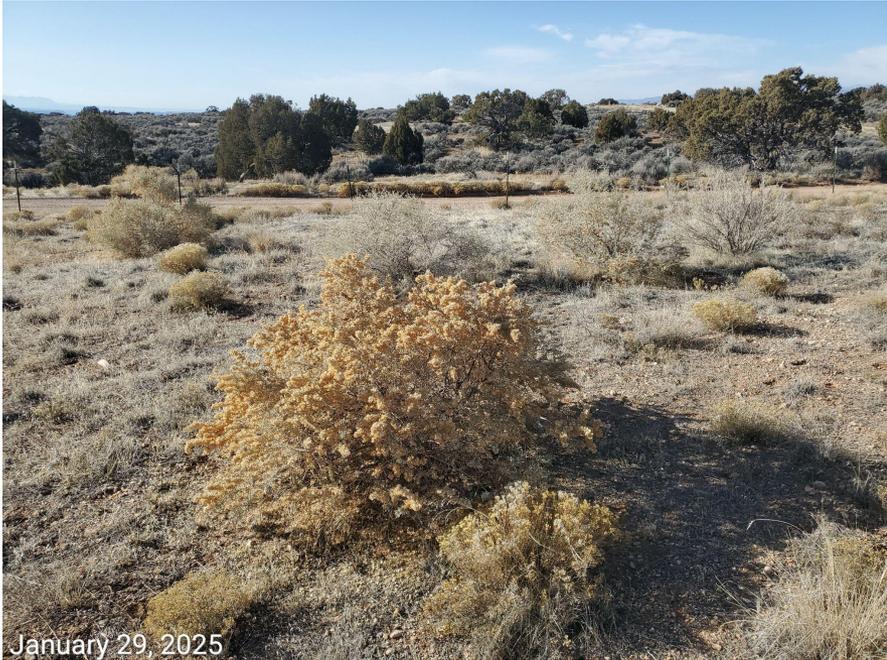
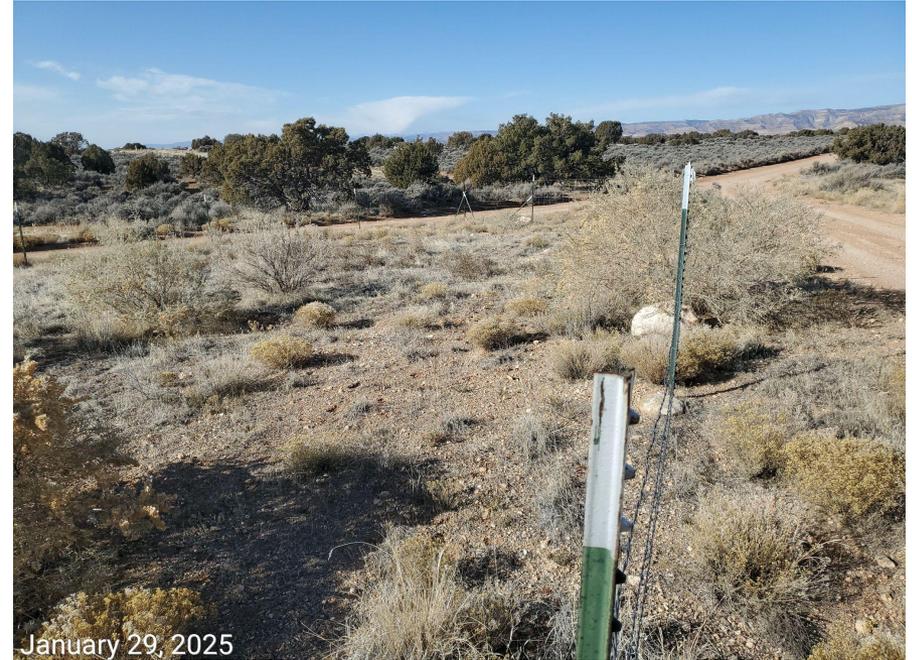
Photo 2: See comments under photo 1.

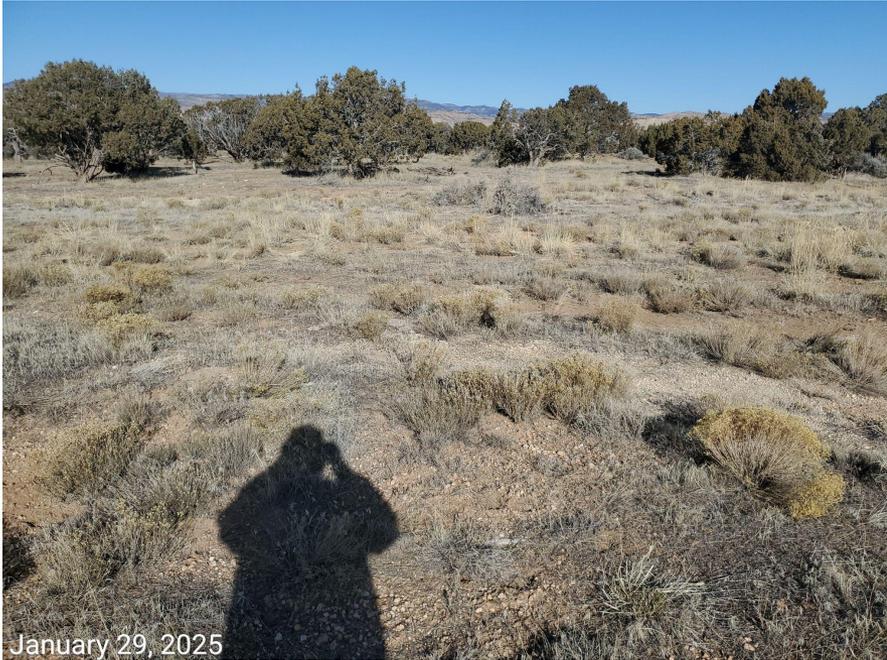
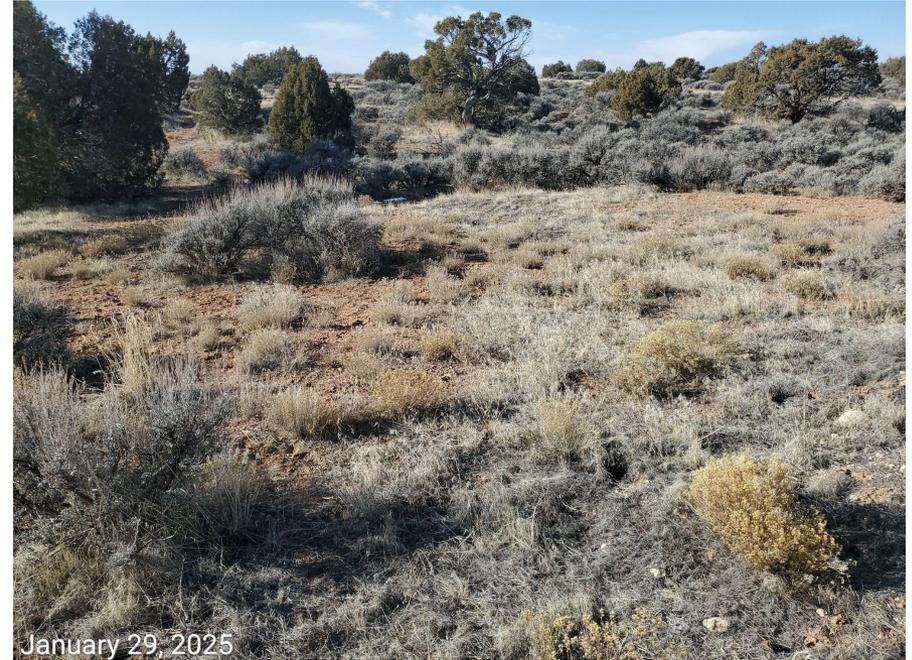
Photo 3: Photos taken from the adjacent reference areas for comparison.

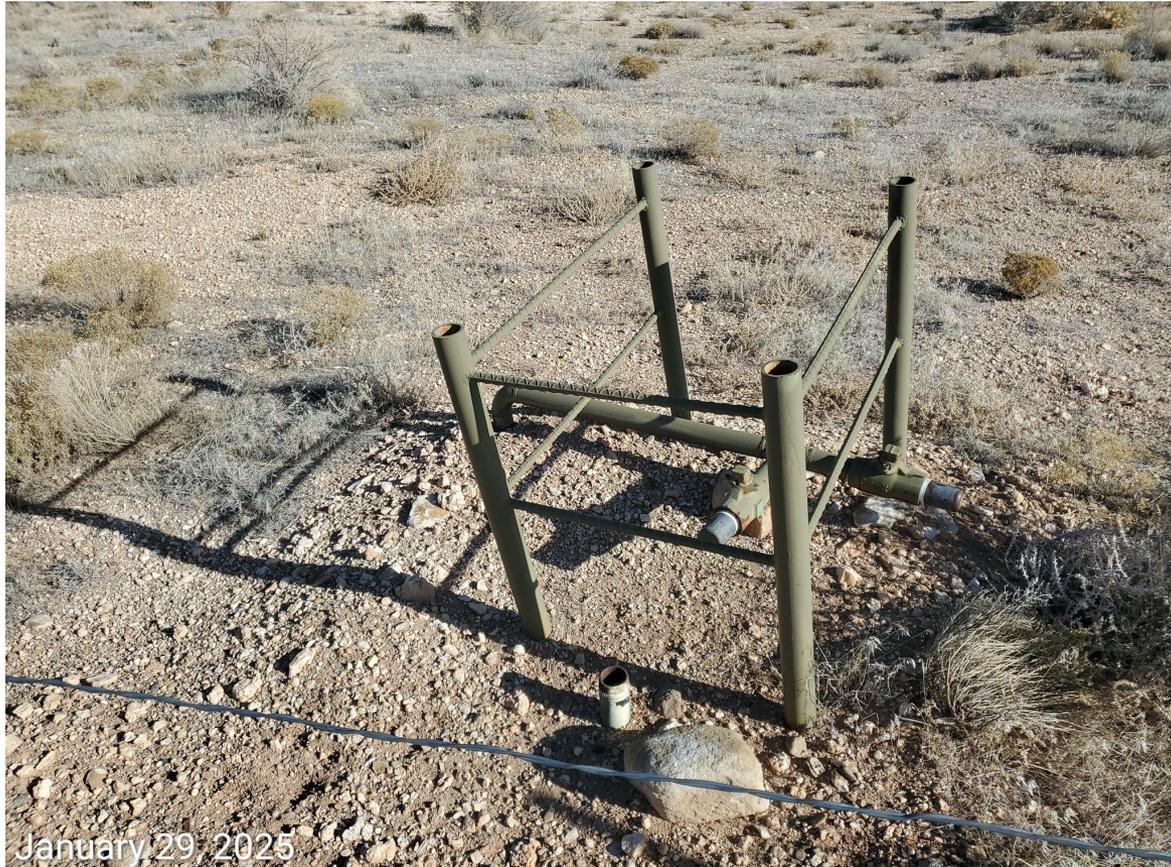
Photo 4: Riser equipment remaining on the south end of the Location. pursuant to Rule 1004.a, all abandoned gathering line risers, flowline risers, and surface equipment shall be removed within three (3) months of plugging a well.
