# Final Reclamation and Stormwater Inspection

Operator: HOUSTON EXPLORATION COMPANY\* THE  
- 10068

Location ID: 411450

Inspection Photos  
Location Name: Bledsoe 3-5-3-43  
Location ID: 411450

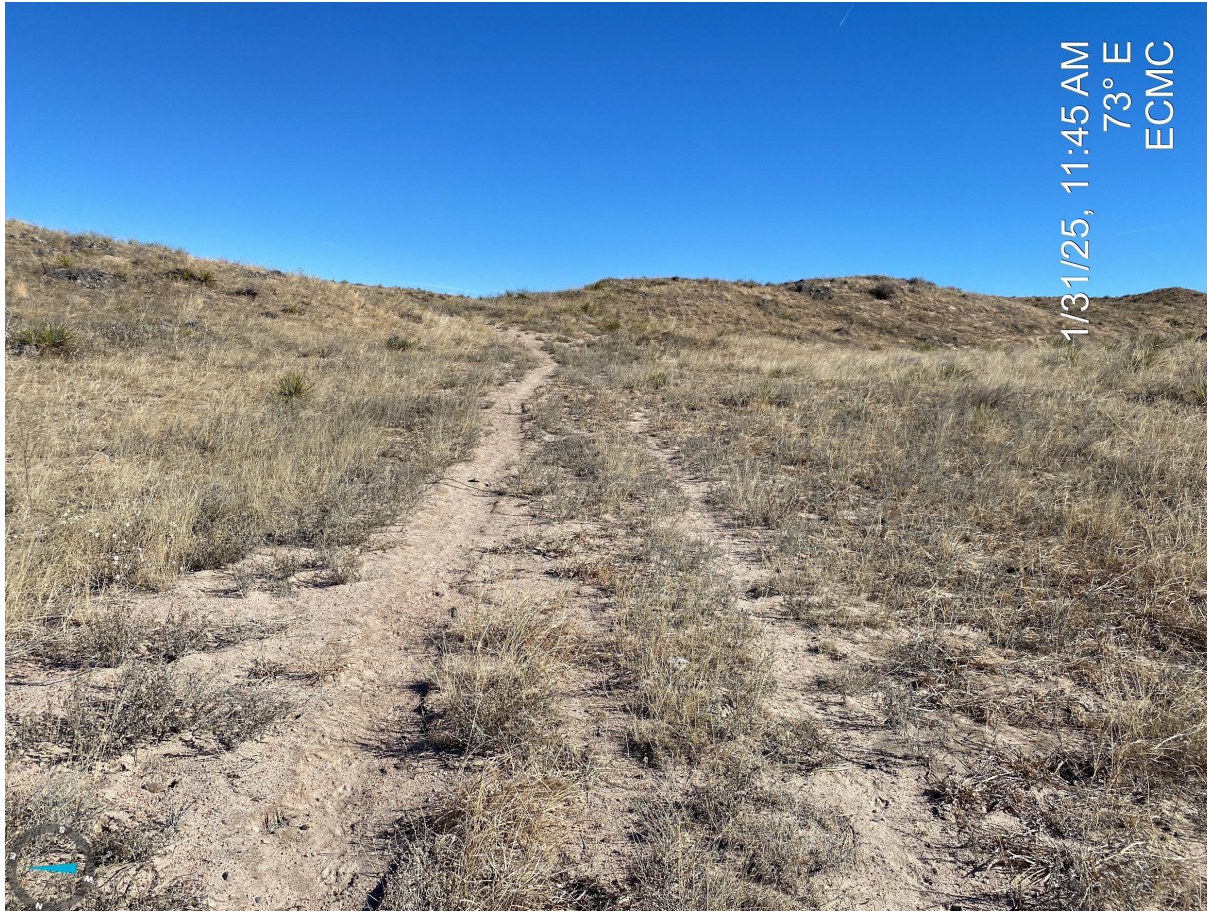
**Photo 1.** Taken near the start of the access road. Portions of the access road do not appear to be progressing towards Rule 1004 standards and regulation with evidence of bare soils.

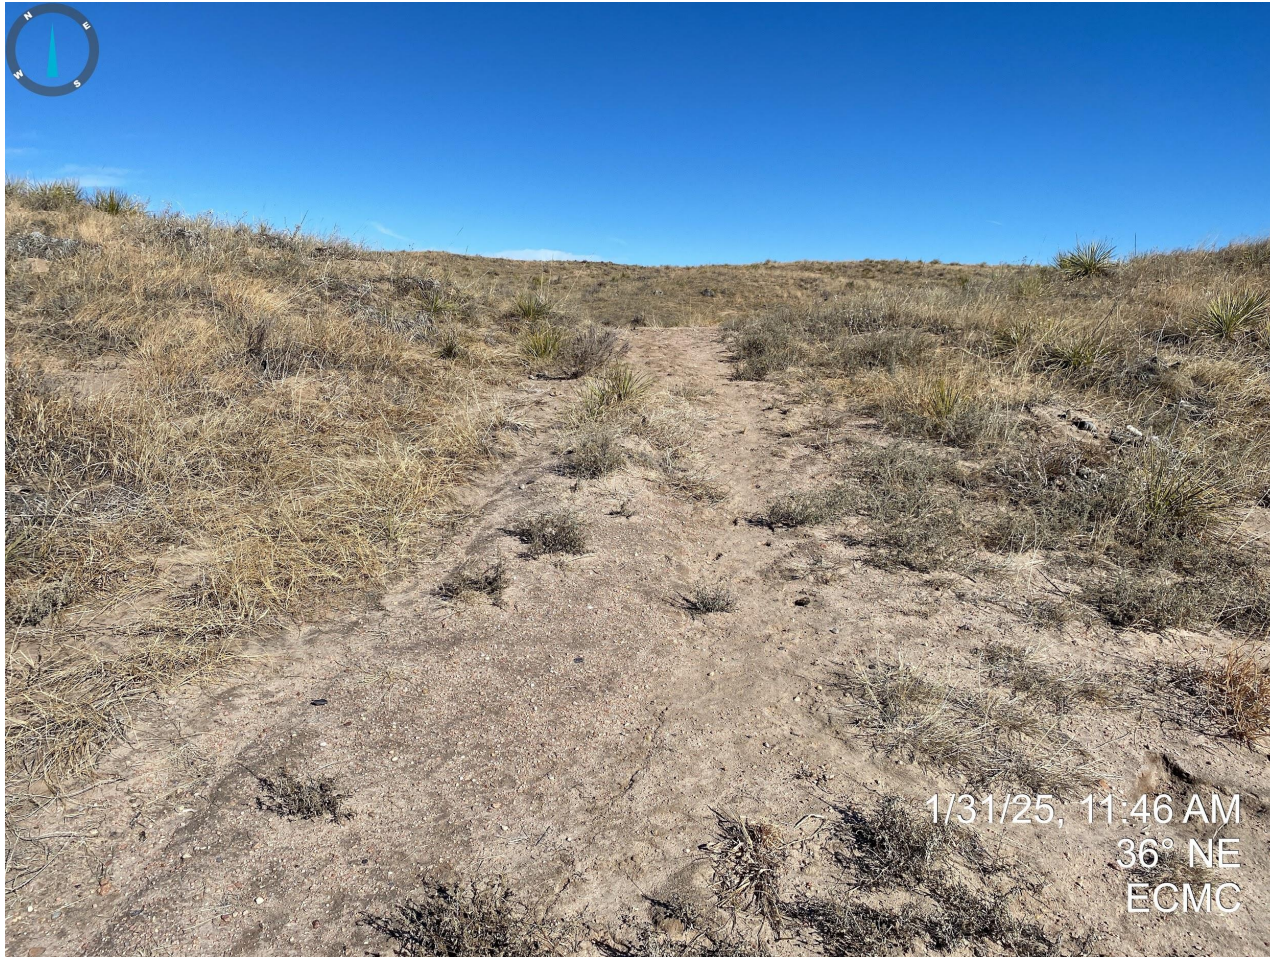
**Photo 2.** Taken along the access road. Portions of the access road do not appear to be progressing towards Rule 1004 standards and regulation with evidence of bare soils.

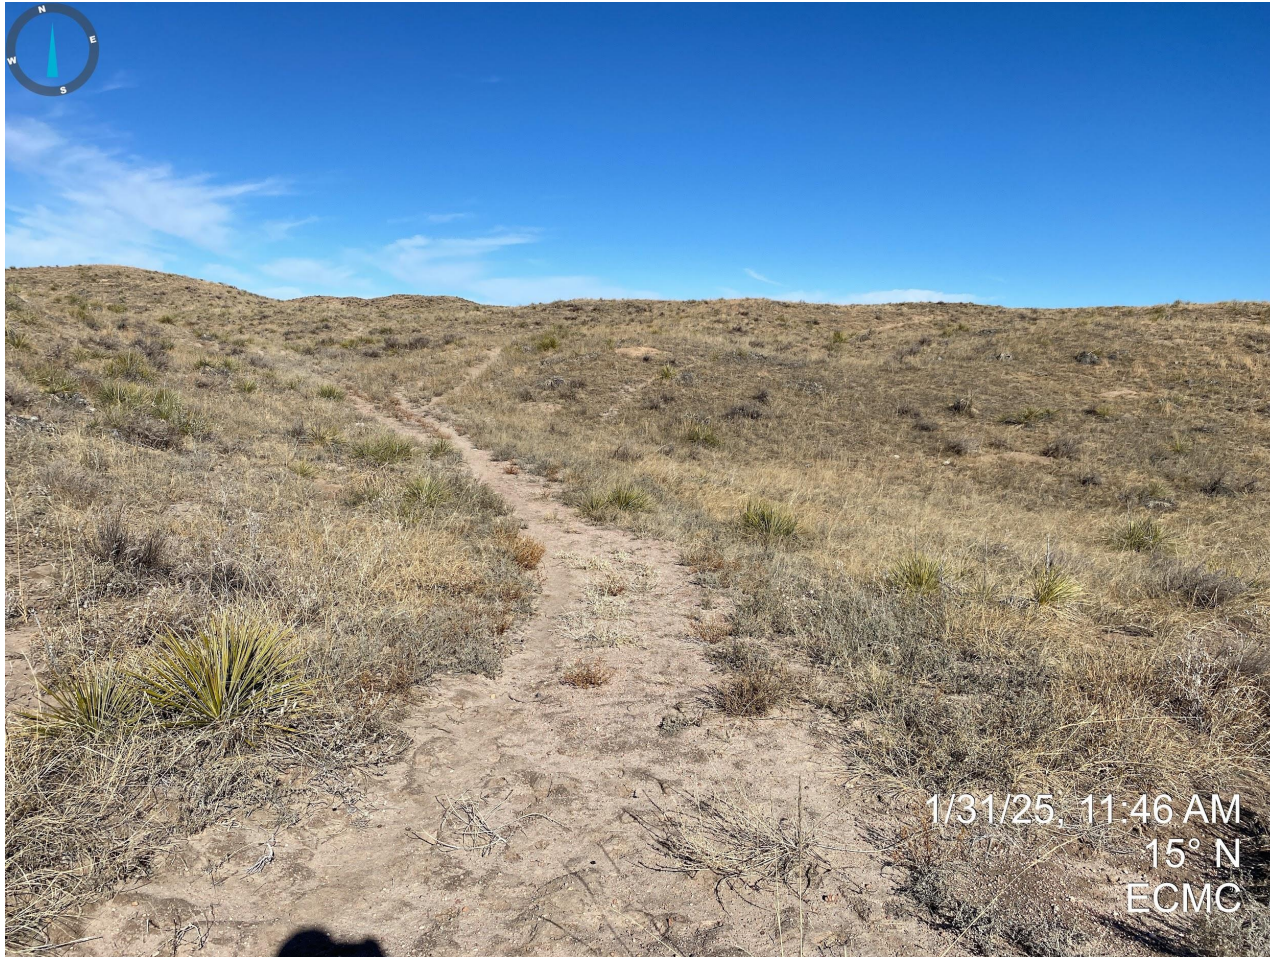
**Photo 3.** Taken along the access road. Portions of the access road do not appear to be progressing towards Rule 1004 standards and regulation with evidence of bare soils.

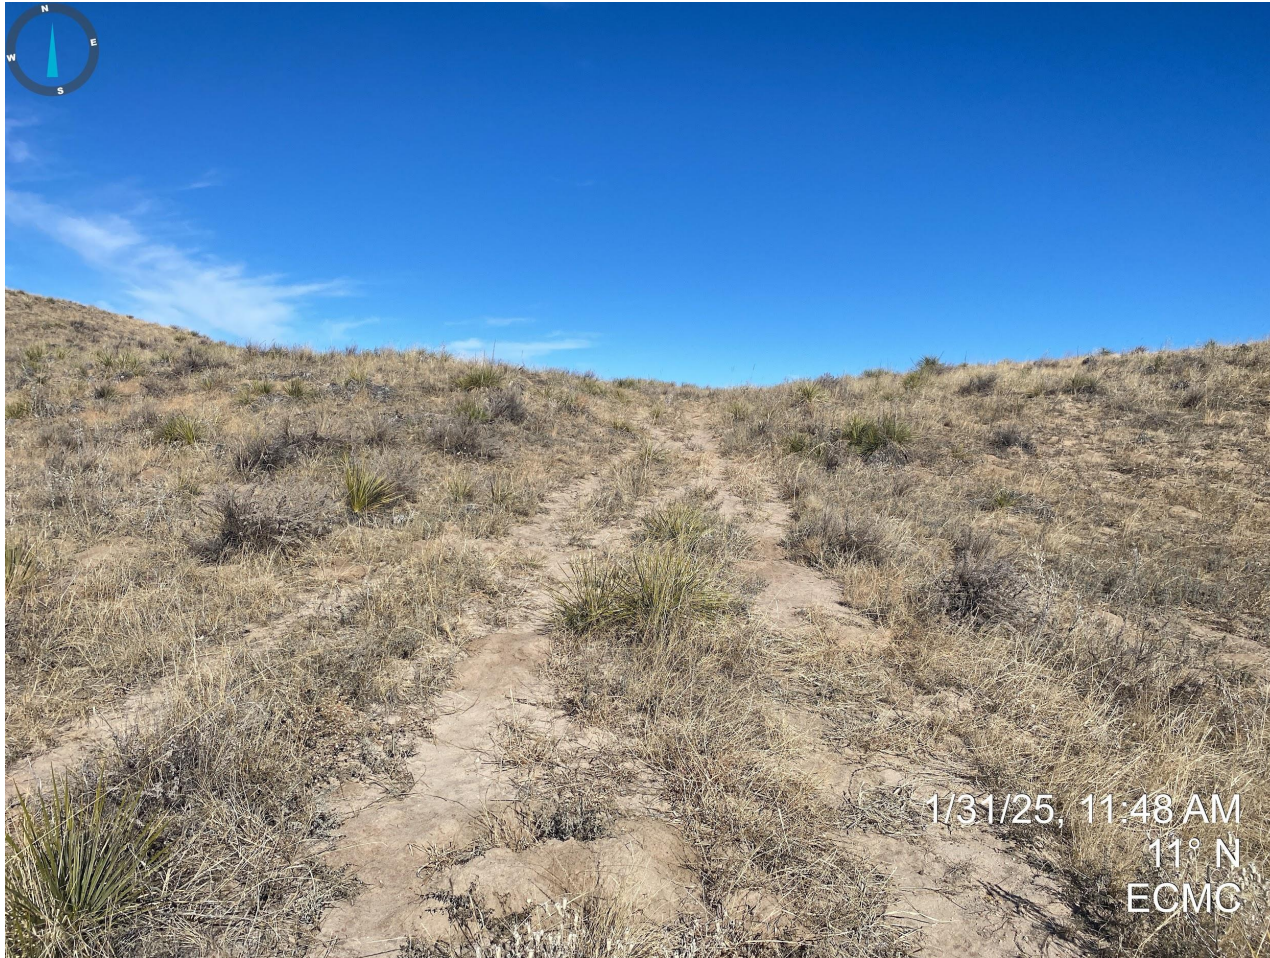
**Photo 4.** Taken along the access road. Portions of the access road do not appear to be progressing towards Rule 1004 standards and regulation with evidence of bare soils.

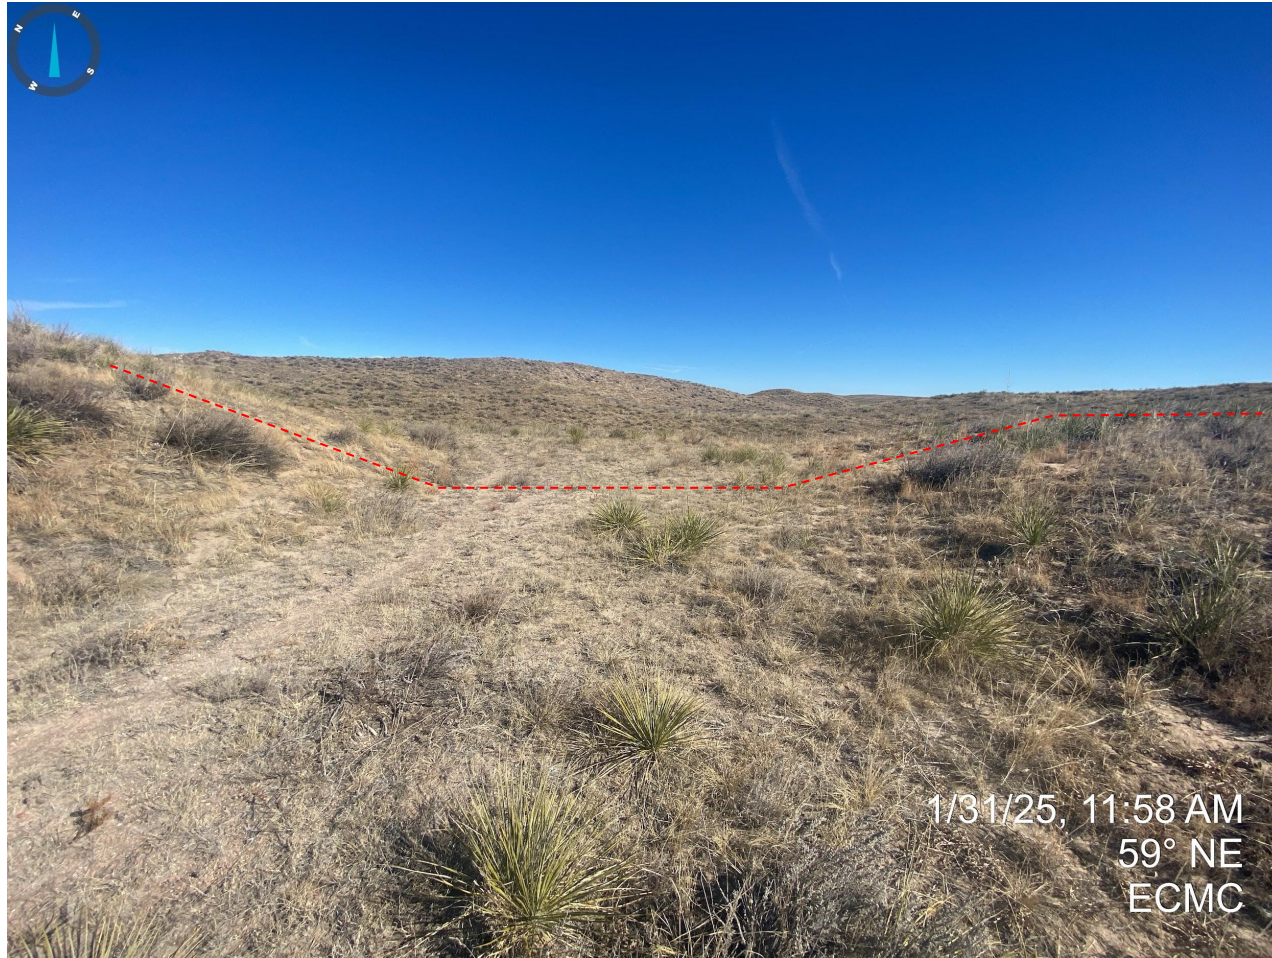
**Photo 5.** Taken along the access road. Red dotted line illustrates that the access road does not appear to have been recontoured to reflect adjacent topography.

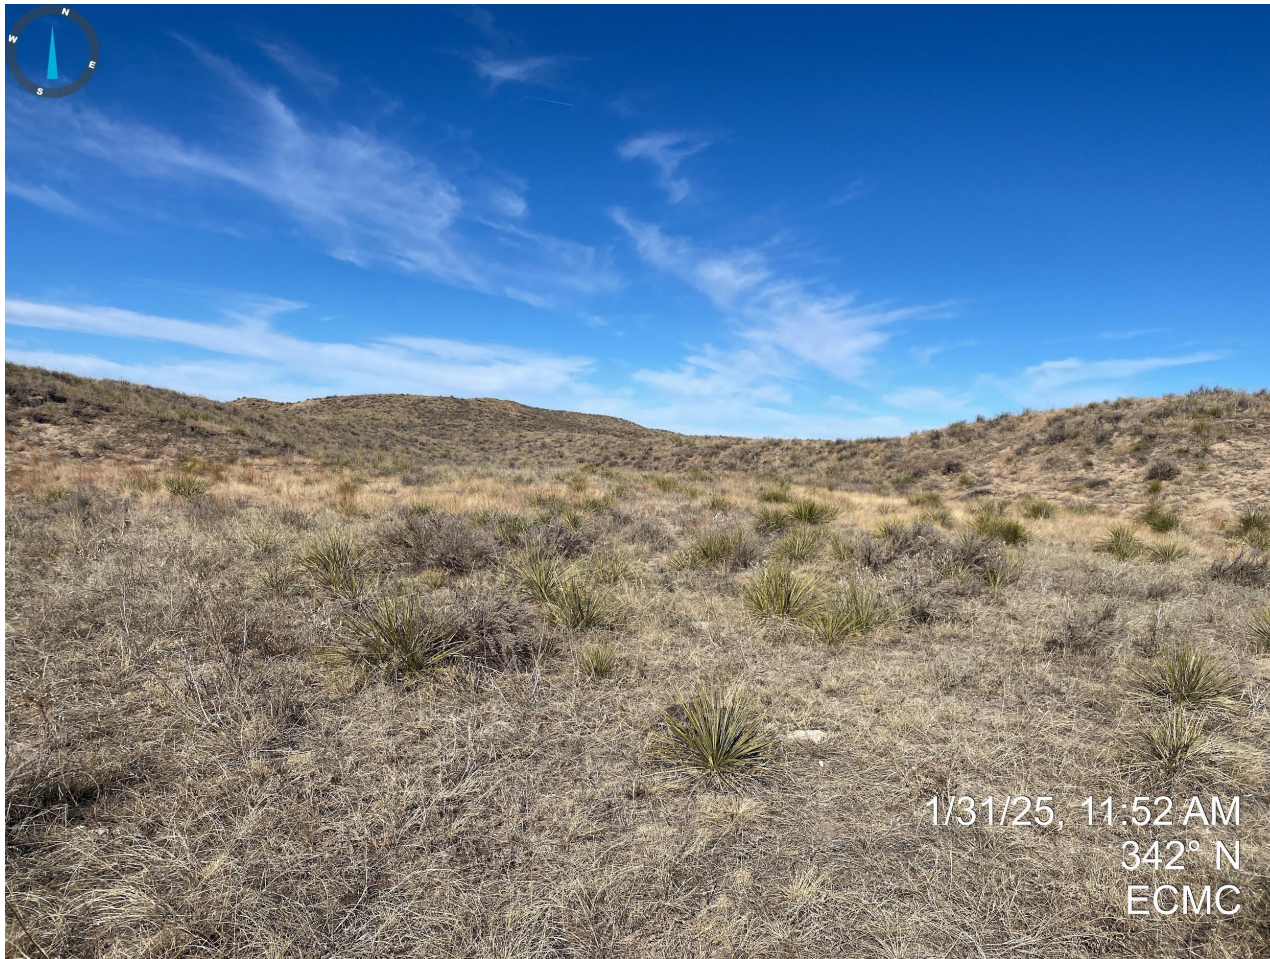
**Photo 6.** Taken from the southern end of the former well location. Portions of the the reclaimed well location appear to be progressing towards reclamation standards with evidence of desirable vegetation.

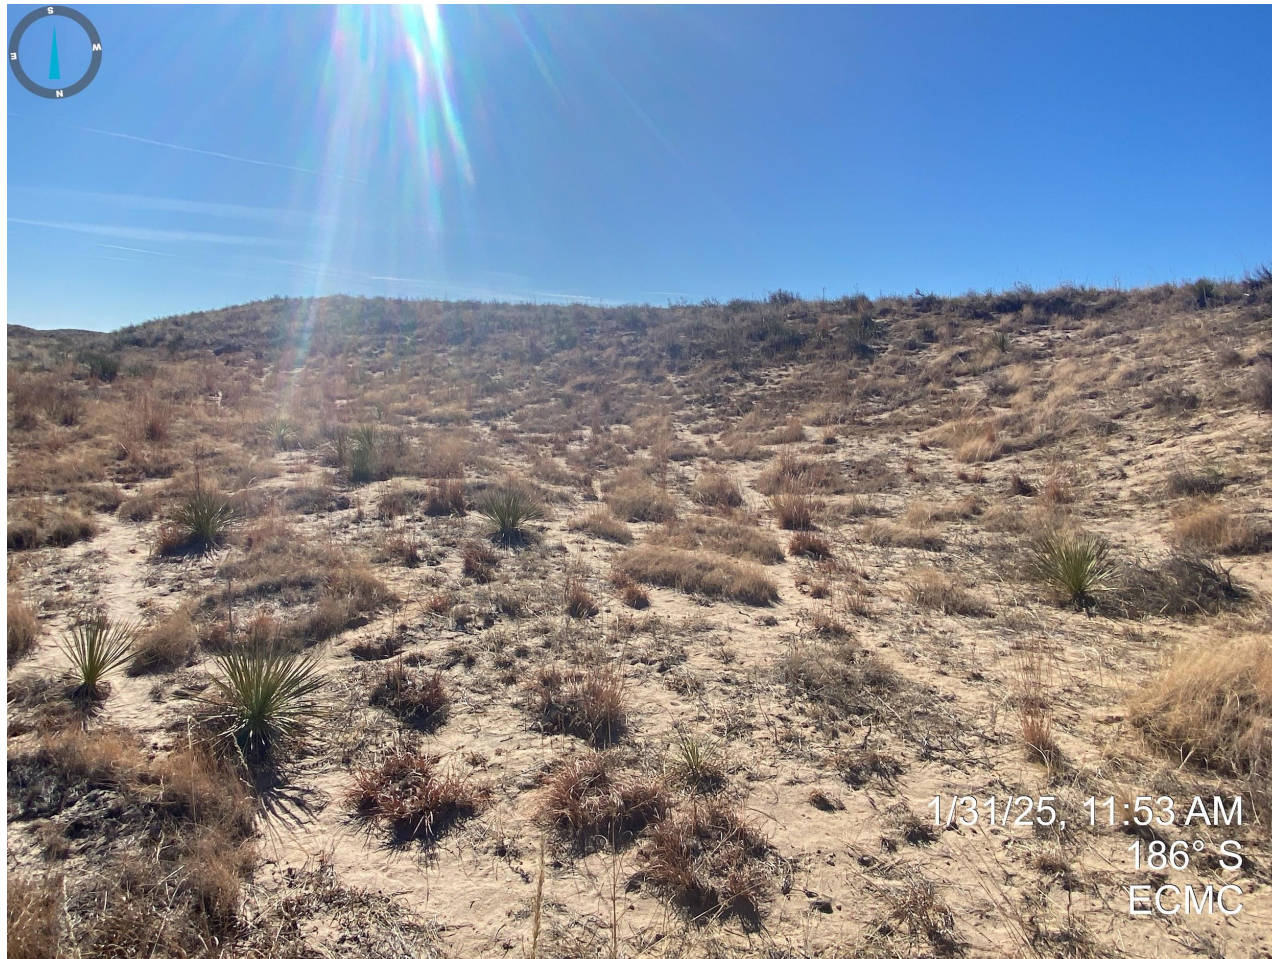
**Photo 7.** Western portions of the former well location do not appear to be progressing towards reclamation standards with areas of non-uniform vegetation cover.

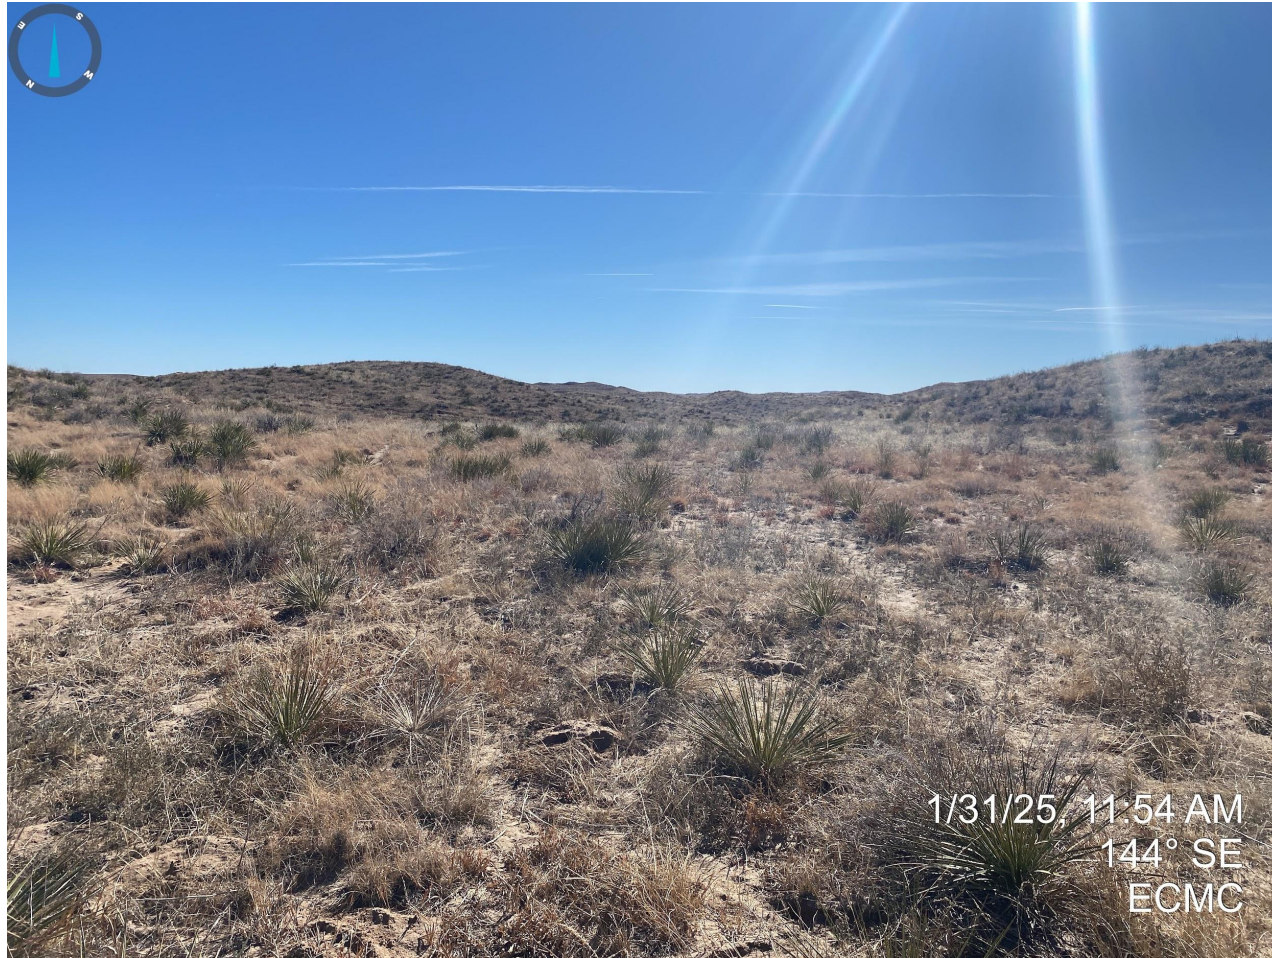
**Photo 8.** Taken from the northern end of the former well location. Portions of the the reclaimed well location appear to be progressing towards reclamation standards with evidence of desirable vegetation.

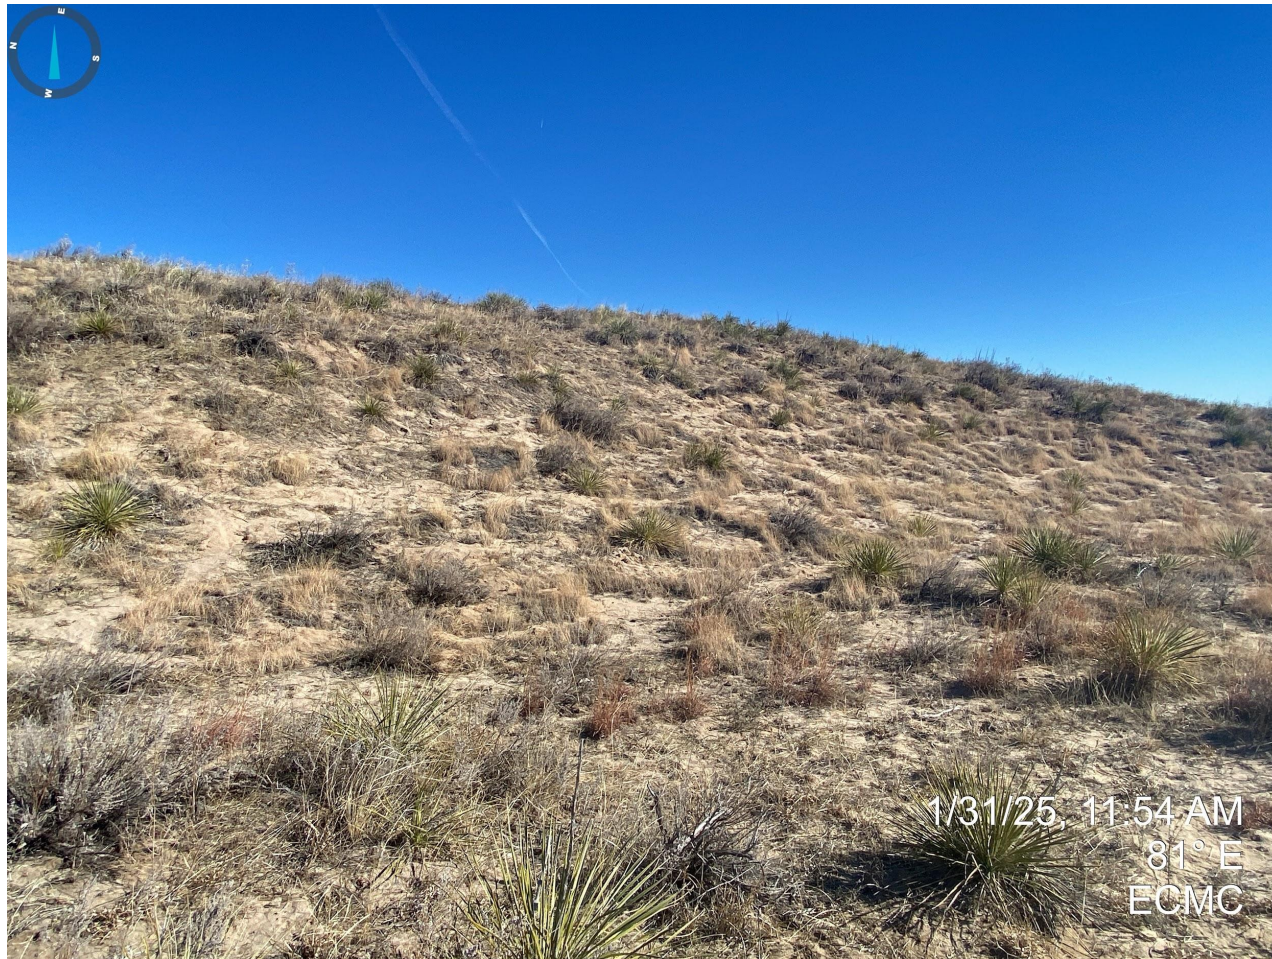
**Photo 9.** Eastern portions of the former well location do not appear to be progressing towards reclamation standards with areas of non-uniform vegetation cover.
