Final Reclamation and Stormwater Inspection

Location ID: 411455

Inspection Document #: 718700037

Inspection Photos
Location Name: Bledsoe 9-17-3-34
Location ID: 411455

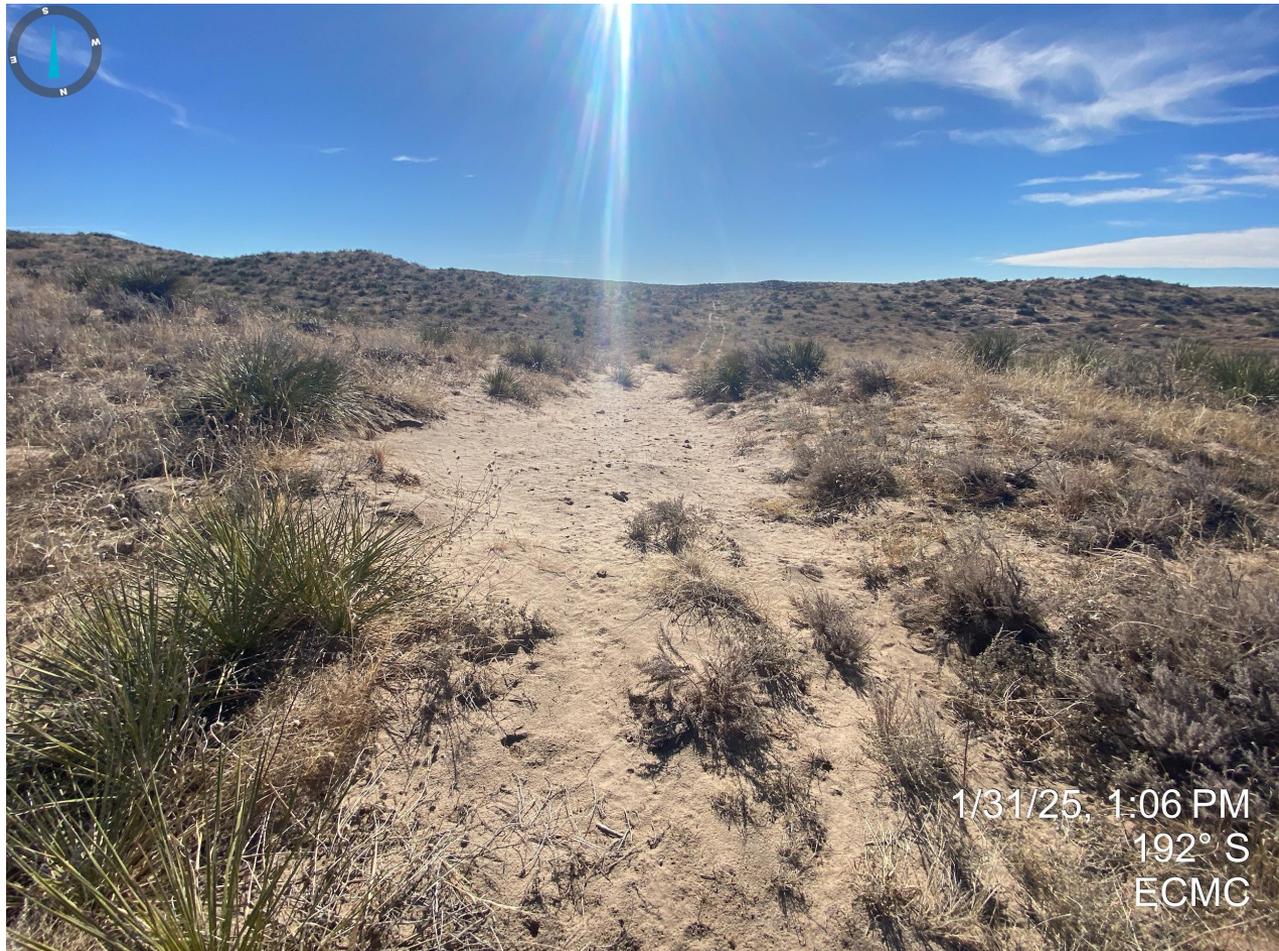
Photo 1. Taken near the start of the access road. It does not appear that the access road has been reclaimed with evidence of non-uniform vegetation cover resulting in bare soil.

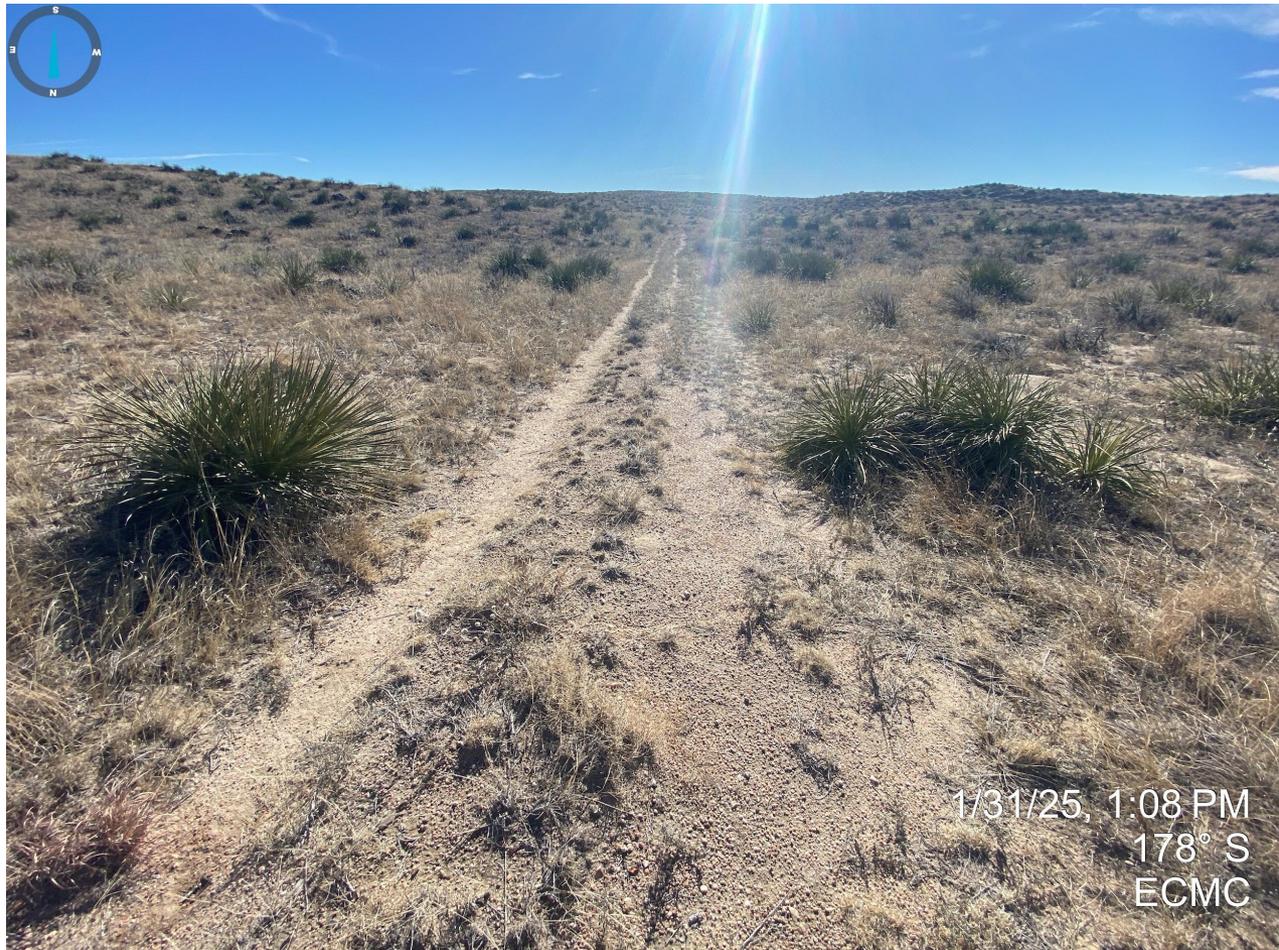
Photo 2. Taken along the access road. It does not appear that the access road has been reclaimed with evidence of non-uniform vegetation cover resulting in bare soil.

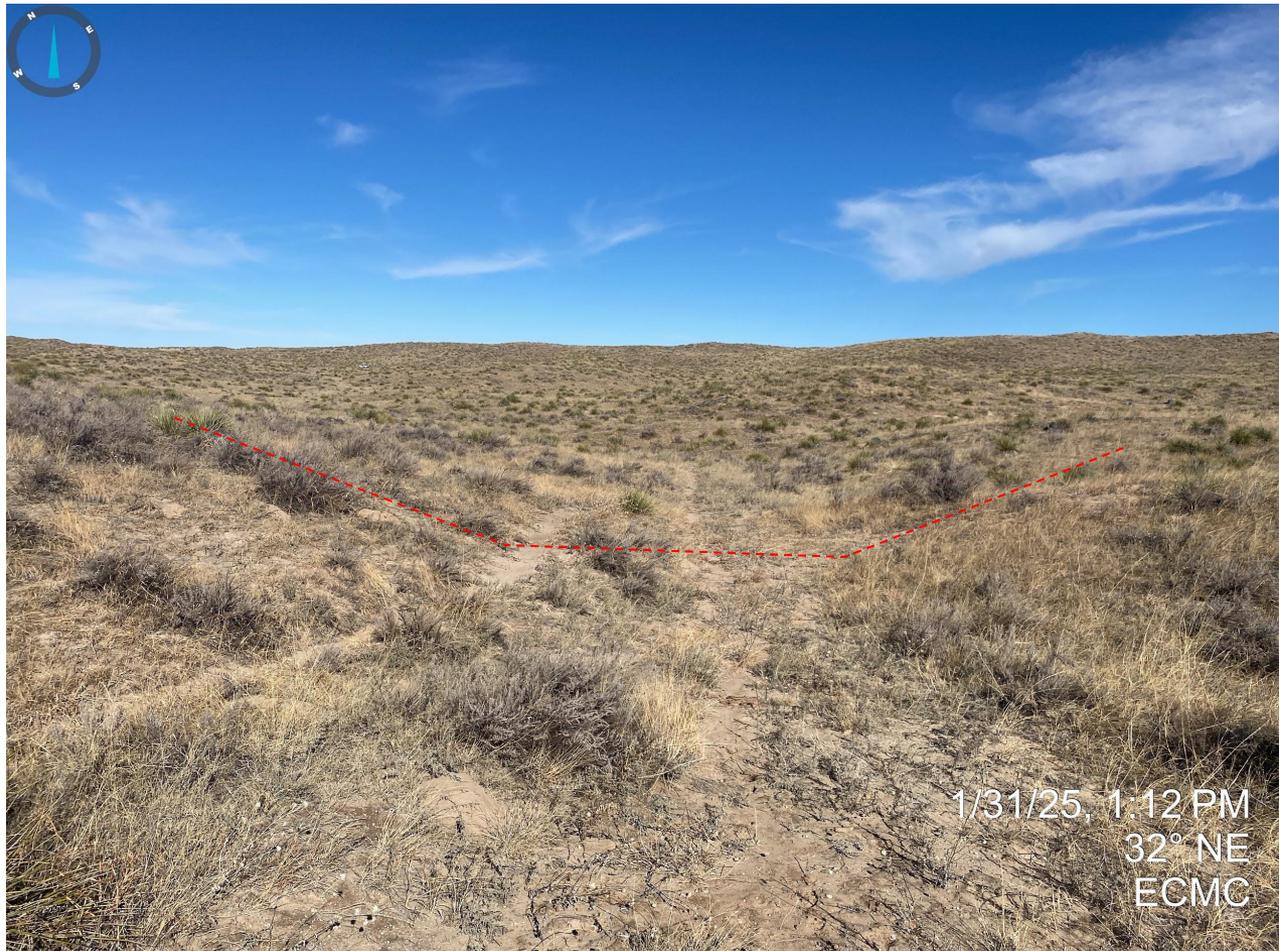
Photo 3. Taken along the access road. Red dotted line illustrates that a portion of the access road does not appear to have been recontoured to reflect adjacent topography.

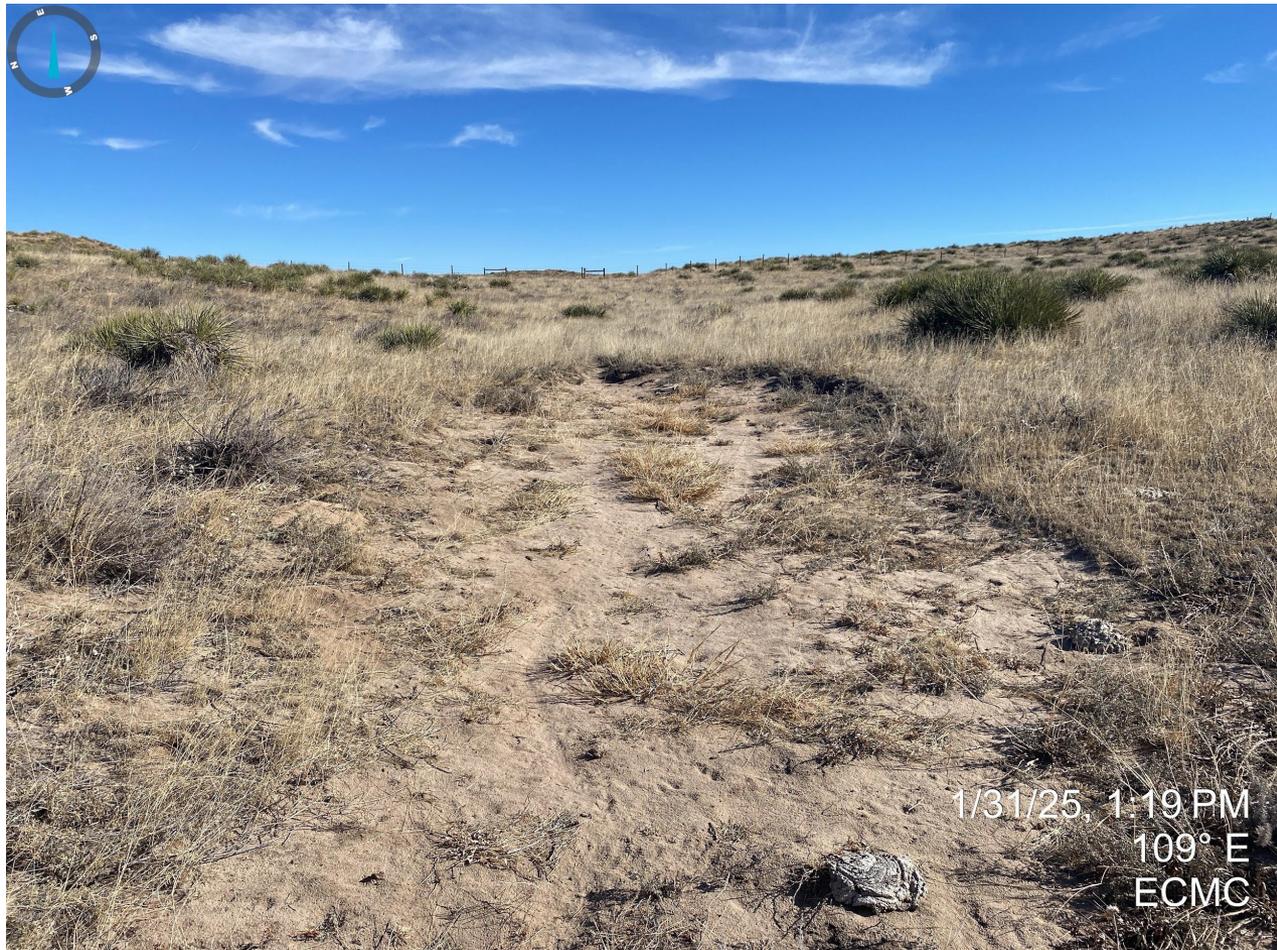
Photo 4. Taken along the access road. It does not appear that the access road has been reclaimed with evidence of non-uniform vegetation cover resulting in bare soil.

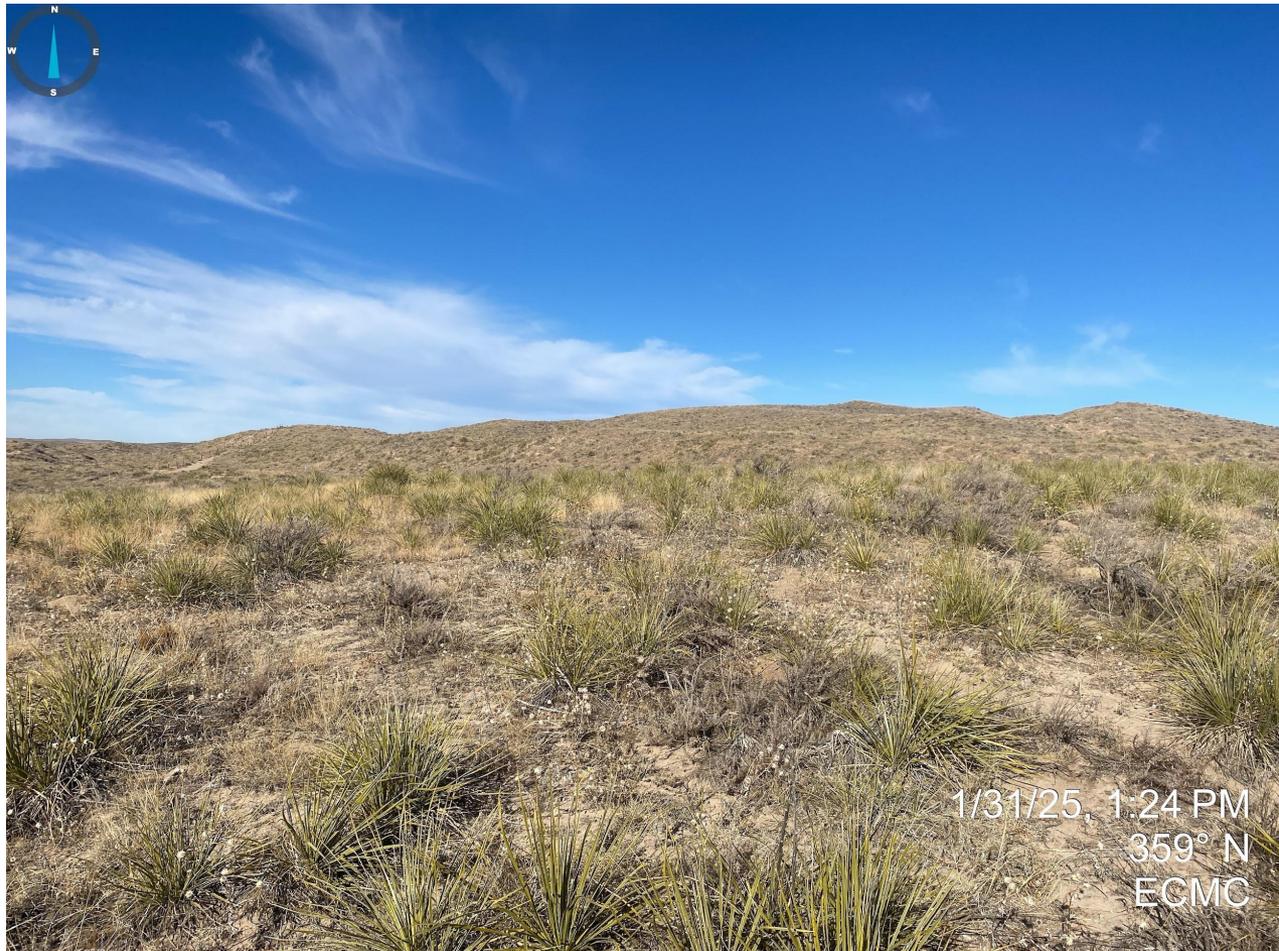
Photo 5. Taken near the southwest corner of the former location. It appears that the former well location is progressing towards reclamation standards and regulations with desirable vegetation observed.

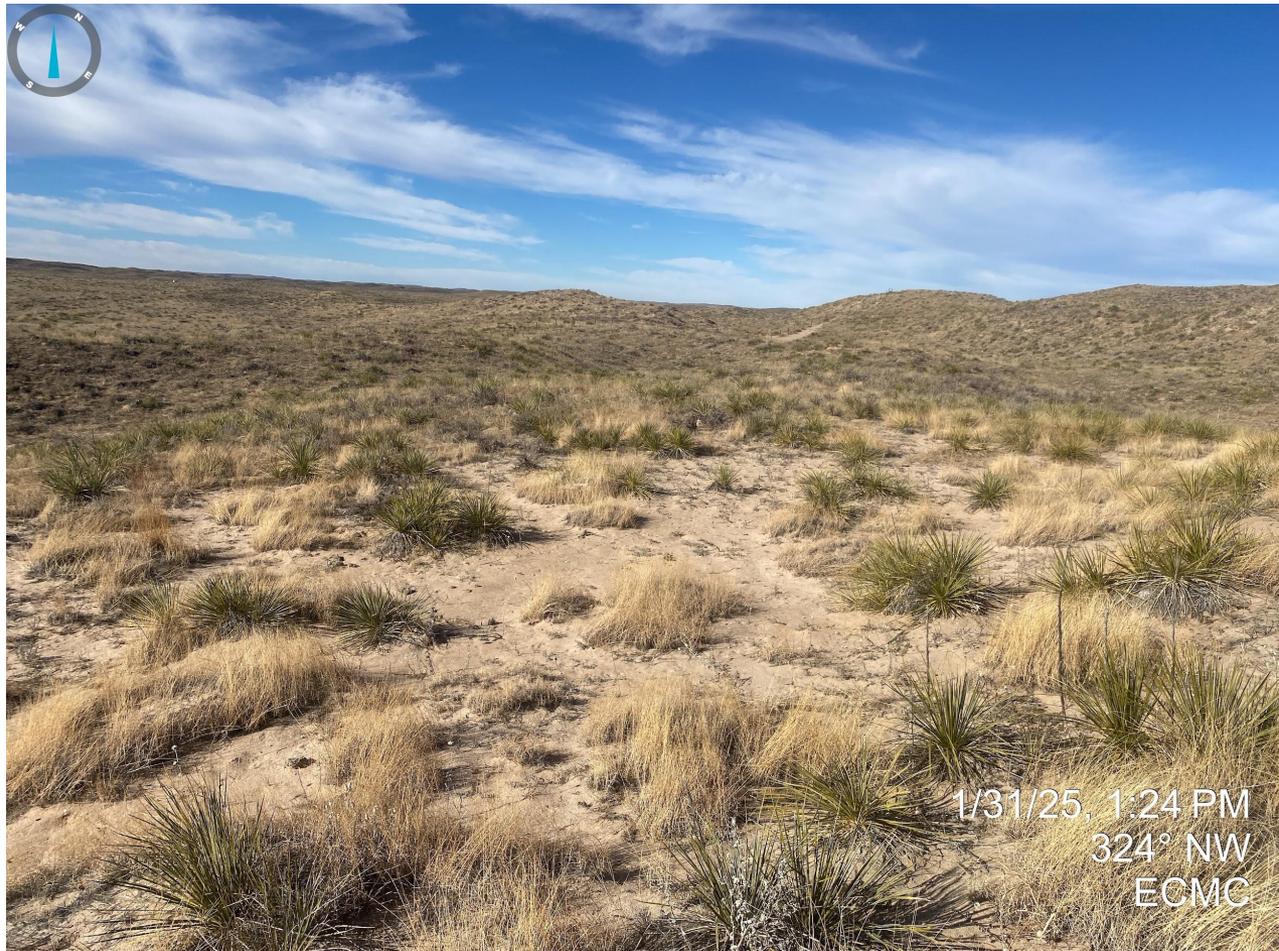
Photo 6. Taken near the northwest corner of the former location. Portions of the location are experiencing non-uniform vegetation cover resulting in areas of bare/exposed soils.

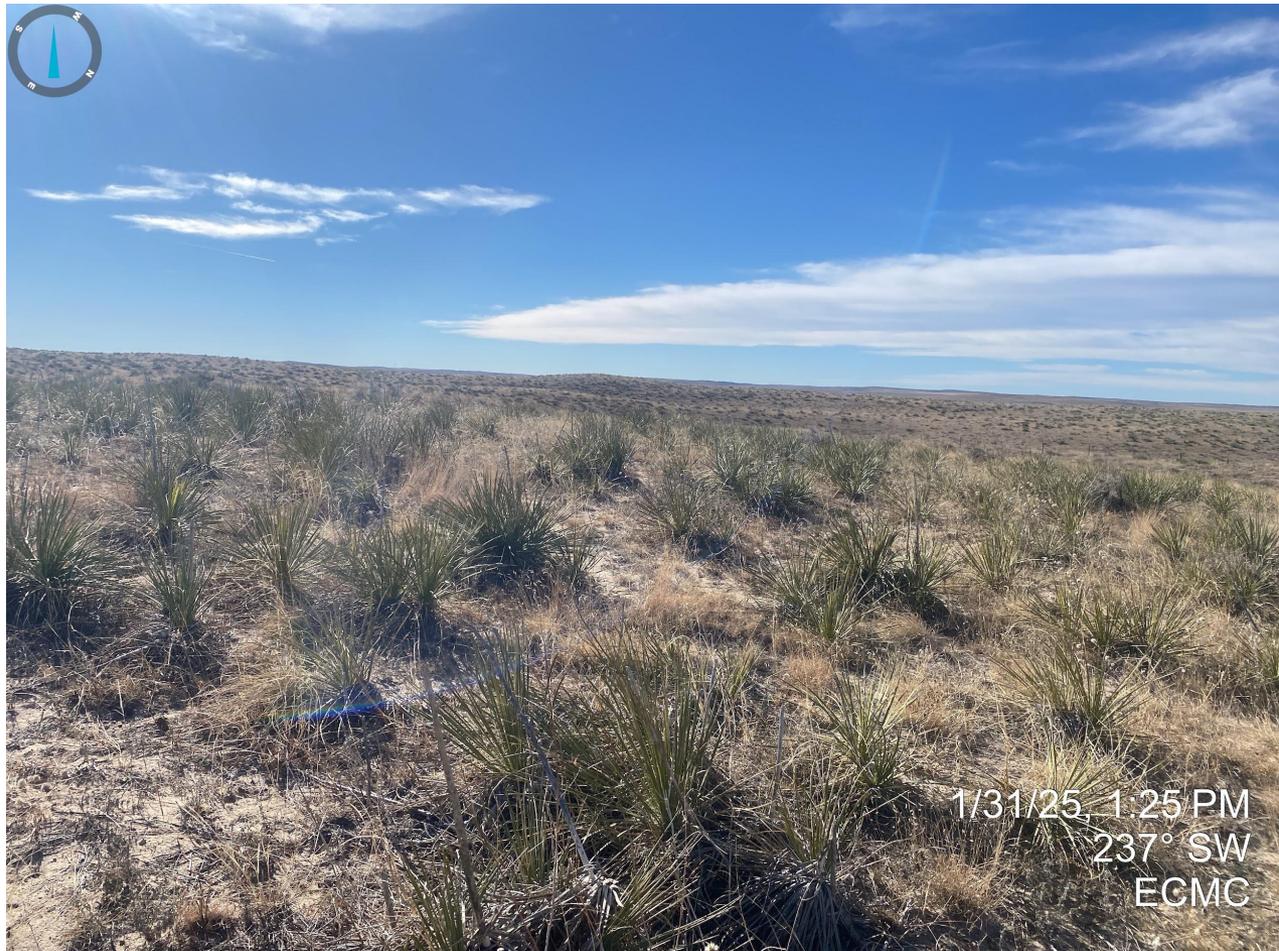
Photo 7. Taken near the northeast corner of the former location. It appears that the former location is progressing towards reclamation standards and regulations with desirable vegetation observed.

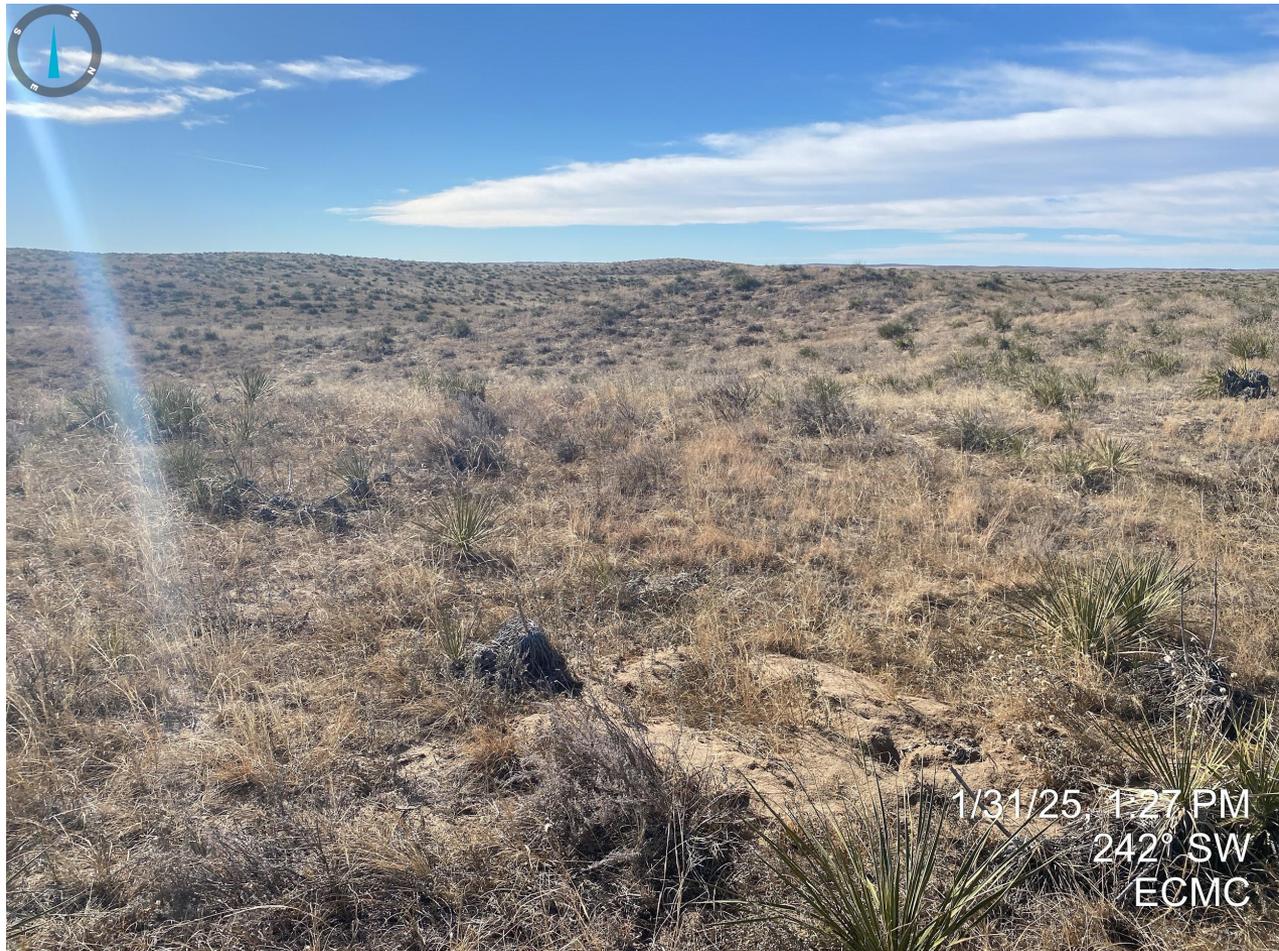
Photo 8. Taken near the southeast corner of the former location. It appears that the former location is progressing towards reclamation standards and regulations with desirable vegetation observed.
