Final Reclamation and Stormwater Inspection

Operator: HOUSTON EXPLORATION COMPANY* THE
- 10068

Location ID: 411471

Inspection Photos
Location Name: Bledsoe 1-31-3-43
Location ID: 411471

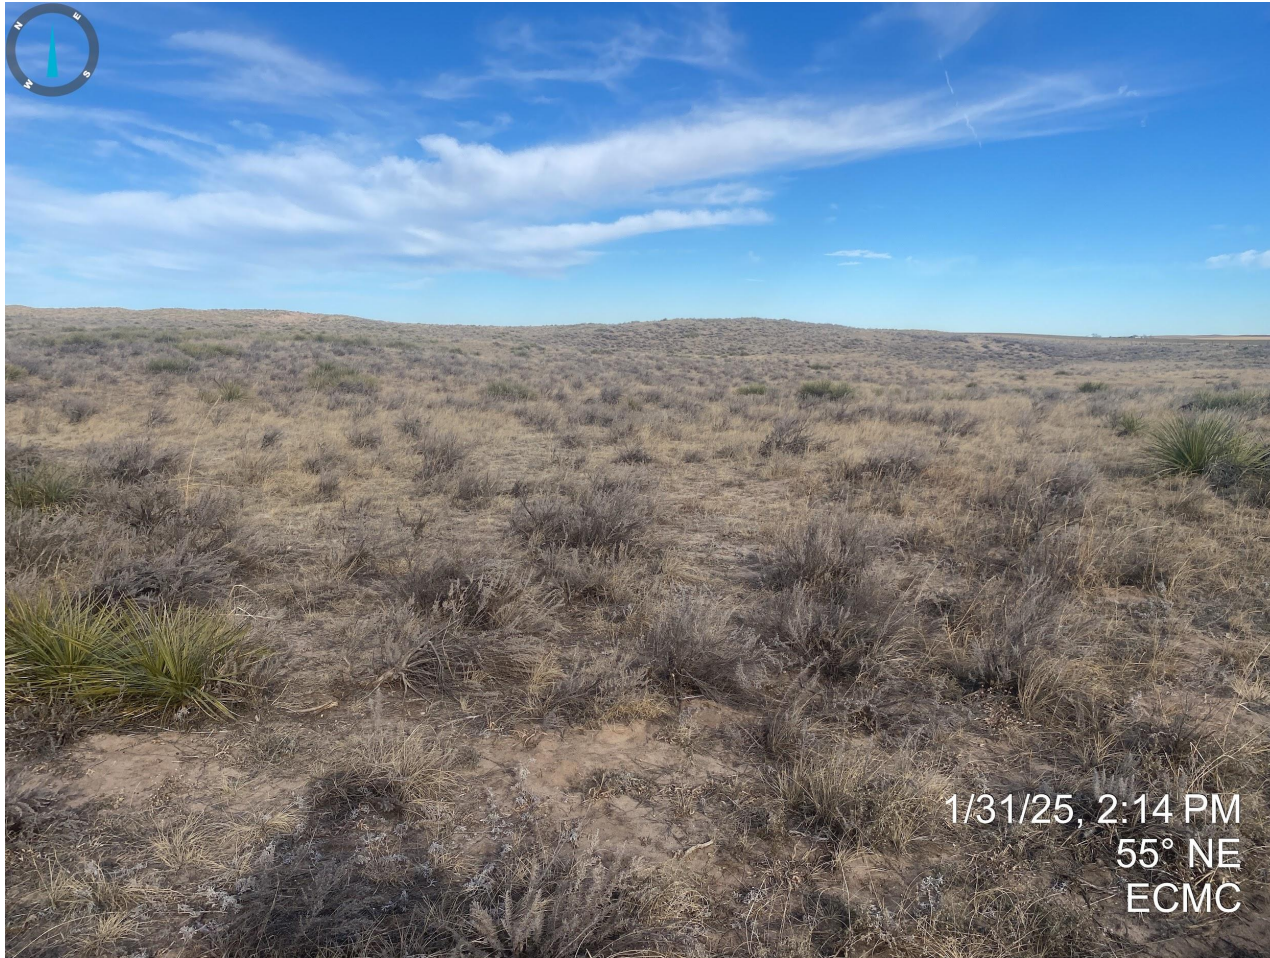
Photo 1. Taken from the start of the reclaimed access road. The access road appears to meet Rule 1004 standards and regulations and is reflective of the adjacent reference areas.

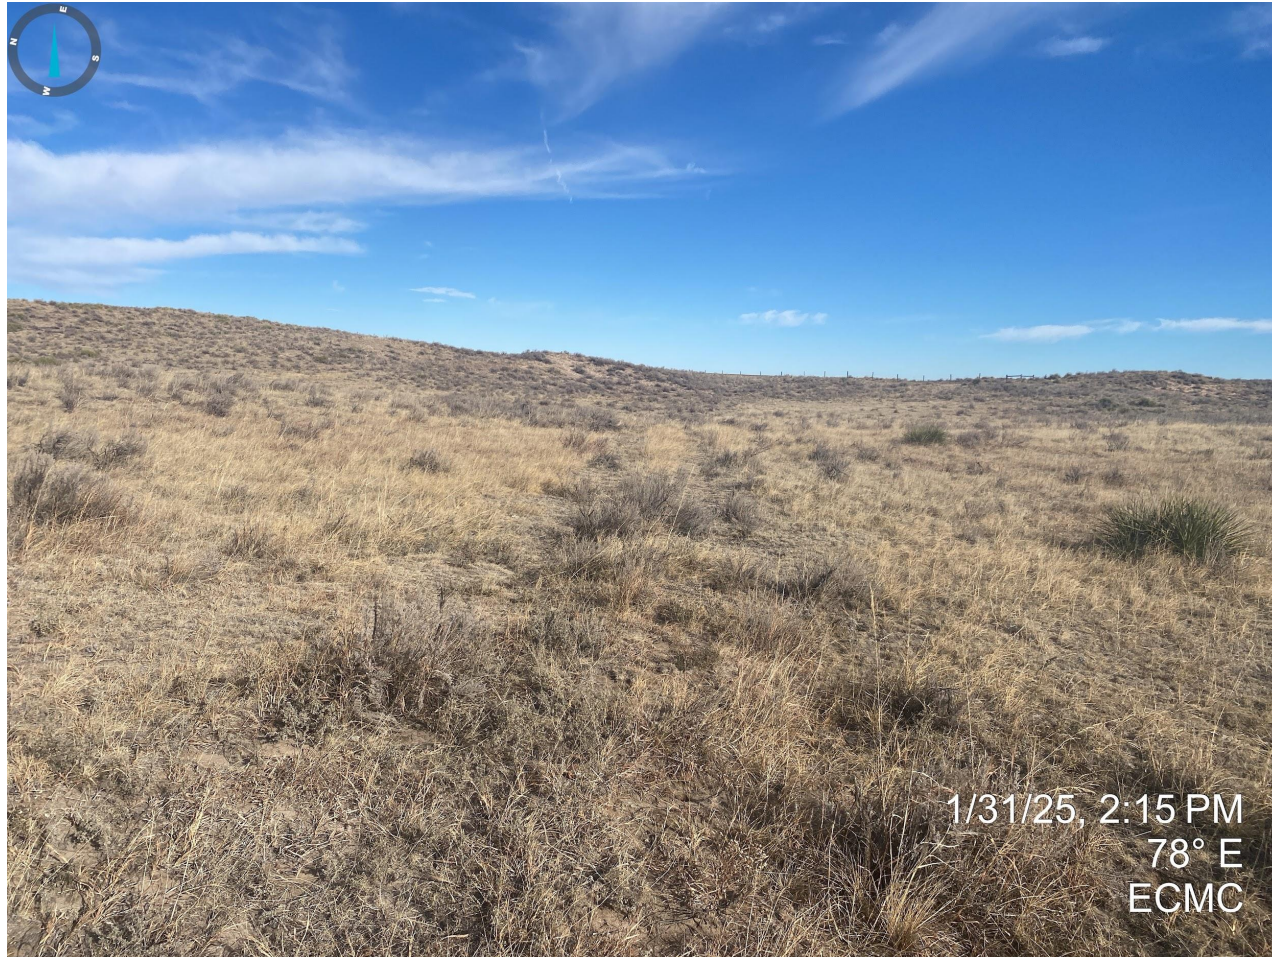
Photo 2. Taken from the mid point of the reclaimed access road; see comments in Photo 1.

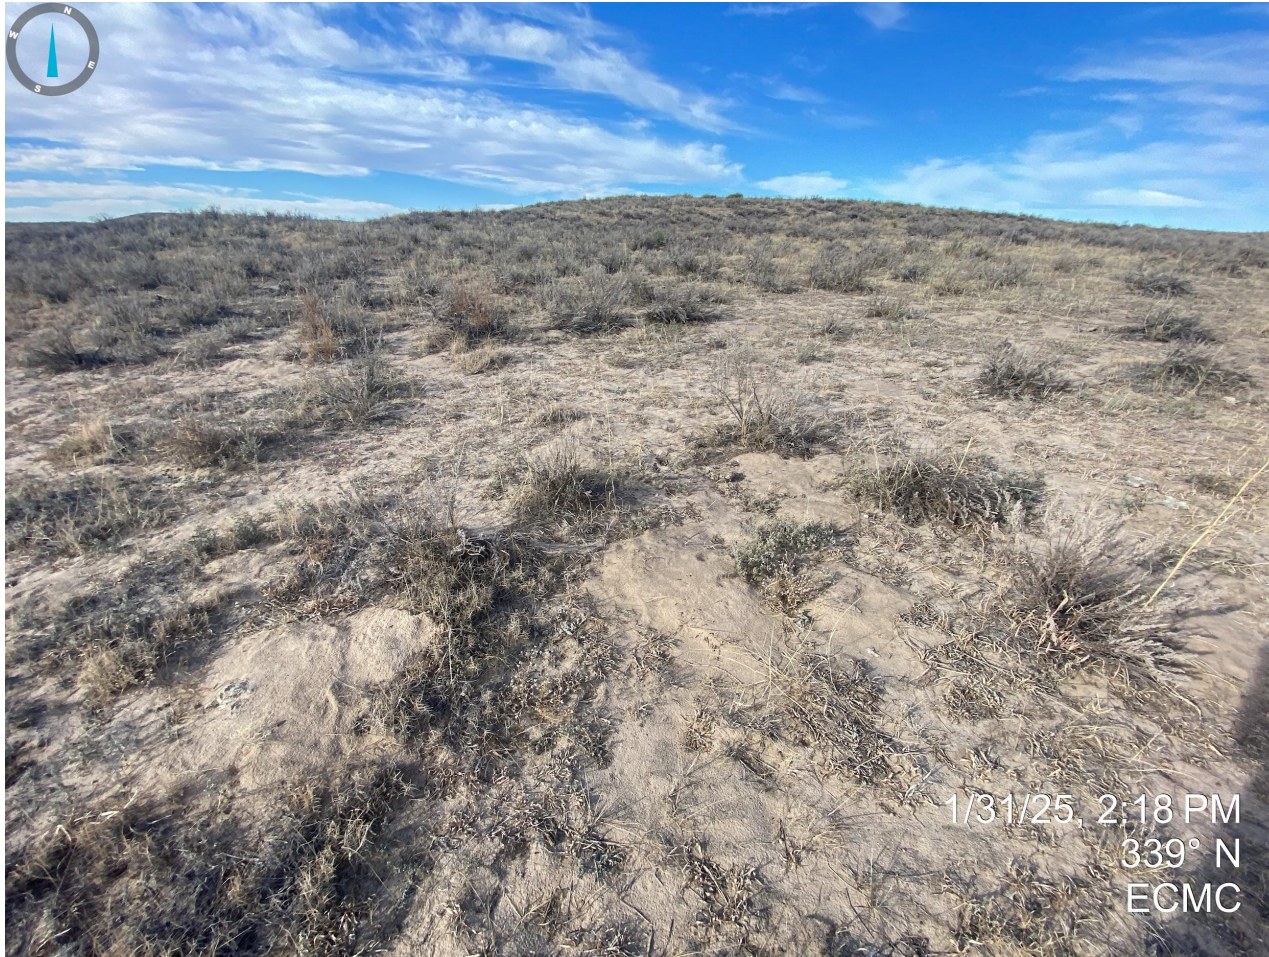
Photo 3. Taken near Well API 125-09174. It does not appear that the location is progressing towards Rule 1004 standards and regulations with evidence of non-uniform vegetation cover resulting in bare/exposed soils. Additional reclamation activities are required.

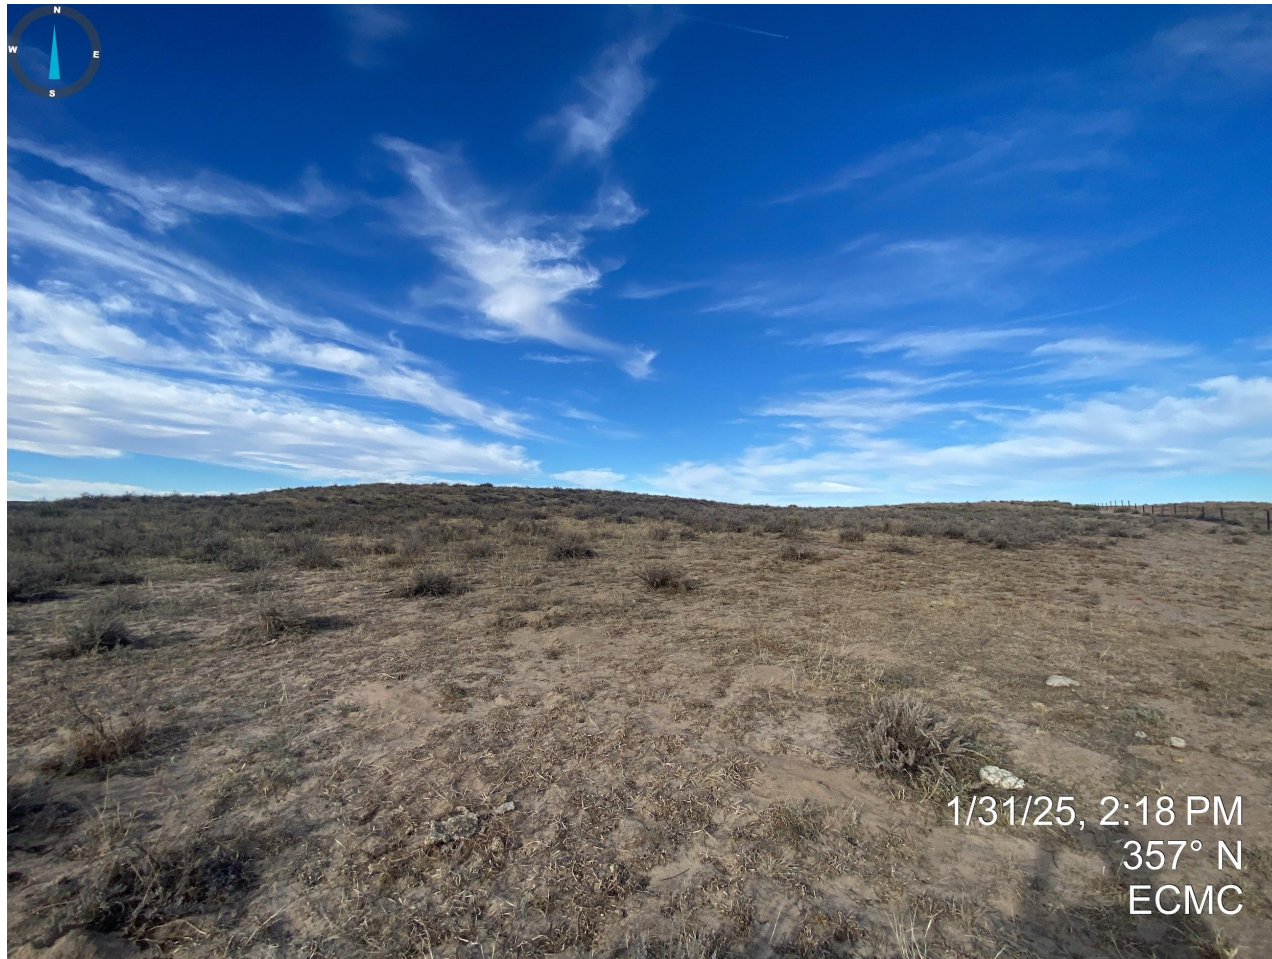
Photo 4. Taken from the southeastern portion of the location, facing north. See comments in Photo 3 for additional information.

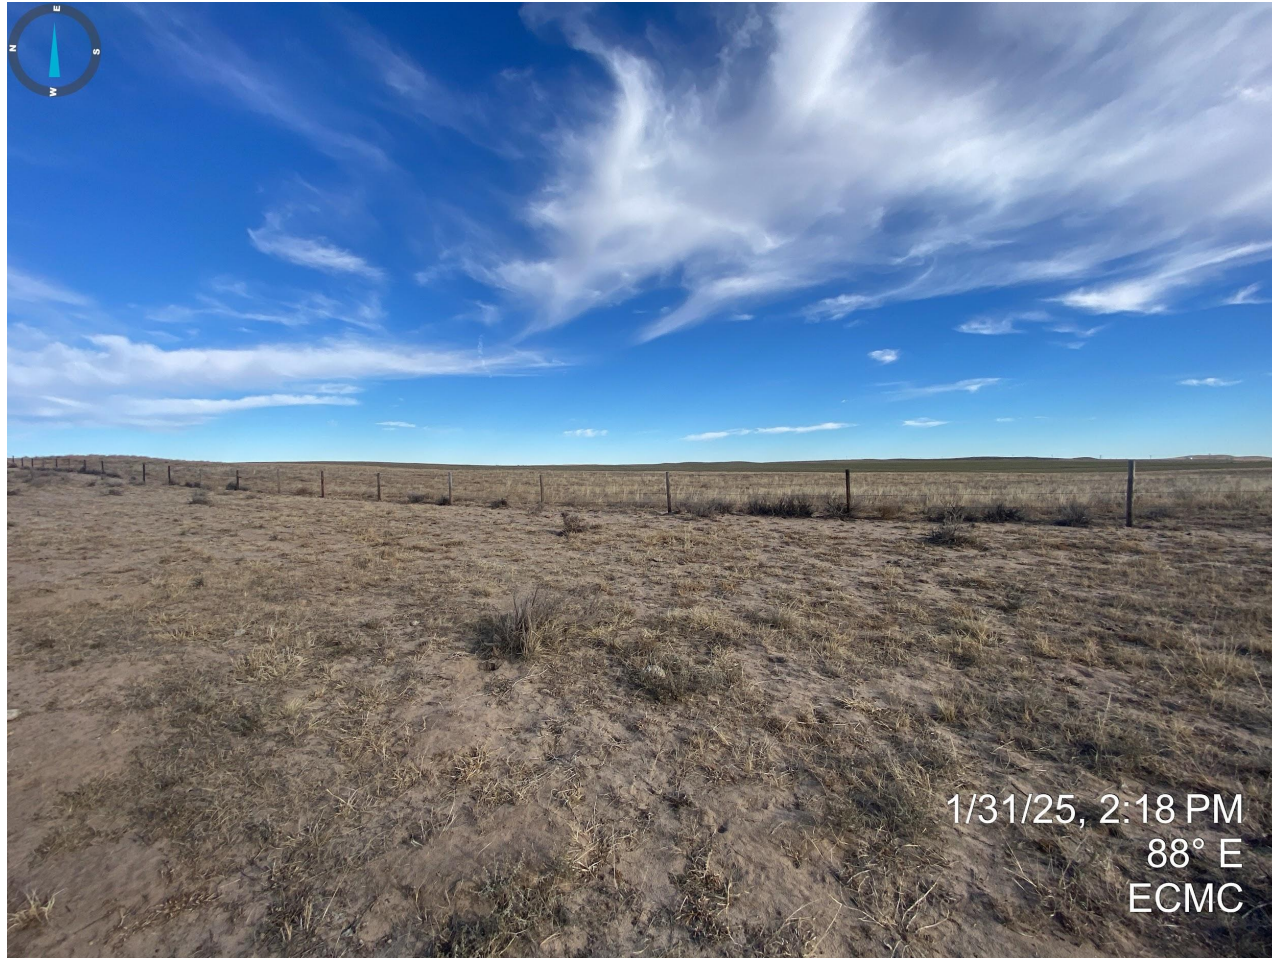
Photo 4. Taken from the western portion of the location, facing east. See comments in Photo 3 for additional information.

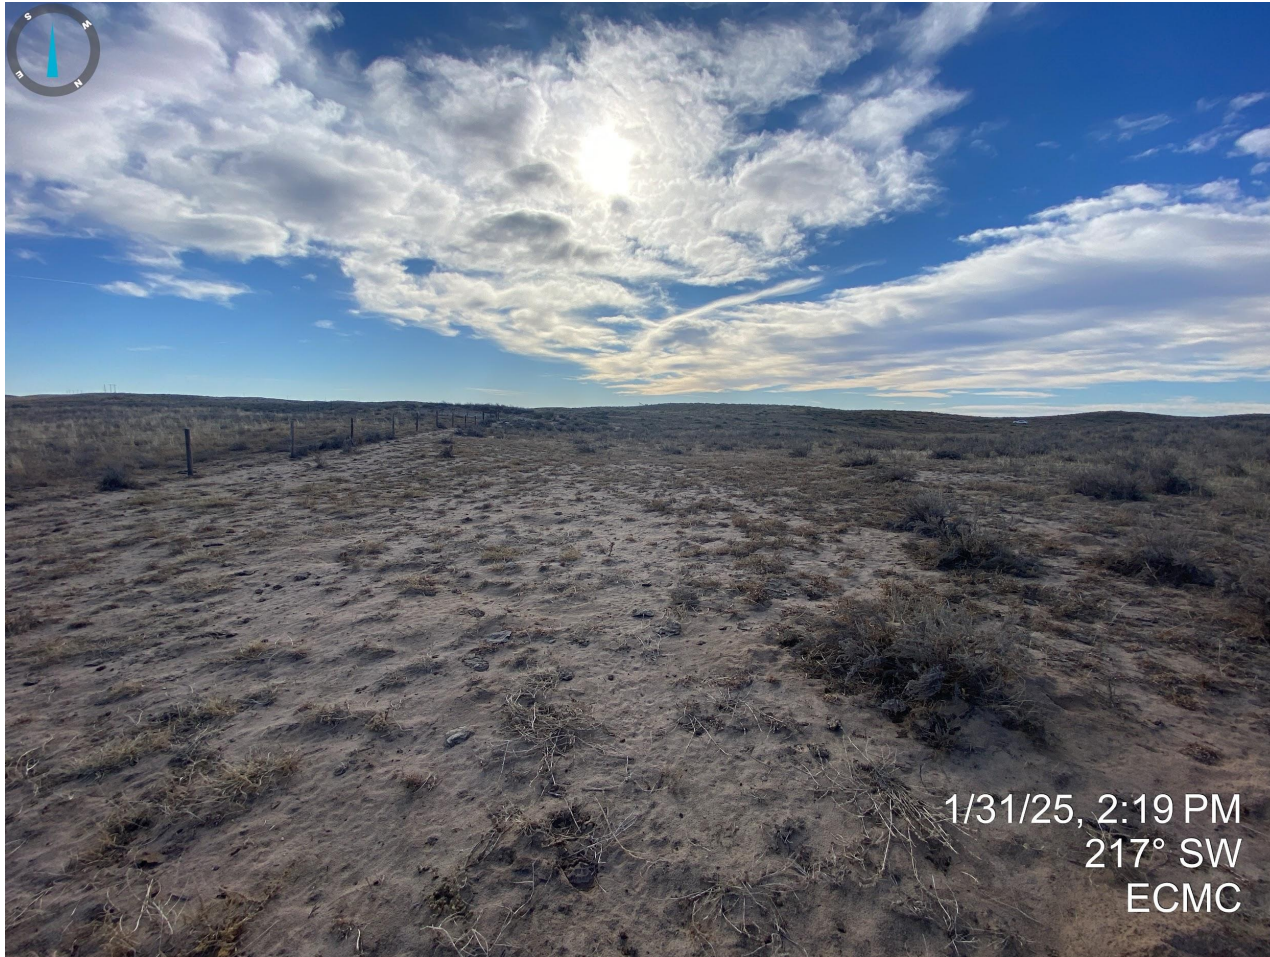
Photo 6. Taken from the northern portion of the location, facing southwest. See comments in Photo 3 for additional information.

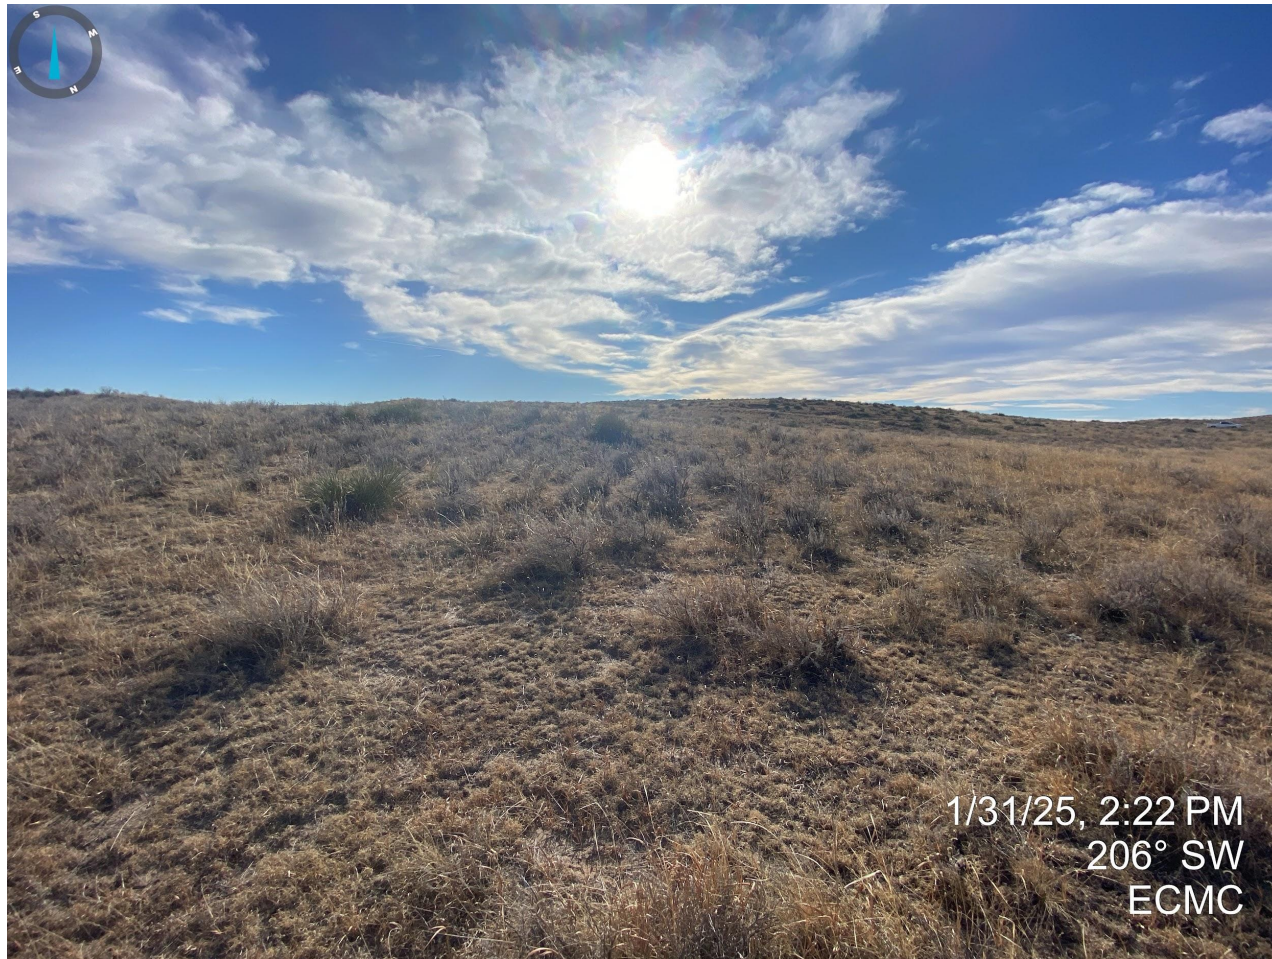
Photo 7. Adjacent reference area southwest of the former location.
