Final Reclamation and Stormwater Inspection

Operator: CRESTONE PEAK RESOURCES OPERATING
LLC - 10633

Location ID: 319613

Inspection Photos
Location Name: Regnier Farms B Unit 1
Location ID: 319613

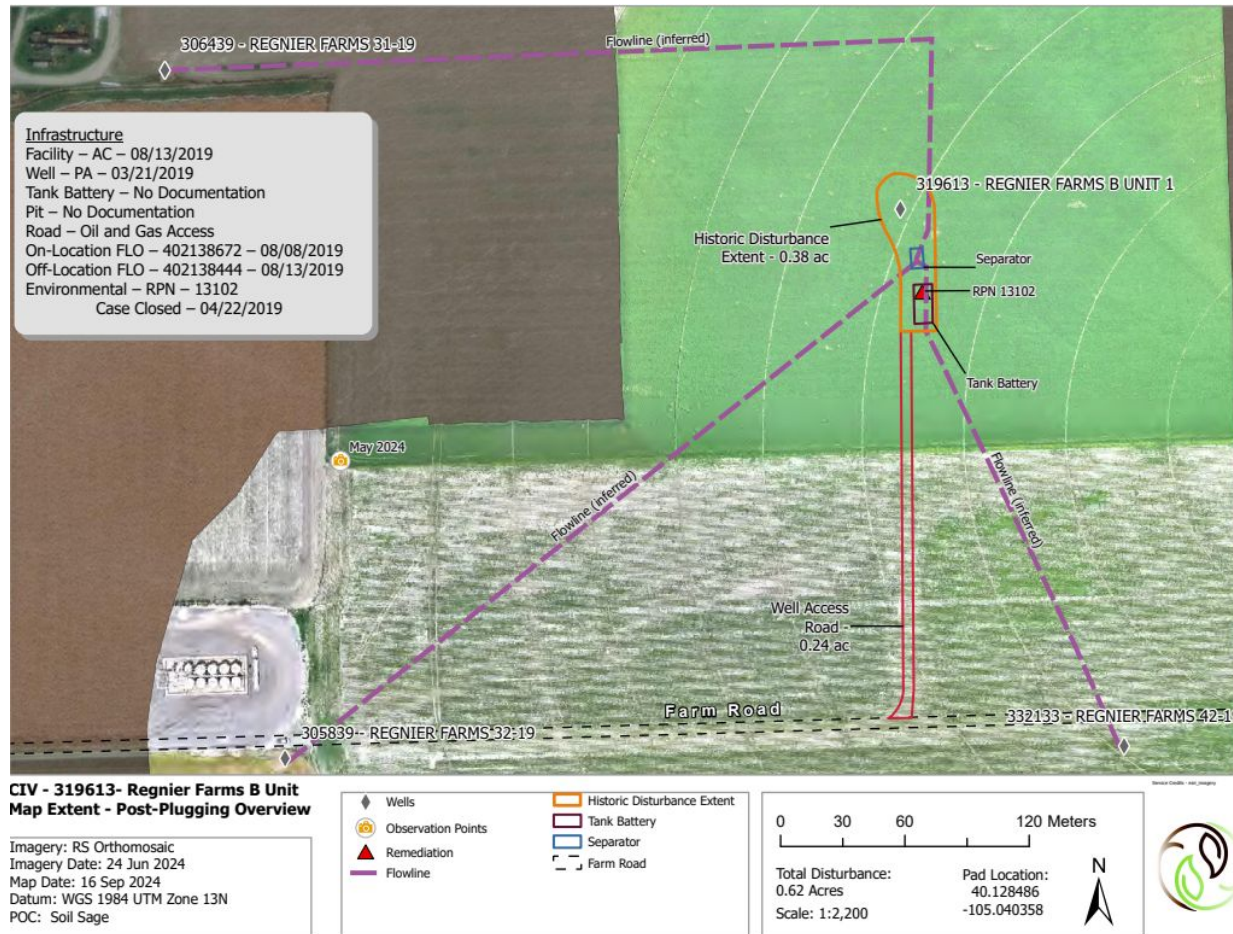
Photo 1. Screenshot from the drone documentation submitted by the Operator. The red outline illustrates the former access road, which appears to be in two different crops, based on orthomosaic imagery.

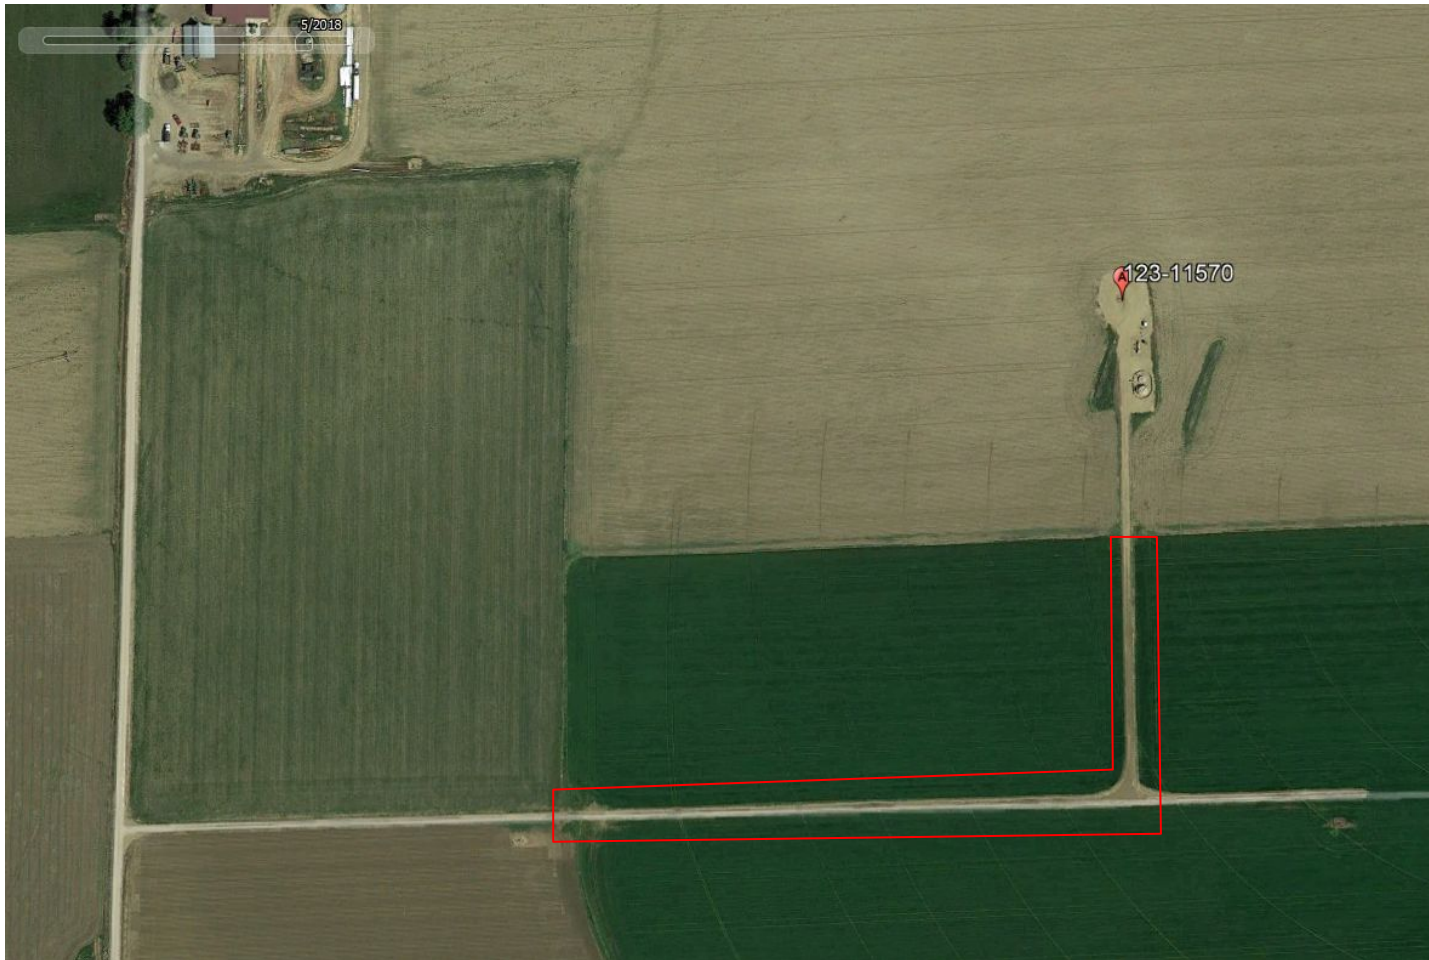
Photo 2. Google Earth aerial imagery (circa 05/2018) illustrating portions of the access road that require additional documentation for the next drone submission.

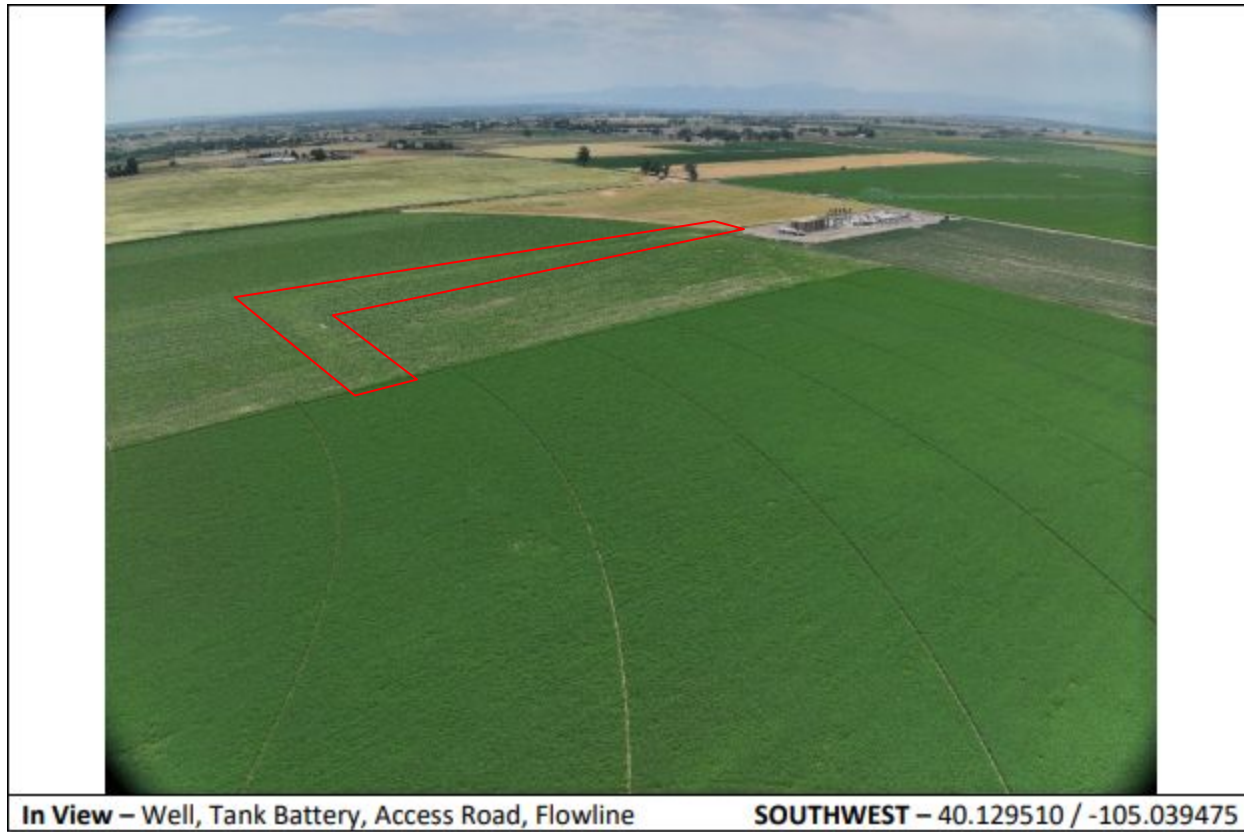
Photo 3. Drone aerial imagery taken from the drone documentation; Page 13, doc #403942075. It is unclear what crop and at what growth stage the access road is planted to. Red outline (drawn by ECMC staff) illustrates the presumed access road that requires additional documentation.
