Final Reclamation and Stormwater Inspection

Operator: PDC ENERGY INC - 69175

Location ID: 306705

Inspection Photos
Location Name: Rothe 24-29U
Location ID: 306705

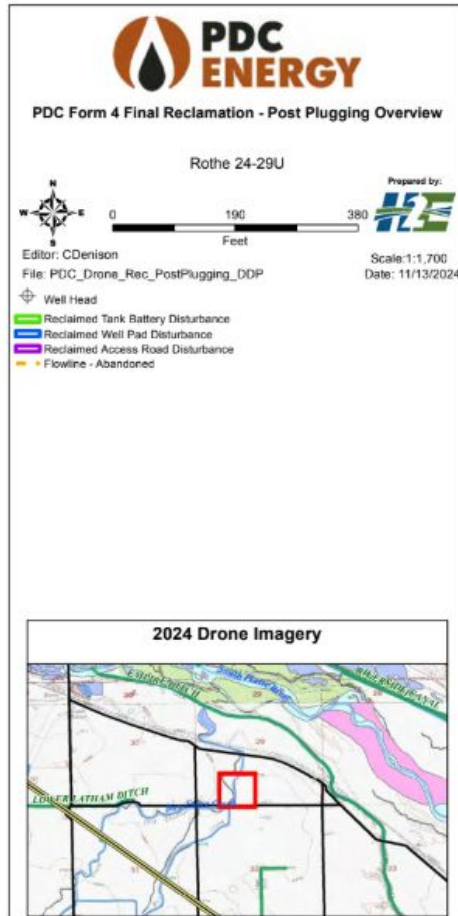
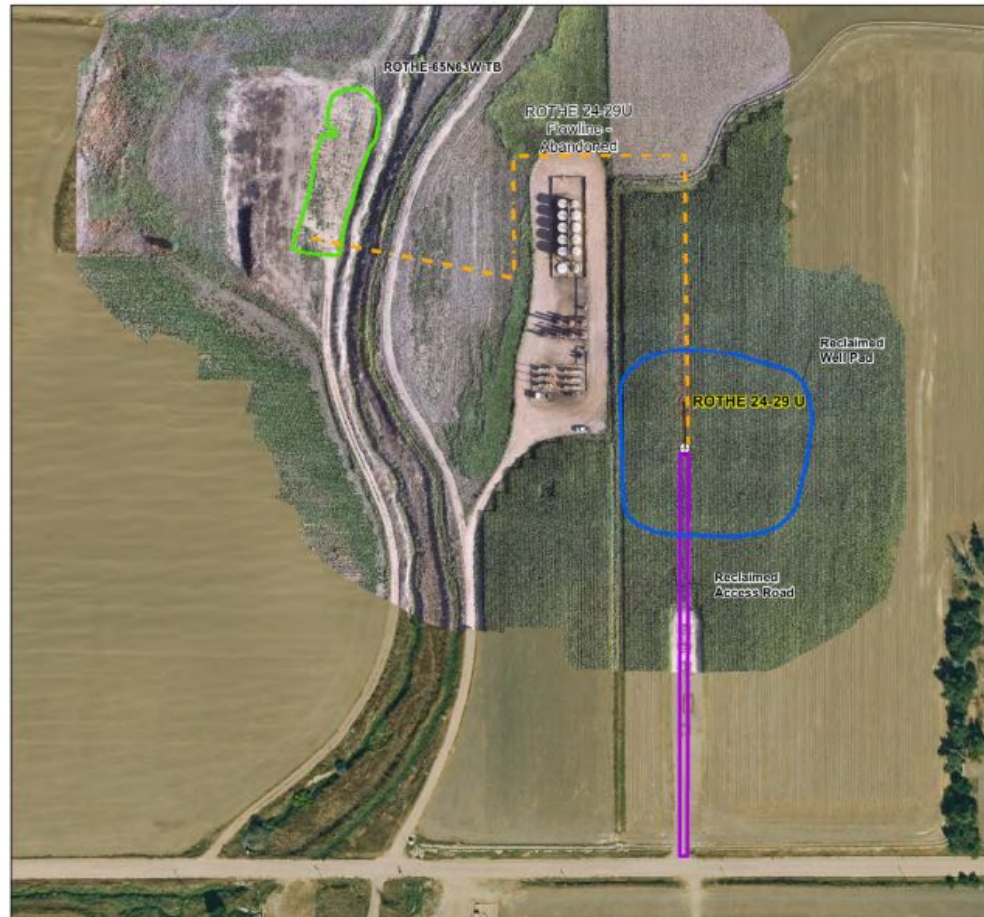
Photo 1. Orthomosaic imagery taken from the drone closure report (Page 12), illustrating the former access road to the subject well (outlined in purple) and the presumed flowline path (outlined in orange dotted line). Subsequent photos illustrate impacts to crops along the former access road and flowline paths.

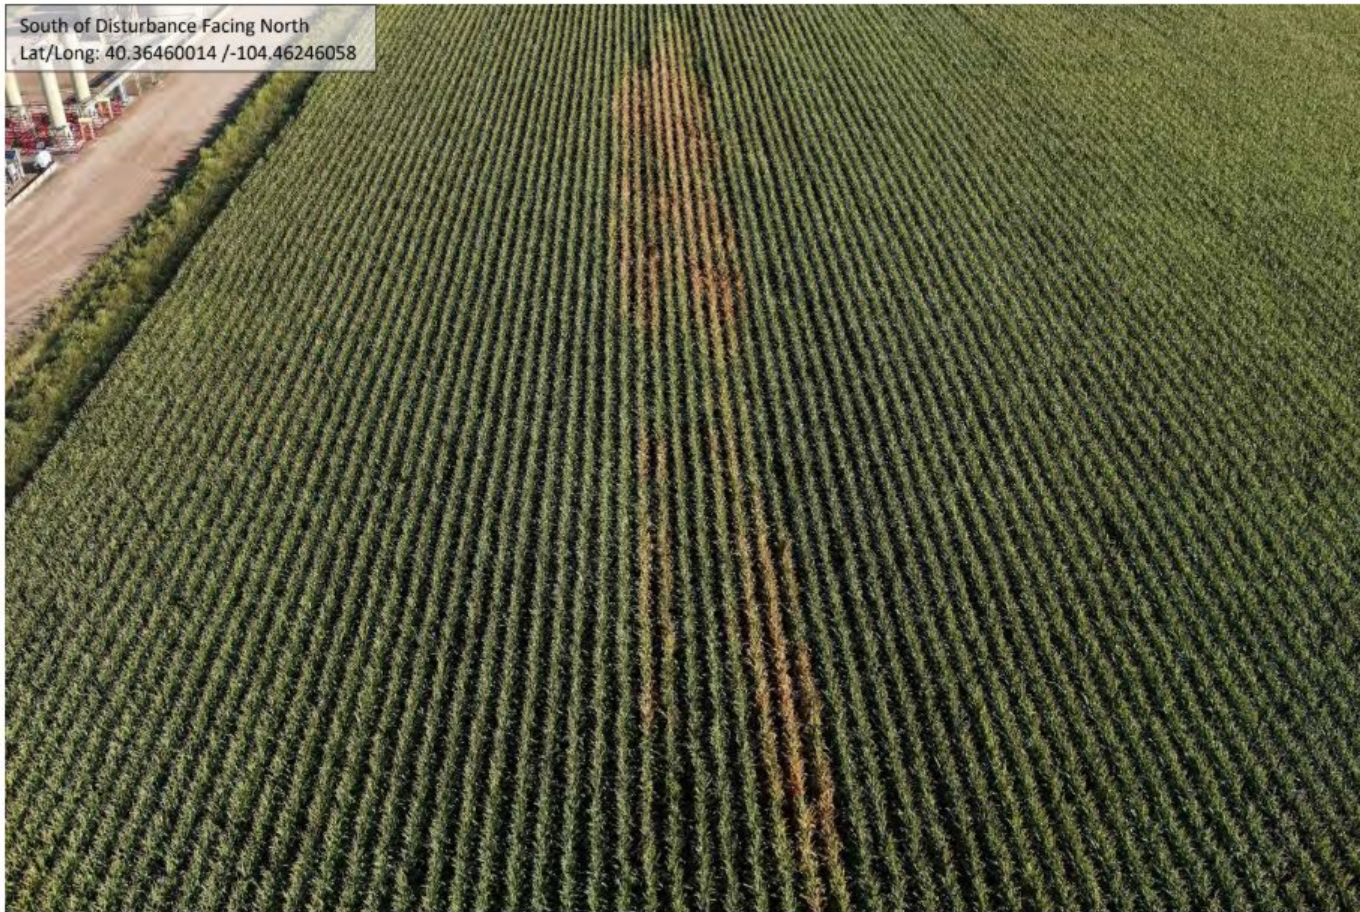
Photo 2. Screenshot taken from Page 14 of the drone closure report illustrating impacted crops north of the subject well location, along the presumed flowline path.

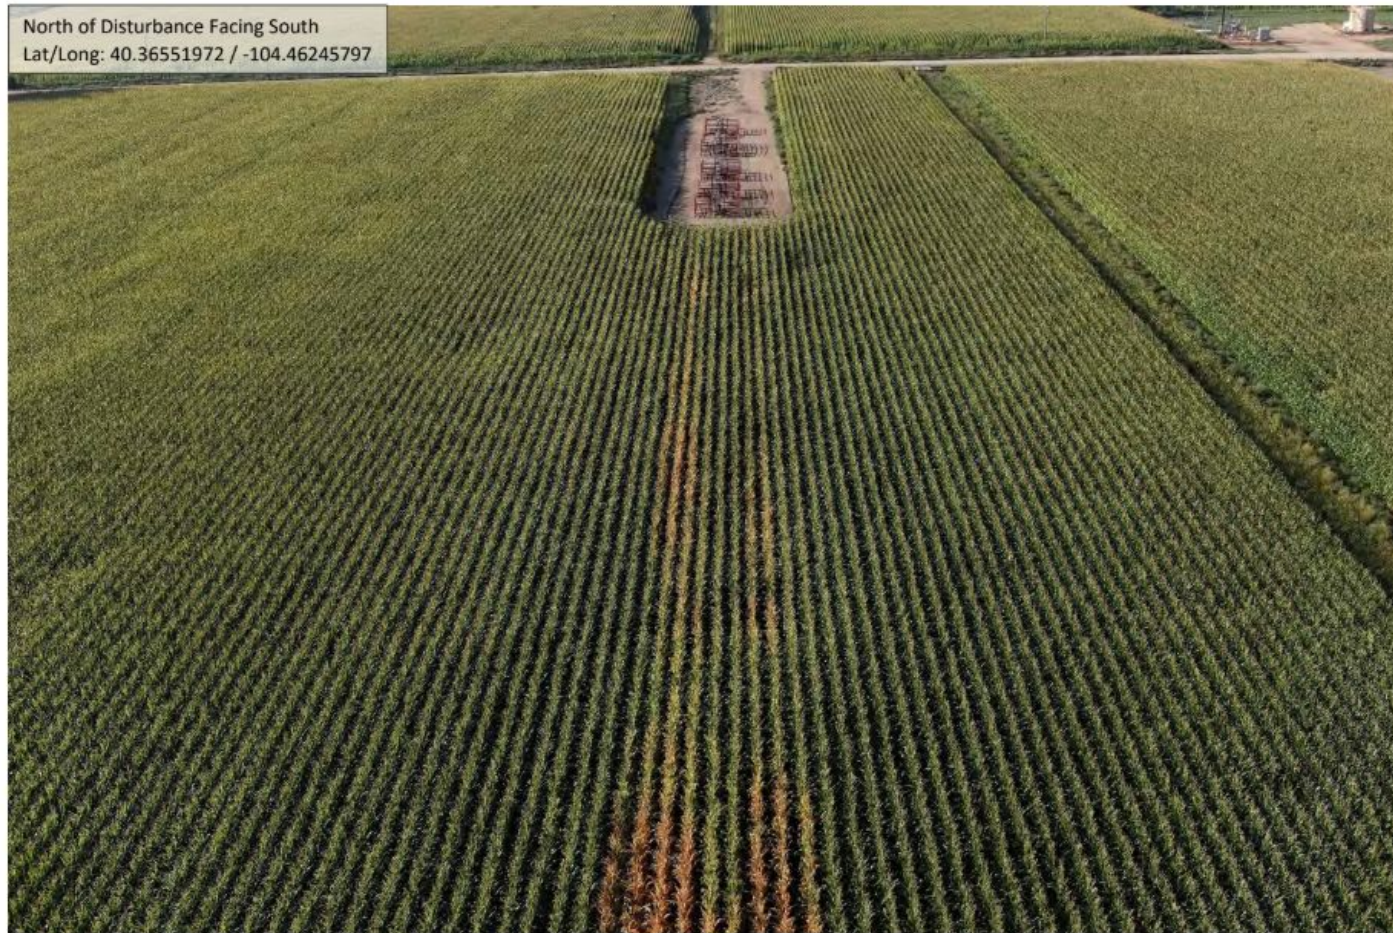
Photo 3. Screenshot taken from Page 15 of the drone closure report illustrating impacted crops south of the subject well location, along the former access road.

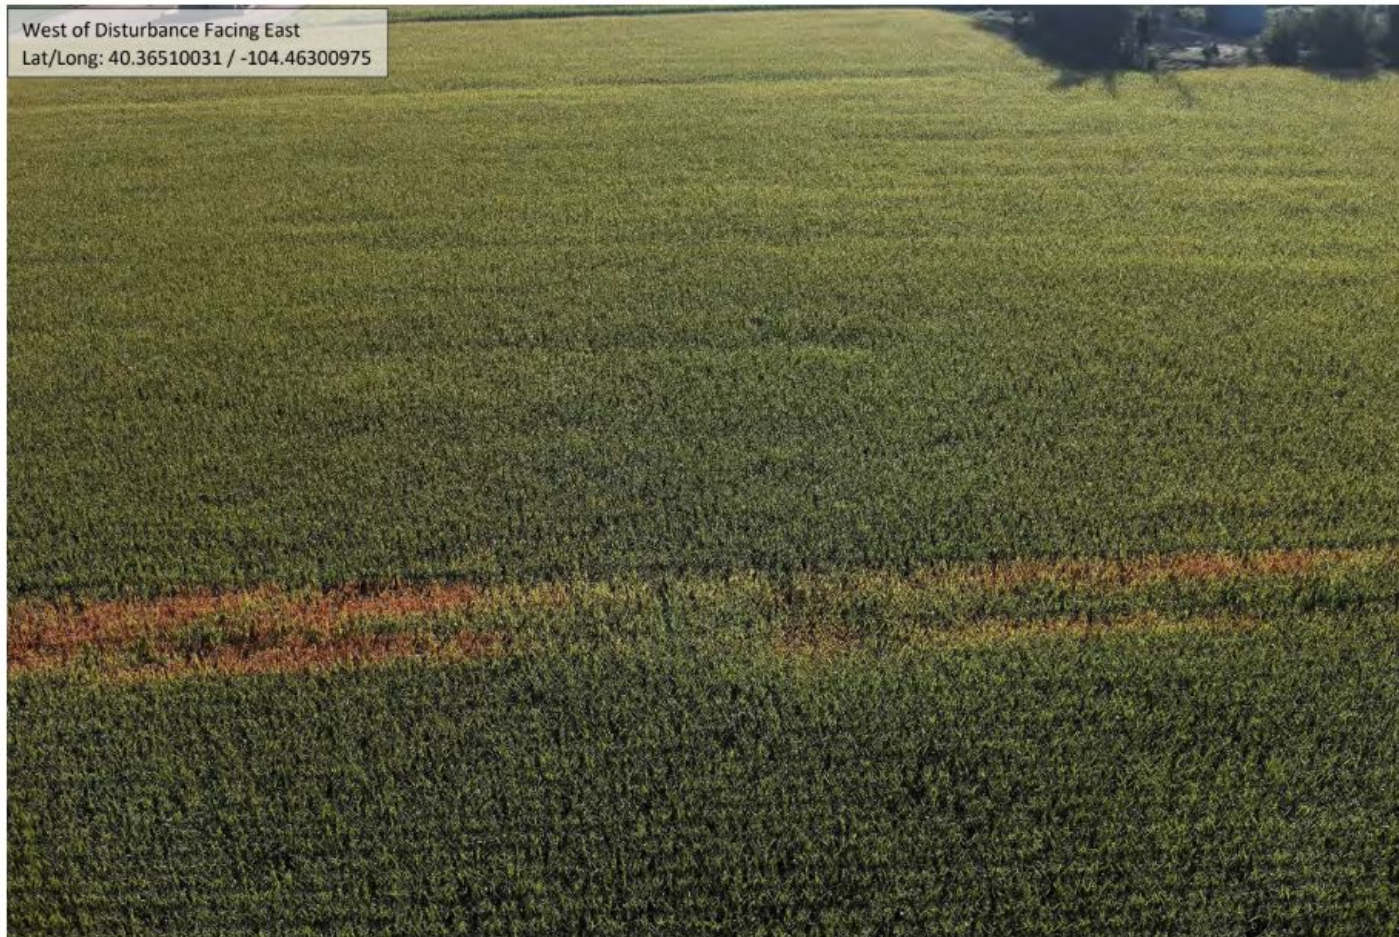
Photo 4. Screenshot taken from Page 16 of the drone closure report illustrating impacted crops north and south of the subject well; presumed flowline path (left) and former access road (right) in view.

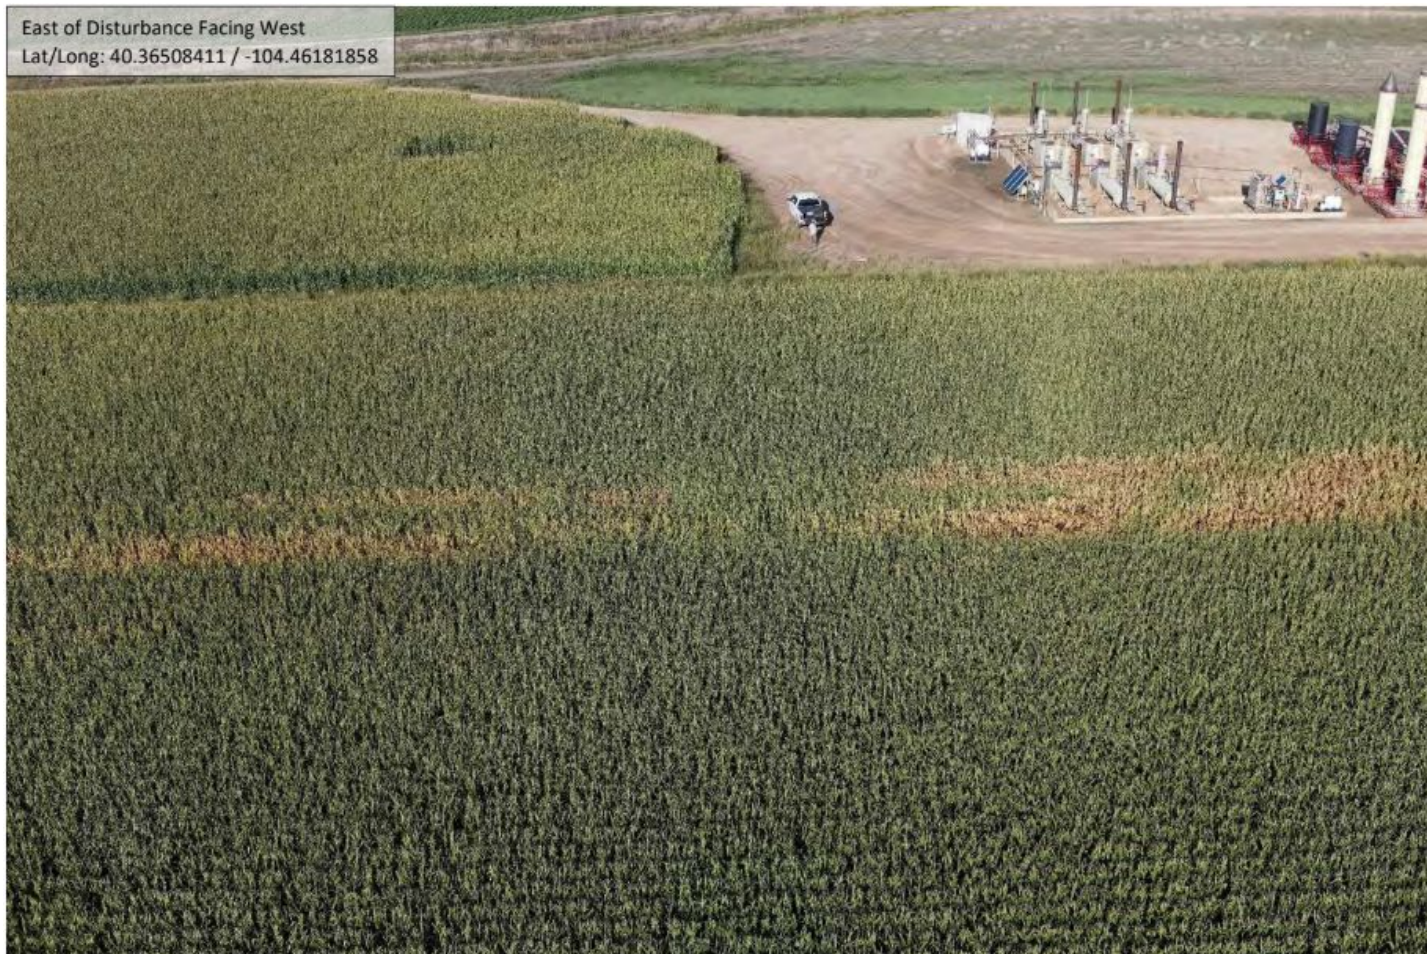
Photo 5. Screenshot taken from Page 17 of the drone closure report illustrating impacted crops north and south of the subject well; presumed flowline path (right) and former access road (left) in view.
