# Inspection Photos

**Operator:** LARAMIE ENERGY LLC - 10433

**Location ID:** 312635

**Inspection Doc:** 718100258

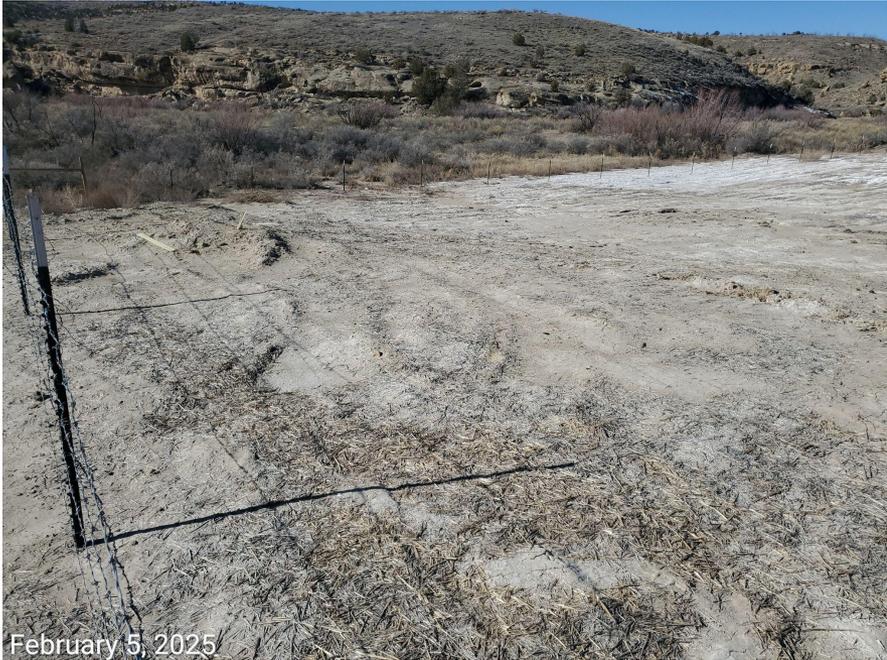
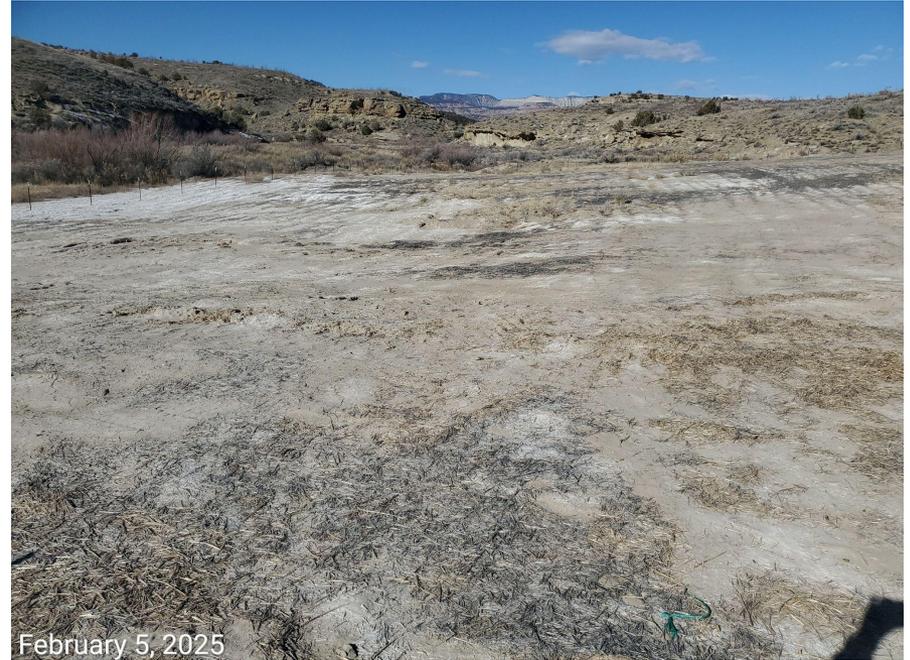
**Photo 1:** Photos taken from the east end of the (fenced) Location. Photos provide an overview of the Location from south, southwest, northwest to north.

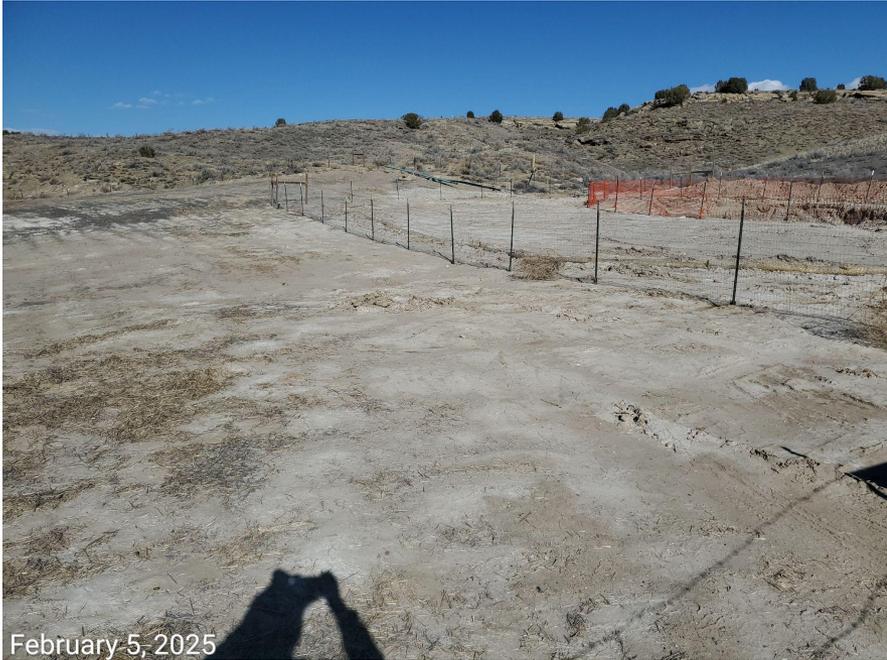
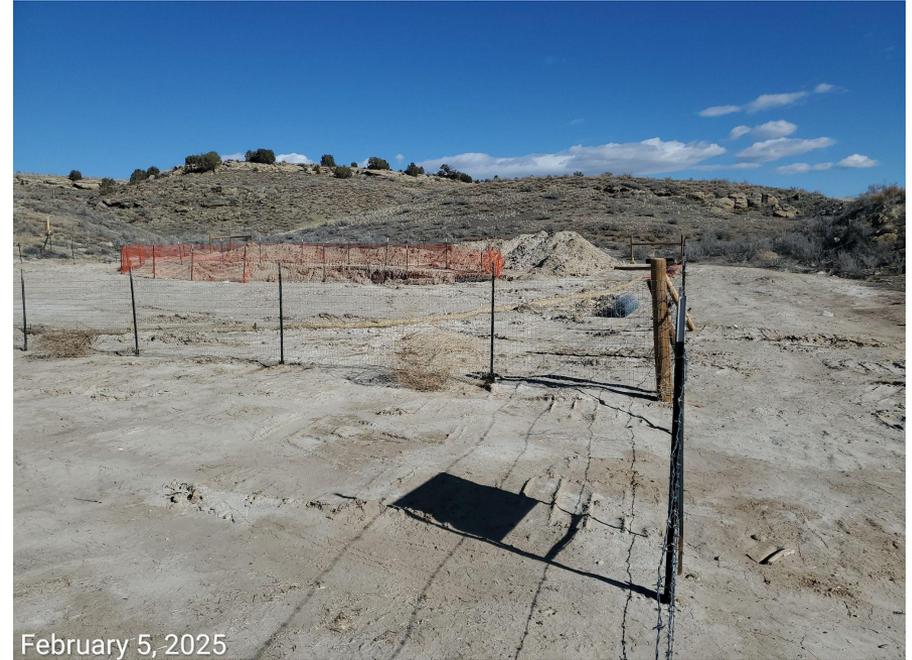
**Photo 2:** See comments under photo 1.

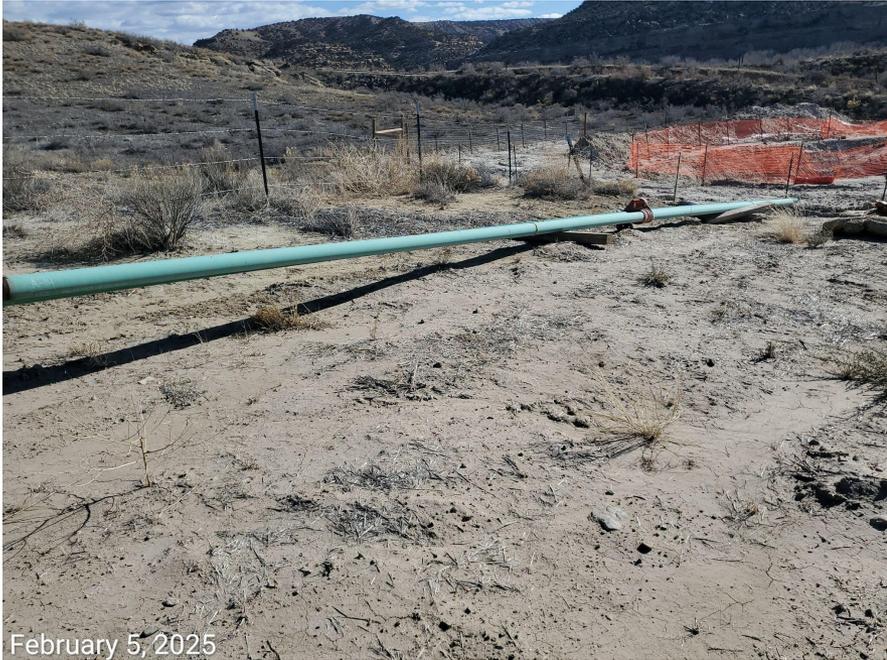
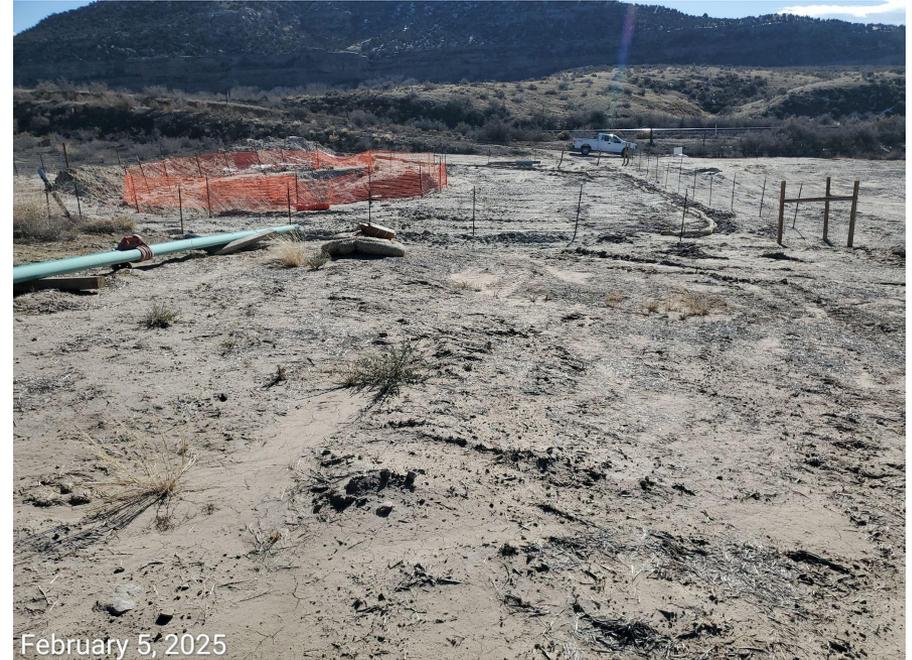
**Photo 4:** Photos taken from the northwest end of the Location, facing northeast and east. Photos provide an overview of the fenced pit/remediation areas. Photos also shows pipe equipment being stored on the northwest end of the Location. Evidence of vehicles/equipment traveling within the reclamation areas observed.

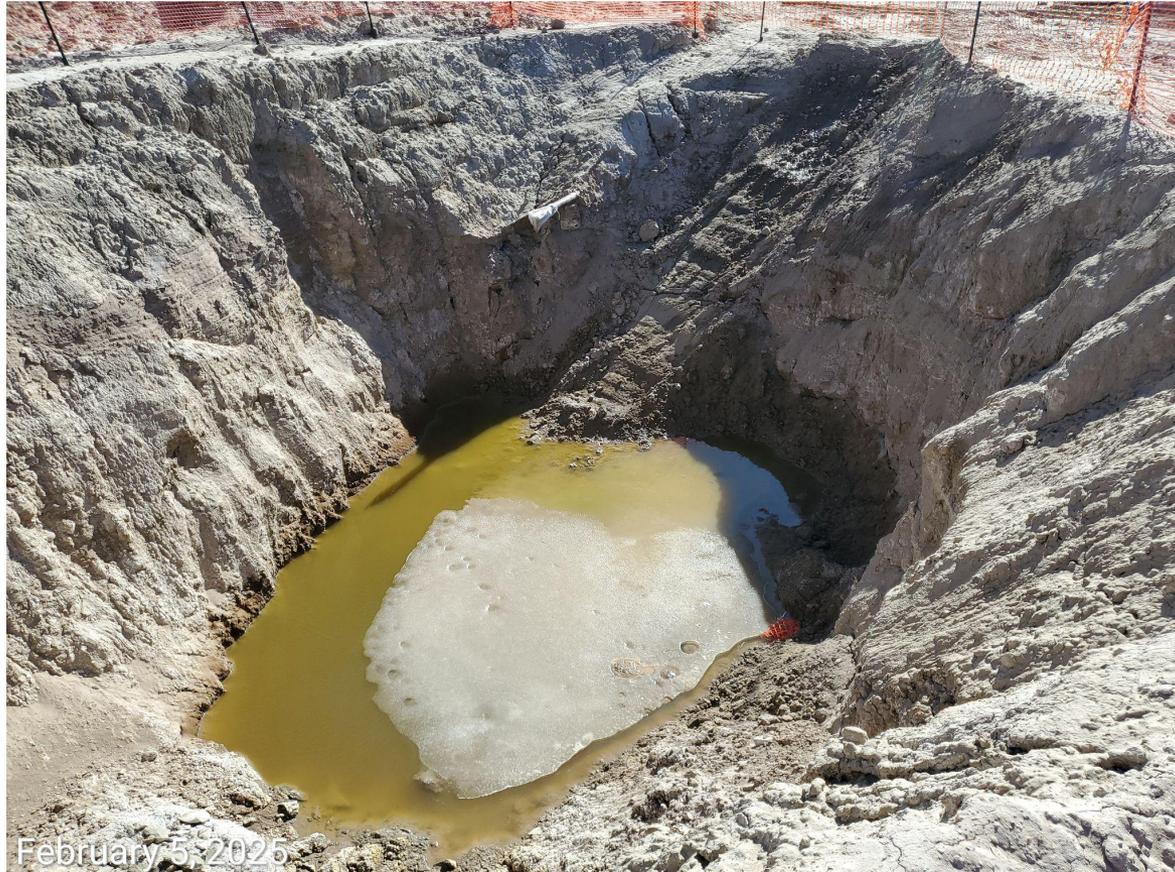
**Photo 5:** Photo shows pit/excavation associated with spill #488131. Photo also shows water within the pit. Water is possibly groundwater.

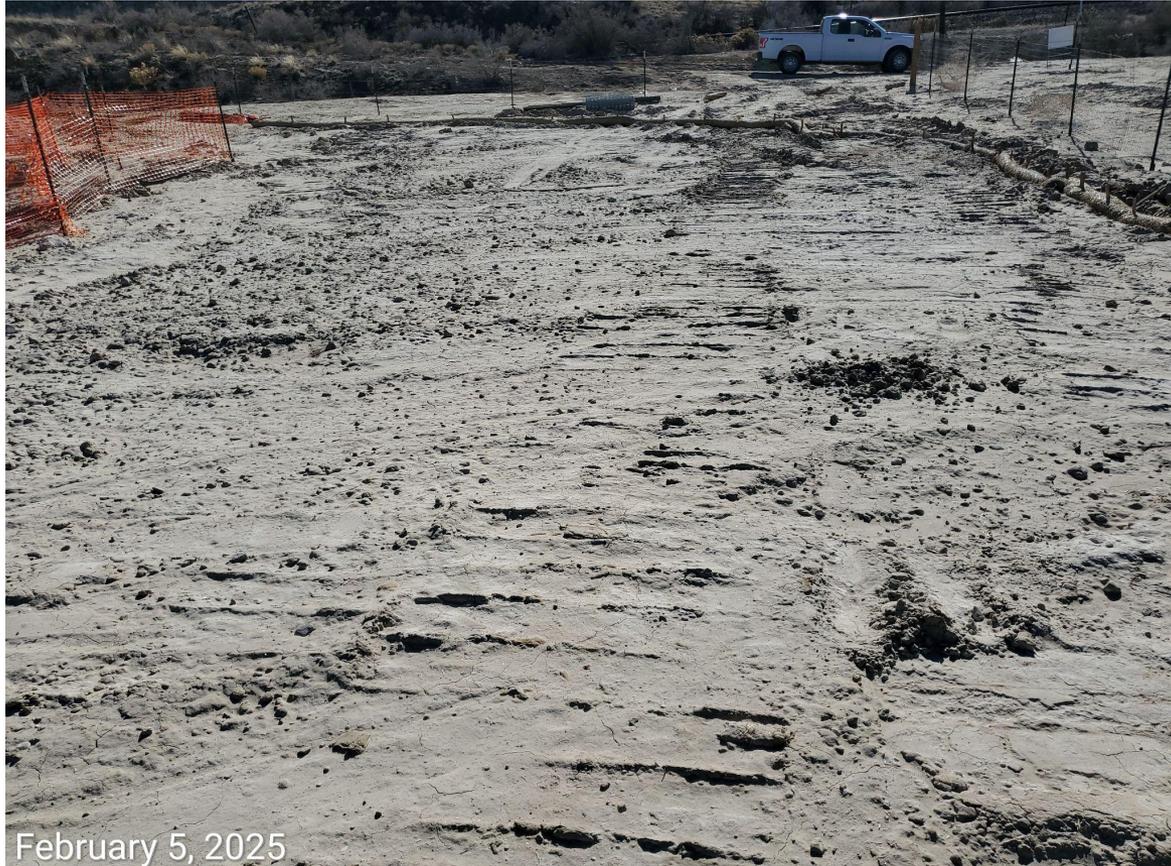
**Photo 6:** Photo example of the re-disturbed areas adjacent to the pit.

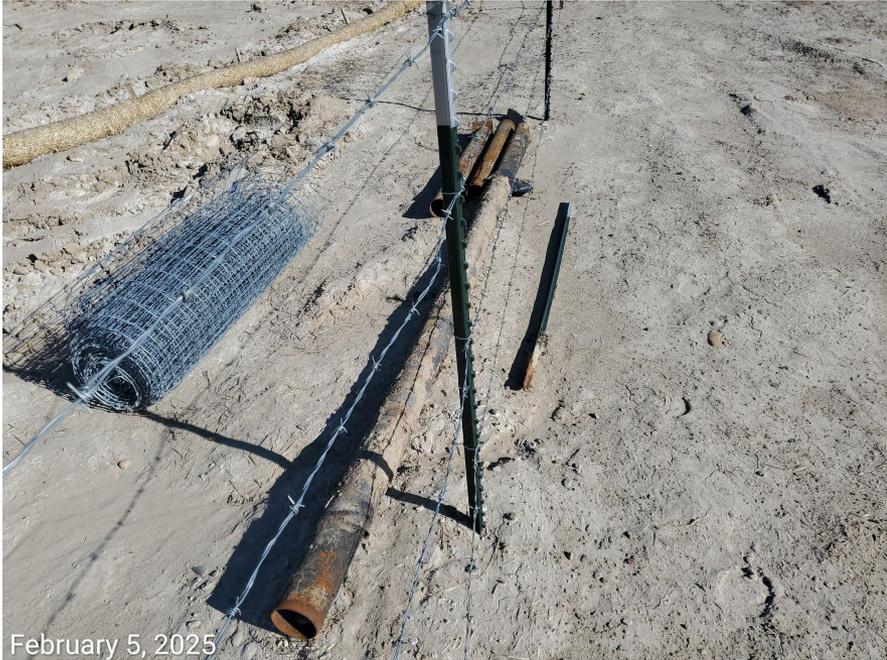
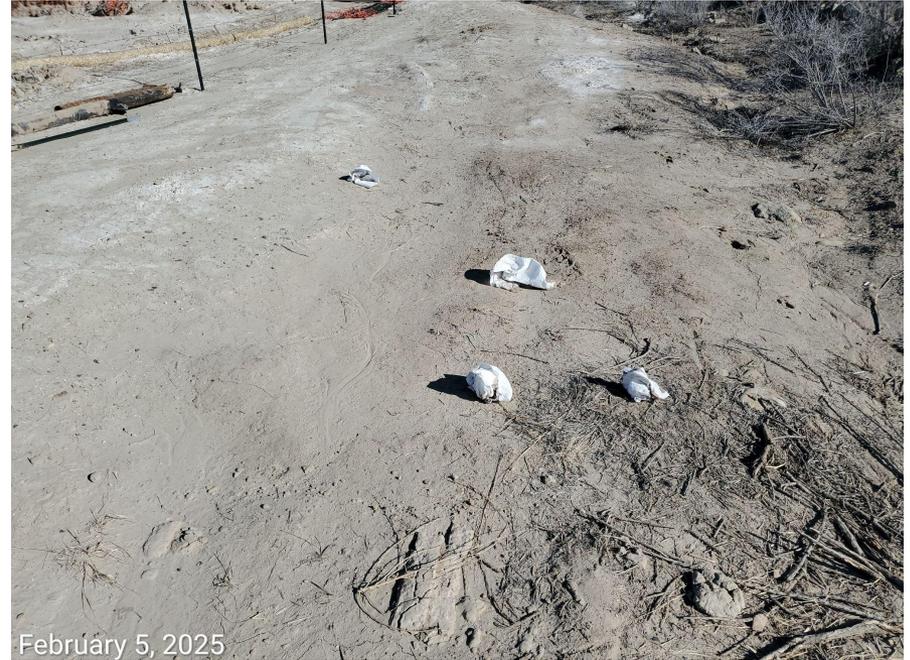
**Photo 7:** Photos examples of various trash/debris or unused equipment/materials improperly placed on the Location.

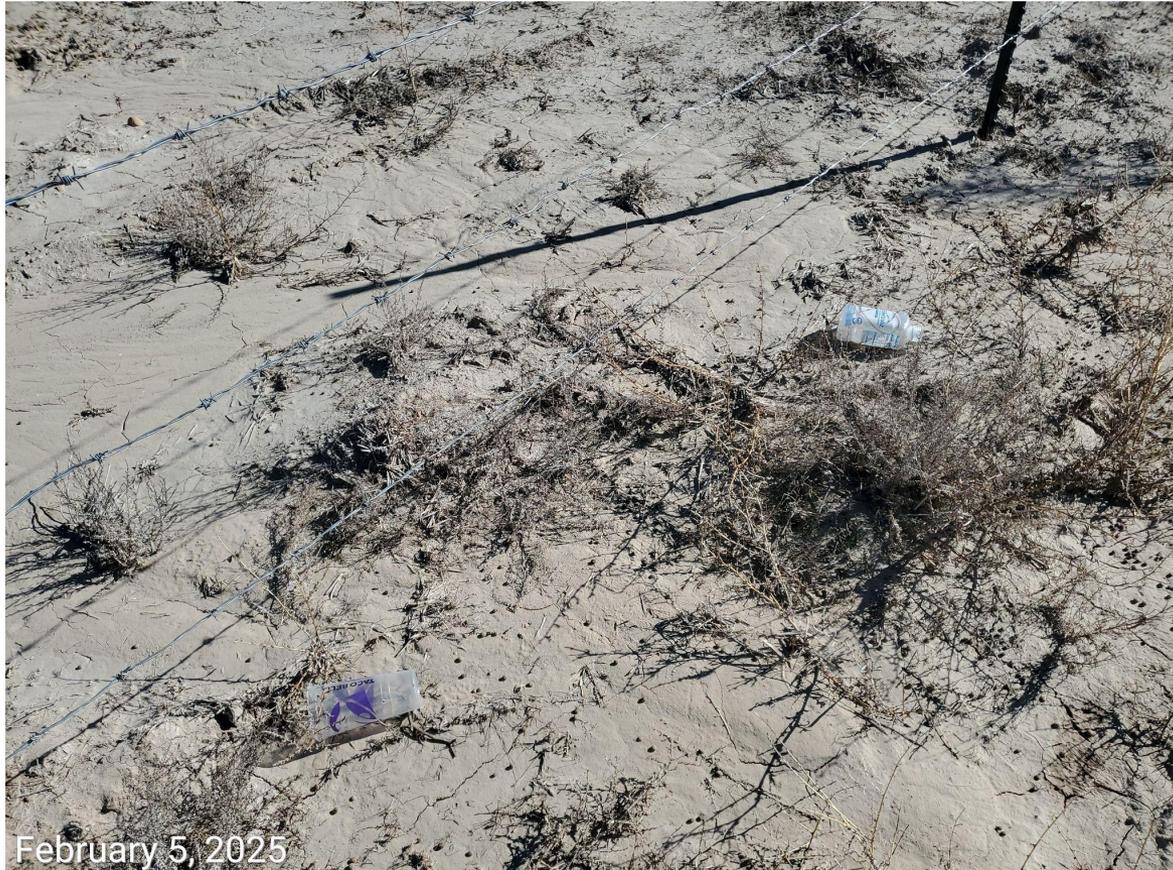
**Photo 8:** Photos examples of various trash/debris or unused equipment/materials improperly stored on the Location.

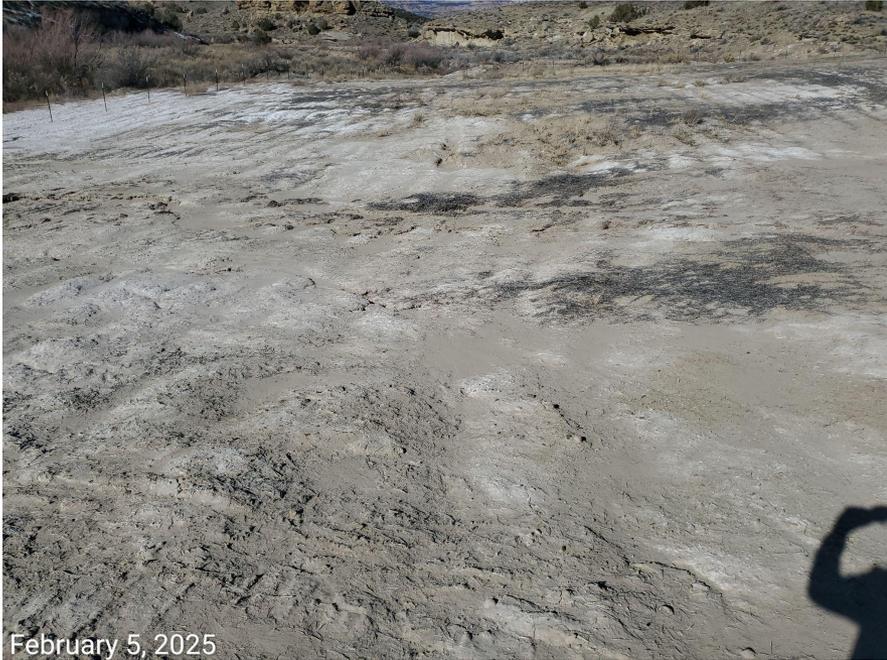
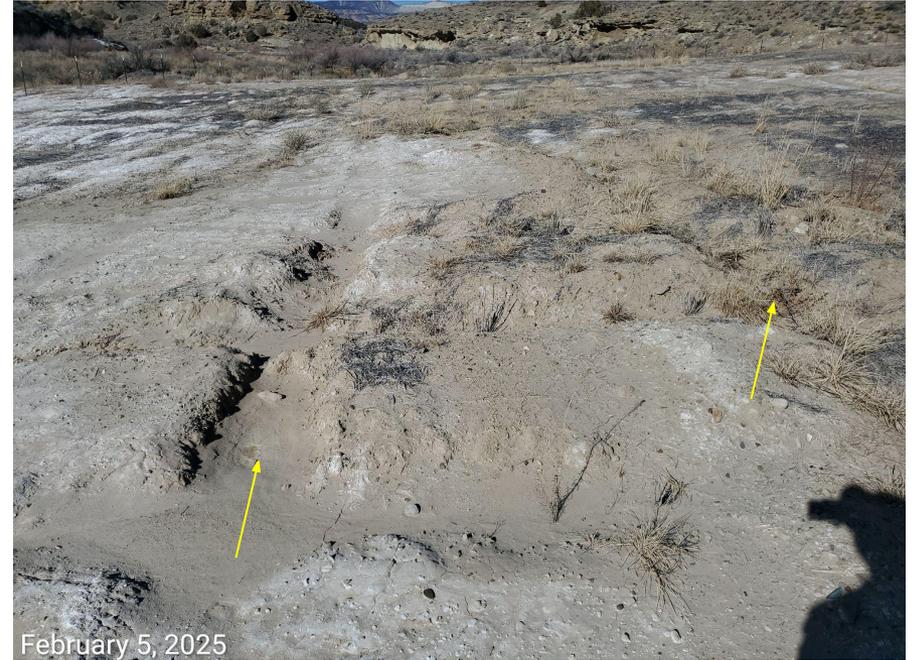
**Photo 9:** Photos 9-11 examples showing that the Location is predominantly bare and exposed soil; germination and establishment of desirable perennial species was not observed and/or not progressing towards ECMC uniform requirements. Photos also show mulch applied to Location is no longer functioning, and erosion, degradation and sediment transport was observed. Photo right also shows what appears to be vehicle/equipment ruts.

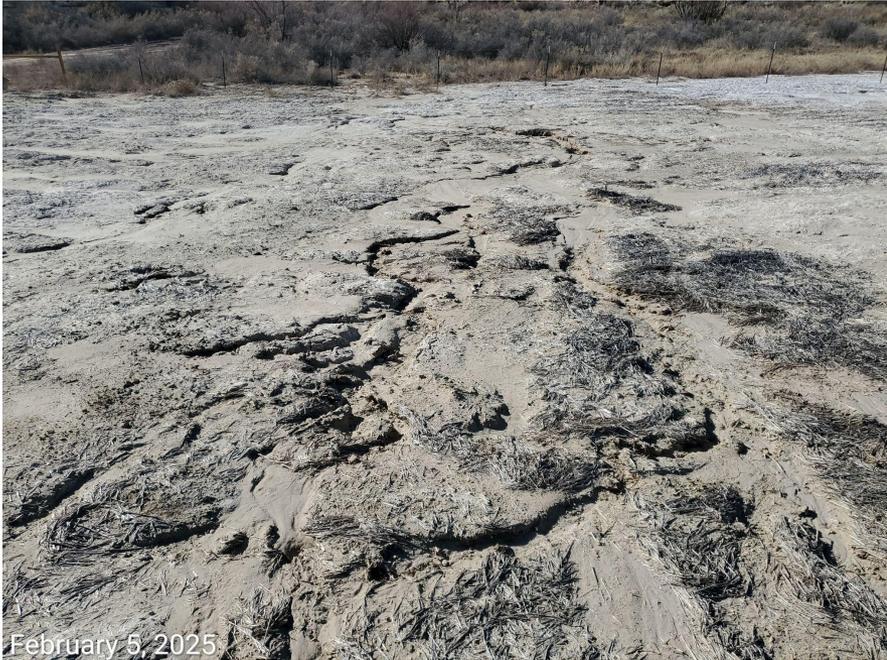
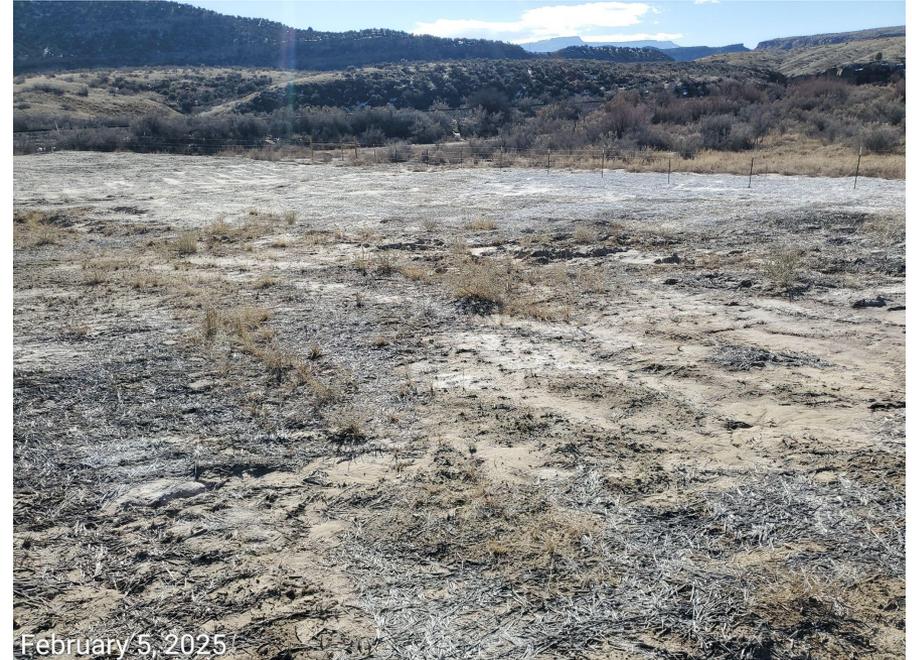
**Photo 10:** See comments under photo 9. Photos also show stormwater and erosion control BMPs are missing or insufficient; erosion, degradation and sediment transport evident.

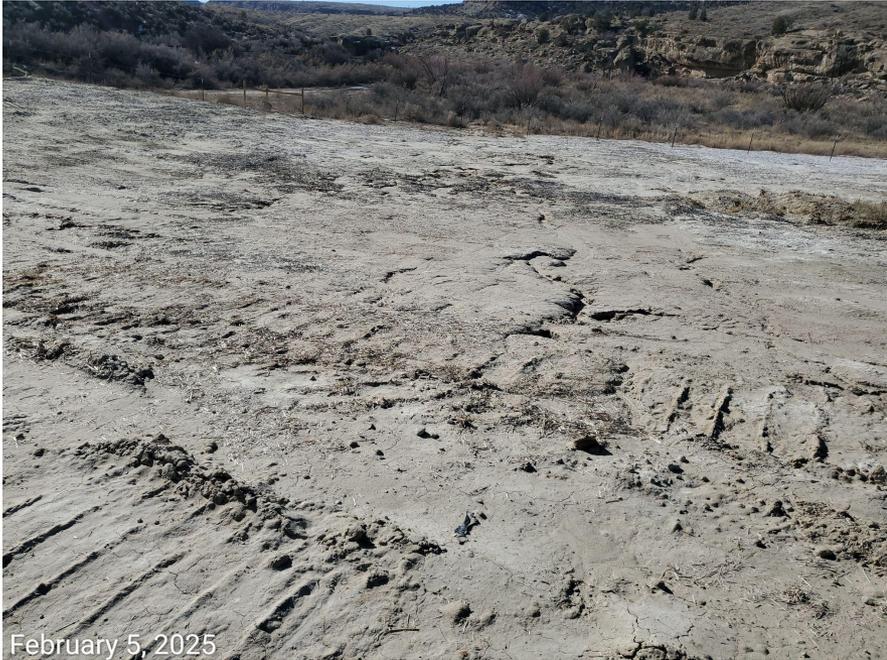
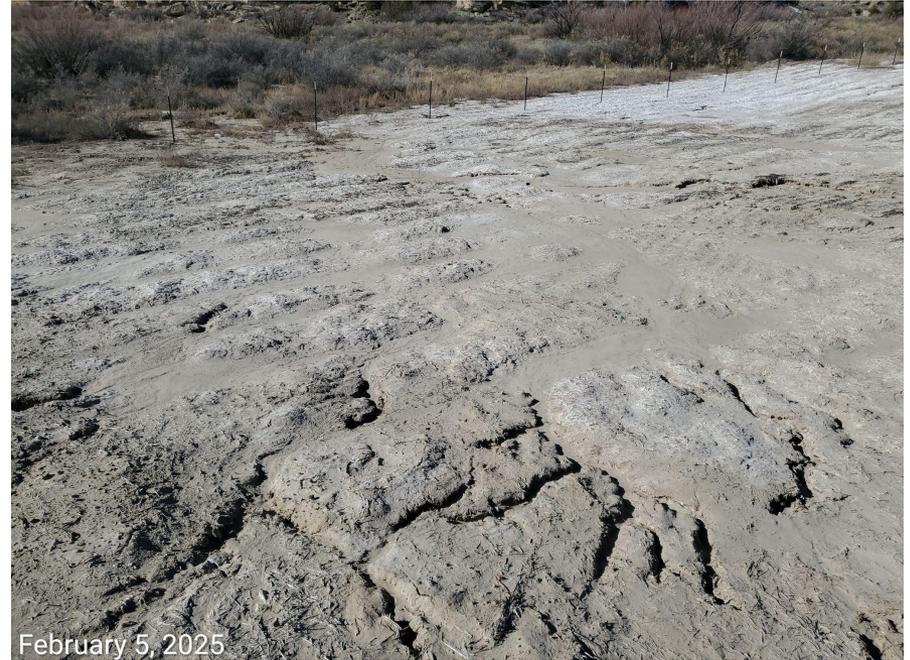
**Photo 11:** See comments under photo 9. Photos also show stormwater and erosion control BMPs are missing or insufficient; erosion, degradation and sediment transport evident.

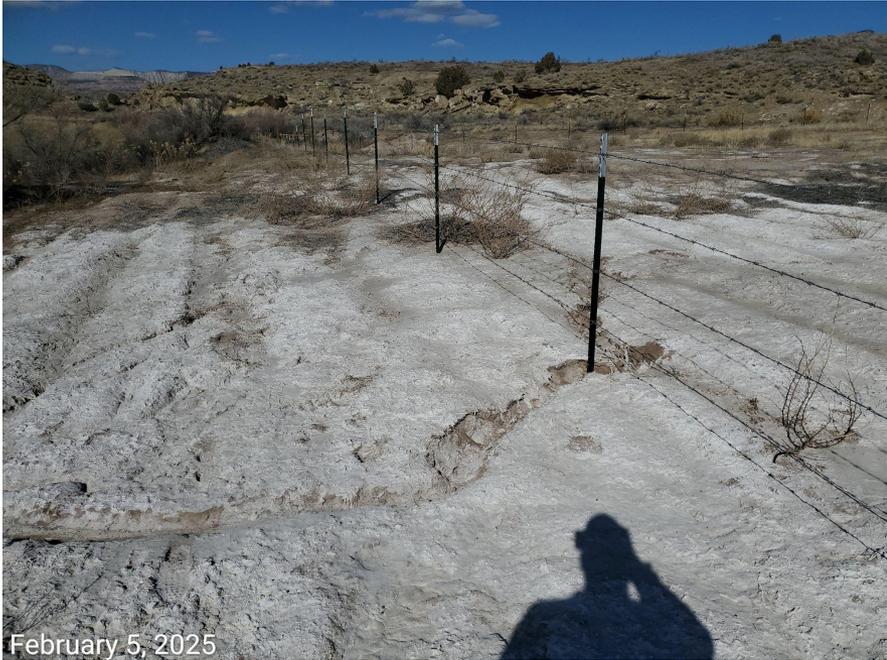
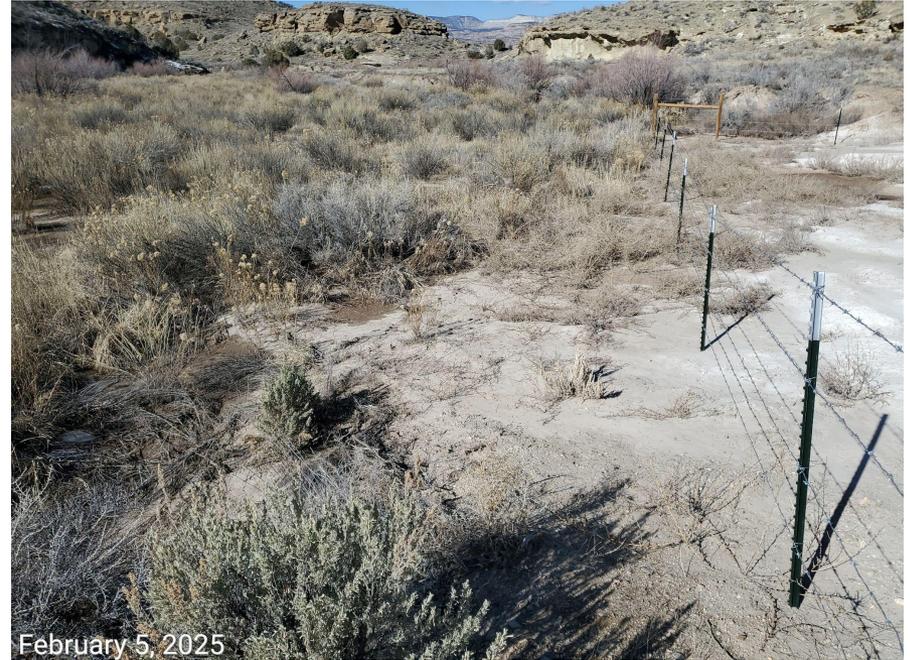
**Photo 12:** See comments under photo 9. Photos also show stormwater and erosion control BMPs are missing or insufficient; erosion, degradation and sediment transport evident.

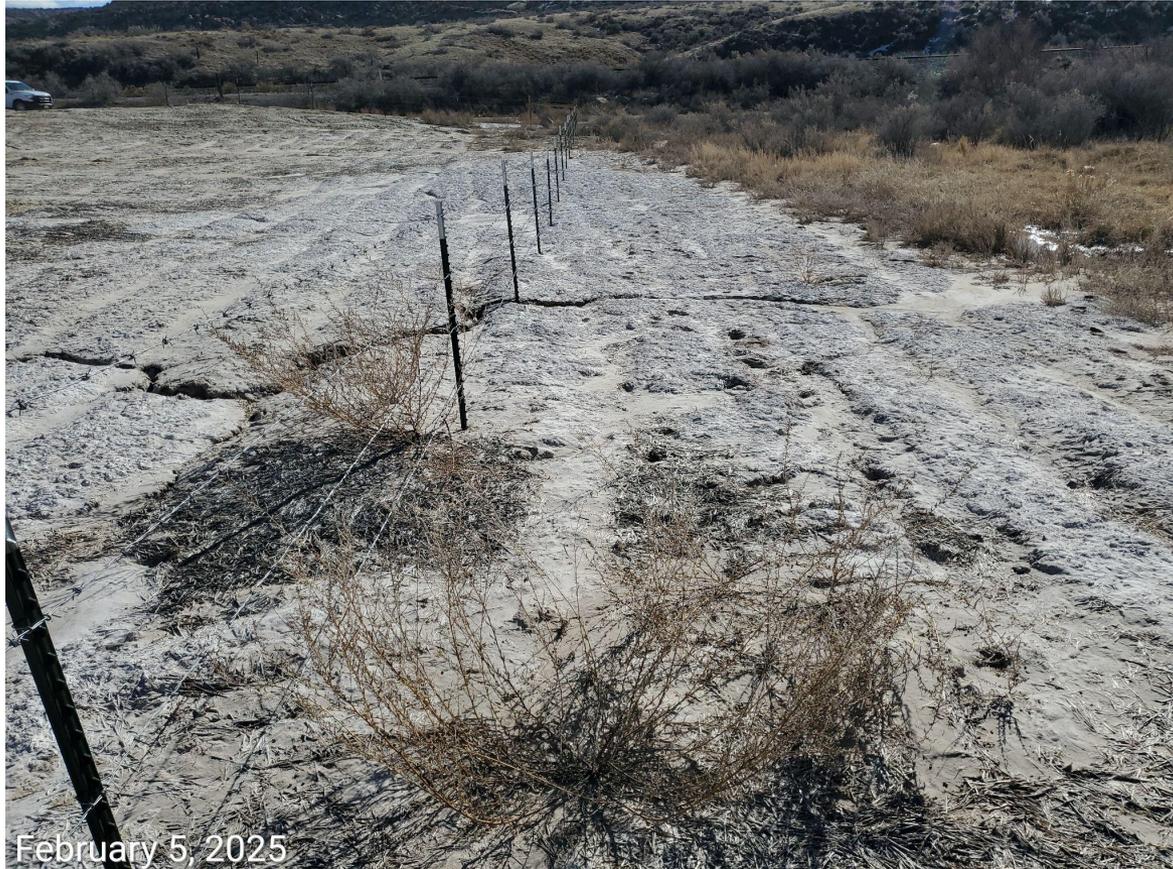
**Photo 13:** See comments under photo 9. Photos also show stormwater and erosion control BMPs are missing or insufficient; erosion, degradation and sediment transport evident.

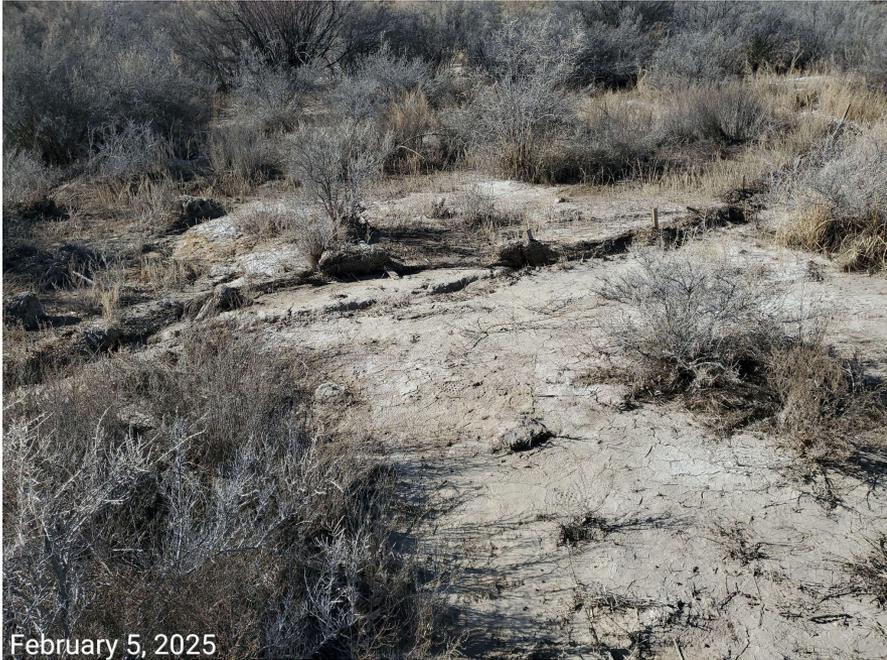
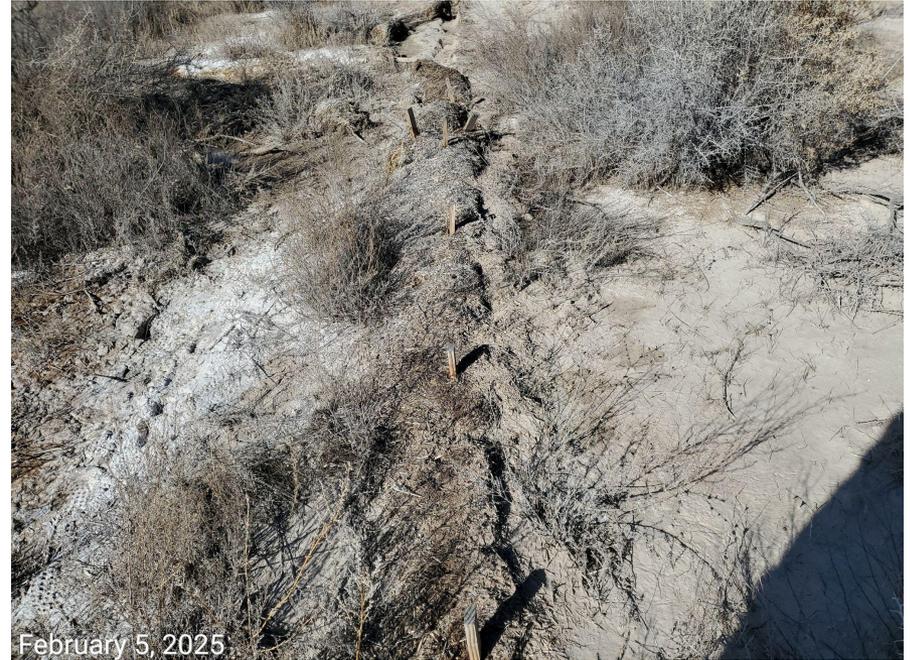
**Photo 14:** Photos taken from the southern perimeter of the Location. Photos examples showing erosion logs are no longer in proper functioning condition. Stormwater and erosion control BMPs are missing or insufficient; erosion, degradation and sediment transport evident.

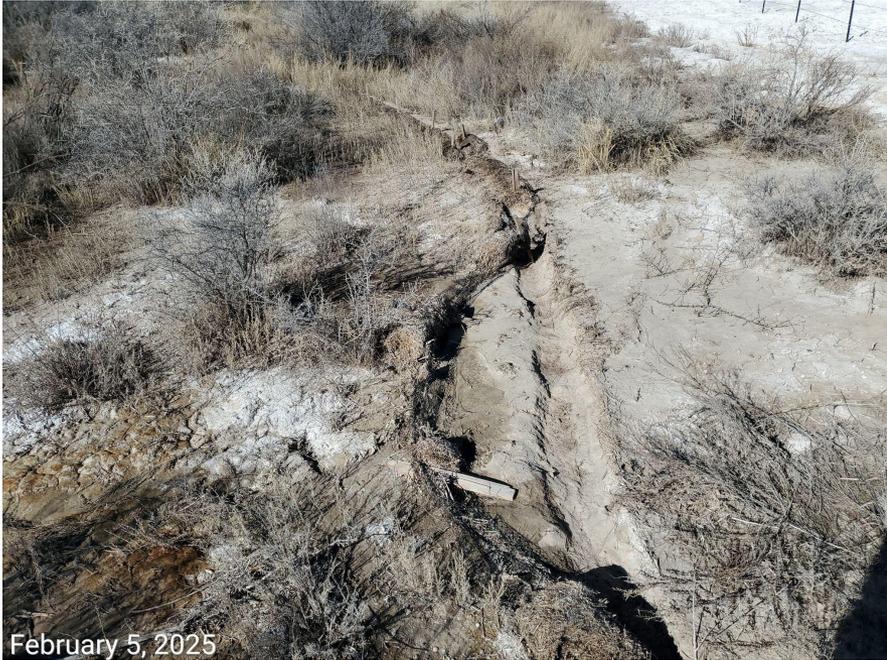
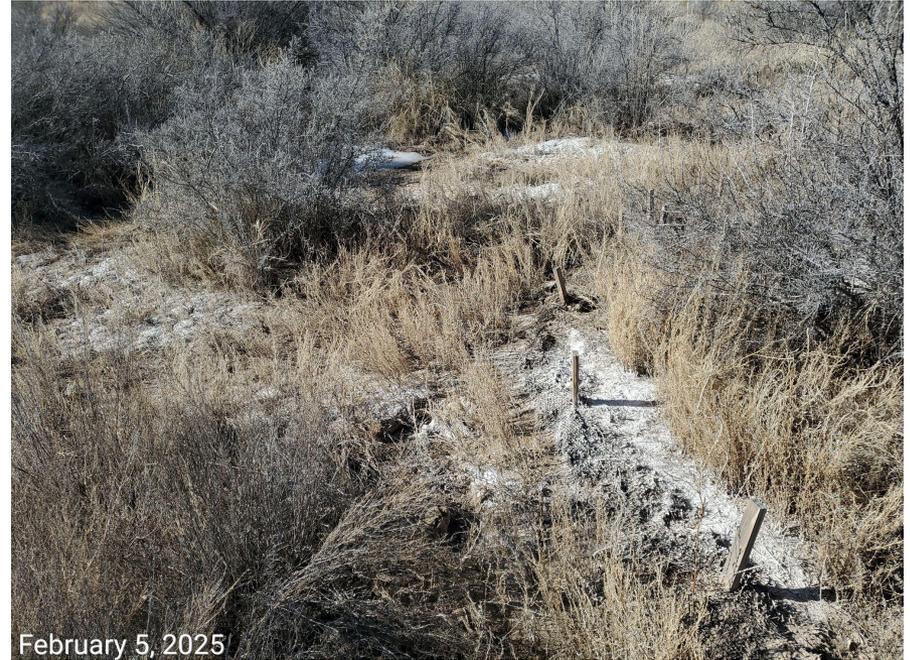
**Photo 15:** See comments under photo 14.

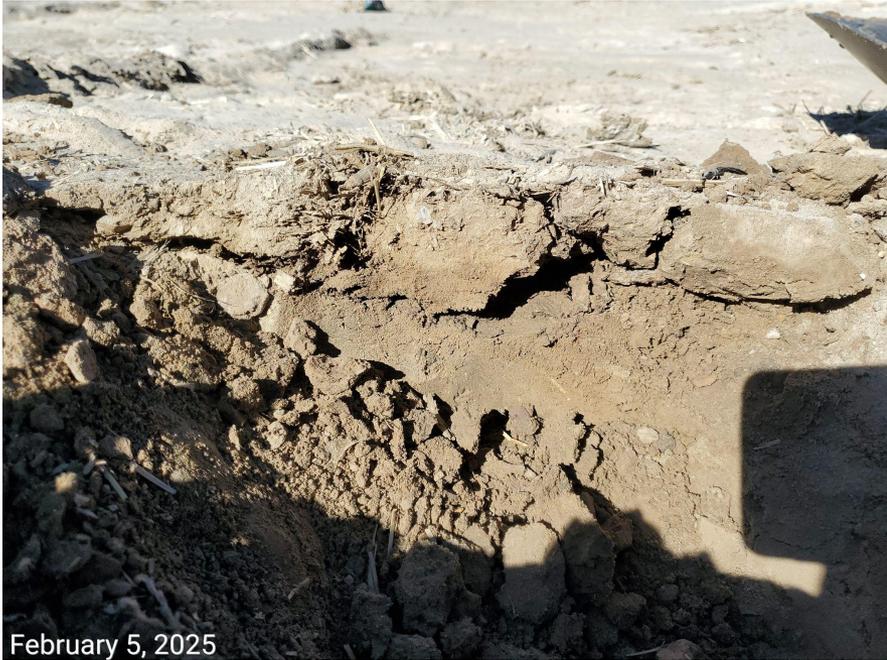
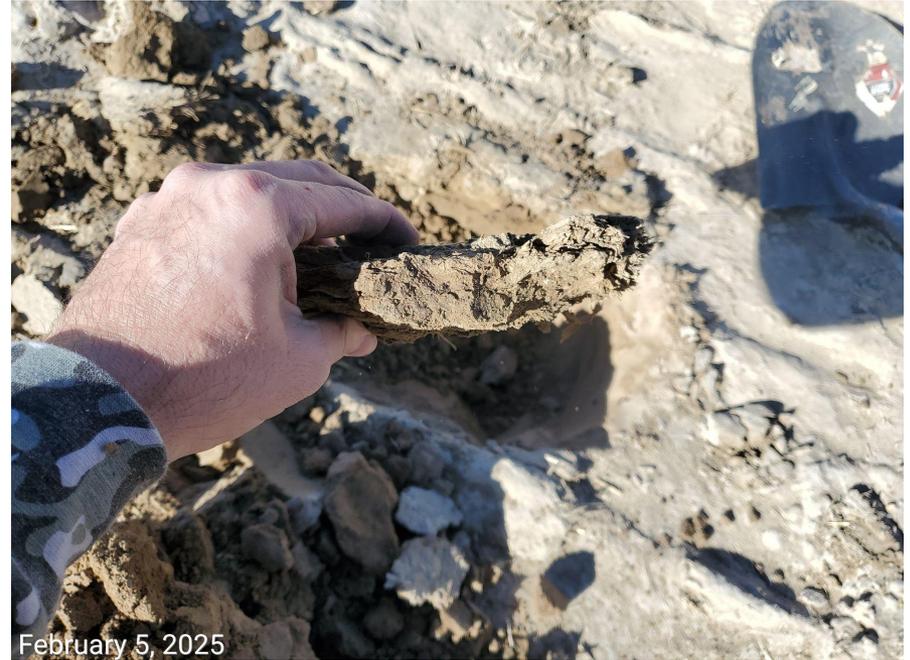
**Photo 16:** Photos taken from the southern areas of the Location; these areas appear to have been traveled over by equipment. Photo shows soils have within these areas have been compacted.

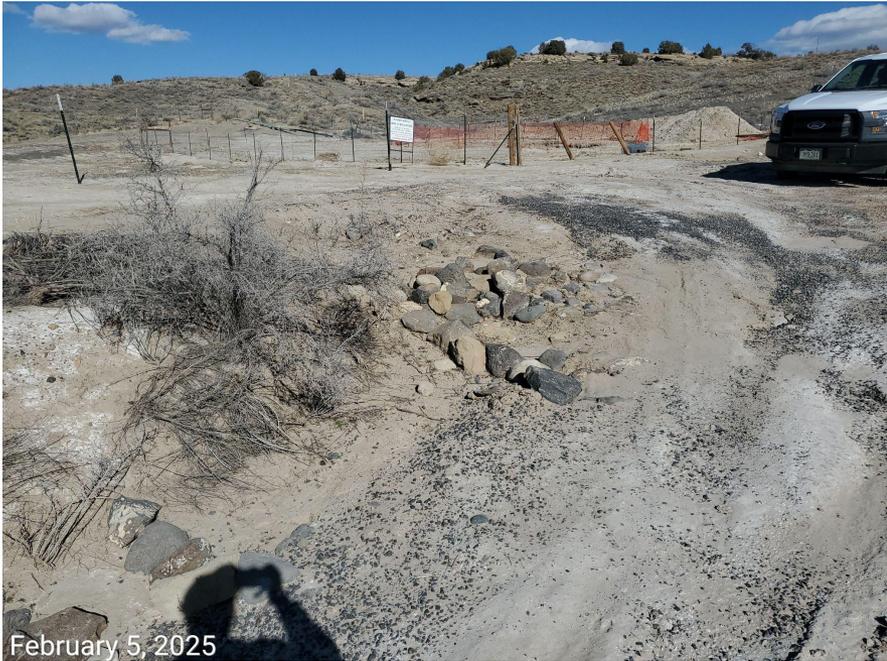
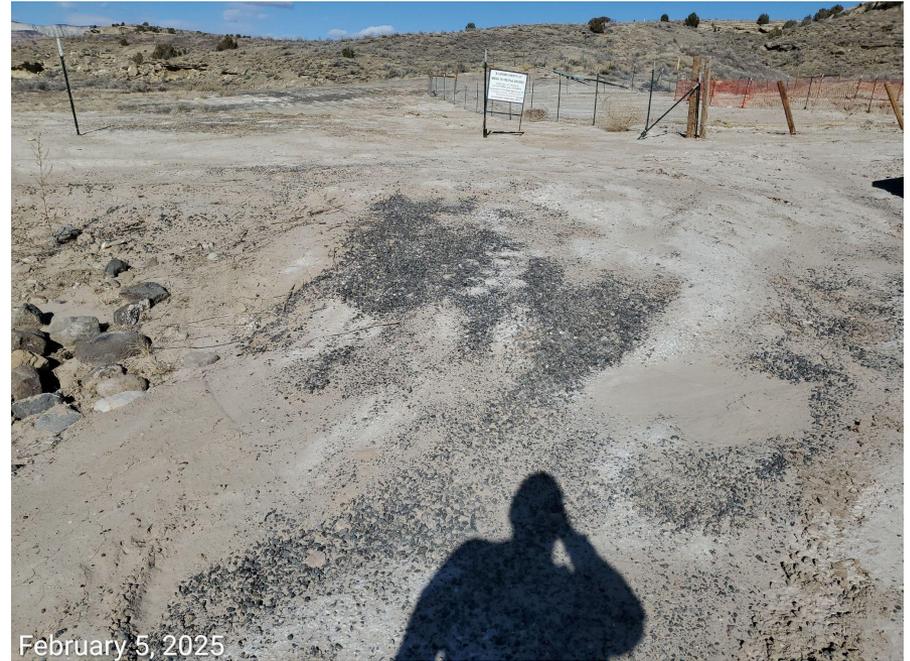
**Photo 17:** Photos taken from the Location entrance. Photos show these areas were not reclaimed during initial reclamation efforts.

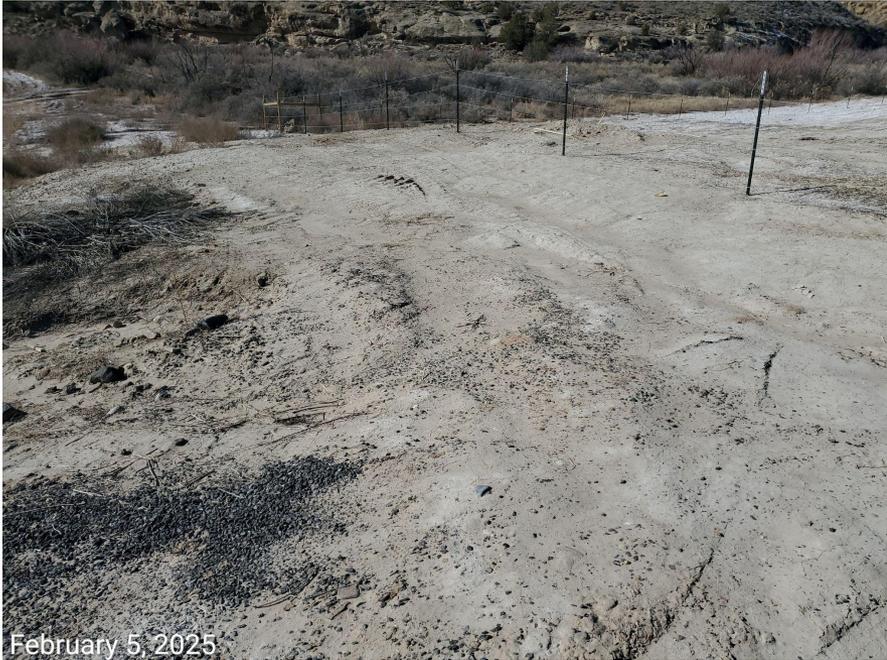
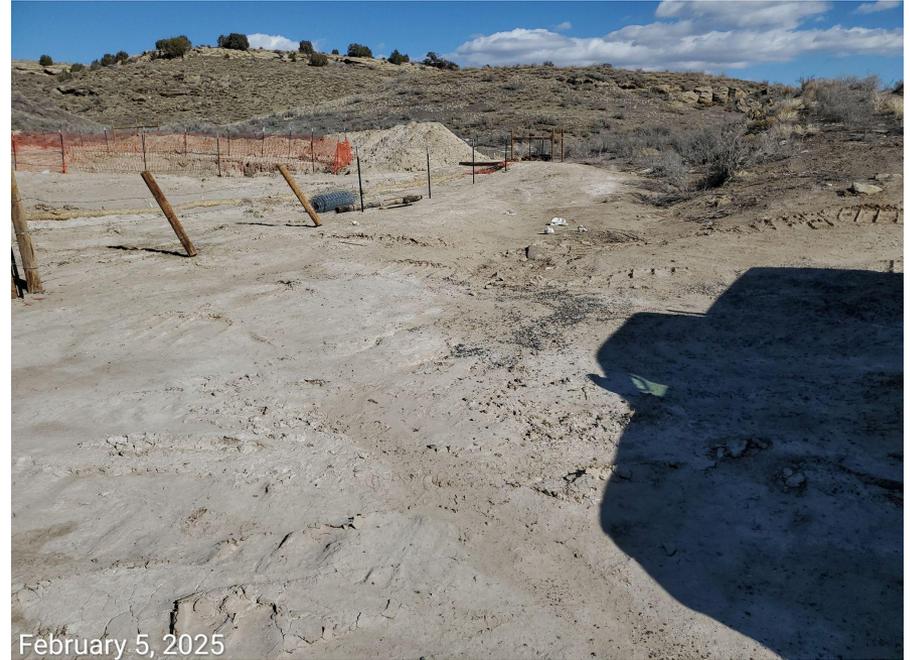
**Photo 18:** Photos taken from the location entrance, on the east end of the Location. These areas do not appear to have been included during initial reclamation efforts.
