FLOWLINE ABANDONMENT FORM

SITE NAME: Torres-USX AB 35-9							DATE: 11/15/2024	REM. PROJECT #: 35770	WEATHER: Cloudy 50s	
SITE DIRECTIONS: Cr 74 and 59, N .3 mi, W 1/10 into site area							CLIENT: Noble			
LEGALS AND LAT/LONG: 40.528050, -104.510100							TASMAN PERSONNEL: M. Reynolds, J. Basilotta			
SOIL TYPES: Well Graded Sand - SW							SURFACE GRADIENT:			
SOIL SAMPLING							FACILITY INFRASTRUCTURE			
Date/Time	Soil Sample ID	PID (ppm)	Visual	Olfactory	Photo?	Grab or Lab Sample?	EQUIPMENT	Quantity	Photo?	
							Above Ground Storage Tank (AST)			
11-15-2024 10:48	FL01-01@4'	0.0	No Staining	No Odor	Yes	Grab	Buried or Partially Buried Vessel			
11-15-2024 11:02	FL01-02@4'	0.0	No Staining	No Odor	Yes	Grab	Separator			
11-15-2024 11:58	FL01-03@4'	0.3	No Staining	No Odor	Yes	Lab	Emission Control Device (ECD)			
11-15-2024 12:09	FL01-04@4'	0.0	No Staining	No Odor	Yes	Grab	Dump Line			
11-15-2024 12:17	FL01-05@4'	0.1	No Staining	No Odor	Yes	Grab	Wellhead

TABLE 1
FIELD DATA SUMMARY TABLE
NOBLE ENERGY, INC. (100322)
TORRES USX AB35-09 FLOWLINE, WELD COUNTY, COLORADO
REM # 35770

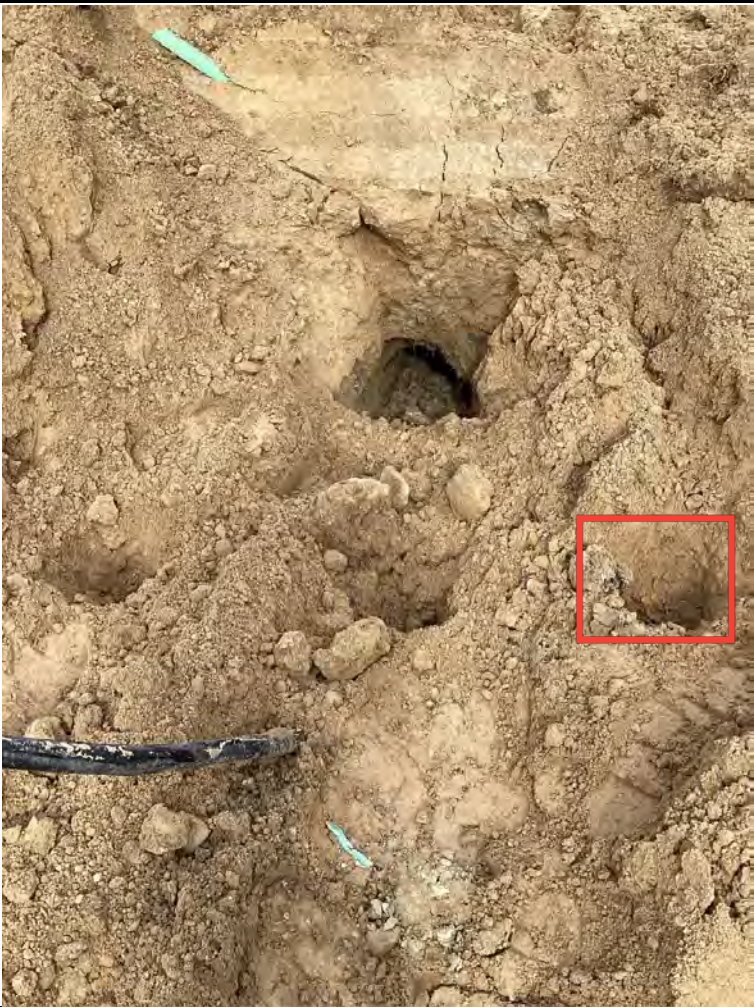
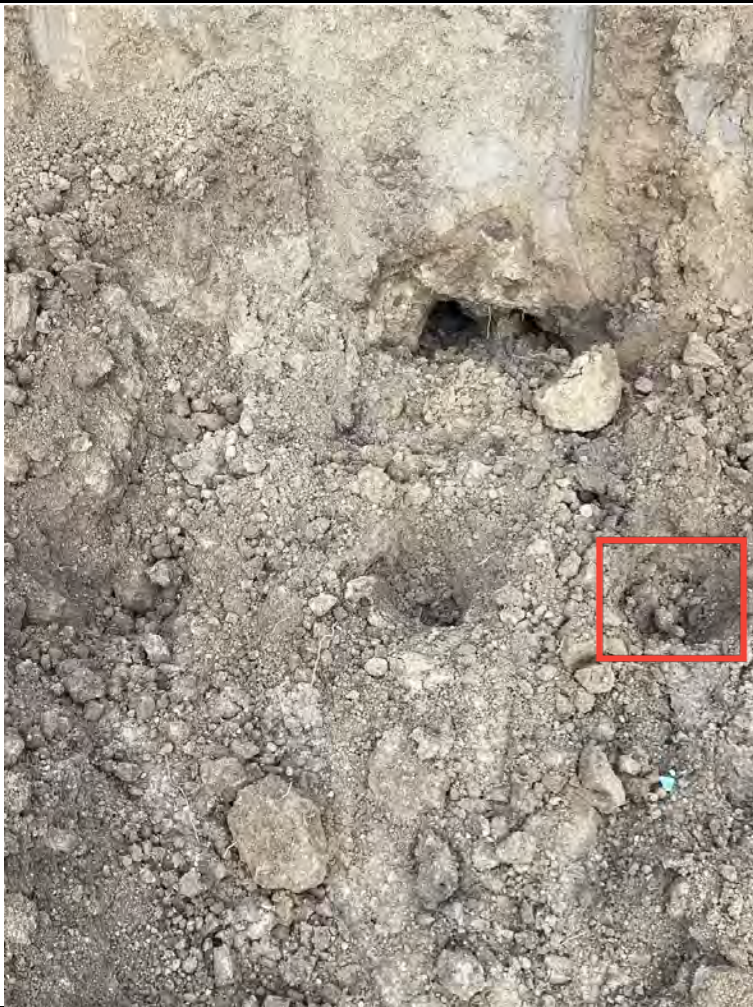
Equipment ID: FL01-01 @ 4'		Equipment Type: Flowline			
Material: Steel	Volume:	Contents: Oil/Gas/Water			
Notes/Conditions: Facing north

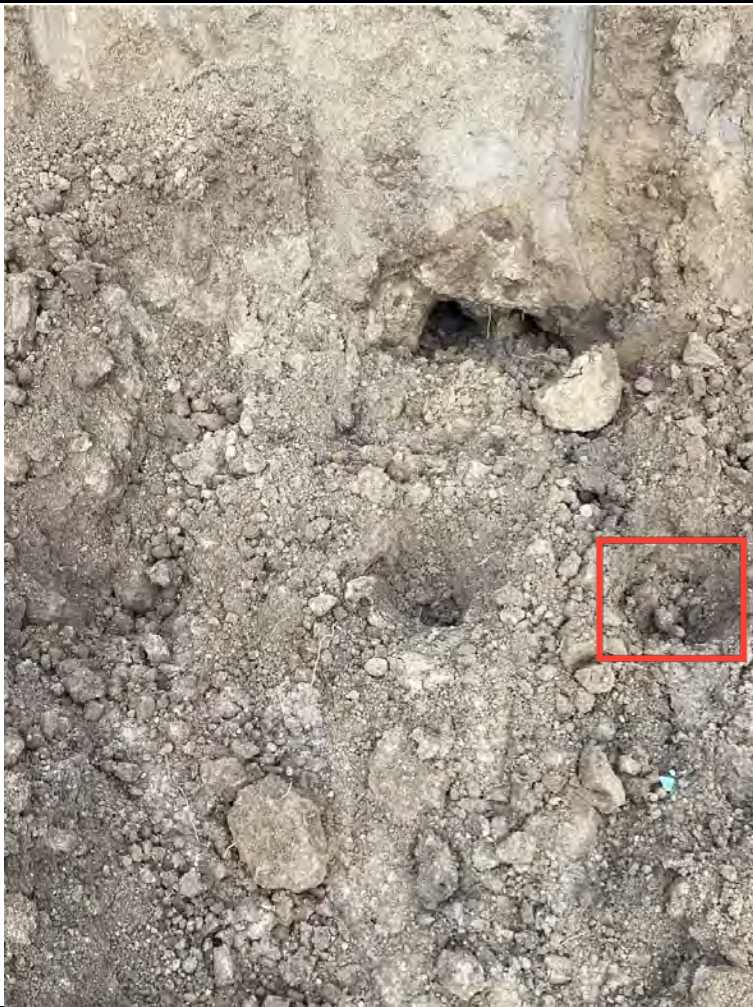
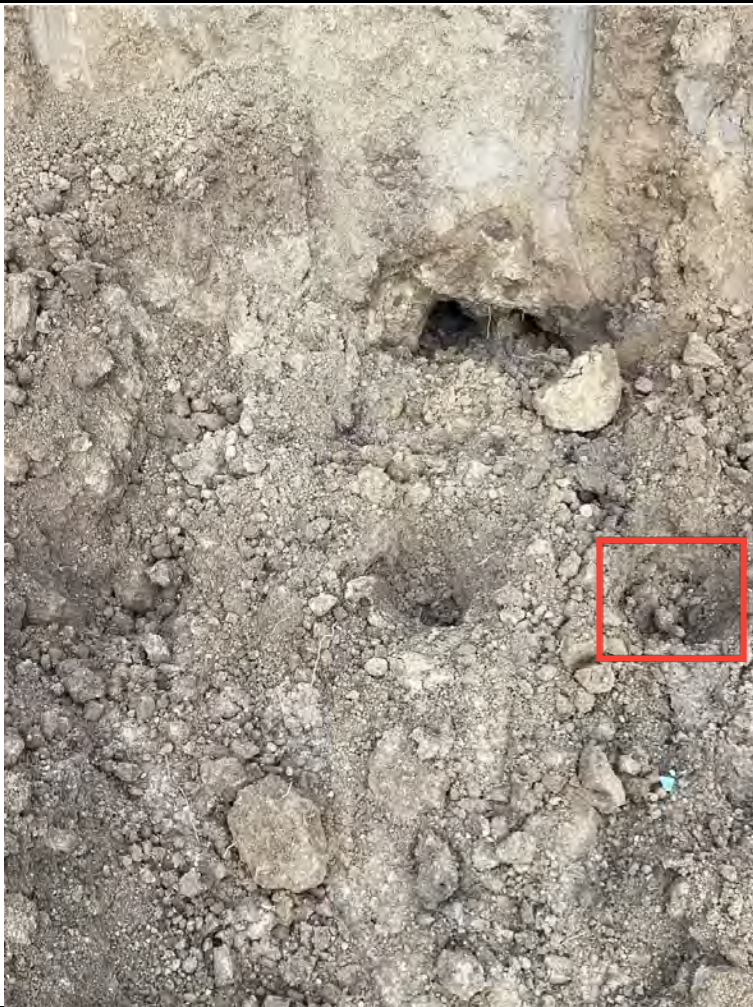
Equipment ID: FL01-02 @ 4'		Equipment Type: Flowline			
Material: Steel	Volume:	Contents: Oil/Gas/Water			
Notes/Conditions: Facing north

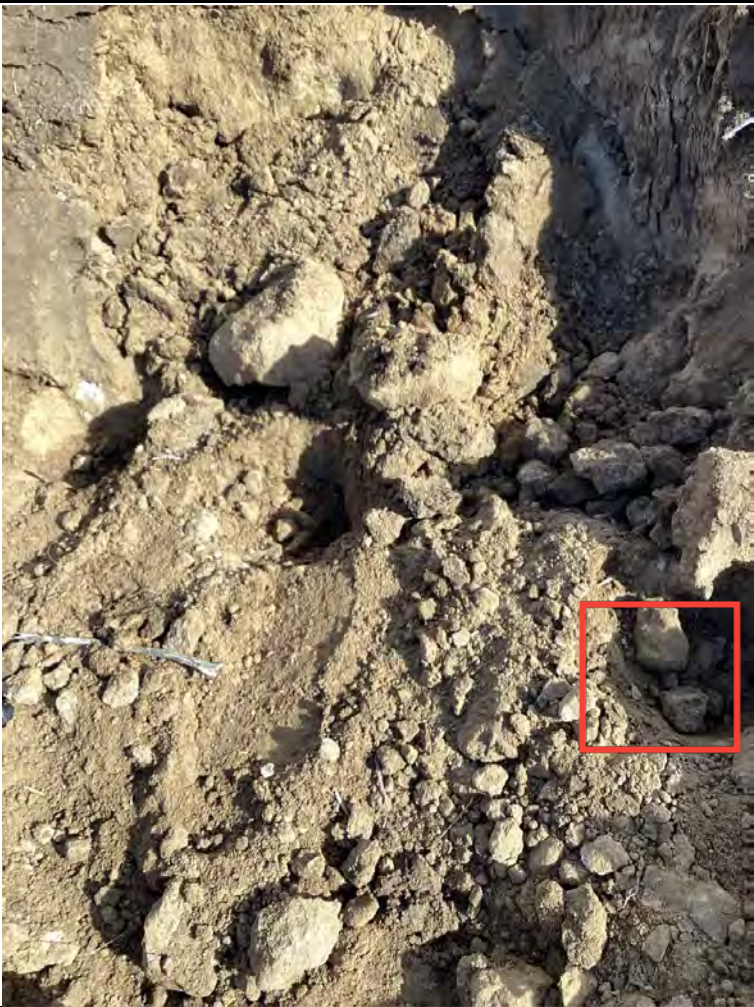
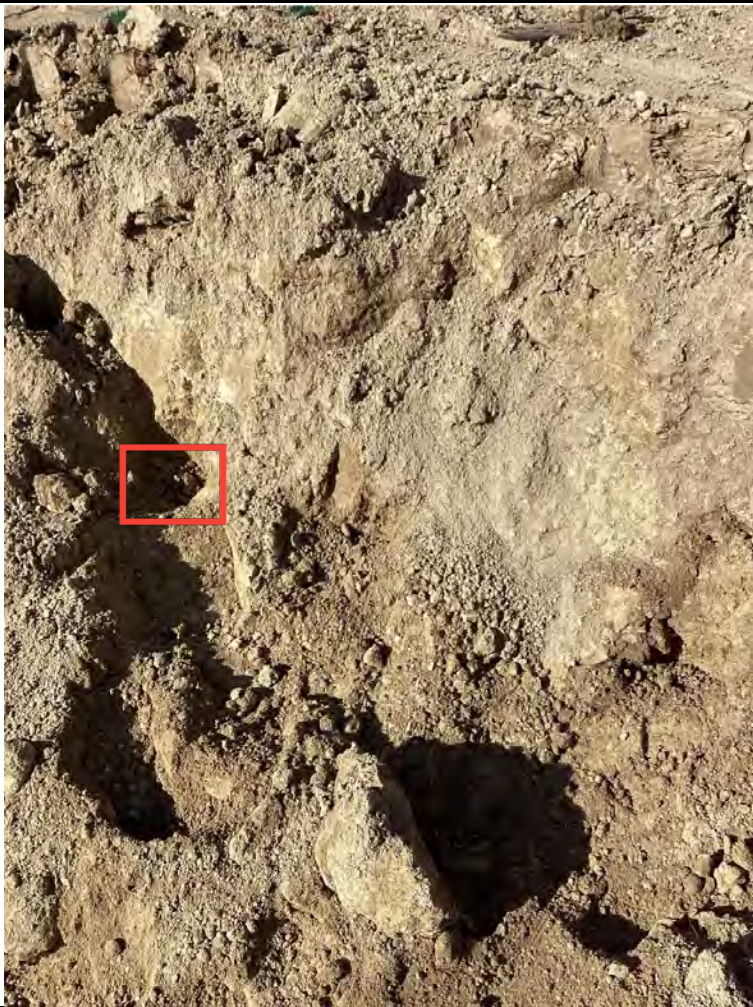
Equipment ID: FL01-05 @ 4'		Equipment Type: Flowline		Equipment ID: FL01-06 @ 4'	
Material: Steel	Volume:	Contents: Oil/Gas/Water	Material: Steel	Volume:	Contents: Oil/Gas/Water
Notes/Conditions: Facing east			Notes/Conditions: Facing north

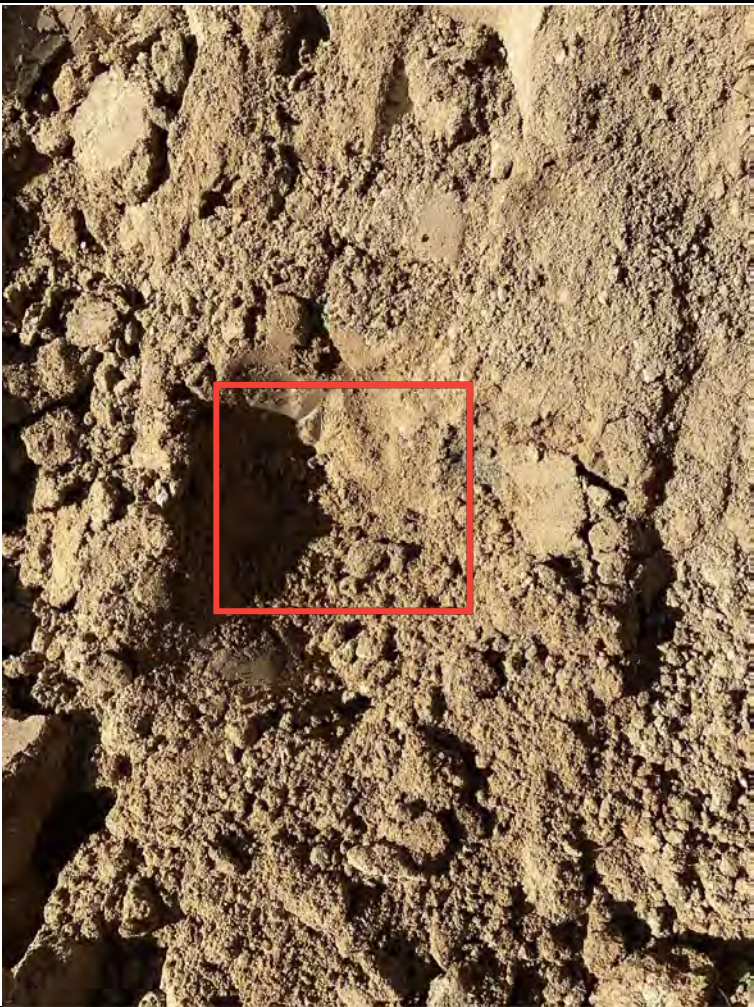
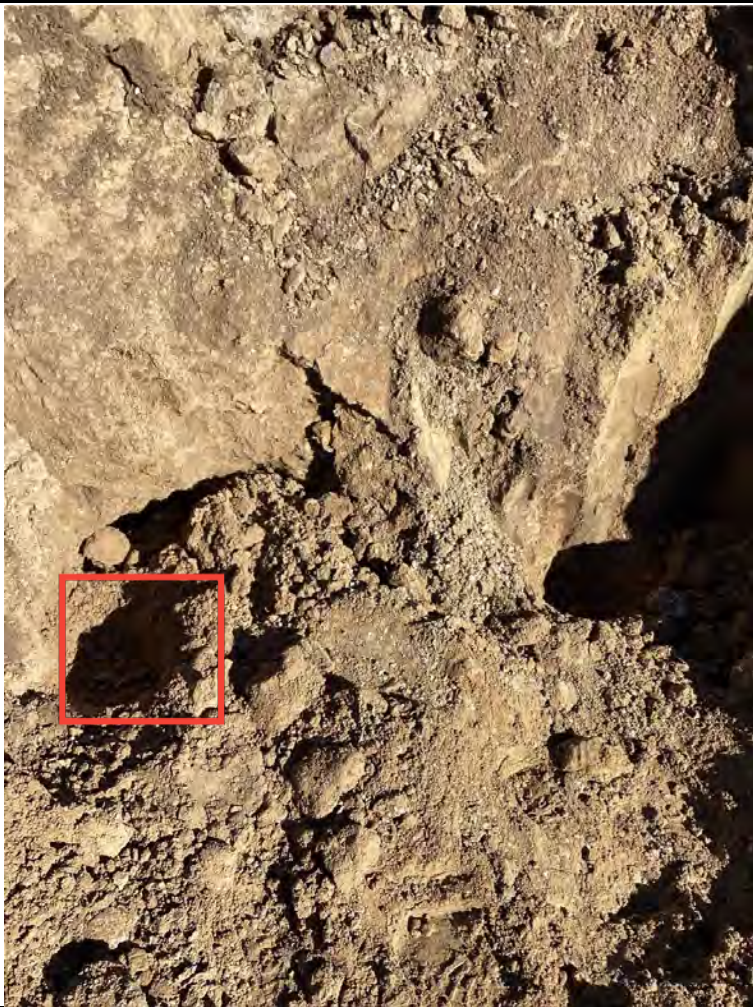
Equipment ID: FL01R-W@4'		Equipment Type: Flowline		Equipment ID: FL01-01@4'	
Material: Steel		Volume:	Contents: Oil/Gas/Water	Material: Steel	
Notes/Conditions: Facing north				Notes/Conditions: Facing east

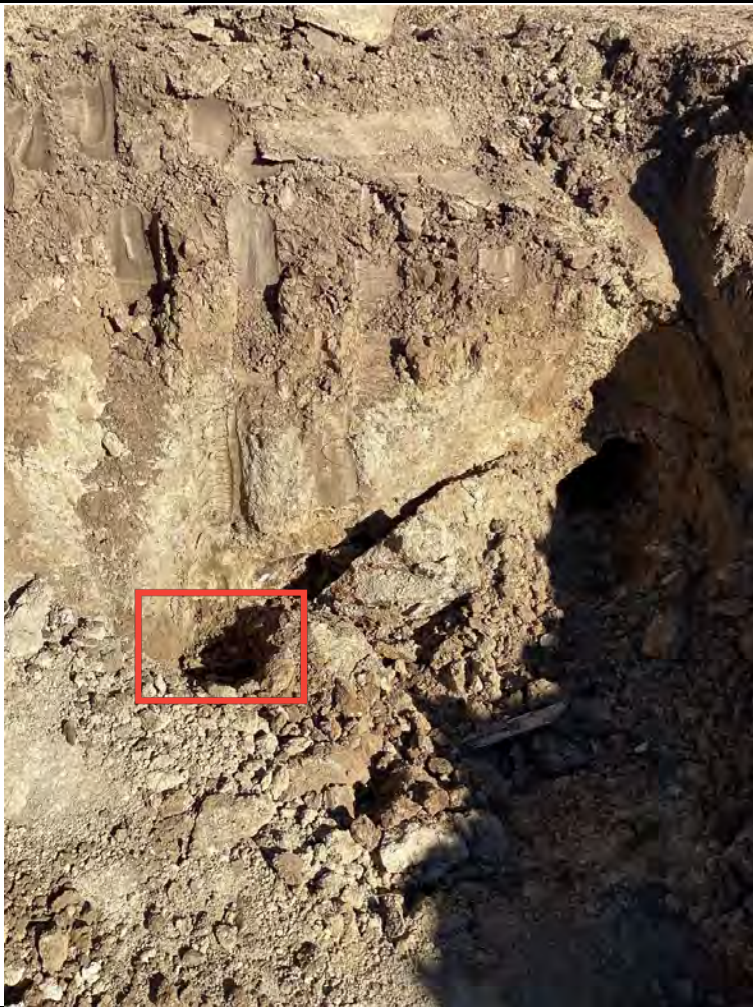
Equipment ID: FL01-02 @ 4'		Equipment Type: Flowline			
Material: Steel	Volume:	Contents: Oil/Gas/Water			
Notes/Conditions: Facing east

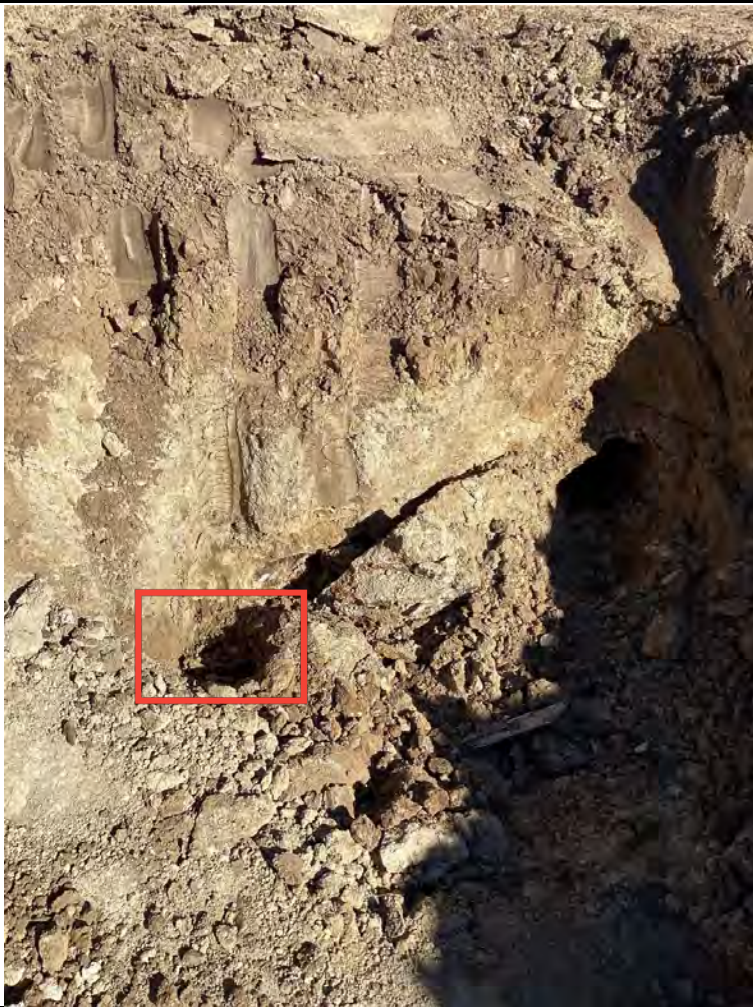
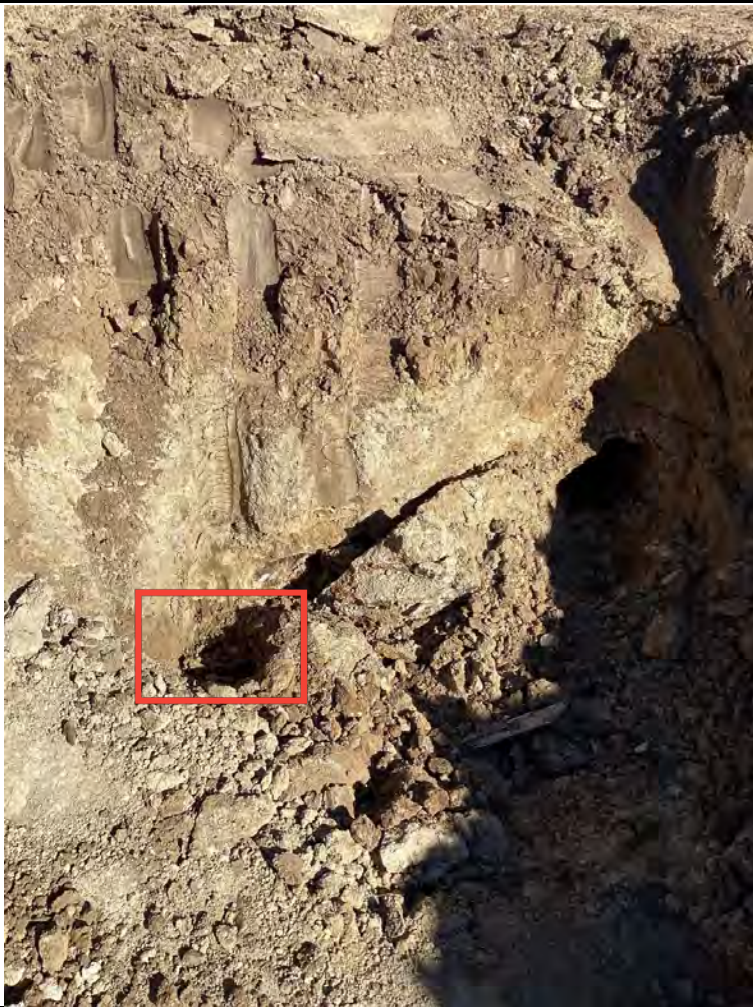
Equipment ID: FL01-03 @ 4'		Equipment Type: Flowline			
Material: Steel	Volume:	Contents: Oil/Gas/Water			
Notes/Conditions: Facing east

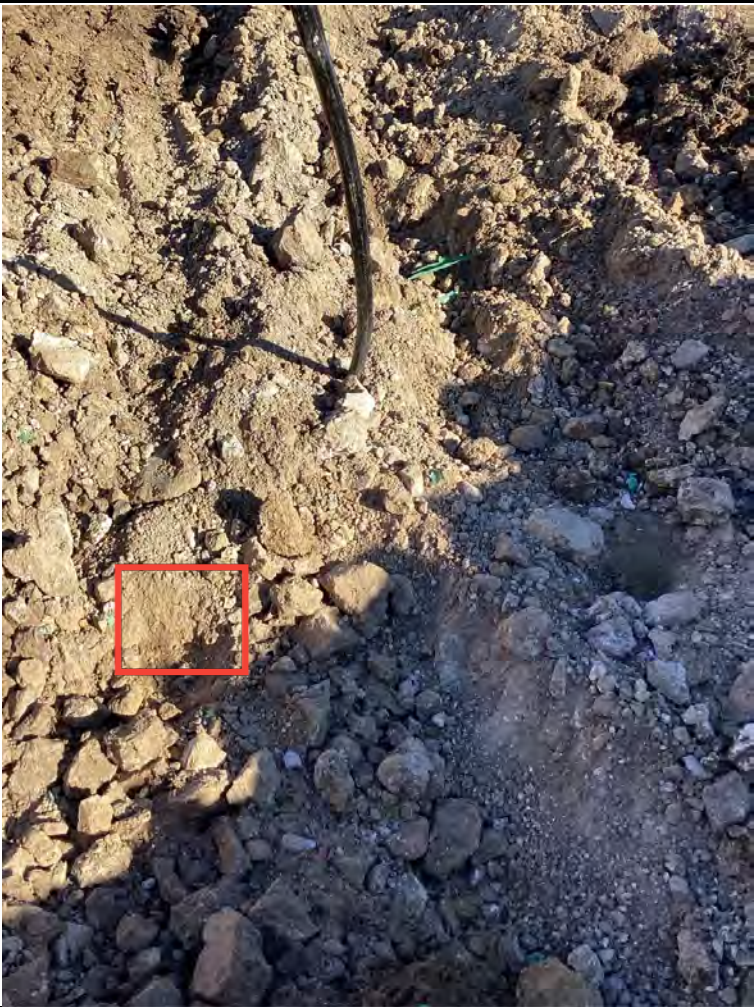
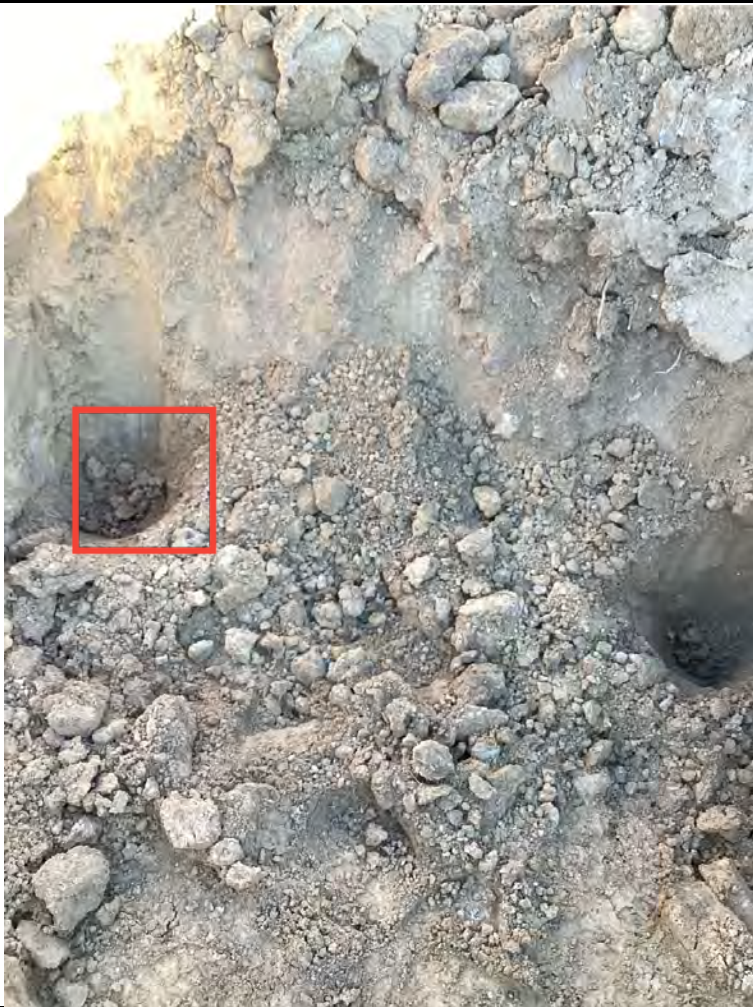
Equipment ID: FL01-04 @ 4'		Equipment Type: Flowline		Equipment ID: FL01-05 @ 4'		Equipment Type: Flowline	
Material: Steel		Volume:		Contents: Oil/Gas/Water		Material: Steel	
Volume:		Contents: Oil/Gas/Water		Material: Steel		Volume:	
Notes/Conditions: Facing east				Notes/Conditions: Facing east

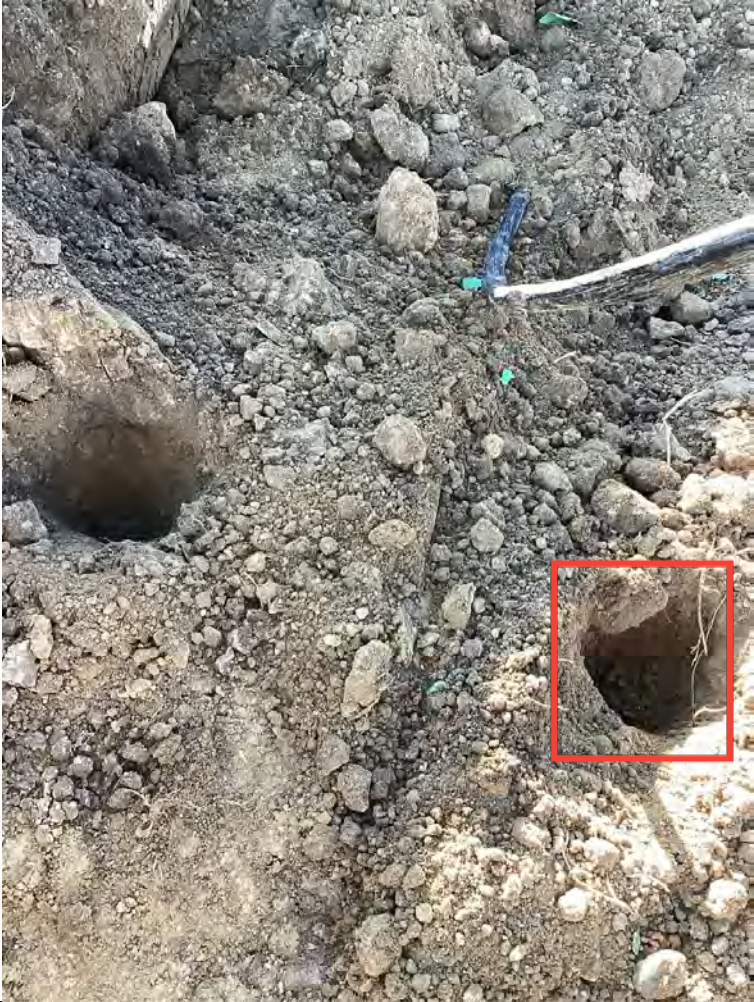
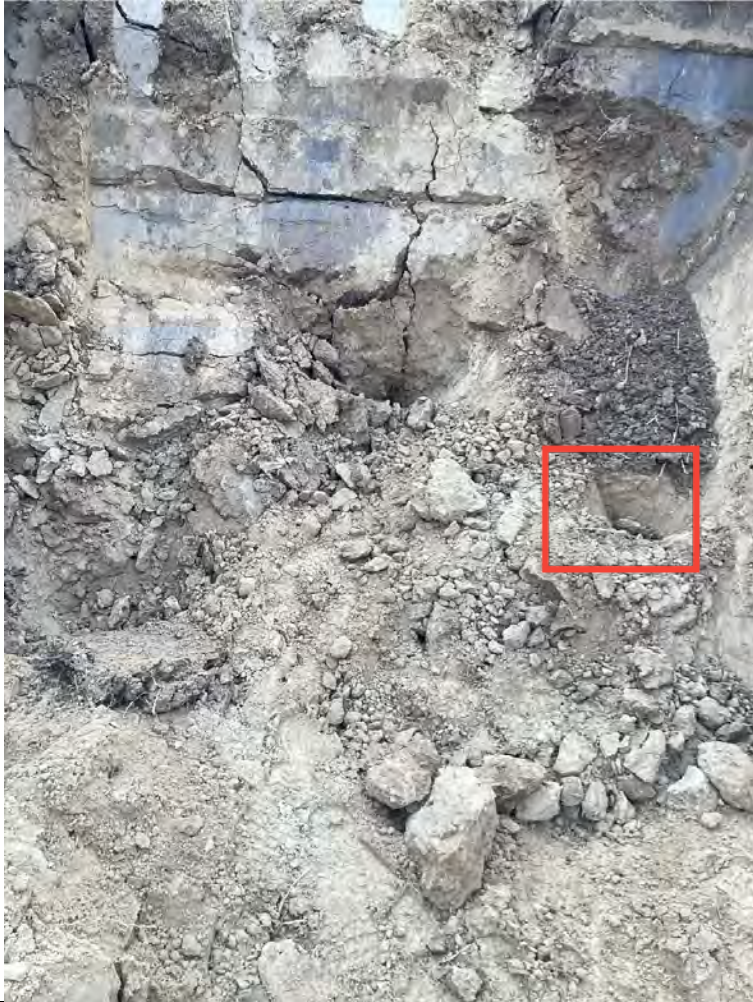
Equipment ID: FL01-06 @ 4'		Equipment Type: Flowline		Equipment ID: FL01-07 @ 4'	
Material: Steel		Volume:	Contents: Oil/Gas/Water	Material: Steel	
Notes/Conditions: Facing west				Notes/Conditions: Facing south

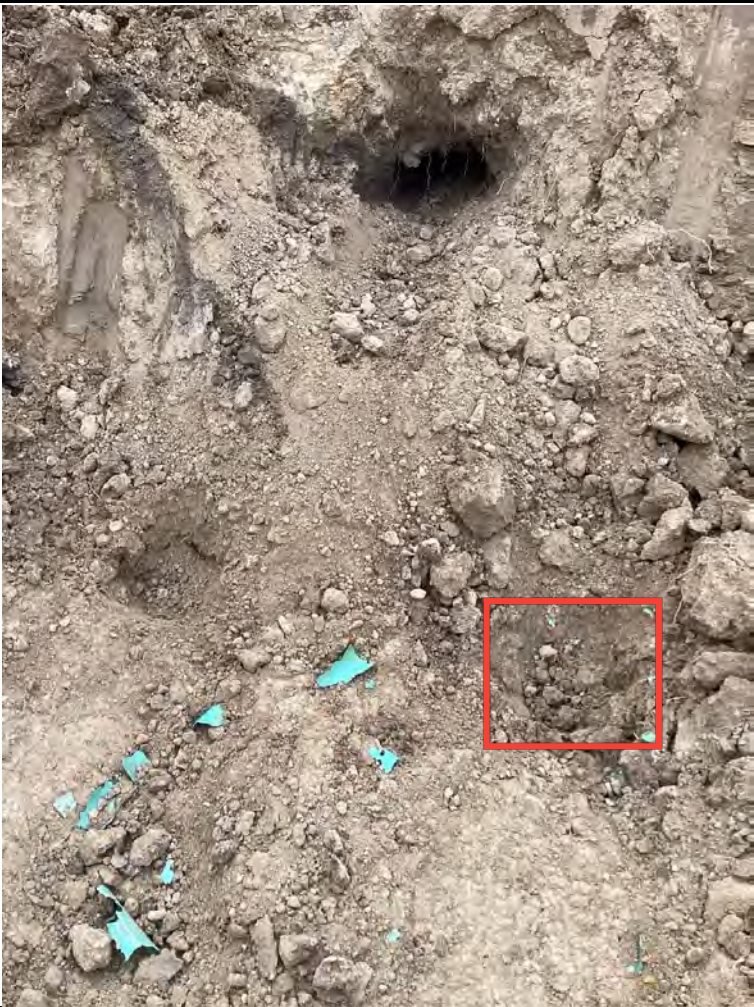
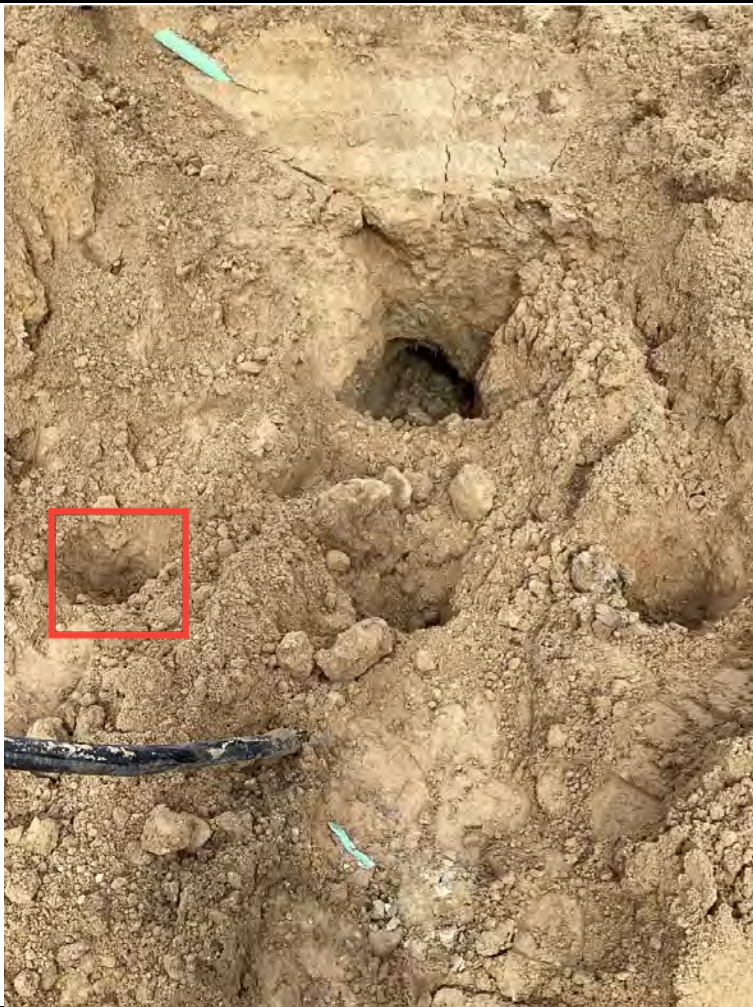
Equipment ID: FL01-08 @ 4'		Equipment Type: Flowline		Equipment ID: FL01-09 @ 4'	
Material: Steel	Volume:	Contents: Oil/Gas/Water	Material: Steel	Volume:	Contents: Oil/Gas/Water
Notes/Conditions: Facing south			Notes/Conditions: Facing north

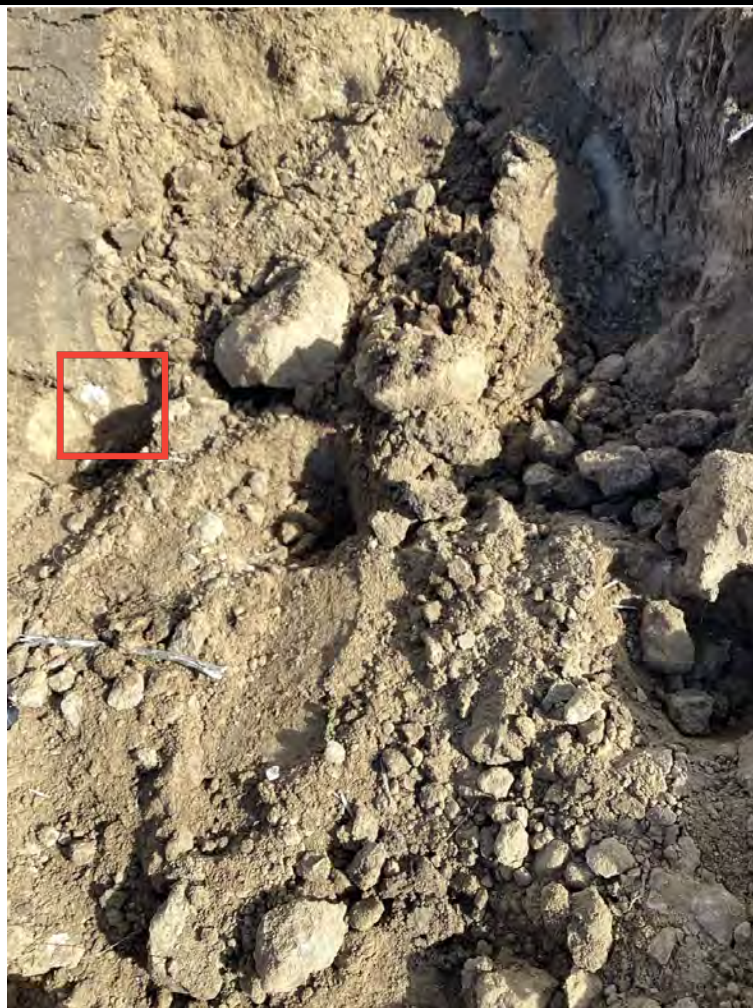
Equipment ID: FL01-12@4'		Equipment Type: Flowline		Equipment ID: FL01-13@4'		Equipment Type: Flowline					
Material: Steel		Volume:		Contents: Oil/Gas/Water		Material: Steel		Volume:		Contents: Oil/Gas/Water	
Notes/Conditions: Facing west						Notes/Conditions: Facing east

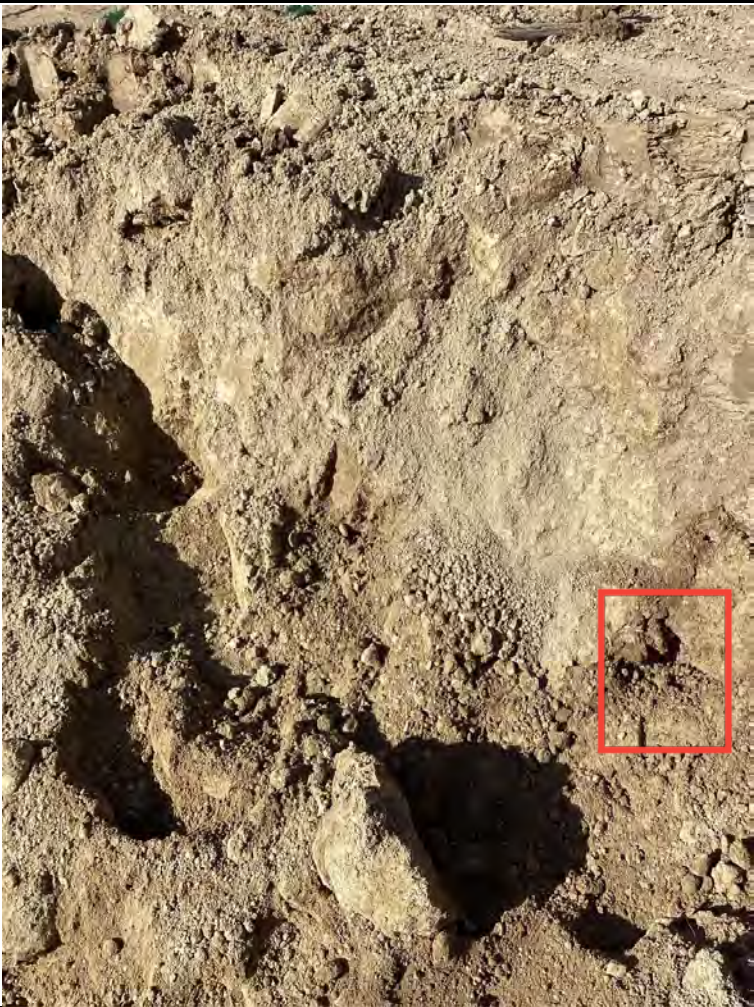
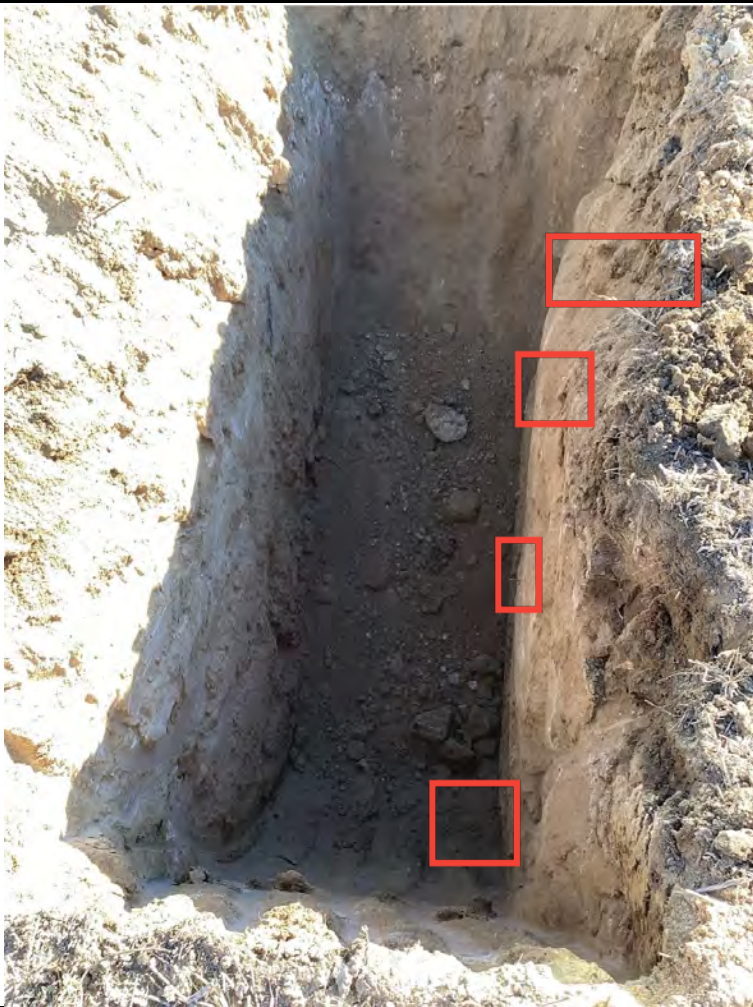
Equipment ID: FL01-14 @ 4'		Equipment Type: Flowline		Equipment ID: BKG01	
Material: Steel	Volume:	Contents: Oil/Gas/Water		Material:	Volume:
Notes/Conditions: Facing north			Notes/Conditions: Facing south Top to bottom - @ 0-1', 2.5', 4', 6' Lithology - SW, well graded sand with silt, light tan, medium, f-mg, dry, no staining, no odor

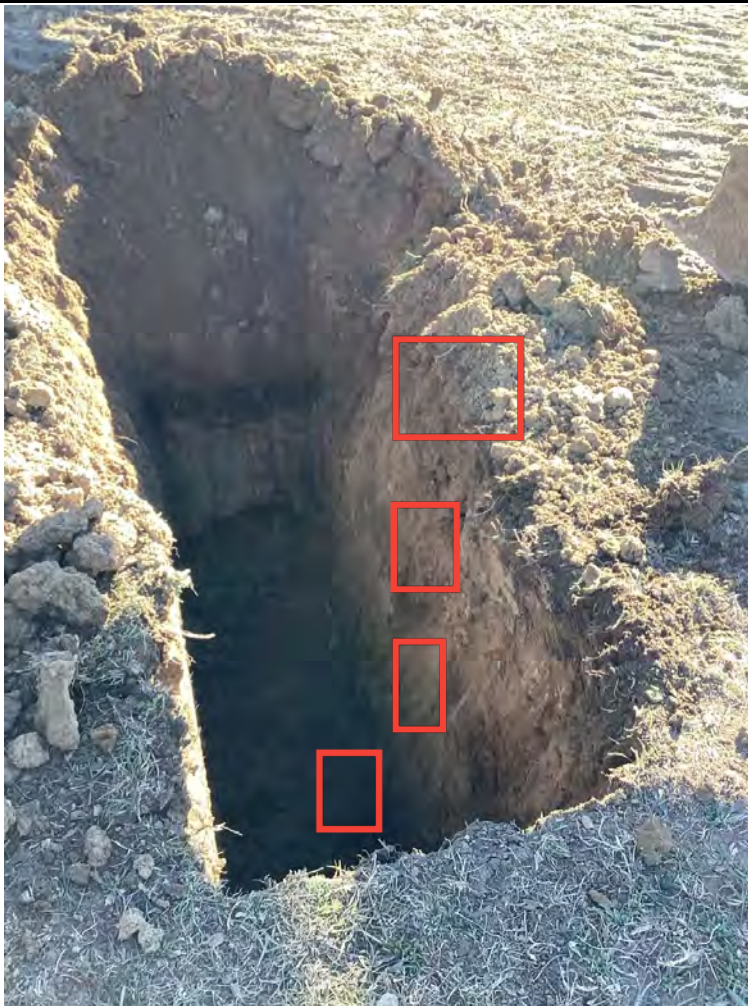
Equipment ID:BKG02

Notes/Conditions: Facing south
Top to bottom - @0-1', 2.5', 4', 6'
Lithology - SW, well graded sand, medium, brown, f-mg, dry-moist, no staining, no odor

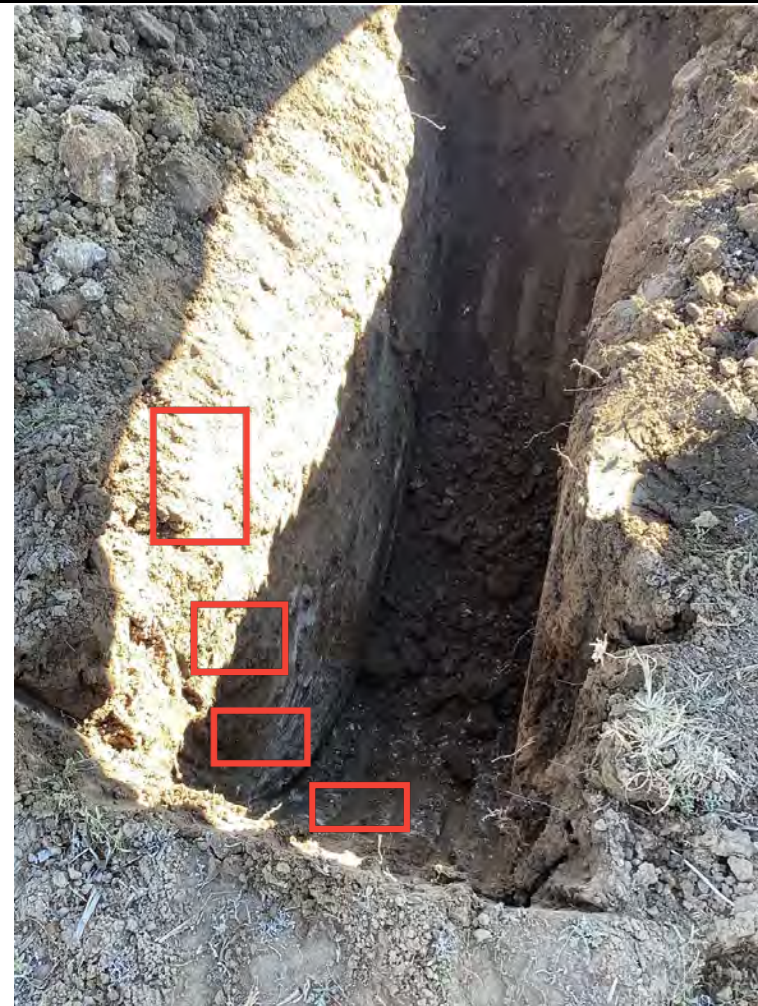
Equipment ID:BKG03

Notes/Conditions: Facing south
Top to bottom - @0-1', 2.5', 4', 6'
Lithology - SW, well graded sand with silt, medium, brown, dry, f-mg, no staining, no odor

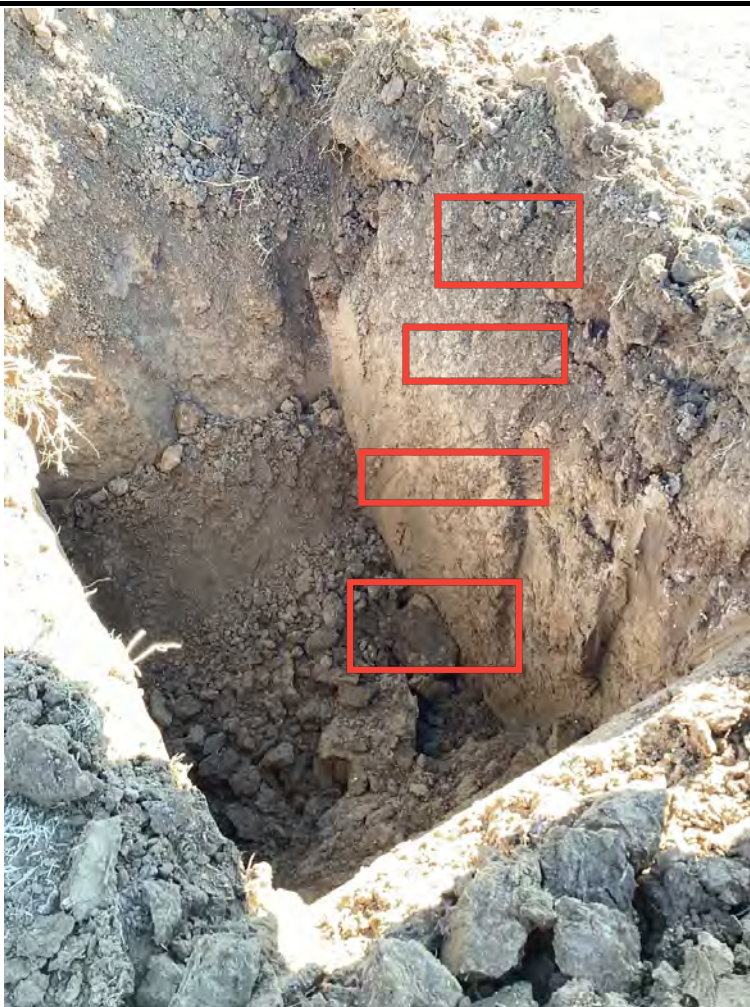
Equipment ID:BKG04

Equipment Type:
Material:
Volume:
Contents:
Notes/Conditions: Facing south
Top to bottom - @2.5', 4', 6', 8
Lithology - SW, well graded sand, medium, light tan, f-mg, dry, no staining, no odor

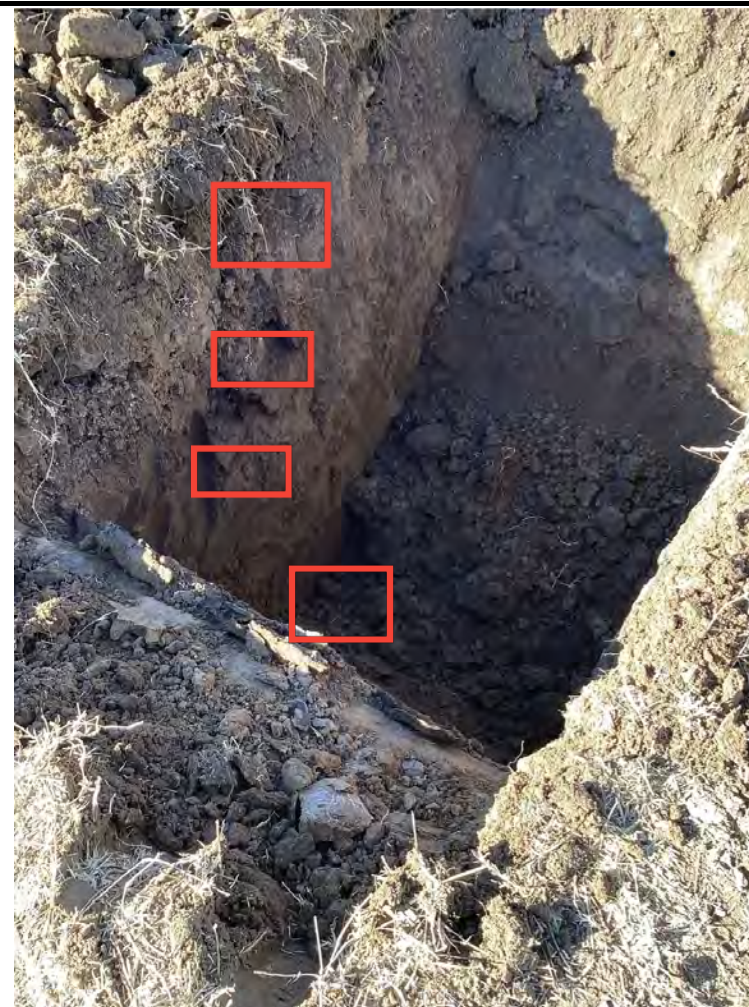
Equipment ID:BKG05

Equipment Type:
Material:
Volume:
Contents:
Notes/Conditions: Facing north
Top to bottom - @2.5', 4', 6', 8
Lithology - SW, well graded sand, brown, medium, f-mg, moist, no staining, no odor
