Final Reclamation Complete Notice – Cropland Drone Imagery Addendum

PERMIT CLOSURE REPORT – CROPLAND

Location ID 448568

Location Name Bliss 10-33 TB Loc./

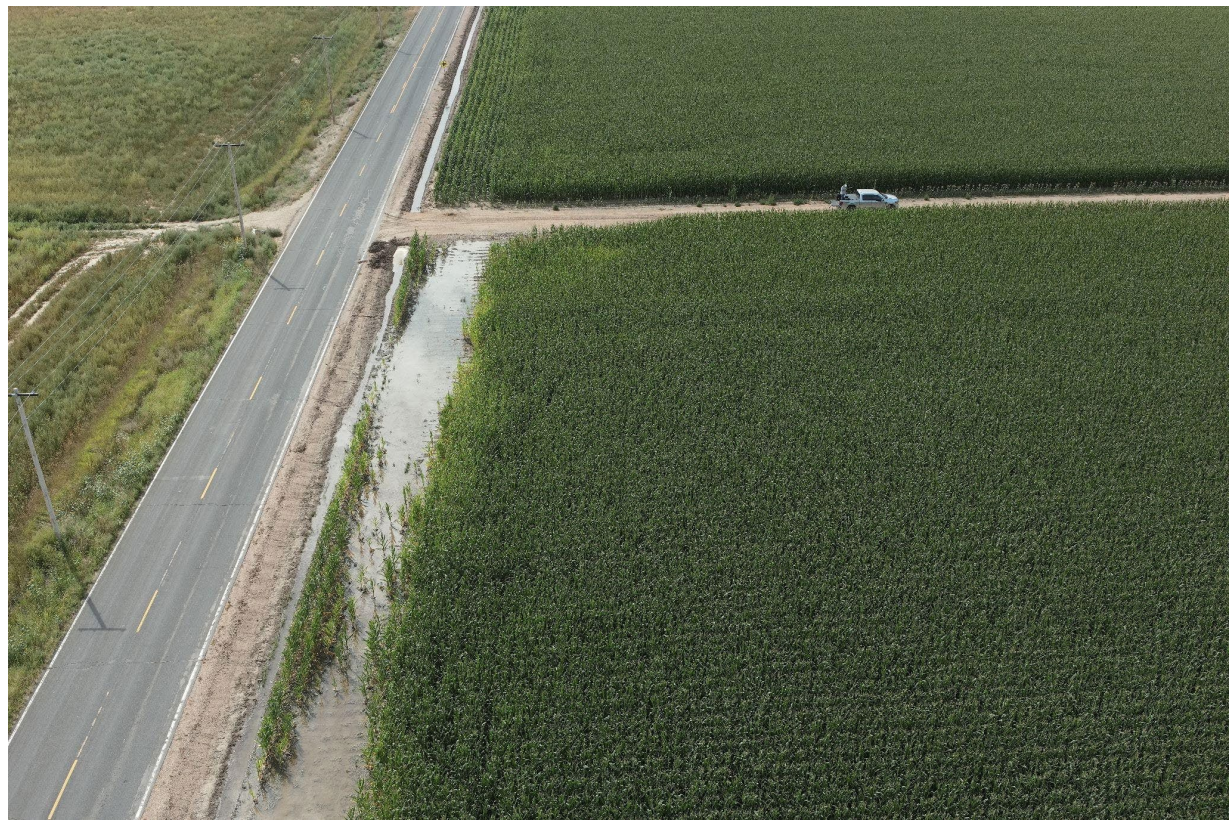
August 2023 Drone Photo - Facing West

The west-facing drone image from August 2023 shows a ditch running along the road, with the eastern section of the field inundated with irrigation water, while the area west of the road remains relatively dry. Additionally, the location of the ponded water aligns with the extent of the former oil and gas disturbance extent. However, this is a correlation rather than an indication of causation related to past oil and gas activities. Our observation also indicates the water in the road ditch flows from west to east.

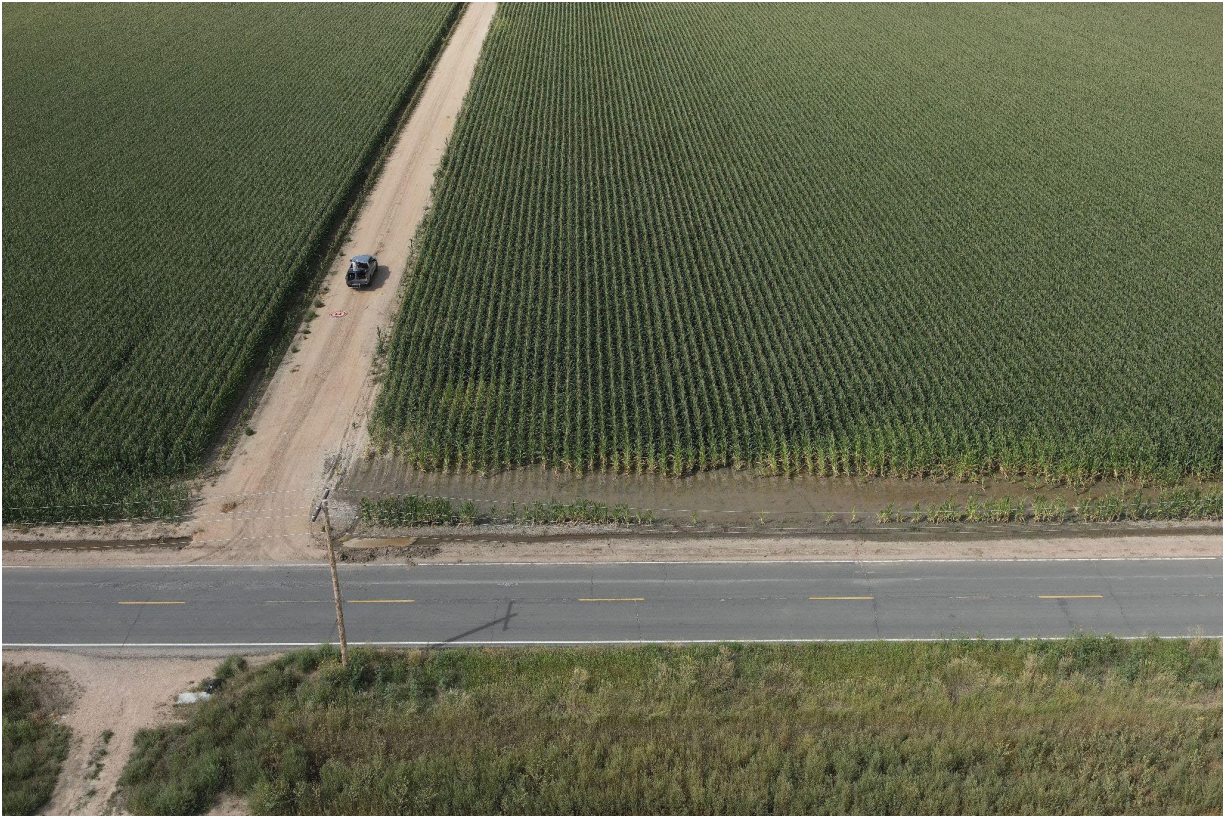
August 2023 Drone Photo - Facing North

The north-facing drone image from August 2023 shows ponded water, along with stunted and yellowing corn, extending along the county road and beyond the boundaries of the former oil and gas disturbance.

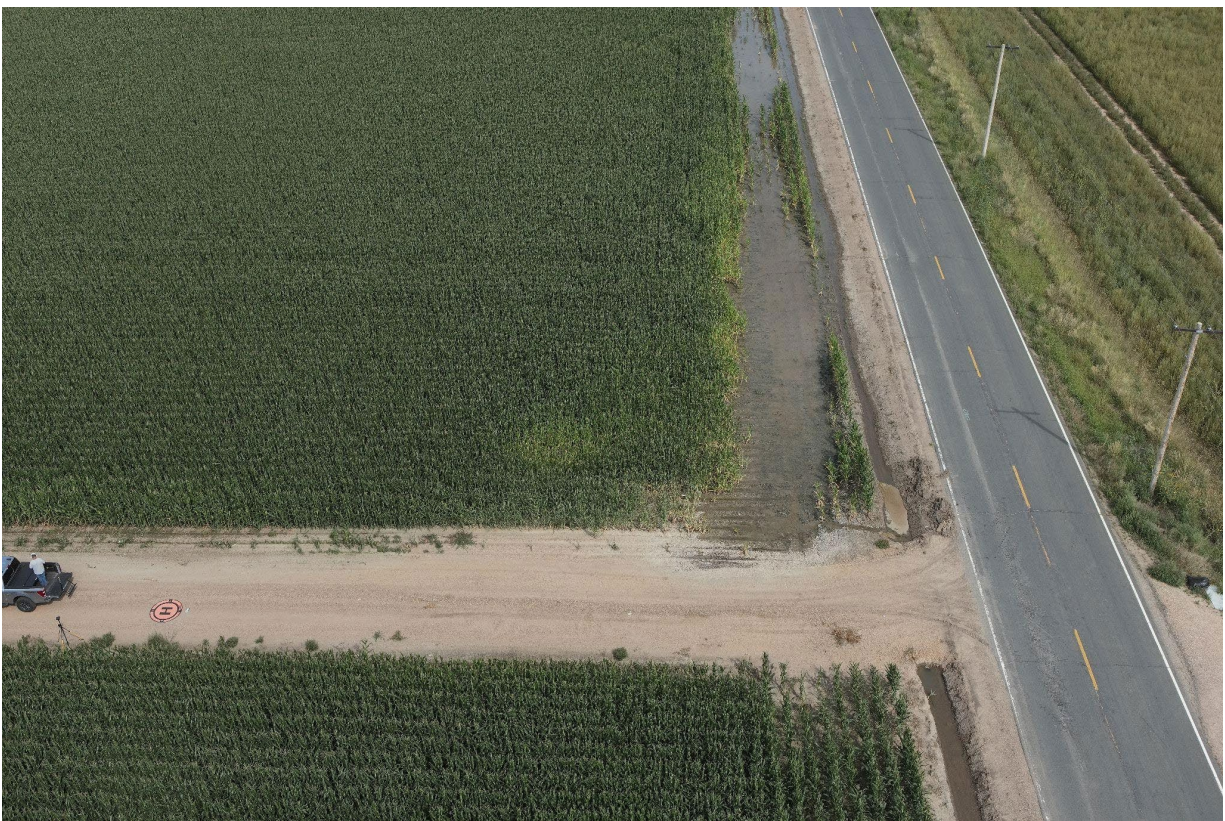
2023 - Facing East

The east-facing drone imagery from August 2023 depicts another angle of the flooding/ponding area. In this image there is a small circle of yellow corn that can be seen that overlaps where the previous disturbance extent.

In a flood irrigation system, crops along the gradient from uphill to downhill typically remain green, provided the landscape is uniform with no visible undulations. However, small depressions in lower-elevation areas can lead to water pooling, causing localized yellowing and stunted growth.

Even a depression of less than 1 cm in elevation can result in standing water, leading to chlorosis in corn. This constitutes a *de minimis* loss that would not occur if water were not backing up into the field. Given the minimal impact, moving equipment into the field to address these areas would likely cause more harm than allowing the farmer to continue regular operations.

Additionally, this image effectively illustrates that where water has pooled, no corn is growing east of the road, whereas the west side remains dry and unaffected.

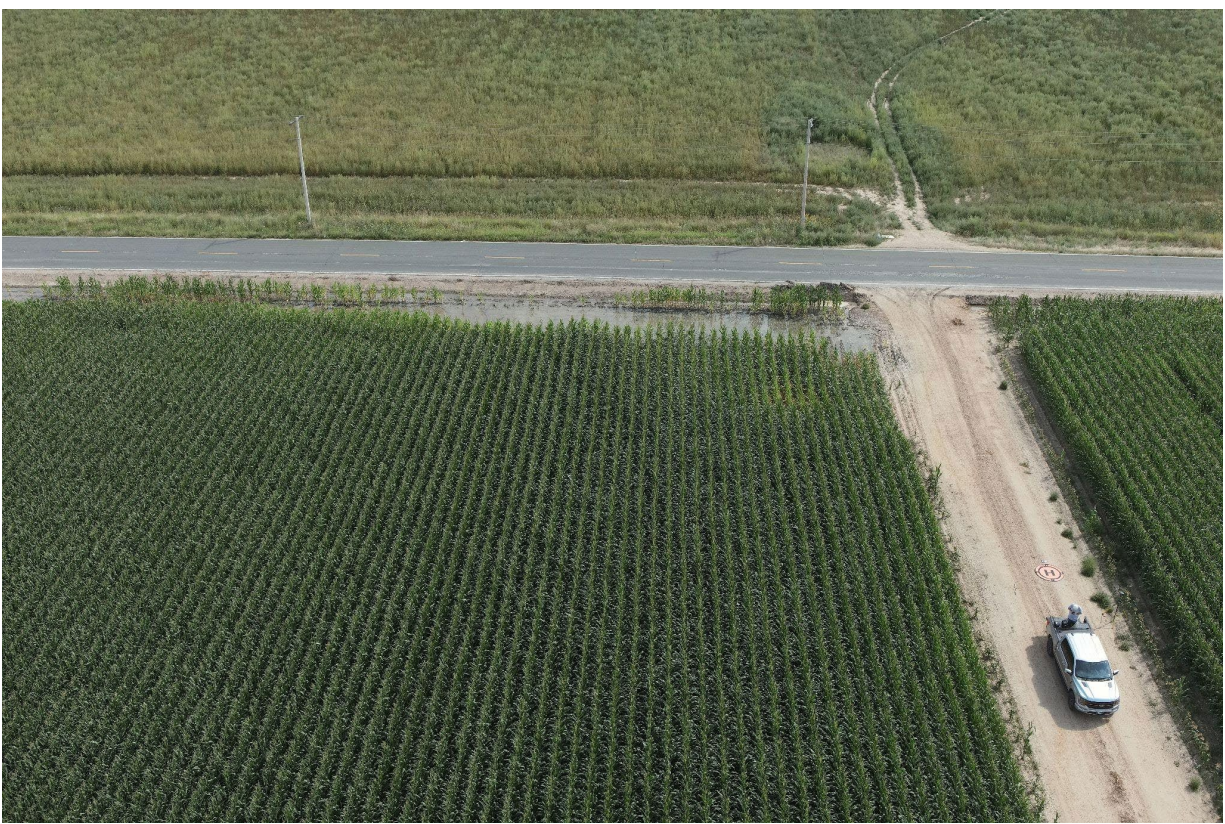
2023 - Facing South

The south-facing drone imagery from August 2023 depicts the water pooled on the east side of the farm road and along the county road, and not to the west side. Further illustrating the landscape dynamics taking place at the edge of this corn field.

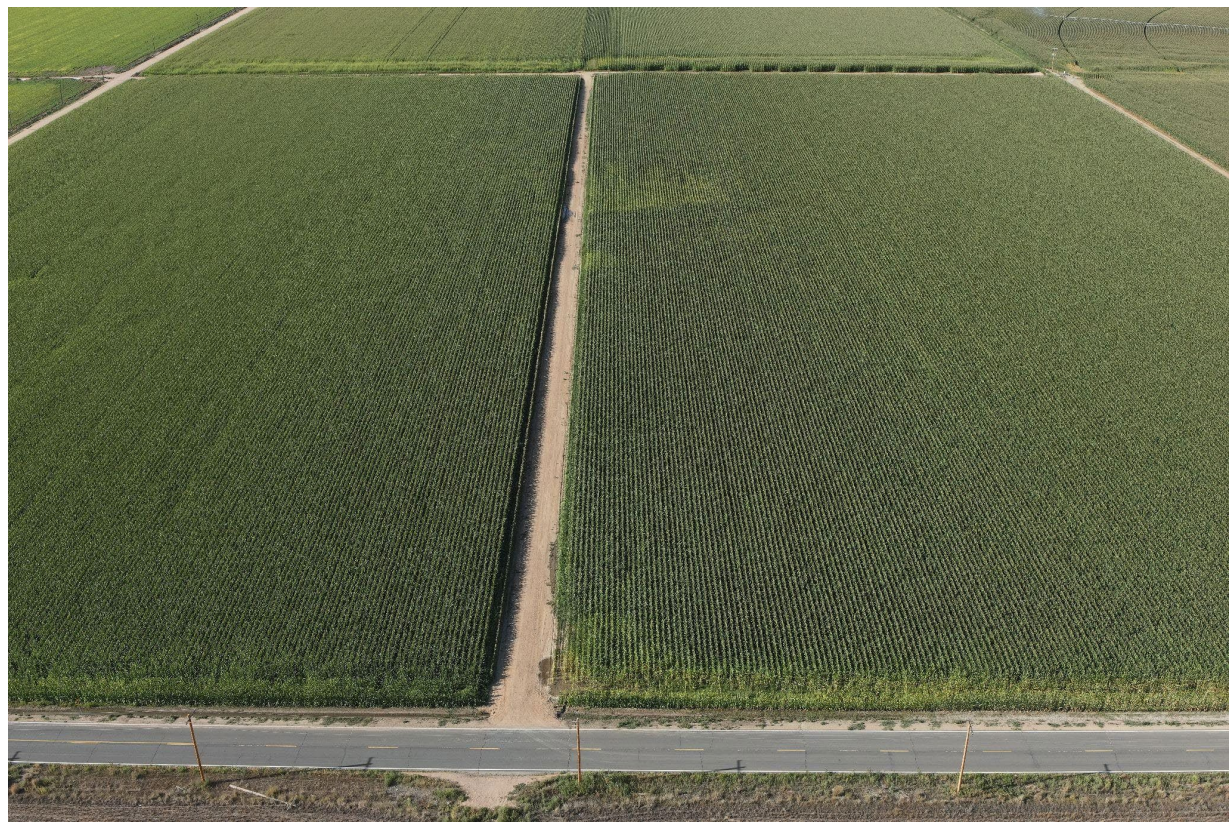
2022 - Facing North

The north-facing drone imagery from August 2022 shows ponding water in the same location, further illustrating that during this growing season, water backed up even further into the field and along the road. This reinforces that the ponding and resulting stunted crop growth are due to the field's characteristics rather than a direct impact of past oil and gas activities. While the affected area aligns with the previous disturbance extent, this is a correlation, not causation. Additionally, the imagery shows that the impacted area along the road extends beyond the historical disturbance boundary.

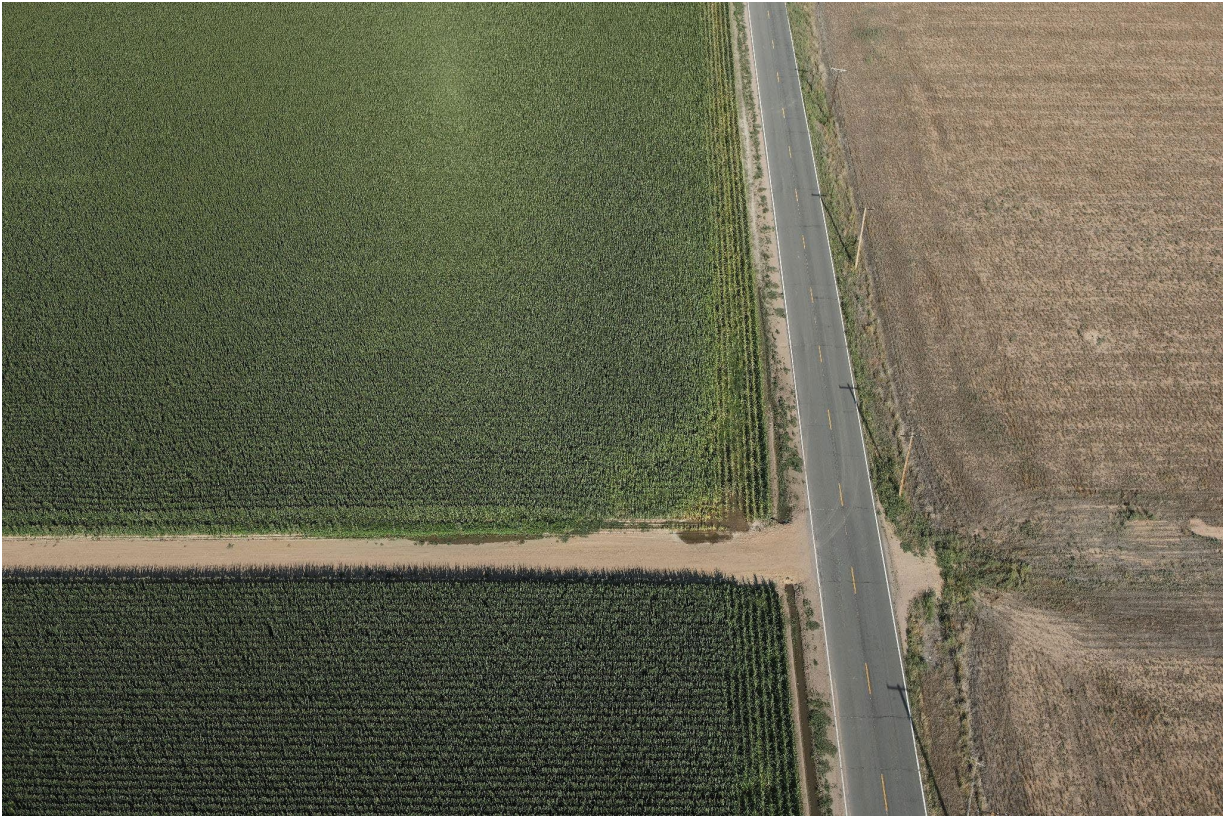
2022 - Facing East

The east-facing drone imagery from August 2022 illustrates that the road ditch is full, and water is backing up into the field. The water extends farther north into the field than the oil and gas disturbance, while the west side of the road remains dry.

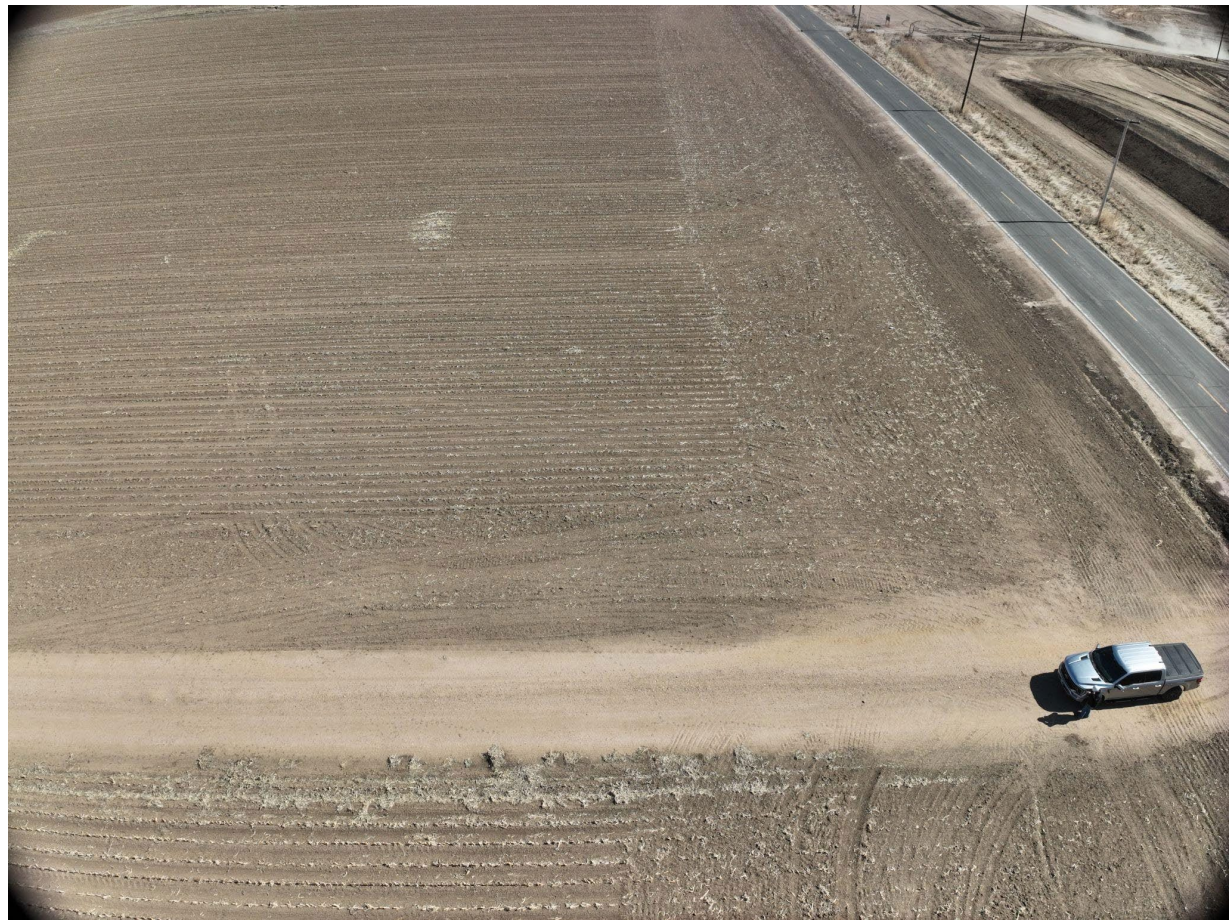
Drone Photo March 2024 - Facing East

The east-facing drone imagery from March 2024 shows that the field is uniformly furrowed, with no visible evidence of the facility's impact once the crop is removed. The image also indicates that the soil maintains consistent color and texture throughout. Additionally, the photo captures the farmer driving on and off the farm road near the area where the water pools, highlighting an impact from routine farming activities. Ground observations in March 2024 confirmed that all gravel had been removed from the previous disturbance extent.

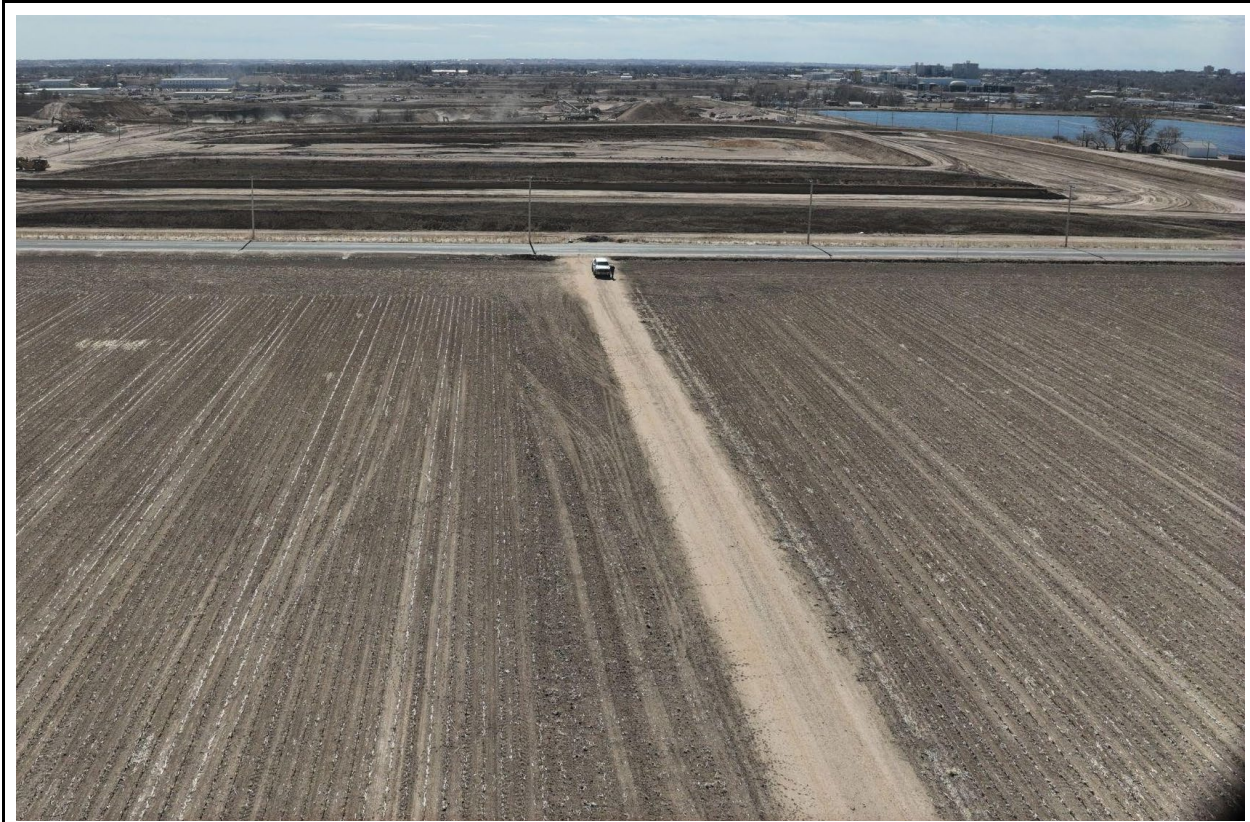
Drone Photo March 2024 - Facing South

The south-facing imagery from March 2024 illustrates the uniformity of the rows across the field including the disturbance. Overlapping the disturbance there are tire tracks compacting the area along the road at the entrance of the field. These are caused by the farmer and can lead to some of the lack of growth along the field.
