Final Reclamation and Stormwater Inspection

Operator: PDC ENERGY INC - 69175

Location ID: 330939

Inspection Photos
Location Name: J&L Farms 23-22
Location ID: 330939

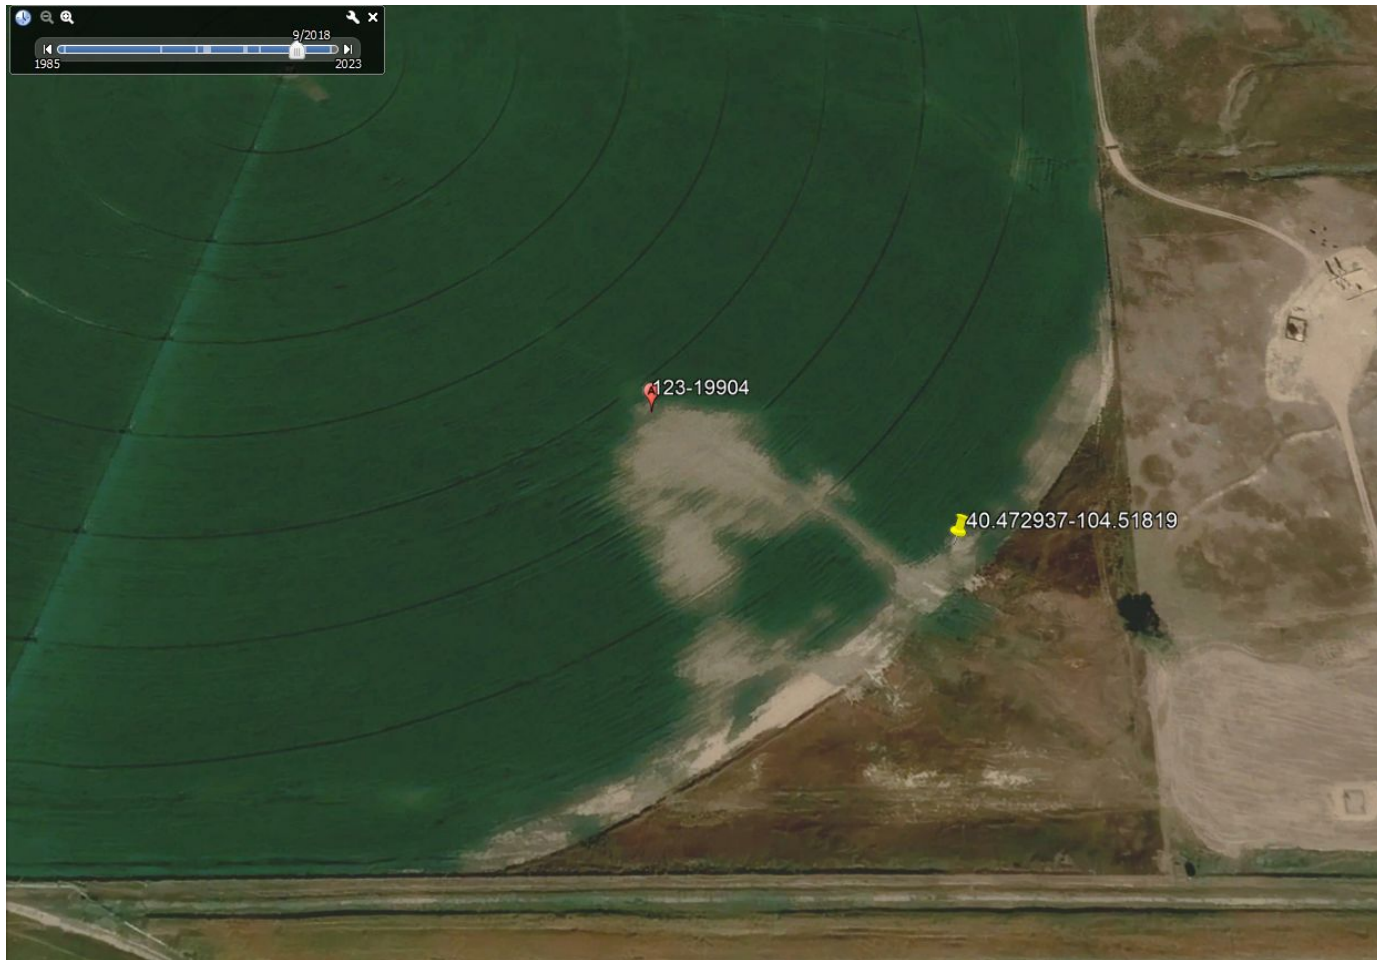
Photo 2. Google Earth aerial imagery (circa 09/2018), approximately 6 months after P&A activities (03/06/2018), illustrating a disturbance around the former well location. (Lat/Long southeast of well location is from Operator supplied drone aerial imagery; Photo 3).

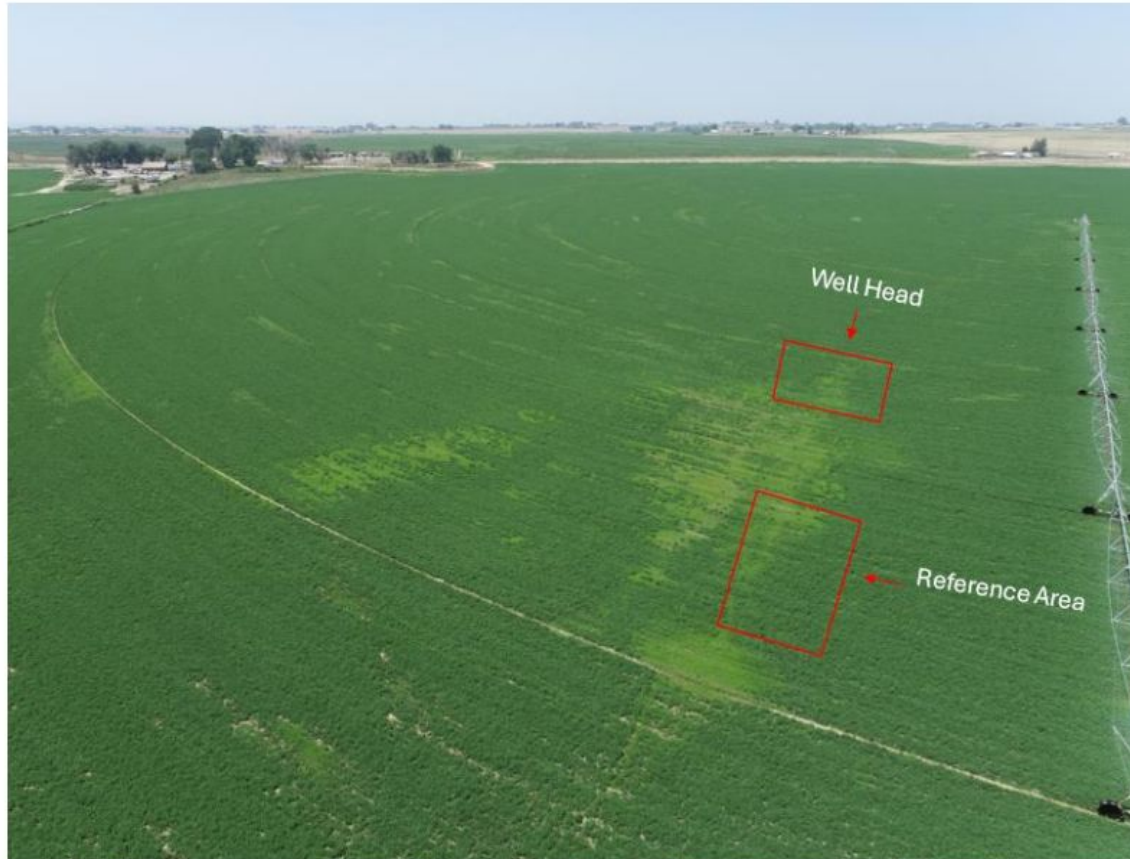
Figure 6: Looking West towards well and reference area, 100 feet in height, Lat/Long: 40.472937/-104.51819.

Photo 3. Screenshot taken from Page 10 of the drone closure report. Image illustrates that the former well location and disturbance areas (as seen in Photo 2) do not appear to be reflective of the adjacent reference areas (not the red outline in image).
