Final Reclamation and Stormwater Inspection

Location ID: 320251

Well Name: ADAMS AGGREGATE #2

Inspection Document #: 718600281

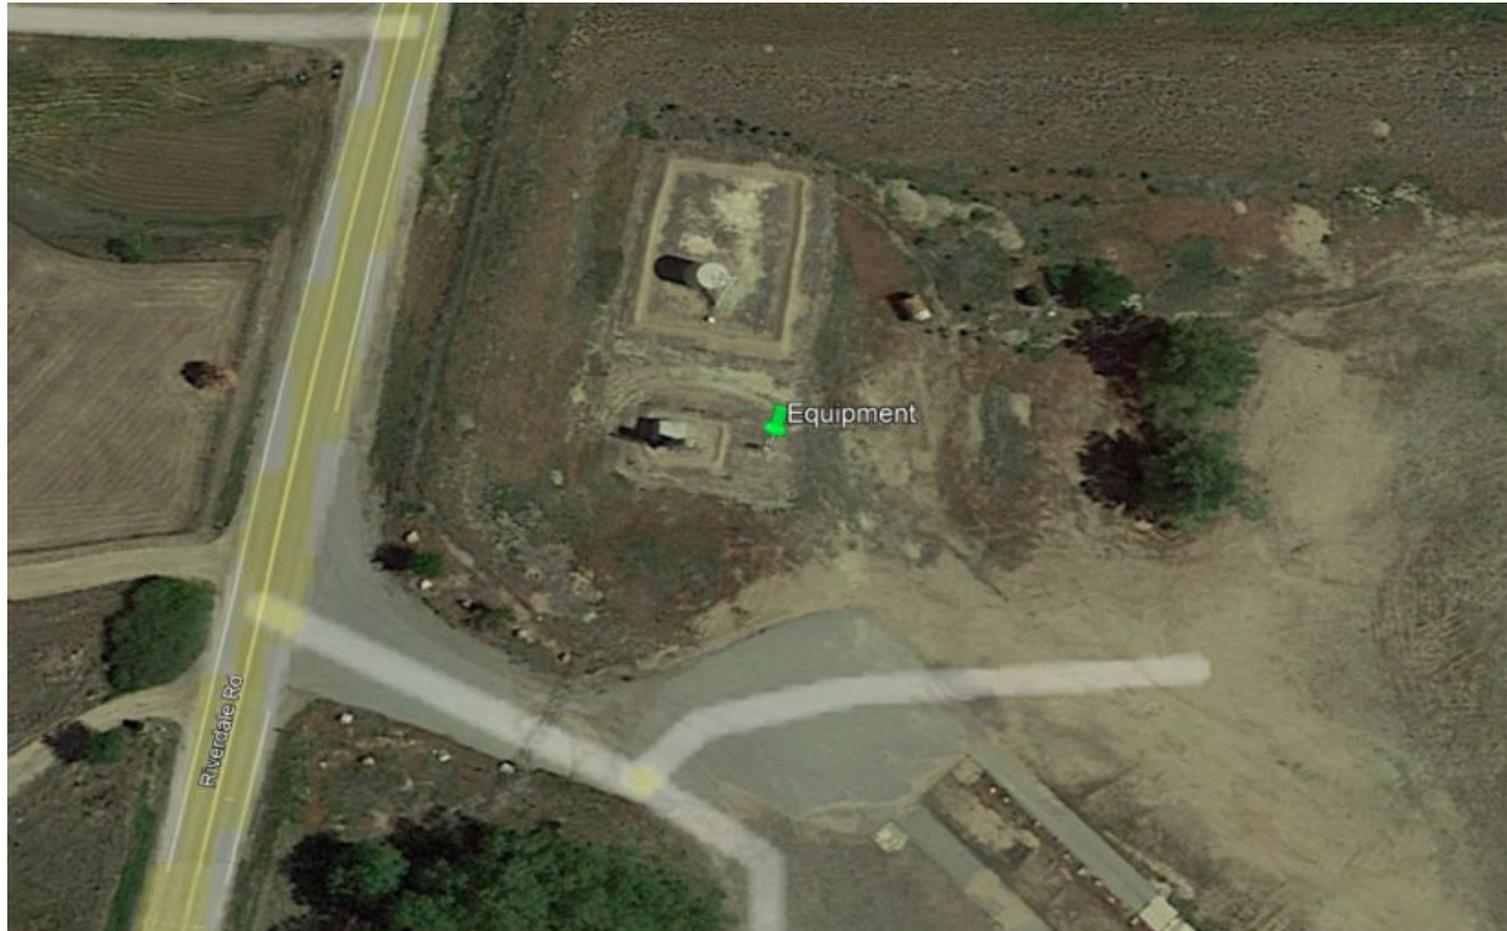
Photo 1. Google earth aerial photo taken 05/2018 prior to decommissioning. A piece of equipment is located to the east of the southern separator.

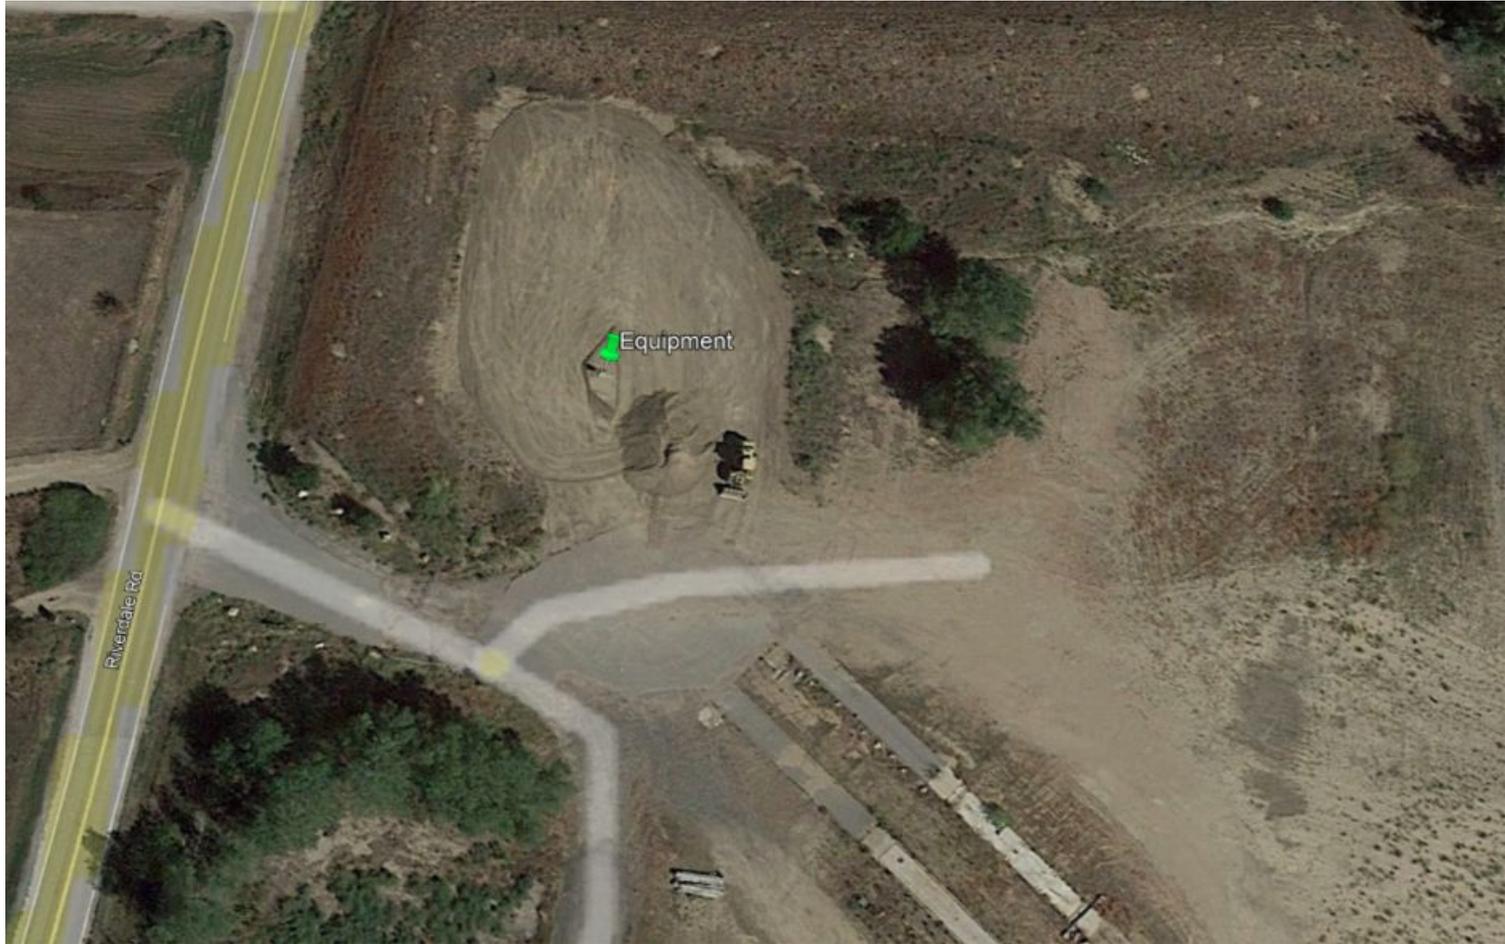
Photo 2. Google earth aerial photo taken 09/2019. The pad is recontoured except for the area around the piece of equipment which appears to remain in place.

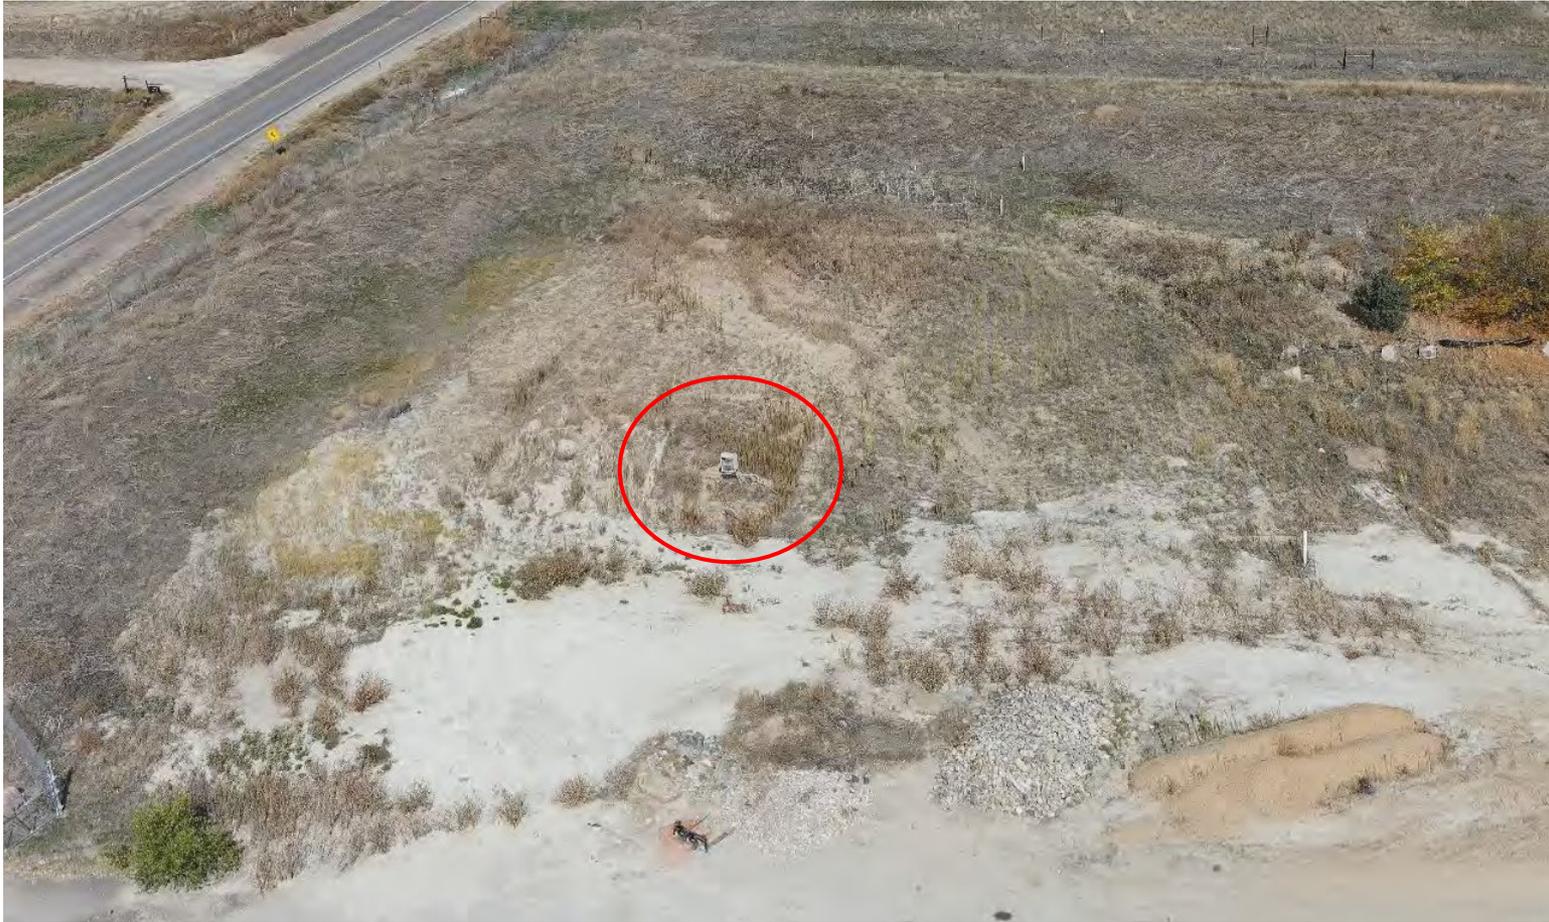
Photo 3. Operator supplied imagery “South of Tank Battery Disturbance Facing North” attached to Doc ID #404012872. It appears the equipment remains in place (red circle).
