Pinnacle Wellheads and Leppla Facility  
© 13-Feb-25 11:27:05 AM  
ECMC Environmental Inspection

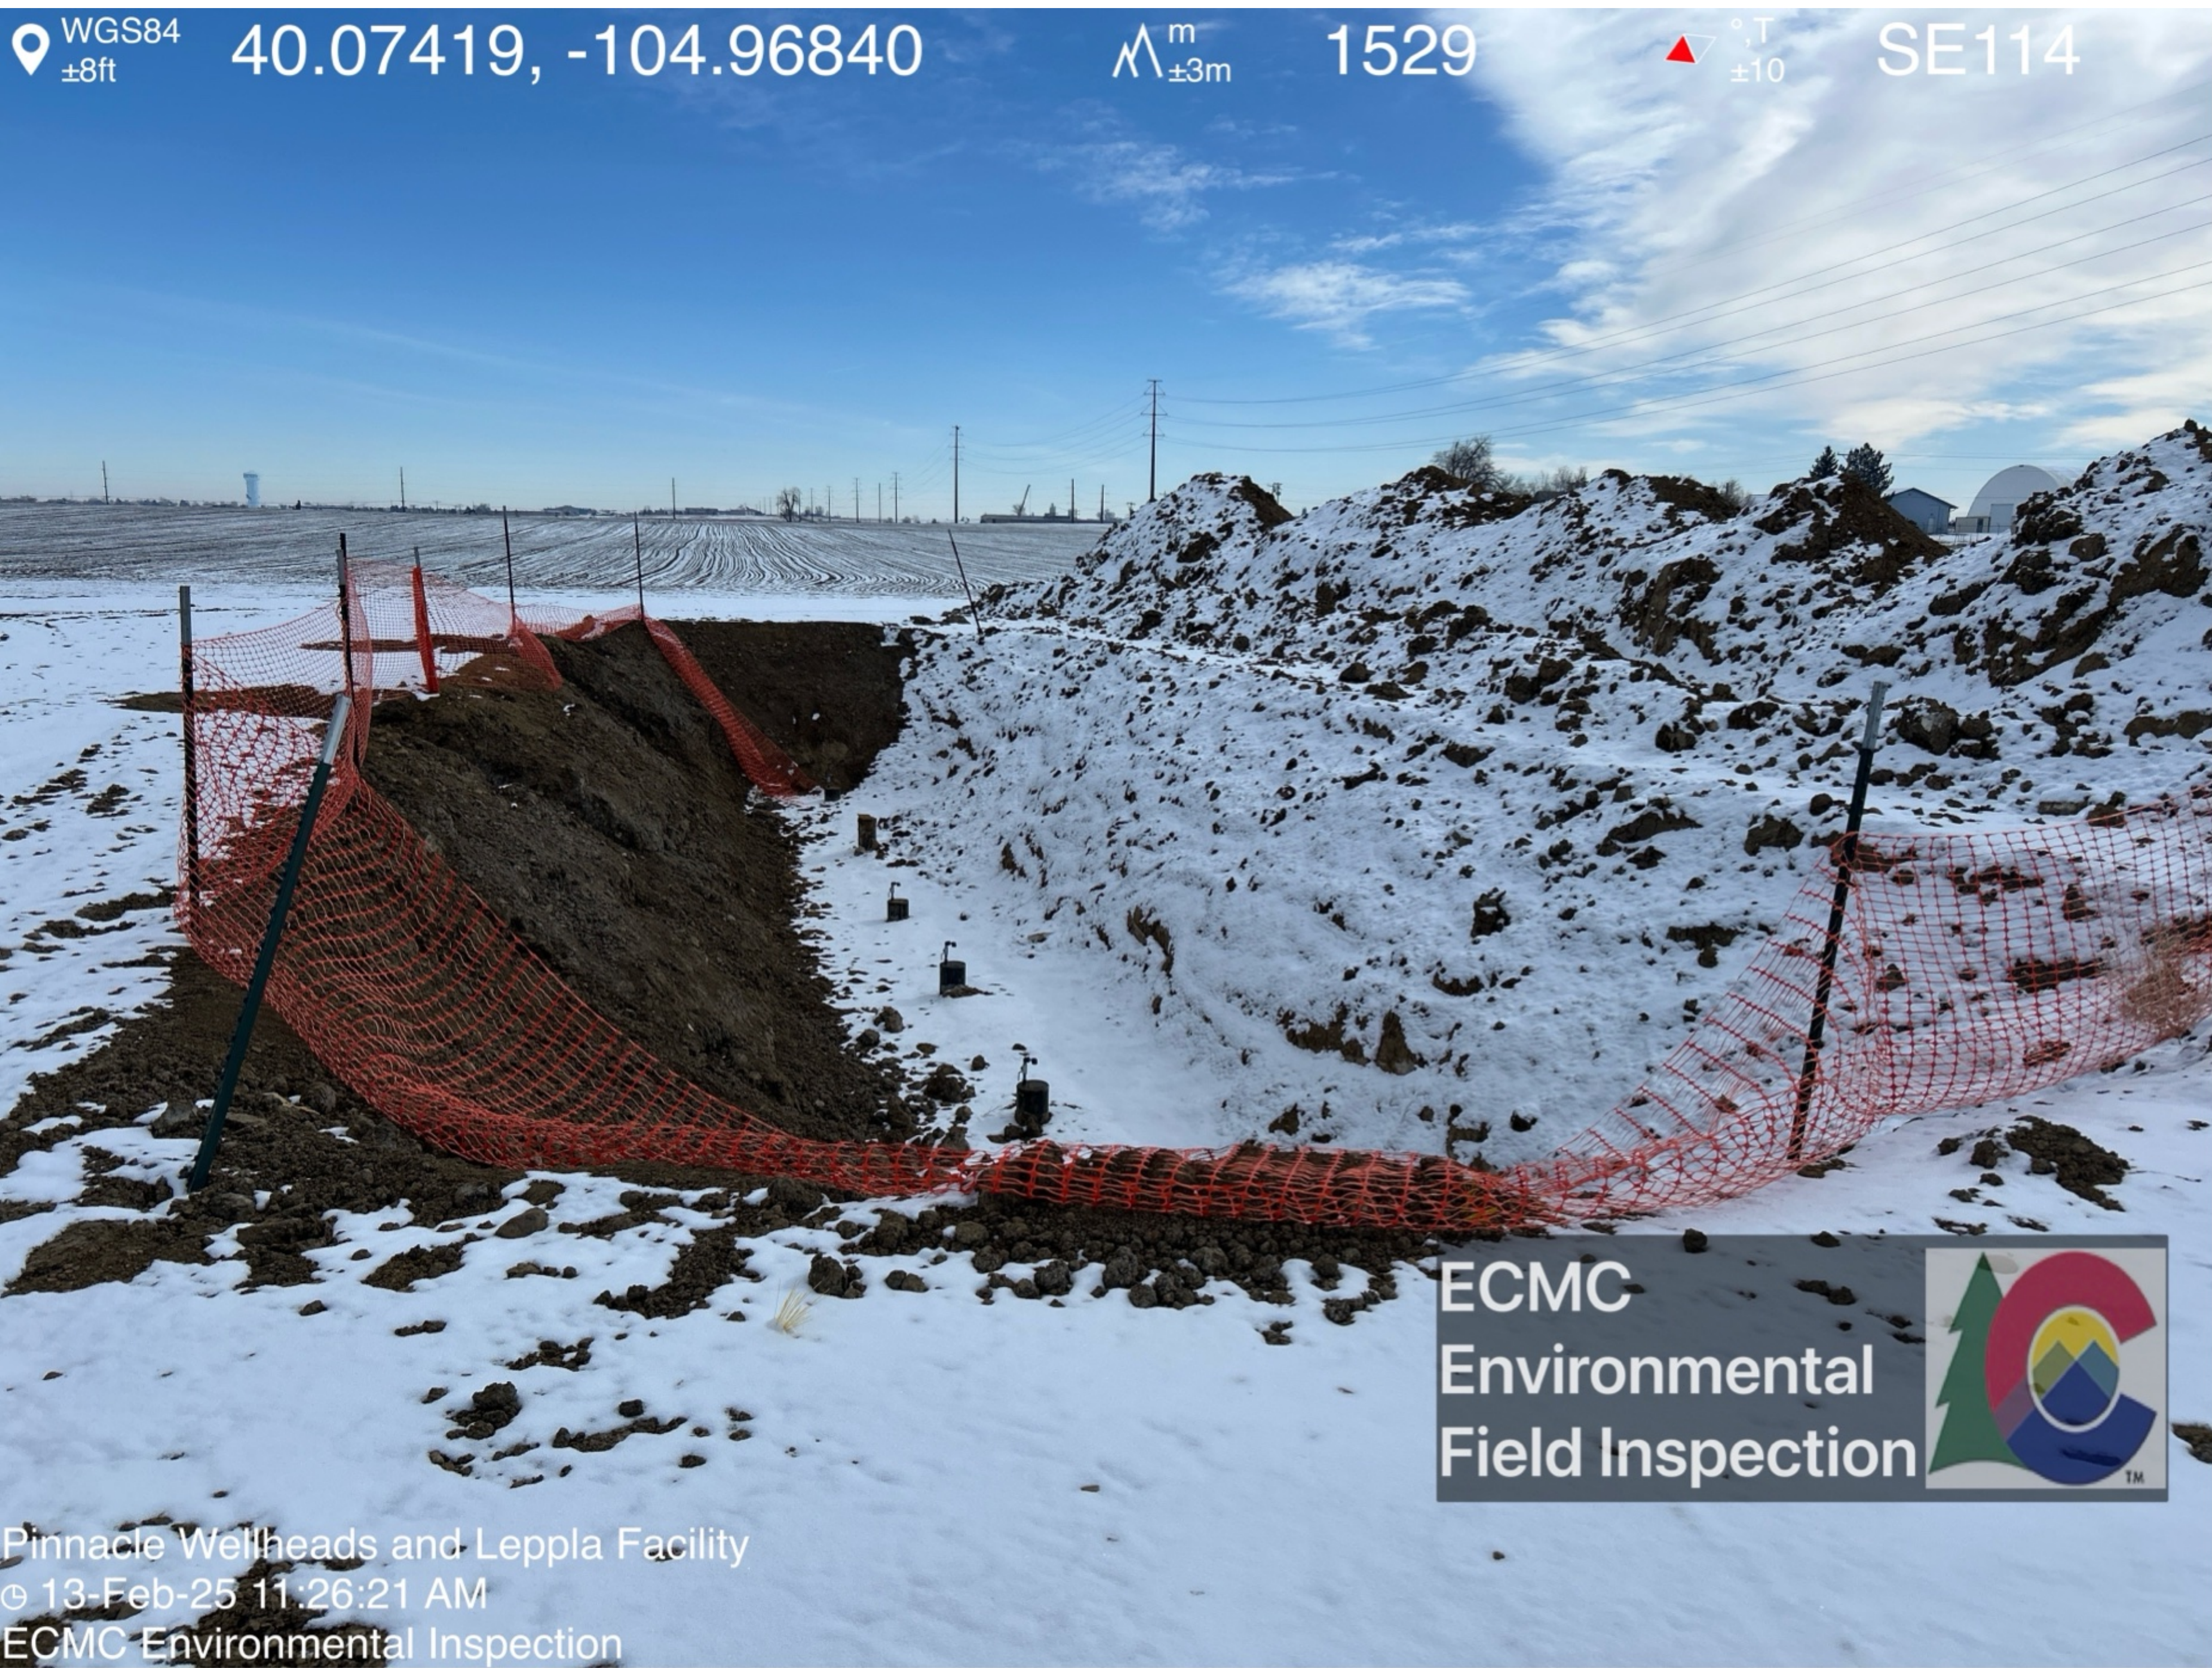
Excavation remains open at the location of the former Pinnacle 9, 10, 15, 16, 37-2 Wellheads. Snow has accumulated. Orange construction fencing has fallen.

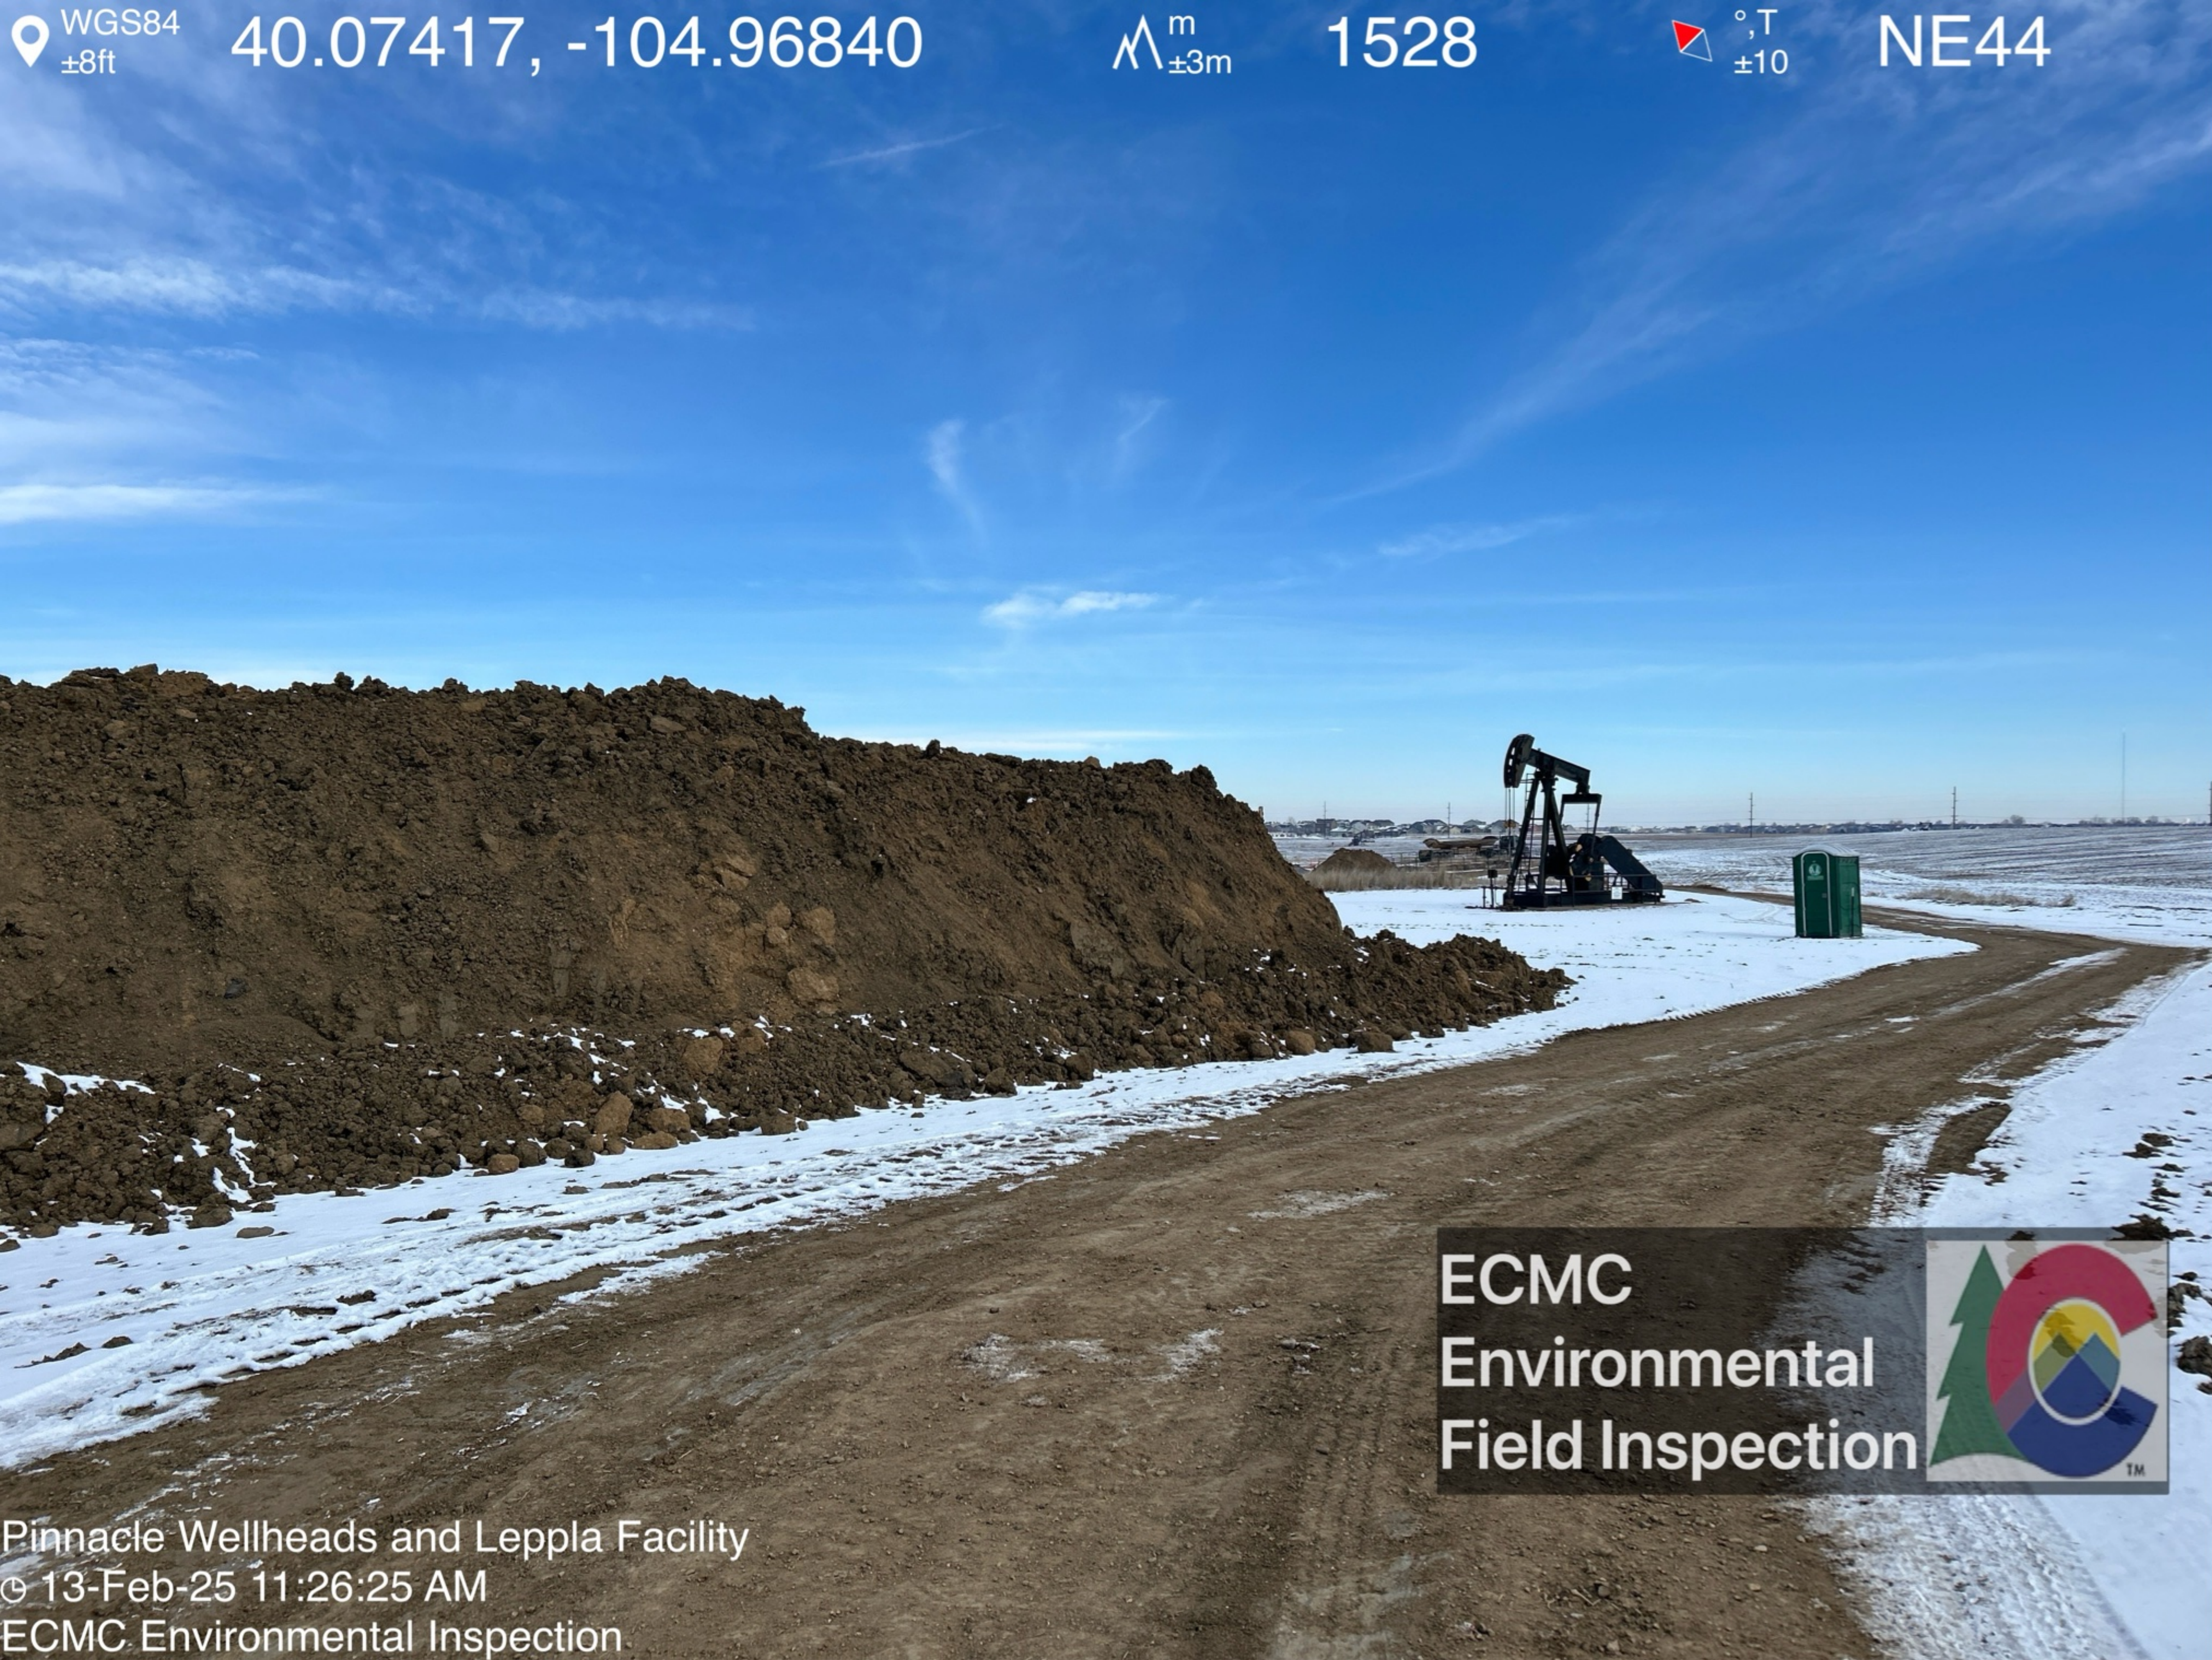
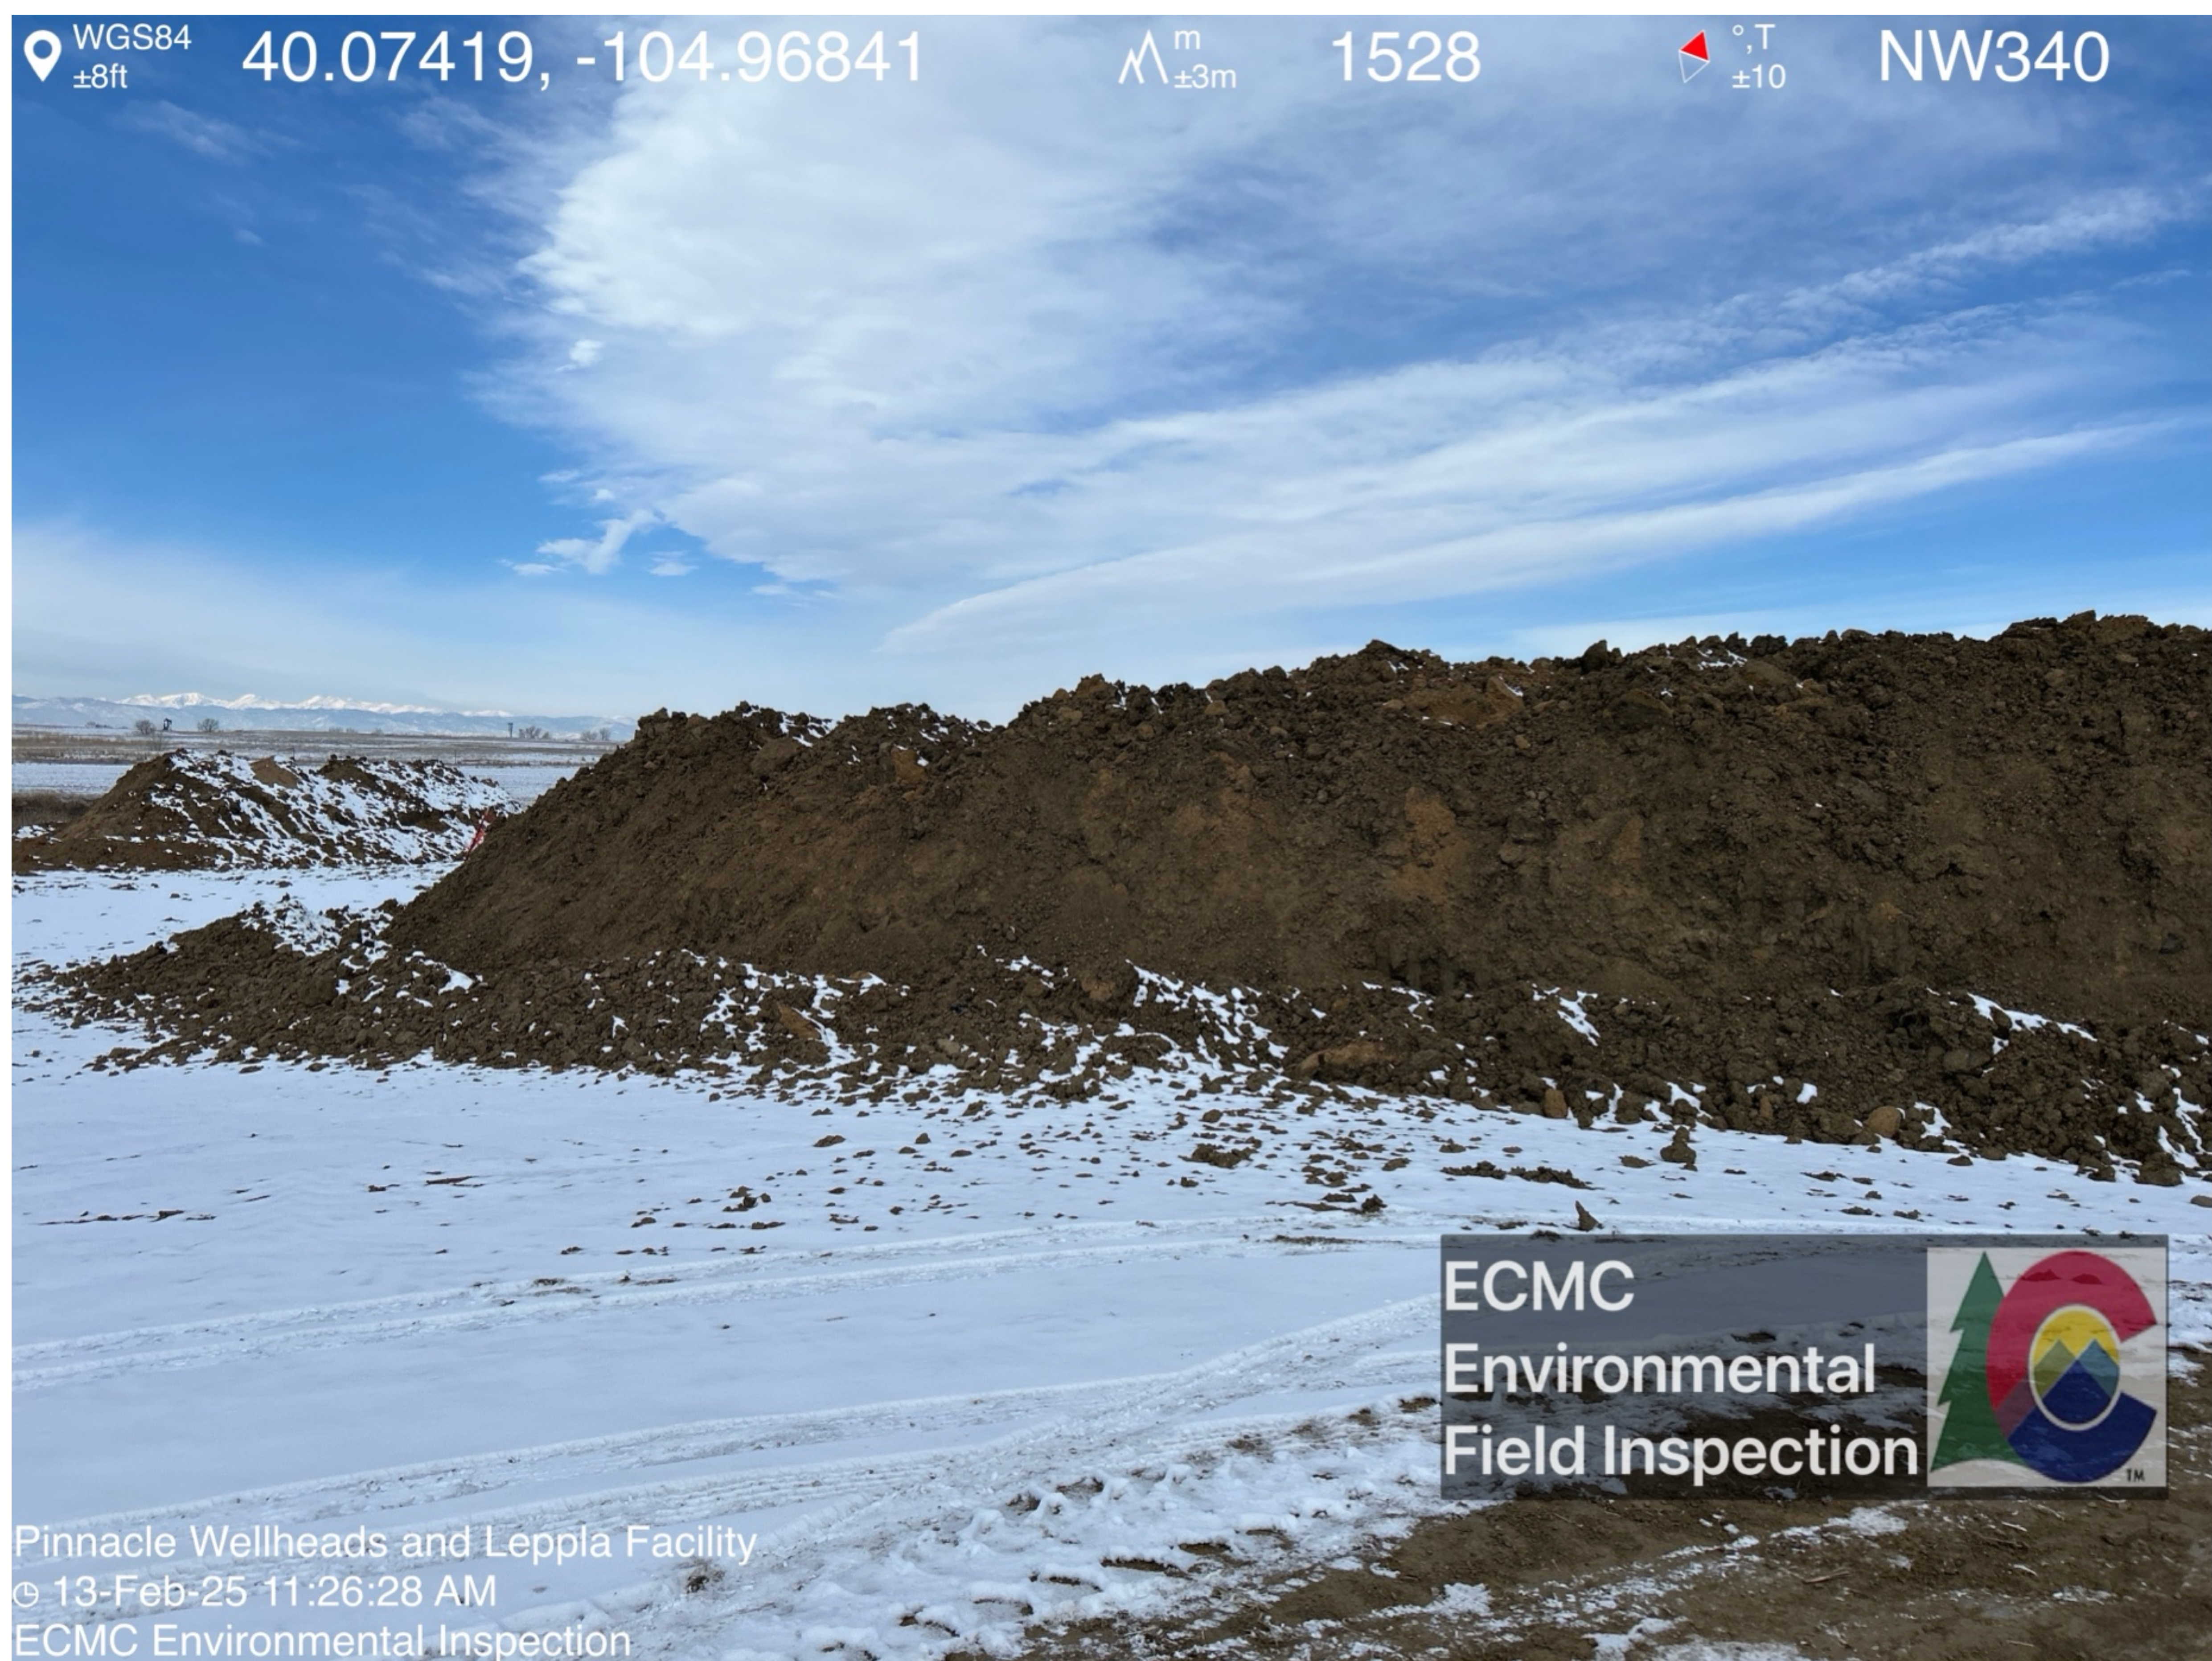
Multiple unmarked soil stockpiles are present on location; BMPs are adequate.

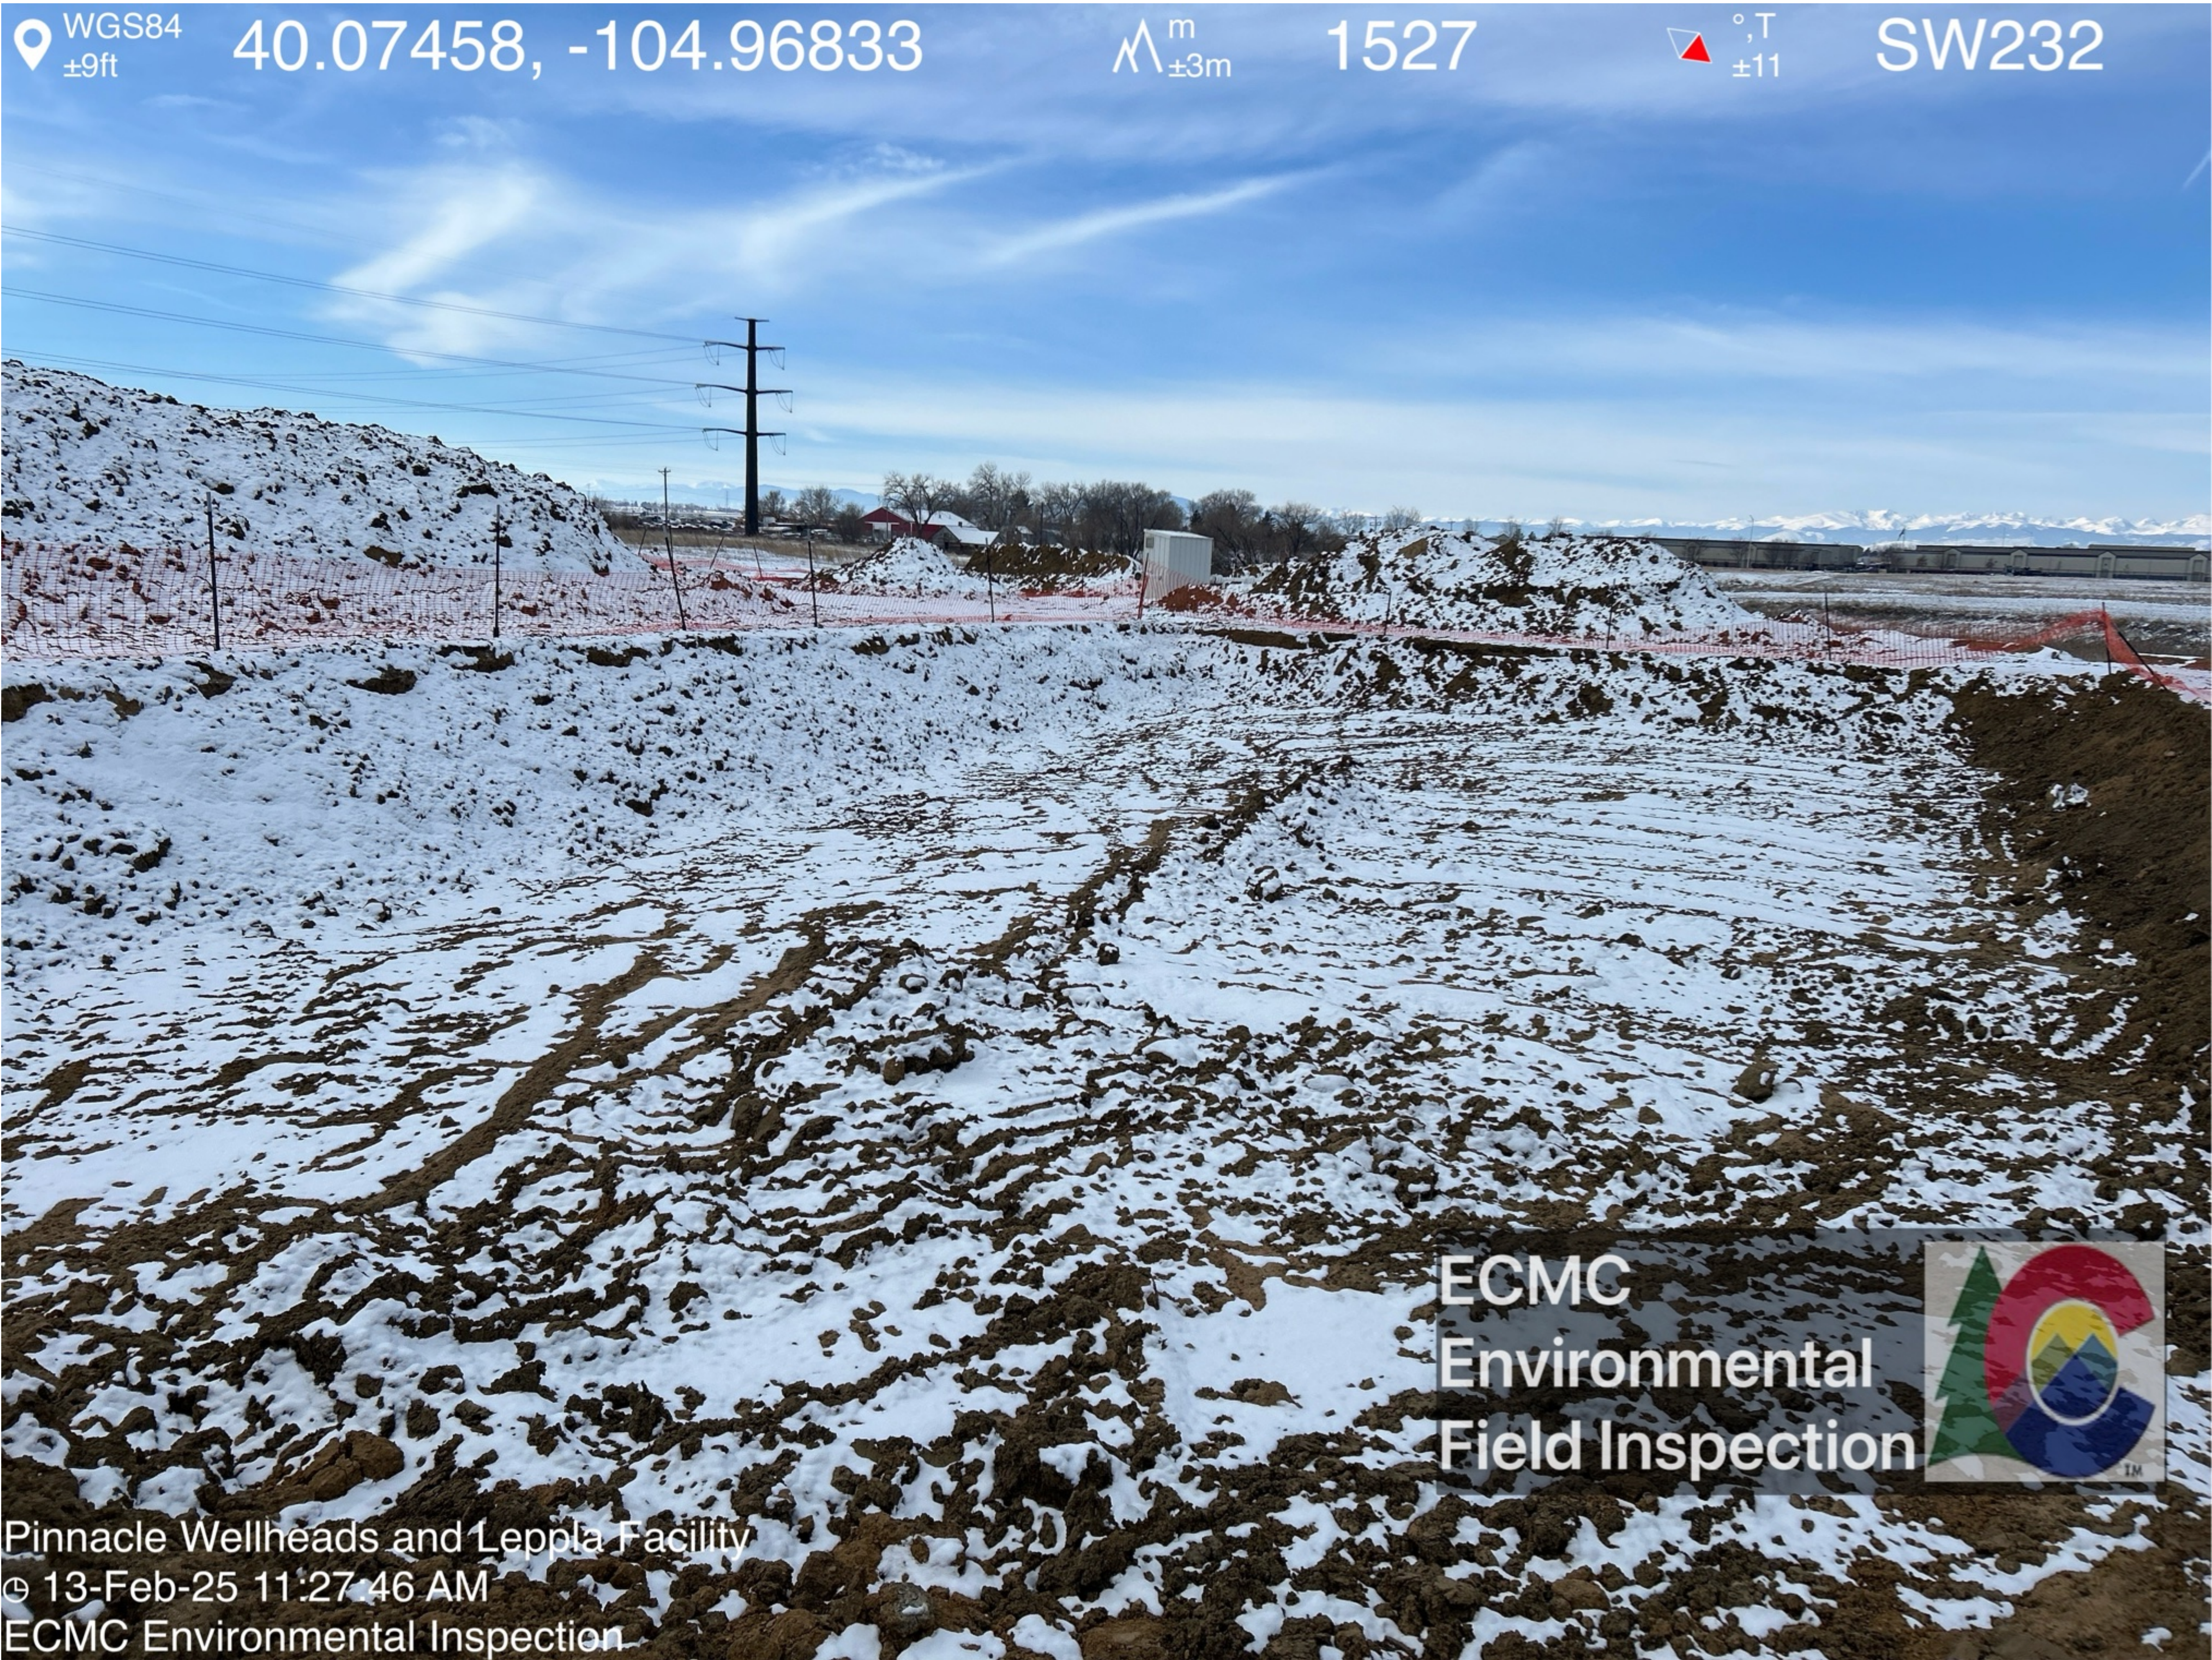
Gray staining is visible in situ at the location of the former Leppla 16-2 Facility production tanks.

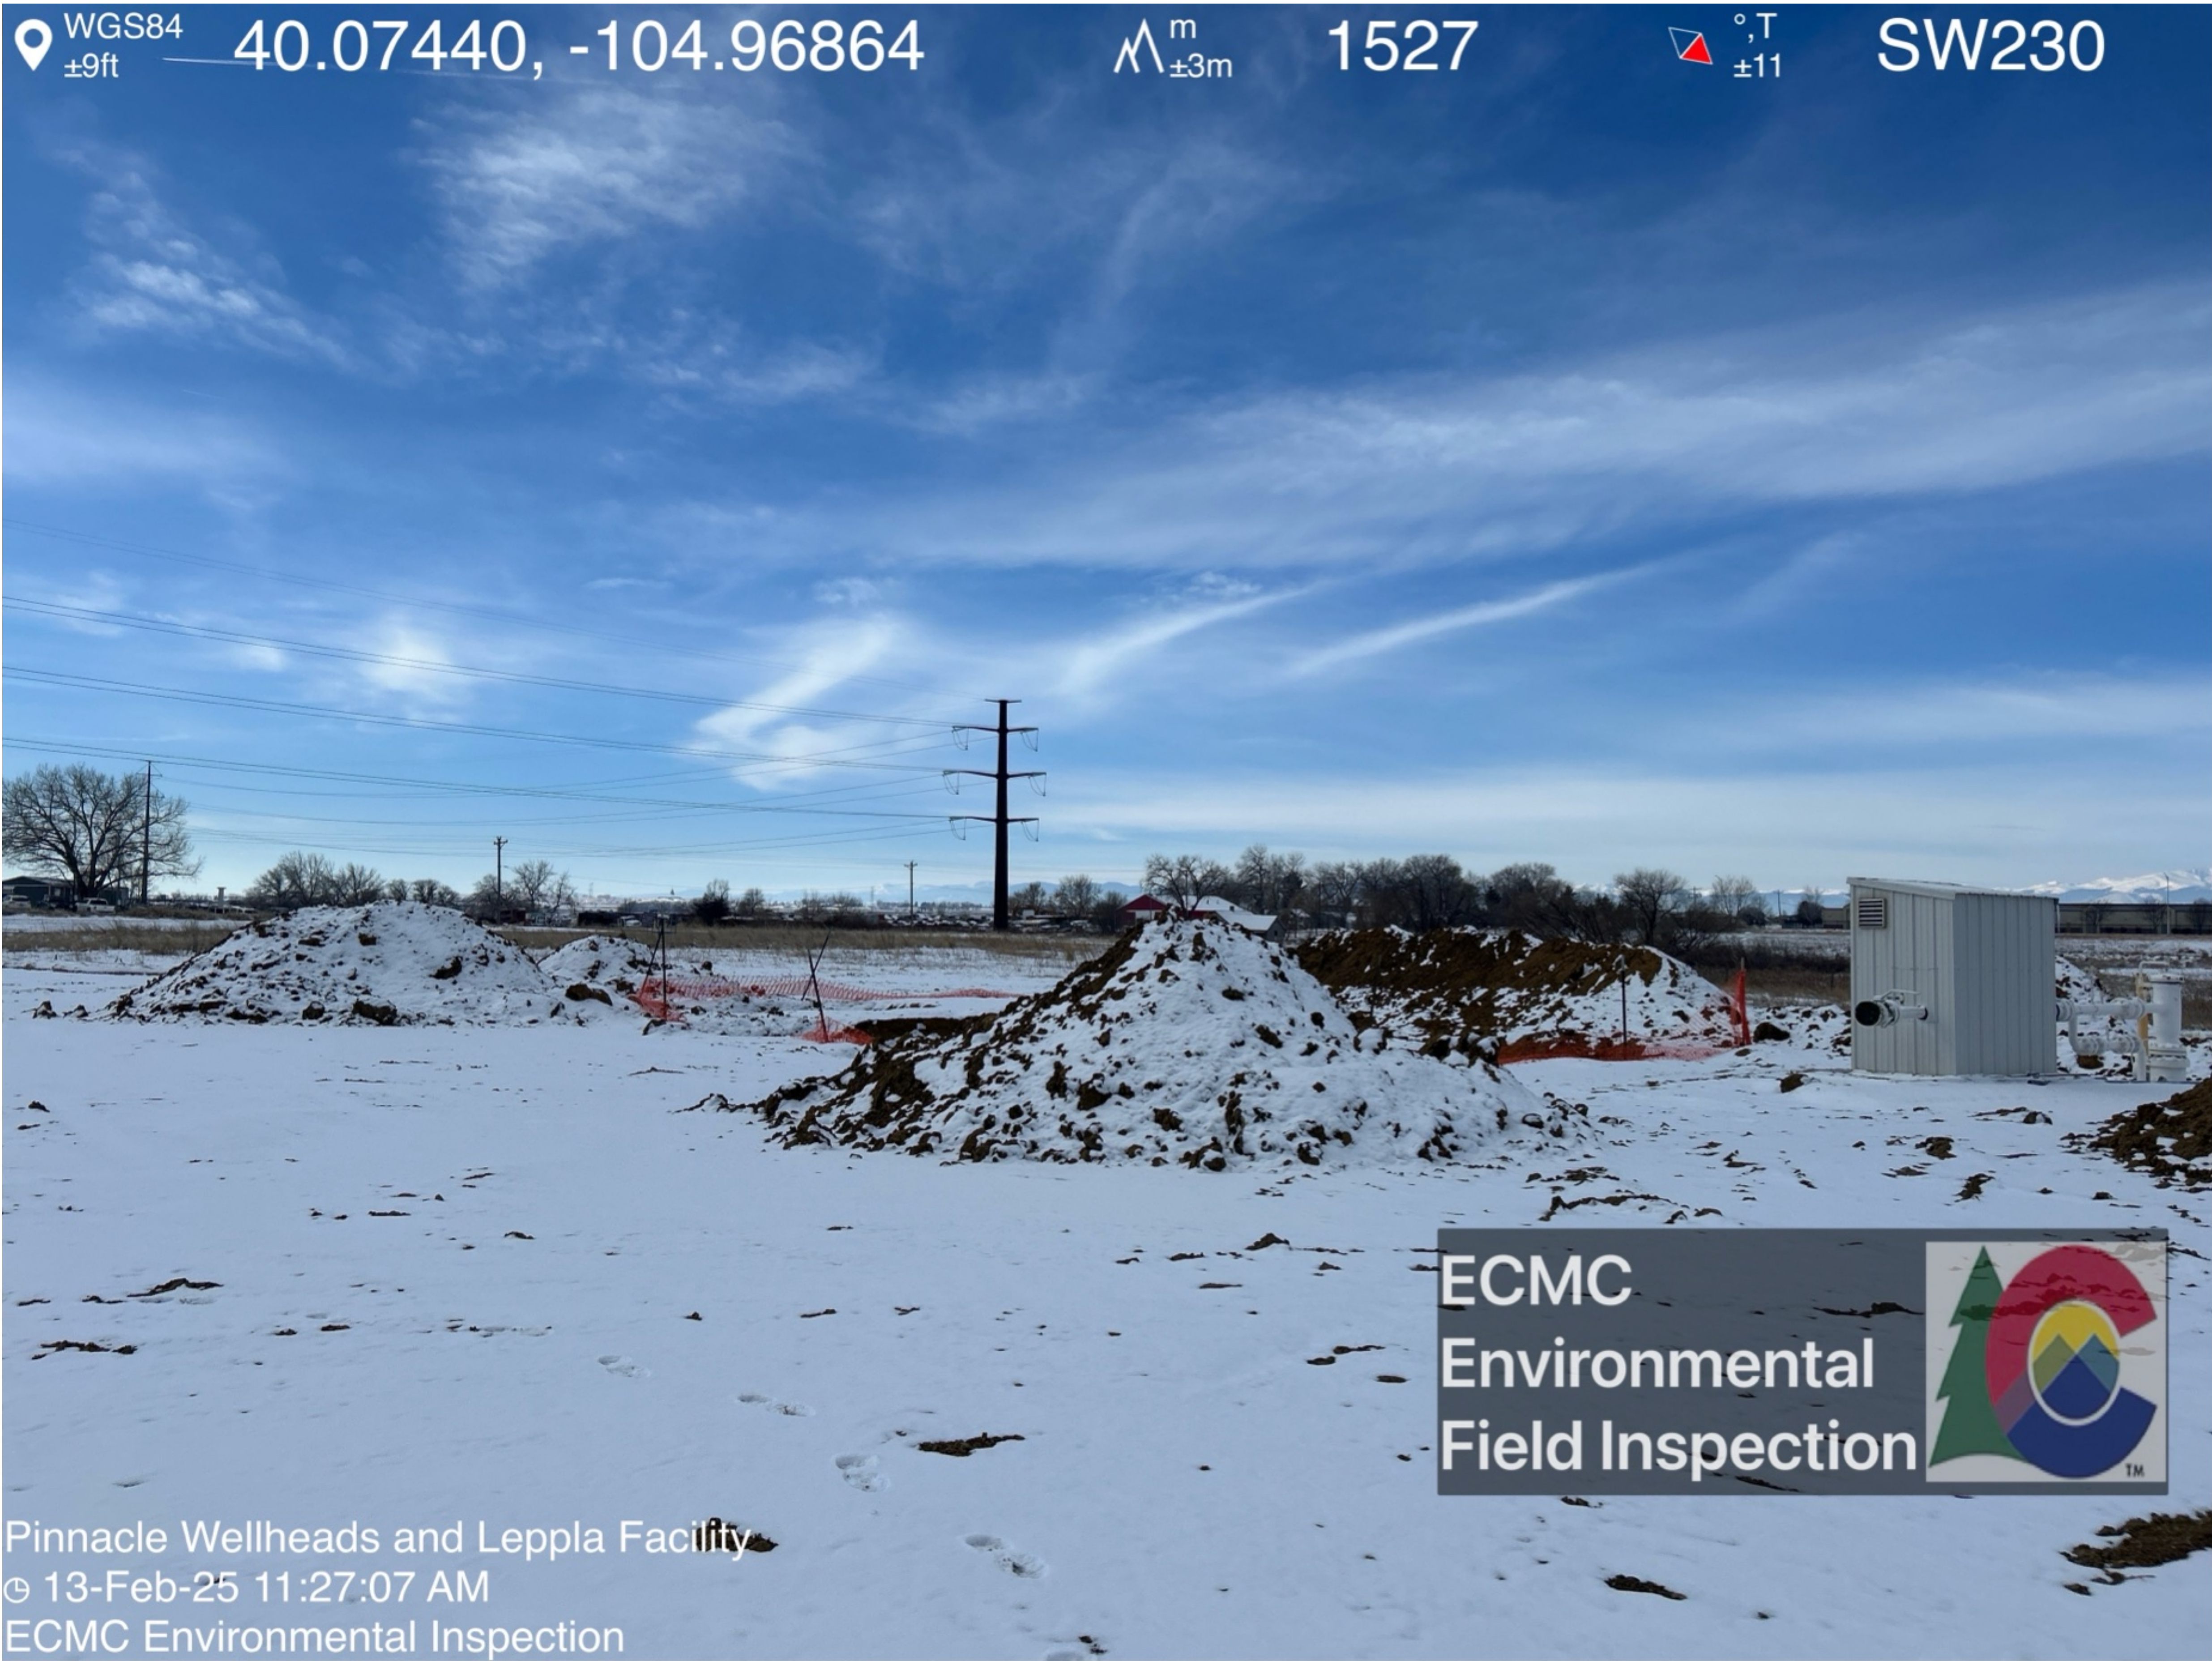
Excavations remains open at the location of the former Leppla 16-2 Facility separators (background). Multiple unmarked soil stockpiles are present on location; BMPs are adequate (foreground).

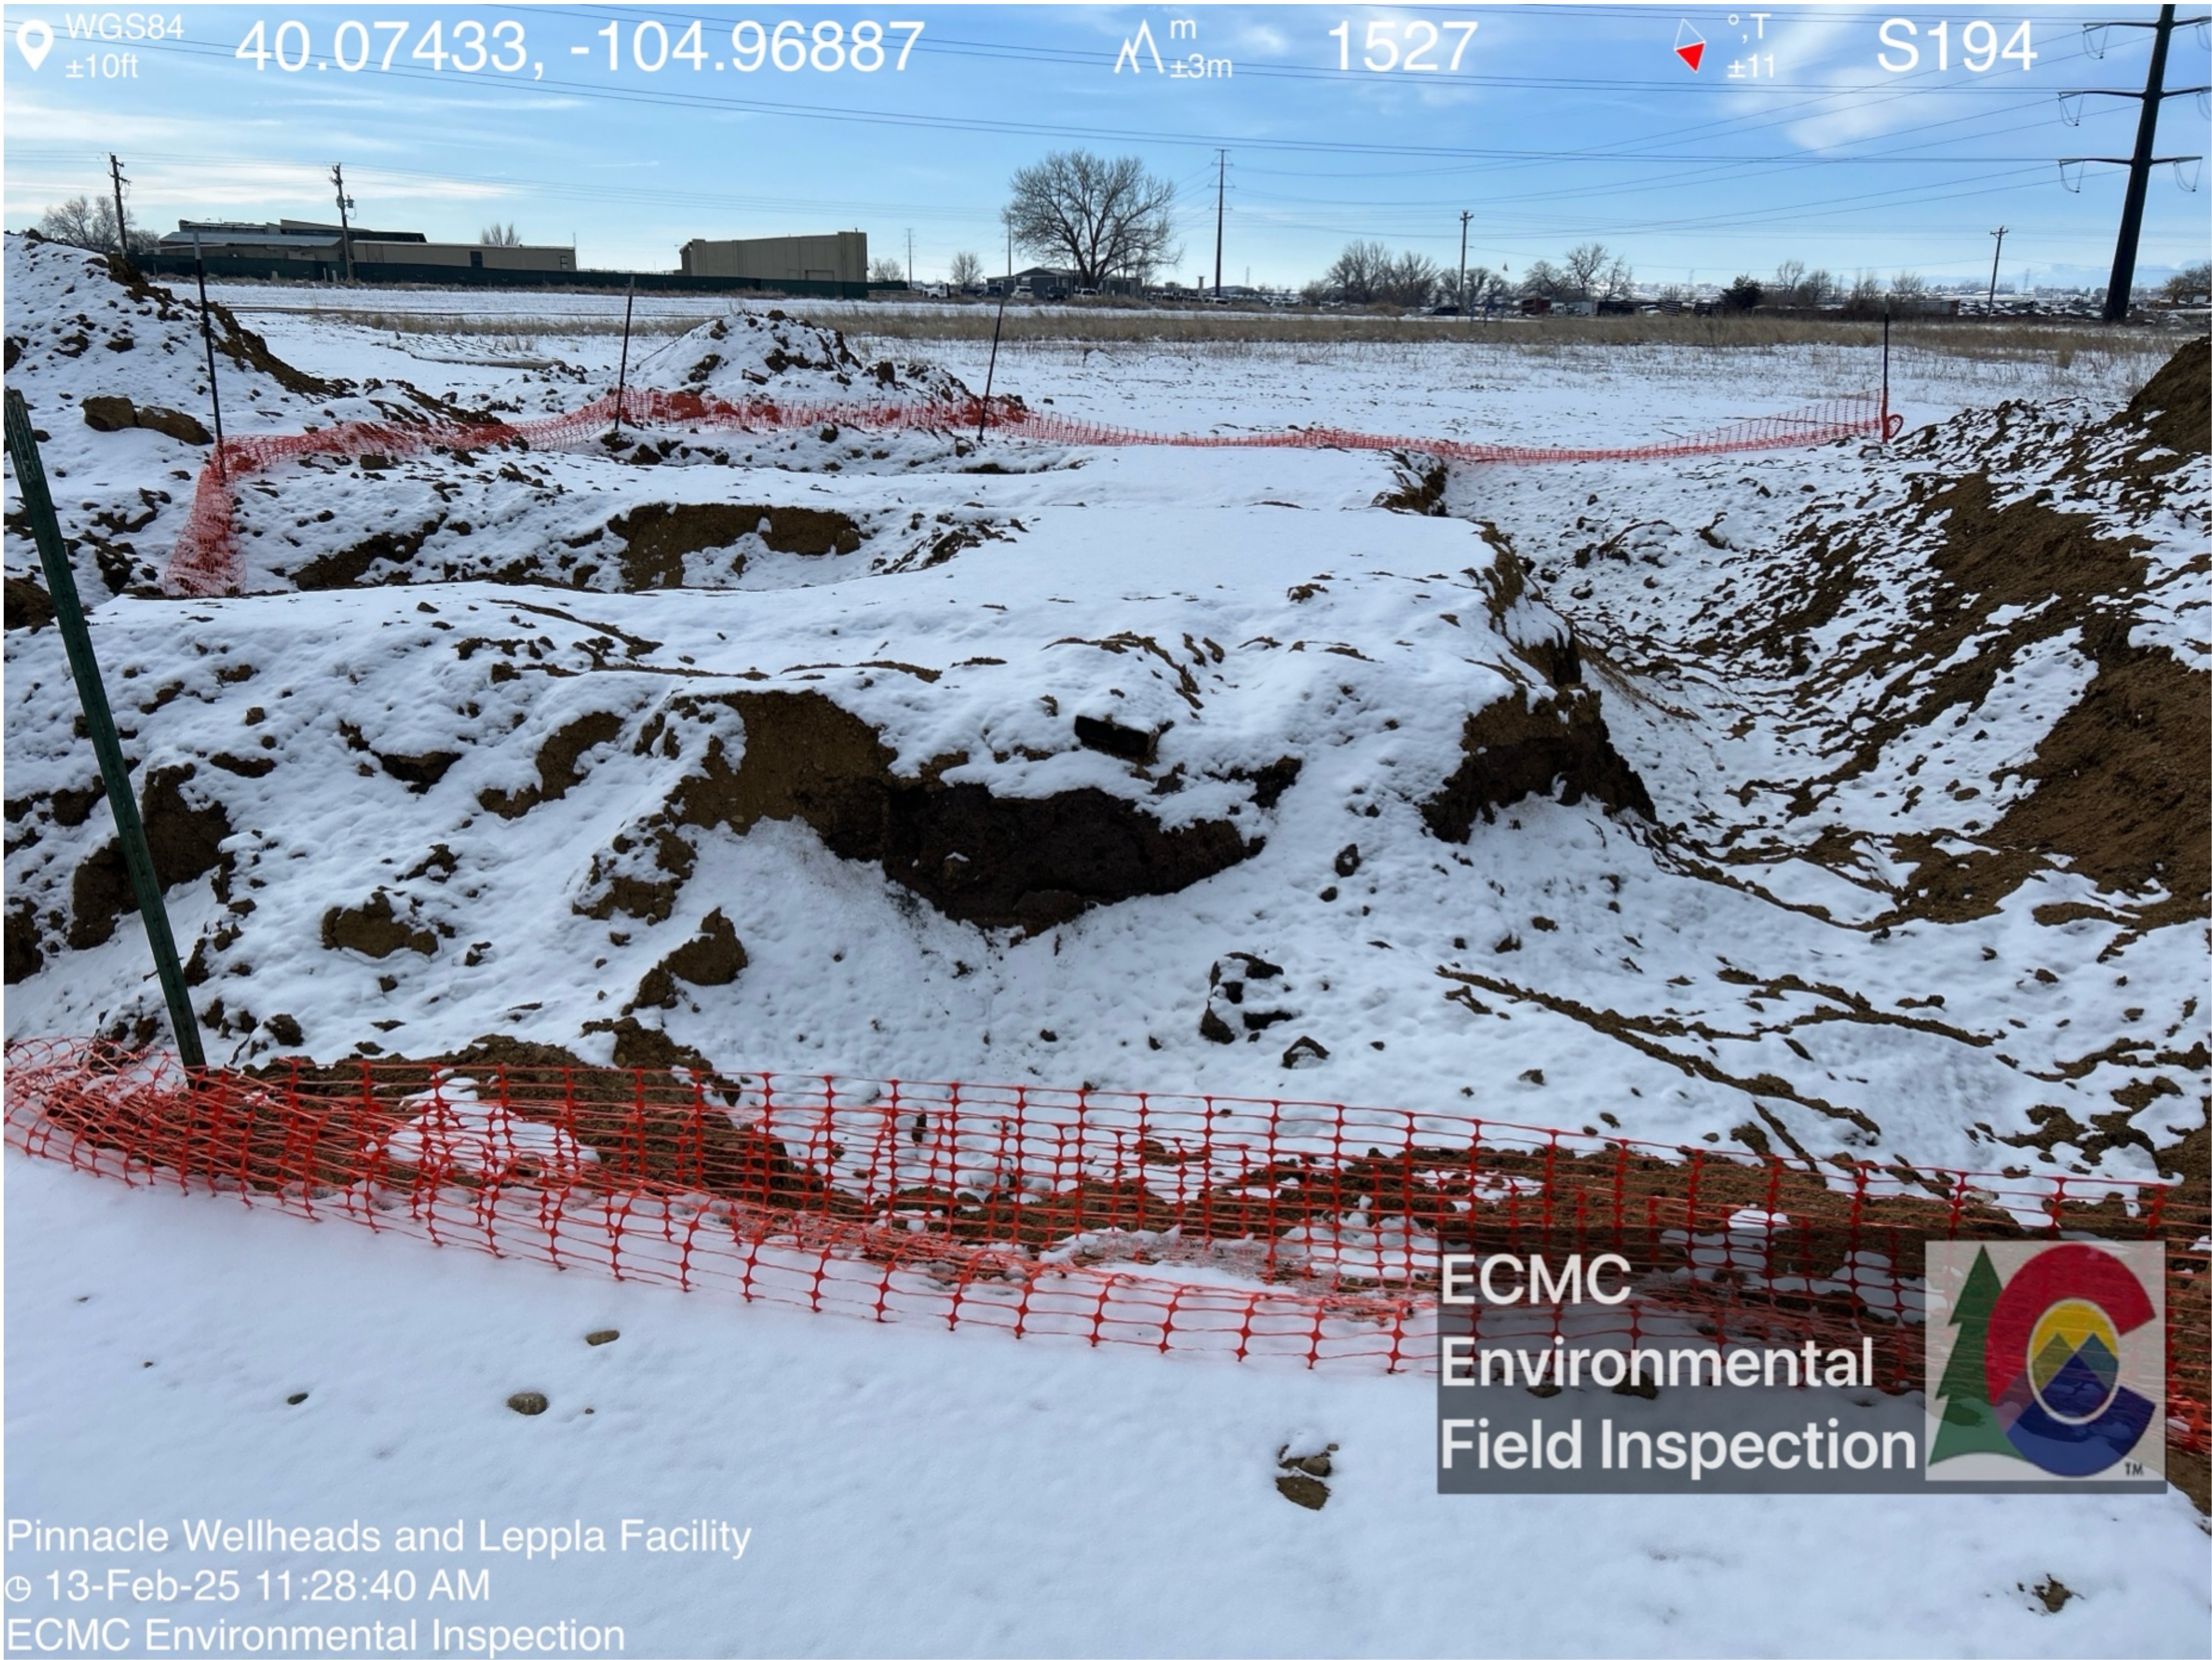
Snow has accumulated within the excavations. Orange construction fencing has fallen.
