Pinnacle Wellheads and Leppla Facility  
© 13-Feb-25 11:27:05 AM  
ECMC Environmental Inspection

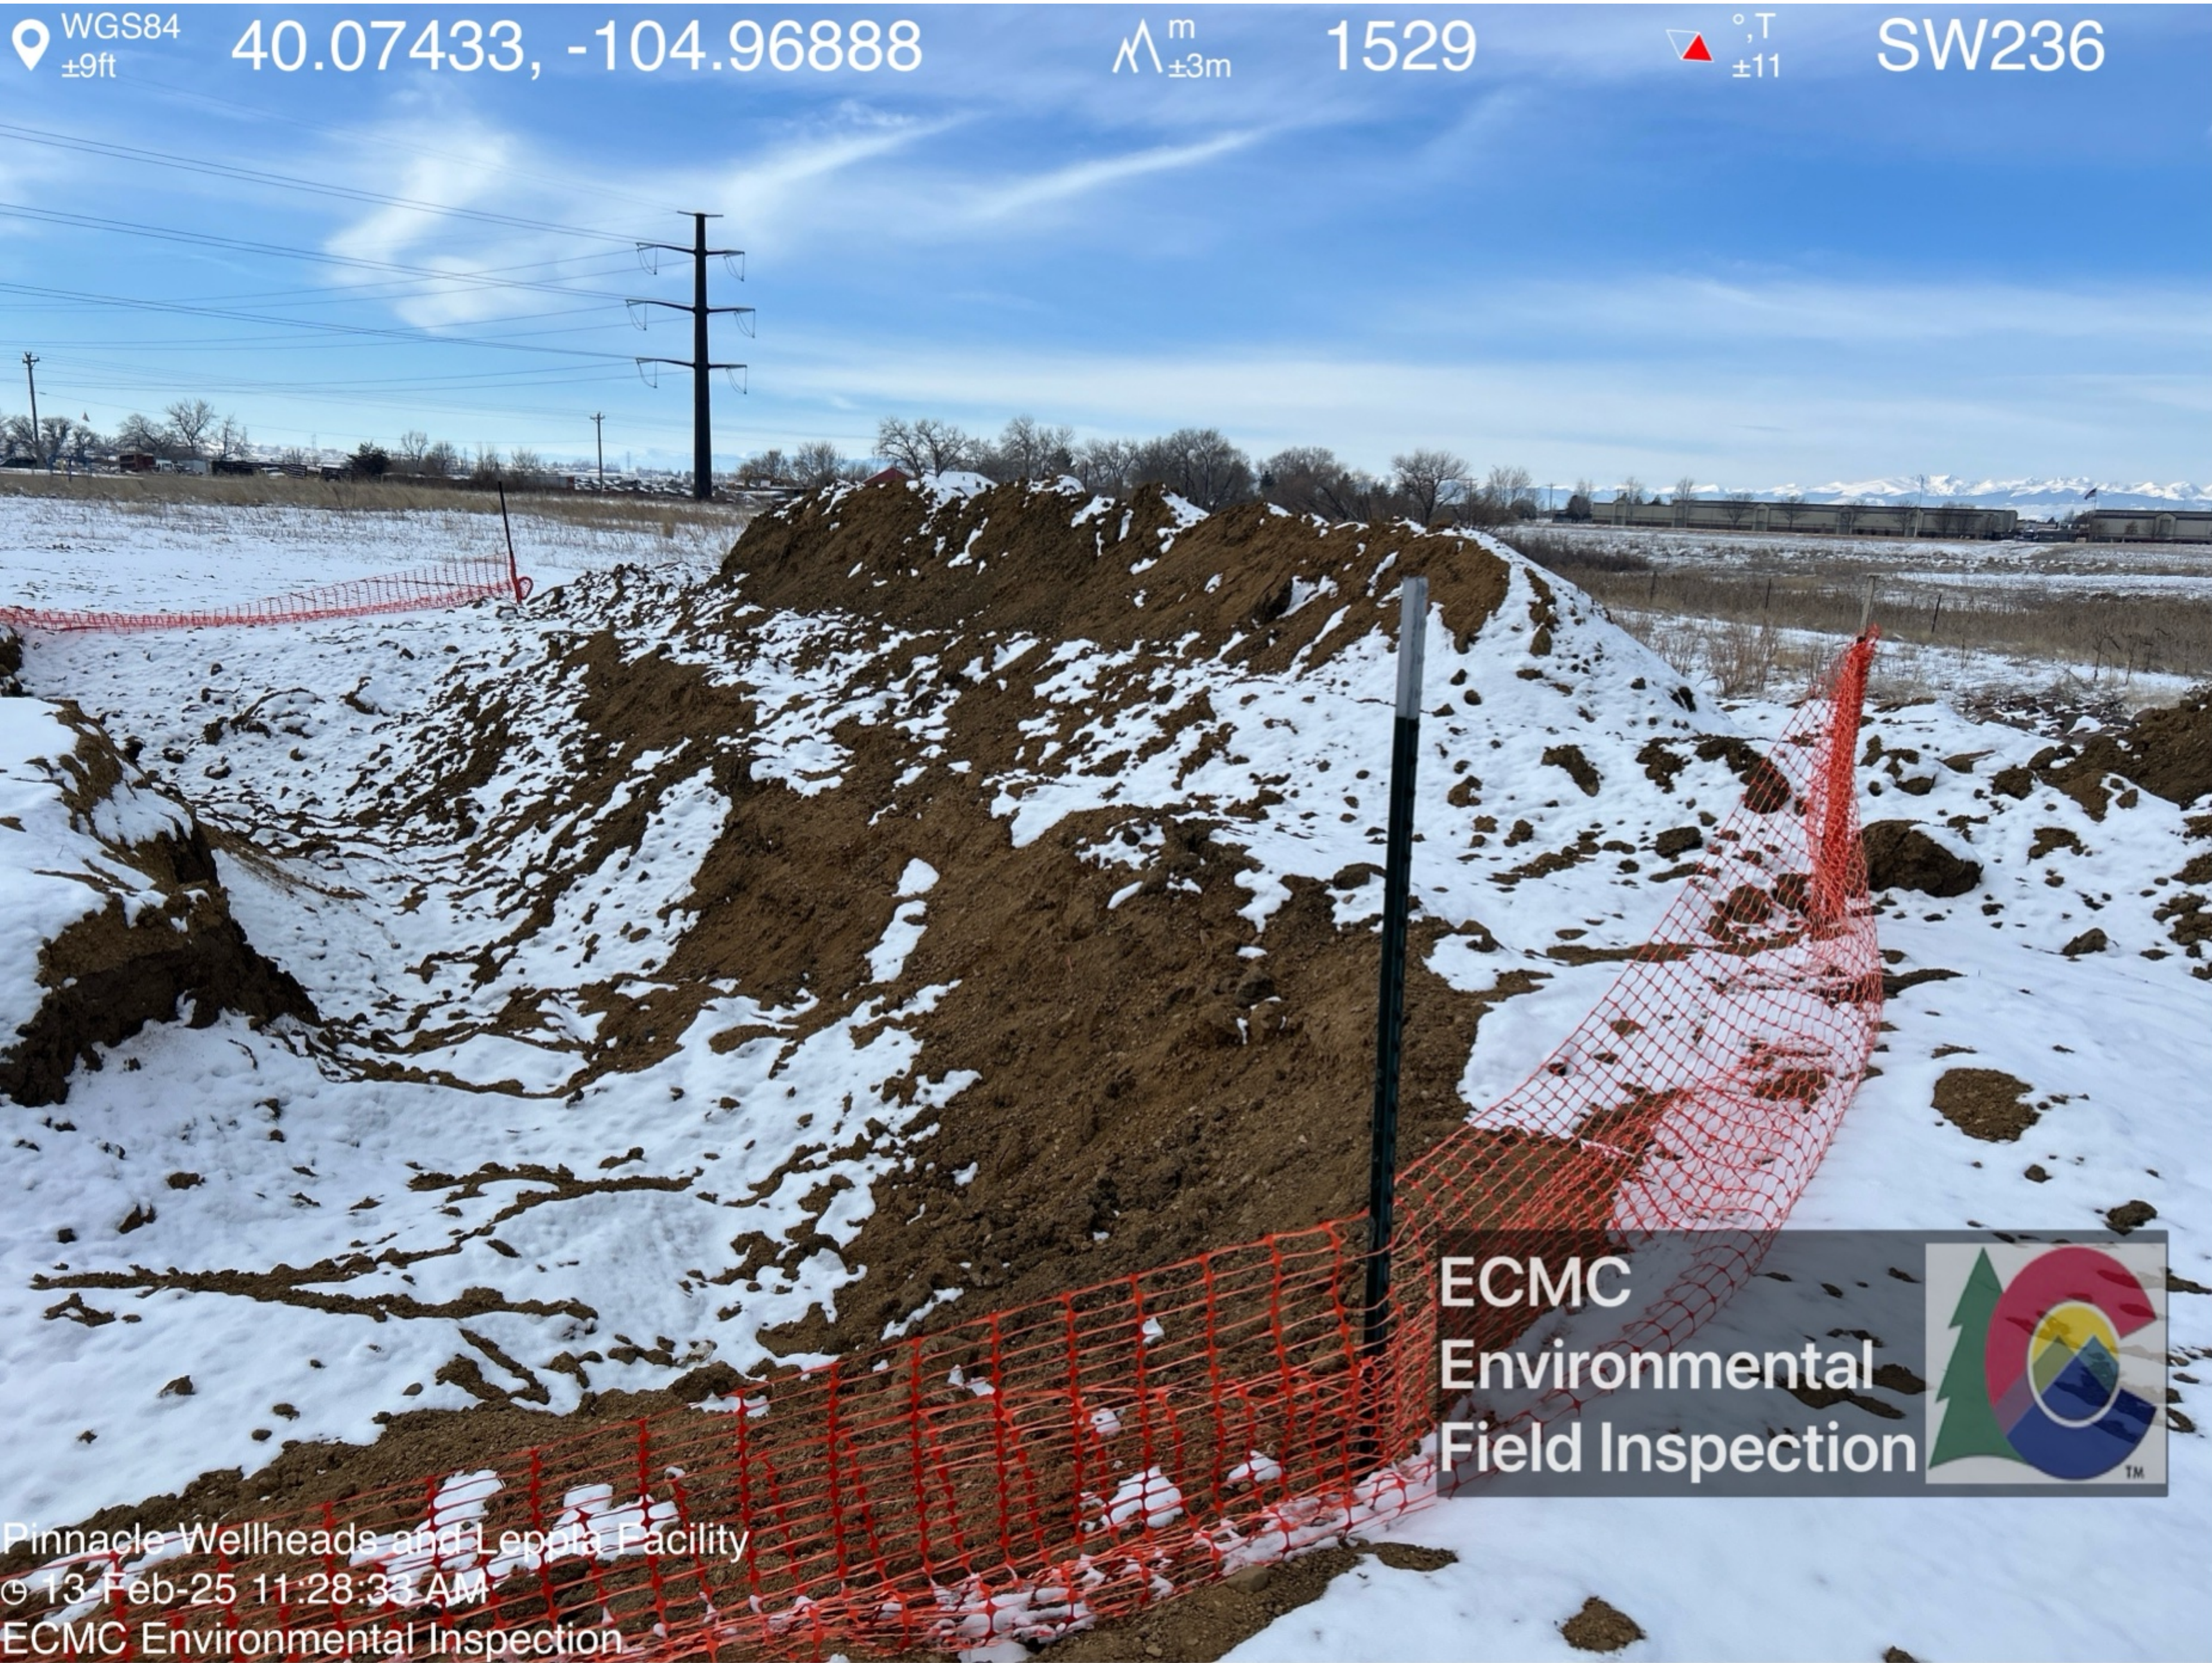
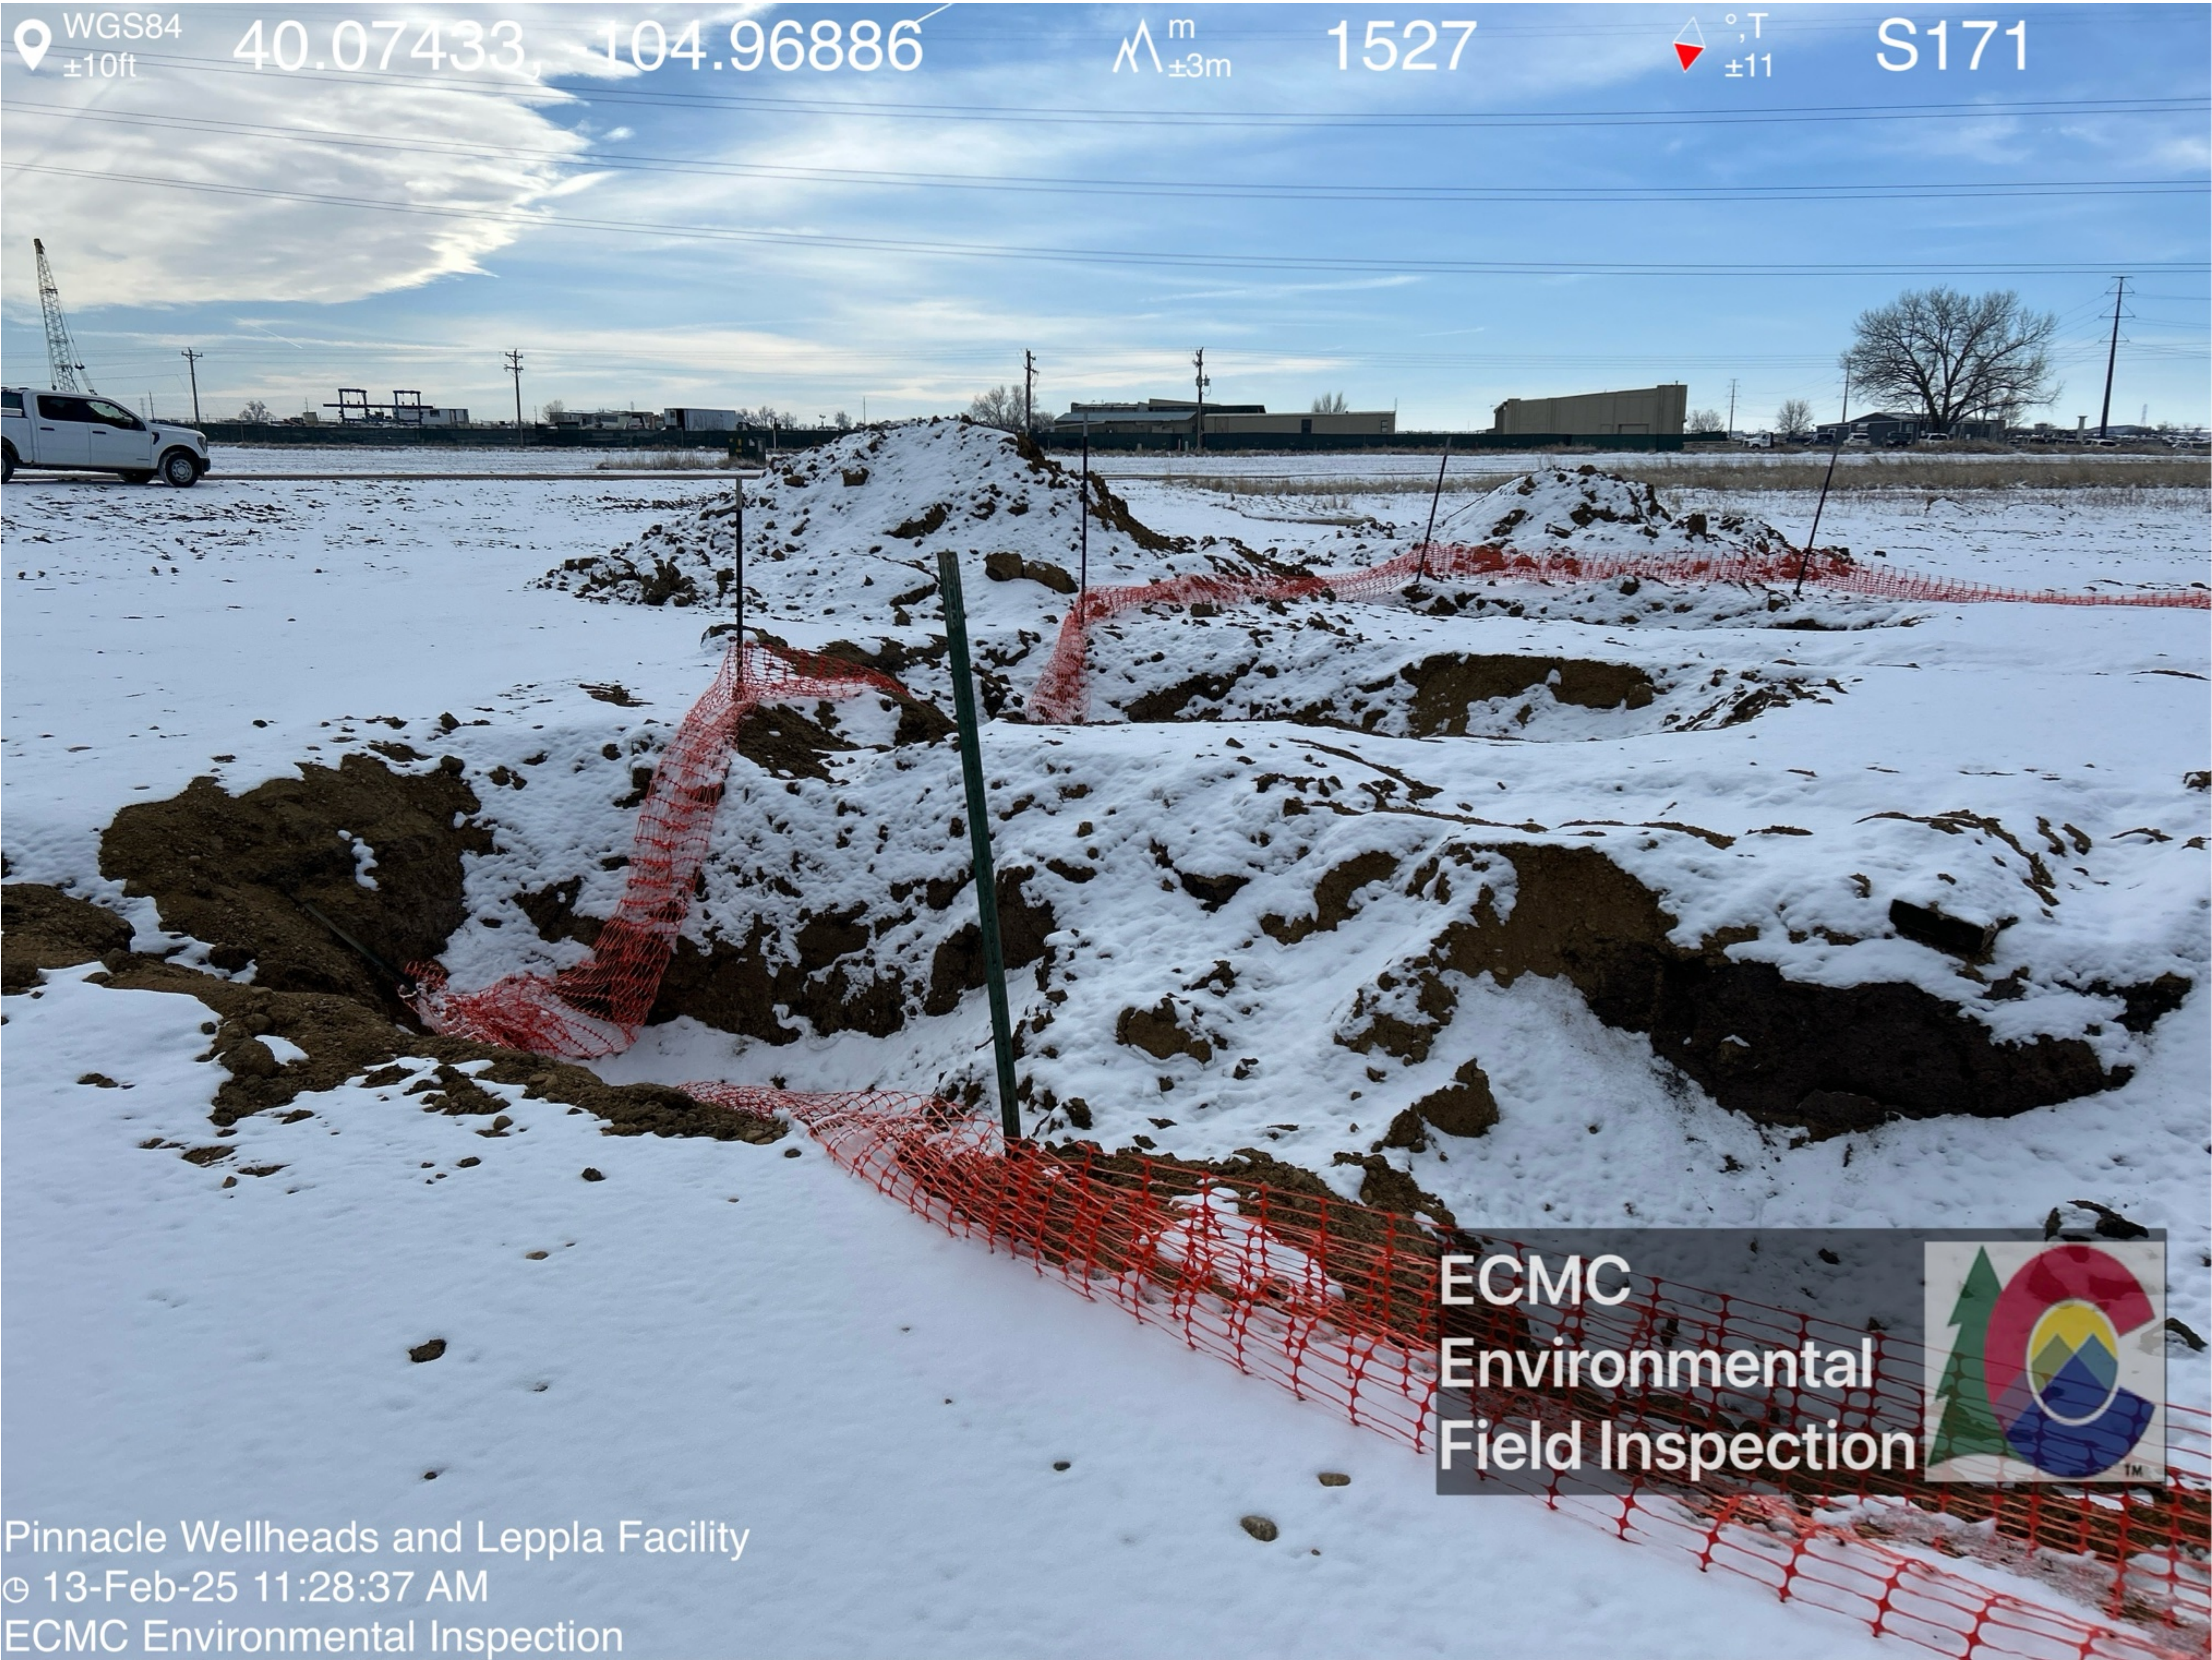
Unmarked soil stockpiles are present on location; BMPs are adequate.

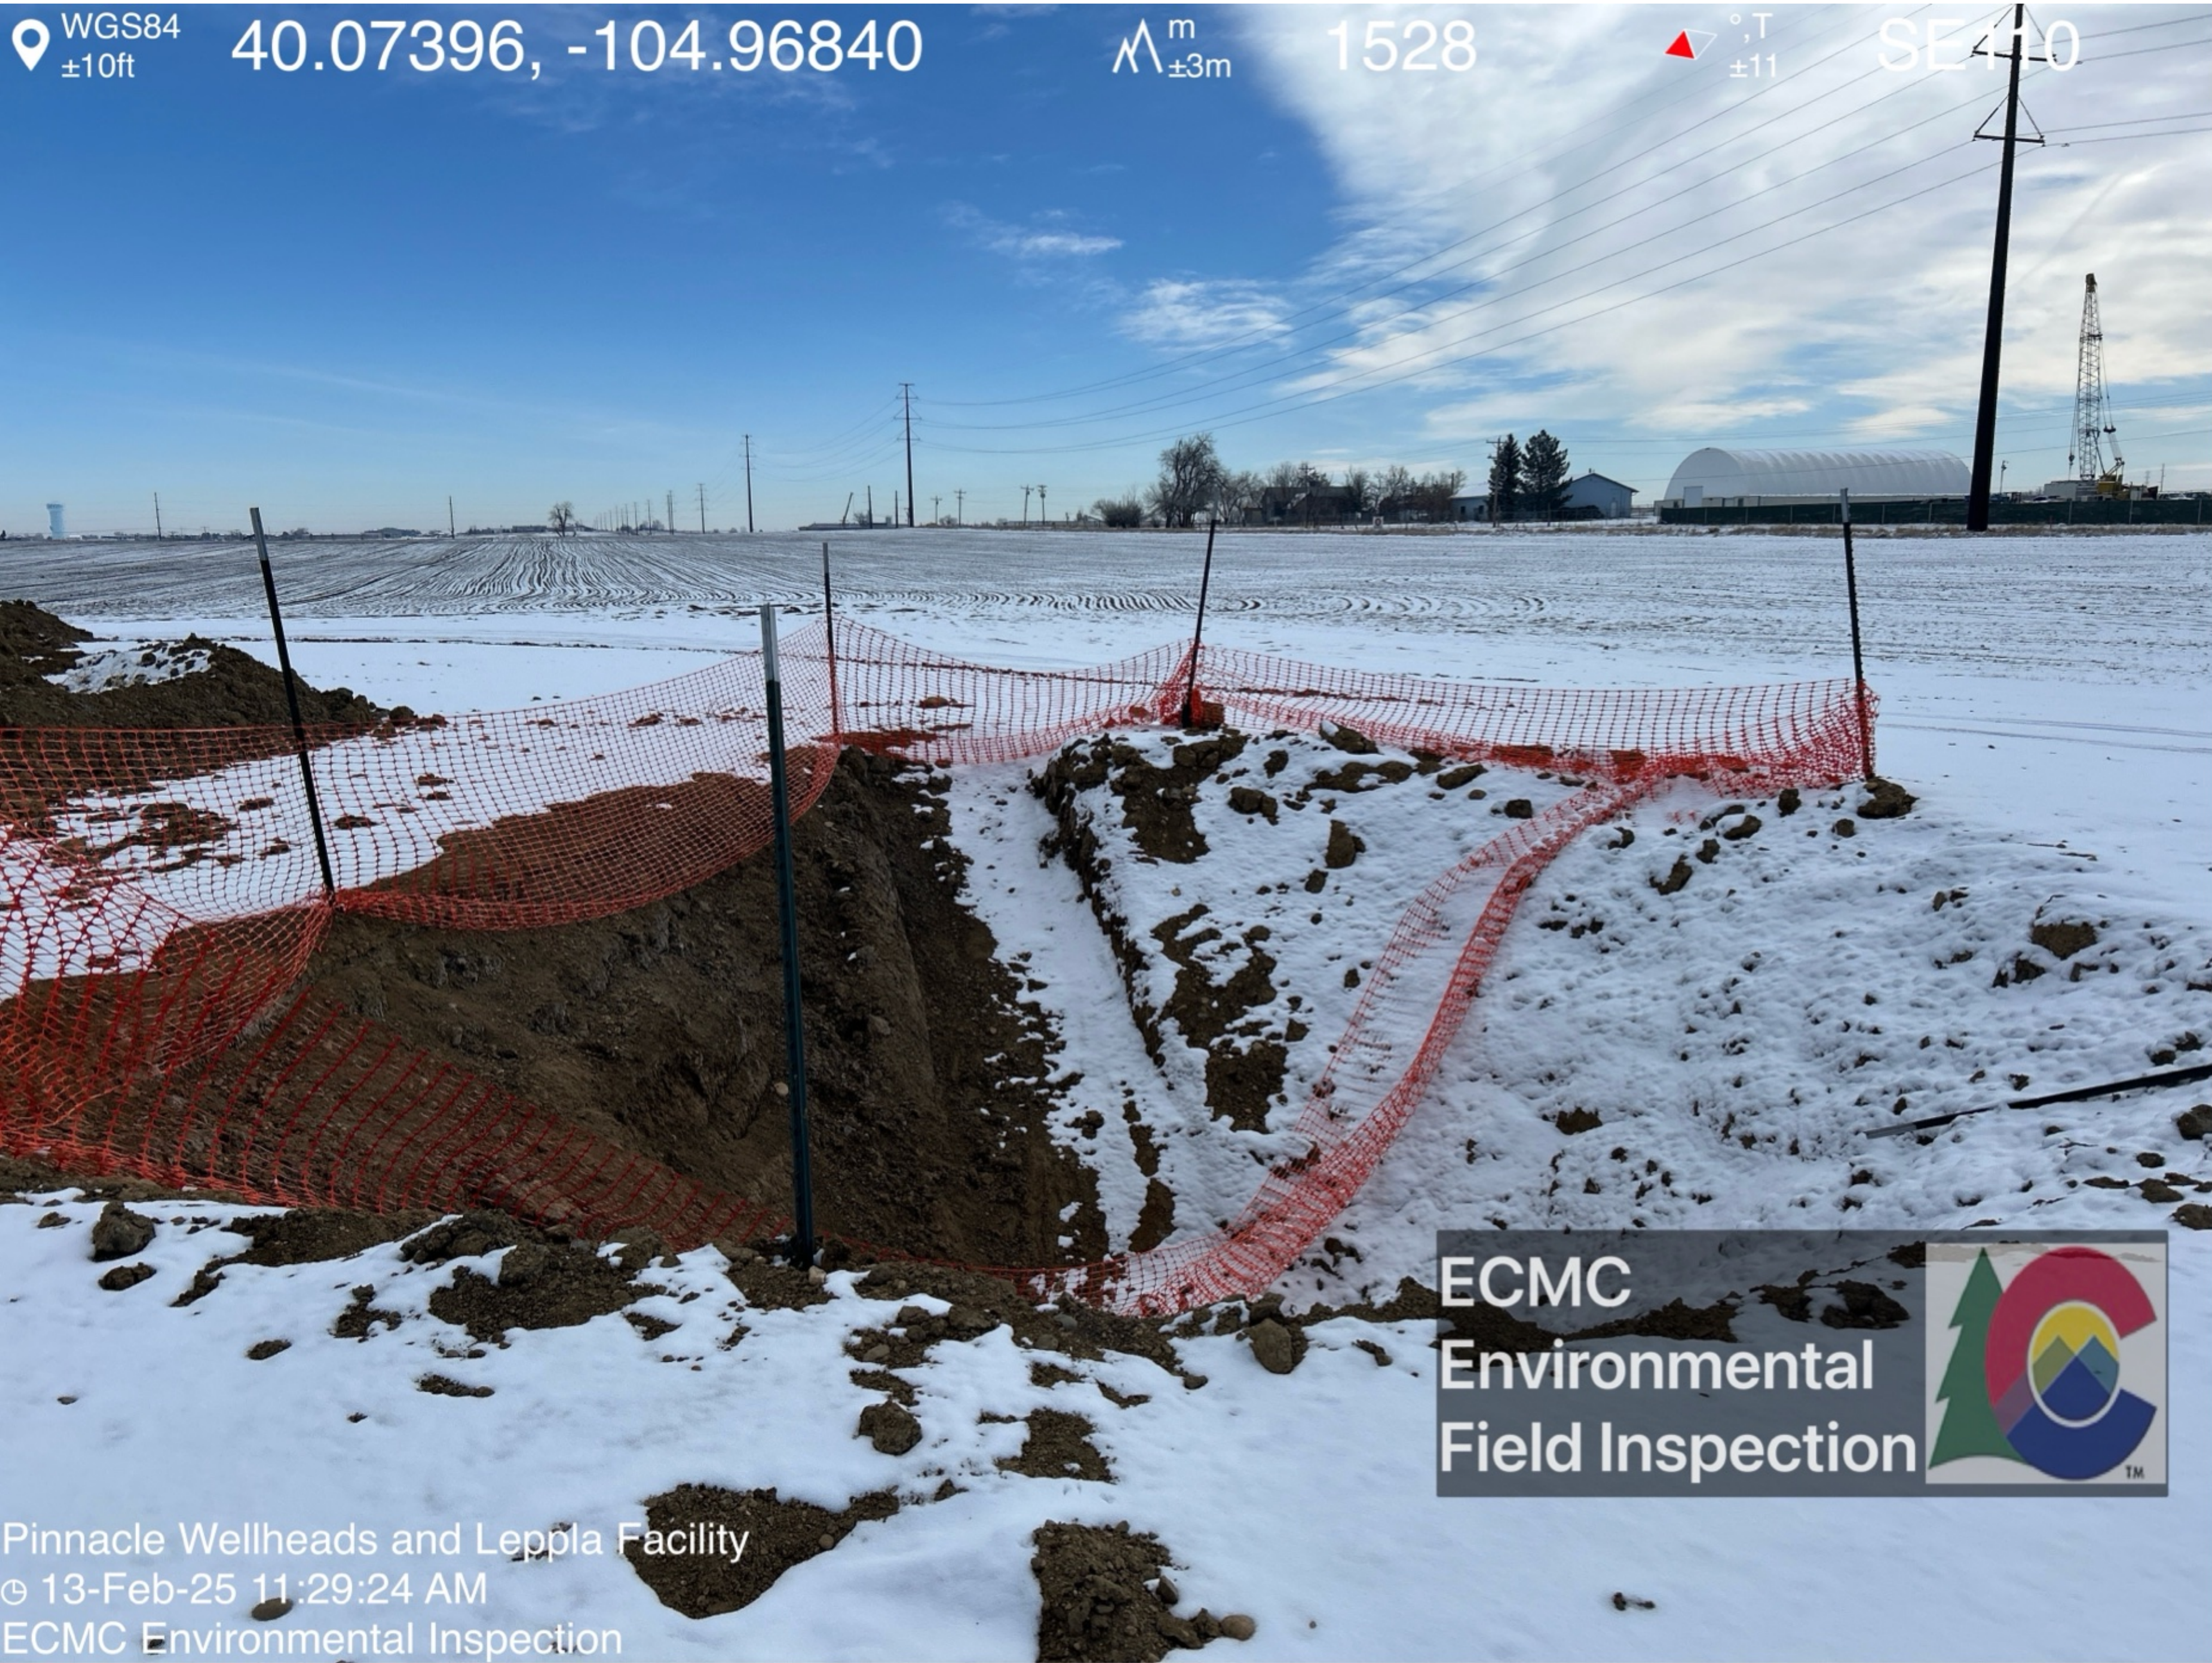
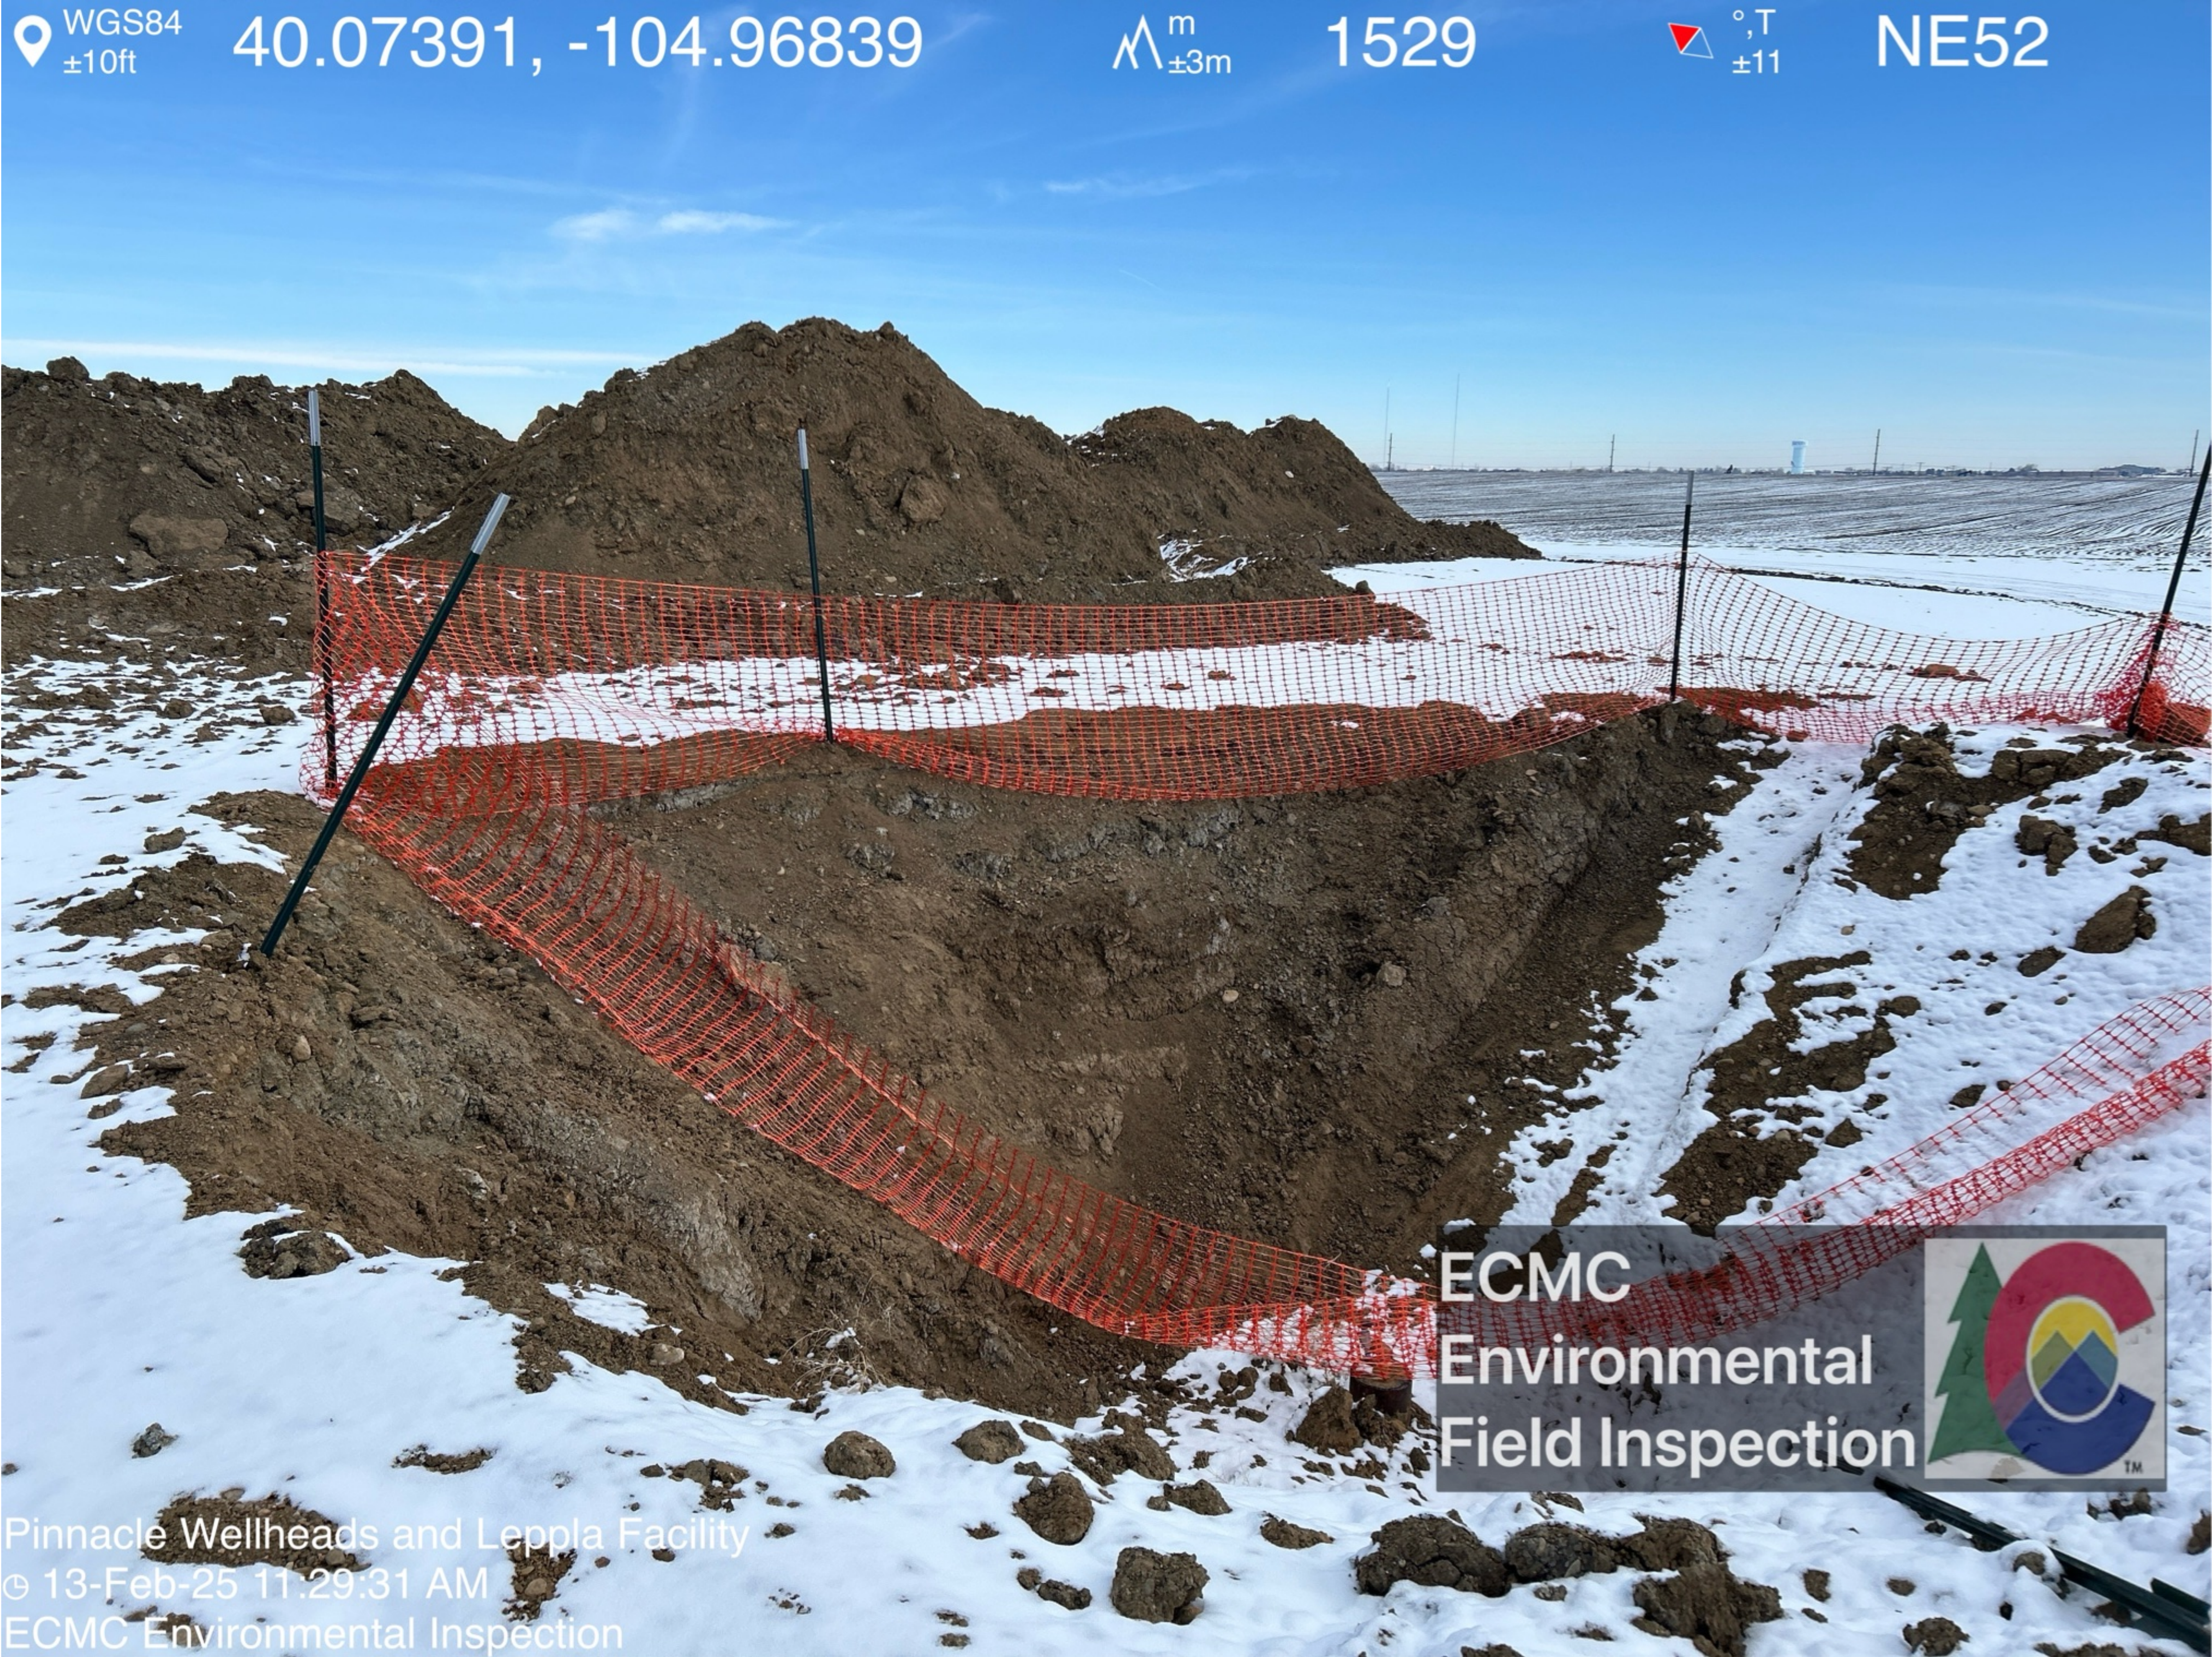
Excavation remains open at the location of the former Pinnacle 2-2HZ Wellhead. Snow has accumulated. Orange construction fencing has fallen.
