# Inspection Photos

Loc: 485654

Operator: BNL (ENTERPRISE) INC

Inspection Date: 2/21/2025

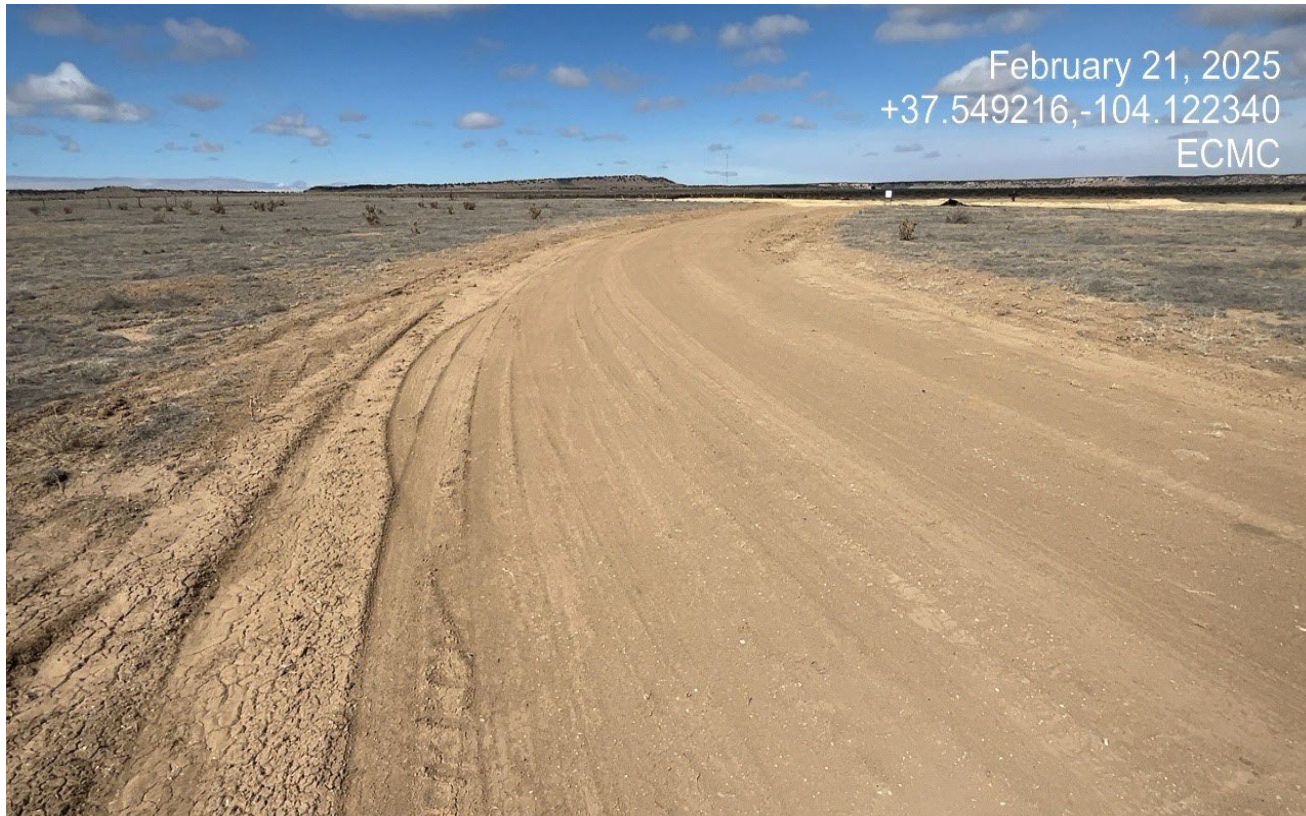
**Photo 1.** Facing west toward the access road. The side of the road needs to be seeded and stabilized. Previous corrective action was not completed.

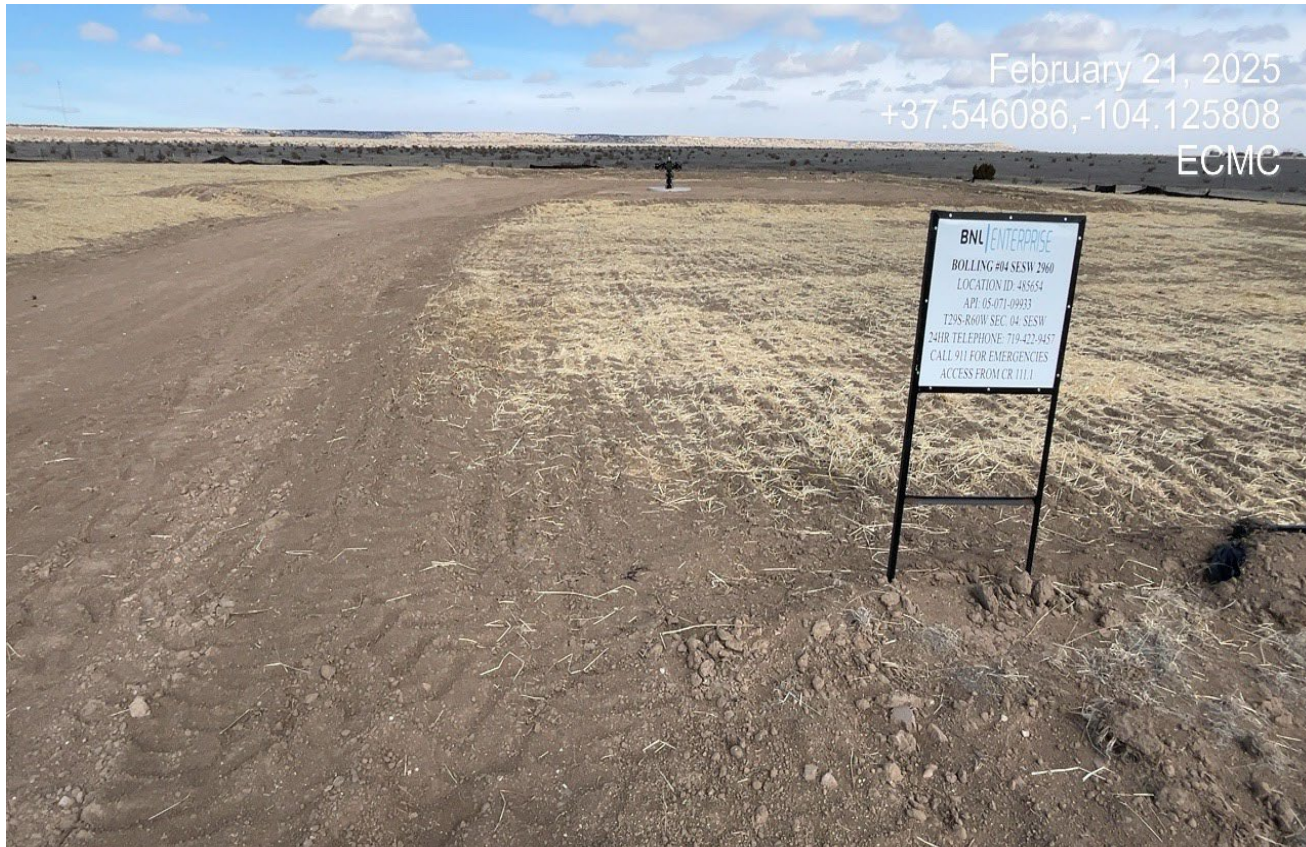
**Photo 2.** Facing northwest toward the location. Sign posted at entrance. The location has been reduced in size and reclaimed.

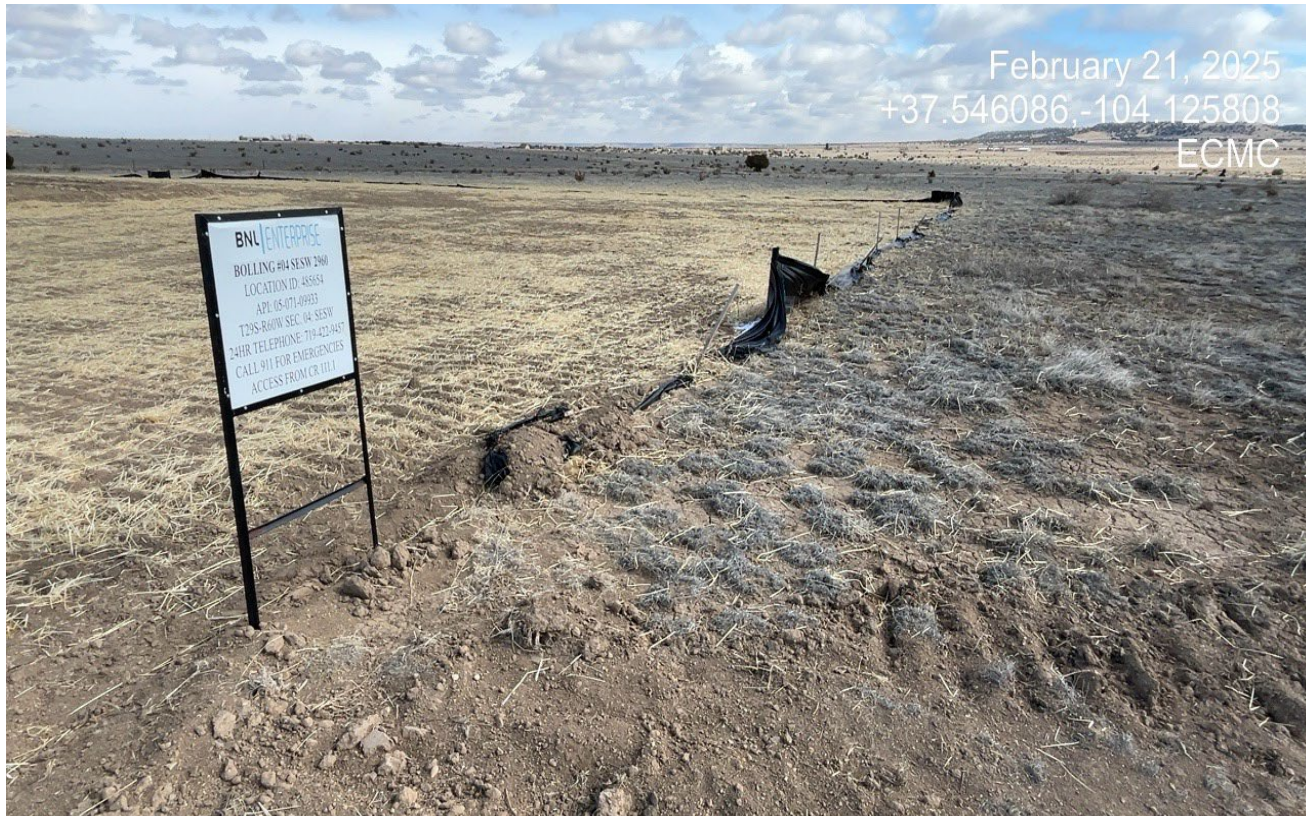
**Photo 3.** The degraded perimeter silt fence has not been repaired or removed.

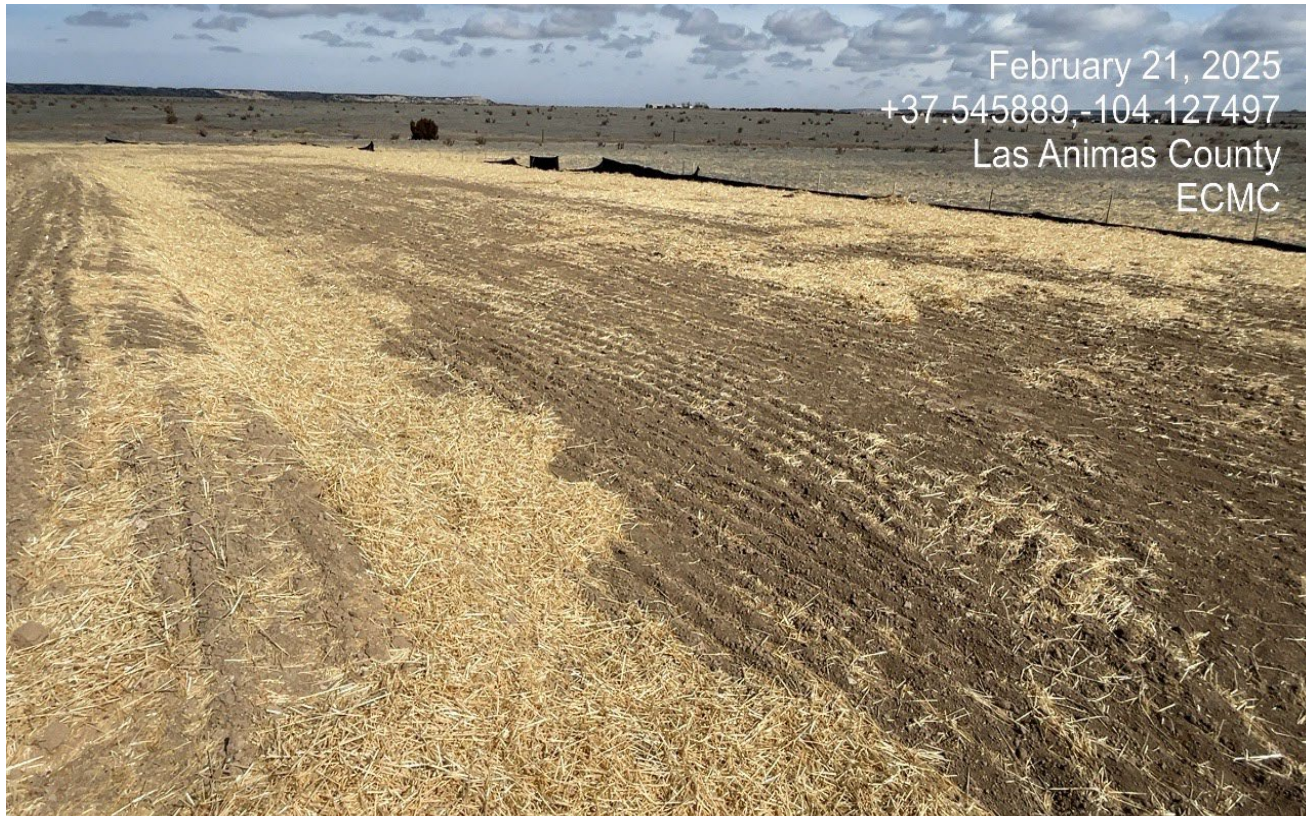
**Photo 4.** Facing northwest toward the interim reclamation area. Some of the straw mulch has blown off the seeded soil.

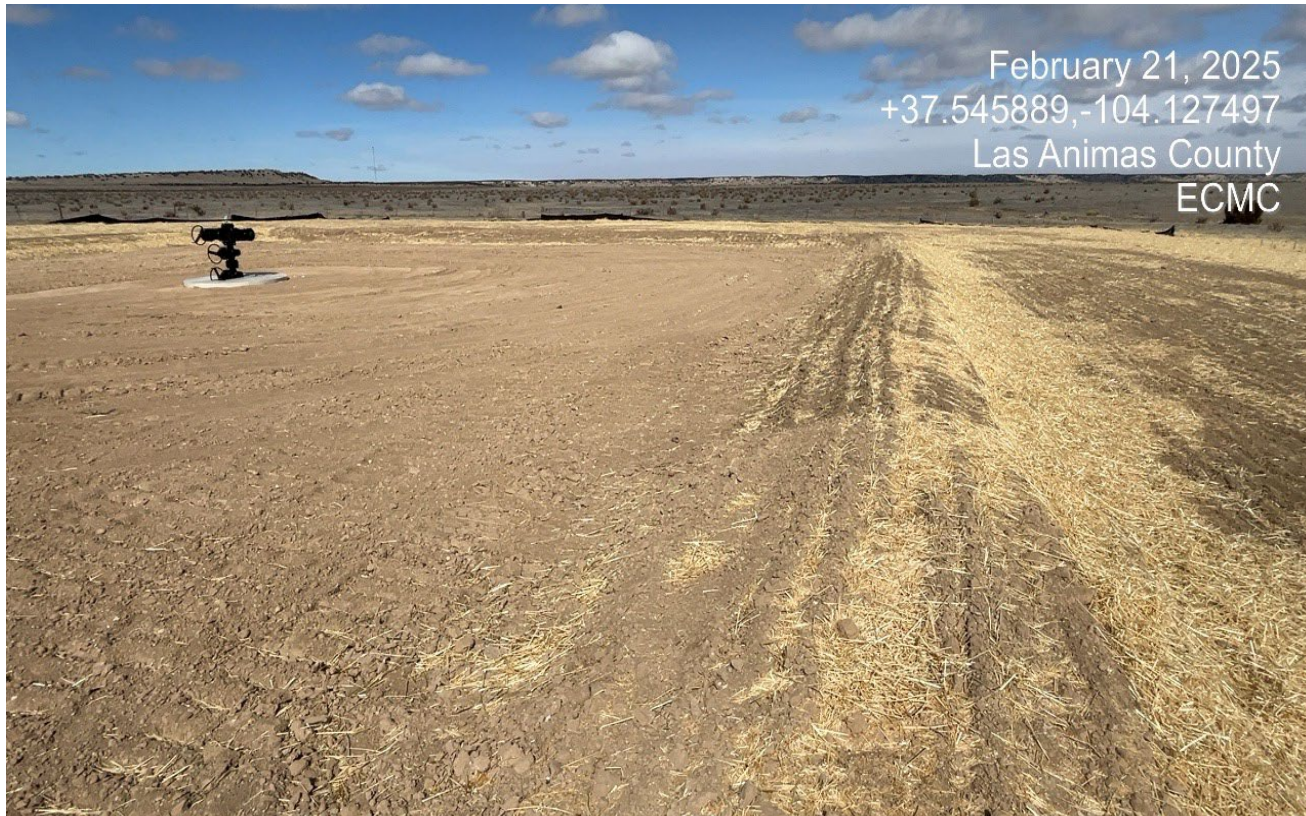
**Photo 5.** Facing northwest at the location. There is a topsoil berm around the perimeter of the pad. Stormwater drainage from the working pad surface will need to be considered.

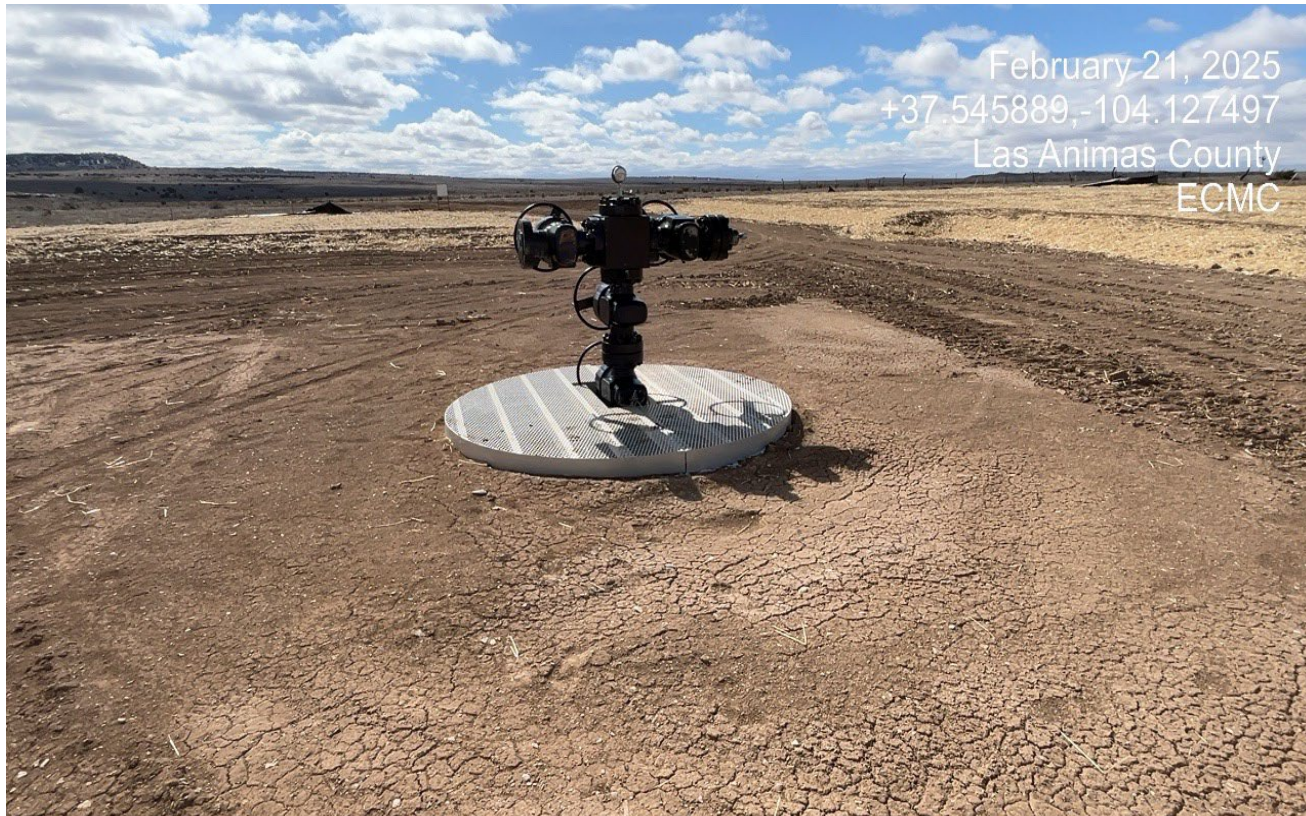
**Photo 6.** Facing toward the wellhead.
