Construction and Stormwater Inspection

Operator: BISON IV OPERATING LLC- 10670

Location ID: 486771

Inspection Document #: 697505798

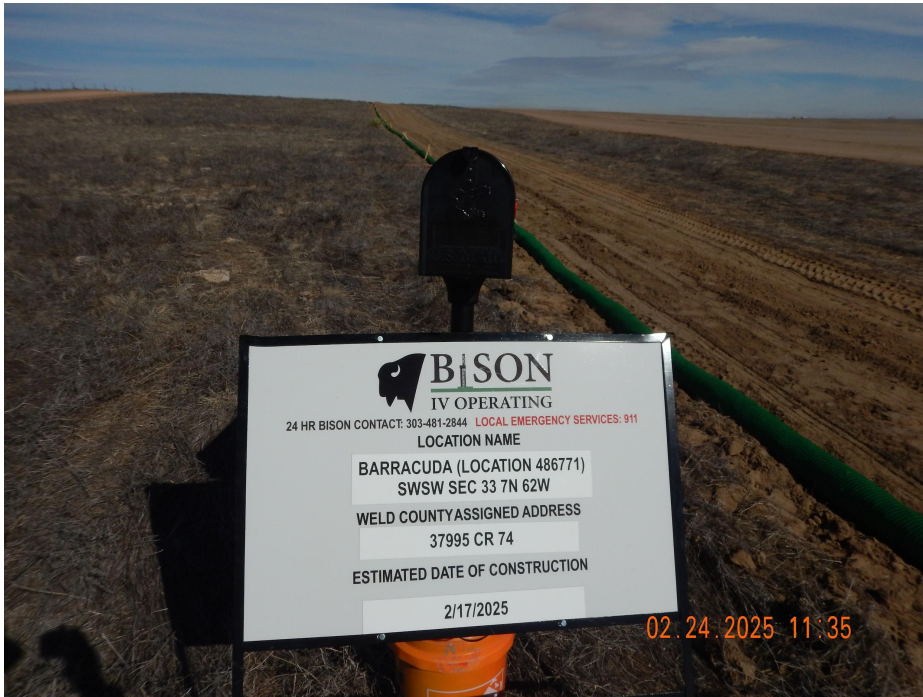
Photo 1. Photo taken from the entrance of location, facing North. Photo illustrates an Operator sign and the mailbox with permits.

Note- the Form 2A was not in the mailbox per Rule 406.c.

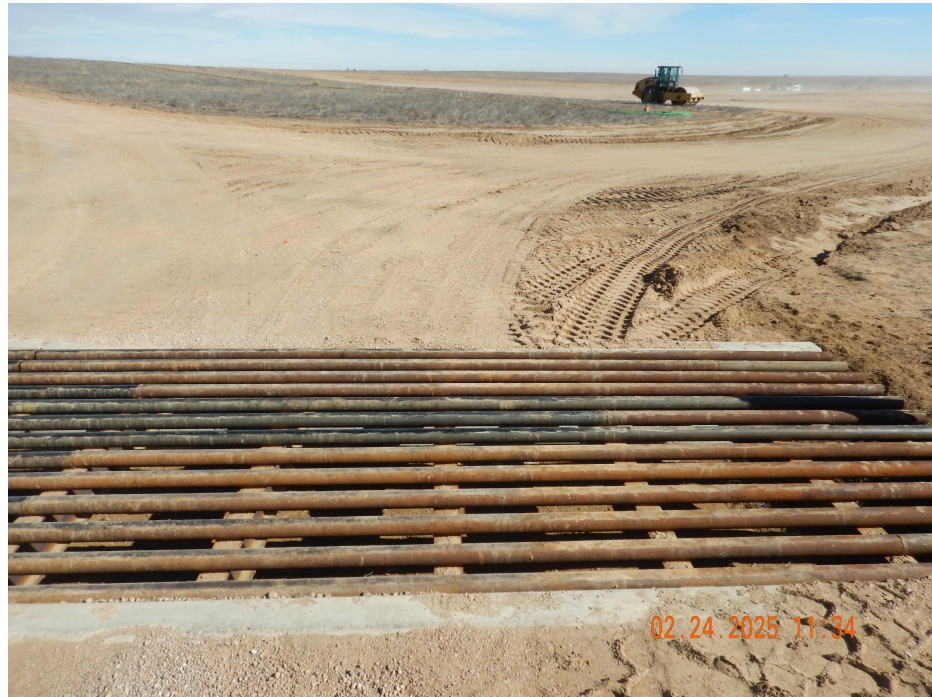
Photo 2. Photo taken west of the entrance to location, facing Northeast. Photo illustrates the Operator has installed a vehicle tracking control (VTC) device BMP. Operator plans to install an addition VTC near the Operator sign shown in Photo 1.

At the time of this inspection, there were no track out issues observed.

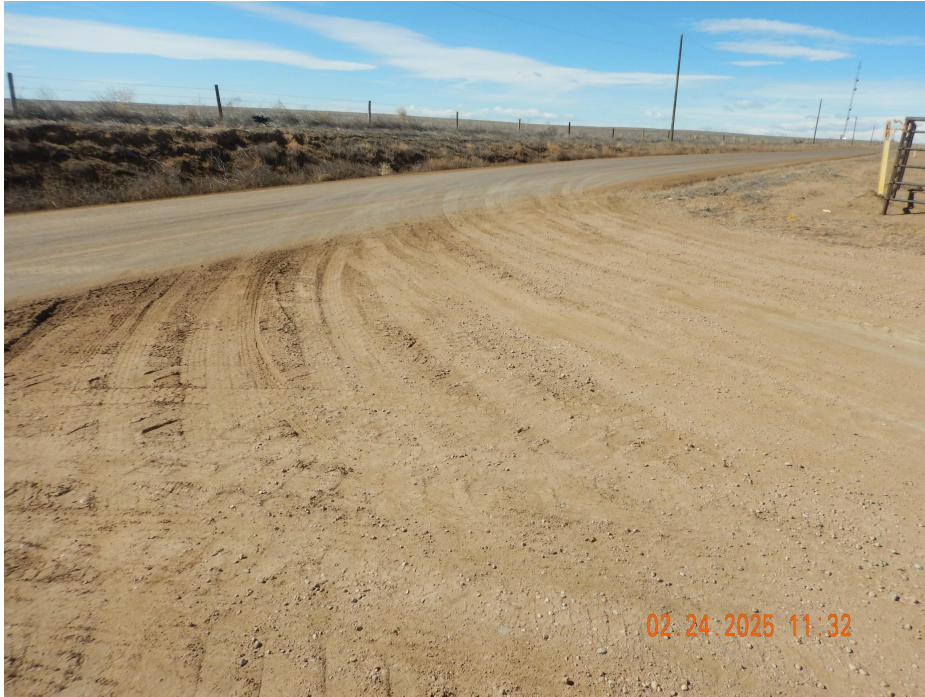
Photo 3. Photo taken from the entrance of location off CR 74, facing Southwest. Photo illustrates there was no track out issues observed at the time of this inspection.

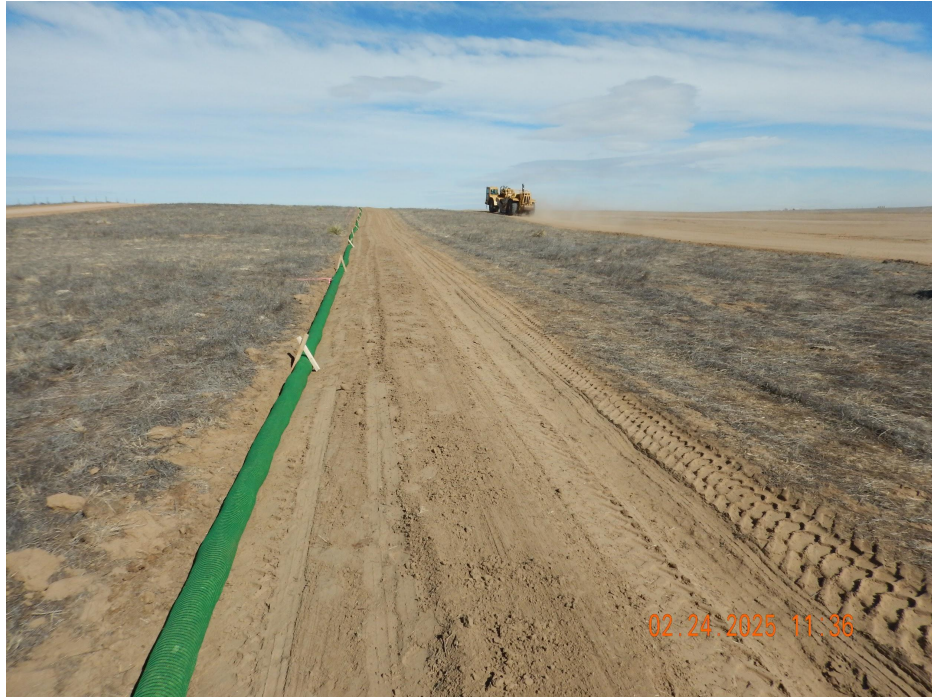
Photo 4. Photo taken from the western portion of location, facing North. Photo illustrates a perimeter stormwater BMP (ditch and berm with filtrex wattles) have been installed along the entire perimeter of location.

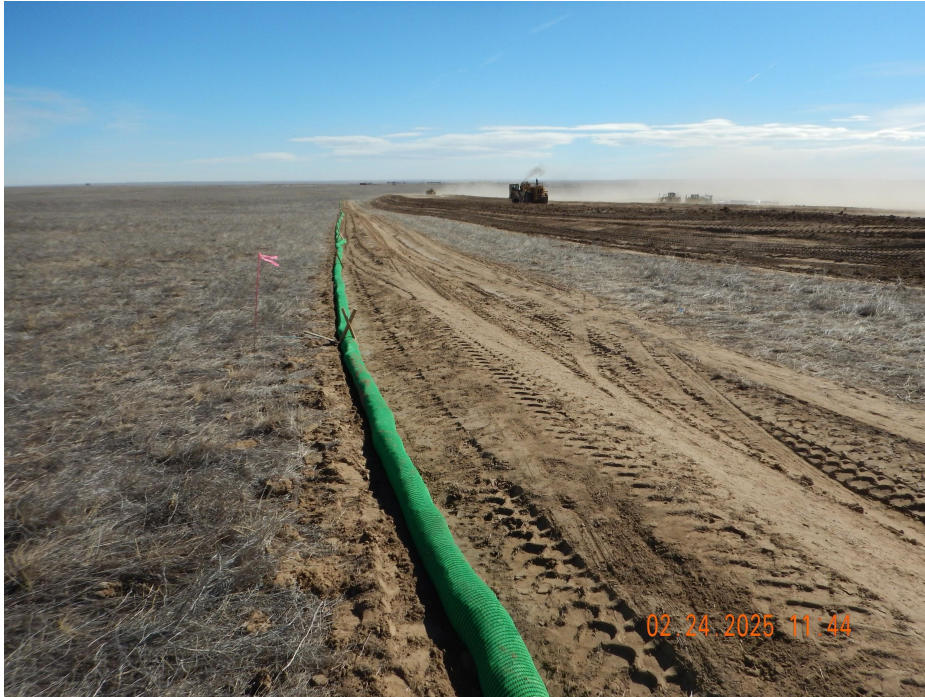
Photo 5. Photo taken from the northwestern perimeter of location, facing East. See comments under Photo 4.

Note- fugitive dust was observed during construction activities and can be observed in the background of the photo.

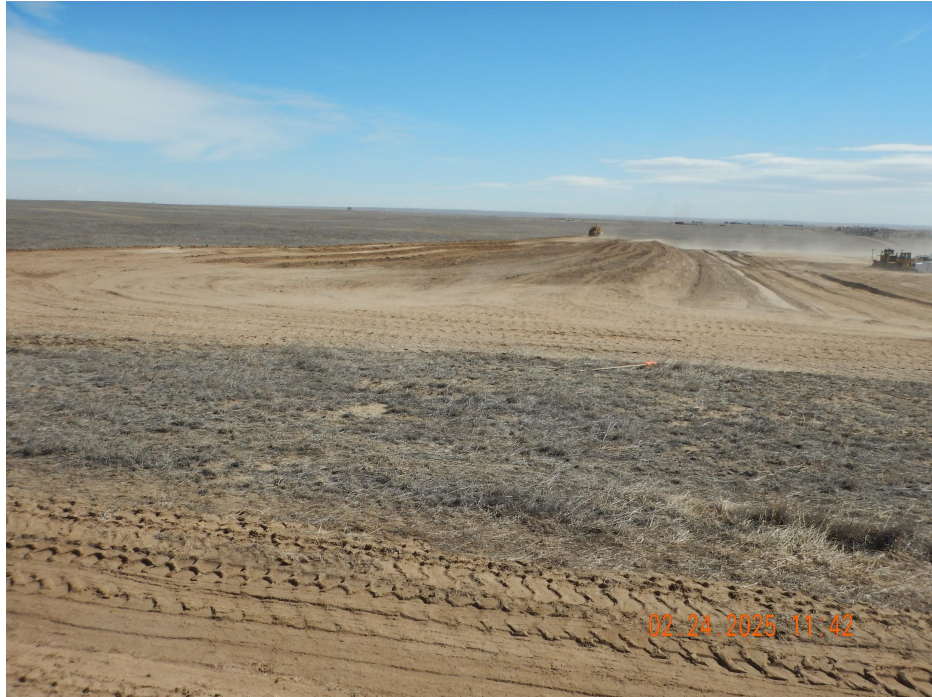
Photo 6. Photo taken from the northwestern perimeter of location, facing East. Photo illustrates the topsoil stockpile being stored along the northern perimeter of location.

At the time of this inspection, the Operator was performing topsoil salvage operations.

Note- fugitive dust was observed during construction activities and can be observed in the background of the photo.

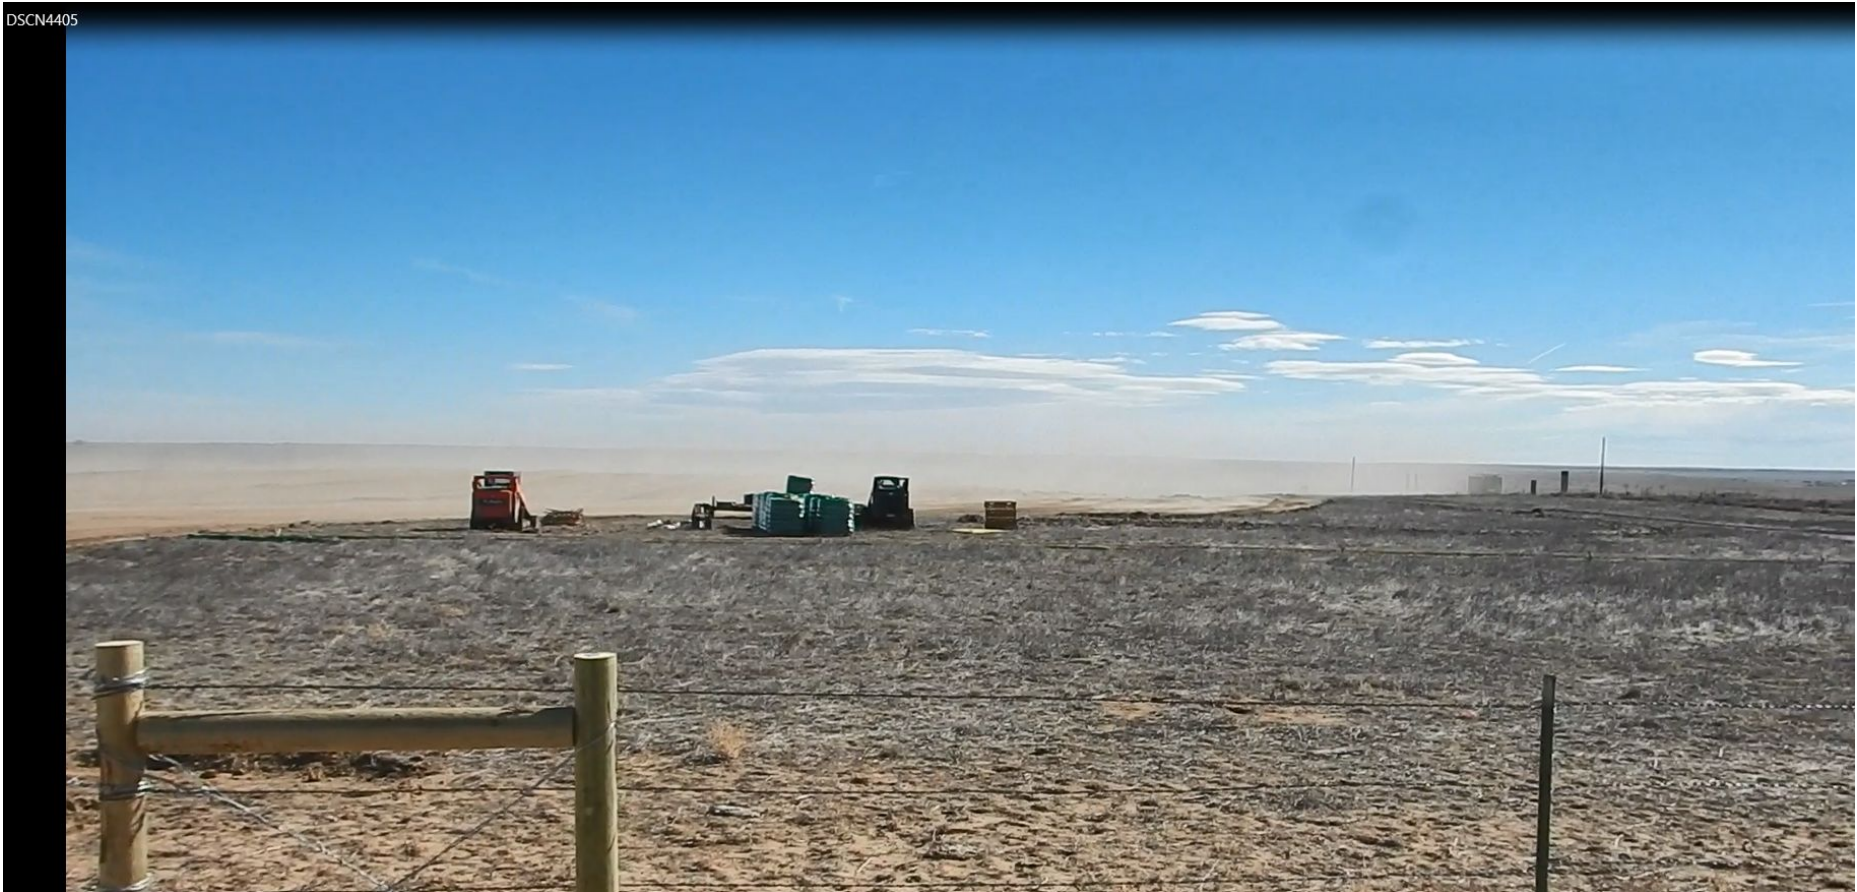
DSCN4405

Photo 7. This is a screenshot from a video taken approximately at 10am illustrating fugitive dust from construction activities that blew in a southeastern direction.

Note- fugitive dust inhibits the background landscape.

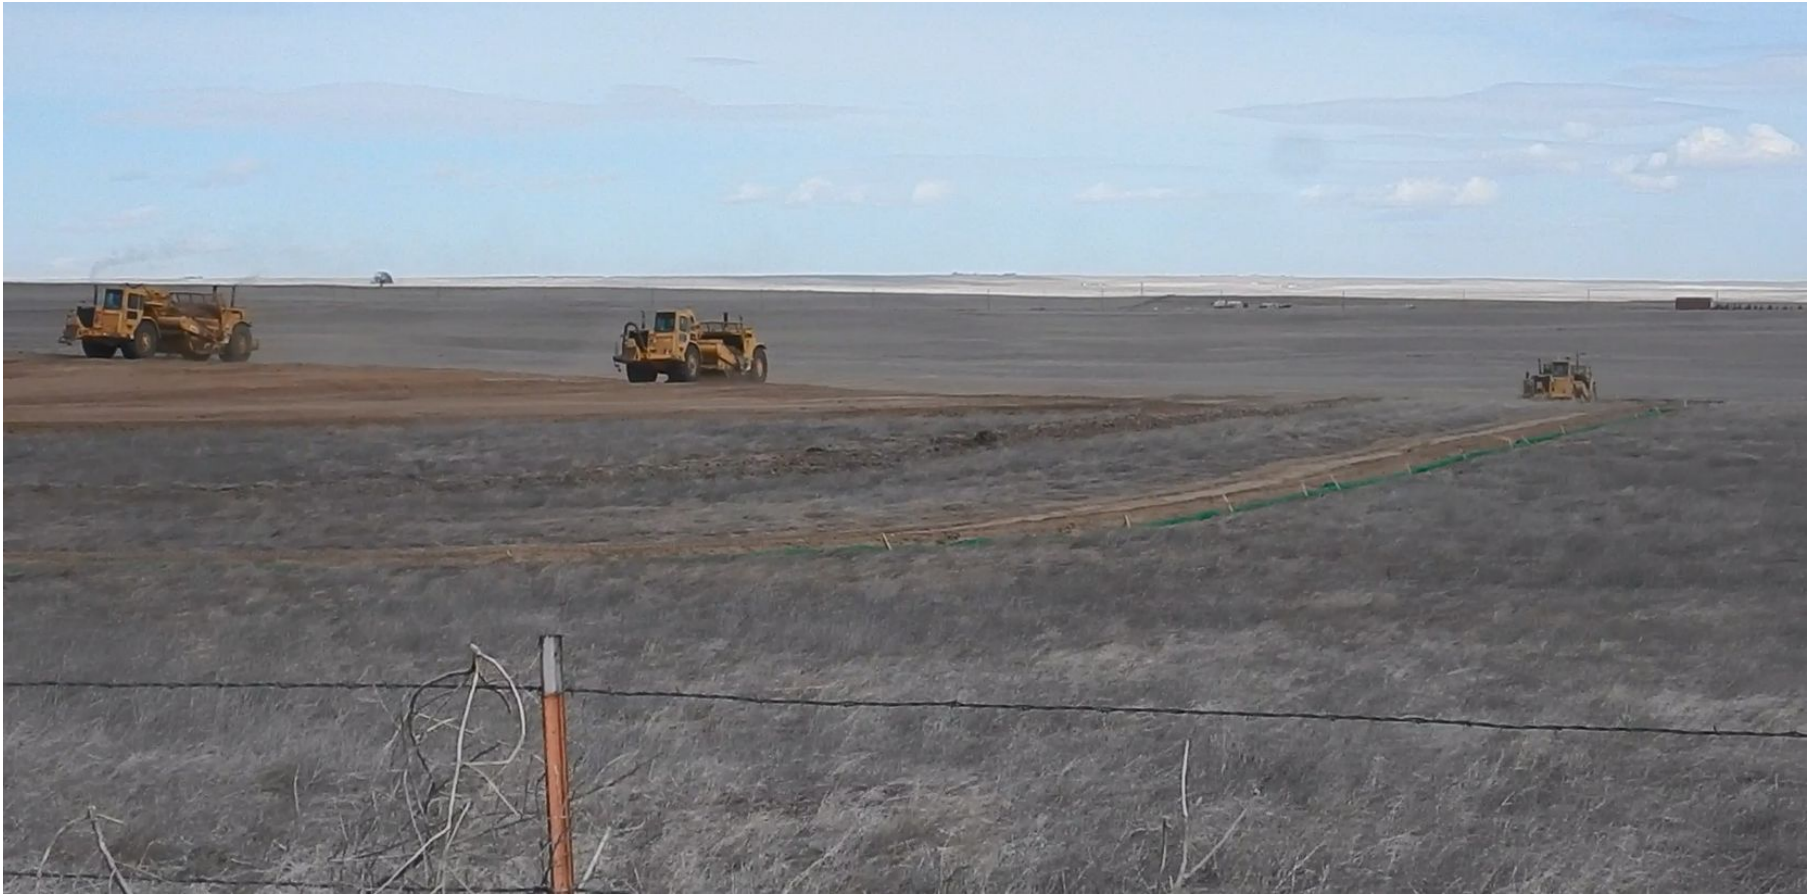
Photo 8. This is a screenshot from a video taken approximately at 2pm illustrating fugitive dust has been mitigated from construction activities.

Note- the background landscape is visible now.
