Inspection Photos

Operator: SCOUT ENERGY MANAGEMENT LLC
- 10779

Location ID: 314456

Inspection Doc: 718100270

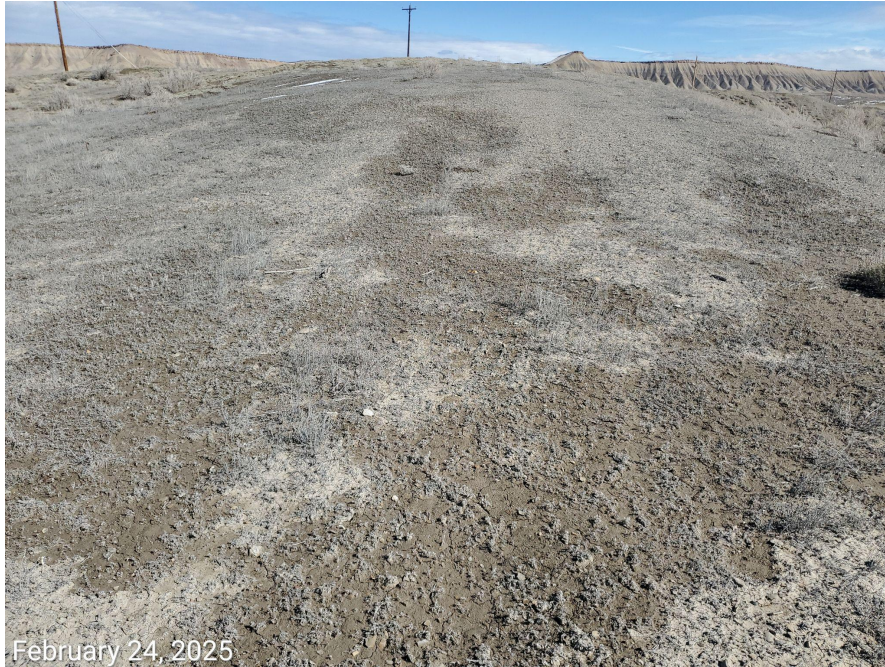
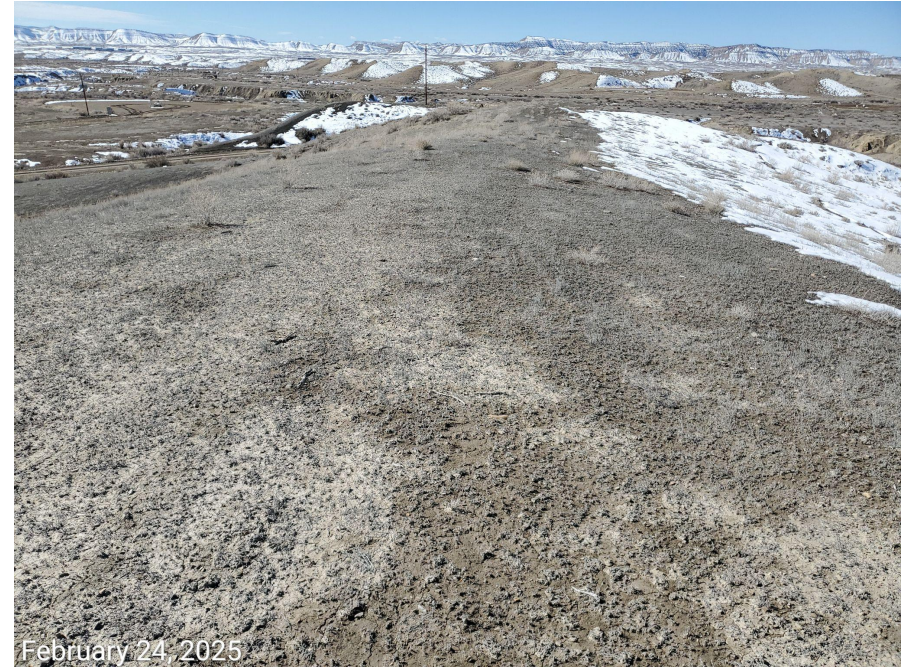
Photo 1: Photos 1-2 examples showing Location does not appear to be progressing towards 1004.c.(2) revegetation requirements; Location appears to be predominantly bare and exposed soils with sparse perennial vegetative establishment. A follow-up inspection will be conducted during the 2025 growing season to determine if perennial germination is occurring, and whether additional reclamation efforts are required.

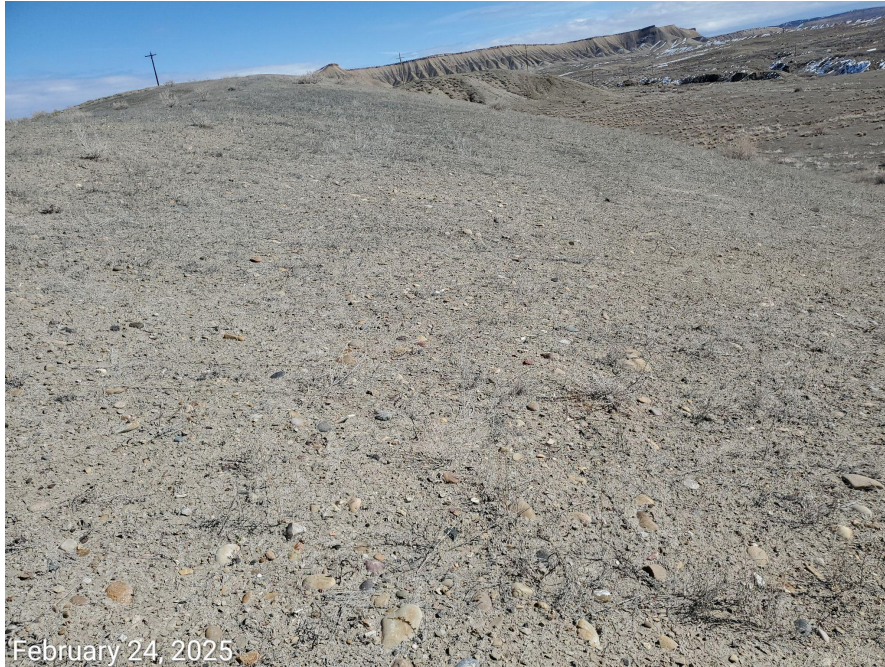
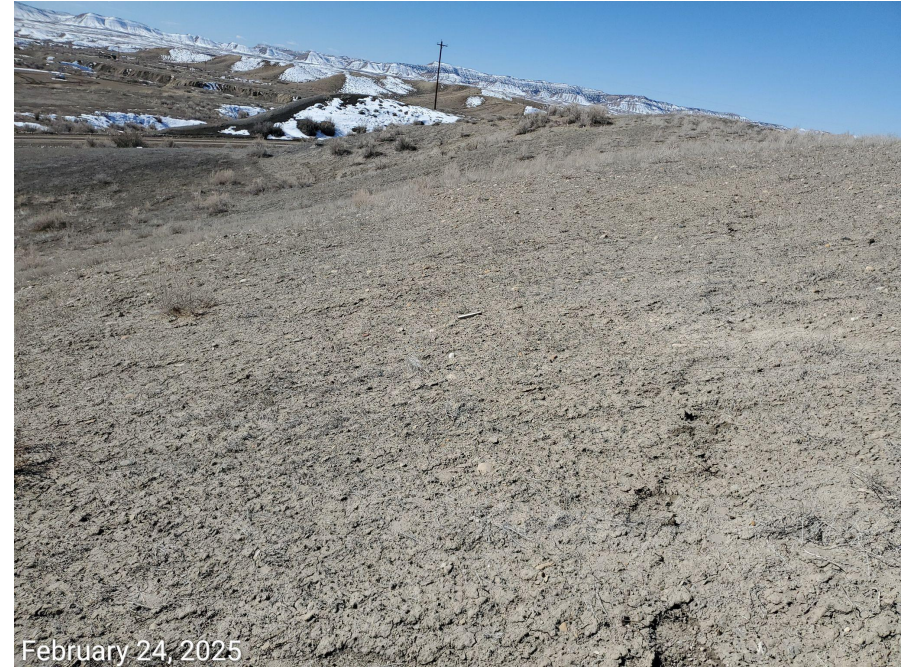
Photo 2: See comments under photo 1.

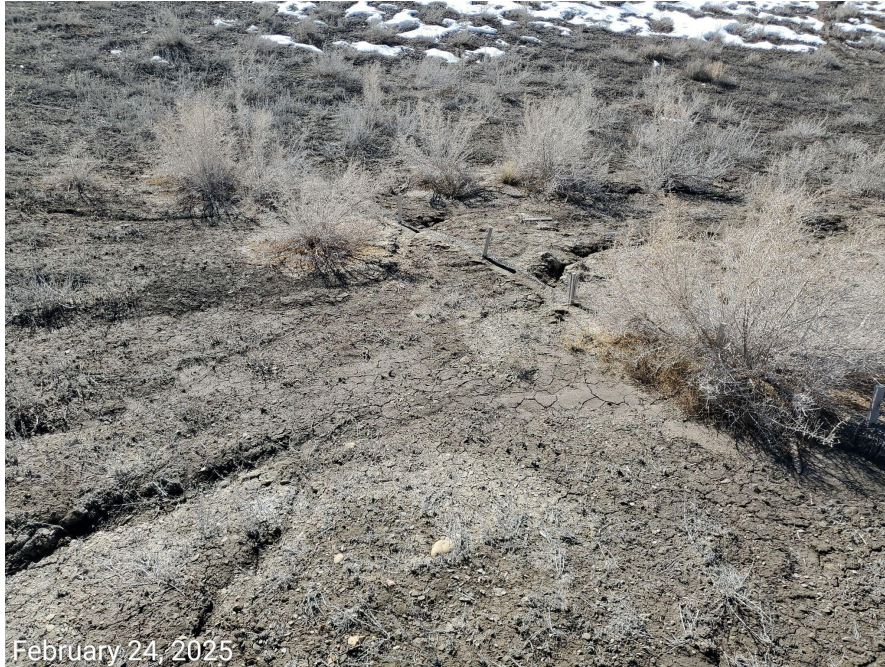
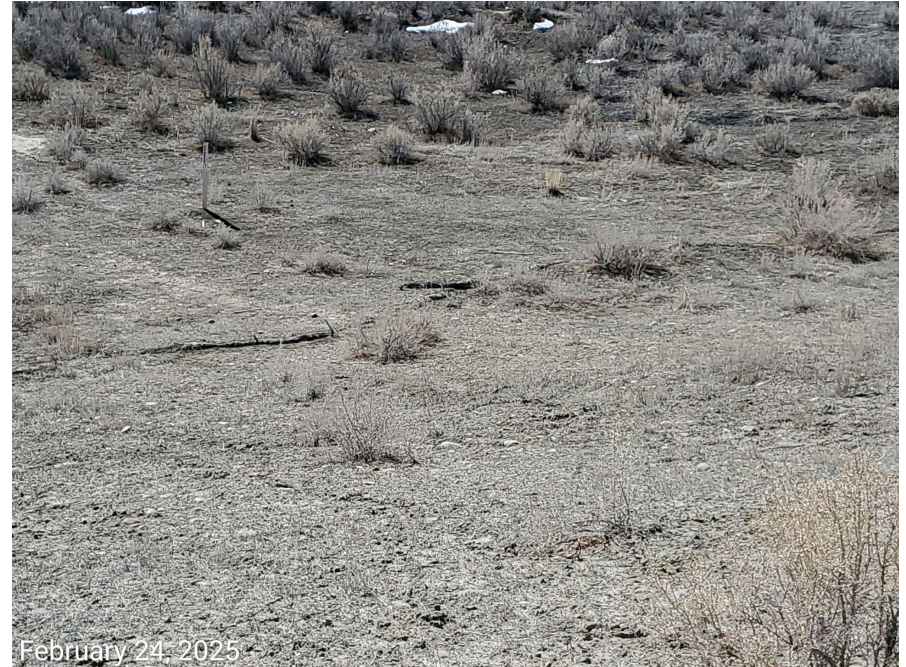
Photo 3: Photos examples showing stormwater and erosion control BMPs are missing or insufficient. Erosion logs are no longer in proper functioning condition. No other BMPs appears to have been implemented in conjunction with the erosion logs. This is not per good engineering requirements.

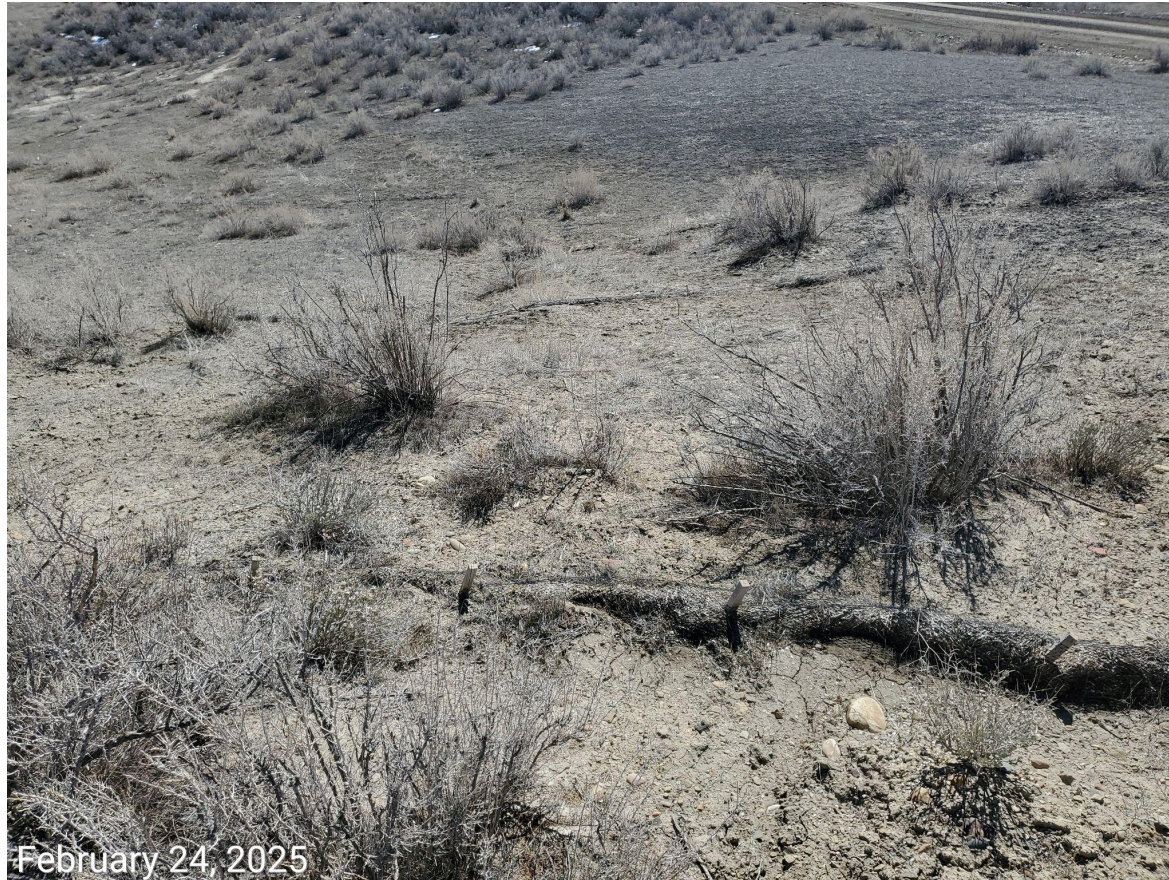
Photo 4: See comments under photo 3.
