## Inspection/Audit Photos

Location Name: TEP ROCKY MOUNTAIN LLC MCLAUGHLIN 42A-27 Pad

Location ID: 335082

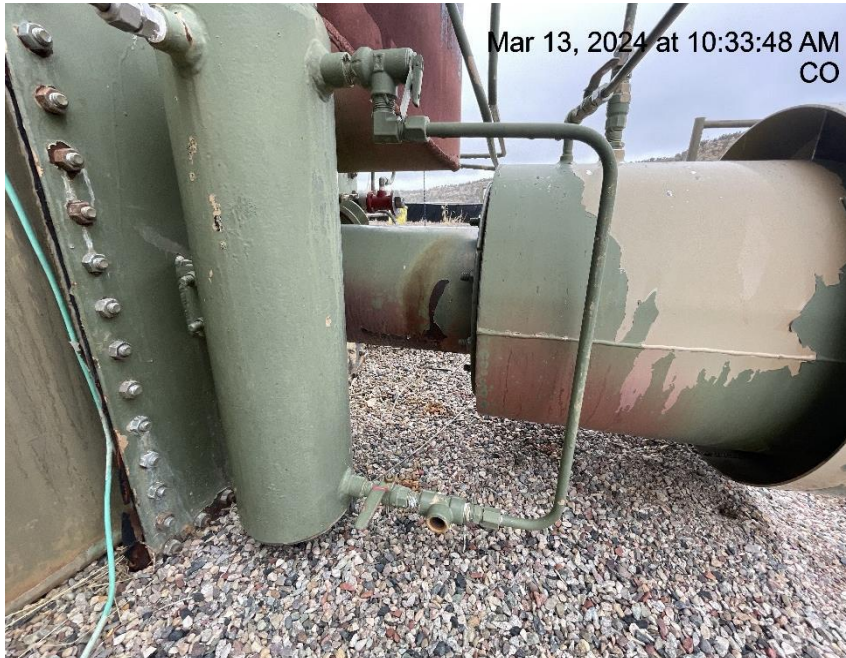
**Photo # 9624 From inspection 708903284 conducted on 03/13/2024 PRV vent line on tank burner terminates in an unsafe manner/does not comply with CECMC pressure safety device rules & general safety rules.**

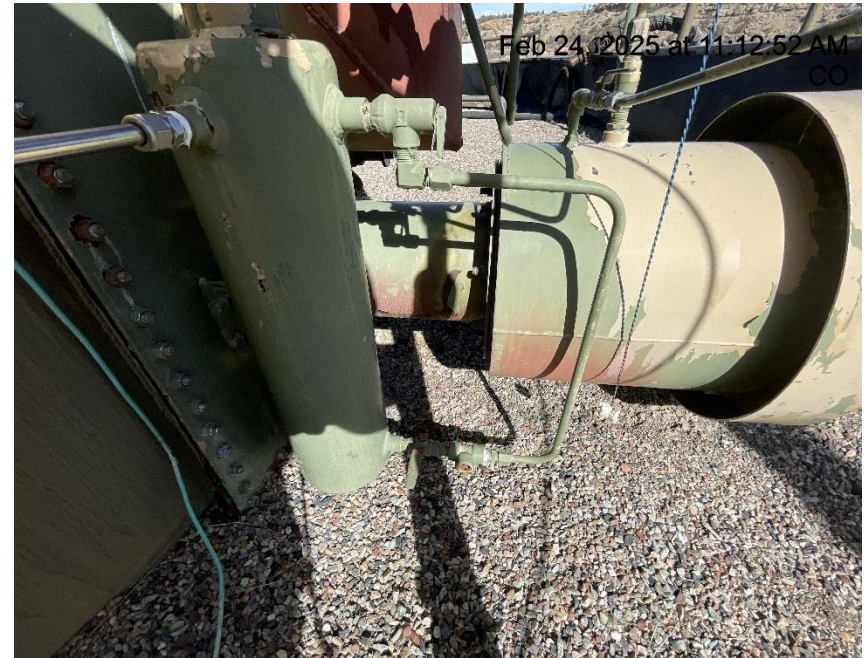
**Photo # 8014 PRV vent line on tank burner terminates in an unsafe manner/does not comply with CECMC pressure safety device rules & general safety rules.**

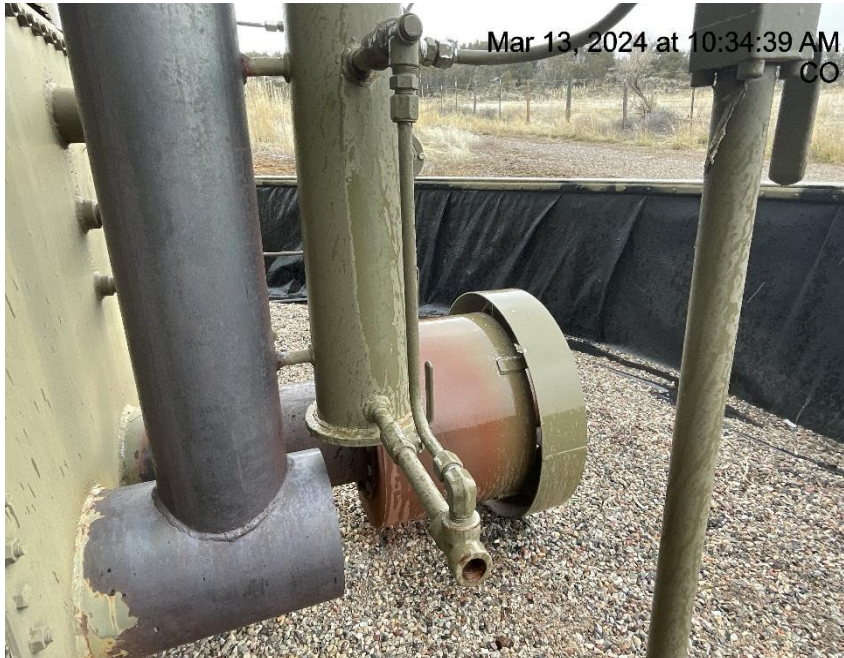
**Photo # 9625 From inspection 708903284 conducted on 03/13/2024 PRV vent line on tank burner terminates in an unsafe manner/does not comply with CECMC pressure safety device rules & general safety rules.**

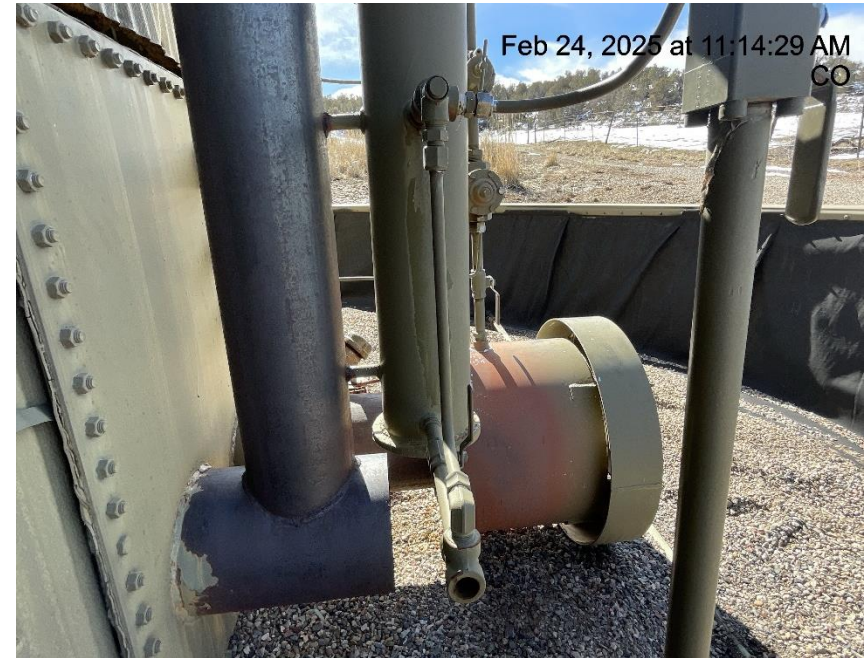
**Photo # 8015 PRV vent line on tank burner terminates in an unsafe manner/does not comply with CECMC pressure safety device rules & general safety rules.**

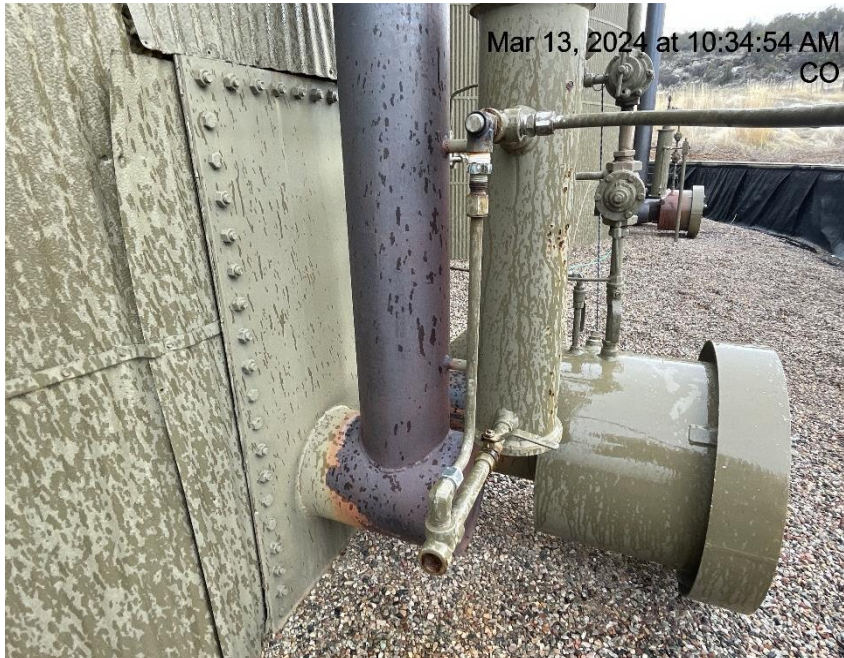
**Photo # 9626 From inspection 708903284 conducted on 03/13/2024 PRV vent line on tank burner terminates in an unsafe manner/does not comply with CECMC pressure safety device rules & general safety rules.**

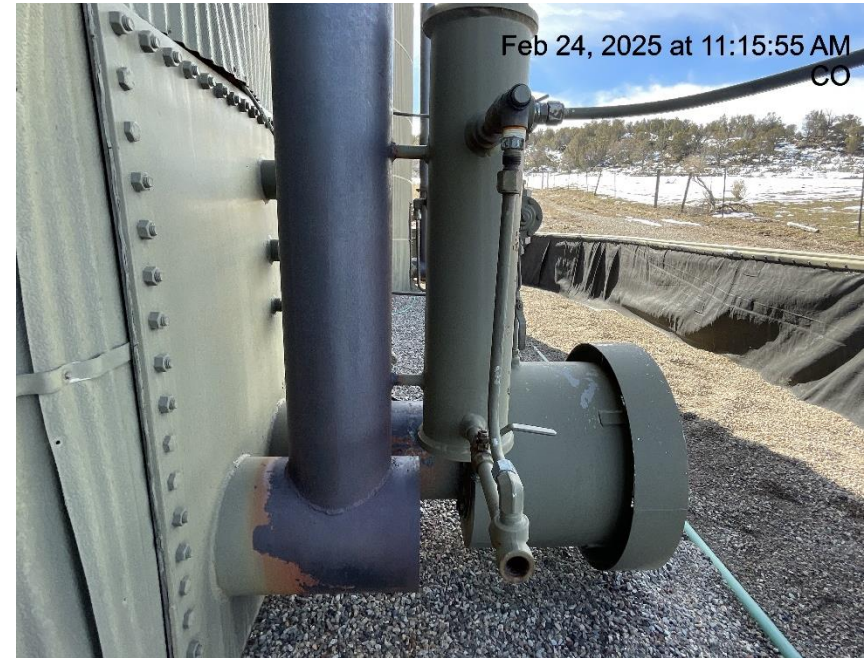
**Photo # 8016 PRV vent line on tank burner terminates in an unsafe manner/does not comply with CECMC pressure safety device rules & general safety rules.**
