Wellhead Closure Checklist						
COGCC Rule 911.a.(4) Environmental Site Closure Assessment Field Form						
Additional attachments (optional):		Pit Closure —		Tank Battery Closure —	Flowline Closure 04/24/23, 10/12-10/13/23	Partially Buried Vault Closure —
Site Name & COGCC Facility Number: HSR - Cutler #14-31		Date: 04/19/23				Remediation Project #: 27651
Associated Wells: 05-123-15168		Age of Site: Years				Number of Photos Attached: 1
Location: (GPS coordinates of wellhead or southeastern most wellhead for multiple)					40.263460 / -104.708560	
General Condition of Site: (General observations regarding housekeeping, corrosion, waste management, etc.)						
Good Condition						
USCS Soil Type: Clayey SAND				Estimated Depth to Groundwater: Approx. 20-30'		
Hydrocarbon Impacted Soils / Spills: (Note estimated size and if impact appears to be surficial or extends to an unknown depth)						
Slight hydrocarbon odor observed in excavation, no staining.

SOIL ANALYTICAL MAP
HSR-CUTLER #14-31
CLOSURE ASSESSMENT
40.263460 / -104.708560
SE¼ SW¼ SEC.31 T4N R65W 6PM
WELD COUNTY, COLORADO
API # 05-123-15168
REMEDIAL # 27651

HSR – Cutler #14-31
API # 05-123-15168
Remediation # 27651

Closu

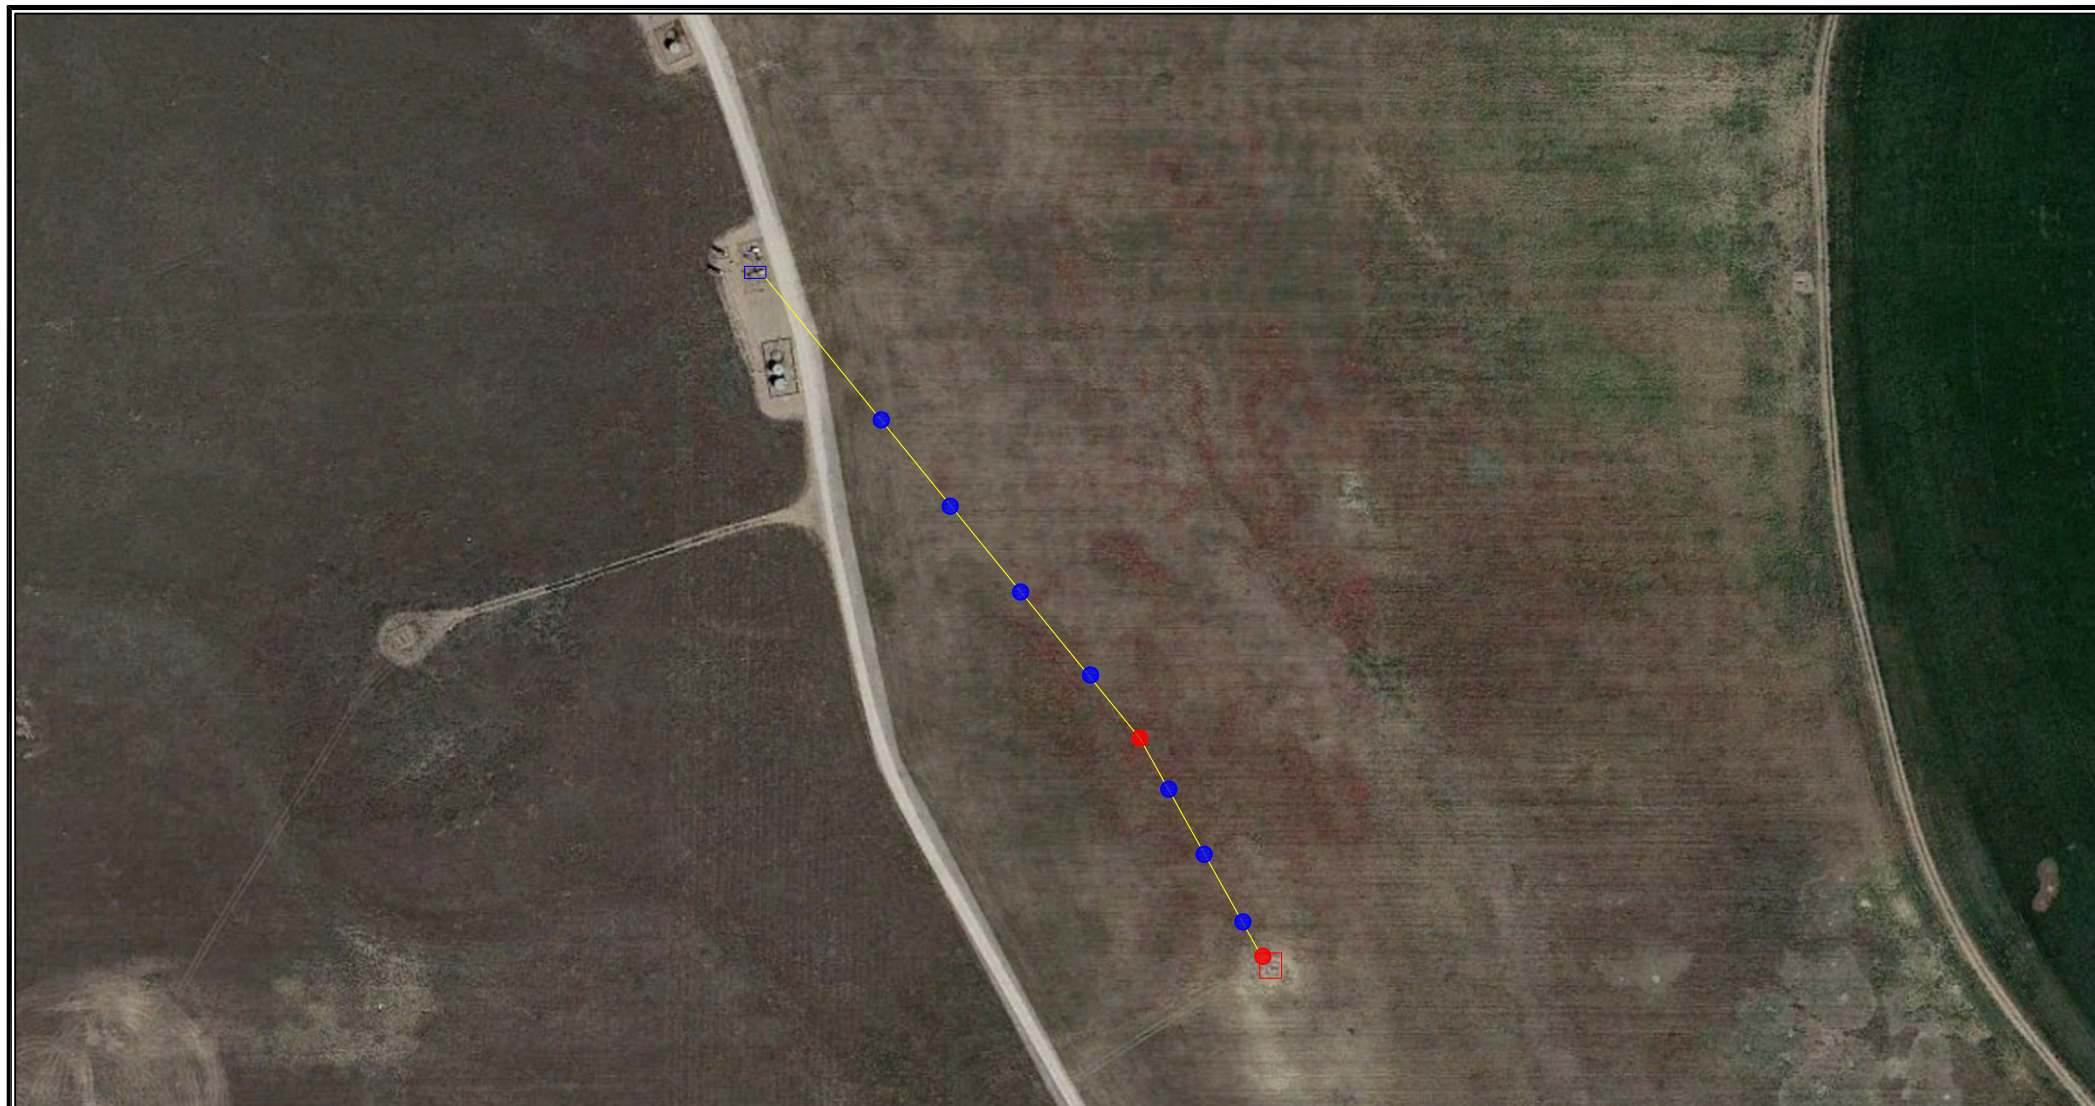
FIGURE NO.

AERIAL SITE LOCATION MAP

HSR-CUTLER #14-31
CLOSURE ASSESSMENT
40.263460 / -104.708560
SE¼ SW¼ SEC.31 T4N R65W 6PM
WELD COUNTY, COLORADO
API # 05-123-15168
REMEDATION # 27651

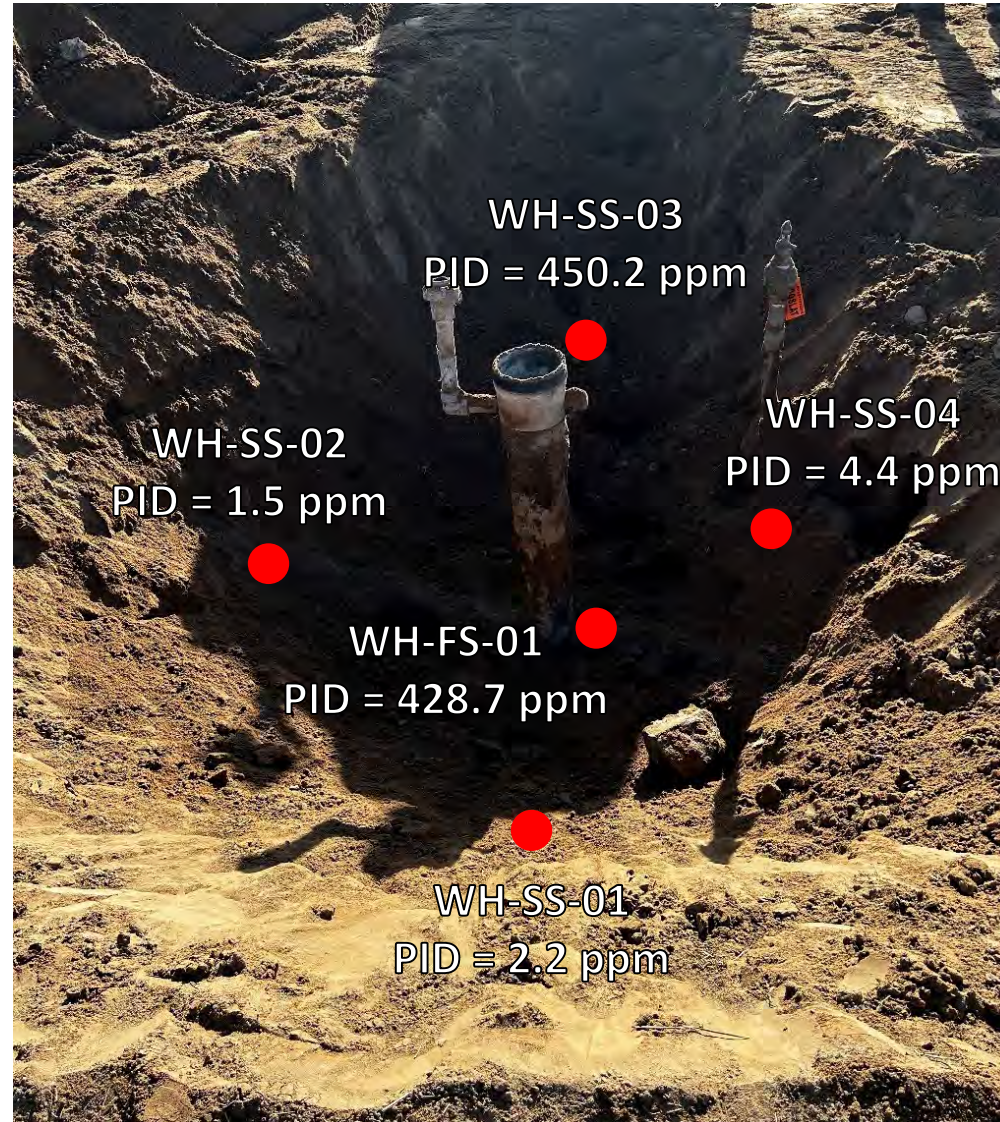
Wellhead Excavation – 04/19/23

Looking south

Slight petroleum hydrocarbon odor observed; no staining observed

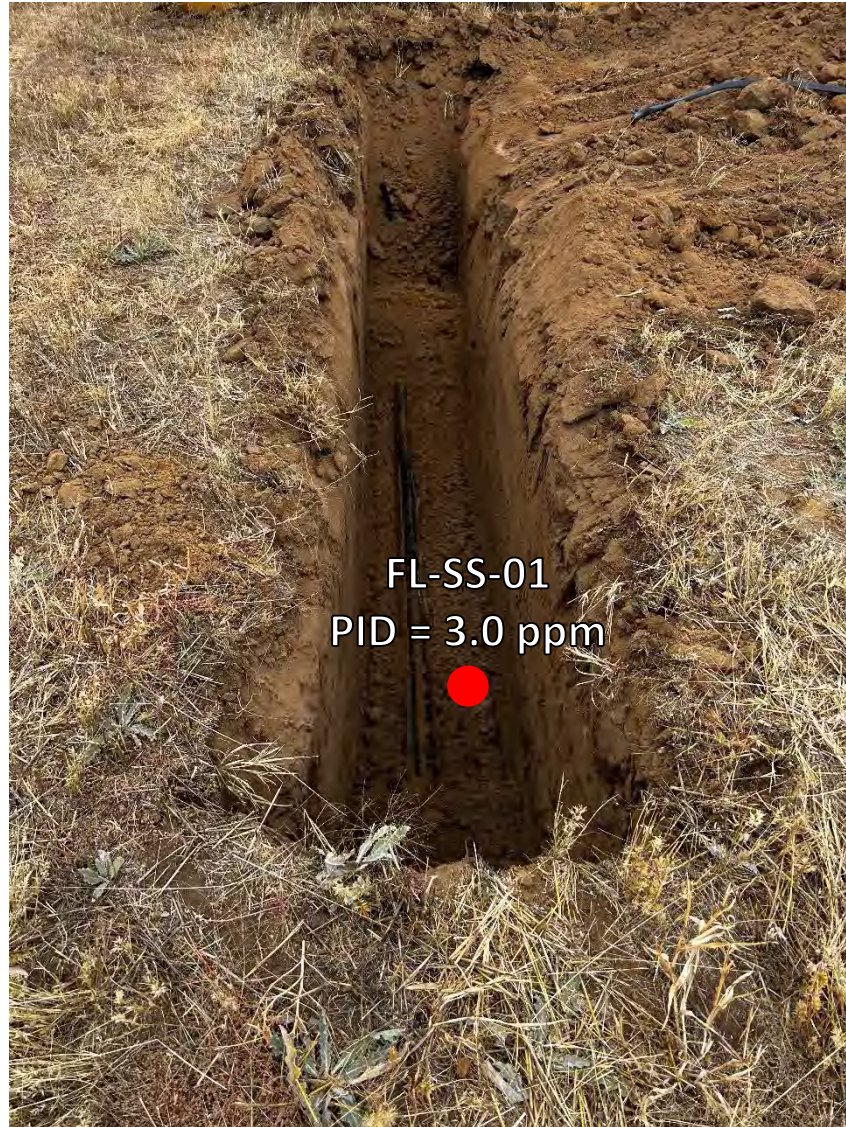
Flowline Removal/Assessment – 10/12/23

Looking northwest at bellhole/cutpoint
No petroleum hydrocarbon staining or odor observed

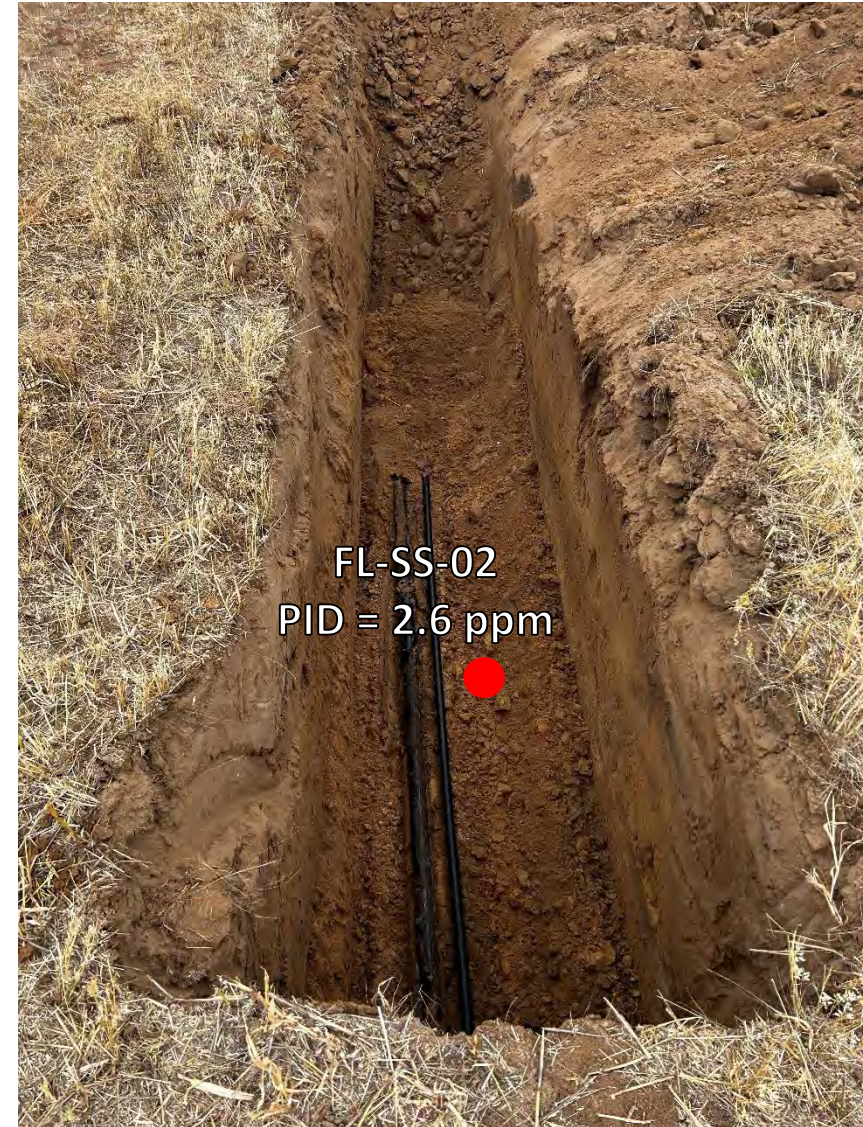
Looking northwest at bellhole/cutpoint
No petroleum hydrocarbon staining or odor observed

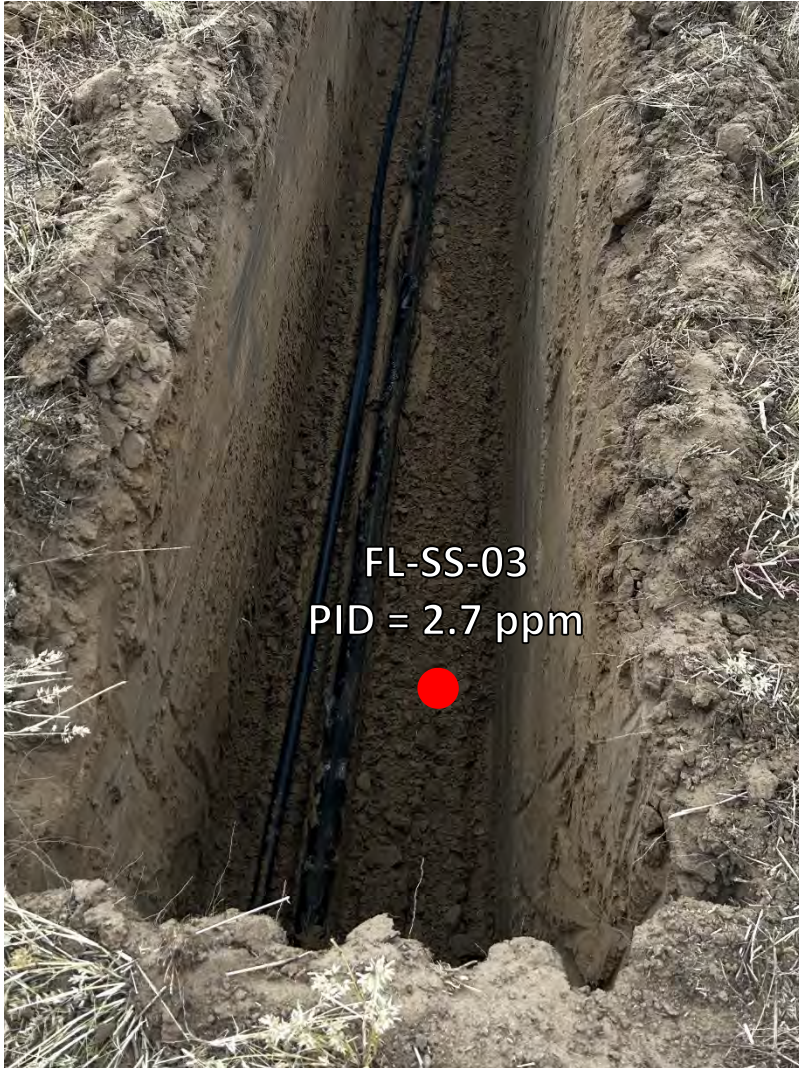
Flowline Removal/Assessment – 10/12/23

Looking northwest at bellhole/cutpoint
No petroleum hydrocarbon staining or odor observed

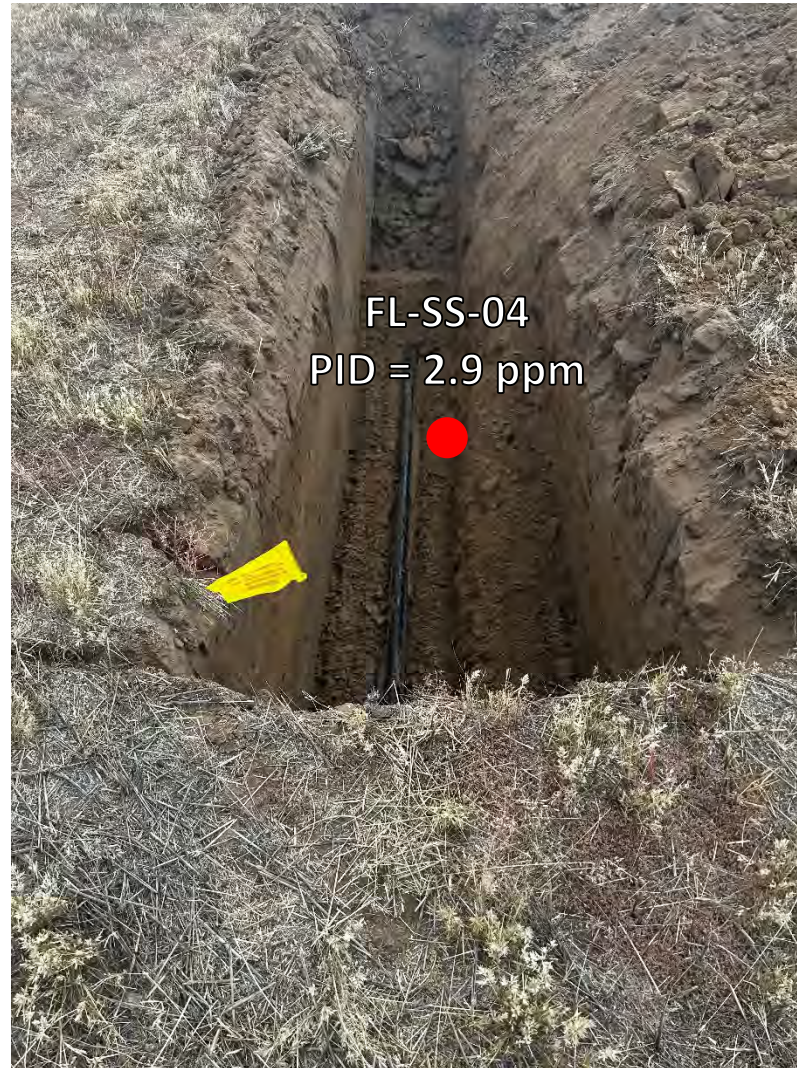
Looking northwest at bellhole/cutpoint
No petroleum hydrocarbon staining or odor observed

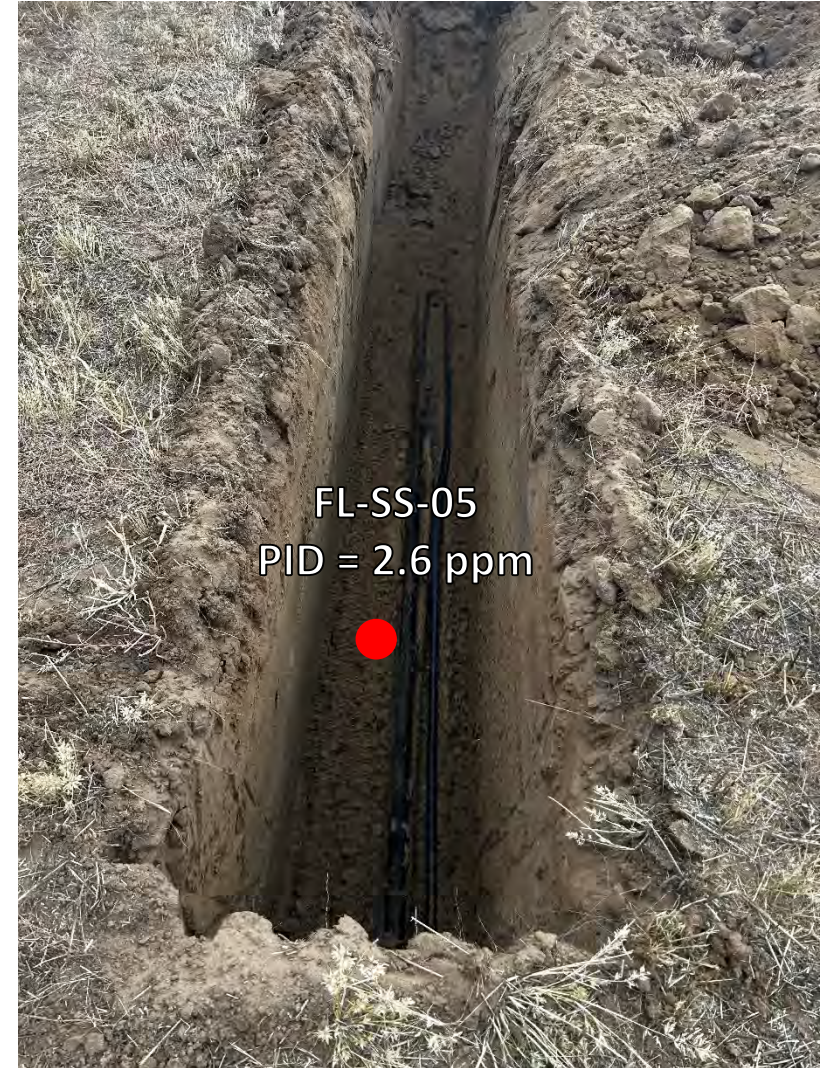
Looking northwest at bellhole/cutpoint
No petroleum hydrocarbon staining or odor observed

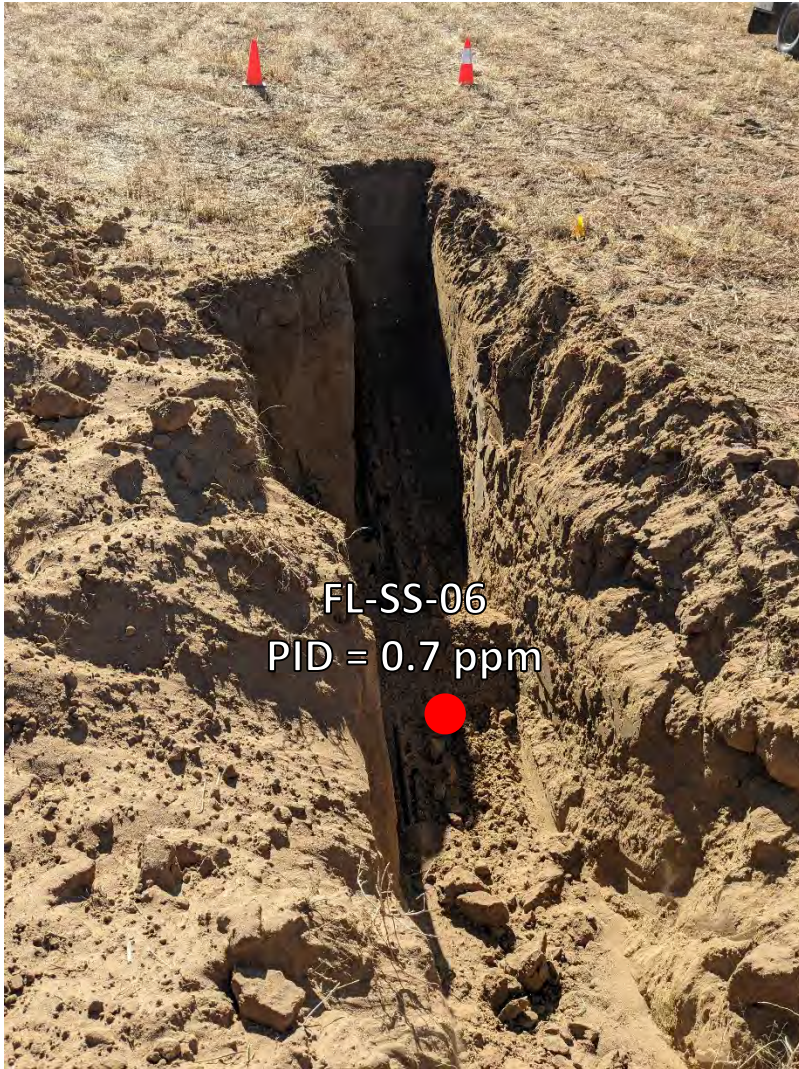
Flowline Removal/Assessment – 10/13/23

Looking southeast at bellhole/cutpoint
No petroleum hydrocarbon staining or odor observed

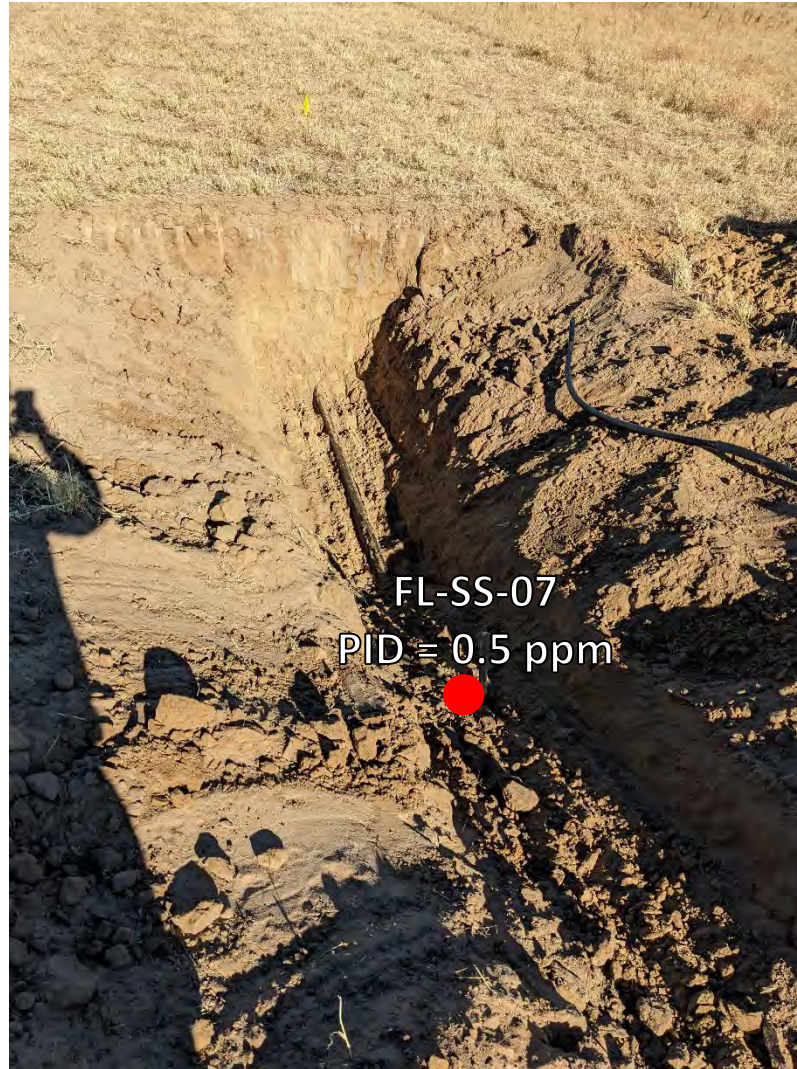
Looking northwest at bellhole/cutpoint
No petroleum hydrocarbon staining or odor observed

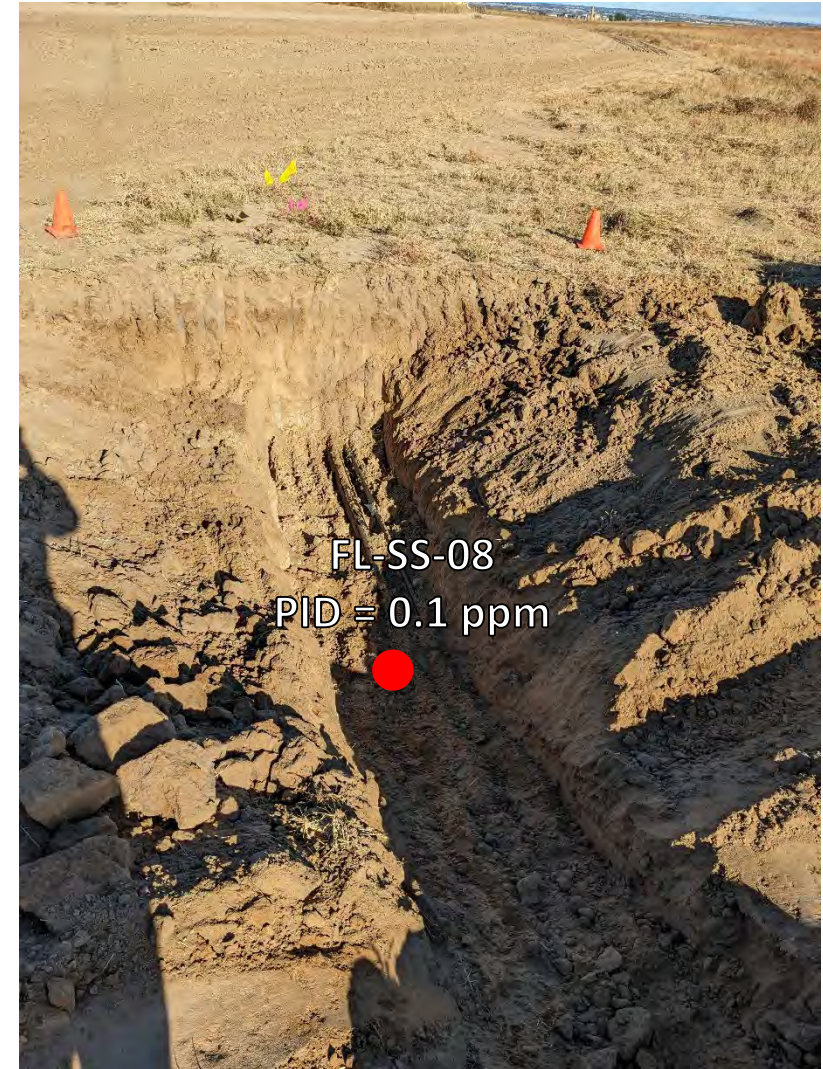
Looking northwest at bellhole/cutpoint
No petroleum hydrocarbon staining or odor observed
