# Inspection Photos

Operator: Simcoe LLC - 10749

Location ID: 312017

Inspection Photos  
 Location Name: Fairfield Farms 2, 4  
 Location ID: 312017

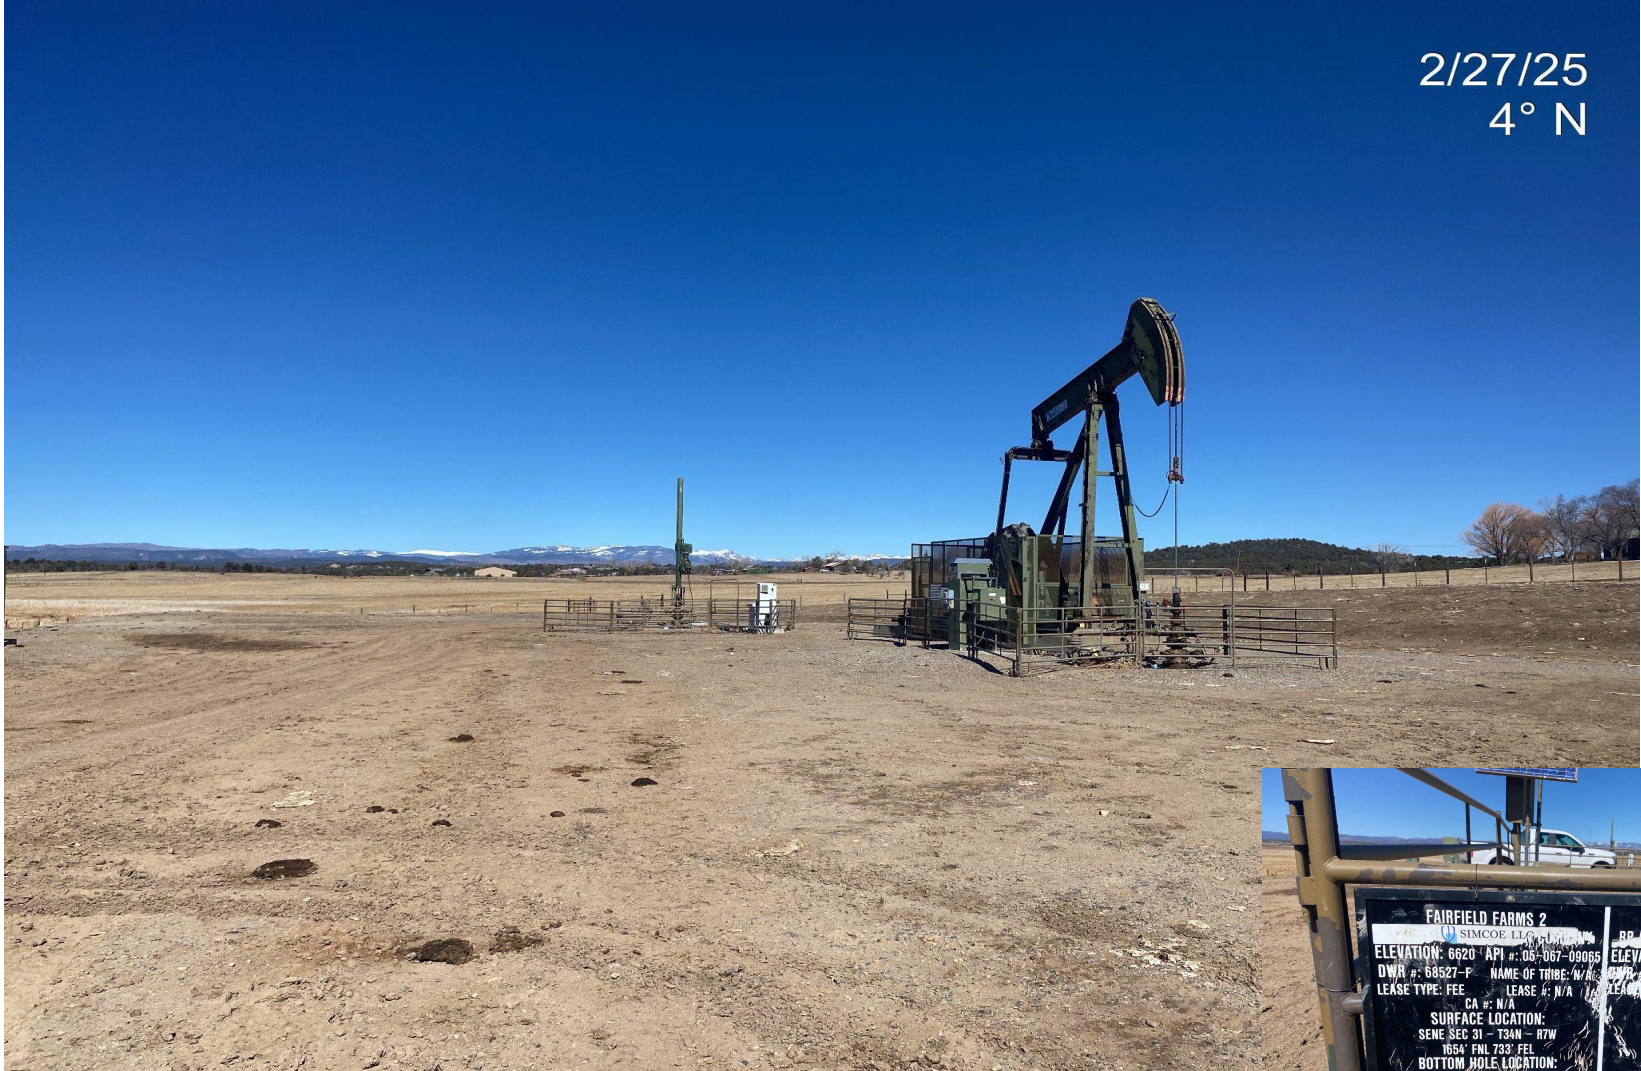
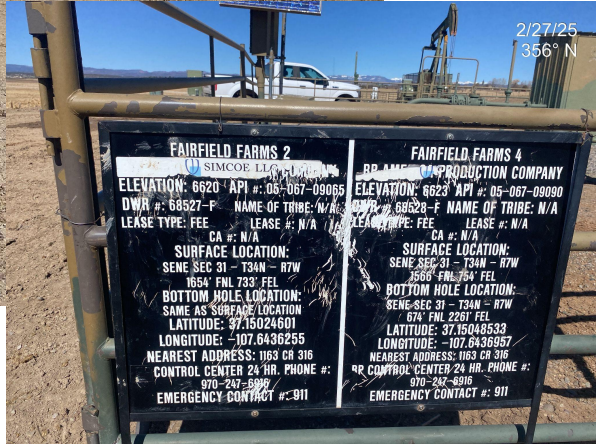
**Photo 1.** View of the well pad taken from the access point facing center. Note: location sign is scratched and illegible.

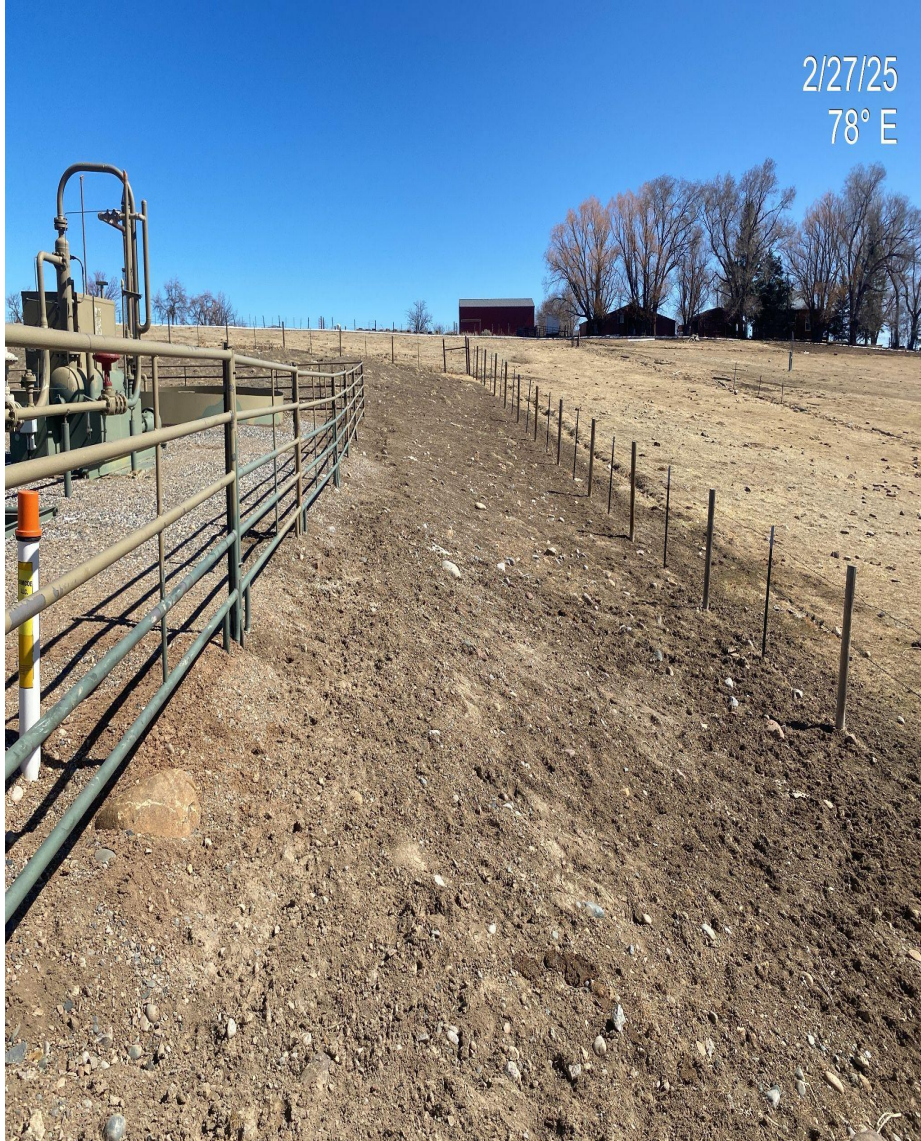
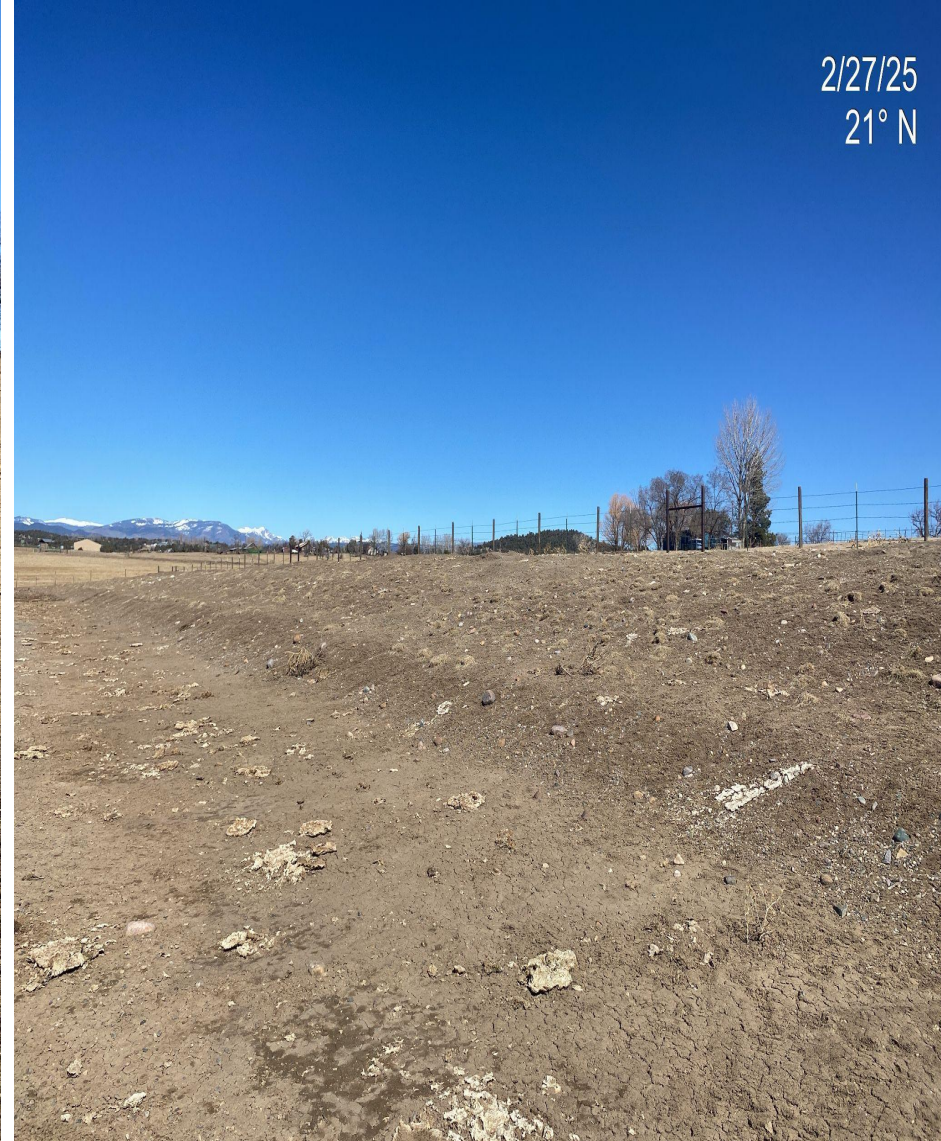
**Photo 2.** Interim reclamation areas remain with bare soils and little to no vegetation. Evidence of grazing observed, cattle exclusion fencing may be needed to promote establishment of interim vegetation.

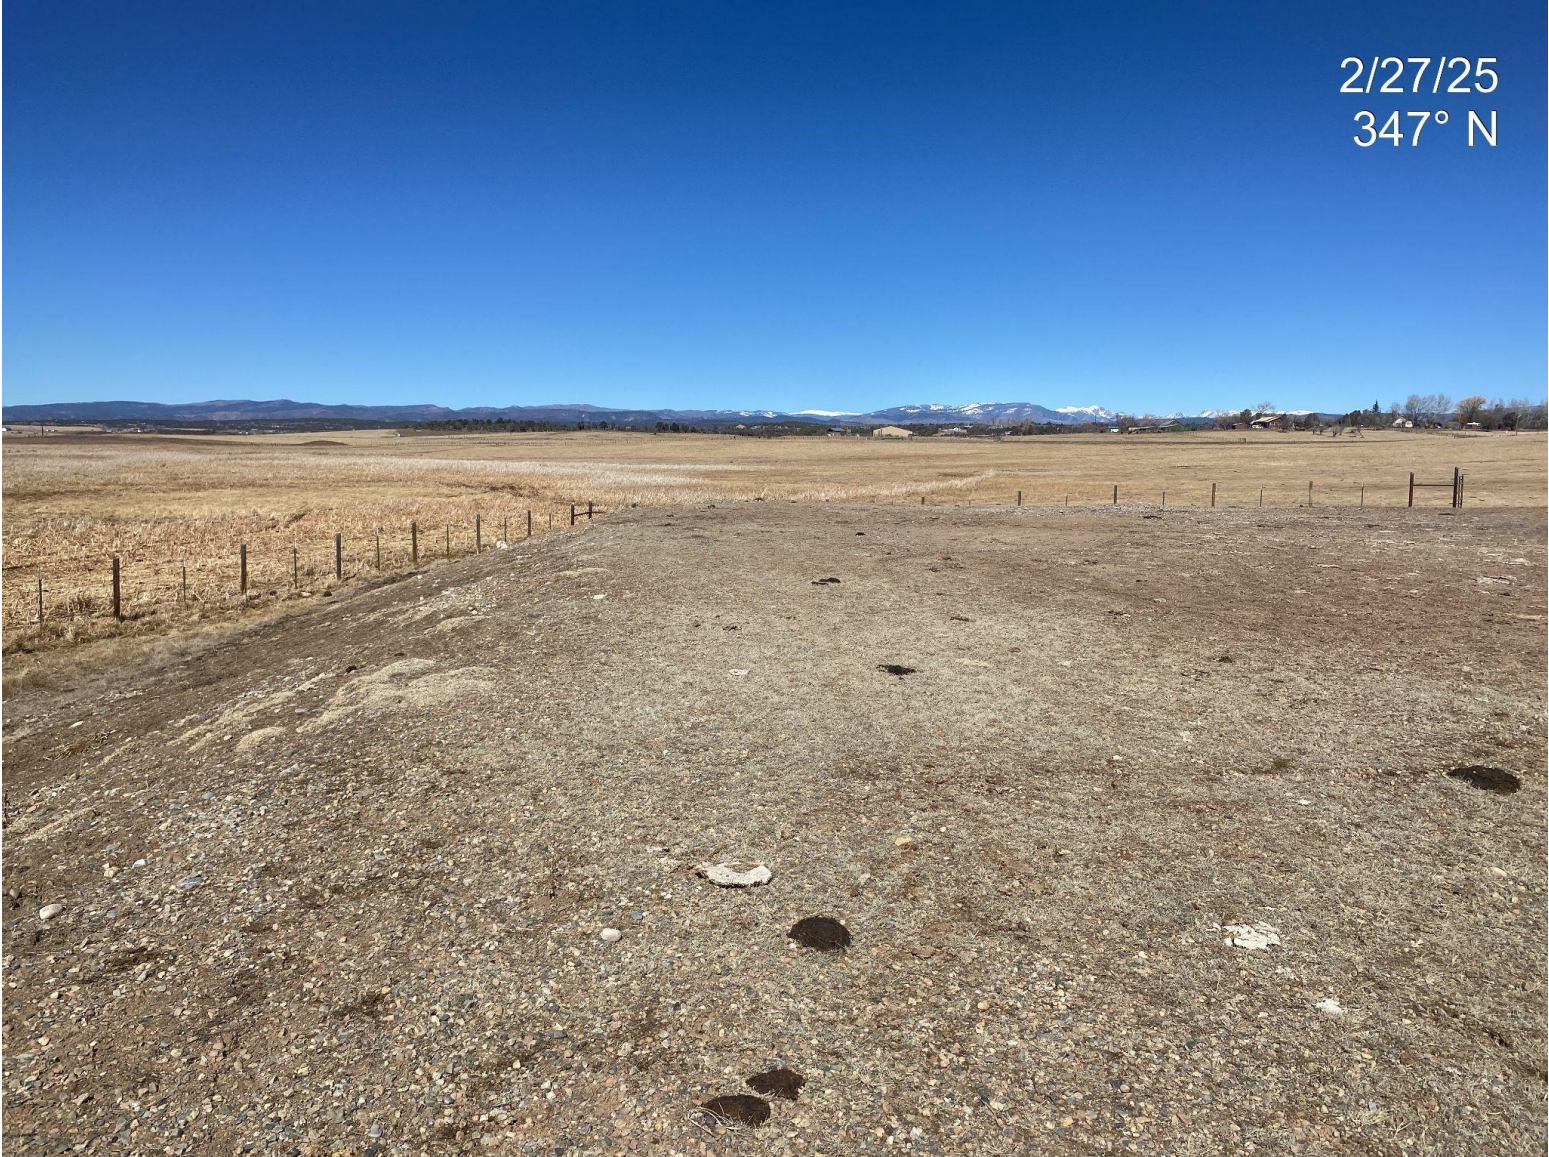
2/27/25  
347° N

**Photo 3.** Northwest corner of disturbance that is not reasonably needed for production has not been interim reclaimed.

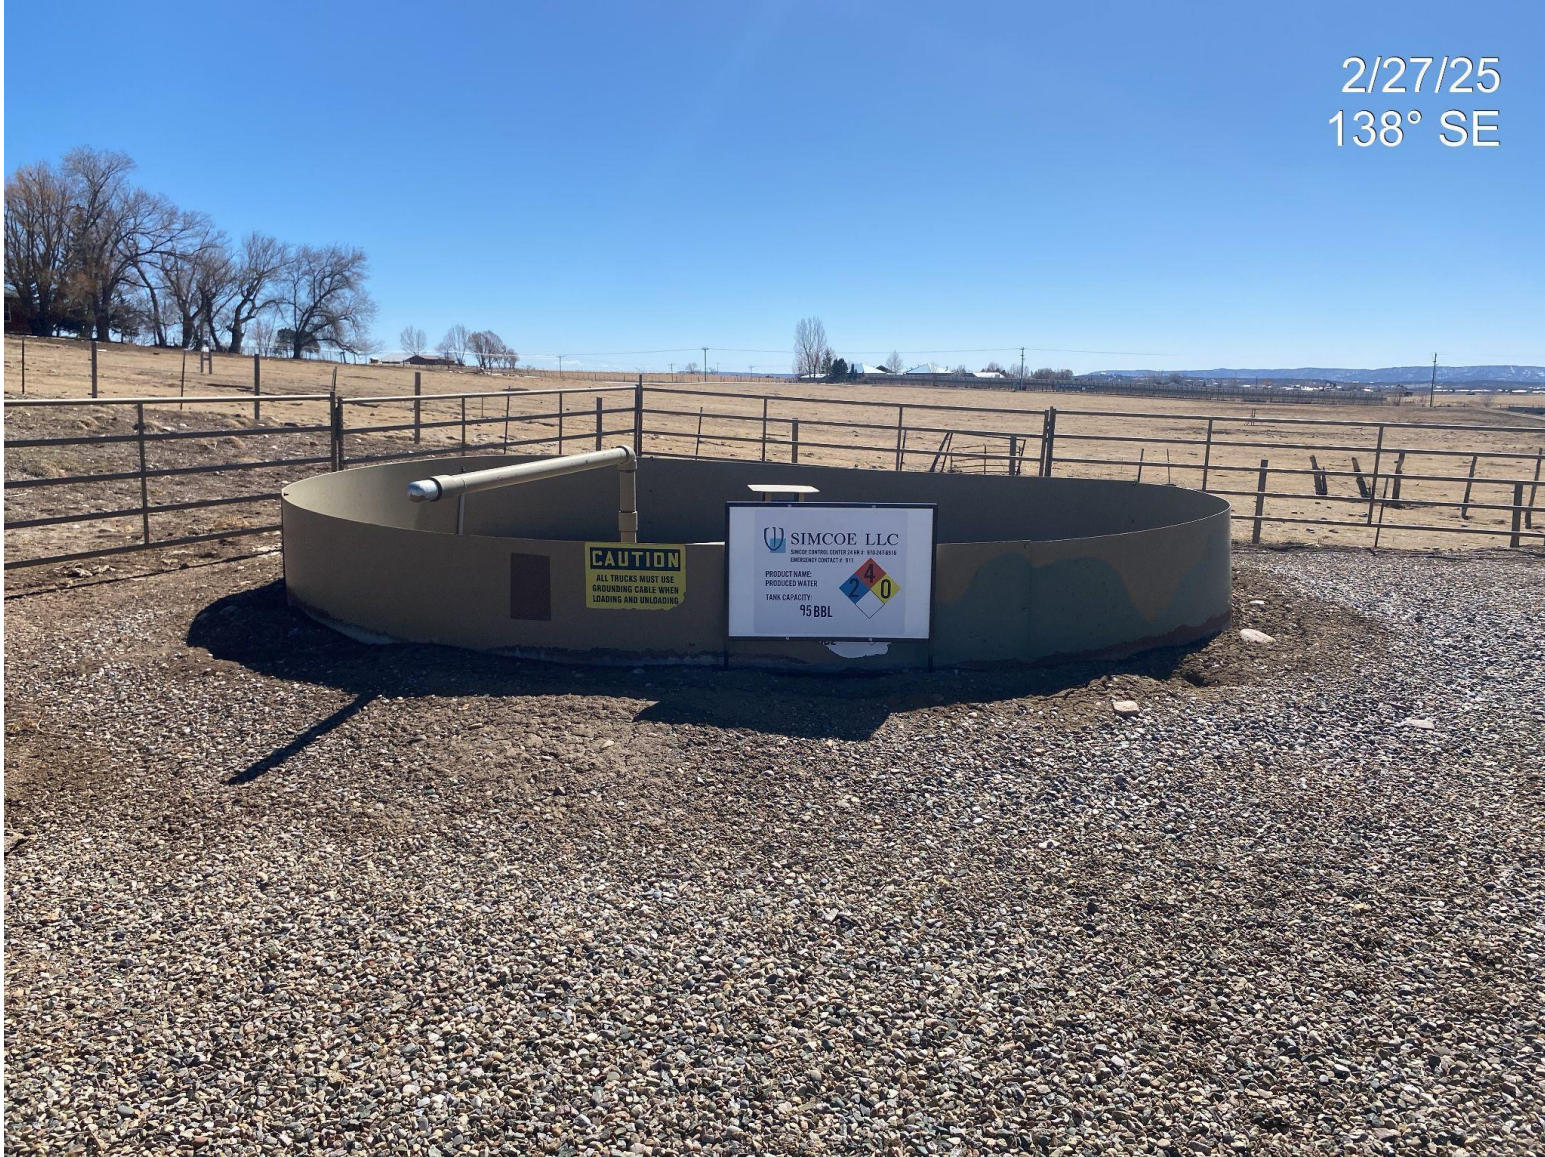
2/27/25  
138° SE

Photo 4. Produced water sign has been updated.
