# Flowline Closure Checklist

## COGCC Rule 911.a.(4) Environmental Site Closure Assessment Field Form

Site Name & COGCC Facility Number: Shelton RG26-08	Date: 8/14/2023	Remediation Project #: 29038
--	-----------------	------------------------------

**Noble Energy, Inc. – DJ Basin**  
**Shelton RG 26-08**  
 SENE, Section 26, Township 4 North, Range 65 West  
 Weld County, Colorado

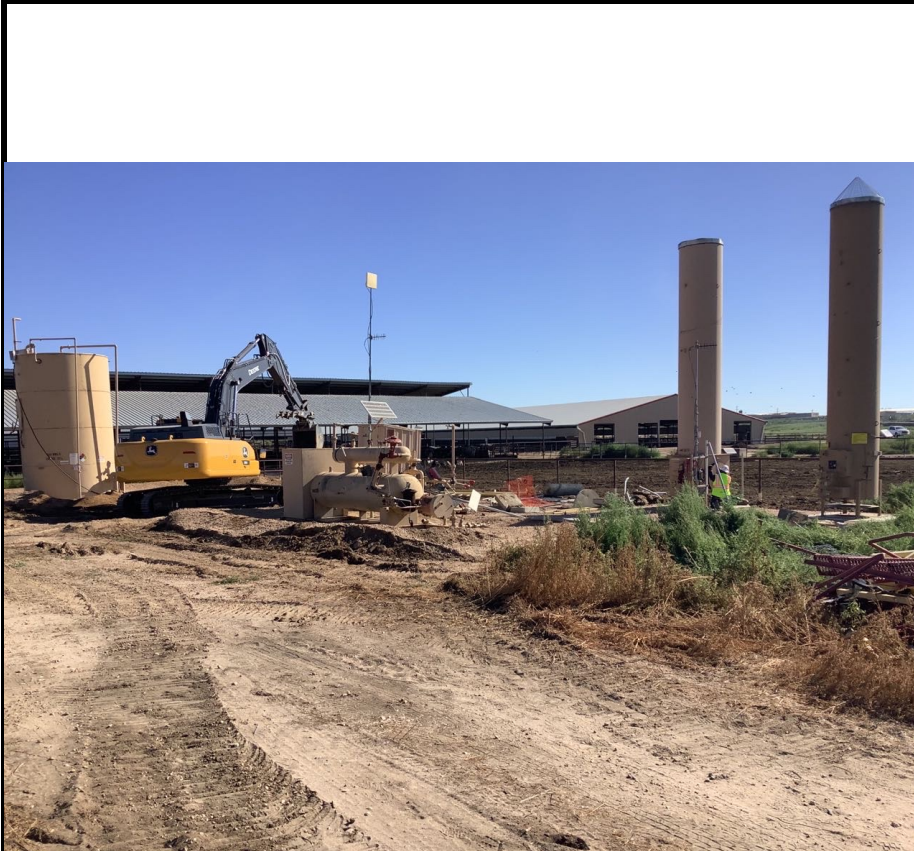
<b>Equipment ID:</b>		<b>Equipment Type:</b>	
<b>Material:</b>	<b>Volume:</b>	<b>Contents:</b>	
<b>Notes/Conditions:</b> Site photo - facility Facing NE

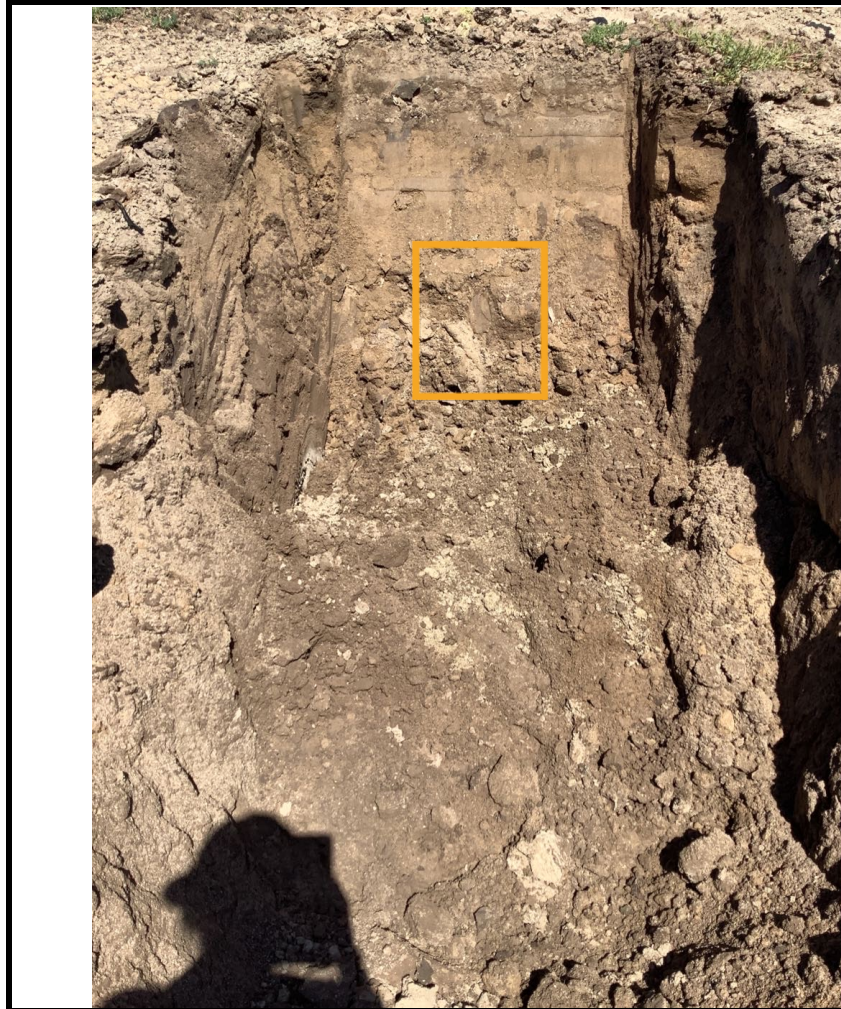
<b>Equipment ID:</b> FL01-D@4'		<b>Equipment Type:</b>		<b>Equipment ID:</b> FL01-E@3.5'		<b>Equipment Type:</b>	
<b>Material:</b>	<b>Volume:</b>	<b>Contents:</b>		<b>Material:</b>	<b>Volume:</b>	<b>Contents:</b>	
<b>Notes/Conditions:</b> Slight direction change				<b>Notes/Conditions:</b>

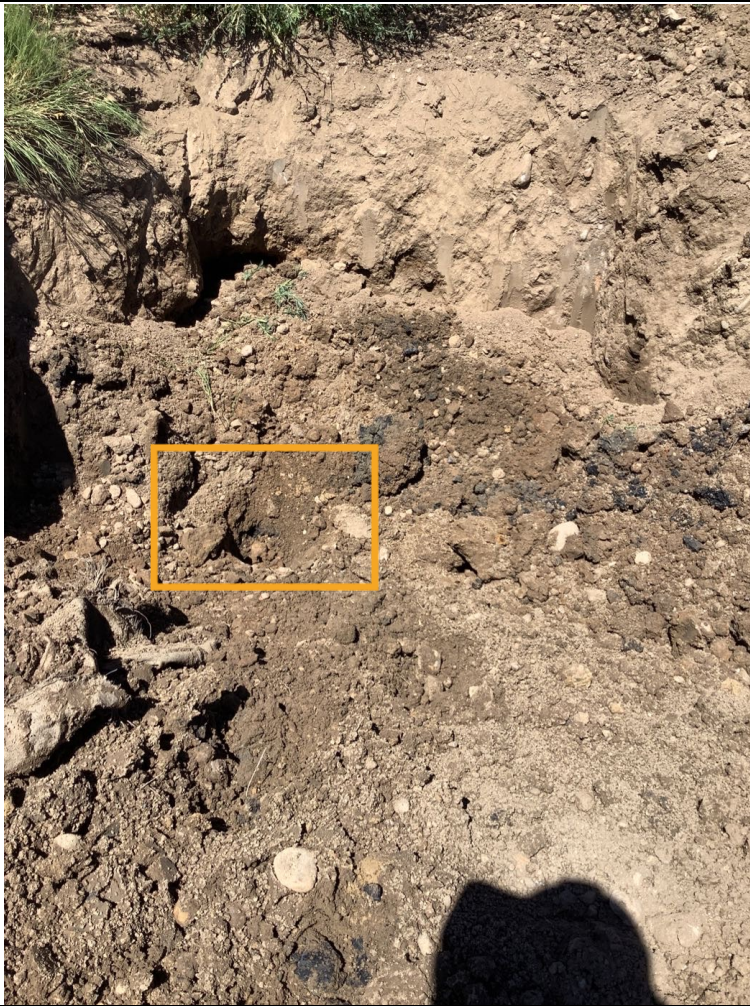
Hydrocarbon Impacted Soils / Spills: (Note estimated size and if impact appears to be surficial or extends to an unknown depth)  
Some staining observed at wellhead, impact appears to be surficial.

<b>Equipment ID:</b> FL01-A@3'		<b>Equipment Type:</b>		<b>Equipment ID:</b>		<b>Equipment Type:</b>	
<b>Material:</b>	<b>Volume:</b>	<b>Contents:</b>		<b>Material:</b>	<b>Volume:</b>	<b>Contents:</b>	
<b>Notes/Conditions:</b> Some staining present in excavation				<b>Notes/Conditions:</b> Site photo, from A point Facing W  Arrow shows direction of flowline path
