WELL NAME: PATHFINDER #1, API #: 043-06216, INSP. # 716300650

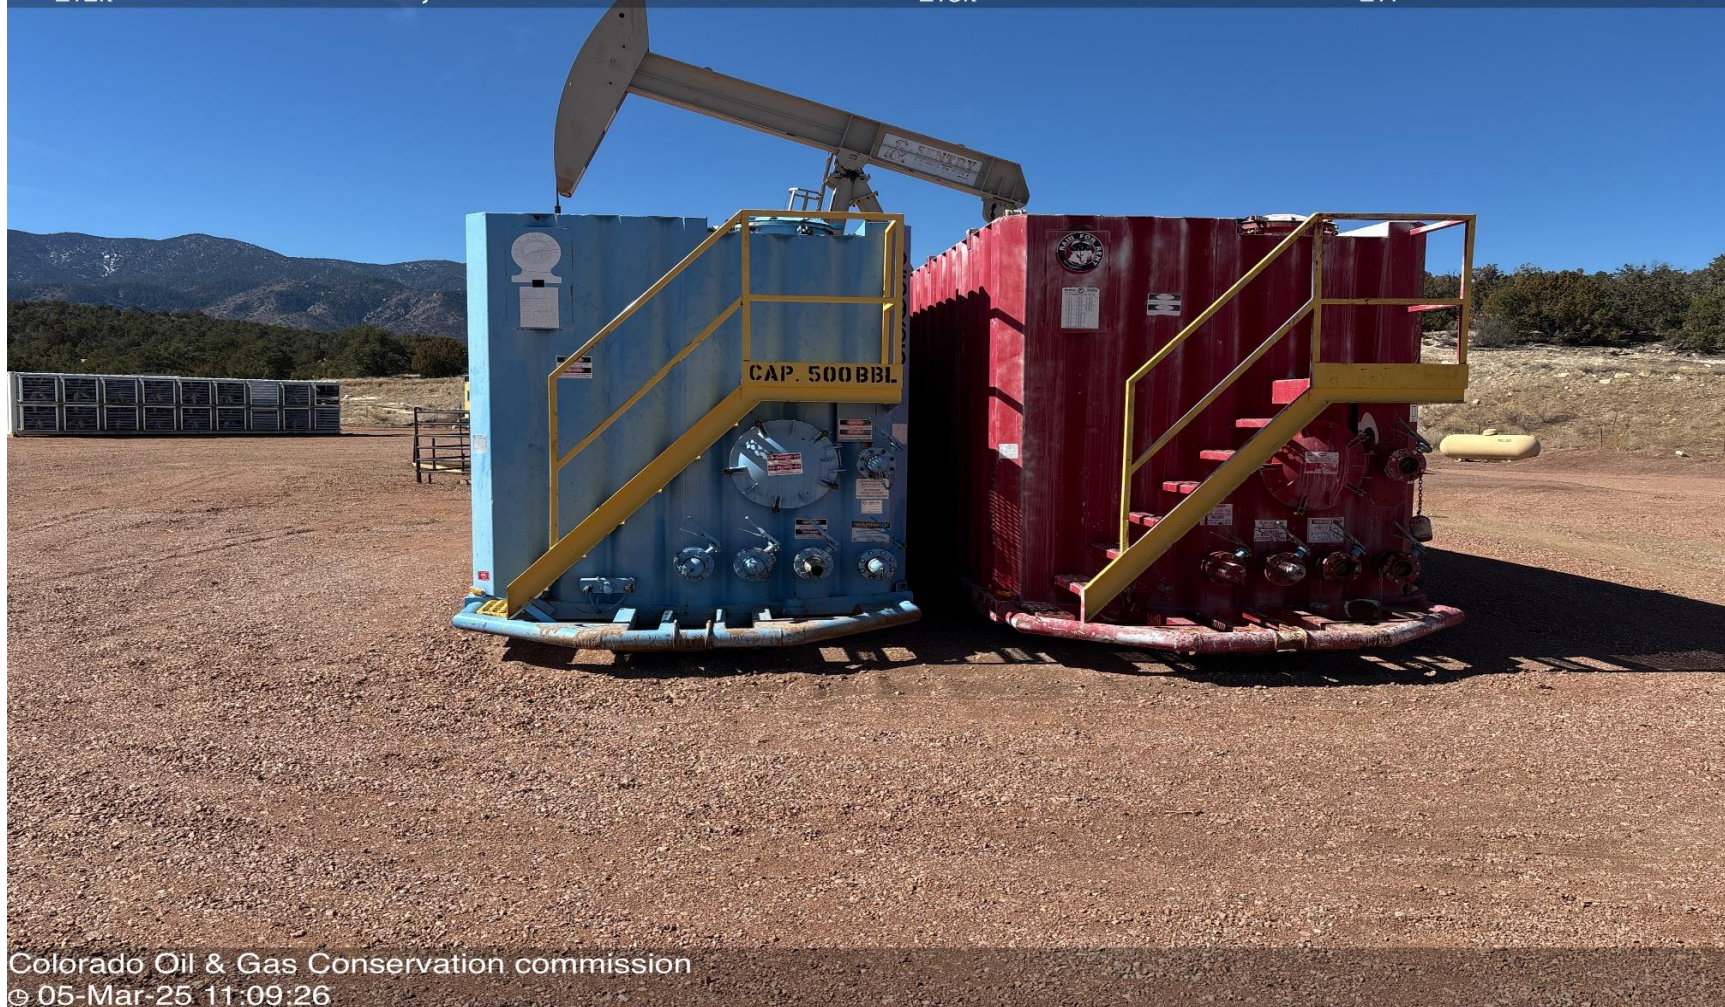
PHOTO 5: TEMPORARY TANK BATTERY HAS NO NFPA STICKERS, NEATHER TANK HAS CONTENTS POSTED AND ONE TANK DOES NOT HAVE CAPACITY POSTED. Install sign to comply with Rule 605.h. CA DATE 4/5/2025.

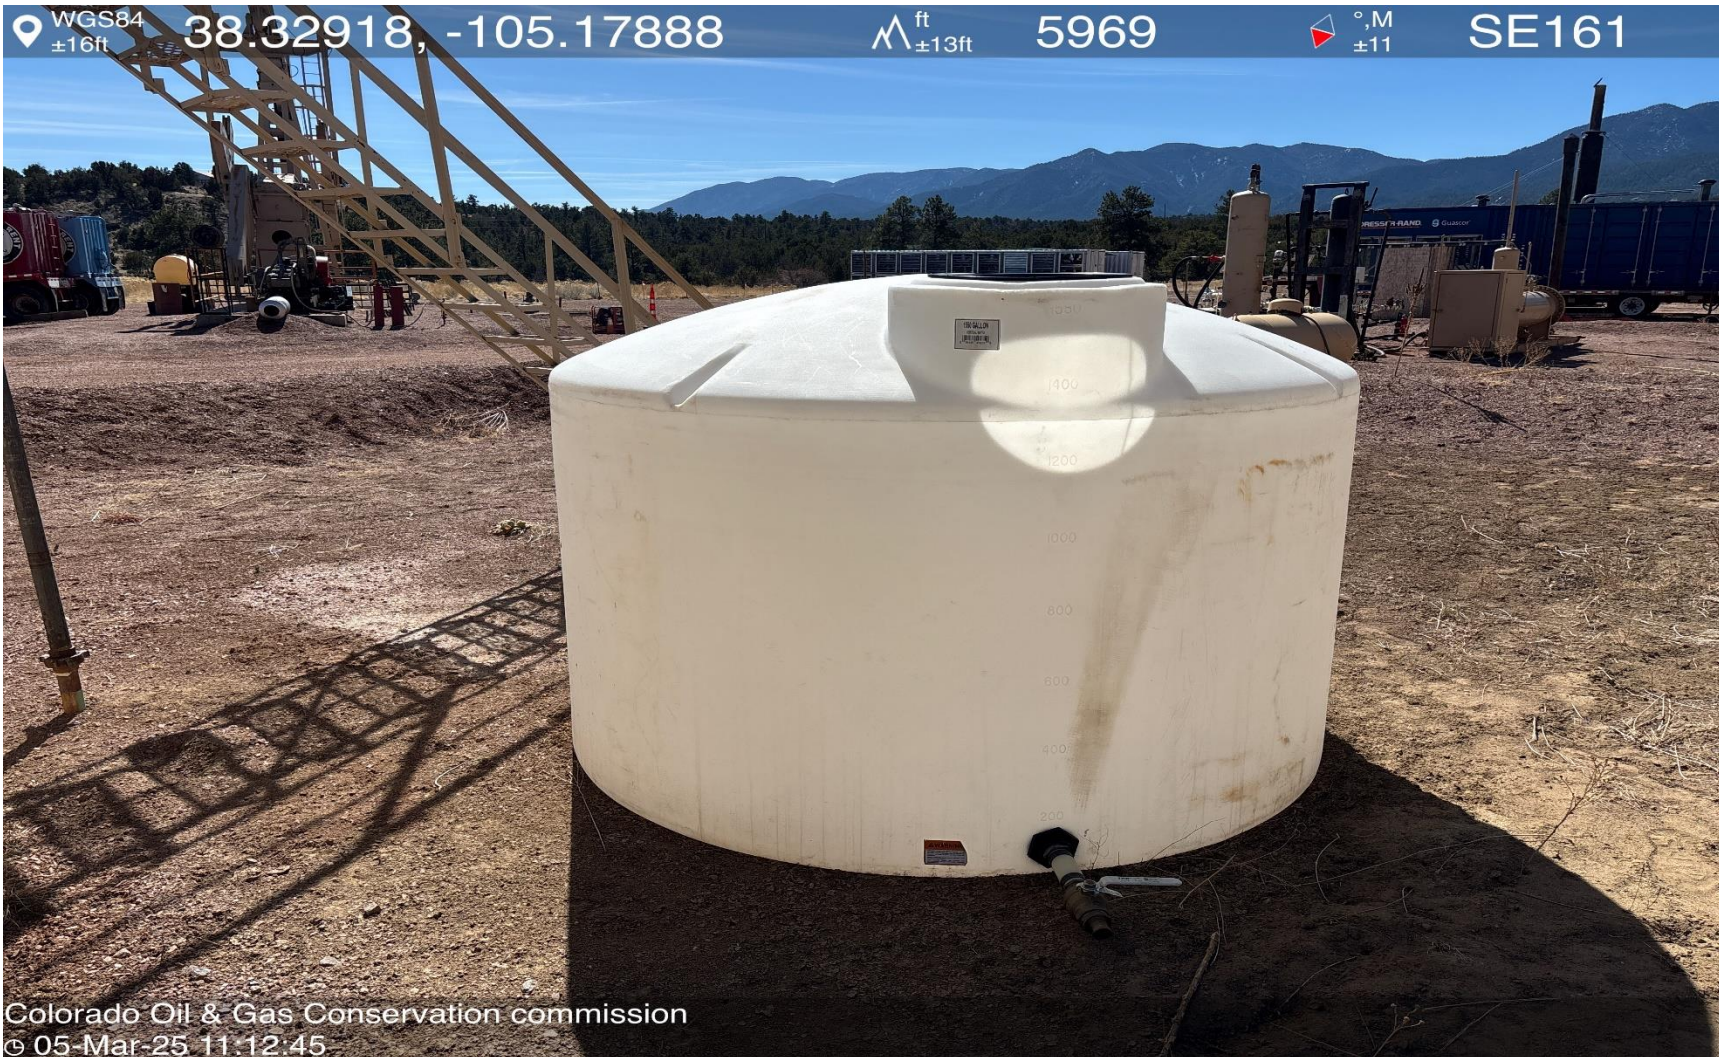
PHOTO 6: 1550 GAL TANK NEXT TO PERMANENT IS NOT LABELED. Install sign to comply with Rule 605.h. CA DATE 4/5/2025.

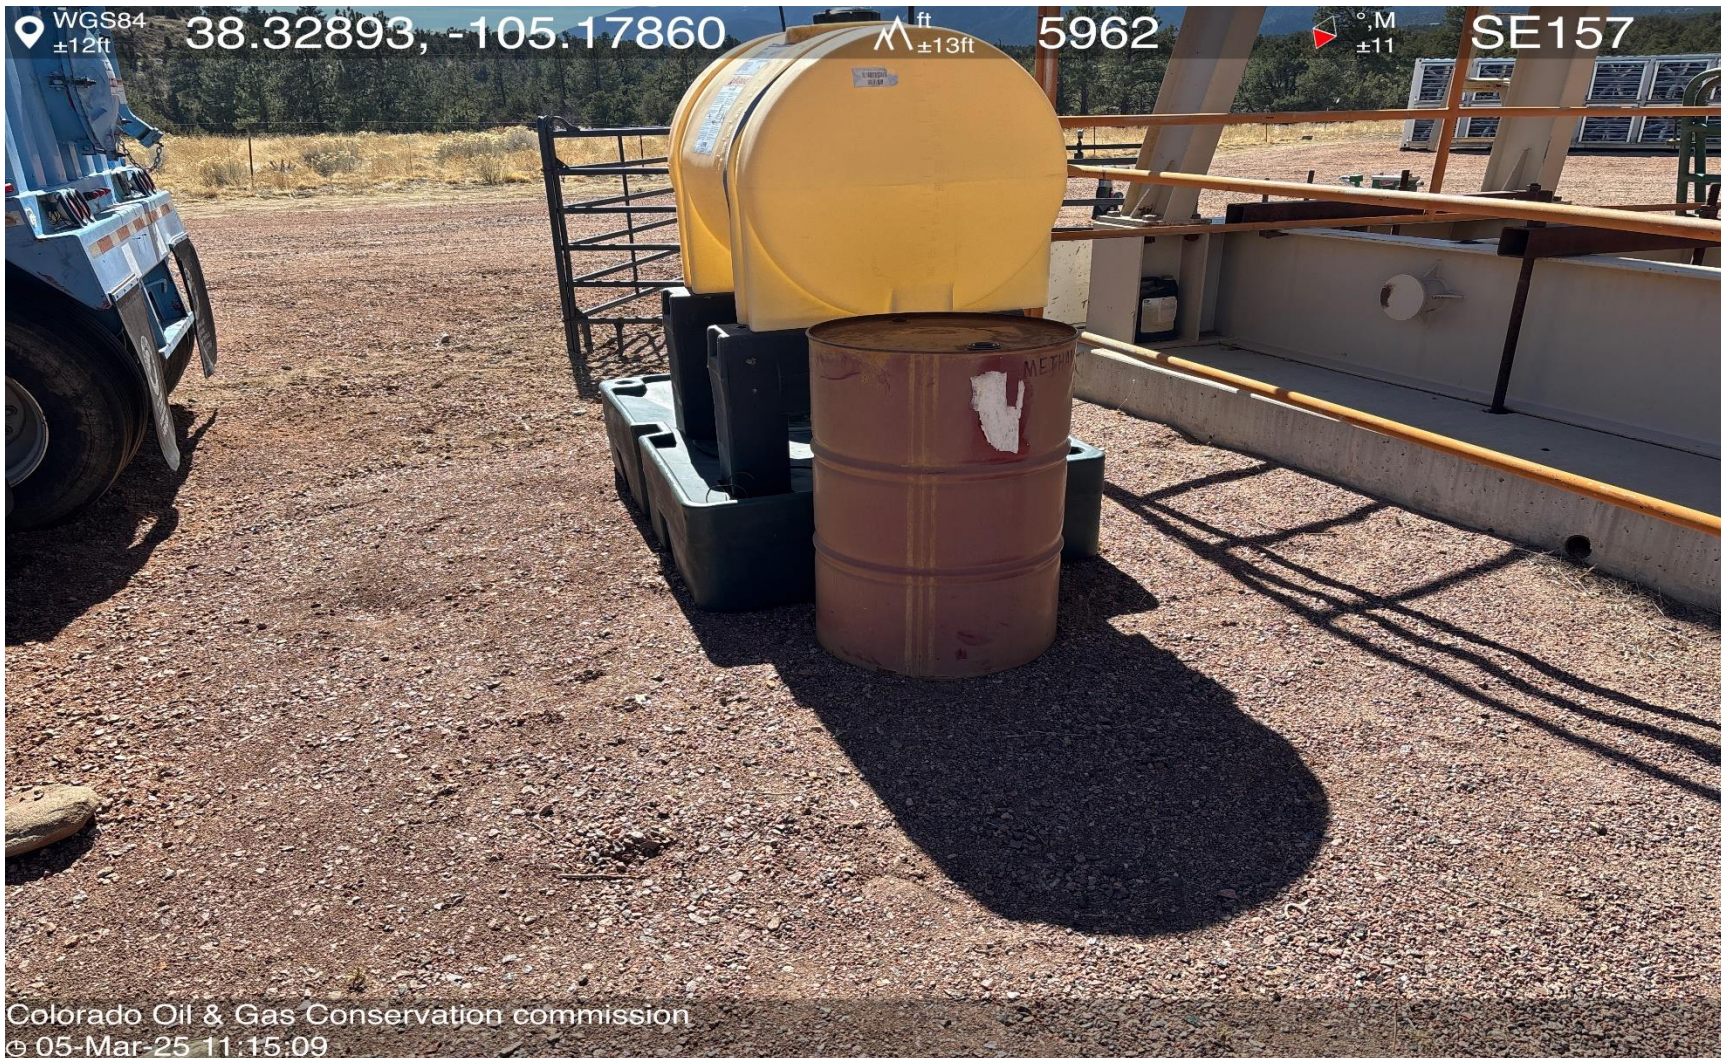
PHOTO 7: 55 GAL METHANOL TANK NOT IN SECONDARY CONTAINMENT. Non E&P Waste not properly stored, handled, transported, treated, or disposed per Rule 906. Contact COGCC EPS staff. Require appropriate cleanup. CA DATE 3/10/2025.

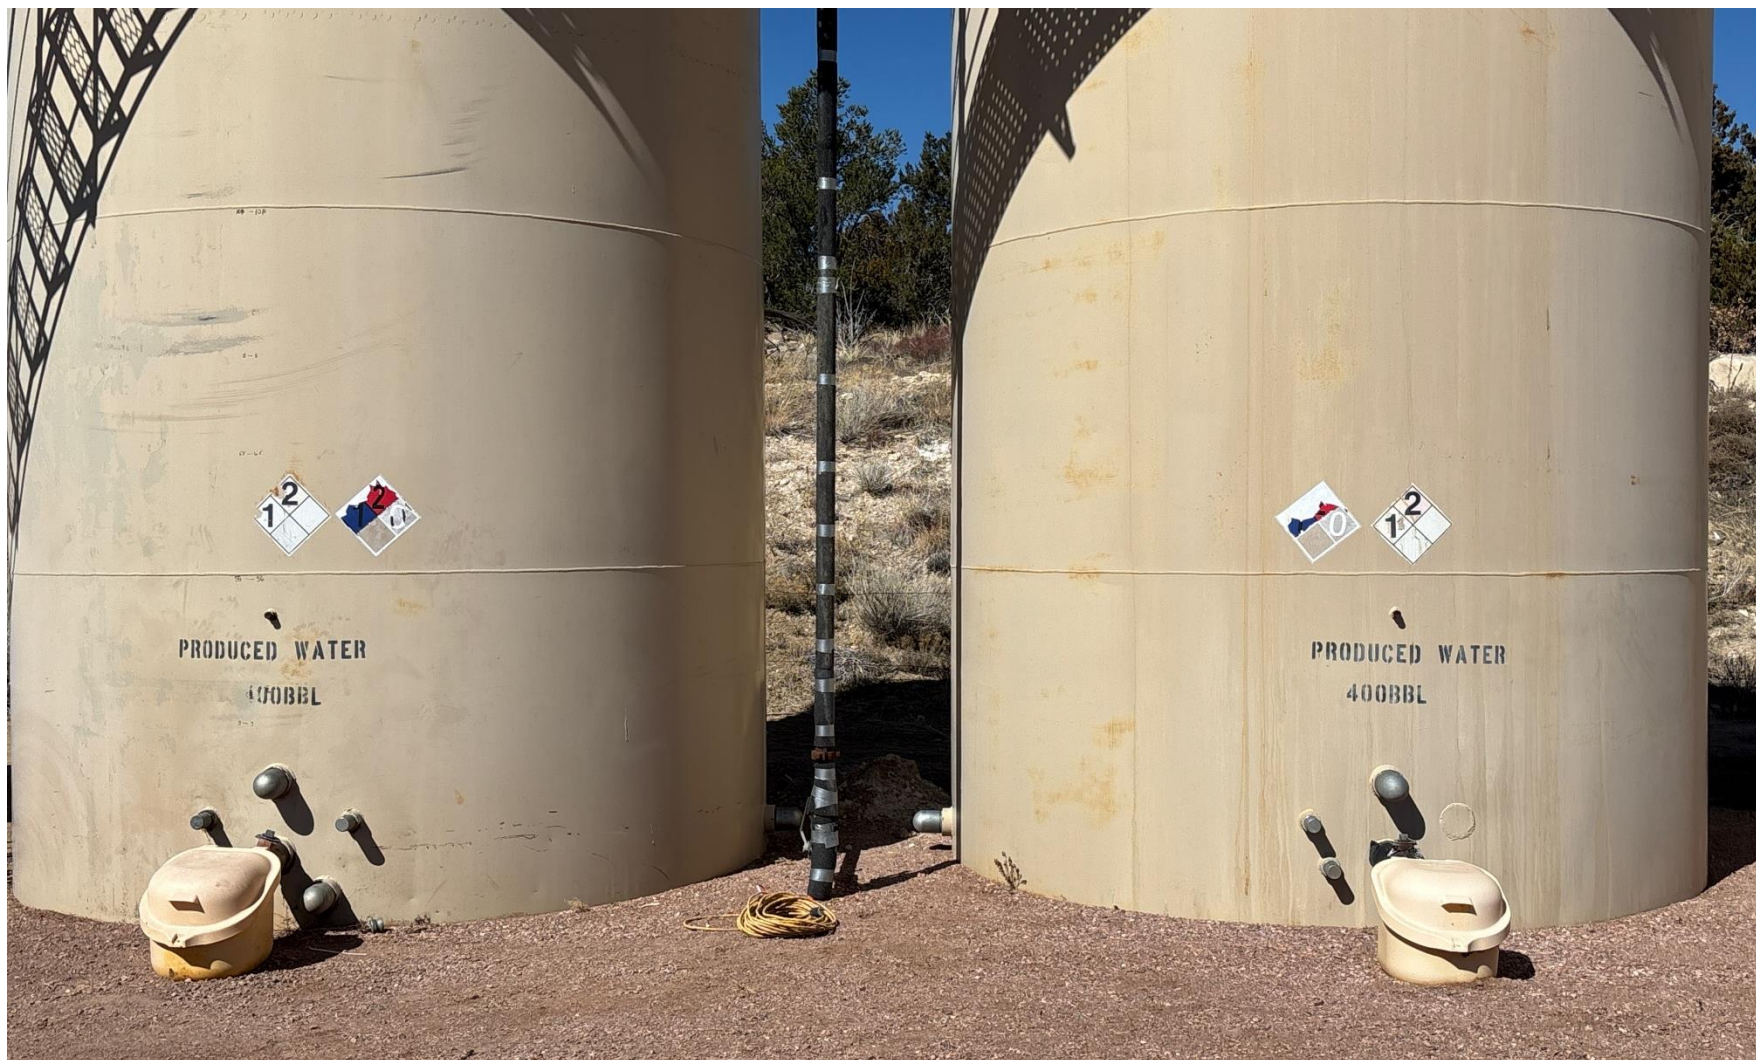
PHOTO 8: NFPA STICKERS ARE FADING AND PEELING. Install sign to comply with Rule 605.h. CA DATE 3/10/2025.

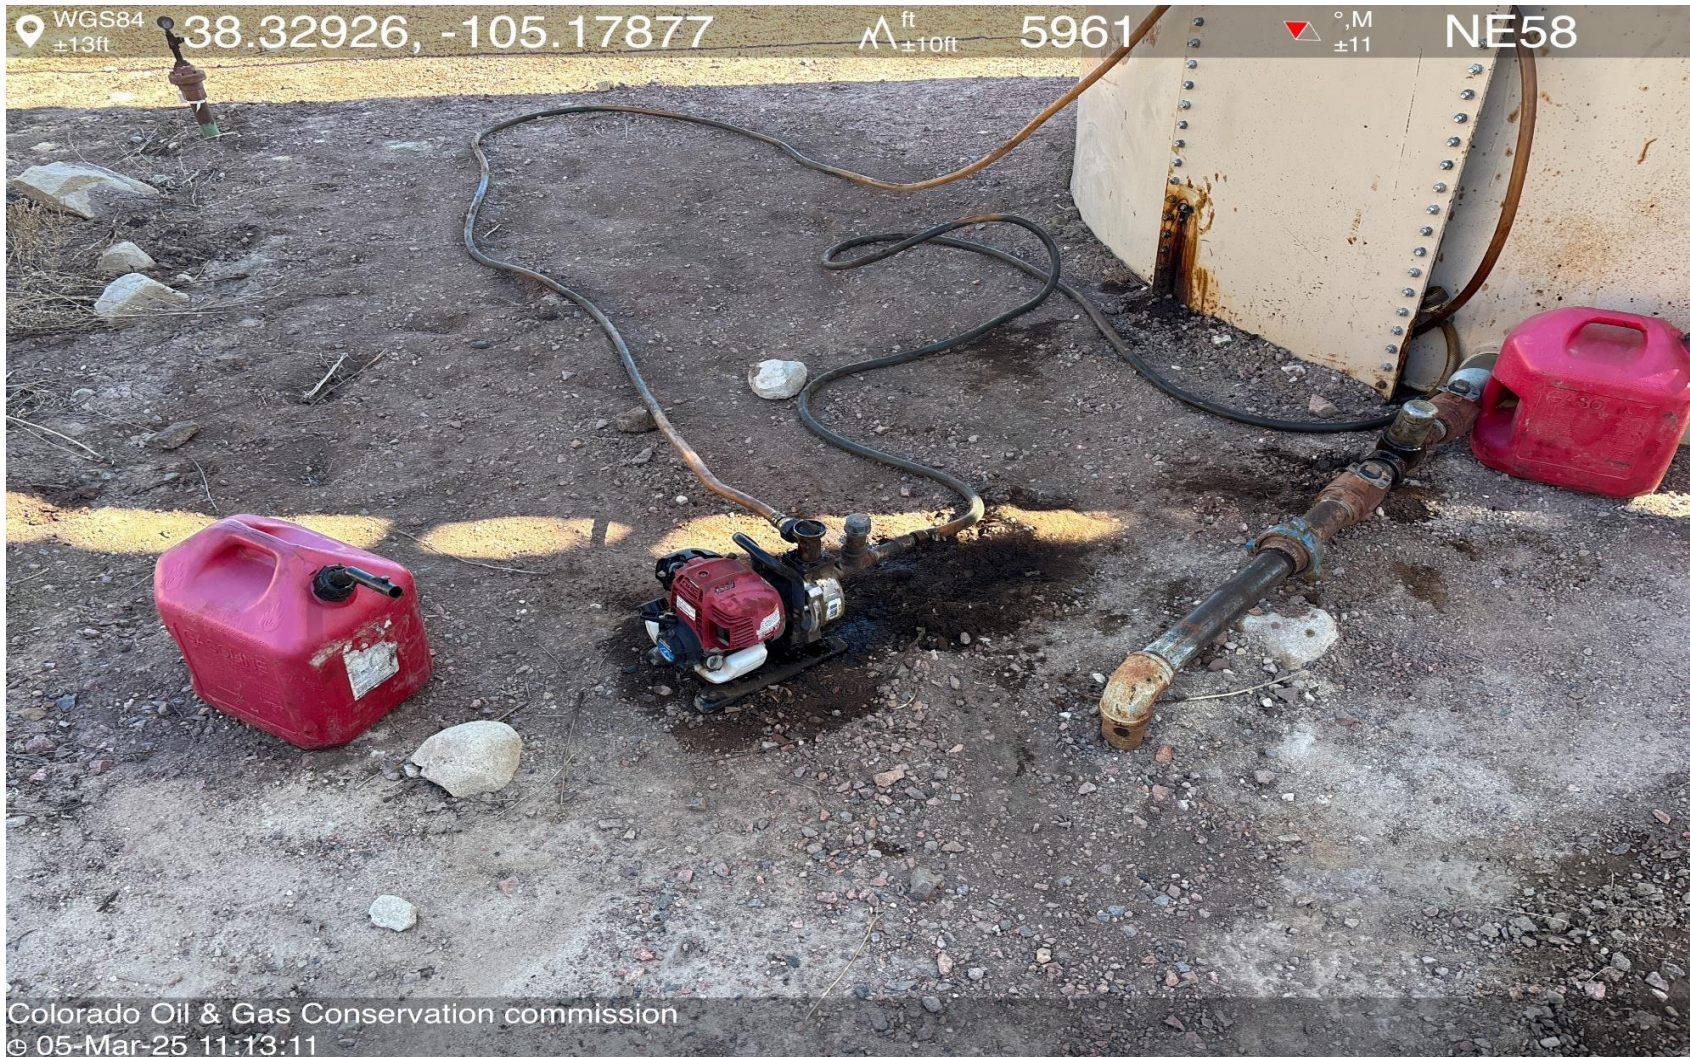
PHOTO 10: AREA OF IMPACTED SOIL FROM LEAKING PUMP ON NORTHERN MOST PERMENANT TANK BATTERY. Conduct maintenance on equipment, cleanup stained material and review self inspection processes. COMPLY WITH RULE 1002,(2).DCA DATE 3/10/2025.

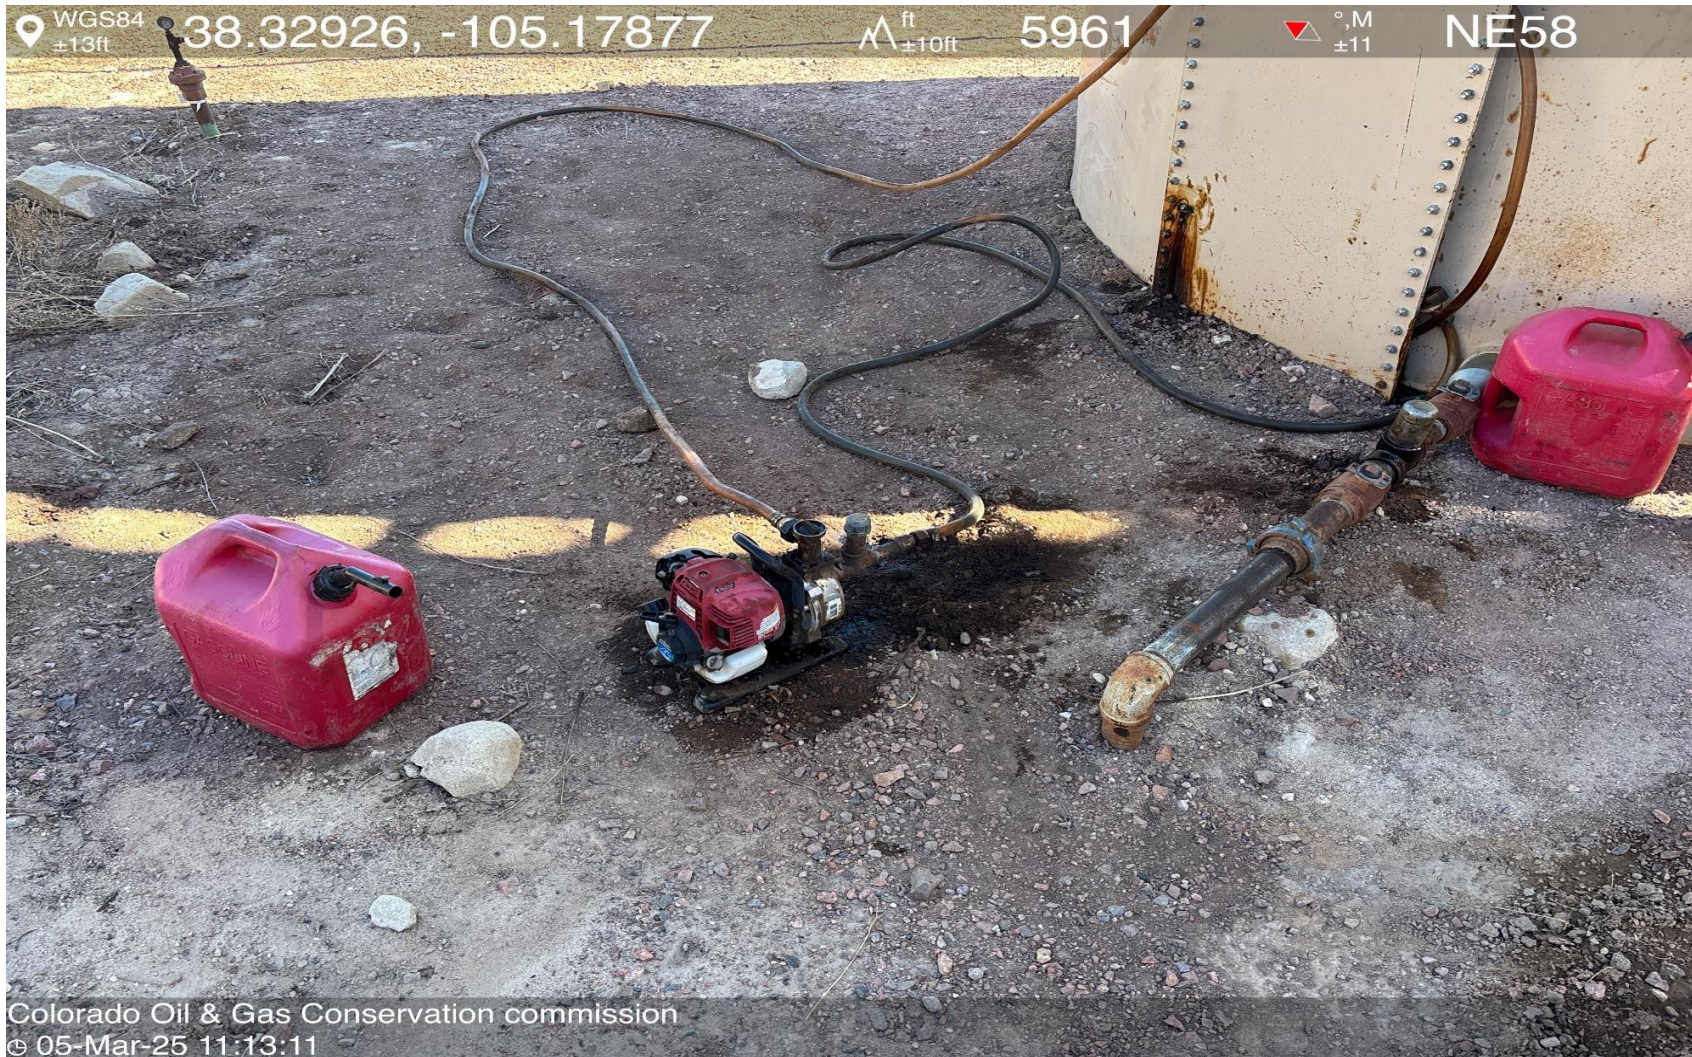
PHOTO 11: UNUSED EQUIPMENT (TWO GAS CANS). REMOVE UNUSED EQUIPMENT PER RULE 606. CA DATE 3/10/2025

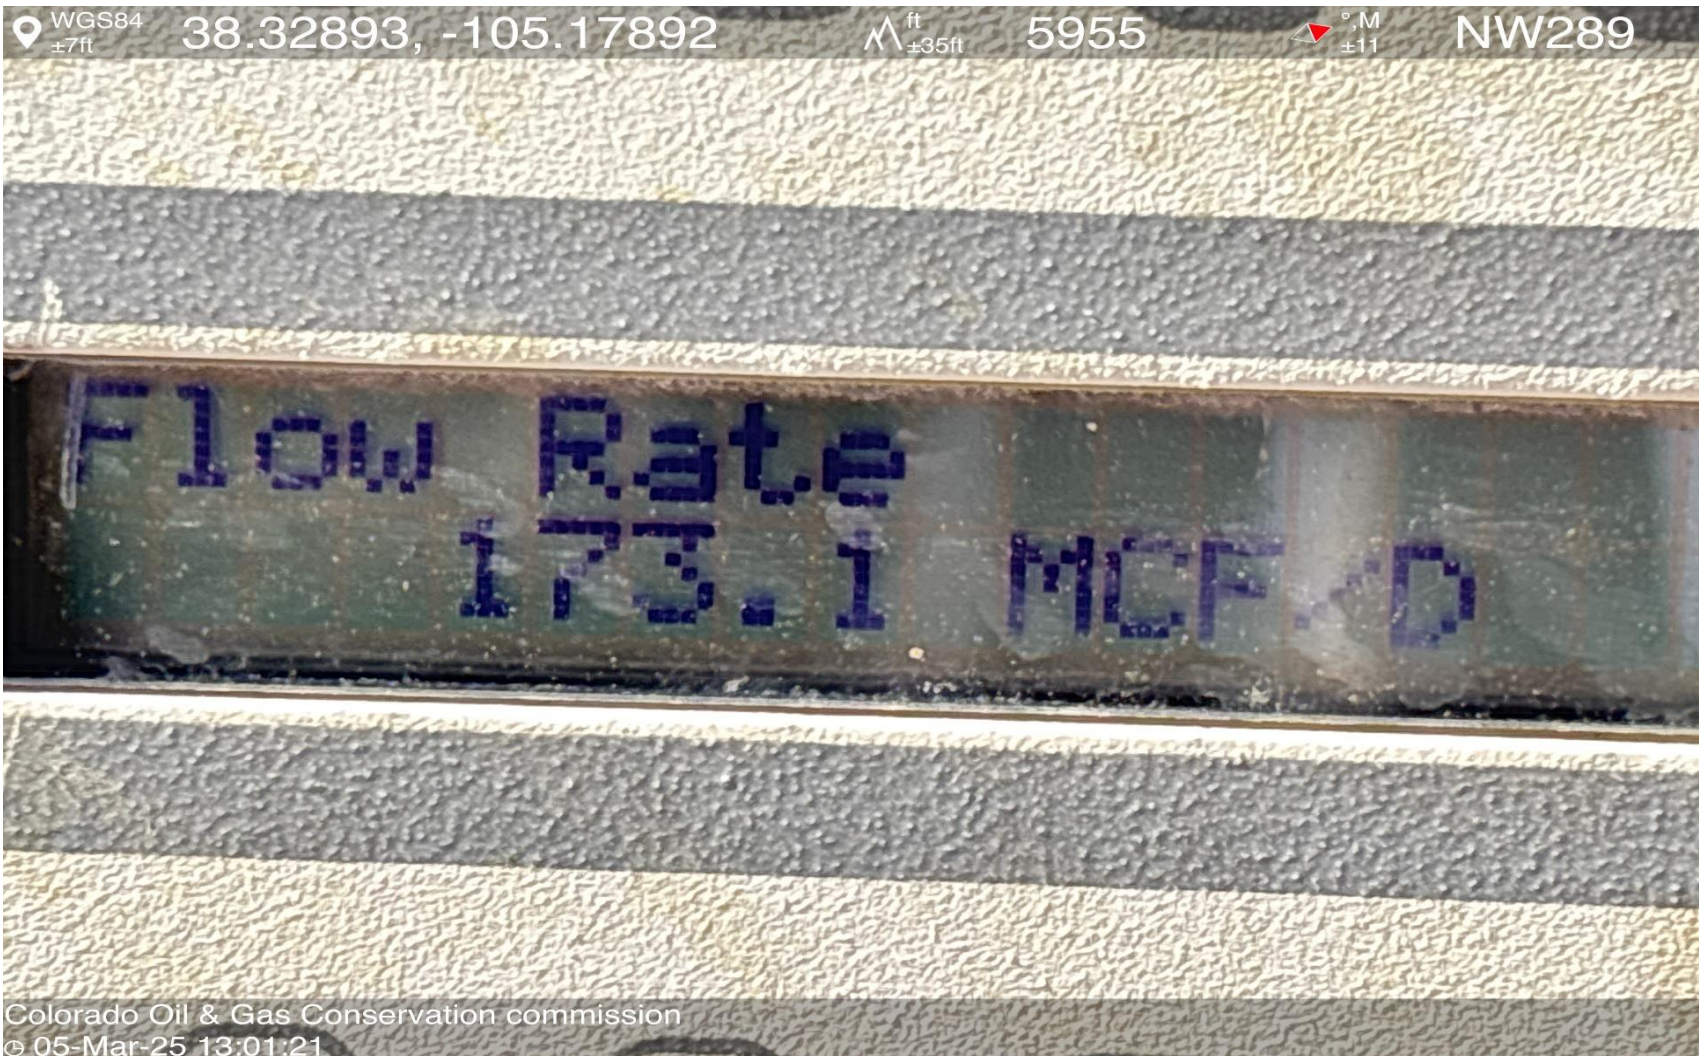
PHOTO 12: METER ONE SHOWS GAS PRODUCTION HOWEVER NO PRODUCTION HAS BEEN REPORTED BY OPERATOR. SUBMIT PRODUCTION REPORTS PER RULE.
