Interim Reclamation and Stormwater Inspection

Operator: BISON IV OPERATING LLC - 10670

Location ID: 427785

Inspection Document #: 718700172

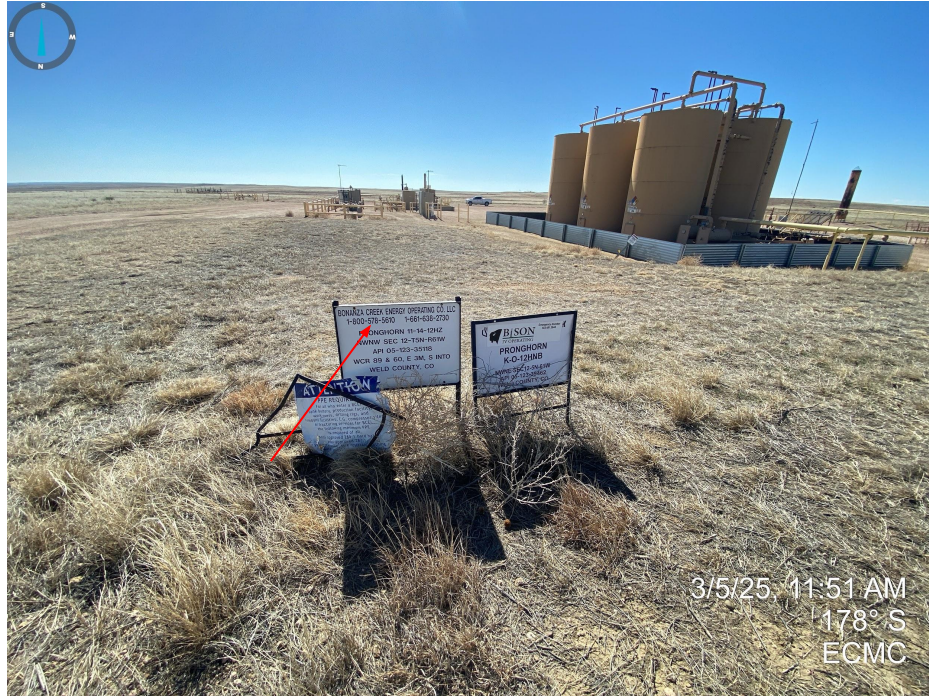
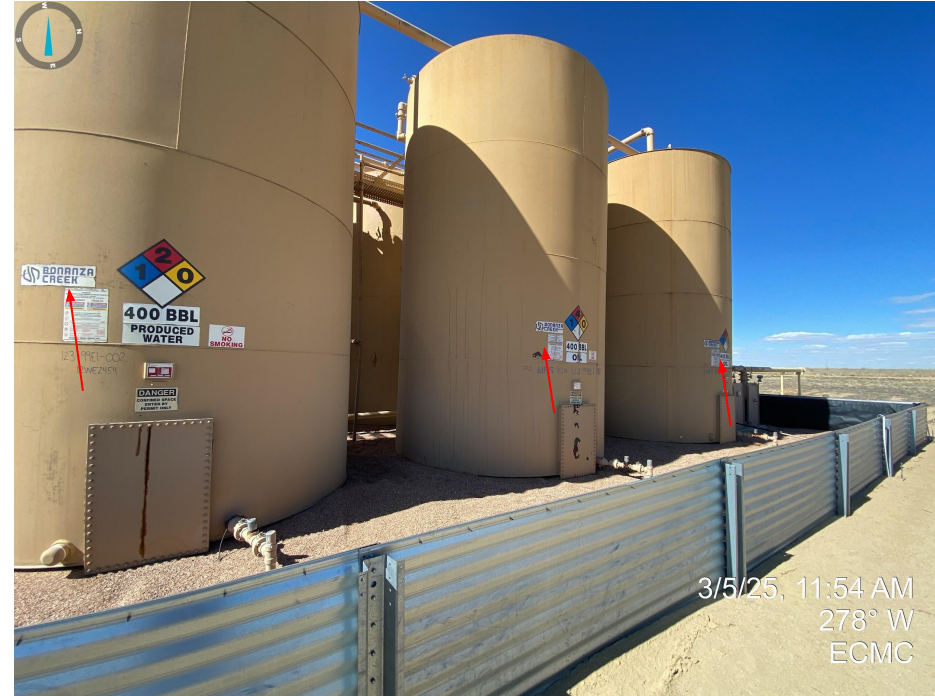
Photos 1 & 2. Signs at entrance, wellhead and tank labels do not reflect current operator of record.

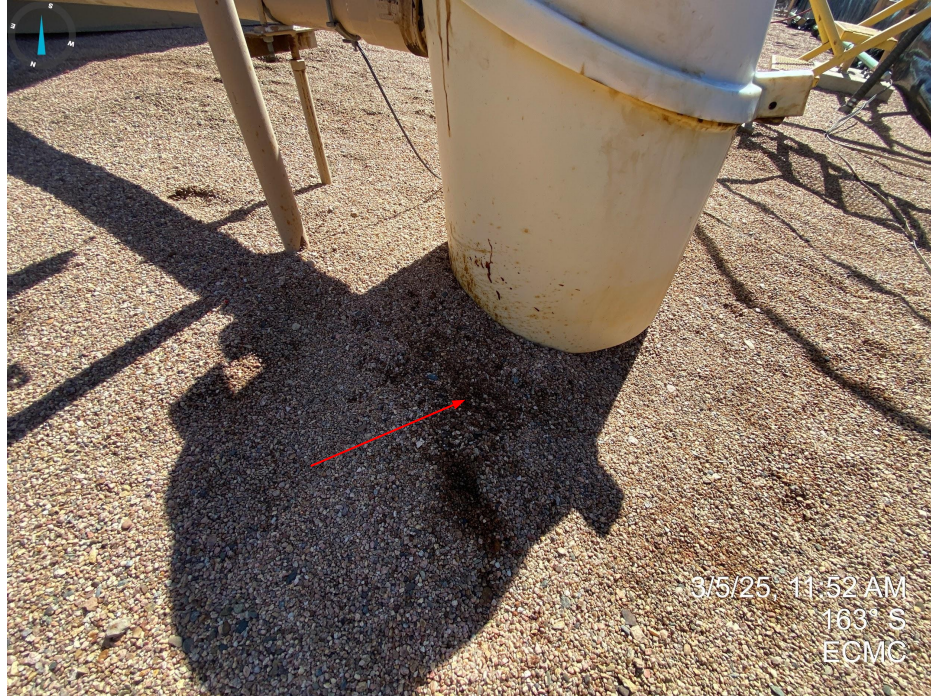
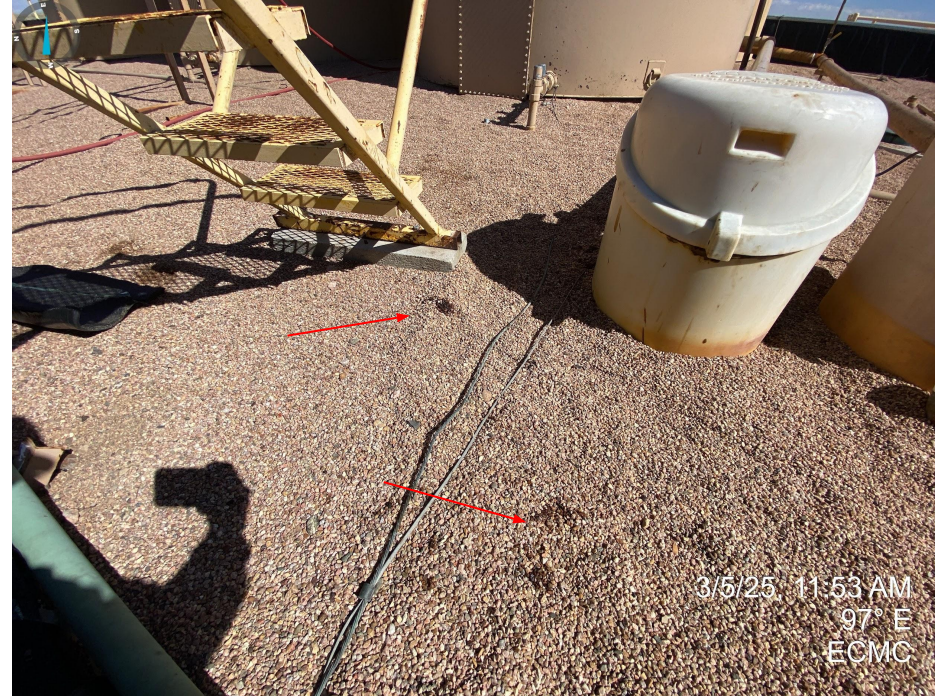
Photos 3 & 4. Hydrocarbon staining observed within the tank battery secondary containment.

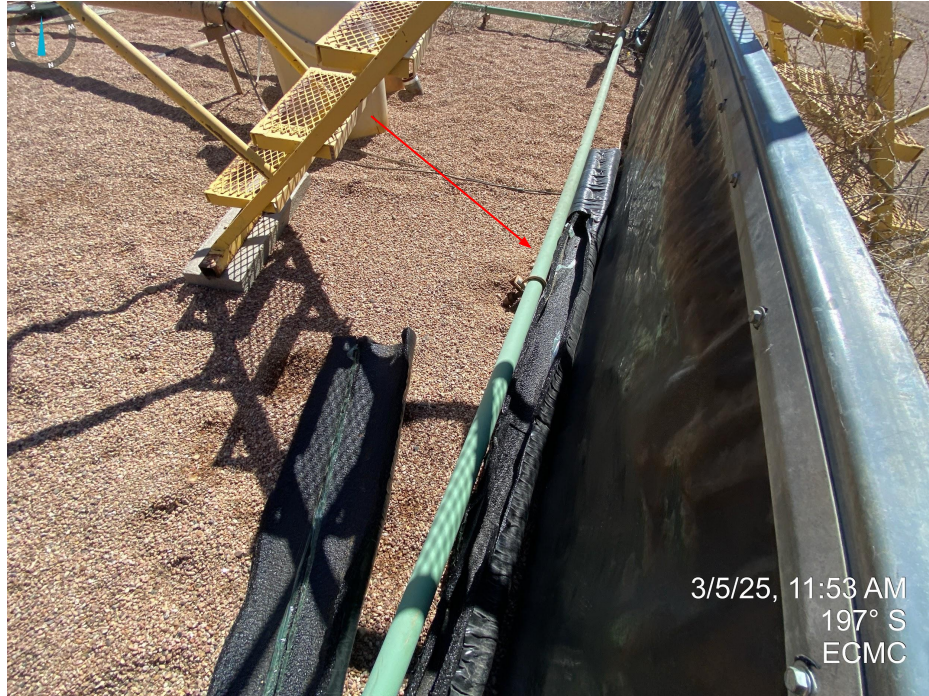
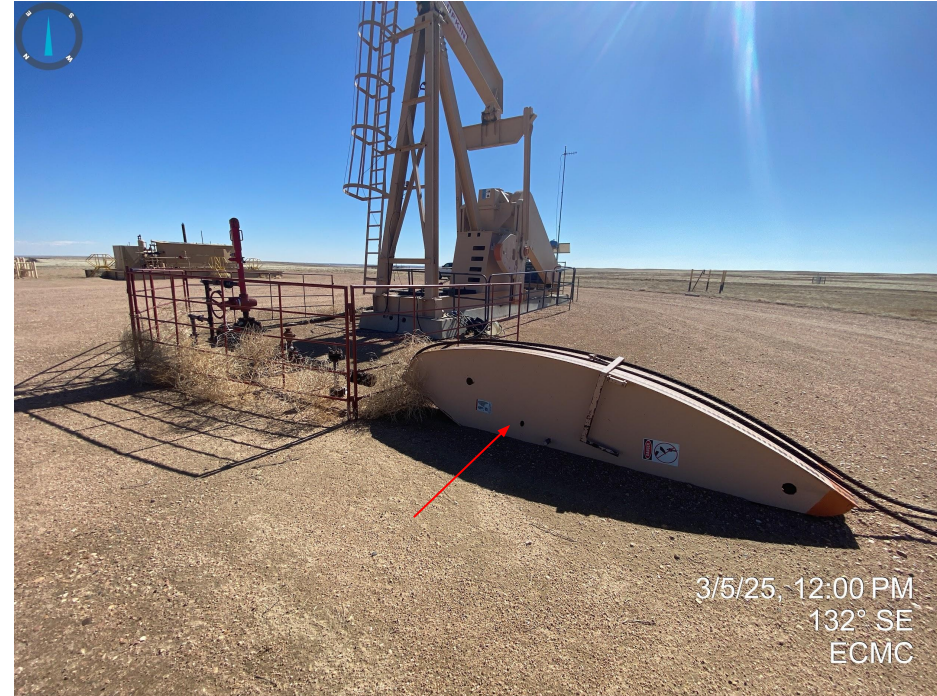
Photos 5 & 6. Unused equipment observed throughout the location.

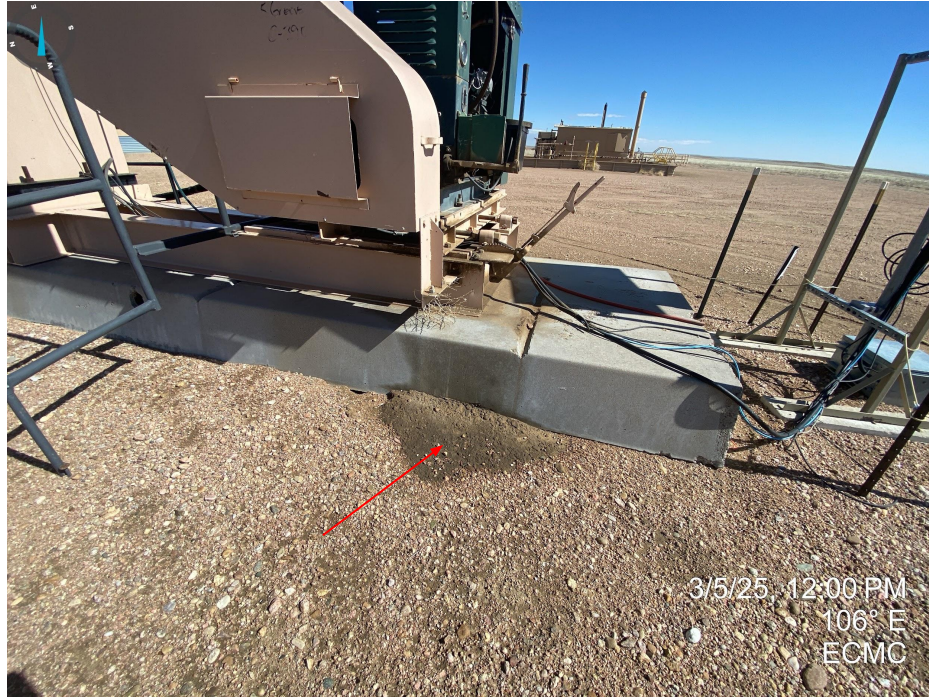
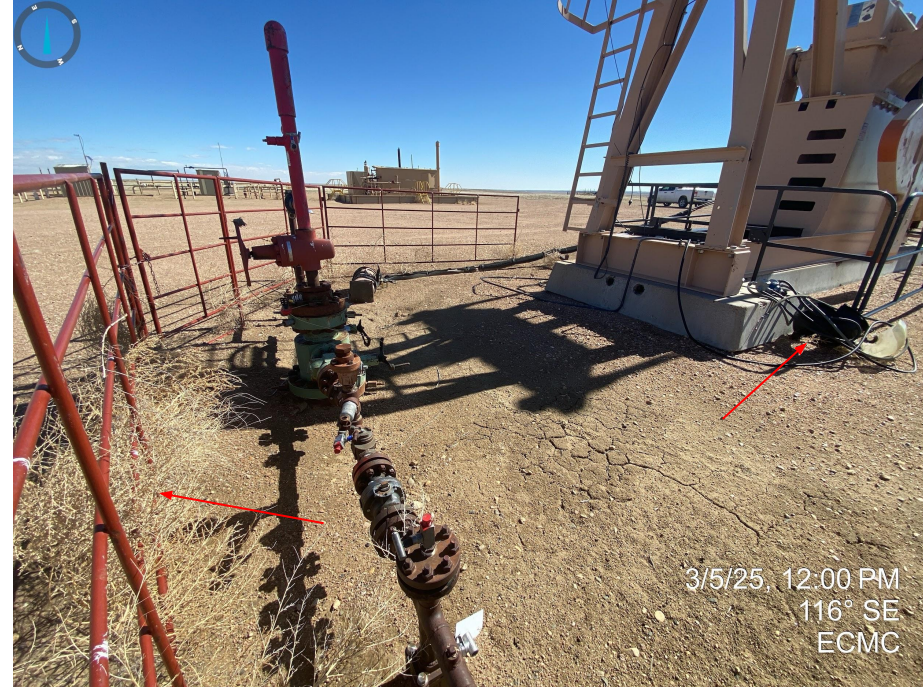
Photos 7 & 8. Hydrocarbon staining at pumpjack (left; Photo 7) and unused equipment and debris at wellhead (right; Photo 8)

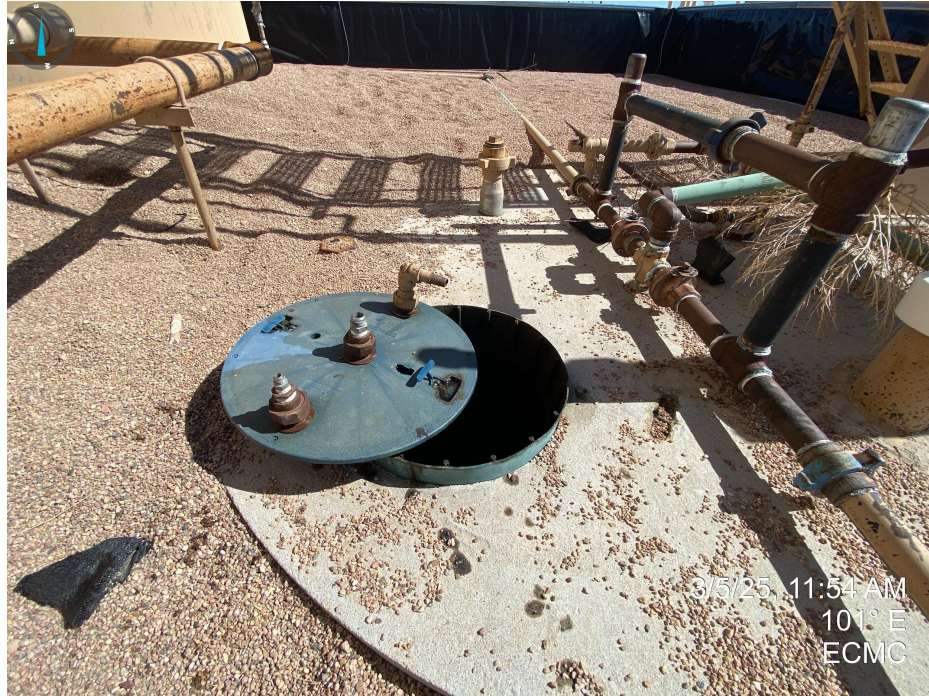
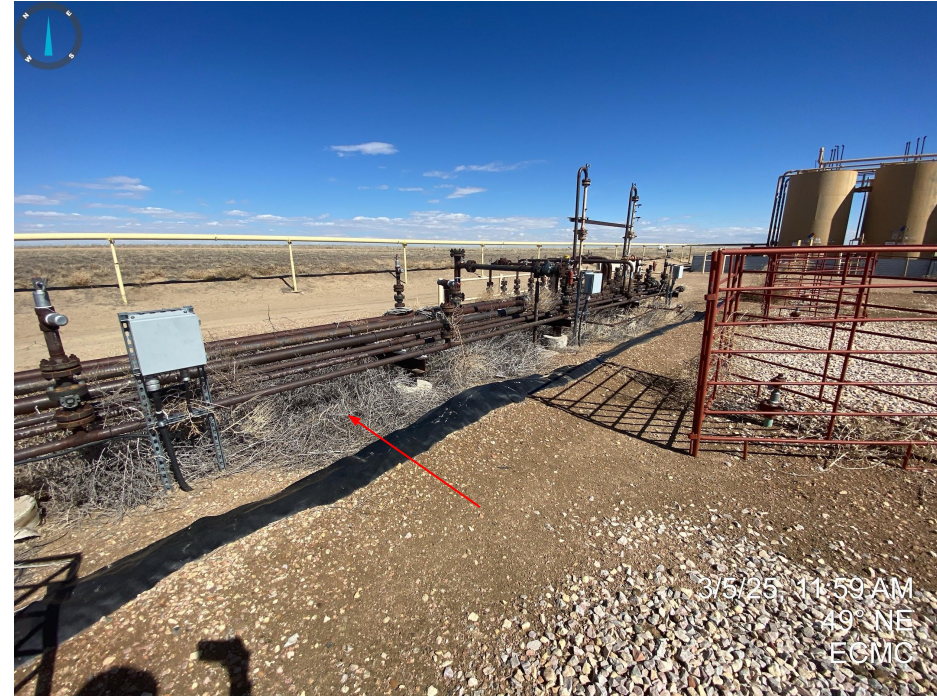
Photos 9 & 10. Lid at buried vessel not securely fastened (left; Photo 9) and tumbleweed debris within equipment (right; Photo 10).

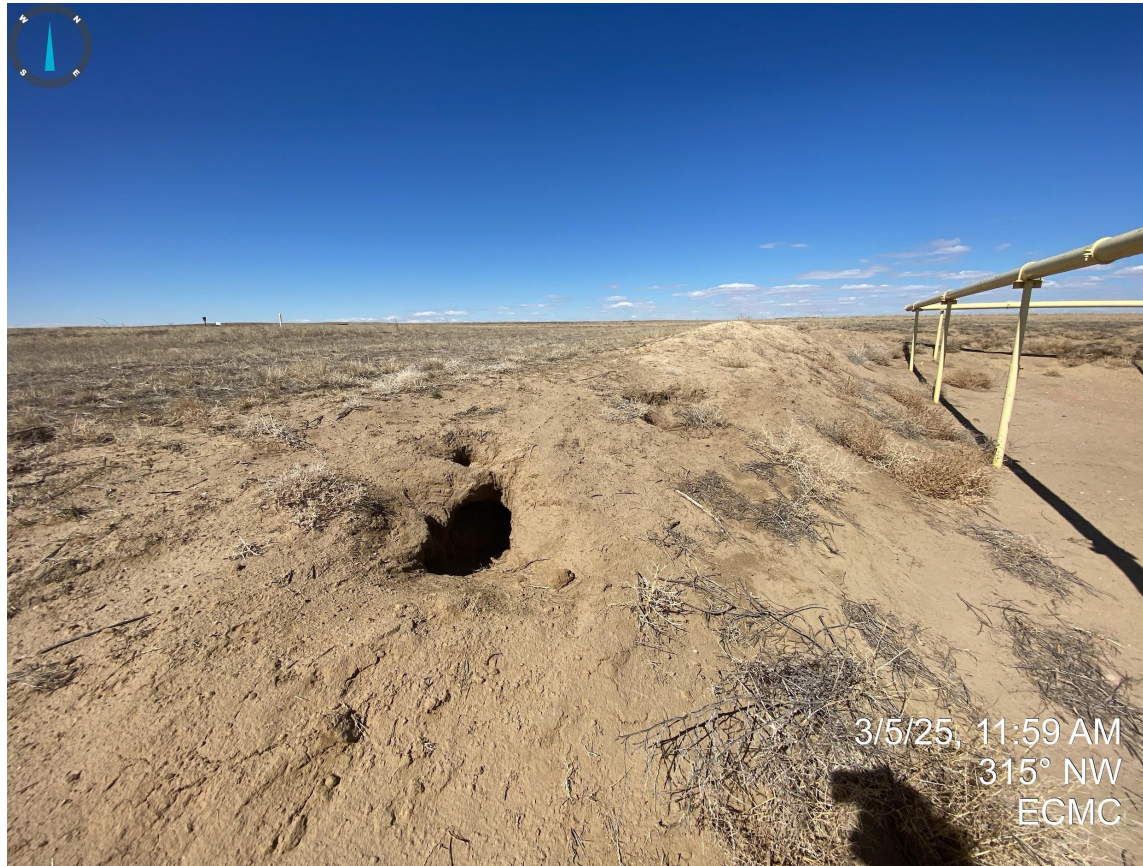
Photo 11. Stockpiled soils on the western portion of the production areas have evidence of undesirable vegetation, animal burrows, and bare/exposed soils.

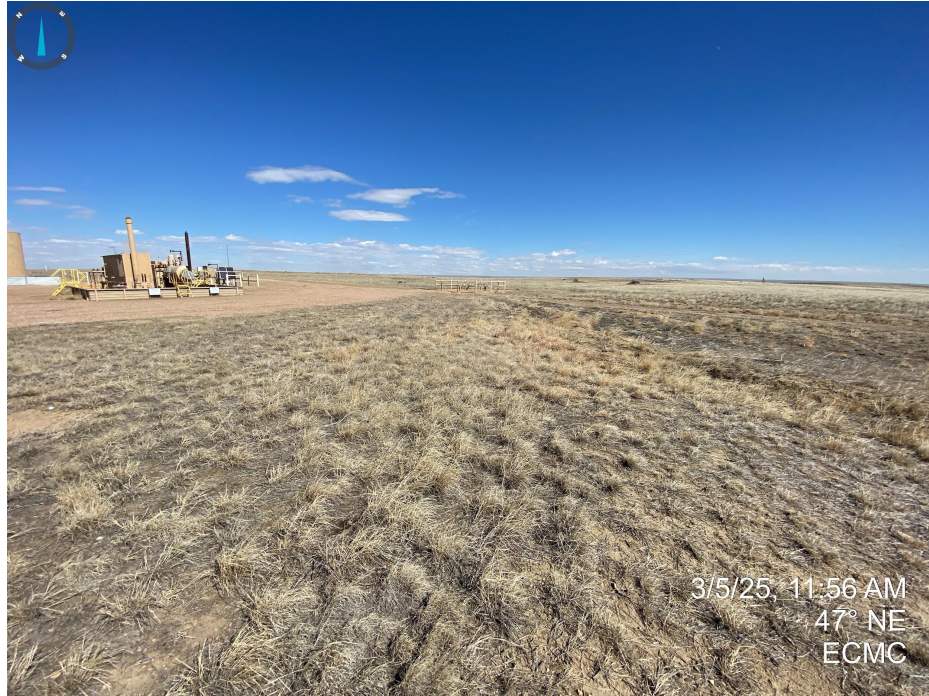
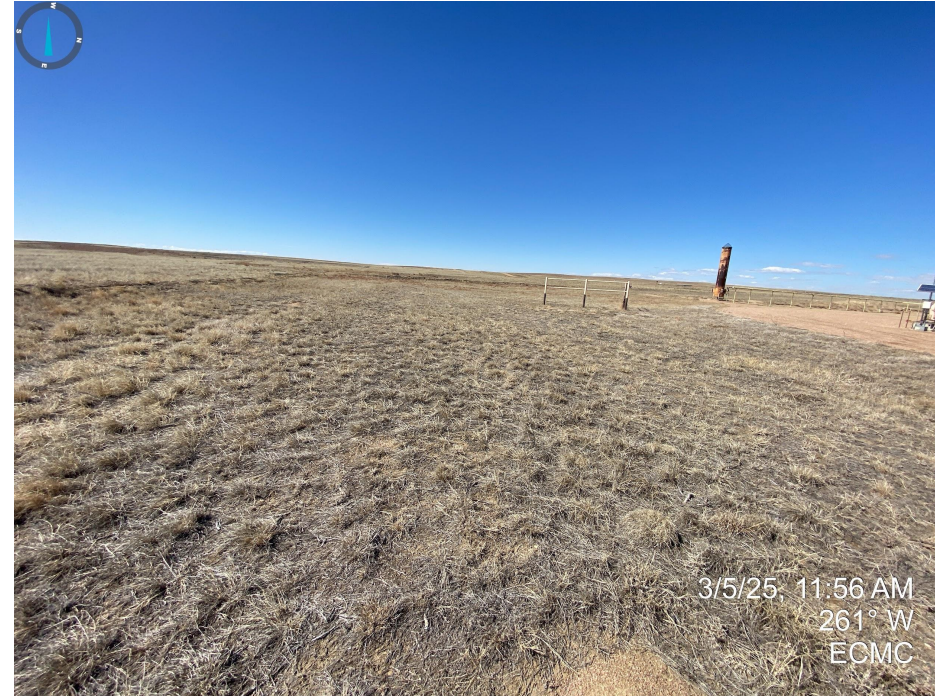
Photos 12 & 13. Southern interim areas. Appears interim reclamation activities have been performed to reduce disturbance areas only needed for production operations. A vegetative assessment will be performed at a later date during the active growing season to verify interim reclamation regulations and standards and will therefore remain "In-Process".

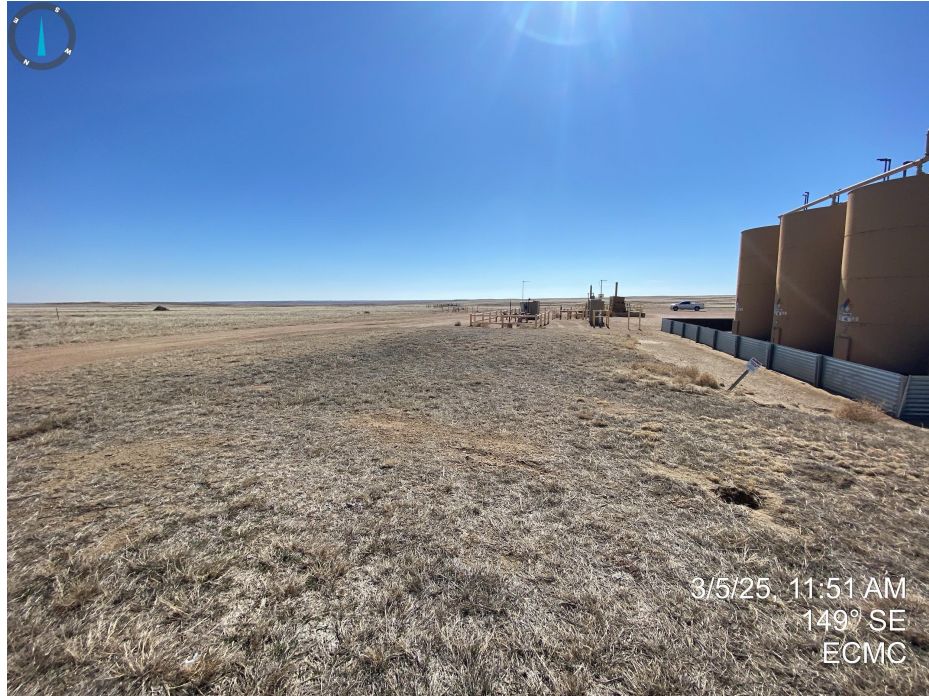
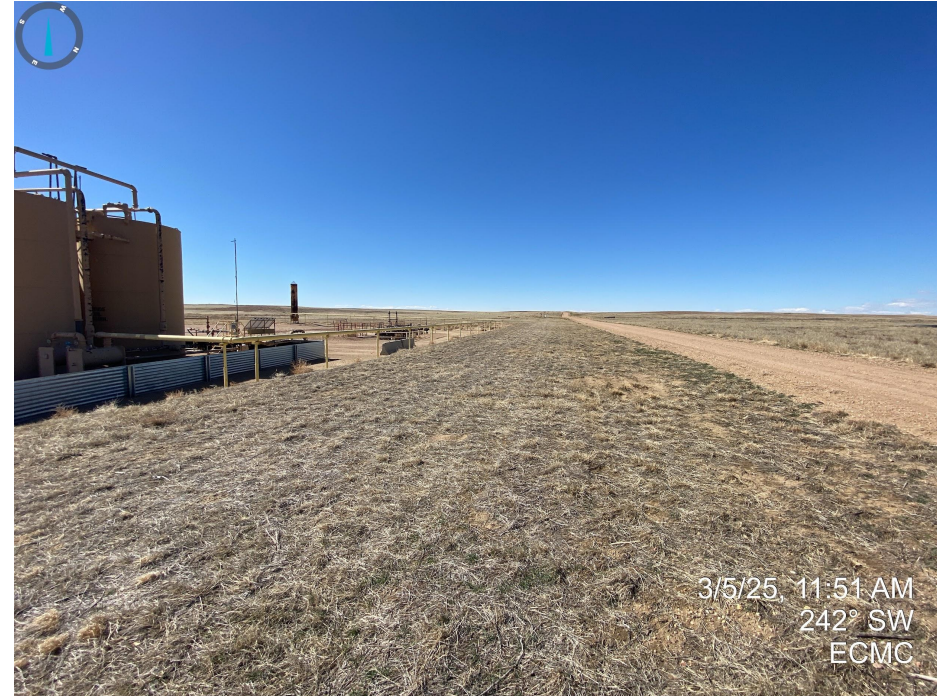
Photos 14 & 15. Northern interim areas. Appears interim reclamation activities have been performed to reduce disturbance areas only needed for production operations. A vegetative assessment will be performed at a later date during the active growing season to verify interim reclamation regulations and standards and will therefore remain "In-Process".
