# Inspection Photos

**Operator:** LARAMIE ENERGY LLC #10433

**Location ID:** 432260

**Inspection Doc:** 718100291

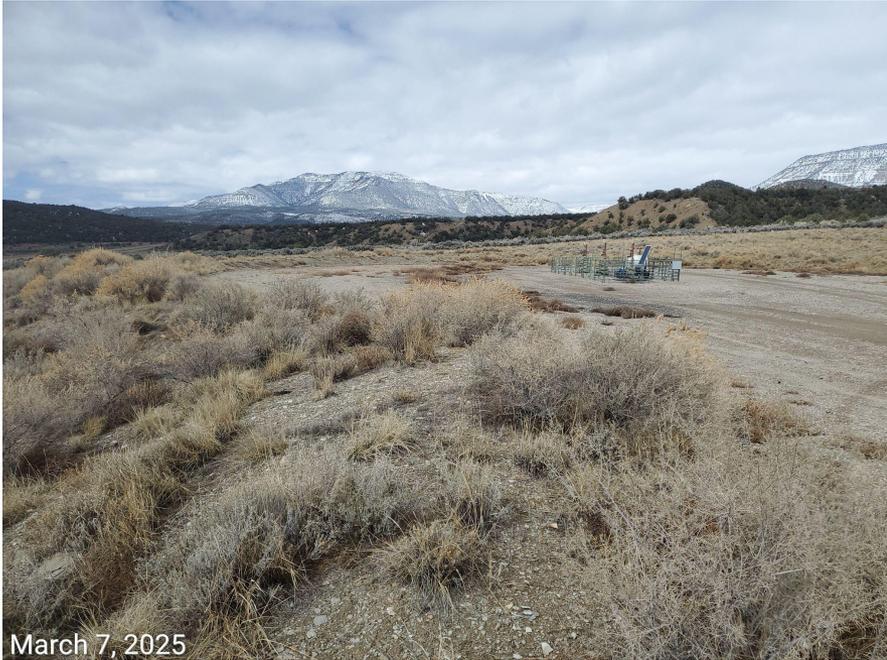
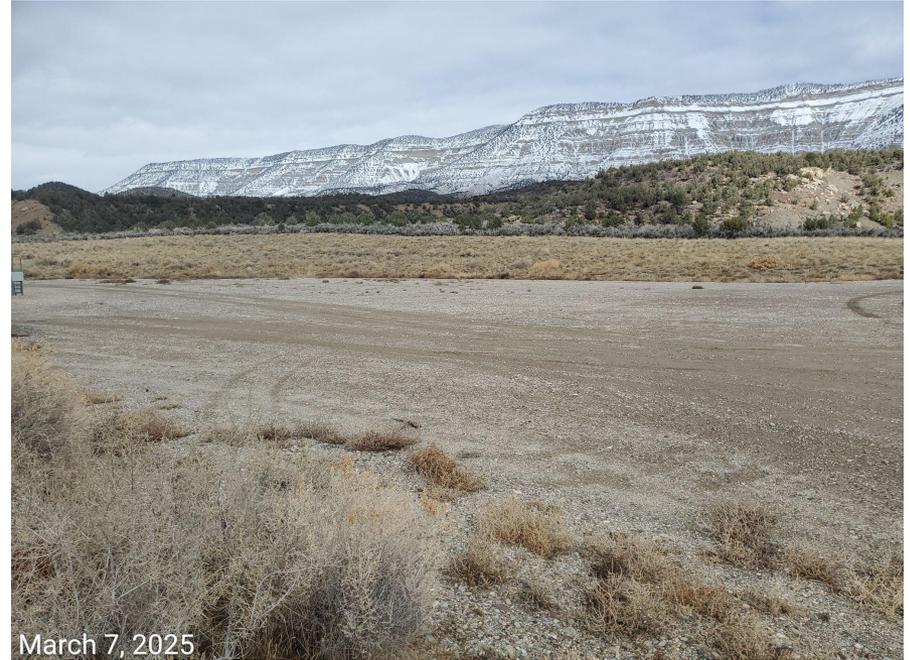
**Photo 1:** Photos 1-2 taken from the south end of the Location. Photos provide an overview of the Location from west, northwest, northeast to east.

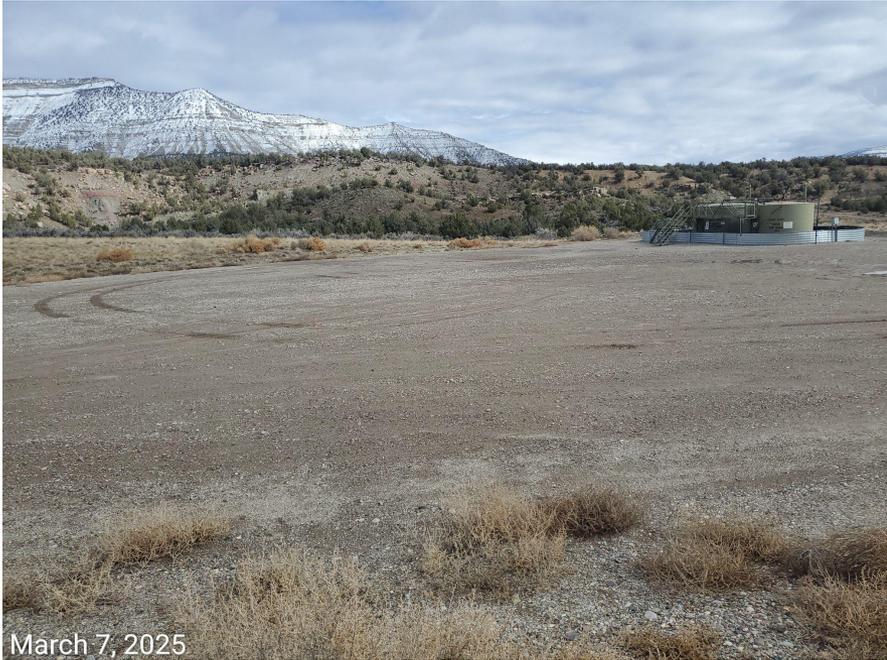
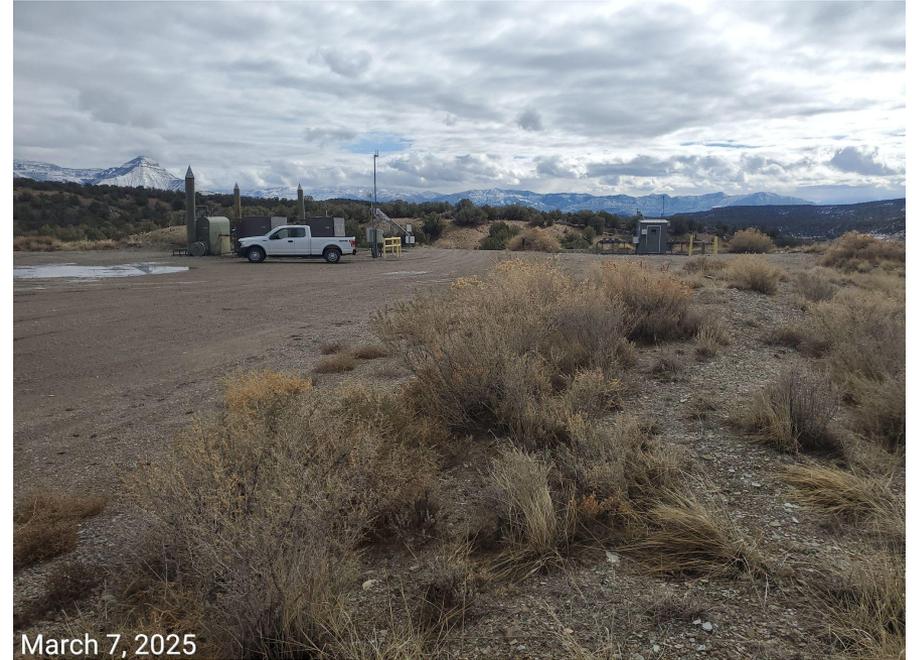
**Photo 2:** See comments under photo 1.

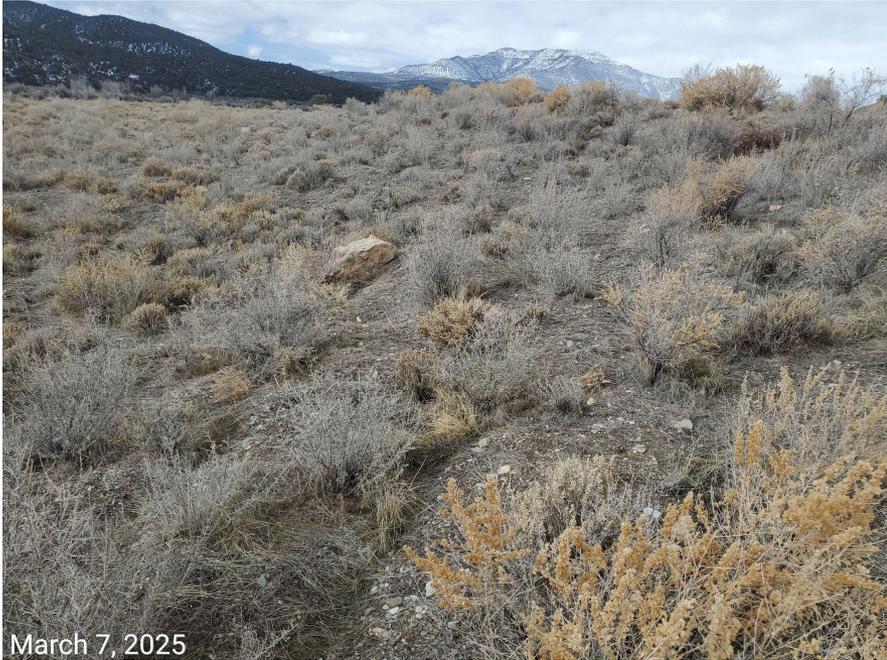
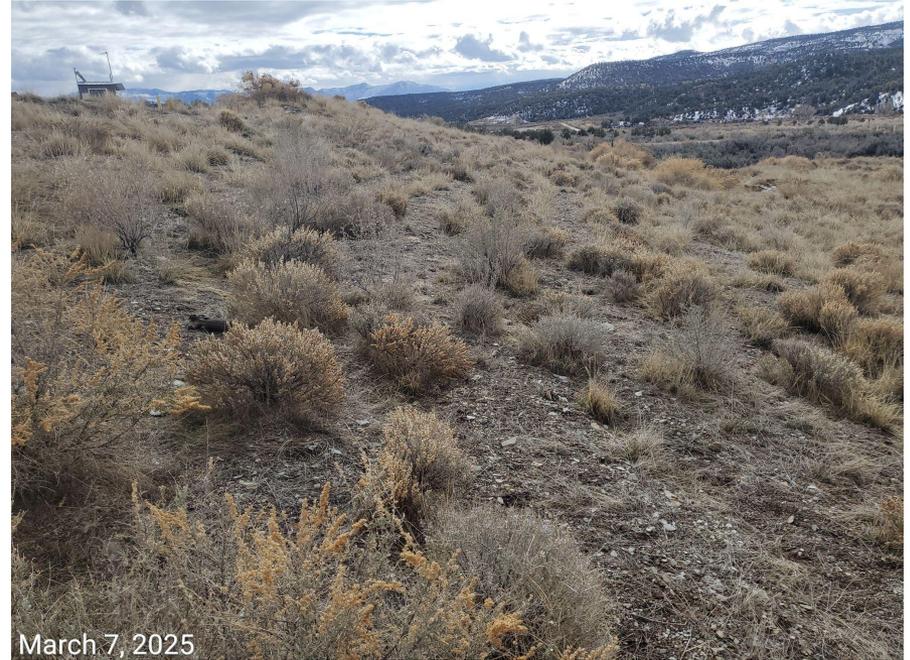
**Photo 3:** Photo example of vegetation establishment within the southern interim areas of the Location. Vegetation is predominantly shrubby species such as 4-wing saltbrush.

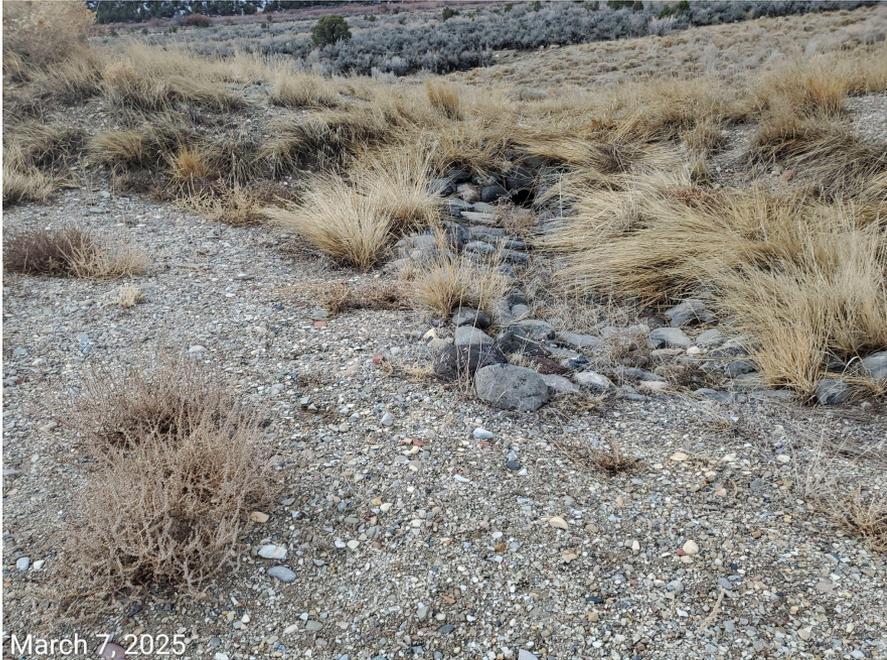
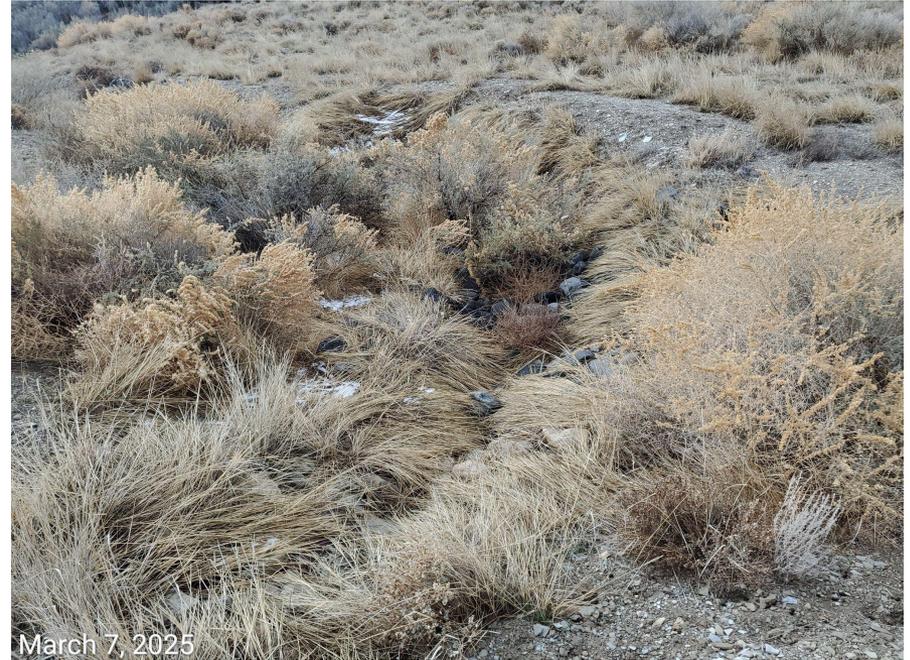
**Photo 4:** Photo of sediment trap on the southeastern working pad surface, and southern interim areas.

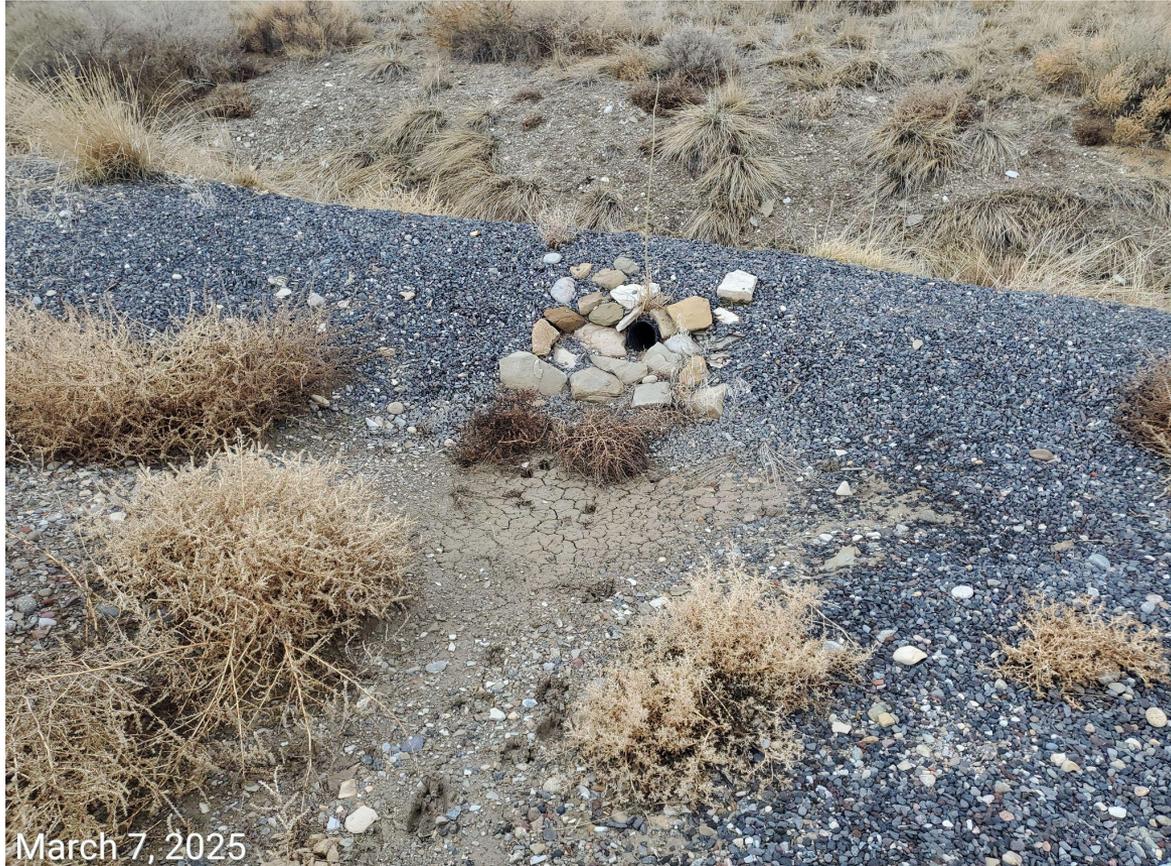
**Photo 5:** Photos shows sediment trap and outlet on the western working pad surface.

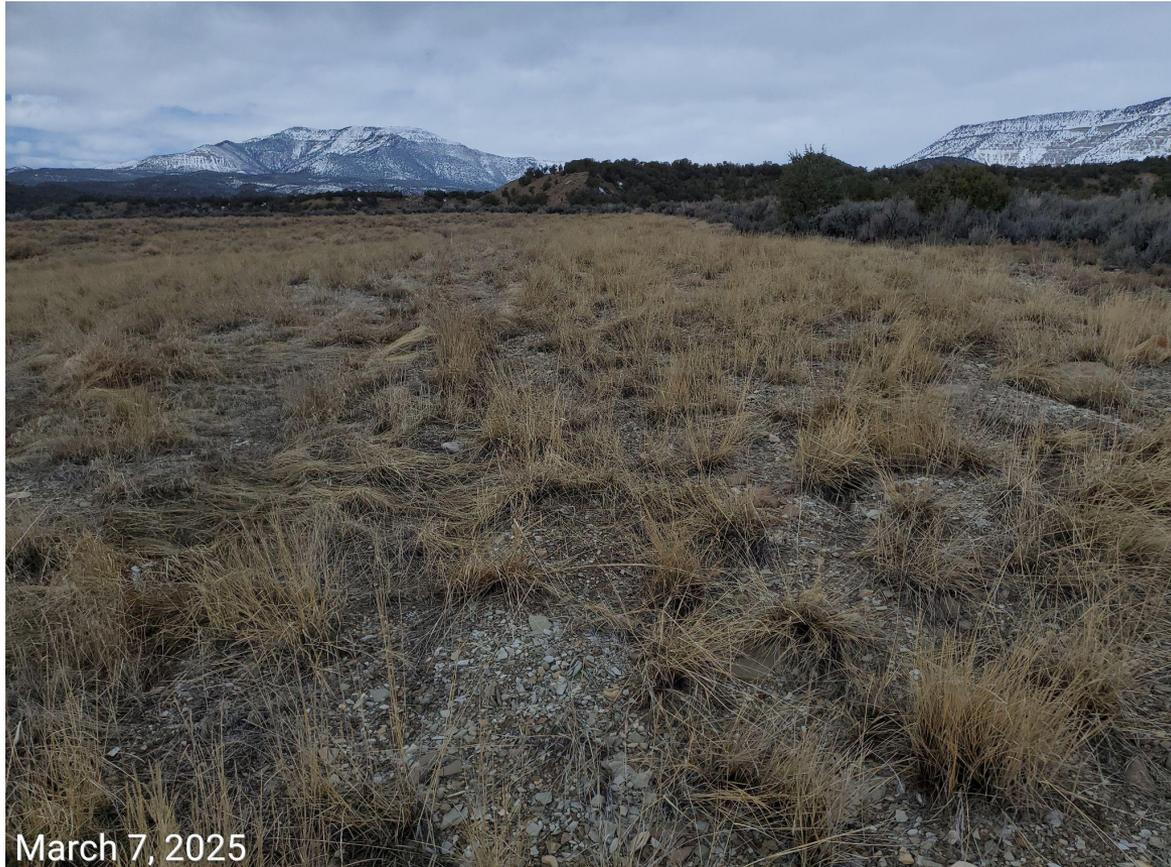
**Photo 6:** Photo taken from the interim areas on the north end of the Location, facing west. Vegetation established are predominantly wheatgrass species.

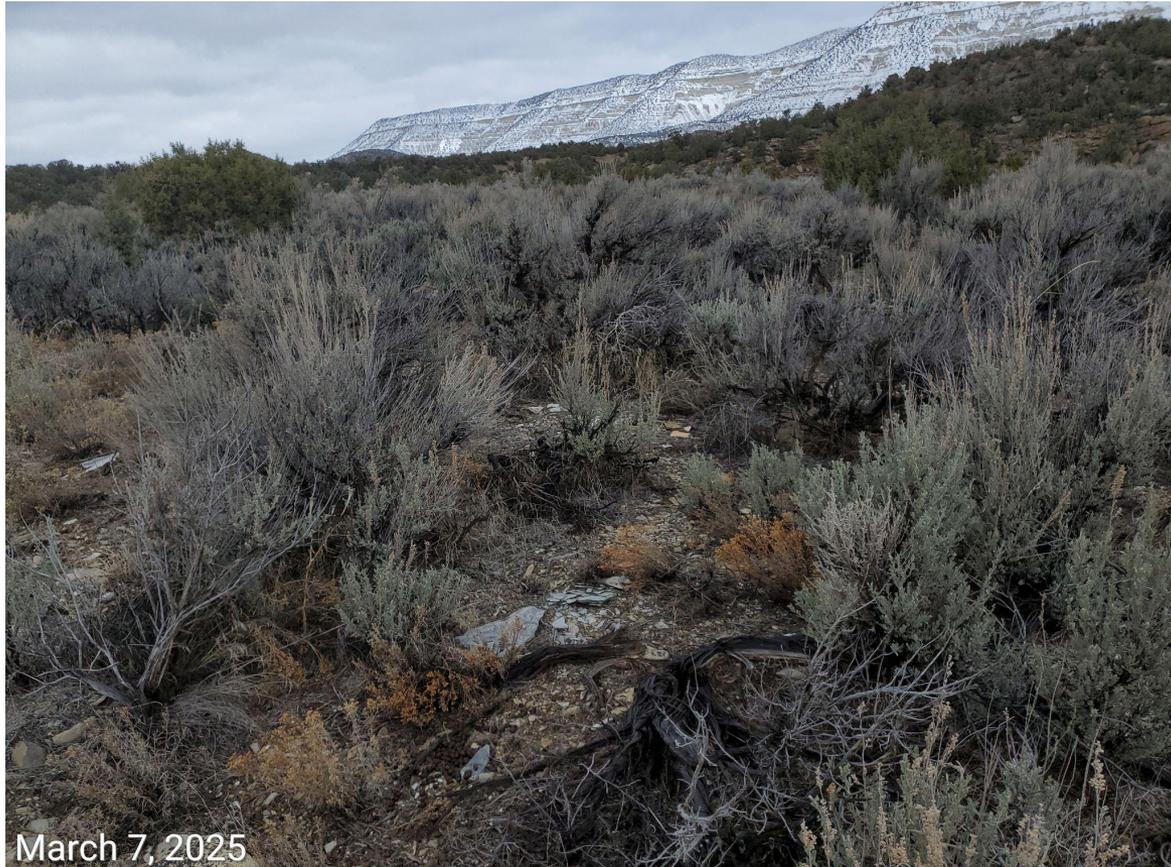
**Photo 7:** Photos examples showing the adjacent reference area vegetation. Species are predominantly shrubs (Sage brush). It is noted that the species observed establishing within the interim areas are not reflective of the adjacent reference areas.

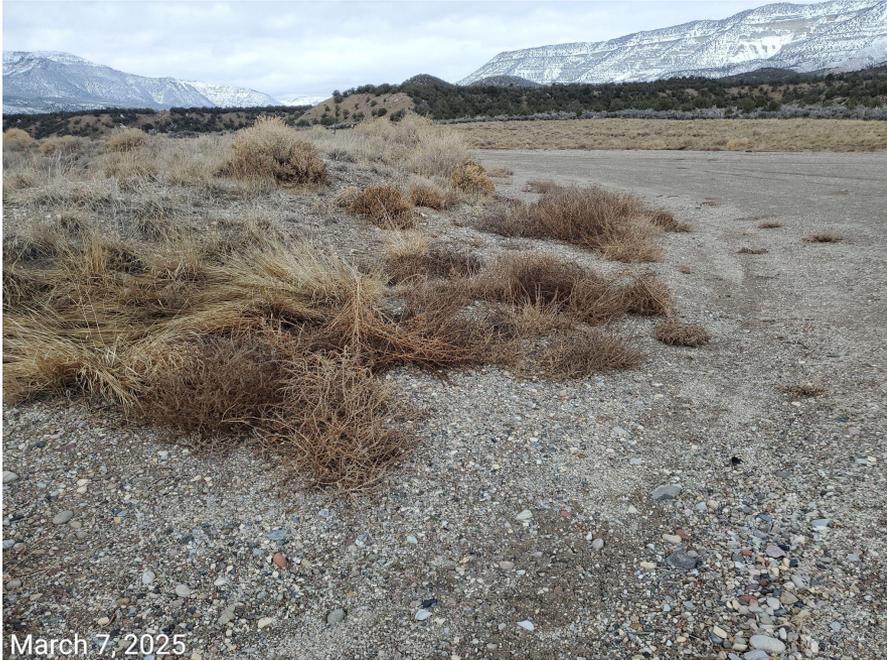
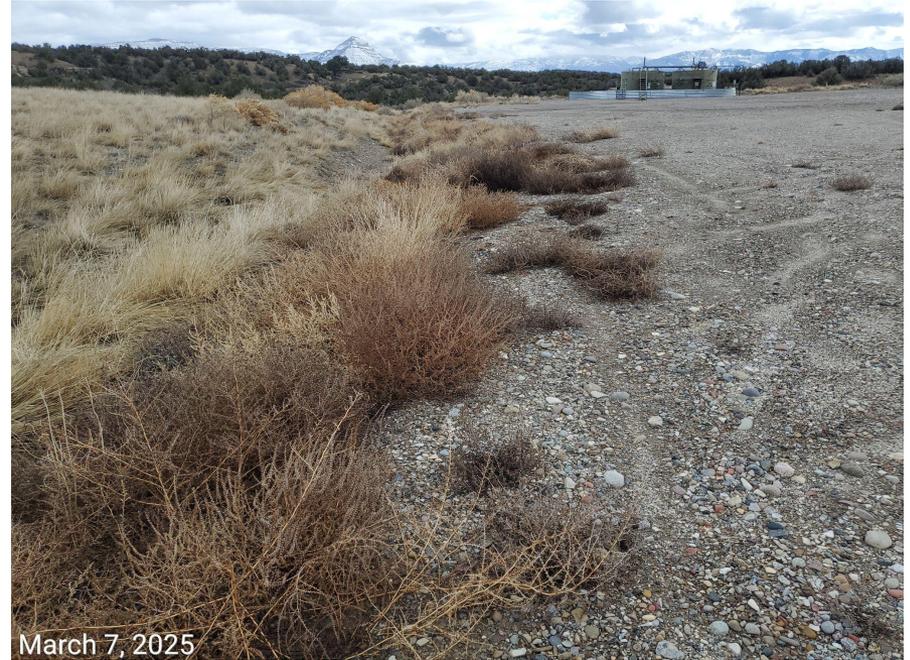
**Photo 8:** Photos 8-10 examples showing Undesirable Plant Establishment (*Salsola* sp., Canada thistle) and weed debris on the working pad surface. Additional and ongoing weed management efforts to keep Location free of Undesirable Plant Species will be needed during the 2025 growing season. Weed debris requires removal and proper disposal.

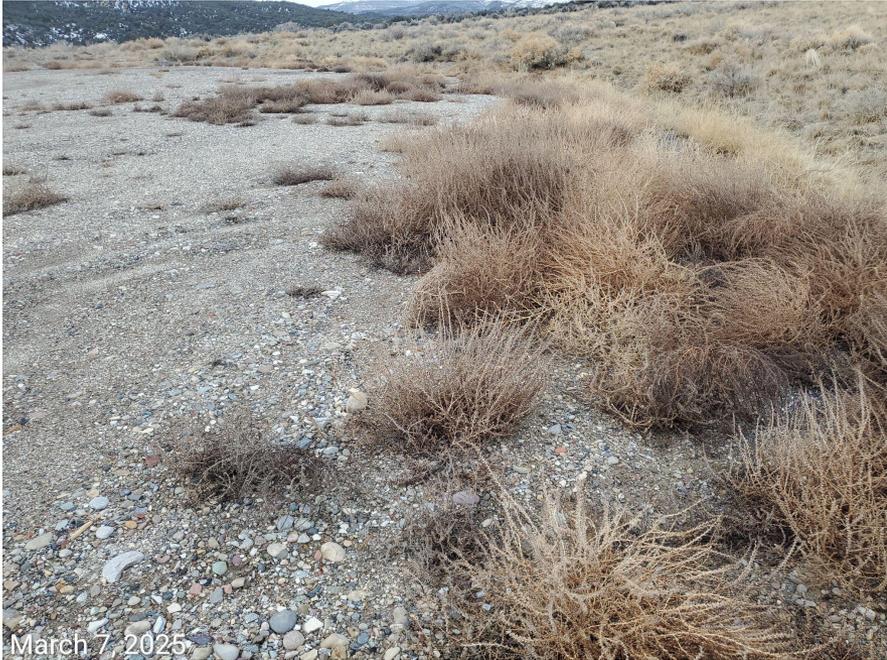
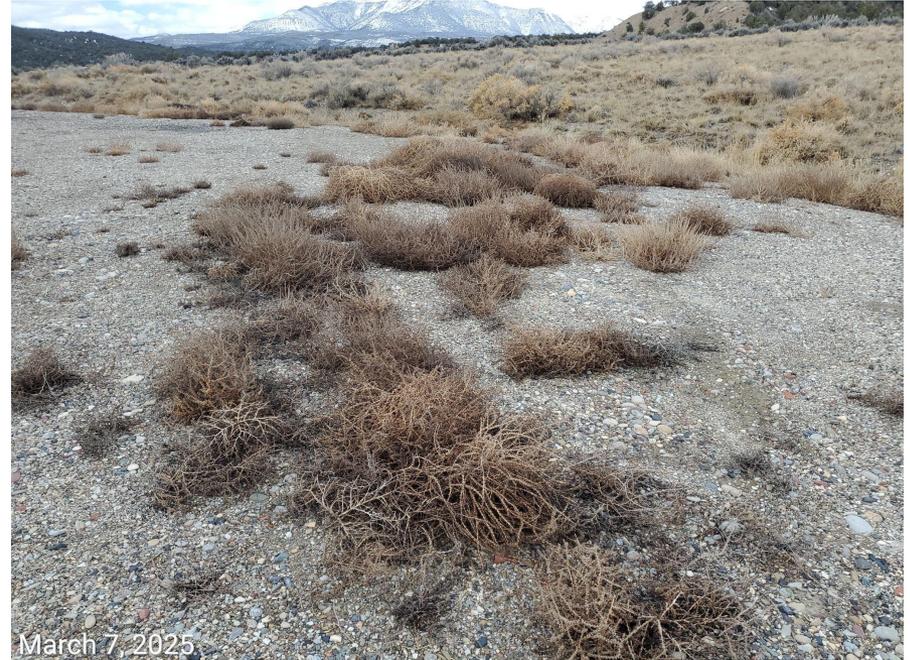
**Photo 9:** See comments under photo 8.

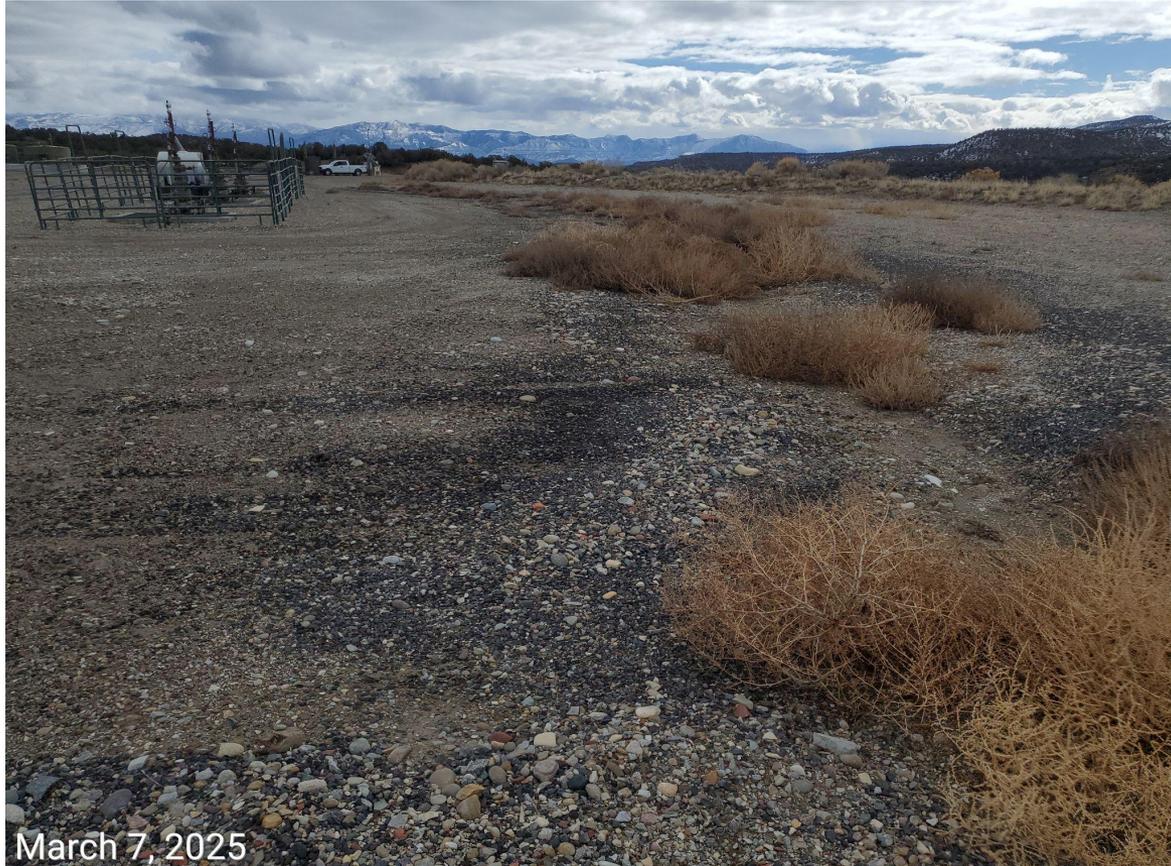
**Photo 10:** See comments under photo 8.
