Inspection Photos

Operator: LARAMIE ENERGY LLC #10433

Location ID: 432255

Inspection Doc: 718100293

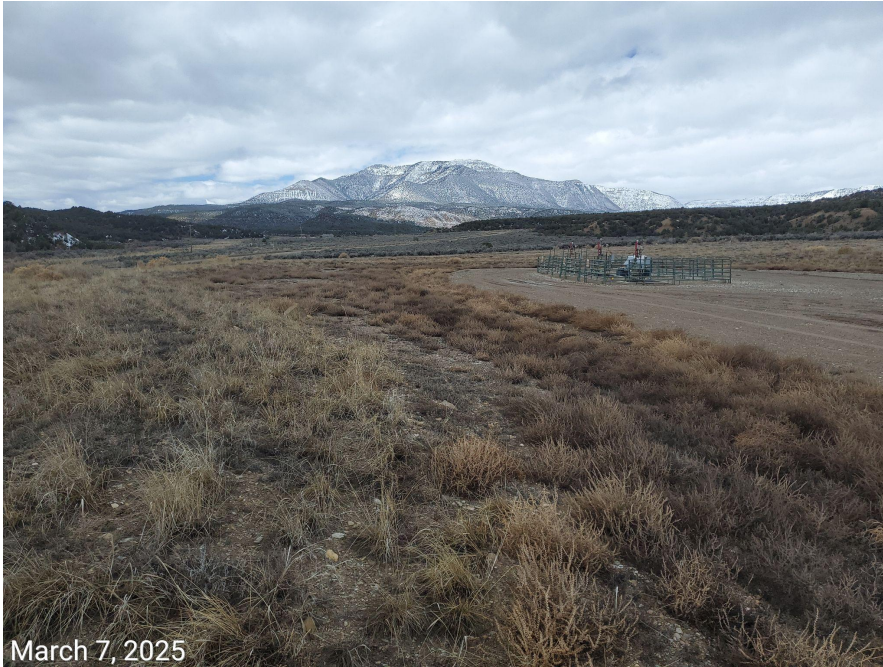
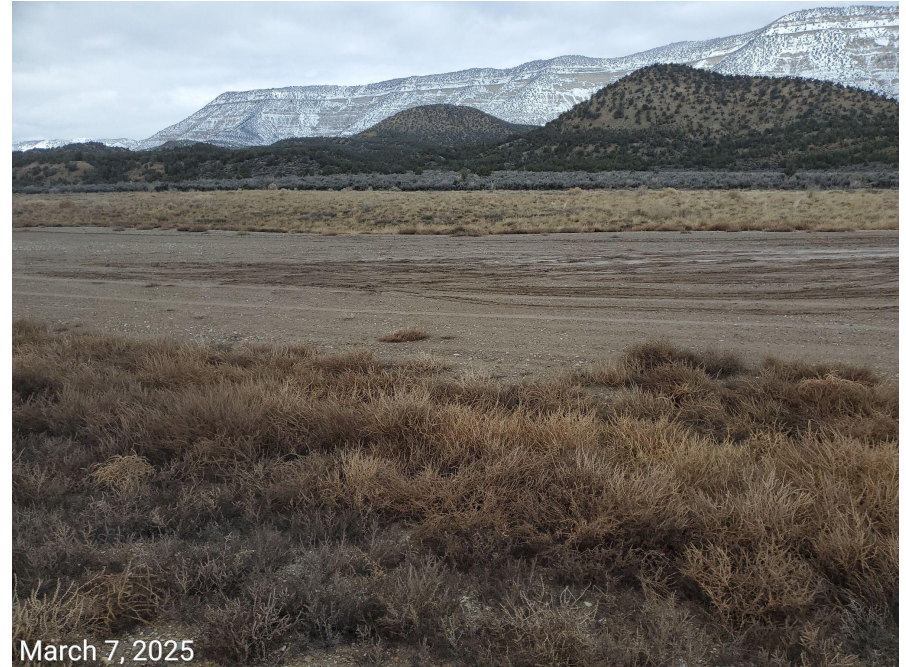
Photo 1: Photos 1-2 taken from the south end of the Location. Photos provide an overview of the Location from west, northwest, northeast to east.

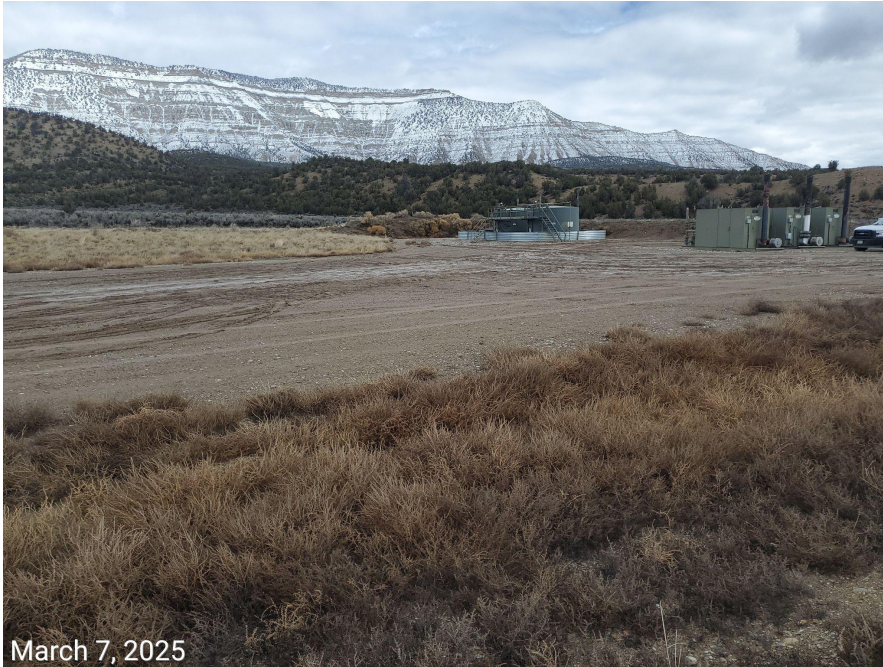
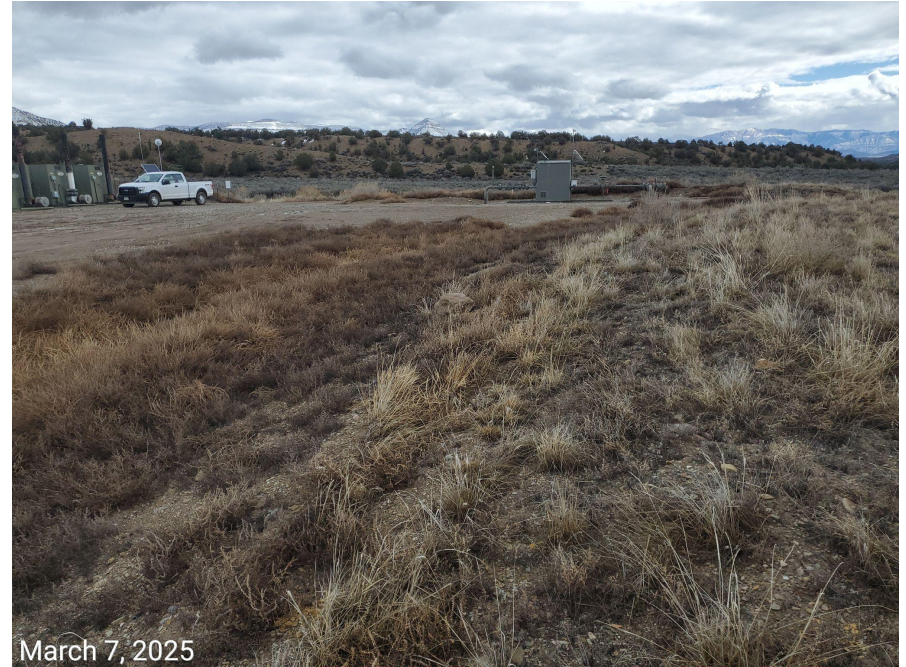
Photo 2: See comments under photo 1.

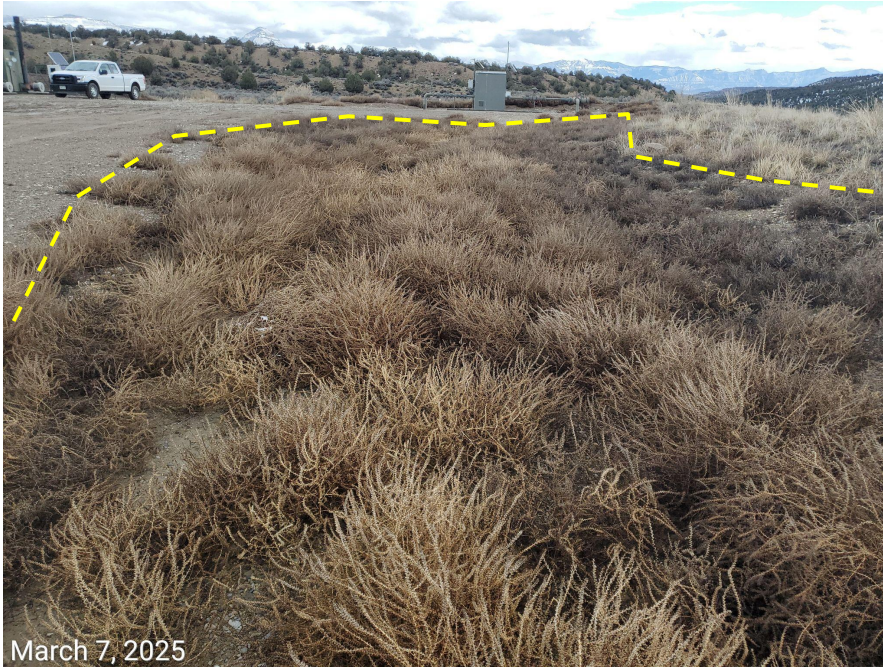
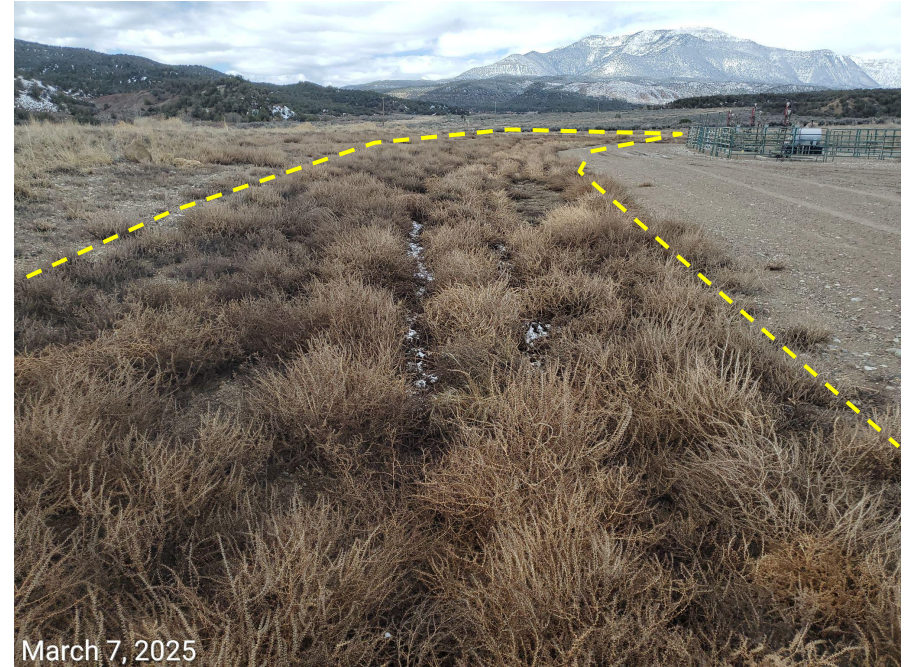
Photo 3: Photos taken from the southern end of the Location. Photos examples showing Undesirable Plant Species (*Salsola* sp., Russian thistle) established in dense populations within the interim areas. Weed management and additional reclamation efforts required within these areas.

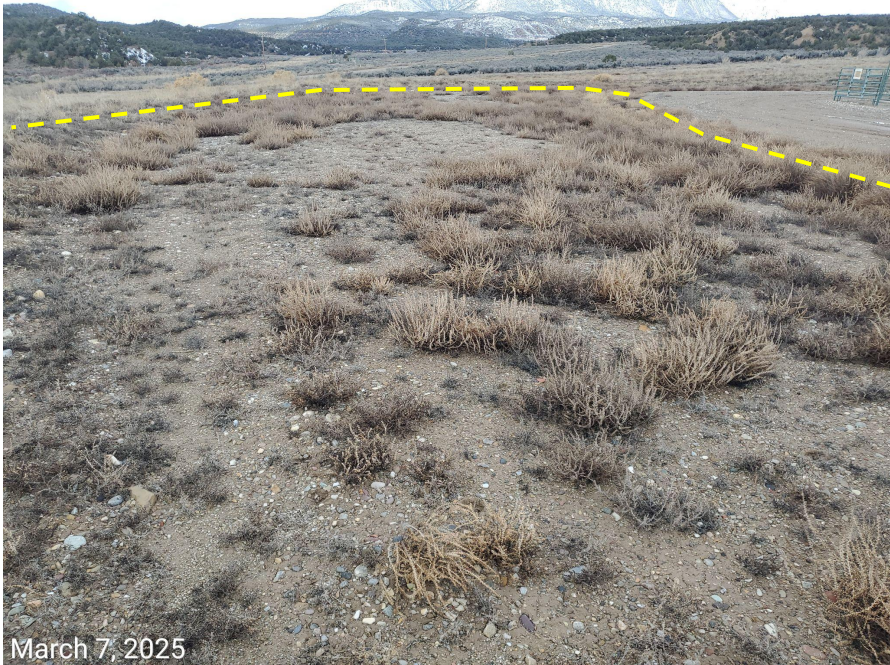
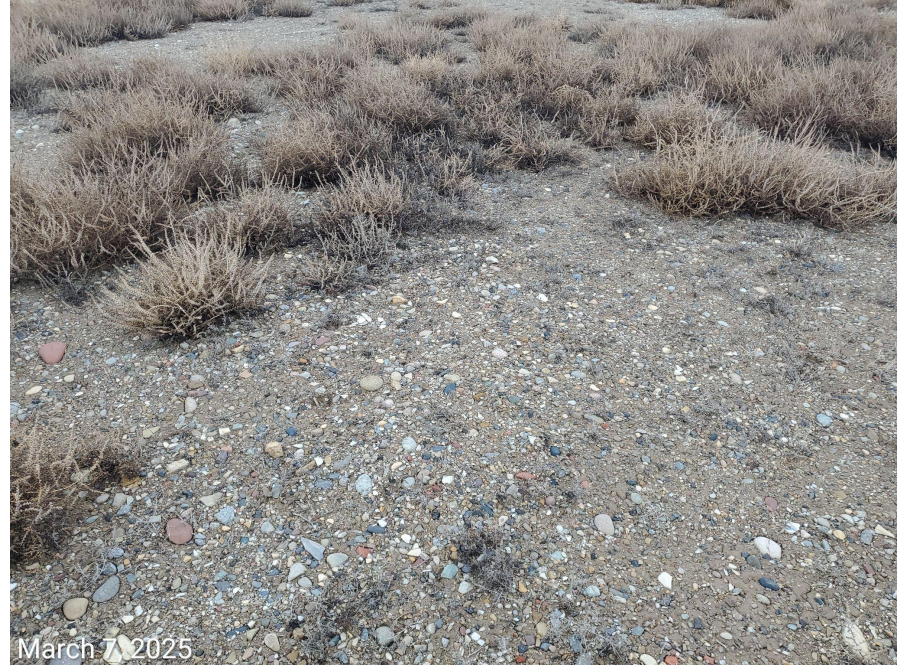
Photo 4: Photos taken from the southern areas of the Location. Photos examples of interim areas of the Location that are bare and unvegetated, or dominated by Undesirable Plant Species (*Salsola* sp., Russian Thistle), and are not progressing towards ECMC 1003 uniform perennial vegetative requirements.

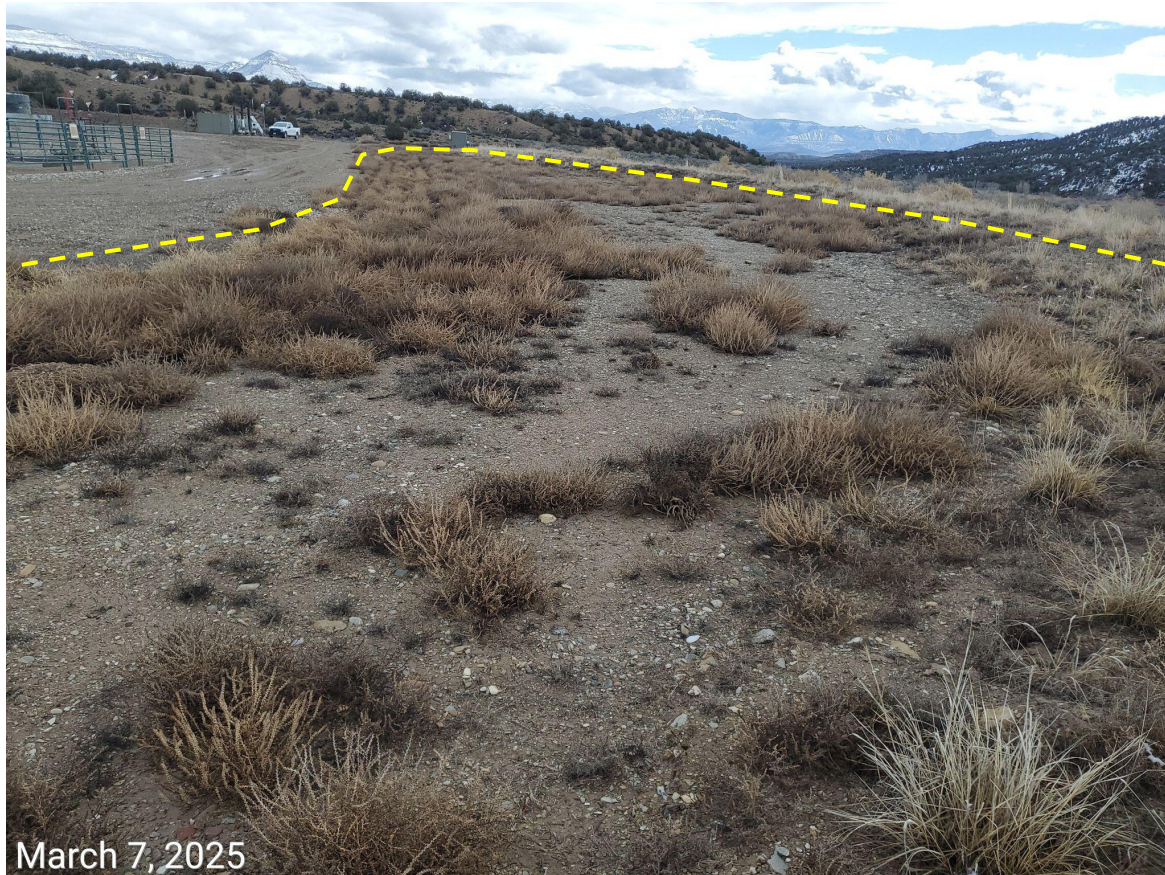
Photo 5: Photo taken from the southwest end of the Location, facing east. See comments under photo 4.

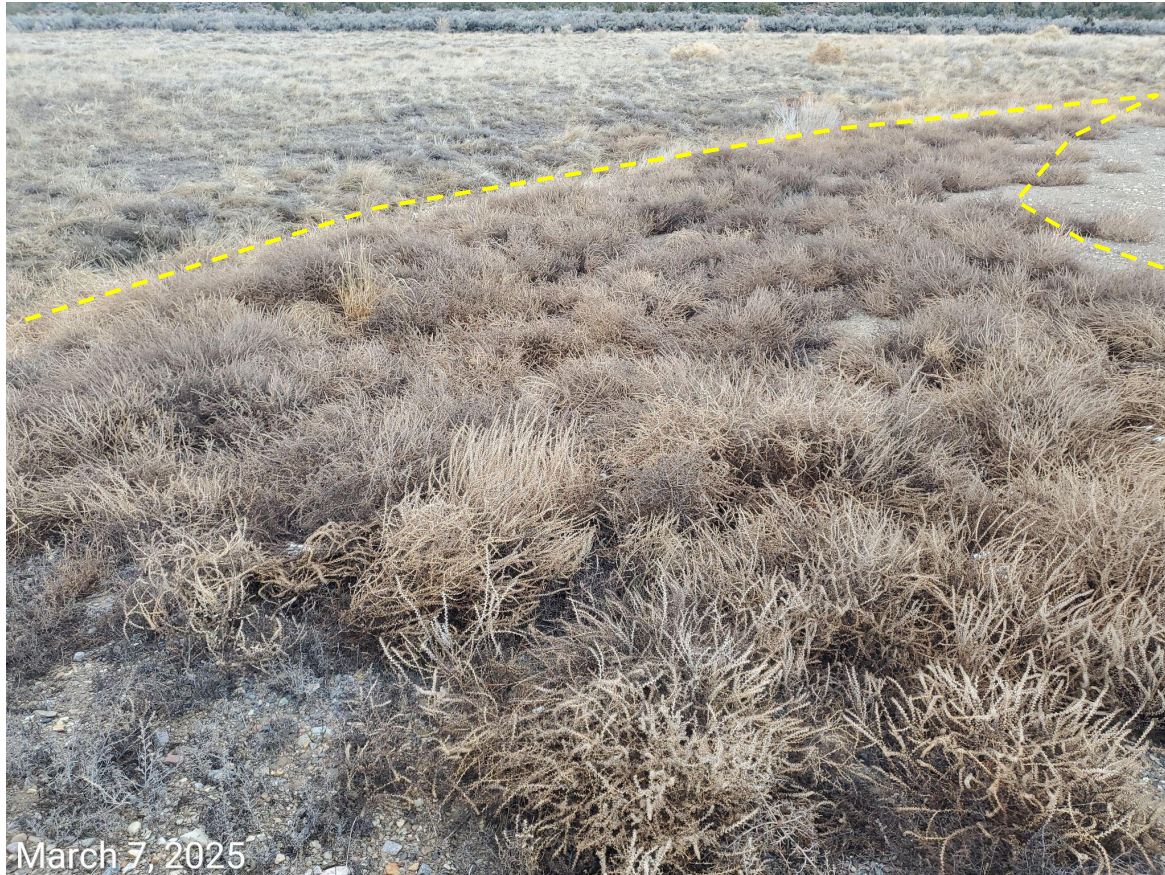
Photo 6: Photo taken from the west end of the Location, facing north. See comments under photo 4

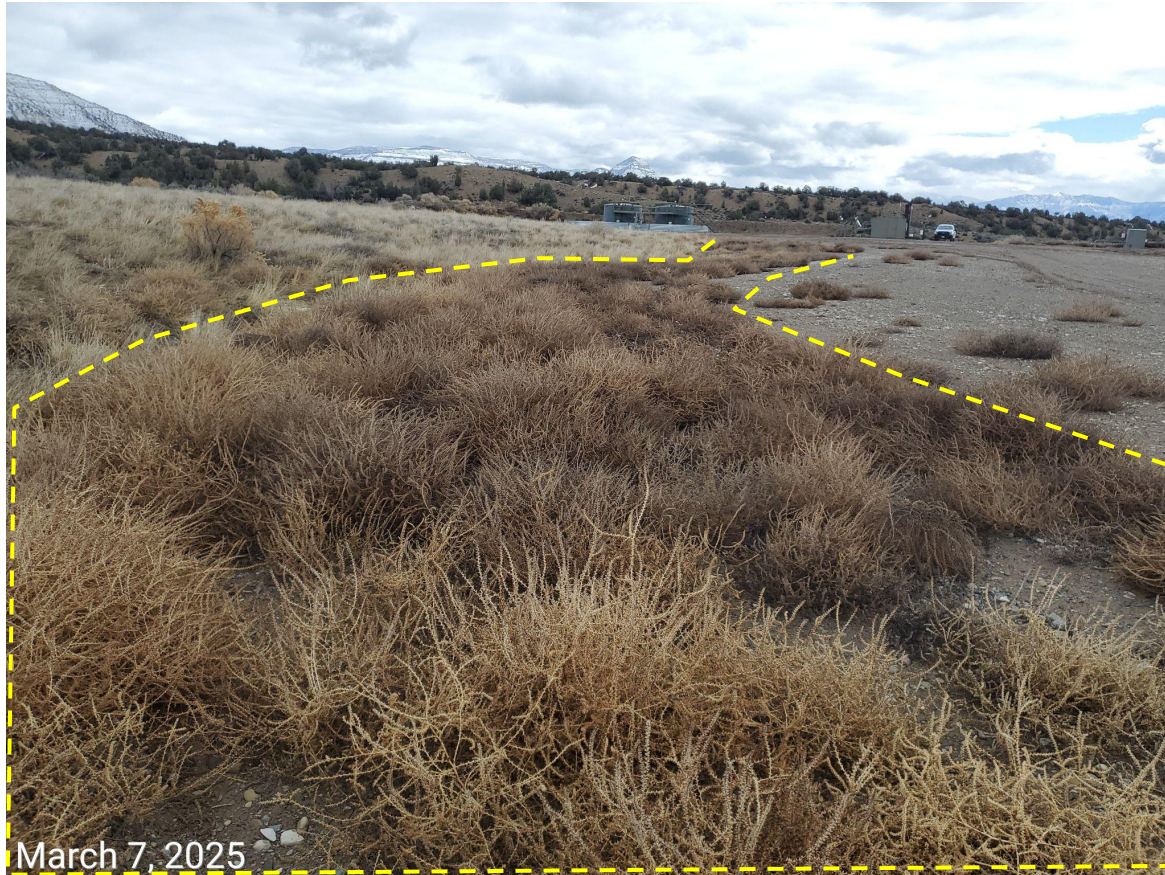
Photo 7: Photo taken from the northwest end of the Location, facing east. See comments under photo 4.

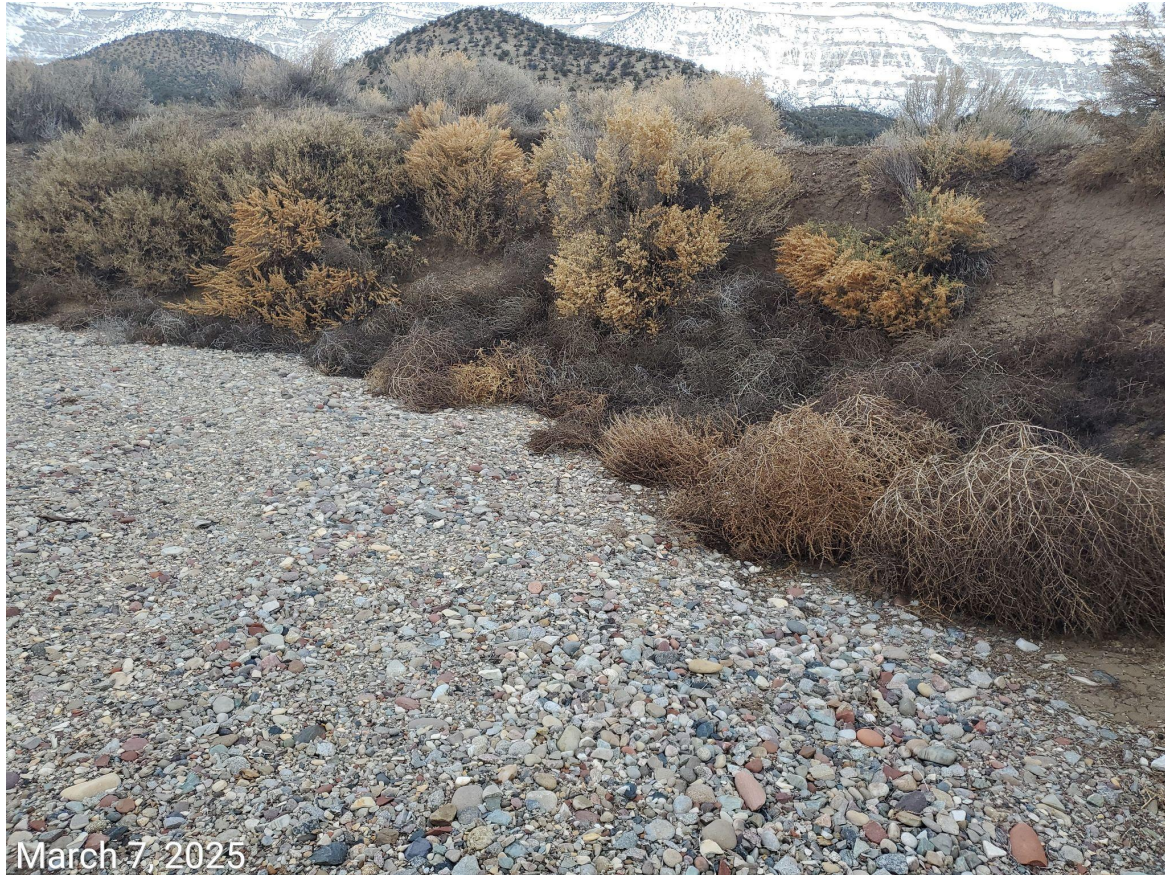
Photo 8: Photos taken from the northeast end of the Location. Photo shows weed debris accumulation.

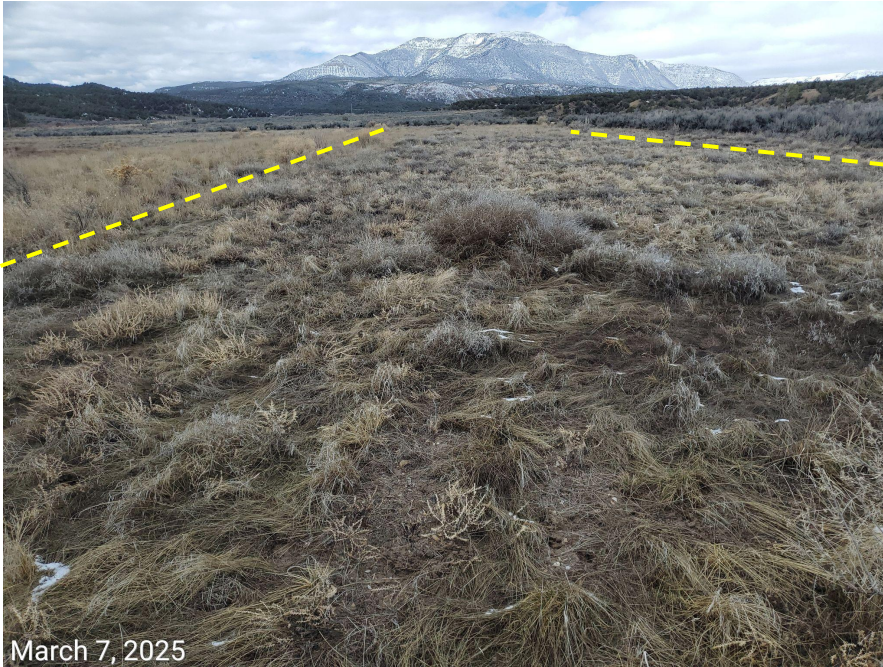
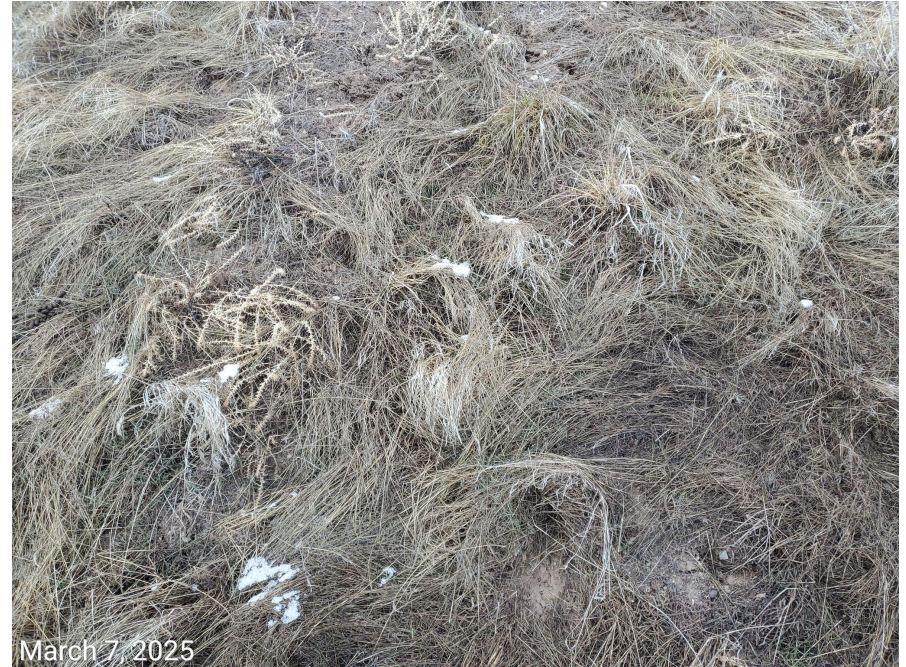
Photo 8: Photos taken from the interim areas on the north end of the Location, facing west. Photo example showing interim areas (between yellow lines) that are not progressing towards ECMC 1003 uniform perennial vegetative requirements. Vegetation within these areas are predominantly annual invasive weeds such as Cheatgrass and Russian thistle. Very little perennial vegetative establishment was observed within these areas.

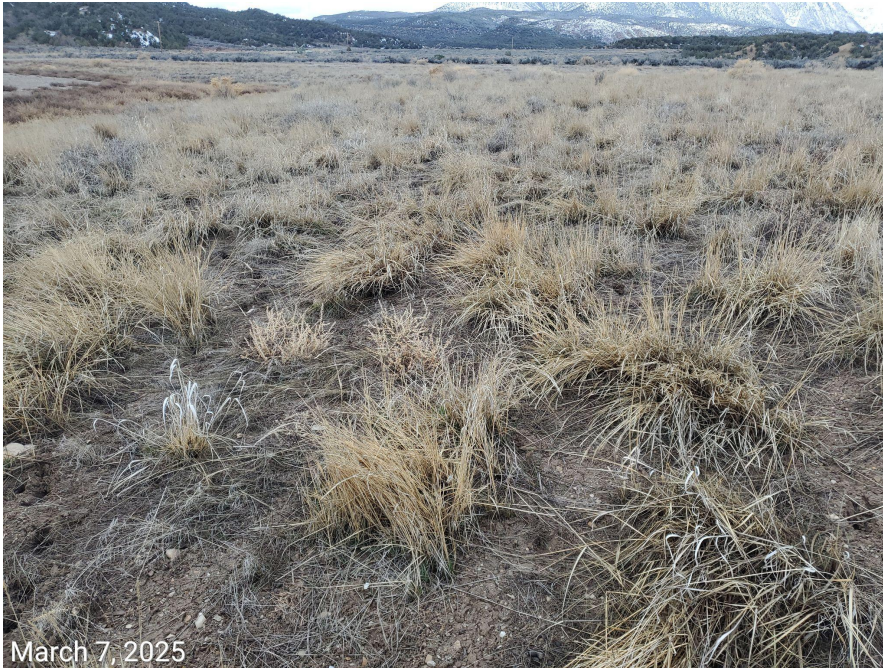
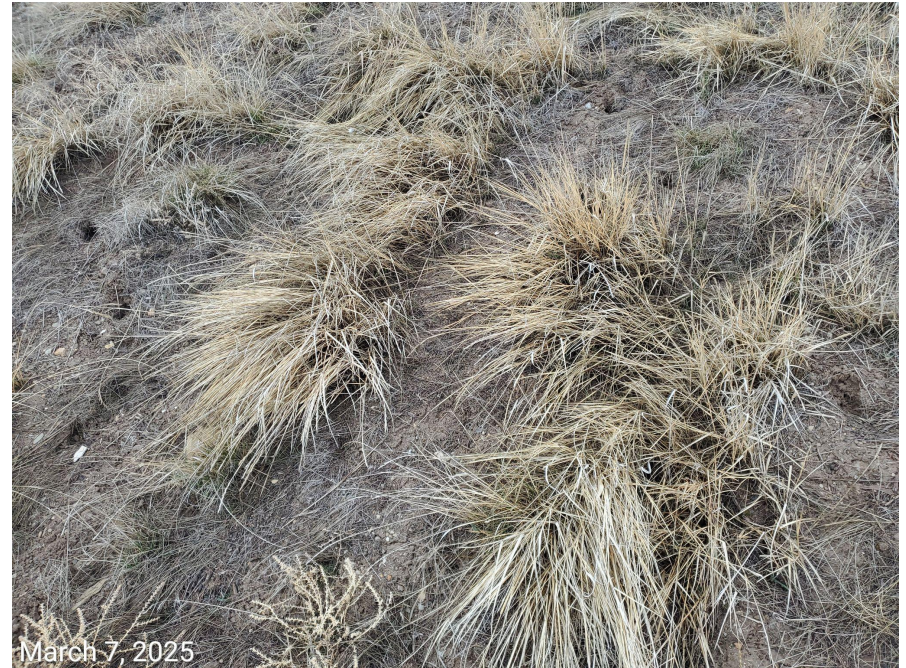
Photo 9: Photo taken from the interim areas on the north end of the Location, facing west. Photo example of areas where vegetation is progressing towards 1003 uniform perennial vegetative requirements. Though Undesirable species such as Russian thistle and cheatgrass were also evident within these areas, perennial wheatgrass species appear to be outcompeting the weeds.

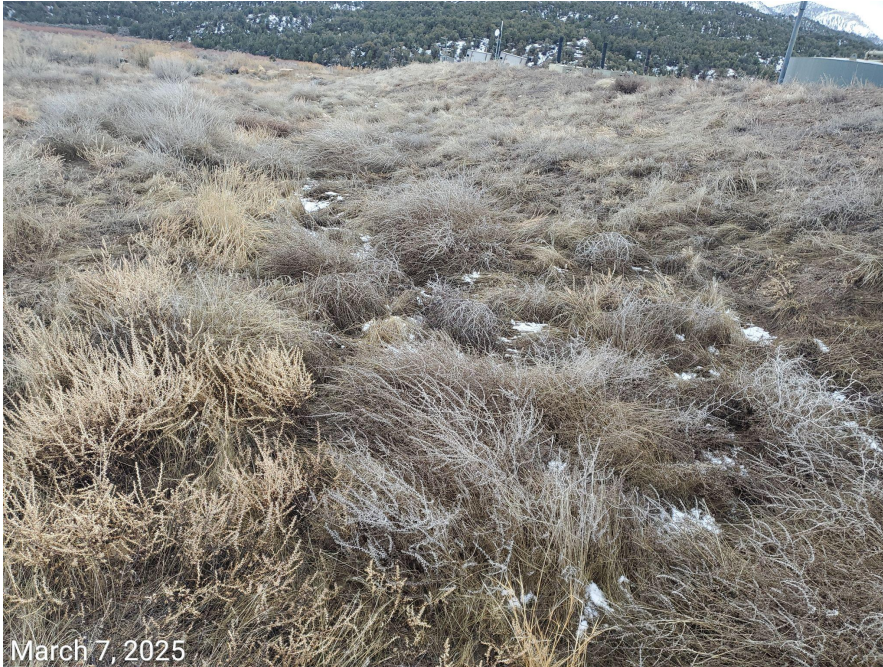
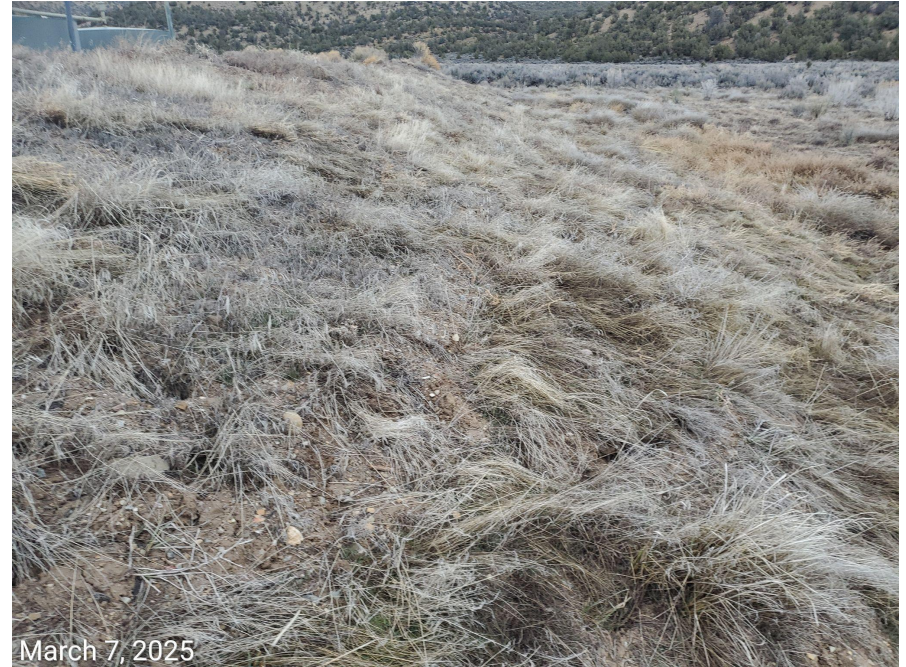
Photo 11: Photos taken from the interim areas/slopes on the north east end of the Location. Photo example showing interim areas that are not progressing towards ECMC 1003 uniform perennial vegetative requirements. Vegetation within these areas are predominantly annual invasive weeds such as Cheatgrass and Russian thistle. Very little perennial vegetative establishment was observed within these areas.

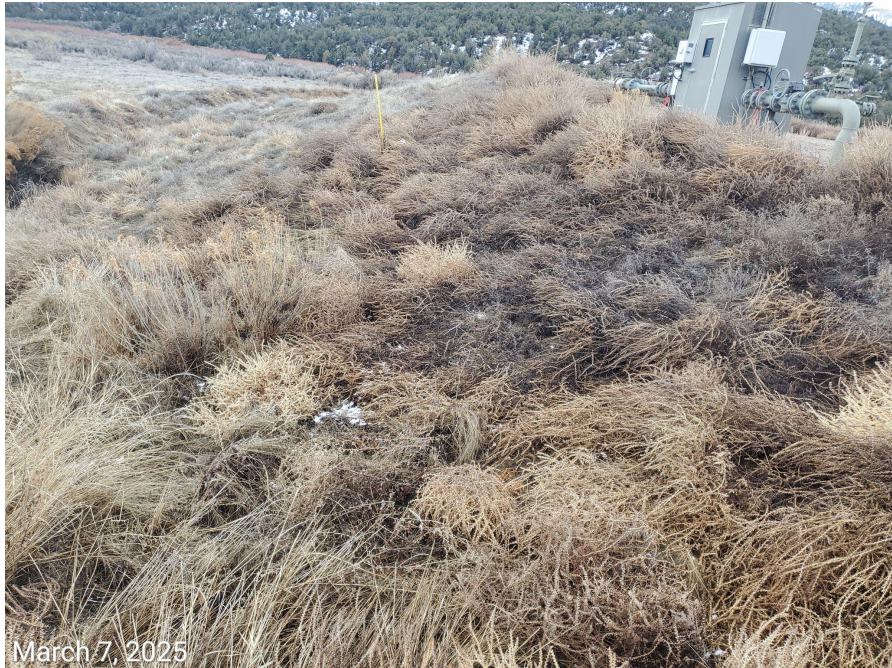
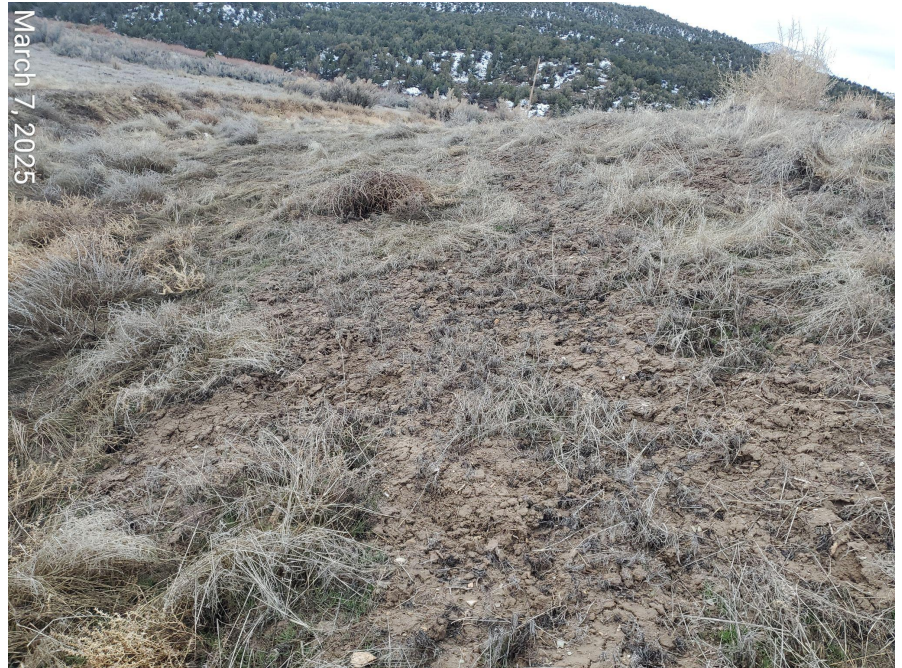
Photo 12: See comments under photo 11.

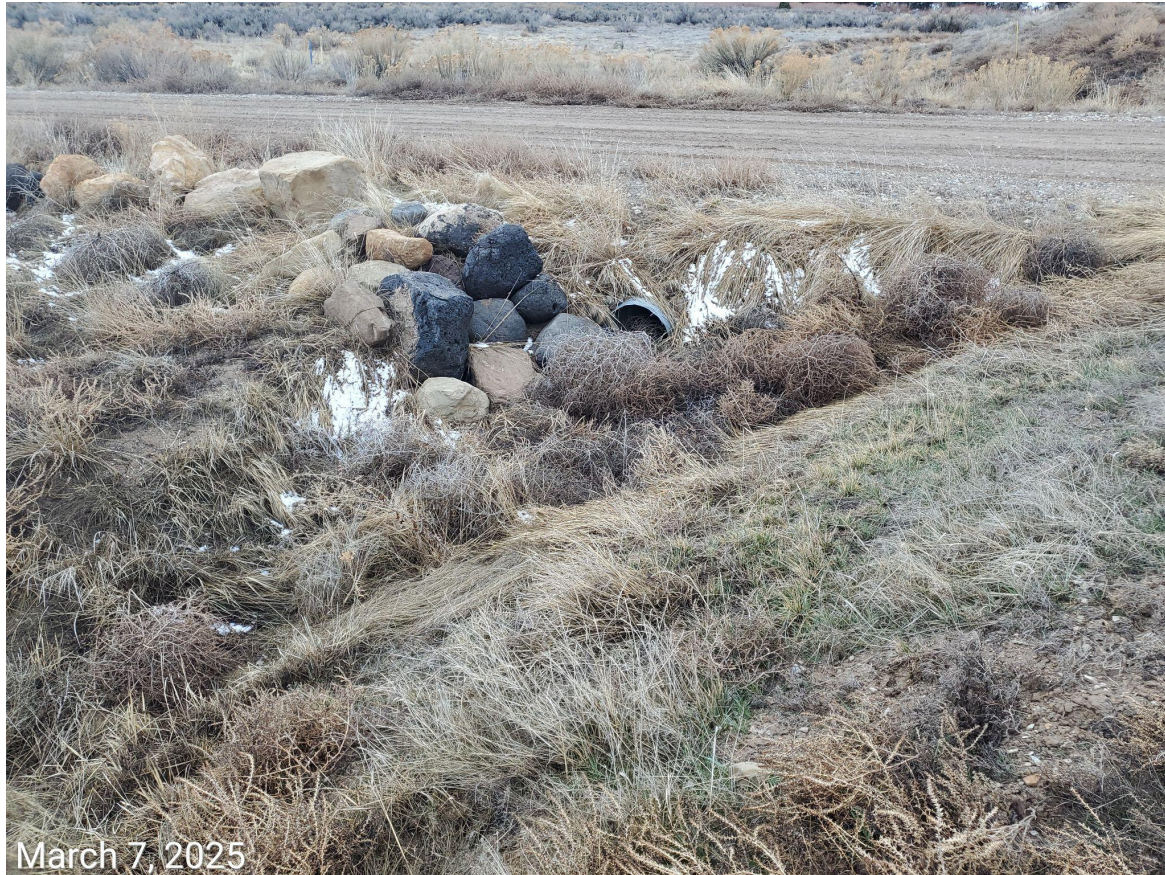
Photo 13: Photo taken from the east end of the Location, facing south. Photo shows weed debris accumulation within the ditch and culvert.

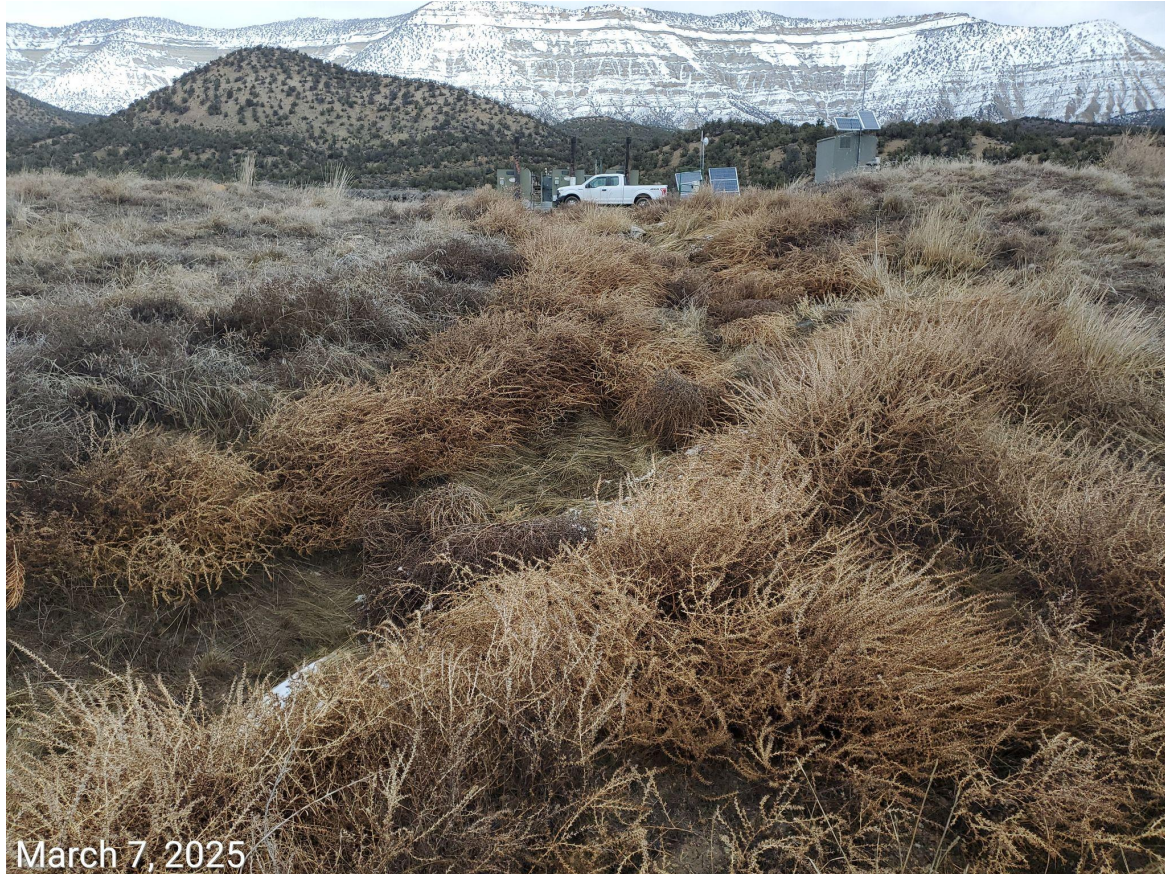
Photo 14: Photo taken from the south end of the Location, facing north. Photo shows dense weed debris accumulation and establishment within the ditch and interim areas of the Location.

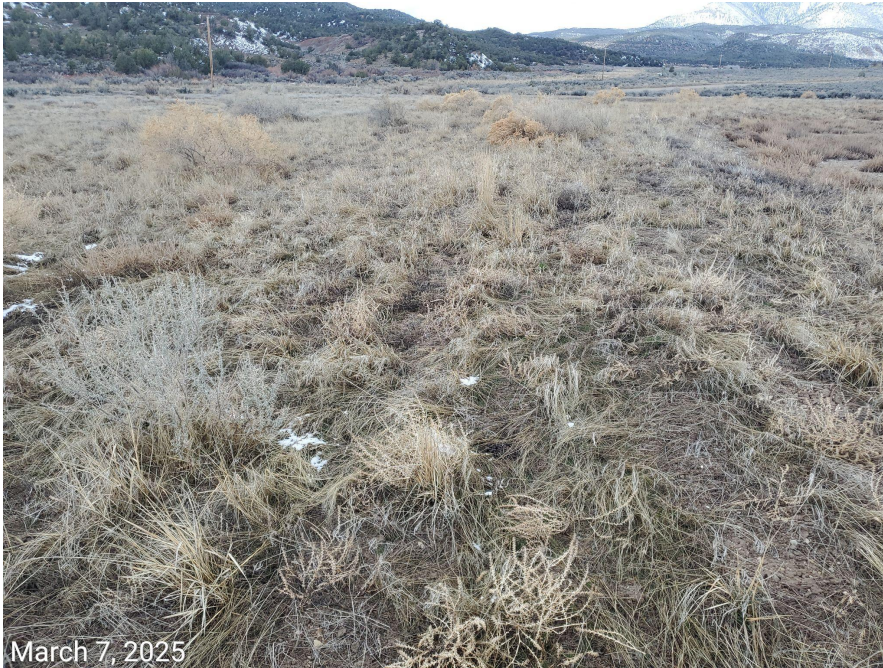
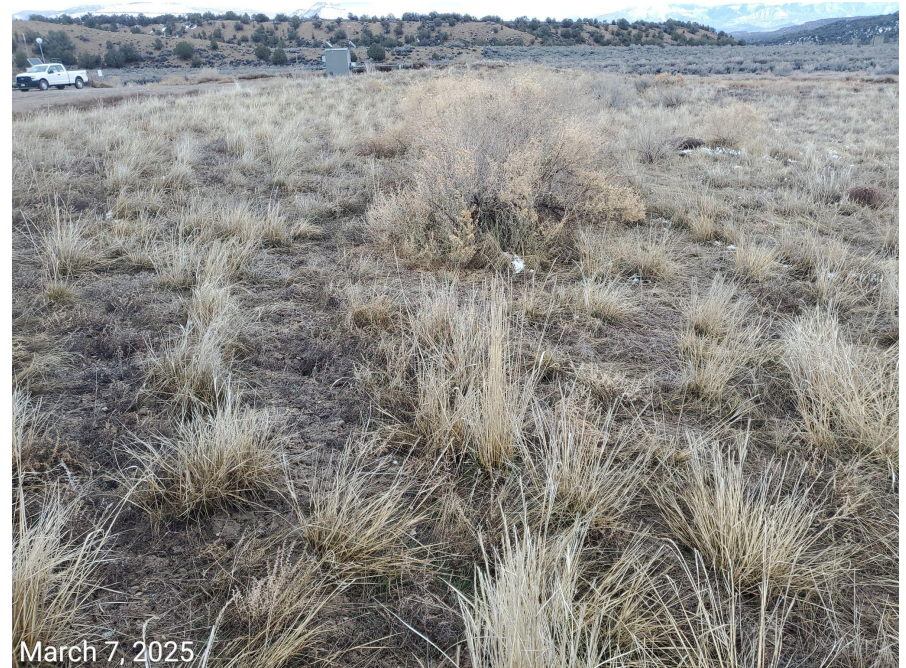
Photo 9: Photo taken from the interim areas on the south end of the Location. Photo example of areas where vegetation is progressing towards 1003 uniform perennial vegetative requirements. Though Undesirable species such as Russian thistle and cheatgrass were also evident within these areas, perennial wheatgrass species appear to be outcompeting the weeds.

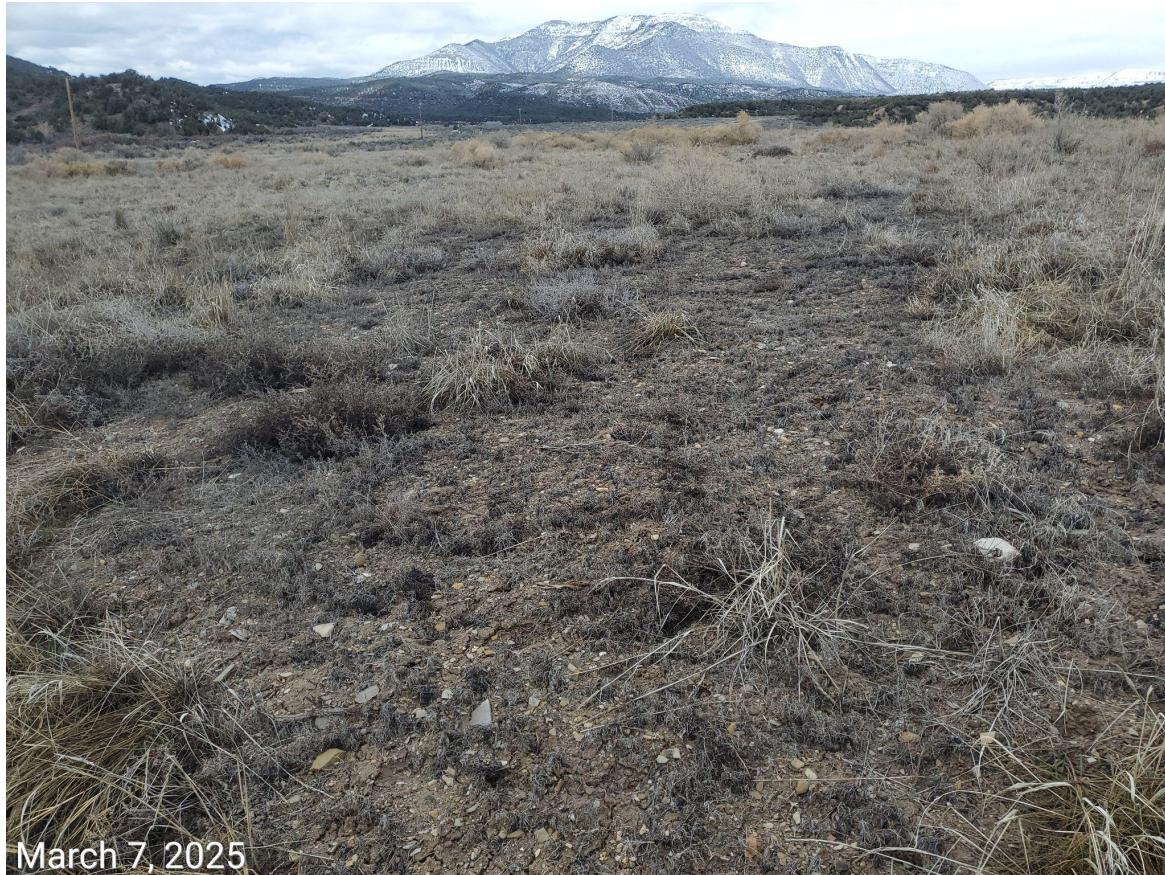
Photo 16: Photo taken from the interim areas on the south end of the Location, facing west. Photo example showing interim areas that are not progressing towards ECMC 1003 uniform perennial vegetative requirements.

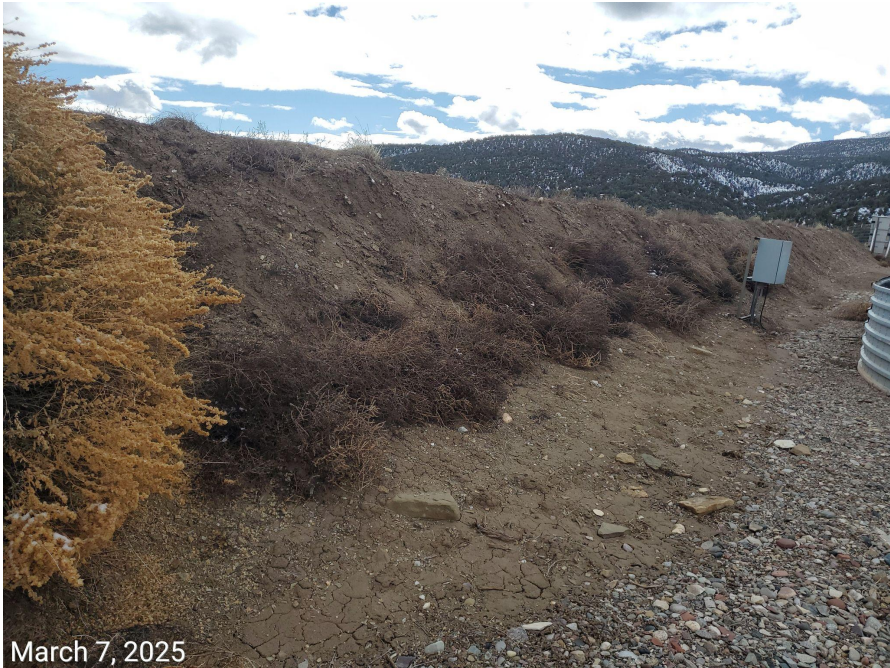
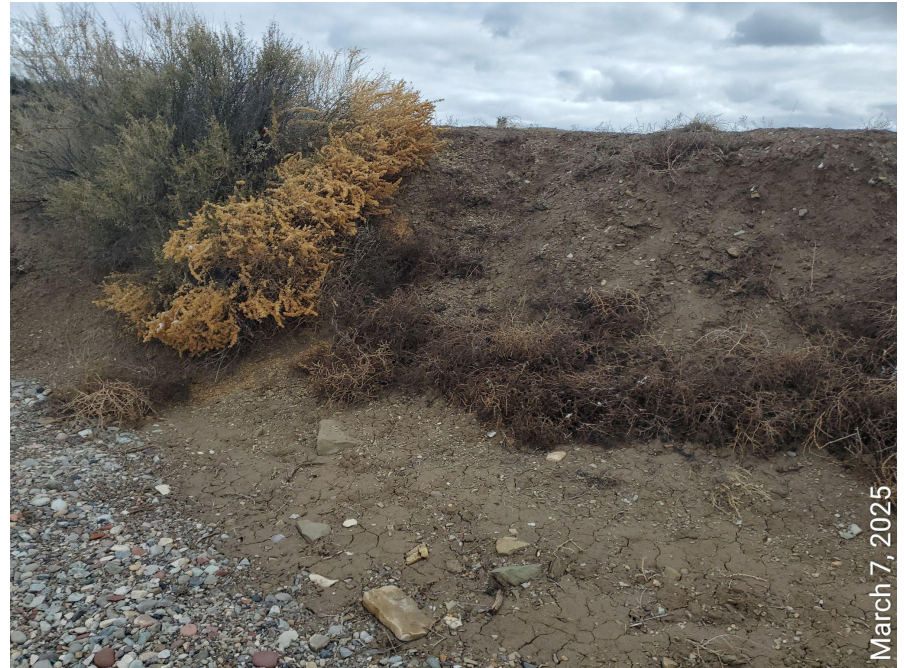
Photo 17: Photos taken from the northeast end of the Location. Photo shows slopes/stockpiled soils are bare and exposed soils; BMPs to minimize erosion and degradation are missing or insufficient. Soils are at risk to wind and water erosion, and sediment migration onto the pad surface is evident.

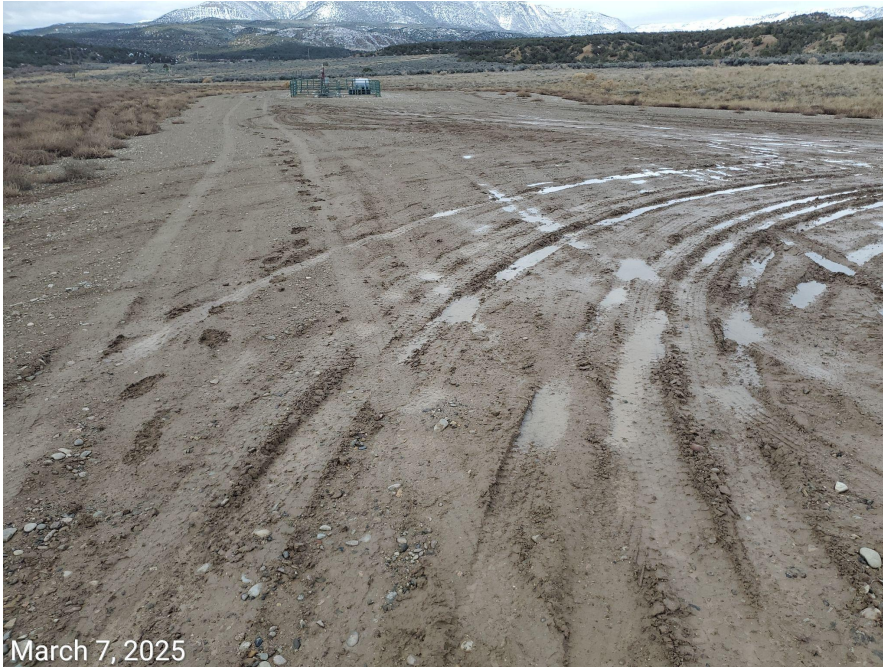
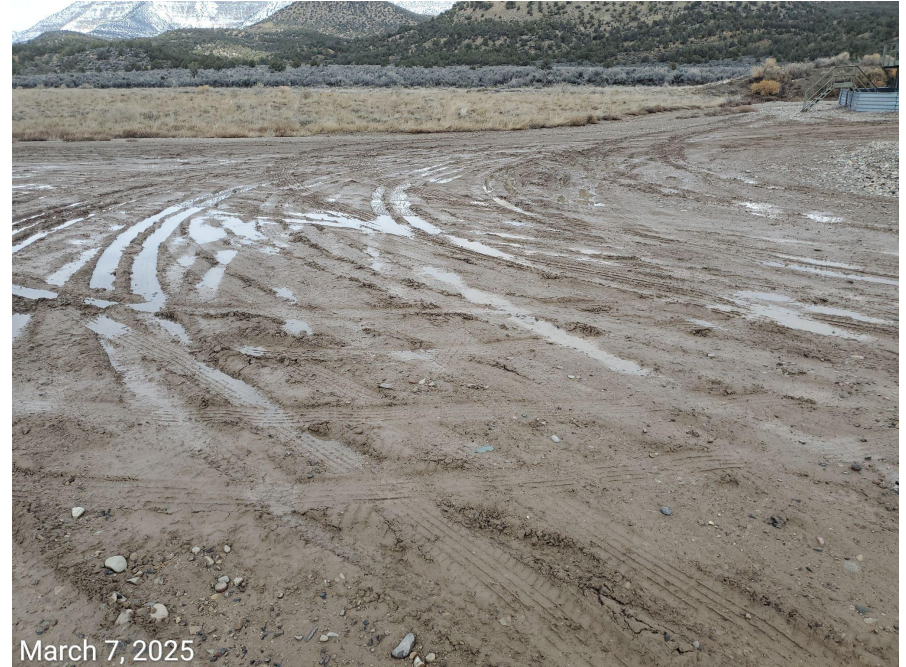
Photo 9: Photos examples showing the working pad surface. Tracking and stabilization control measures are showing signs of disrepair at the working pad surface and access road; tracking and rutting are becoming evident. Maintenance advised to ensure BMPs remain in proper functioning condition.

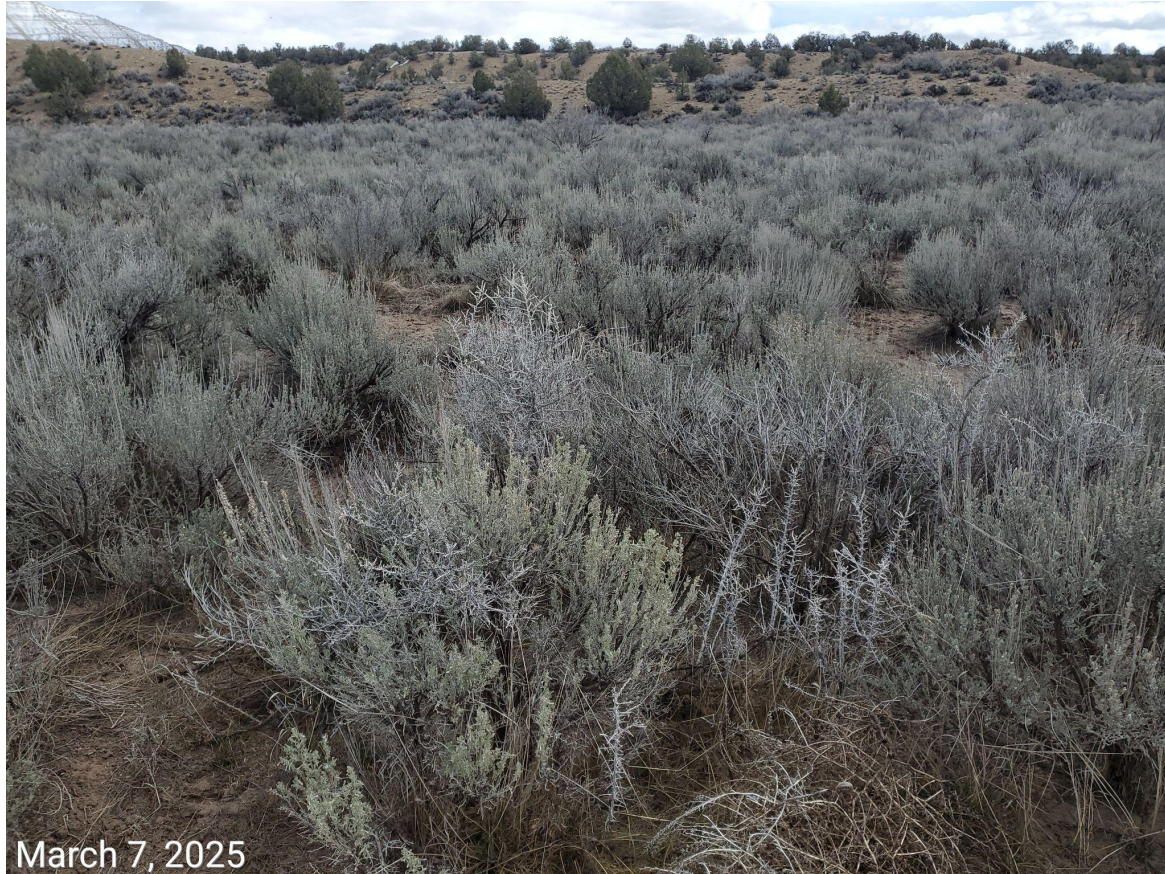
Photo 10: Photo example of the adjacent reference areas for comparison.
