# Inspection Photos

**Operator:** LARAMIE ENERGY LLC #10433

**Location ID:** 436835

**Inspection Doc:** 718100295

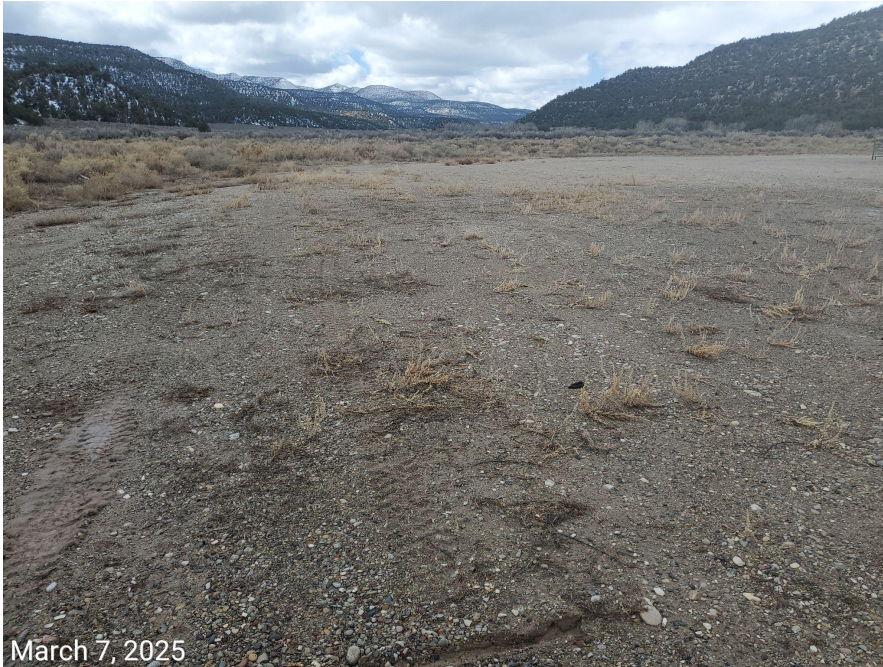
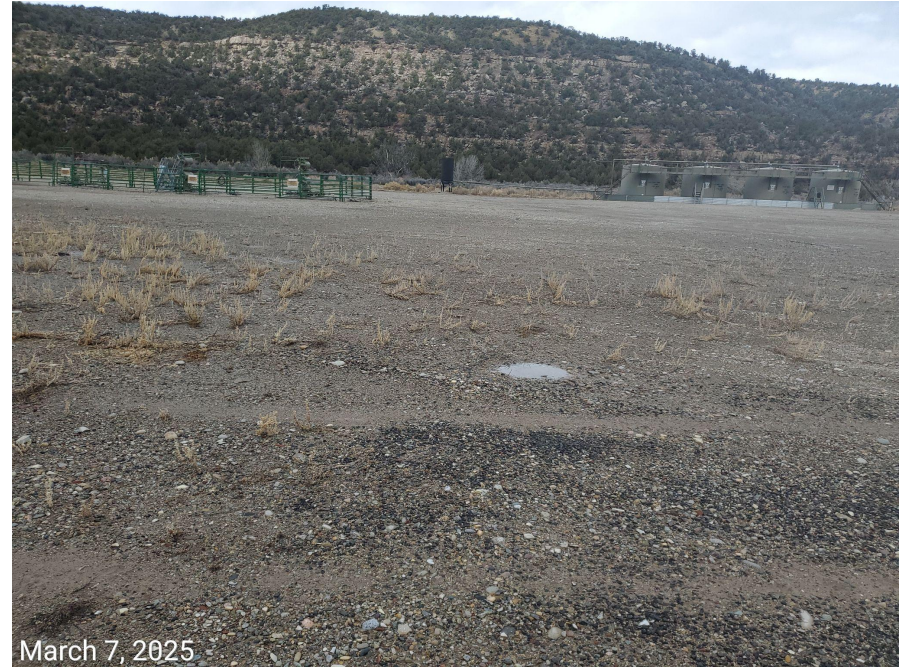
**Photo 1:** Photos 1-2 taken from the south end of the Location. Photos provide an overview of the Location from west, northwest, northeast to east.

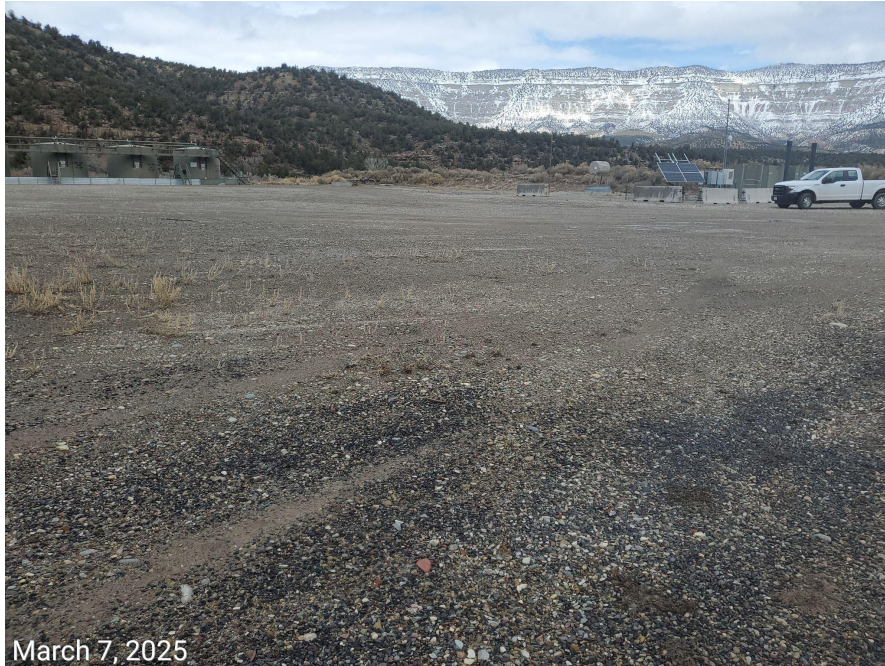
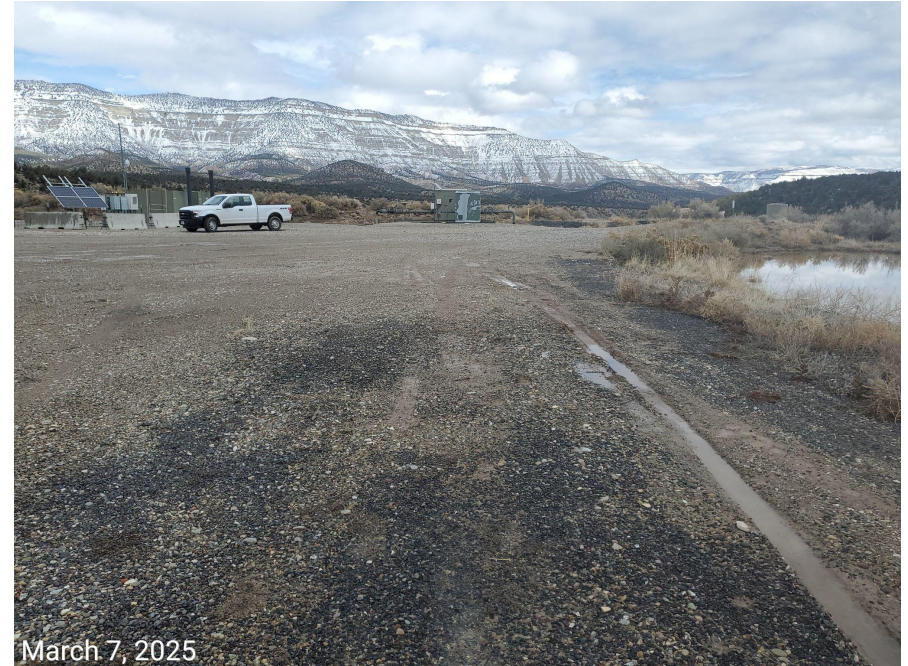
**Photo 2:** See comments under photo 1.

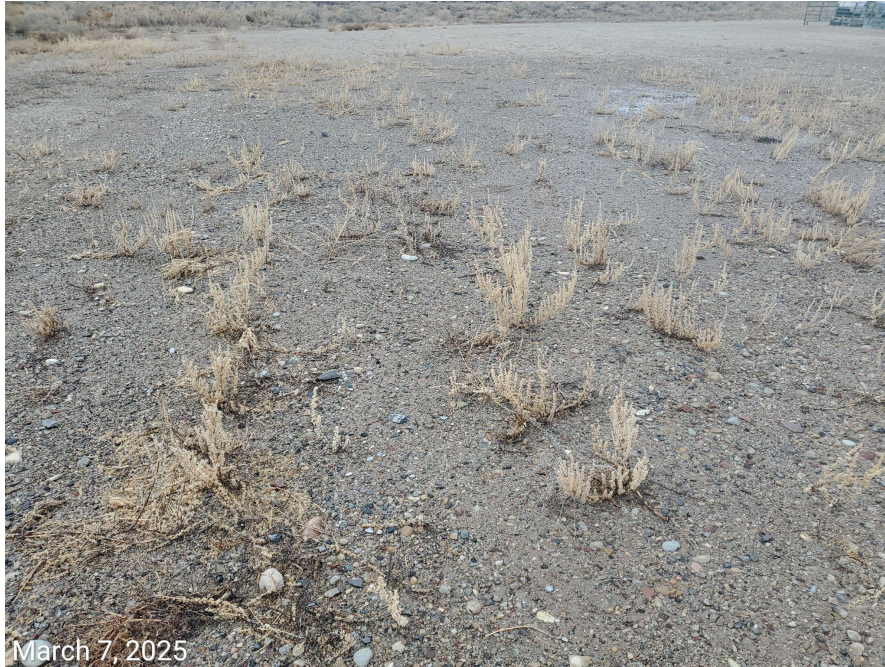
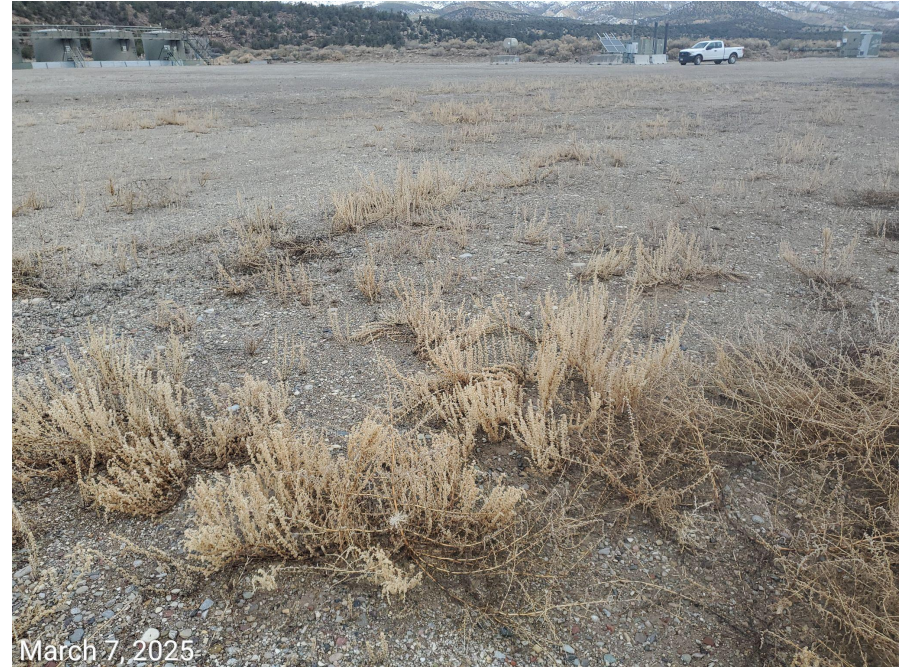
**Photo 3:** Photos taken from the southern end of the Location. Photos examples showing Undesirable Plant Species (Halogeton) established on the working pad surface. Weed management efforts required to comply with Rule 606.c

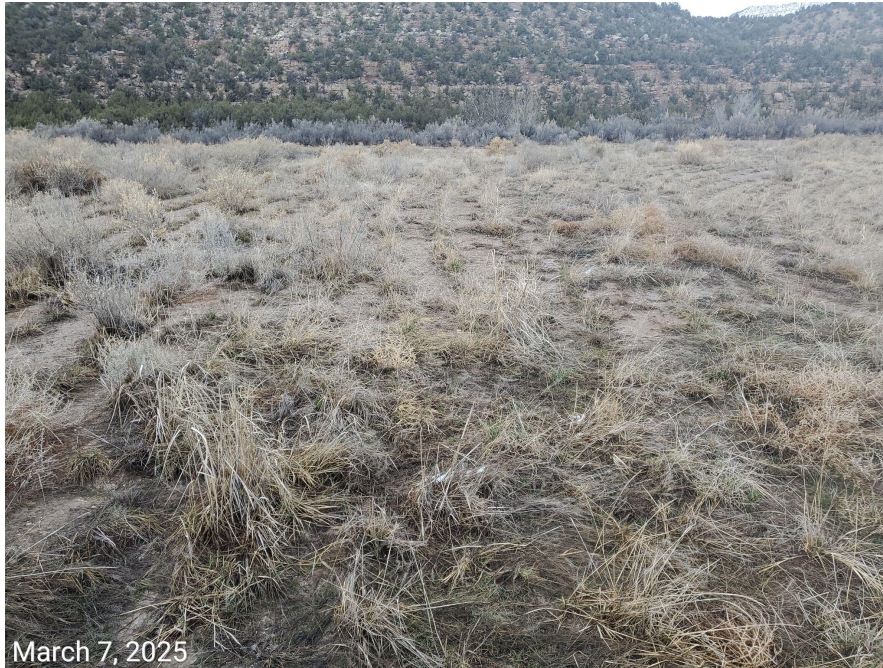
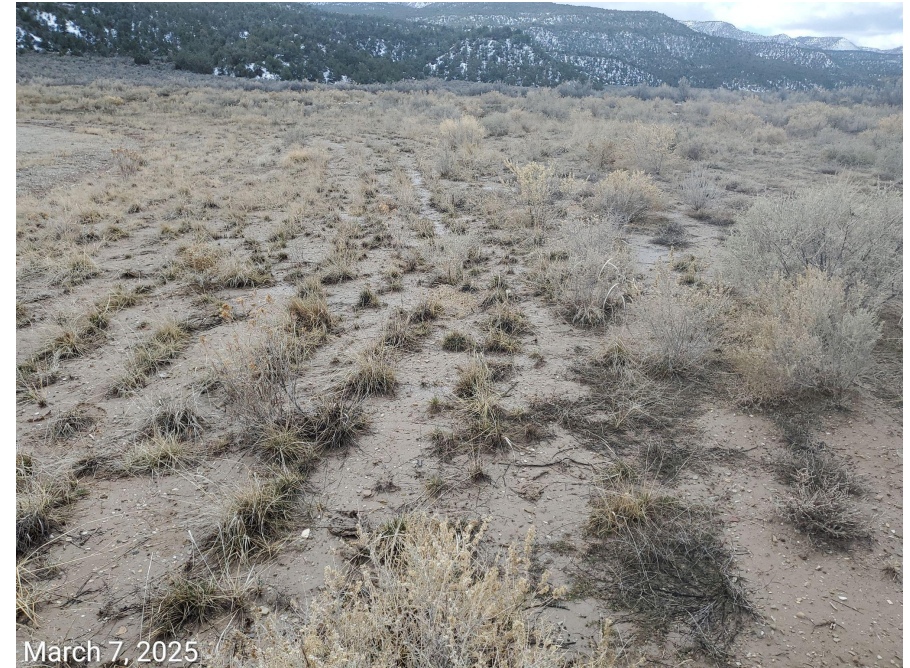
**Photo 4:** Photos taken from the interim areas on the west end of the Location. Photo example of areas throughout most if the interim that are progressing towards ECMC 1003 uniform standards.

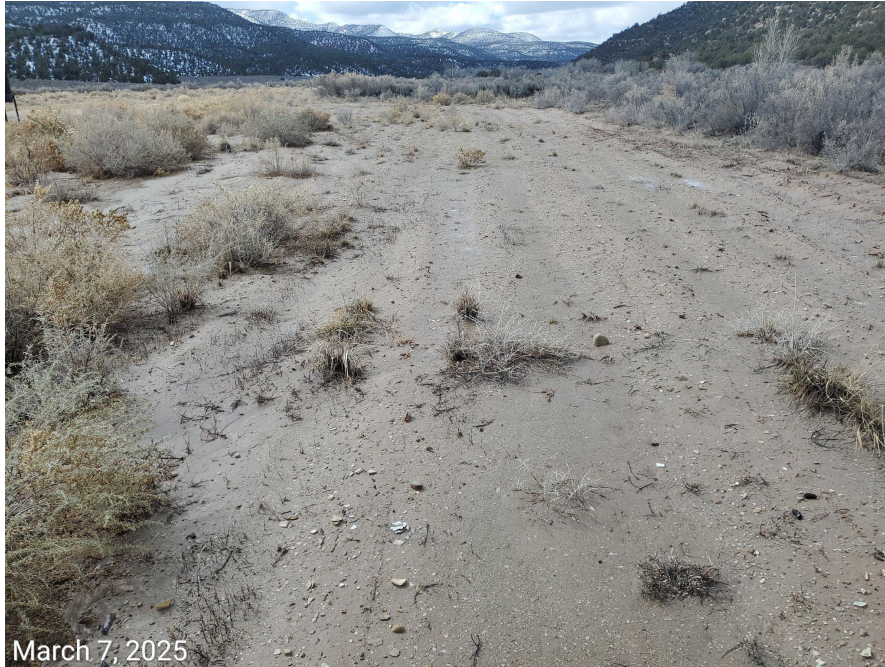
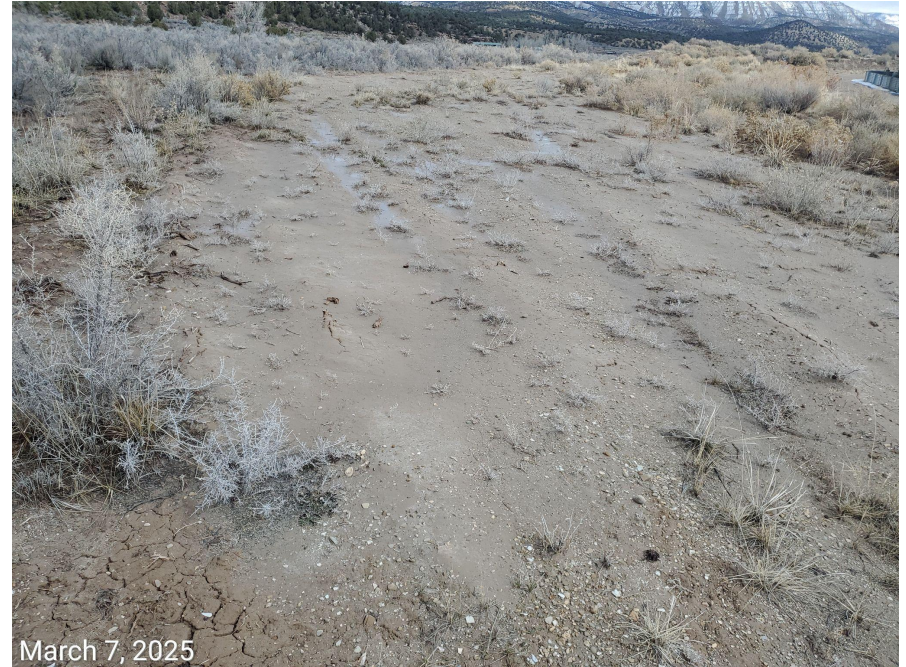
**Photo 5:** Photos 5-6 taken from the northern and southern interim areas of the Location. Photos examples of areas where desirable, perennial vegetative establishment is not occurring in a uniform manner. Additional reclamation efforts, such as interseeding, required within these areas.

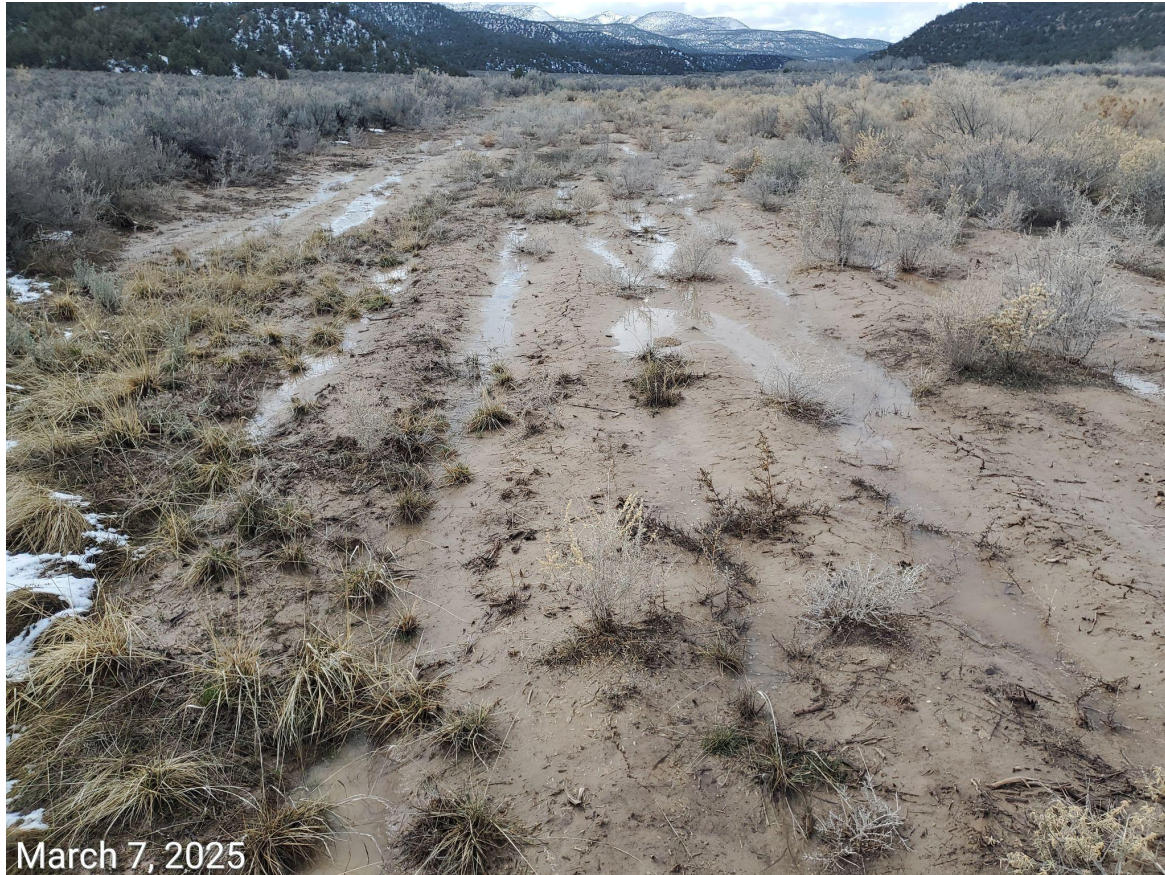
**Photo 6:** See comments under photo 5.

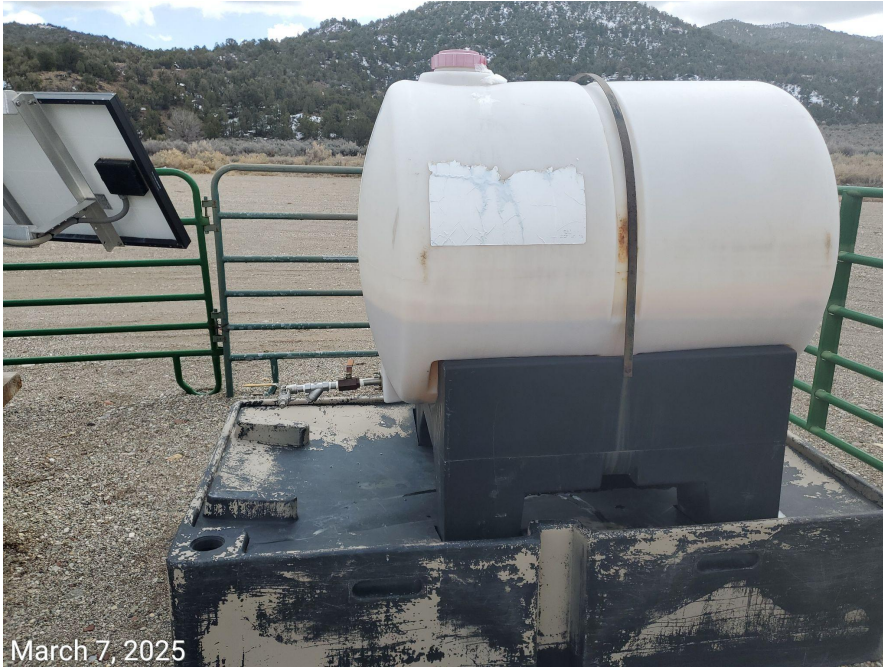
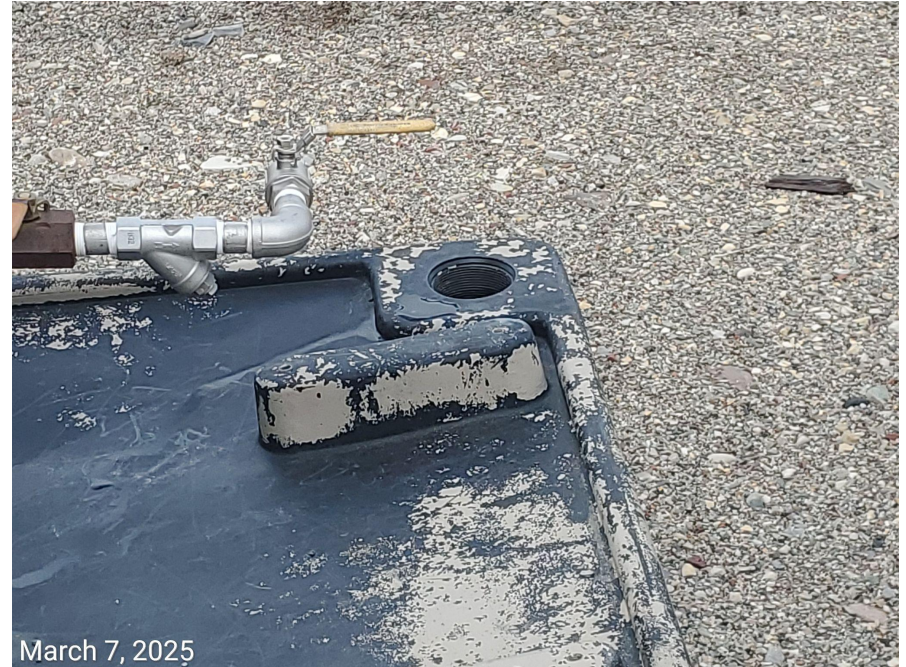
**Photo 7:** Photos taken from the methanol tank on the west end of the well string. Photo shows that a cap missing from containment BMP; Cap requires replacement to prevent wildlife access, such as birds, to the containment BMP

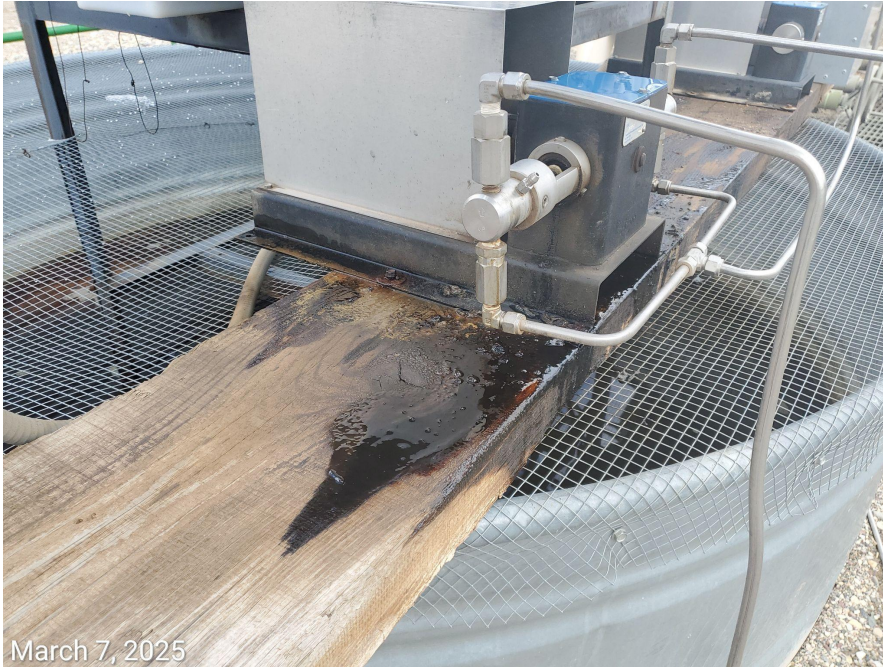
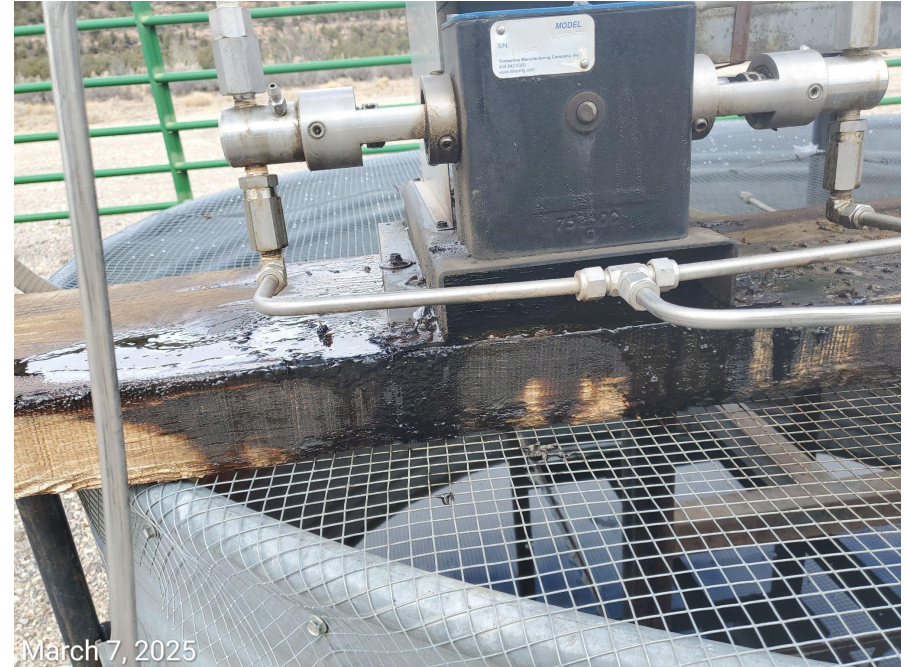
**Photo 8:** Photo taken from the second tank along the well string. Photo shows equipment appears to be leaking, as dark fluids beneath the equipment and on the wooden platform are evident.
