Final Reclamation and Stormwater Inspection

Location ID: 309874

Well Name: WARNER W #13-24

Inspection Document #: 718600373

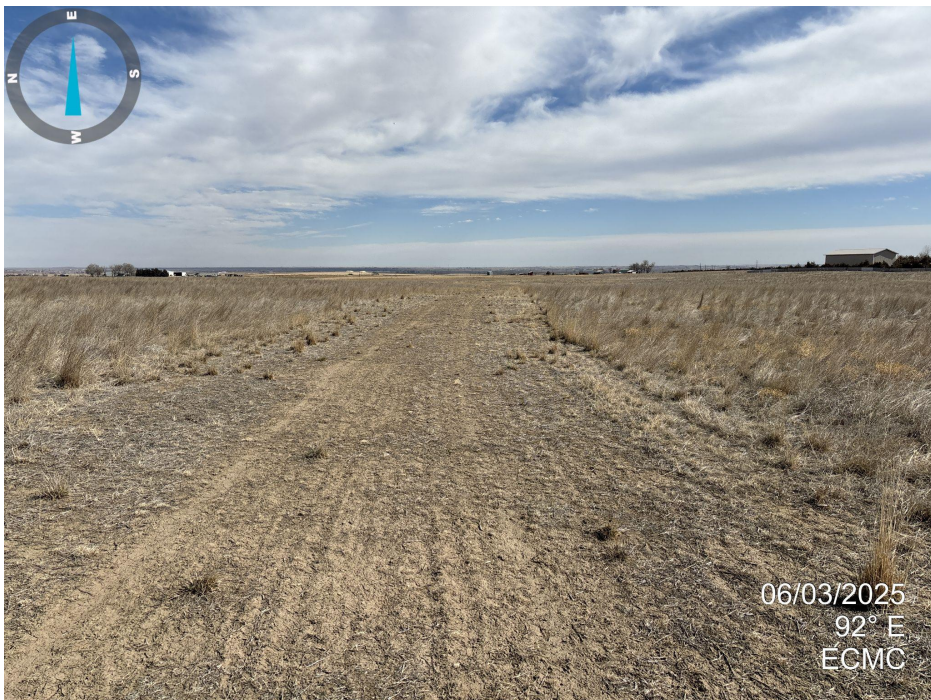
Photo 1. Looking east down the access road from well UPRC #13-110. Some vegetation has established but there appears to be less than 80% coverage with bare dirt patches.

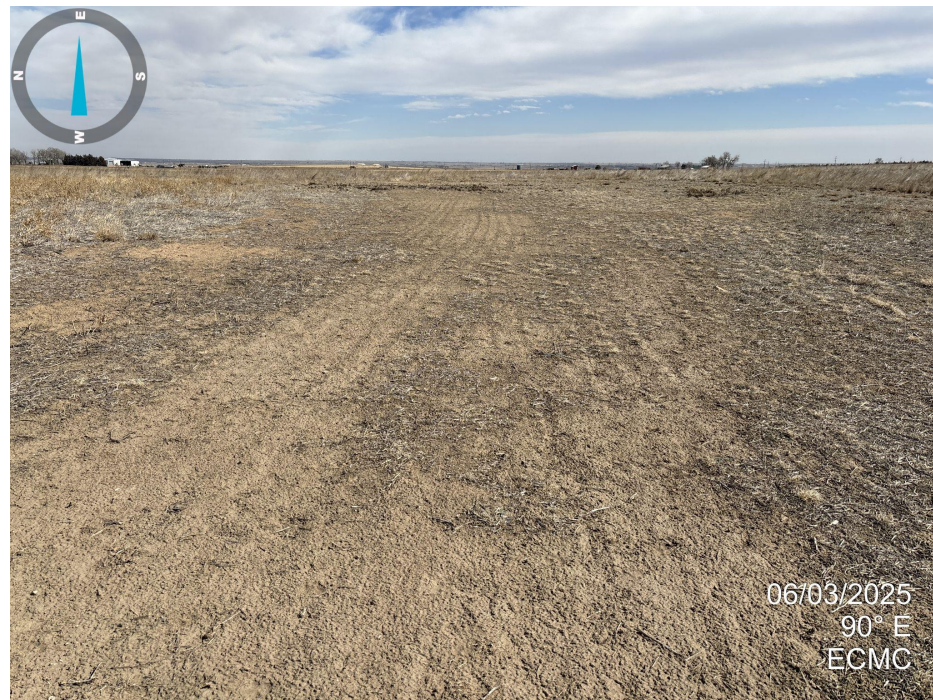
Photo 2. Looking east across location and access road. No oil and gas equipment remains. bare patches and lower vegetation coverage appear to be concentrated on the former access road and interim wellbore area.

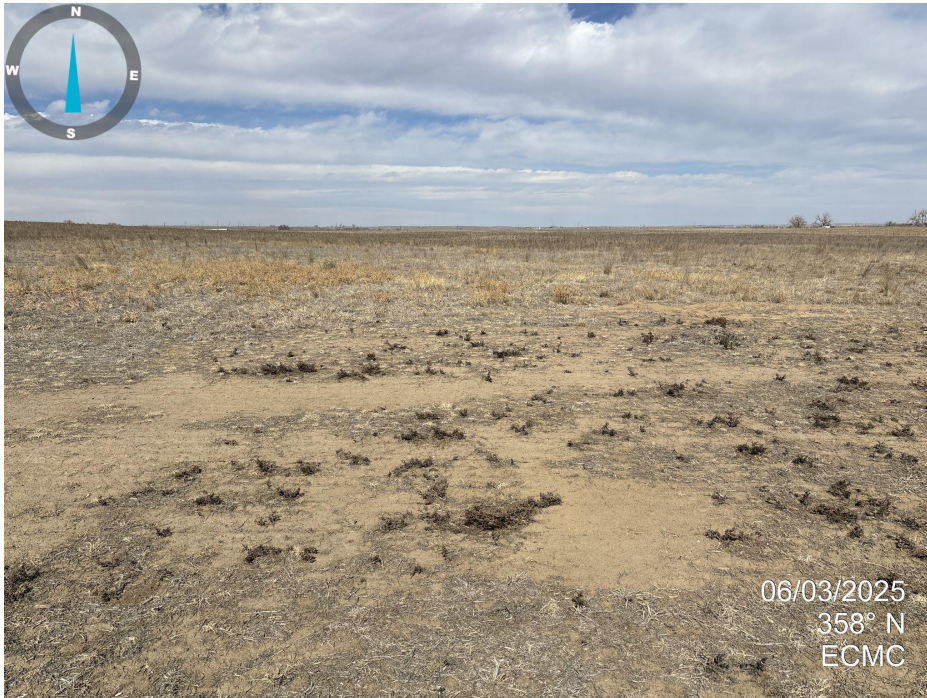
Photo 3. Looking north from wellbore from the wellbore. Some vegetation has established but there appears to be less than 80% coverage with bare dirt patches.

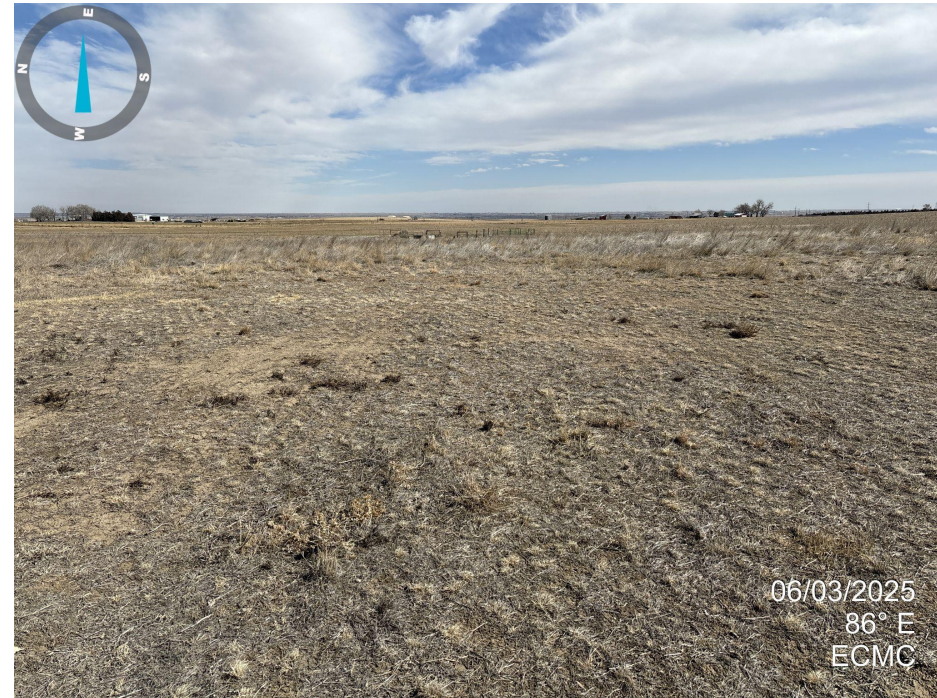
Photo 4. Looking east from the wellbore. See photo 3 comments.

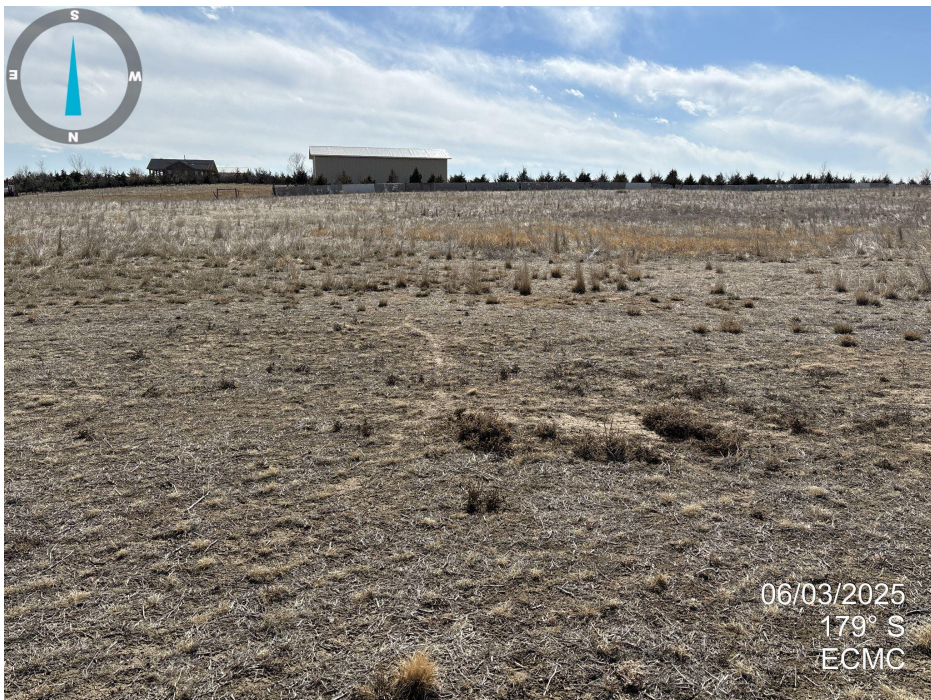
Photo 5. Looking south from wellbore. The southern side of the location appears to be progressing towards 80% of reference area.

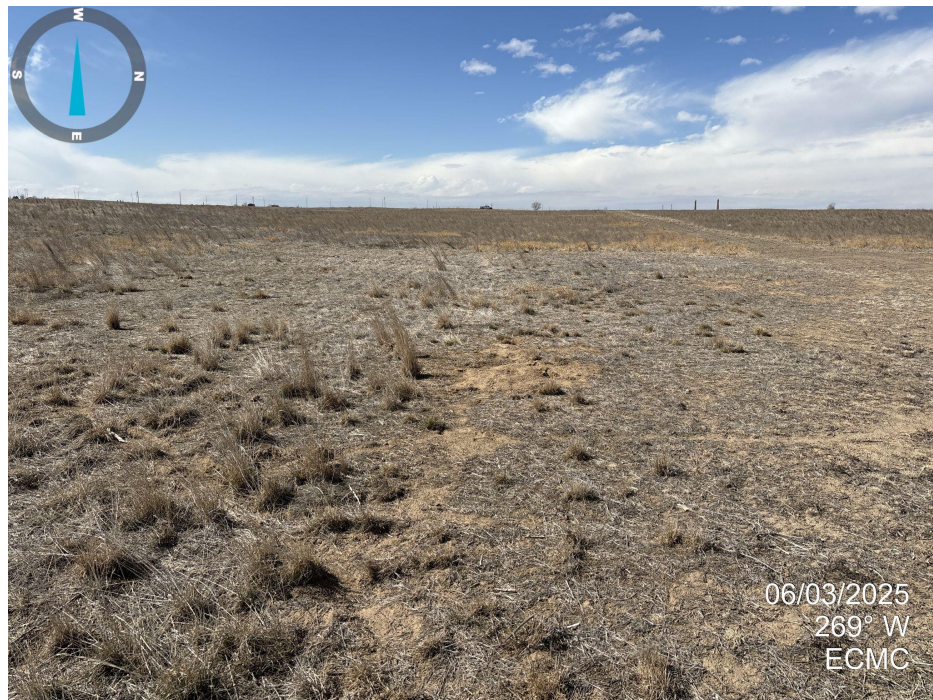
Photo 6. Looking west from wellbore. See photo 5 comments.

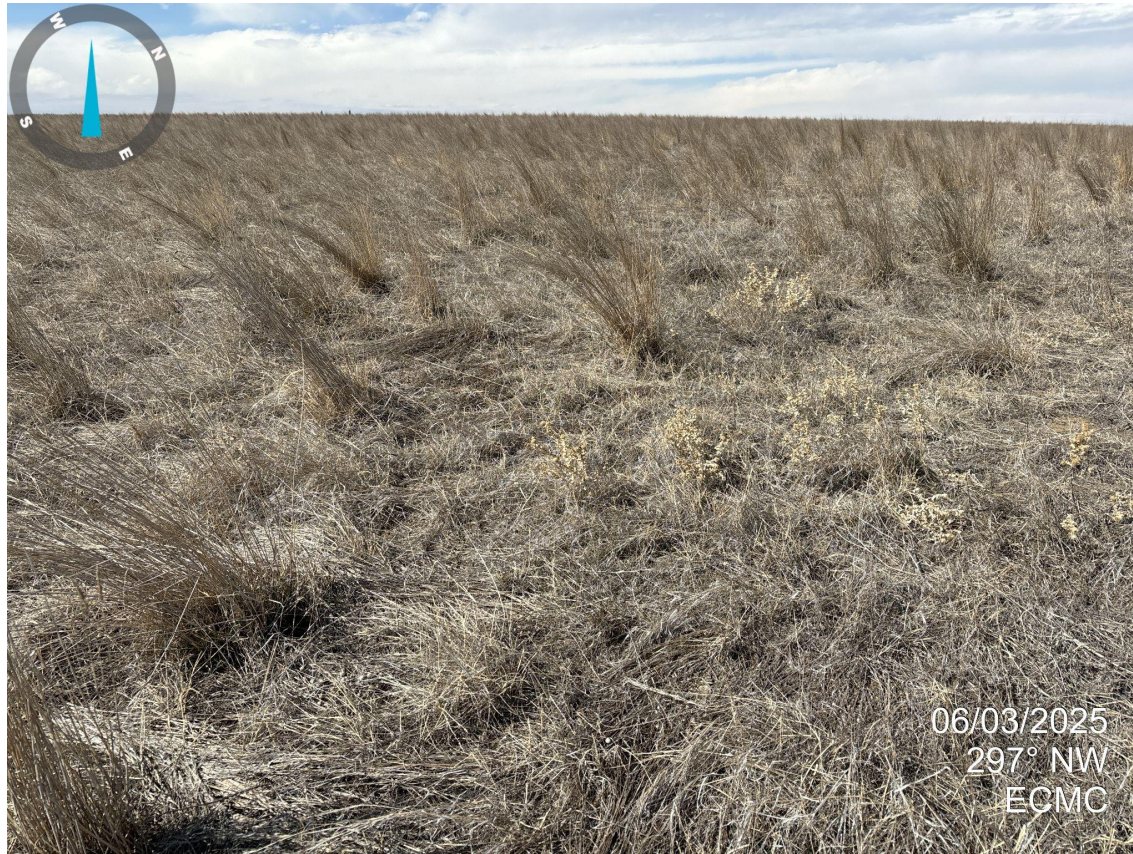
Photo 7. Reference vegetation to the northwest of the well location.
